## **ARCHAEOLOGICAL MONITORING REPORT**

SCCAS REPORT No. 2010/011

**61 Whiting Street, Bury St Edmunds  
BSE 342**

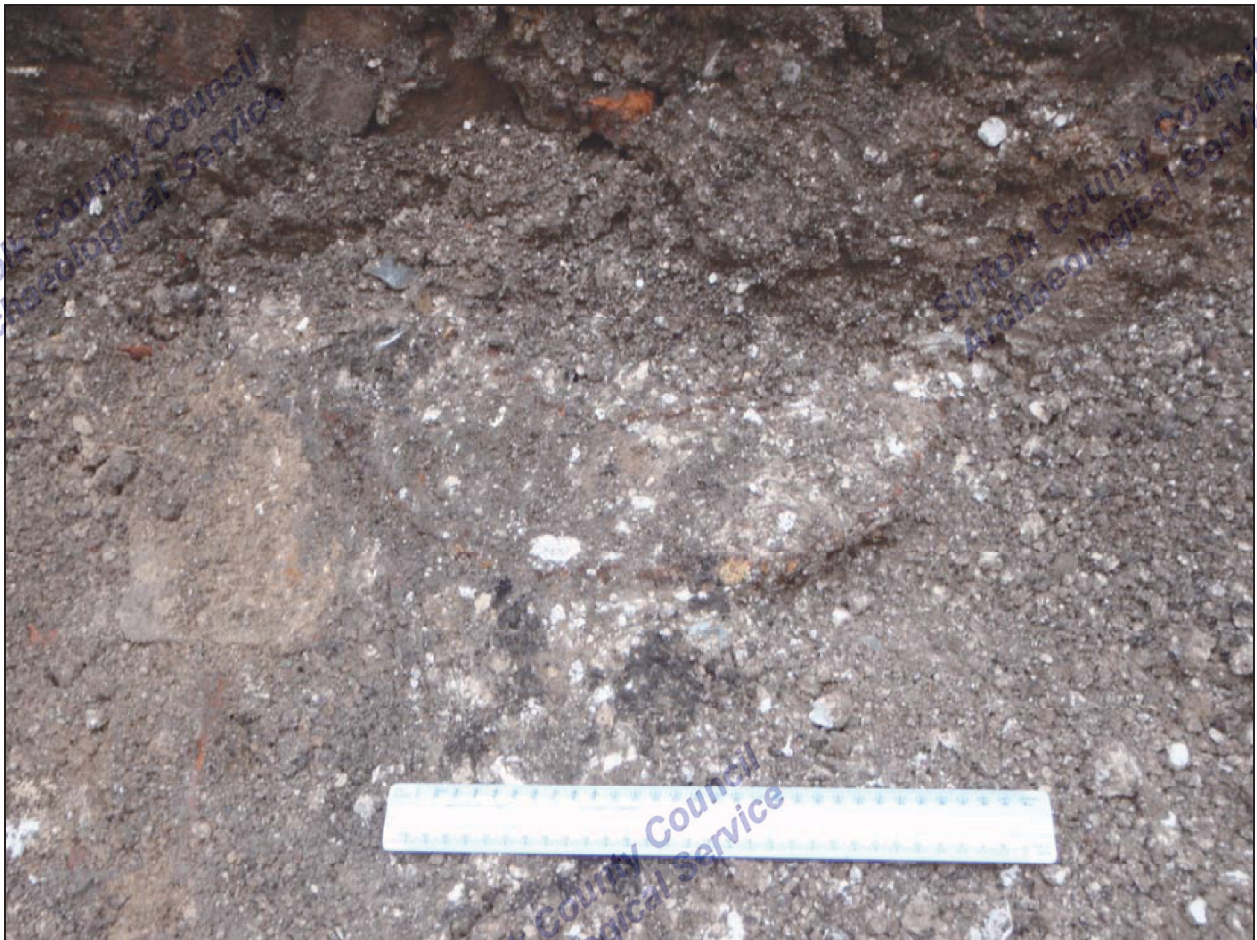
Plate 1. Two iron artefacts in pit 0013, scale is a 30cm ruler

Pit 0013 cut fill 0011 in cut 0012. It was probably oval in plan although it had been largely truncated. It measured 0.5m+ in length and 0.45m+ in width. The fill 0014 was light whitish grey friable clay silt with abundant chalk flecks and moderate charcoal flecks. Two iron artefacts were noted in the fill (Plate 1). These were probably originally circular although had been seemingly truncated by the yard wall. The artefacts appeared to be nested, the larger outer one being 0.45m in diameter and the inner one being 0.25m in diameter. Exploration of the edge of the outer artefact indicated that it had a curved upper profile and may have been bowl shaped. However, this was a cursory examination and their full form remains uncertain.

The sequence of small pits 0013, 0015 and 0017 cutting into this surface were undated but clearly extended below the current yard wall predating its construction. The concentric iron objects within the earliest pit 0013 appeared to have been chopped in half by the wall, and a cursory investigation suggested that they may have been nested metal bowls, although corrosion had destroyed their surfaces.

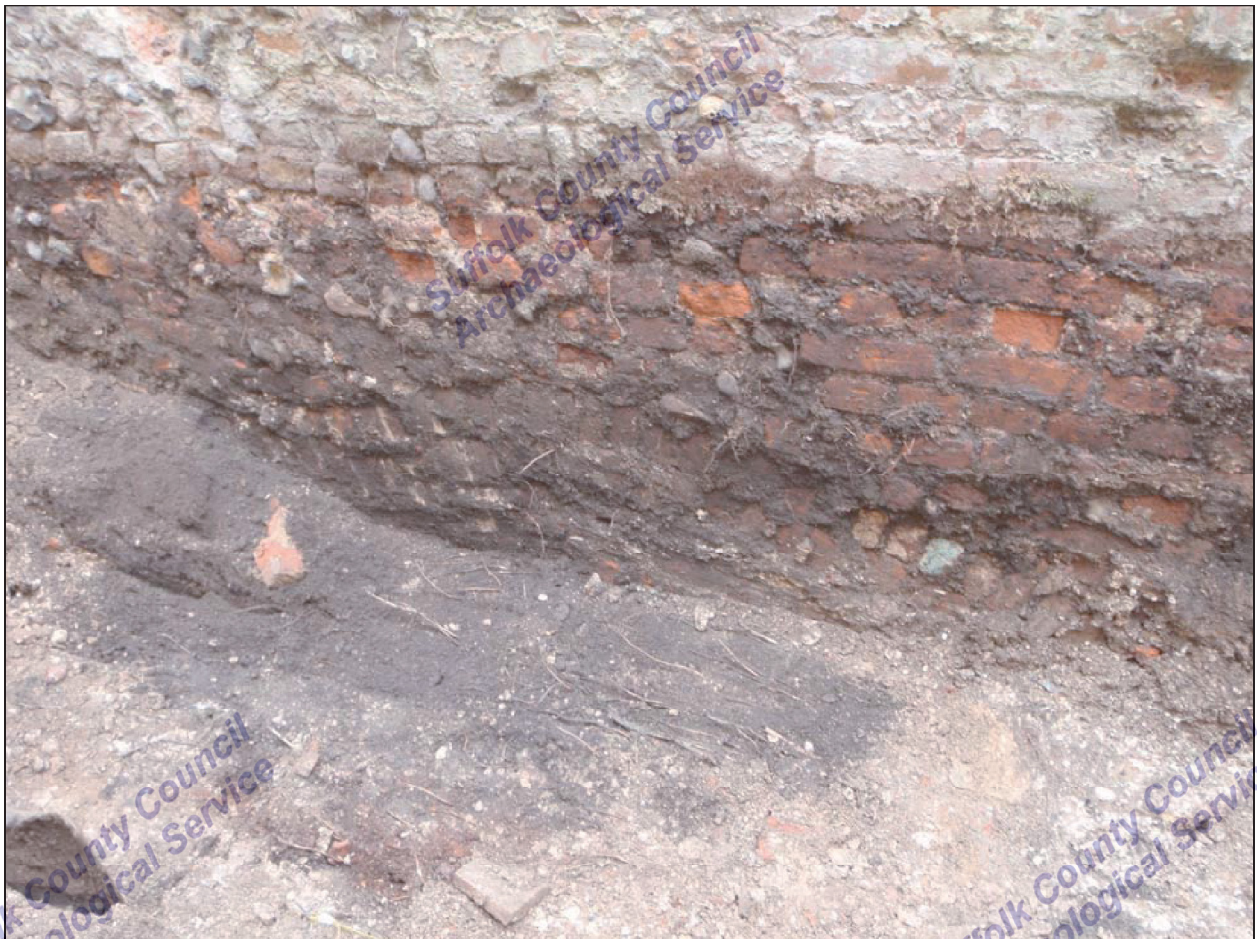
Plate 2. Arch built in yard wall to strengthen it where it crossed pit 0019

Pit 0019 was probably oval in plan but had been truncated by the yard wall. It measured 2.15m in length and 0.8m+ in width. The pit truncated earlier smaller pit 0017. It contained two fills; lower fill 0020 was loose mid orangey brown clay silt with frequent chalk fragments and frequent ceramic building material rubble. The fill was un-compacted and peeled readily from the sides of the pit suggesting that it was of relatively recent origin. Two sherds of late post-medieval pottery were recovered from this fill, one dating from between the 18th and 20th century and the other from the 19th century onwards. Upper fill 0021 was very dark brownish grey loose clay silt with the

appearance of topsoil. A void appeared during excavation to reveal a gap beneath the wall.

Larger pit 0019 extended below the wall and had been loosely backfilled during the 19th century at the earliest. An arch had been incorporated into the yard wall at this point (Plate 2) presumably to strengthen it as it crossed the pit. A yard wall is shown on the 1880 1st edition OS map, which enclosed the same area and it is likely to be the same wall (Fig. 3). The latest fill 0021 was similar to the garden soil and may have been of very recent origin.

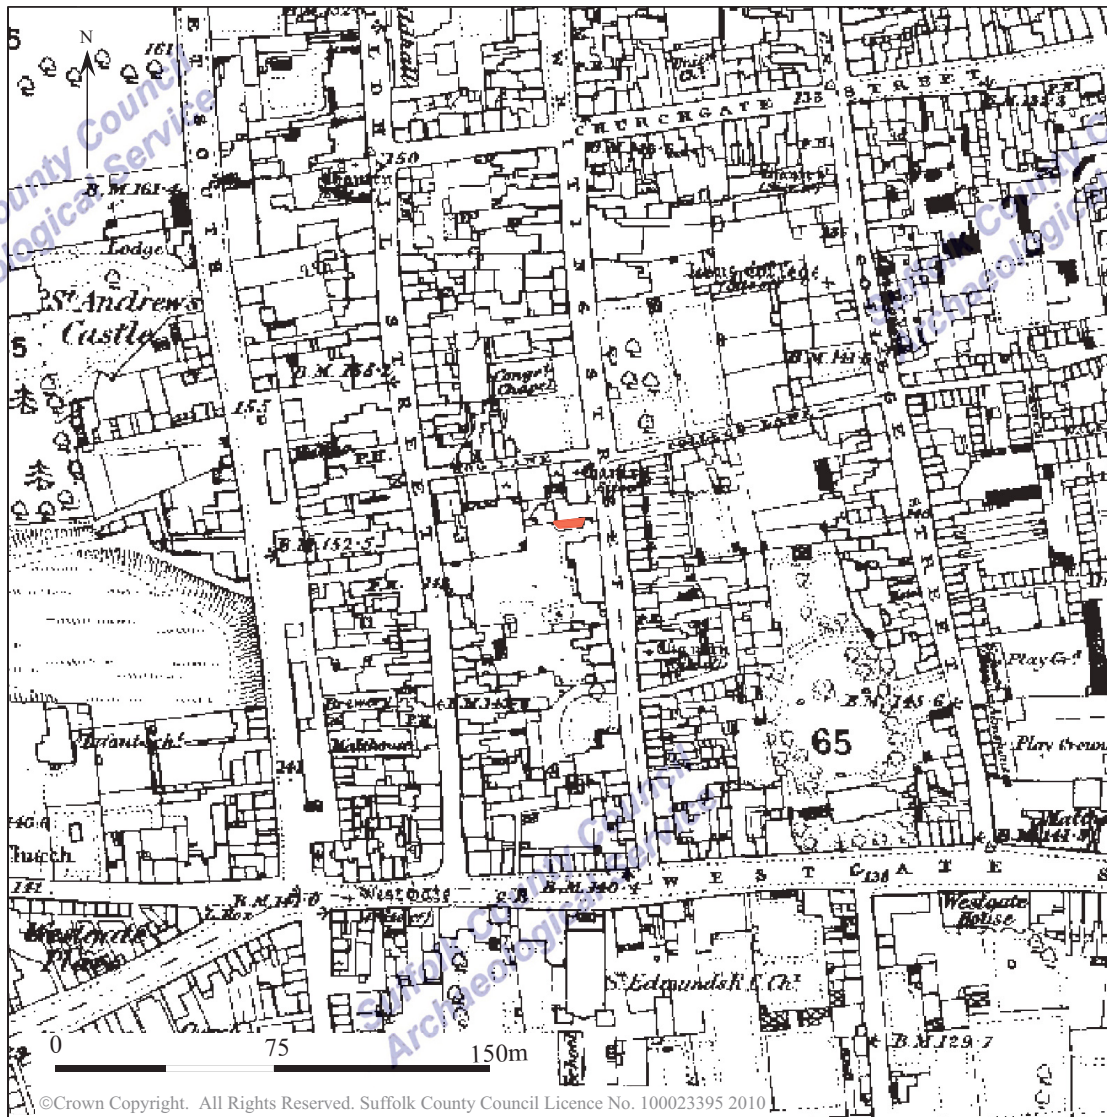
Figure 3. 1st edition OS map showing yard area shaded red

The lack of firm dating evidence means that few conclusions can be drawn about the deposits and features encountered during the monitoring. However, the sequence revealed does indicate that earlier medieval deposits in this area are likely to remain below these later medieval and post-medieval features. The presence of the possible surface 0011 suggests that a structure was present here. This together with the later pits 0013 to 0019 all predated the construction of the yard wall indicating that the plot boundaries have altered since their construction.
