**Oxdown Barn,  
Glemsford,  
Suffolk  
GFD 035**

**Historic Building Record**

# **Outbuilding at Oxdown Barn, Duffs Hill, Glensford, Suffolk**

## **Historic Building Record**

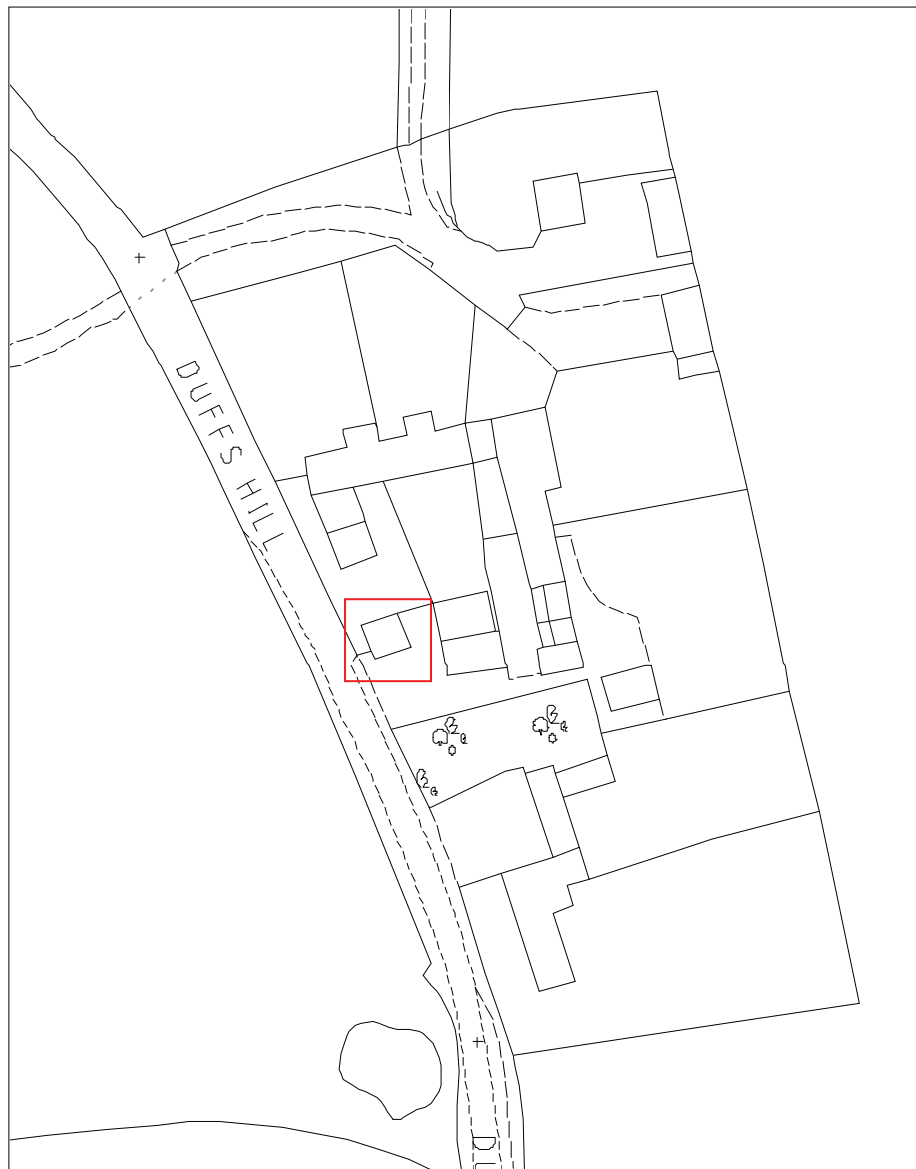
**Figure 1**

**Current Ordnance Survey Site Plan**

**Showing the outbuilding within a red square and the former farmhouse to the south. The property known as Oxdown Barn consists of the western end of the barn immediately to the north, together with its attached sheds, and is one of four dwellings created in 2000 by converting the buildings of a grade II-listed farm yard.**

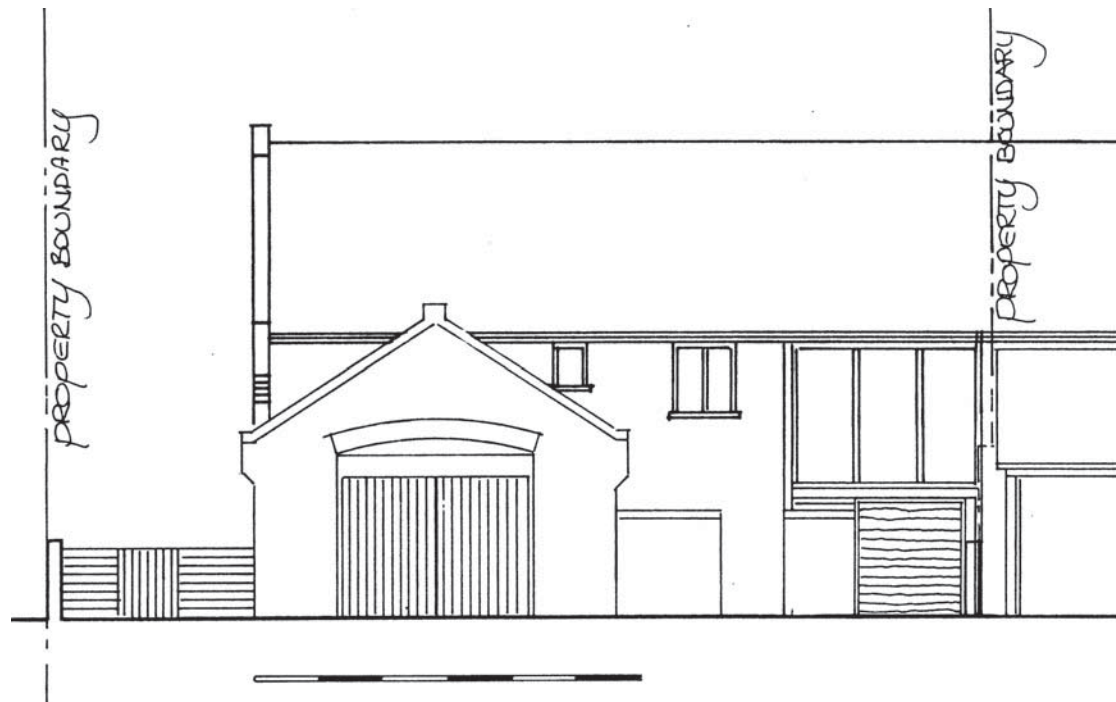
**Figure 7**  
**Southern gable showing double doors with converted barn in rear**

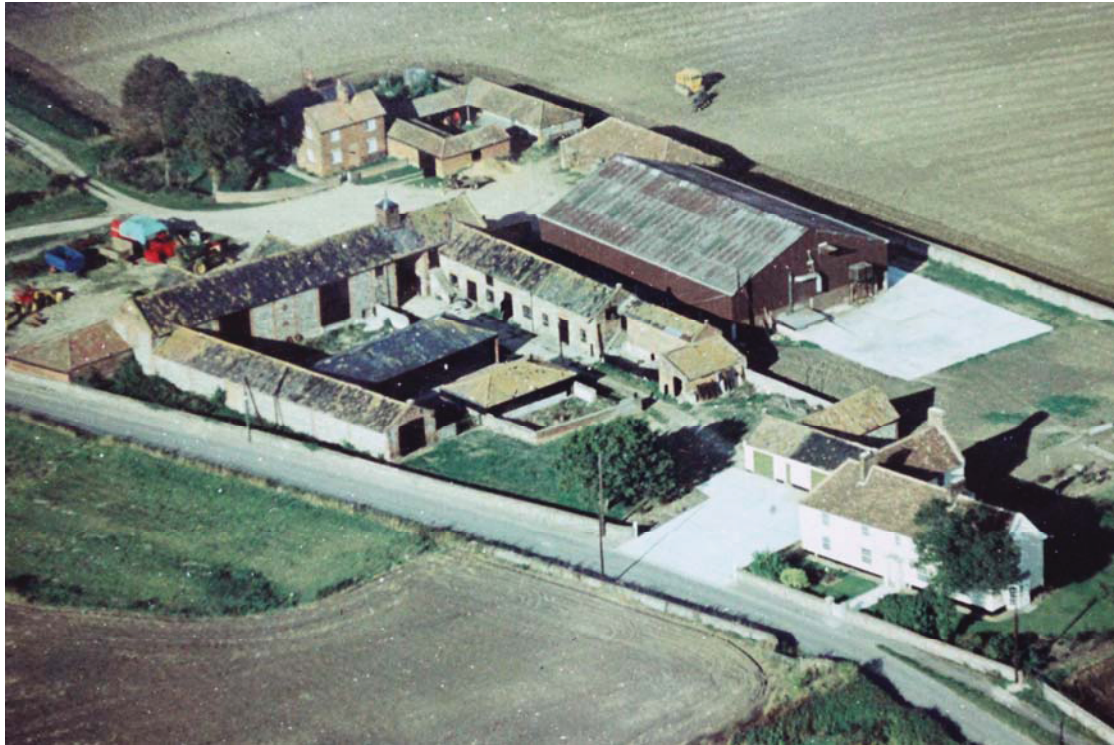
A2.1 Aerial view of site before conversion from south-west (dated 1972) showing farmhouse to right and single-storied linear shed to left (note black-painted vehicle doors in gable). Original in possession of owner.

The shed lay at the southern end of a much longer range of identical fabric, as described above, and contained double doors in its southern gable. The present doors are replacements of 2000, but the aperture is respected by the masonry and shown in A2.1. The gable adjoined the road, facing a broad yard between the yard complex and farmhouse, and was designed either as a vehicle shed or feed store without additional doors or windows. A low, narrow doorway was subsequently inserted into the centre of its eastern elevation, adjoining the cattle yards. This feature interrupts the original brick dressing and lies beneath a limestone or shuttered-concrete lintel with jambs of red-brick. It appears to have been converted into a window before being blocked entirely. The door was 75 cm wide by just 1.4 m in height (2.5 ft ins by 4.5 ft) and probably operated as a feed hatch.

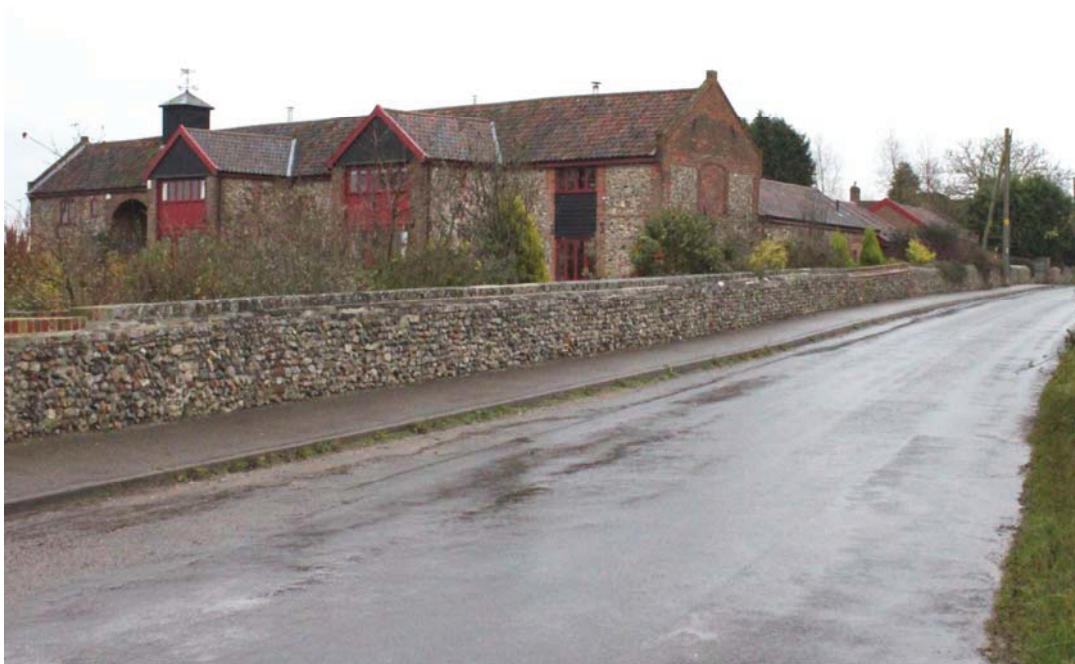
A2.2 General view of site from road to north-west, showing main barn with twin northern porches to left and shed in rear to right. The uniform porches and arched gateway to the left are not shown on the tithe map and it is not clear how much of the barn pre-dates 1841

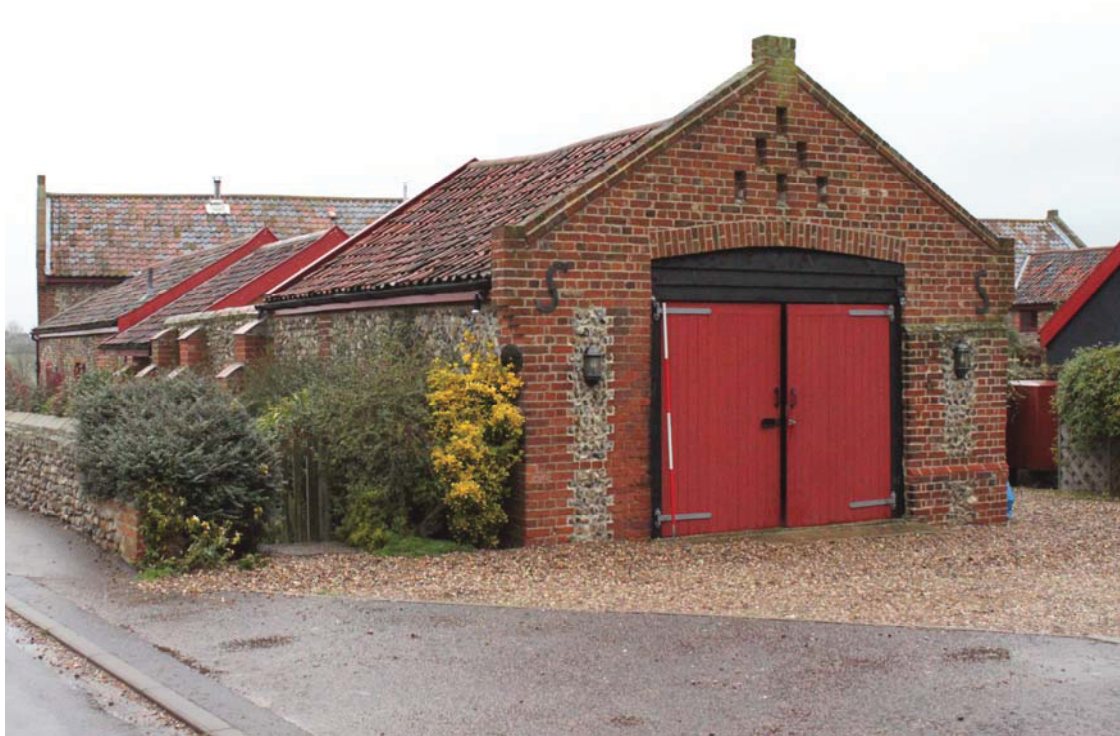
A2.3 Exterior from Duff's Hill to south showing double doors and blocked ventilation holes of southern gable with main barn in rear to left. The doors and much of the brickwork was renewed in 2000

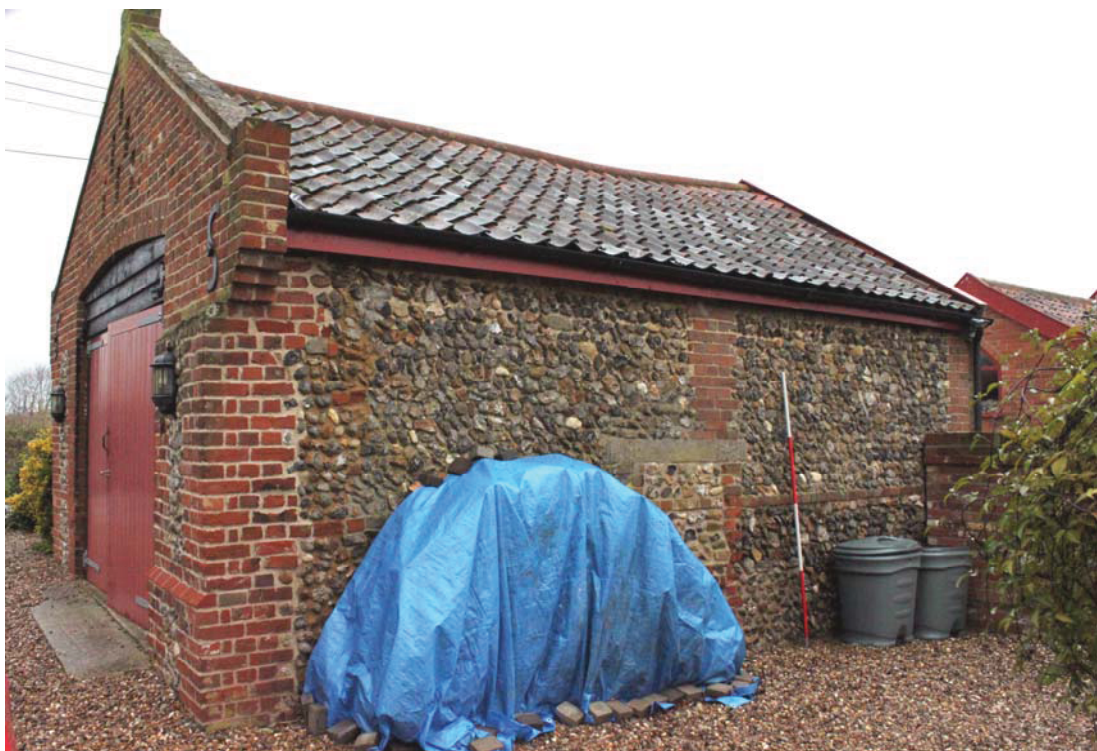
A2.4 Exterior of shed from south-east showing southern gable to left and blocked central aperture of eastern elevation to right. The shed formerly continued further to the north (right) but was partly demolished during the conversion of 2000 and the gable shown here to the extreme right is a more recent 'extension' to its extant northern end.

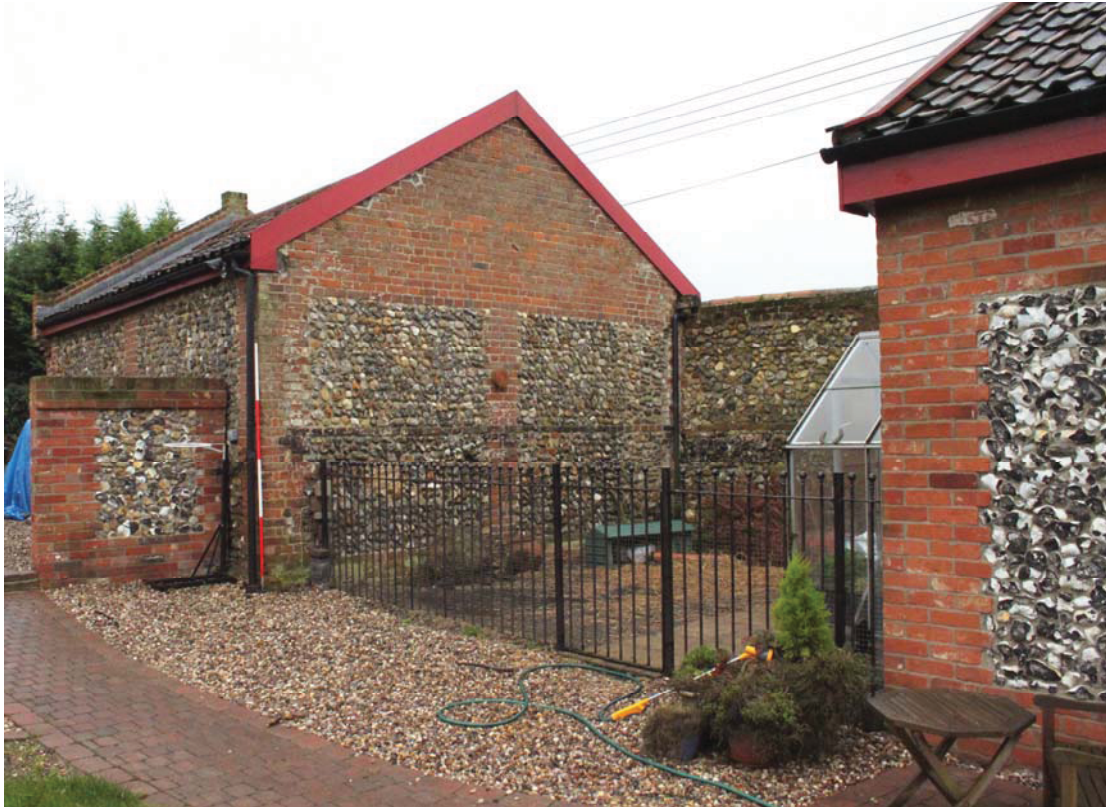
A2.5 Exterior of shed from north-east showing its truncated northern gable with the modern extension to its surviving northern section visible to right

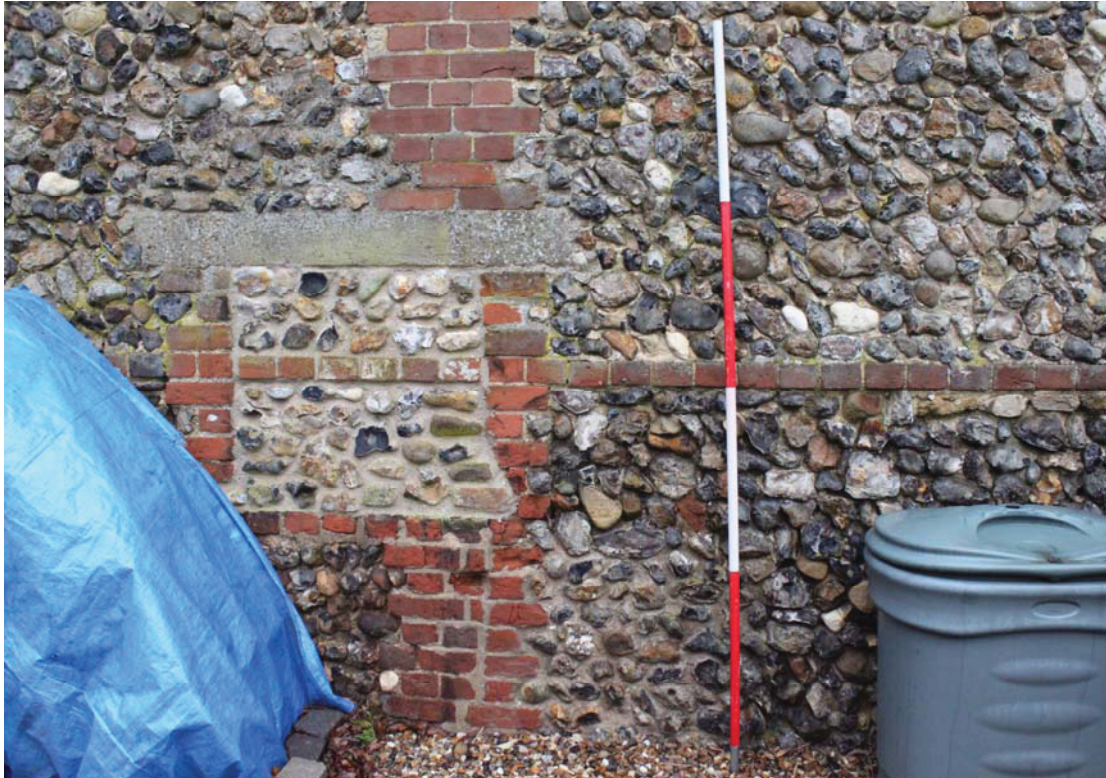
A2.6 Detail of blocked secondary door with stone or concrete lintel in centre of eastern external elevation. This probably formed a feed hatch onto the cattle yard, but was subsequently converted into a window. It interrupts the original red-brick dressing above

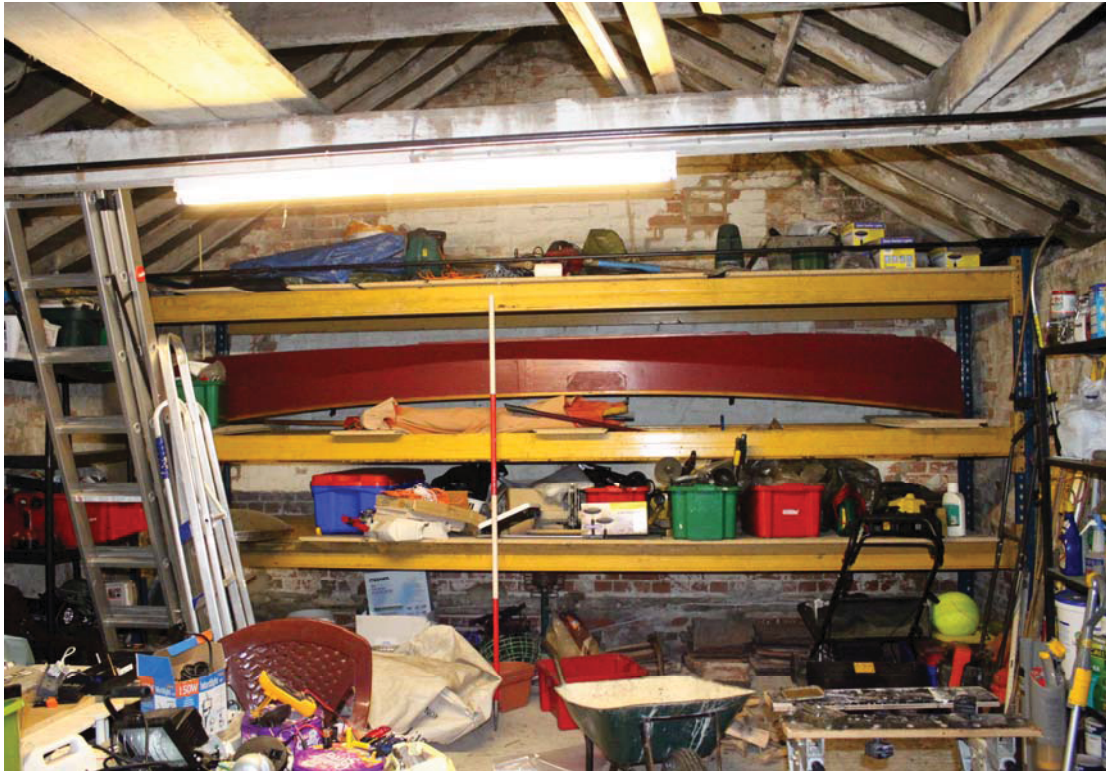
A2.7 Interior from south showing the northern gable and the shed's current purpose as a general storage 'garage' with metal shelving against its walls. Note the original whitewashed tie-beam spanning the shed's width, with horizontal axial and diagonal braces to the south.

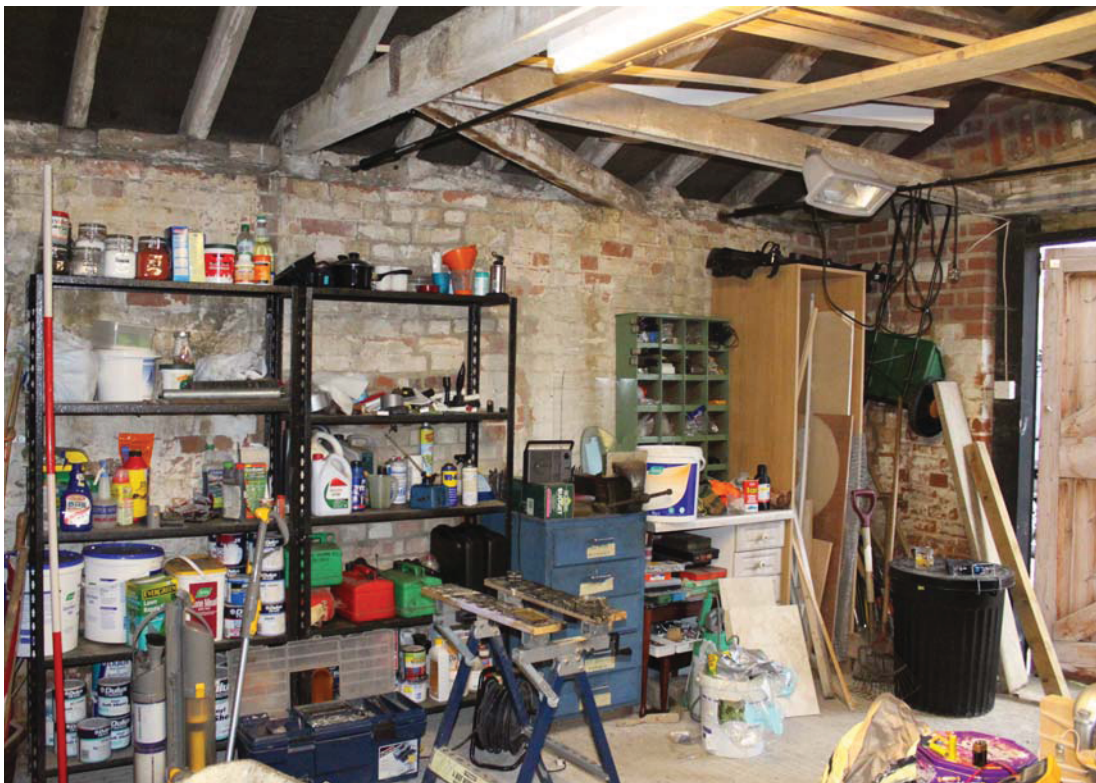
A2.8 Internal eastern elevation showing southern gable to right with original horizontal braces to tie-beam. The inserted eastern aperture to the left is obscured by shelving.

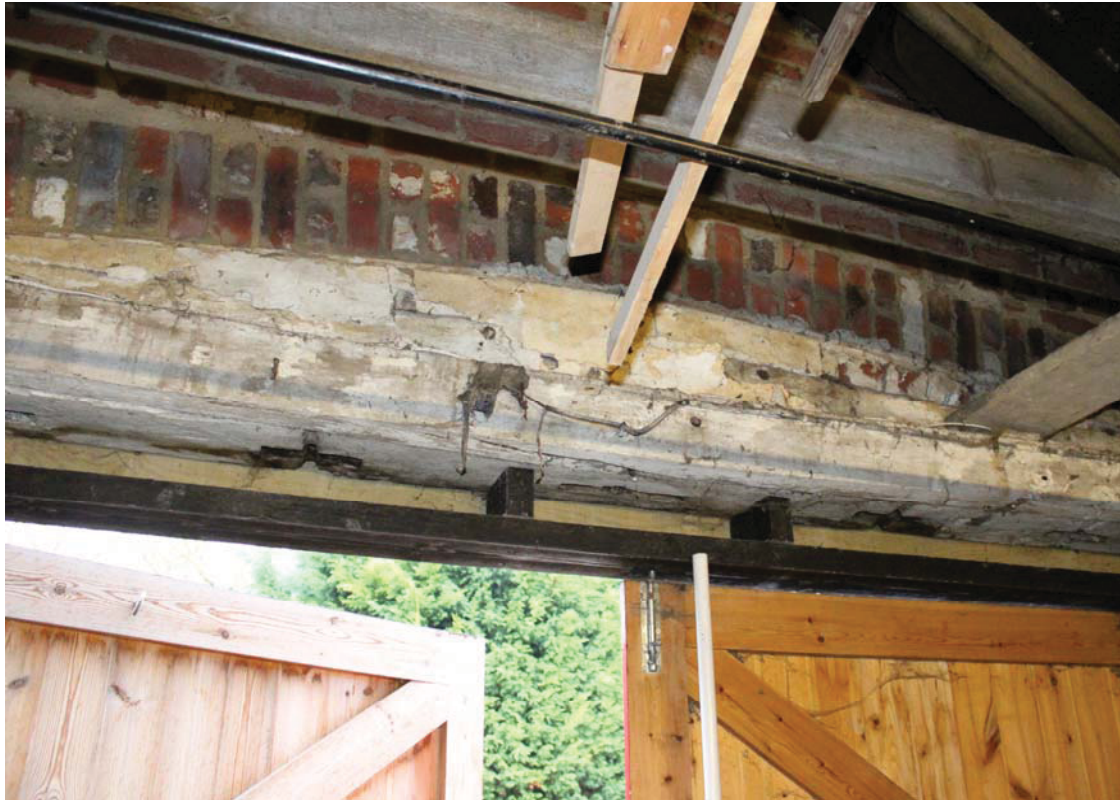
A2.9 Detail of re-used cambered medieval tie-beam above southern entrance doors showing empty pegged mortises in its underside

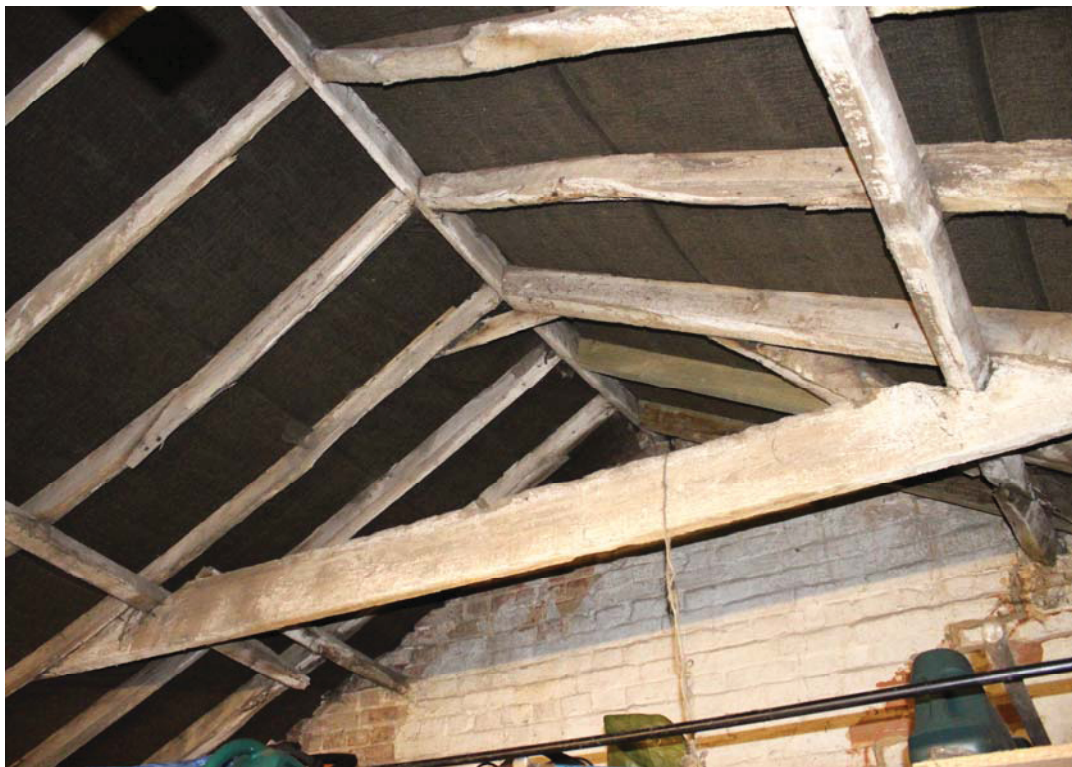
A2.10 Original roof structure from south showing clasped purlins with nailed collar and ridge-board. The rafters vary in size and several show evidence of re-use from earlier structures.

The shed's roof structure is characteristic of the mid-19<sup>th</sup> century and is highly unlikely to date from the early-19<sup>th</sup> century when ridge-boards were rarely used (although the farm complex is assigned to this period in the Schedule of Listed buildings). Its present layout probably dates from the remodelling of the farm yards in *circa* 1860, but it is possible that some flint fabric survives from the longer range shown on the tithe map of 1841.
