**Hall Farm,  
Saxmundham,  
Suffolk  
SXM 021**

# **Historic Building Record**

**Hall Farm,  
Church Street,  
Saxmundham, Suffolk**

## **An Archaeological Record**

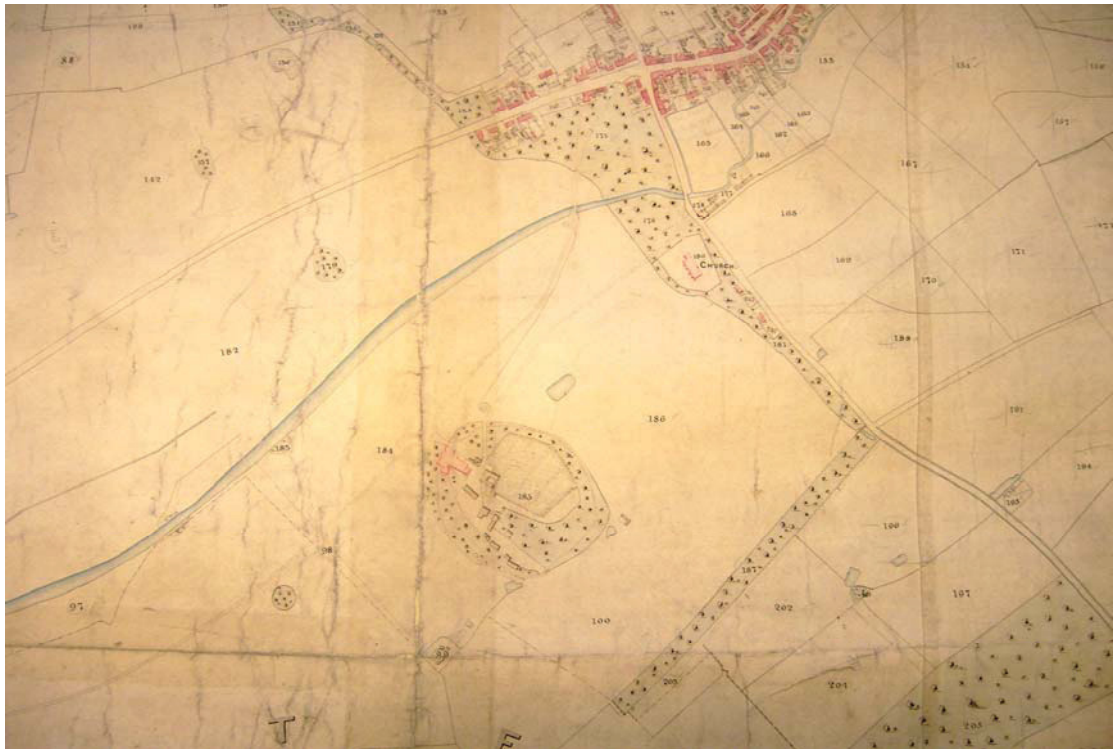
**Figure 2**  
**The Saxmundham Tithe Map of 1840 (Suffolk Record Office) with detail below. Showing the town of Saxmundham above, with the unusual oval-shaped site of Hurts Hall and its farm buildings surrounded by parkland below. North lies towards the top right-hand corner. Neither the shed (1) nor the granary (2) are shown, although the L-shaped early-19<sup>th</sup> century stable is present (photo A2.2).**

The Saxmundham tithe map of 1840 (figure 2) and its accompanying apportionment records the size of the hall's home farm at 192 acres, owned and occupied by William Long, and names the site simply as 'Hurts Hall' (no. 185 on the map). The surviving L-shaped brick stable range is clearly shown to the west of buildings 1 and 2 in figure 1, as is the walled garden to the north, but the two buildings themselves are conspicuous by their absence. Two structures of different widths lie on the same site as the granary (2), but extend considerably further to the south, and the site of the northern shed (1) is occupied only by a plantation of trees.

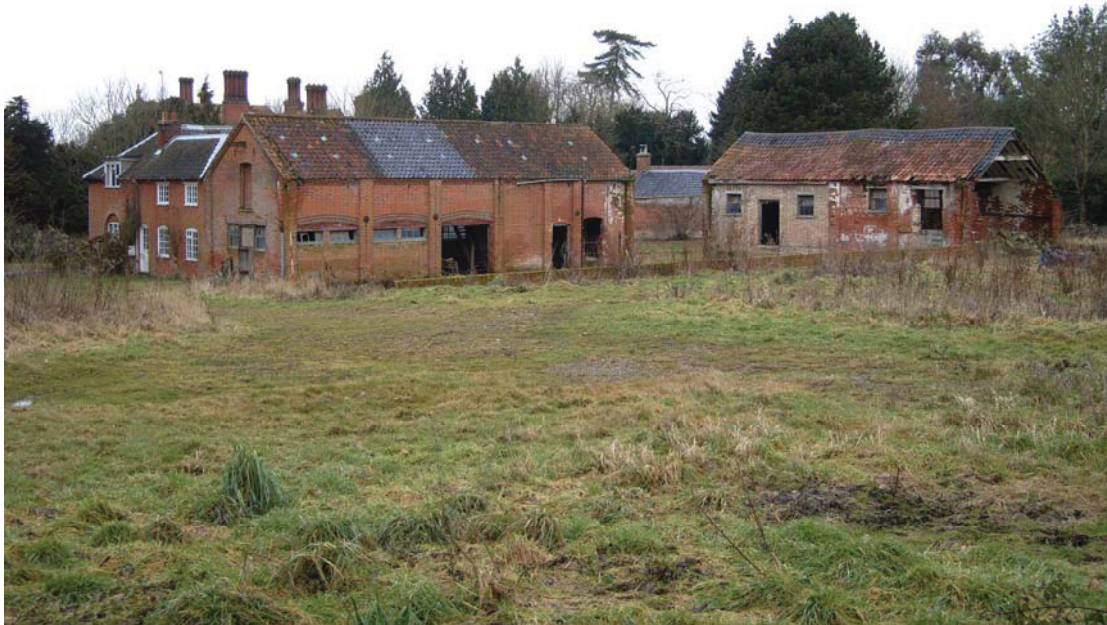
A2.1 General view from south-east showing shed 1 to right and granary 2 to left with chimneys of Hurts Hall in rear

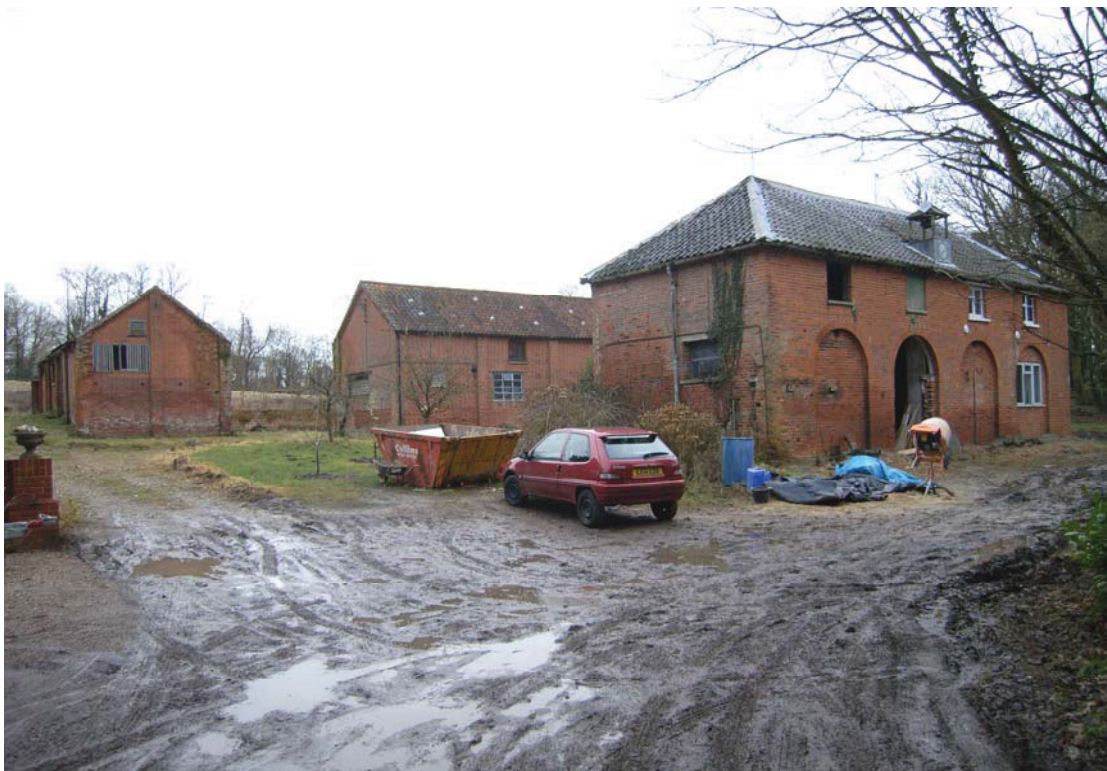
A2.2 General view of site from entrance to north-west showing Georgian stable to right with shed 1 to left and granary 2 in centre

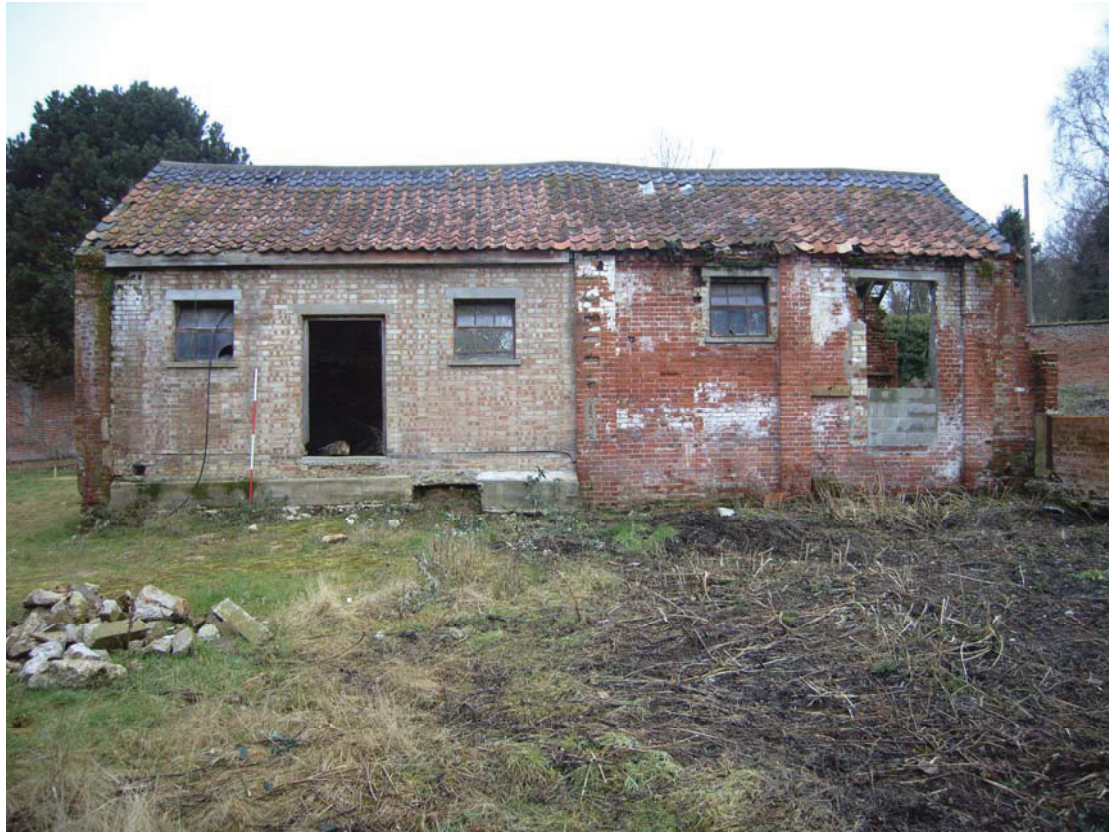
A2.3 Shed 1. External southern elevation showing 20th century brickwork to left and original brickwork with secondary windows to right

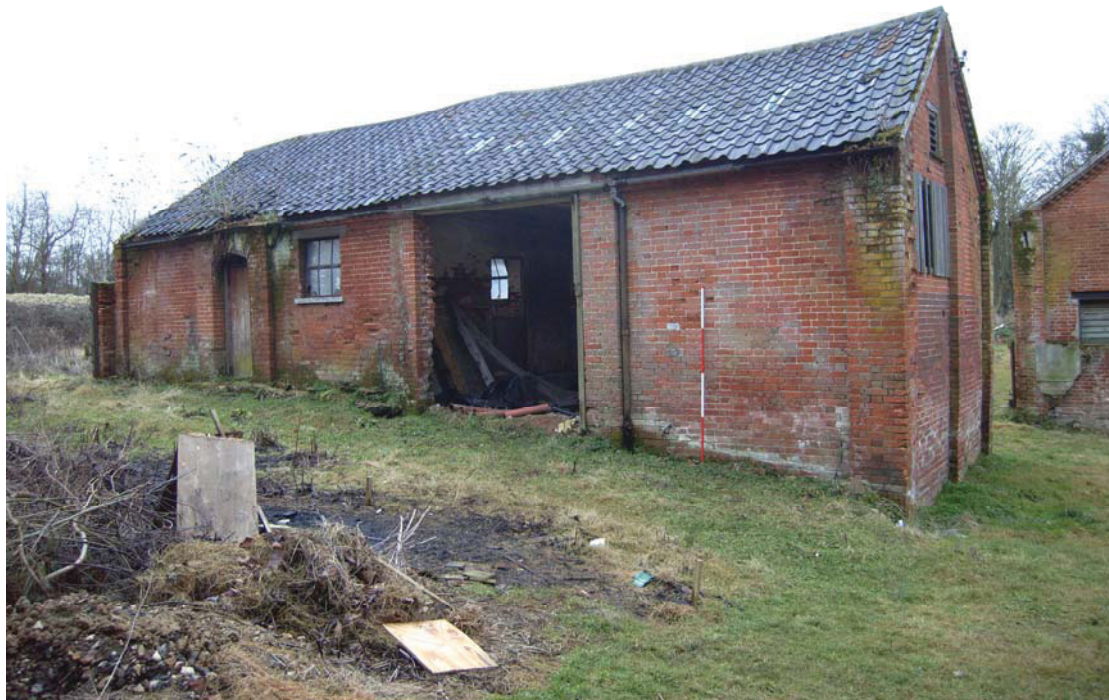
A2.4 Shed 1. External northern elevation showing secondary opening to right with original door to left

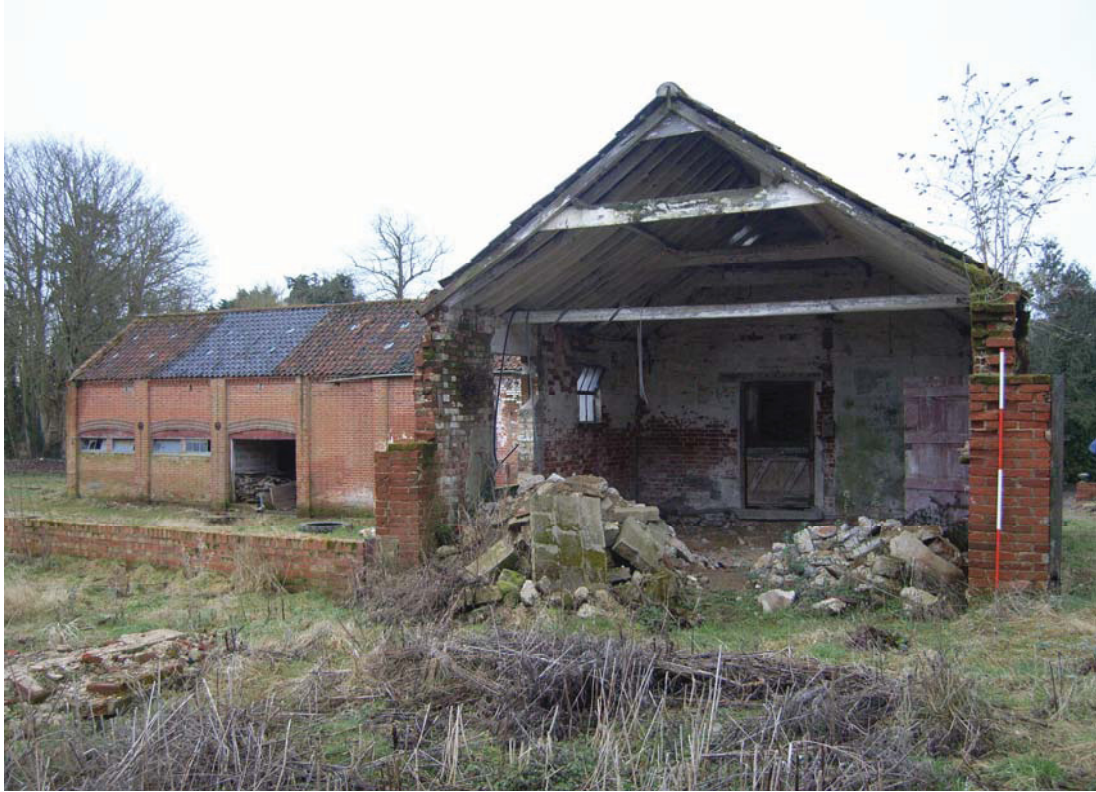
A2.5 Shed 1. Exterior of truncated eastern gable showing granary 2 to left

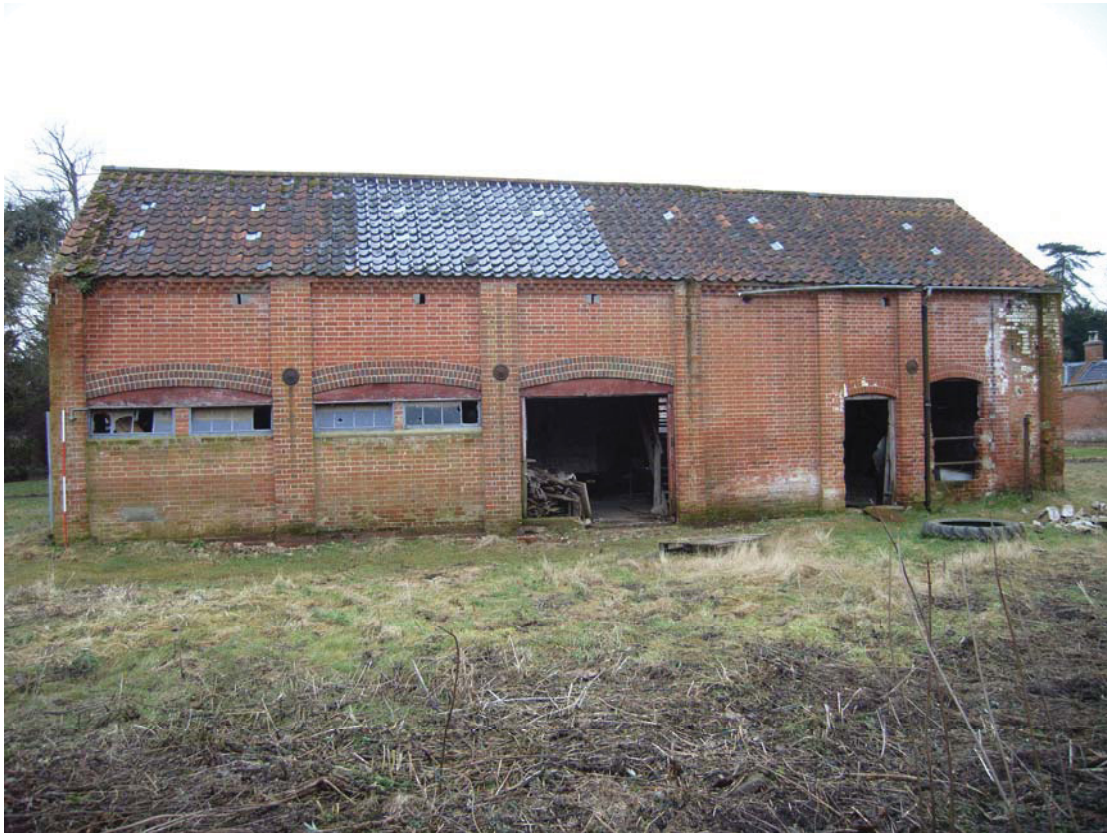
A2.6 Granary 2. External eastern elevation showing former open arcade to left & enclosed with external door and enlarged northern window to right

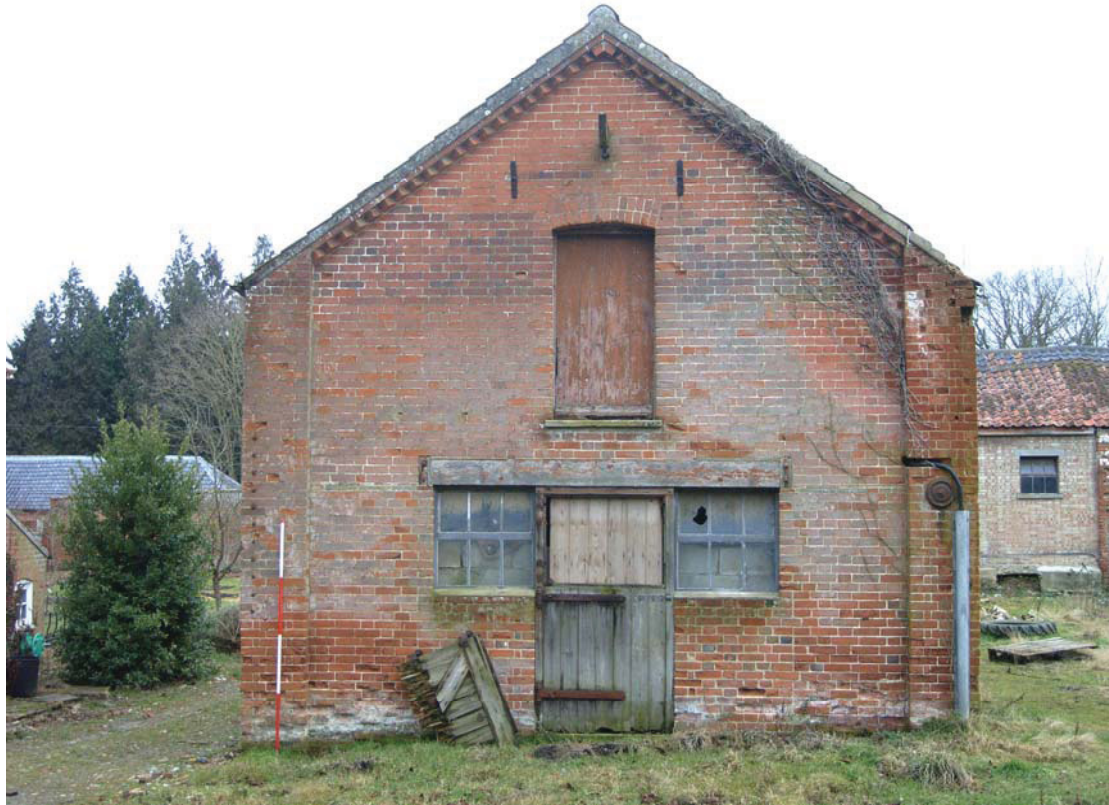
A2.7 Granary 2. External southern gable showing original loading door to first-floor granary above blocked wide aperture on lower storey

The upper storey was designed as a granary reached by a loading door in the southern gable (where a hoist bar still projects from the brickwork) and another smaller example in the western elevation. The present internal stair in the central compartment is a 20<sup>th</sup> century insertion. The grain bins have been removed but their scars remain on the brickwork, and suggest the presence of an axial passage. Only a sack barrow and two mummified rats remained within at the time of inspection. The granary floor was divided into two compartments linked by an internal door, with the northernmost (of 6.8 m in length) directly served by the western loading door. The clasped-purlin roof structure of machine-sawn softwood with a ridge-plank and nailed collars is not rendered and may have been renewed.

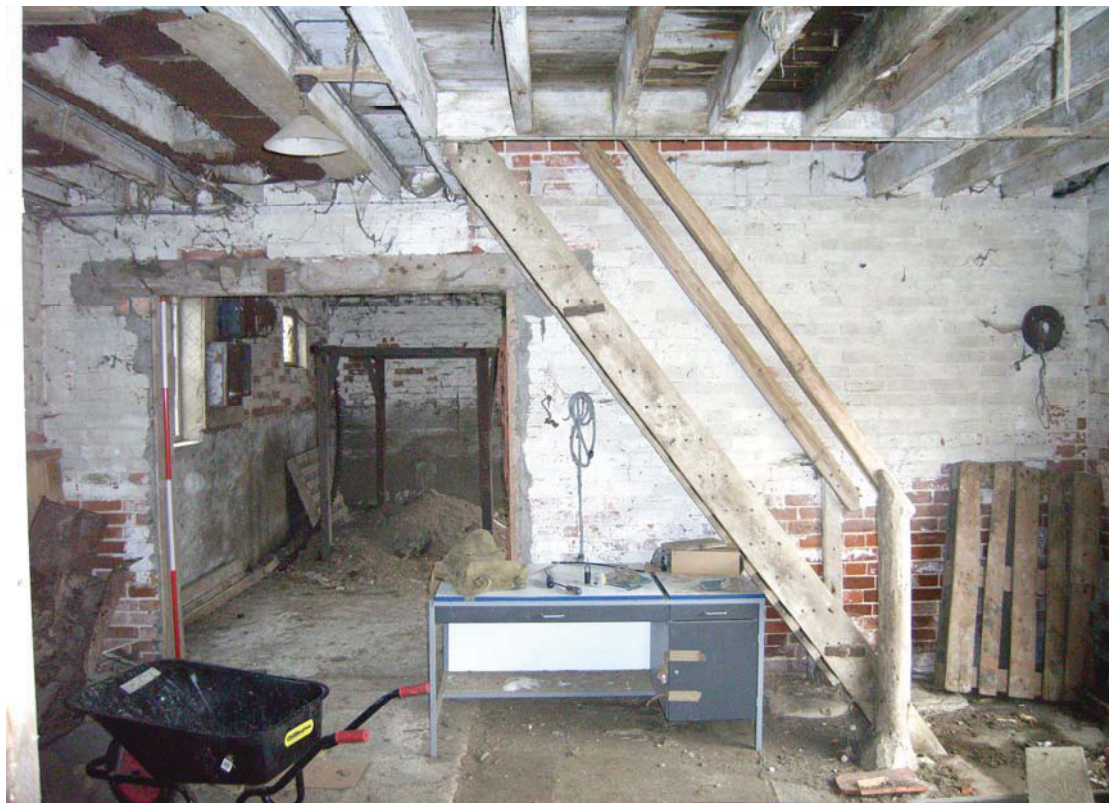
A2.8 Granary 2. Secondary stair in central compartment seen from south

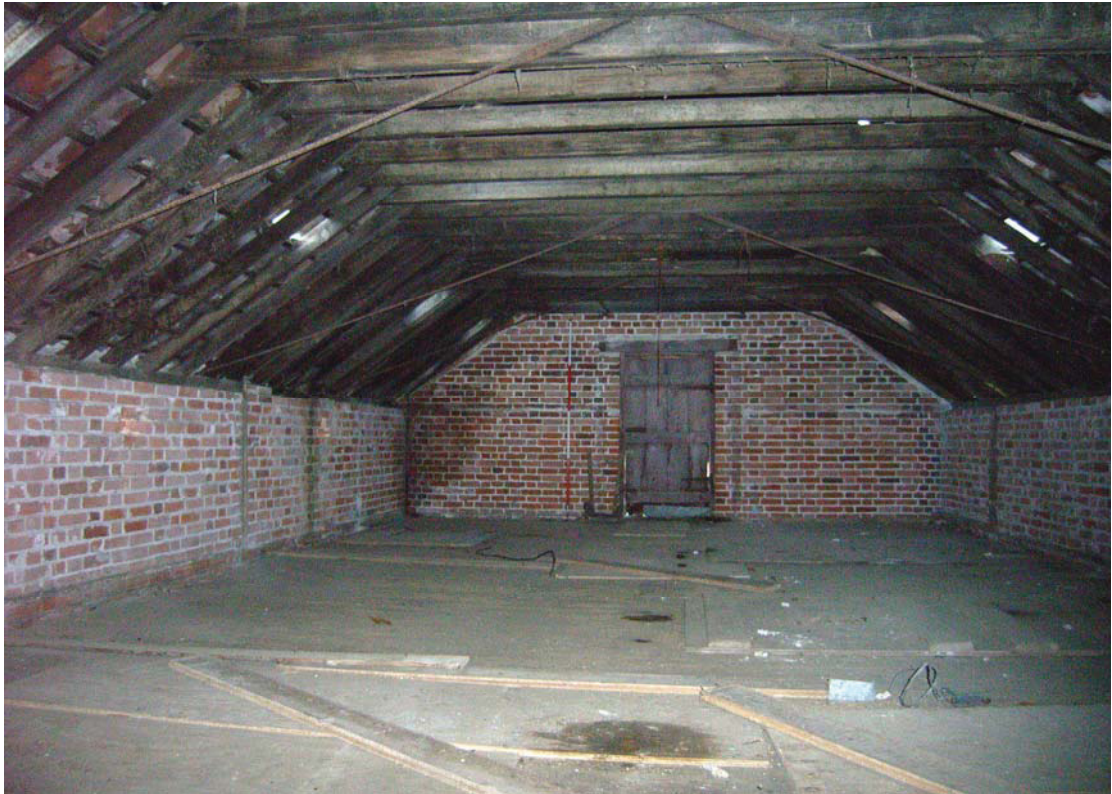
A2.9 Granary 2. Upper granary floor looking to southern gable from internal partition showing vertical scars of removed grain bins to left and right

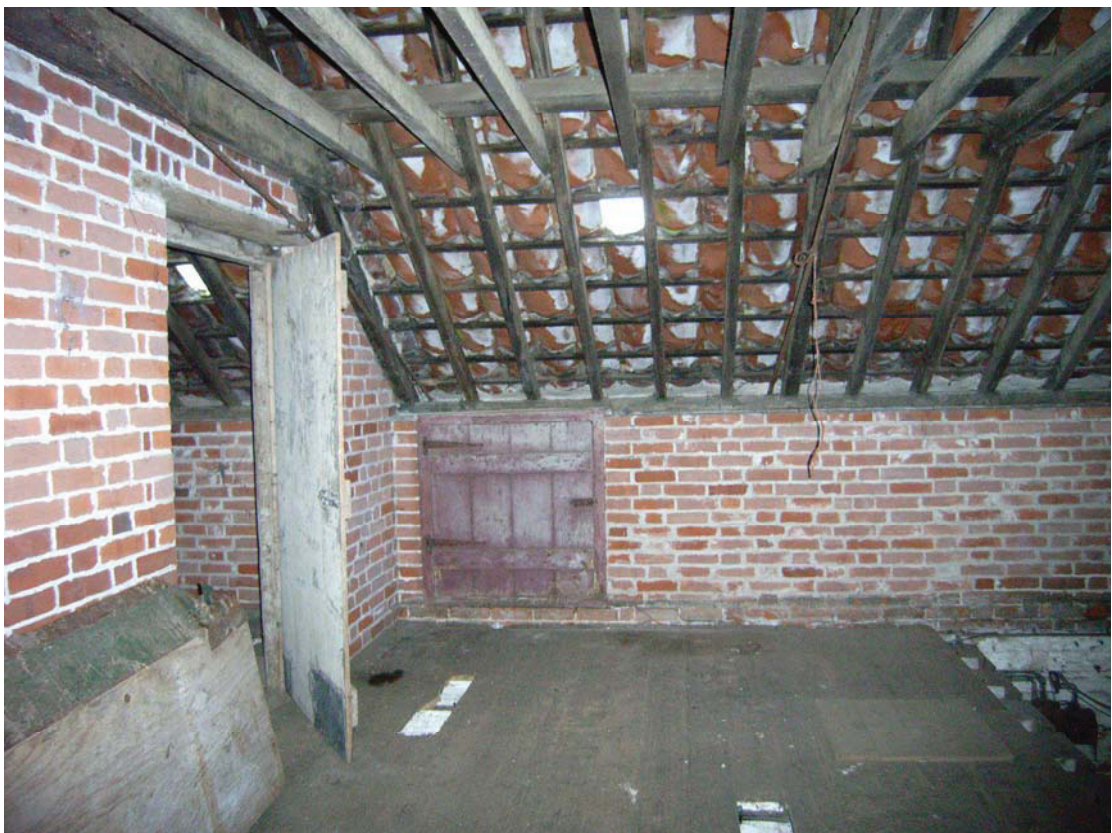
A2.10 Granary 2. Internal western elevation of northern first-floor granary compartment showing original external loading door to right and door to southern compartment to left
