**Brown's Farm,
Holbrook,
Suffolk,
HBK 043**

Historic Building Record

The Barn, Brown's Farm, The Street, Holbrook, Suffolk

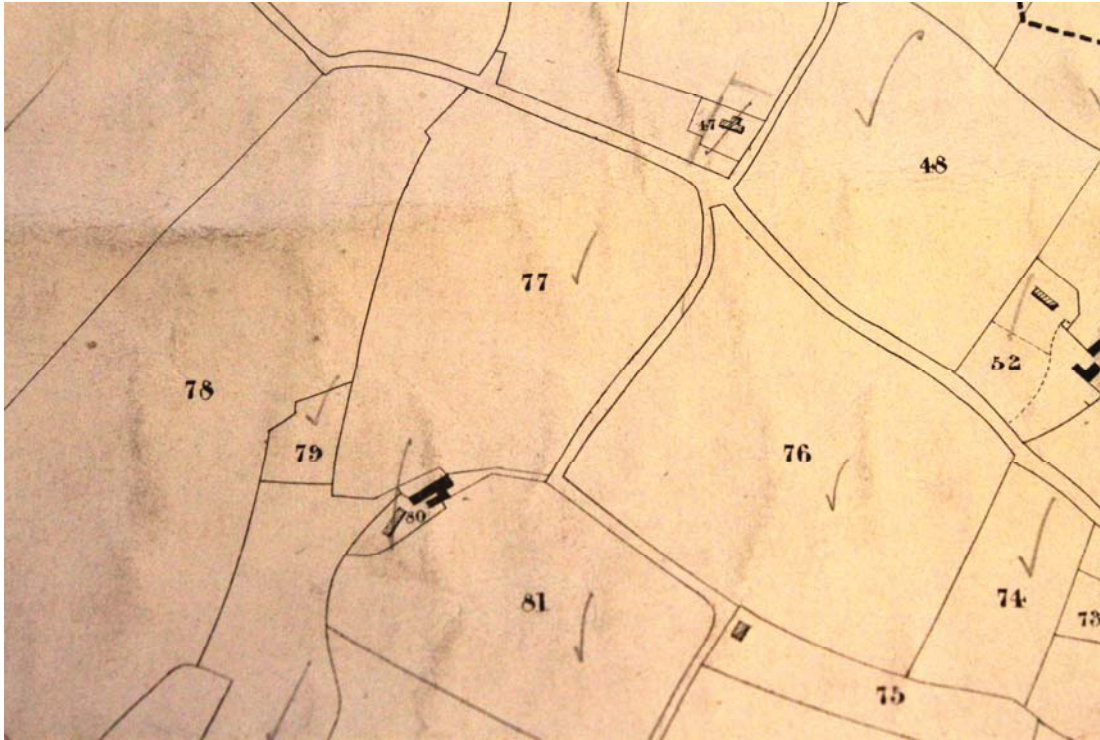
Figure 2

Brown's Farm on the Holbrook tithe map of 1840 (SRO), showing north at top-right. The farm (no. 80) is reached by a track from a sharp bend in what is now Holbrook Street, but this bend was straightened in the mid-19th century and the track lengthened accordingly.

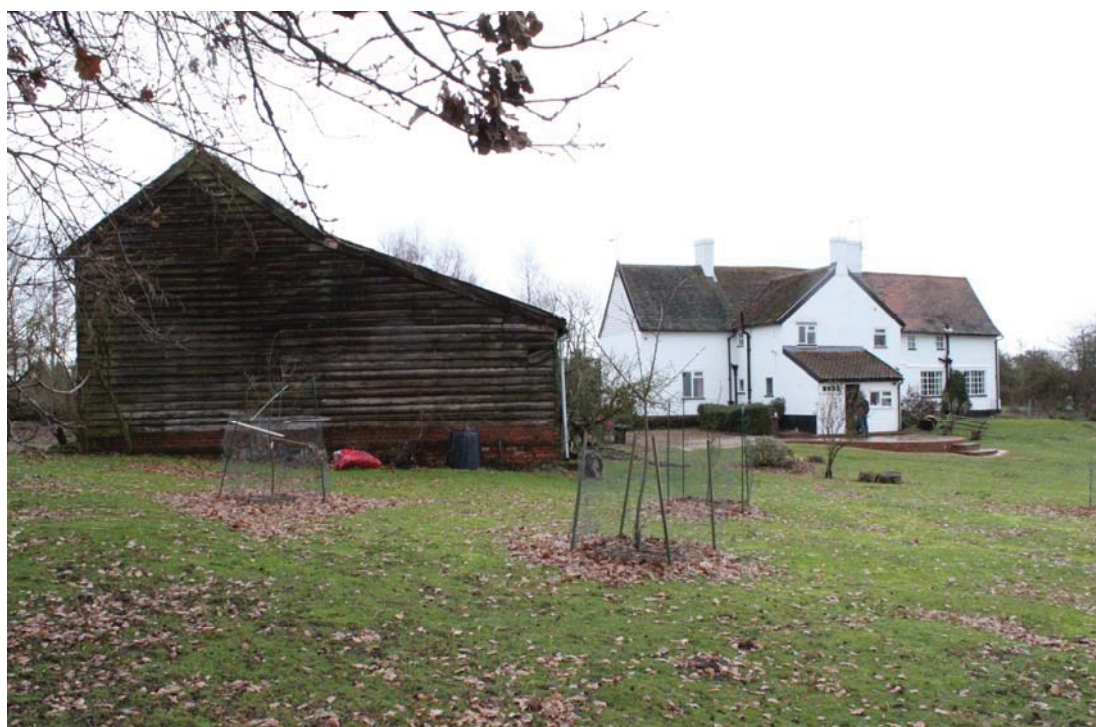
A2.1 General view of site from west showing barn with contemporary lean-to sheds to left and farmhouse to right. The late-16th or early-17th century farmhouse contains a parlour to the right with a central hall and a 20th century extension beyond the small chimney to left. The central wing was added in the mid-19th century.

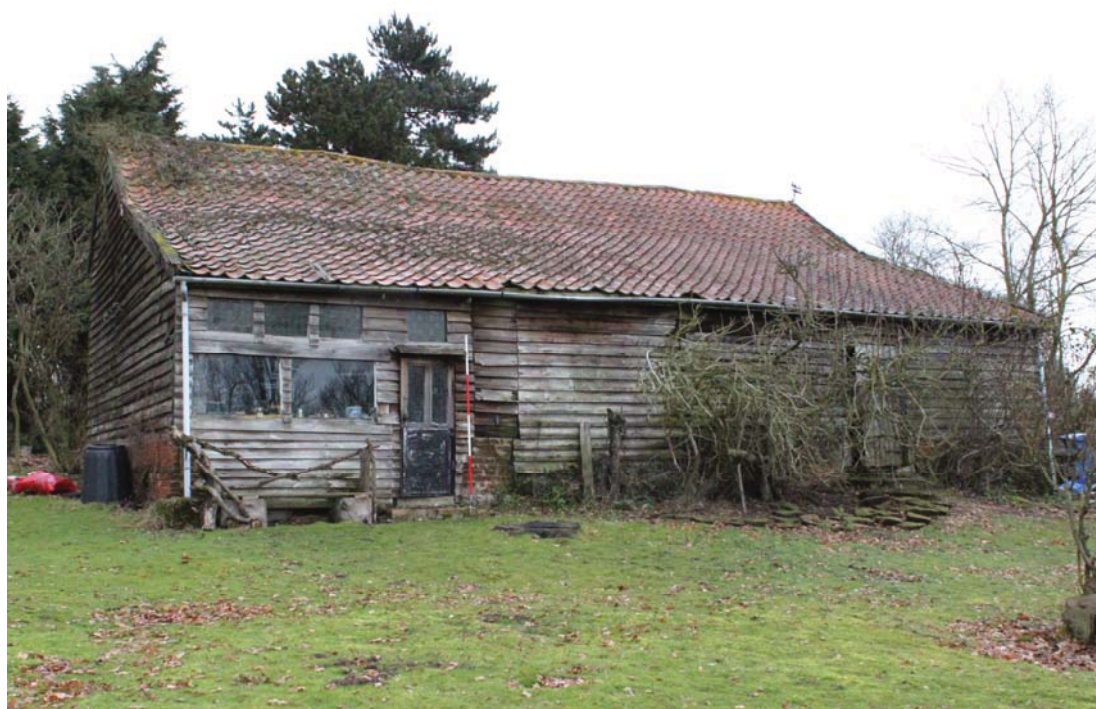
A2.2 Exterior of barn from south-west showing 20th century glazing of lean-to cow-shed (D) to left, blocked doors to lean-to porch (B) in centre and double-hung doors to eastern shed (E) to right. A shelter shed and cattle yards have been demolished from the foreground.

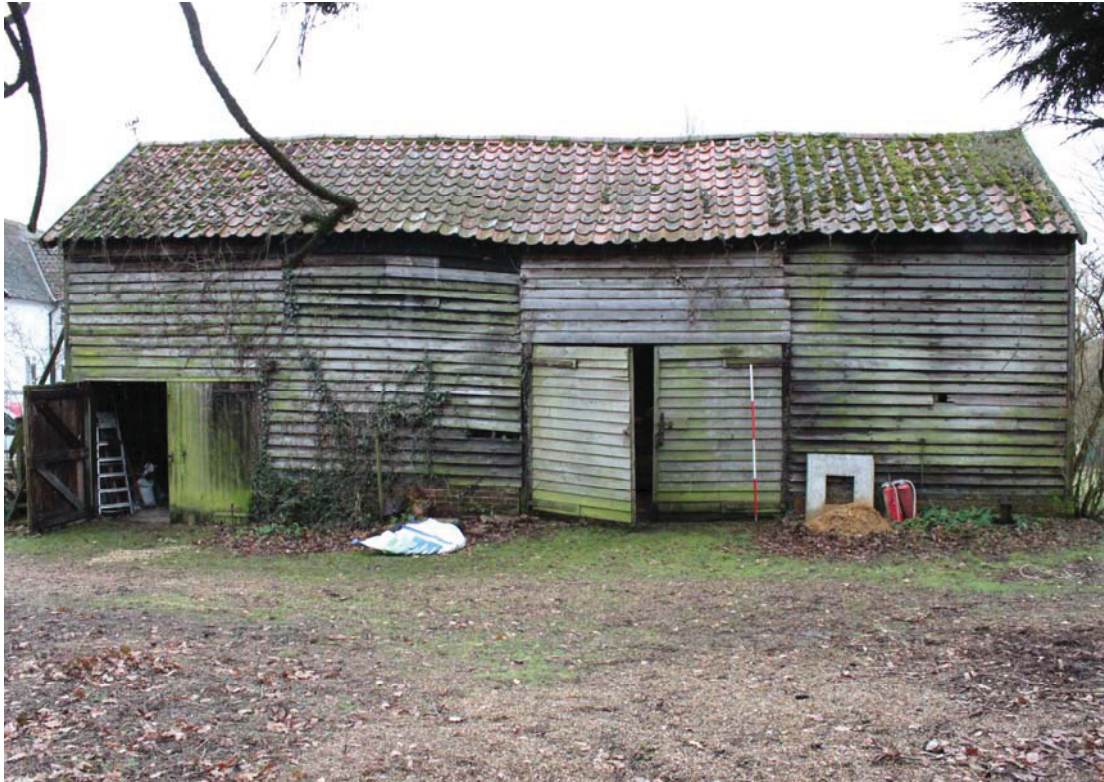
A2.3 Northern external elevation showing doors to vehicle shed (C) left & barn doors in centre. The latter have been reduced in height.

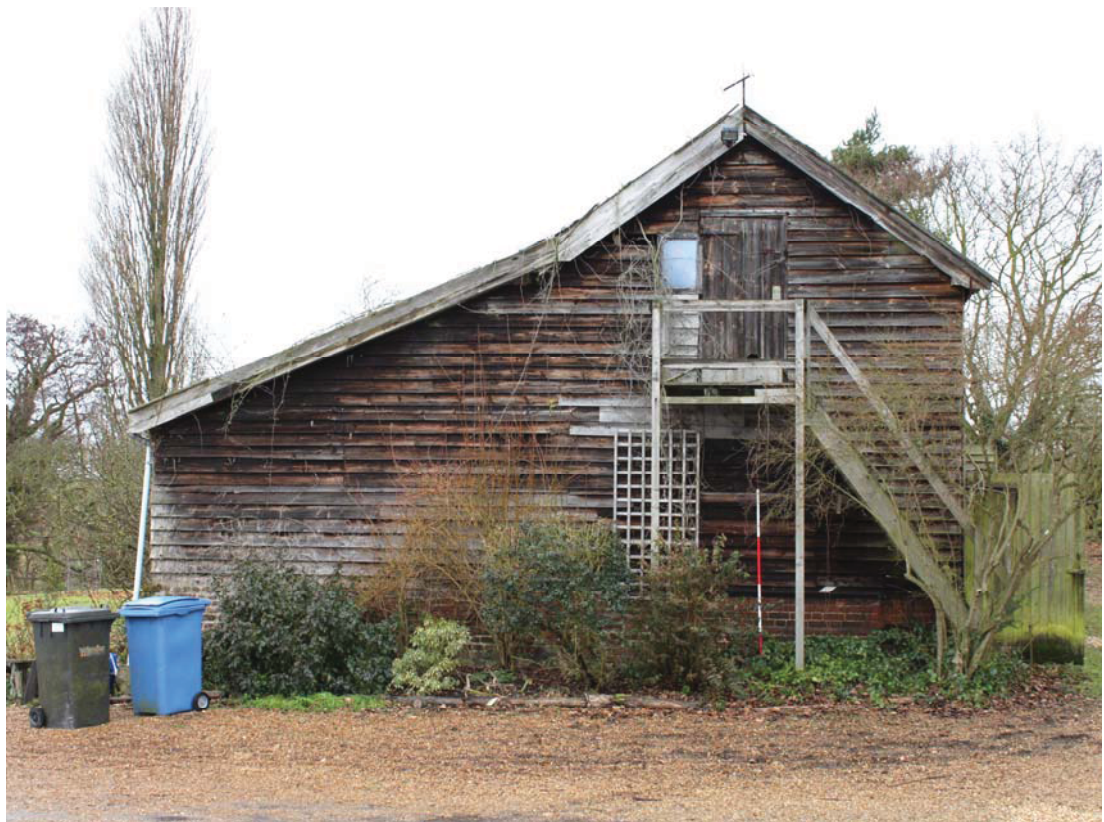
A2.4 Exterior of eastern gable showing external stair to granary above vehicle shed (C) (the stair renewed in the late-20th century) and the profile of the contemporary southern lean-to sheds to left.

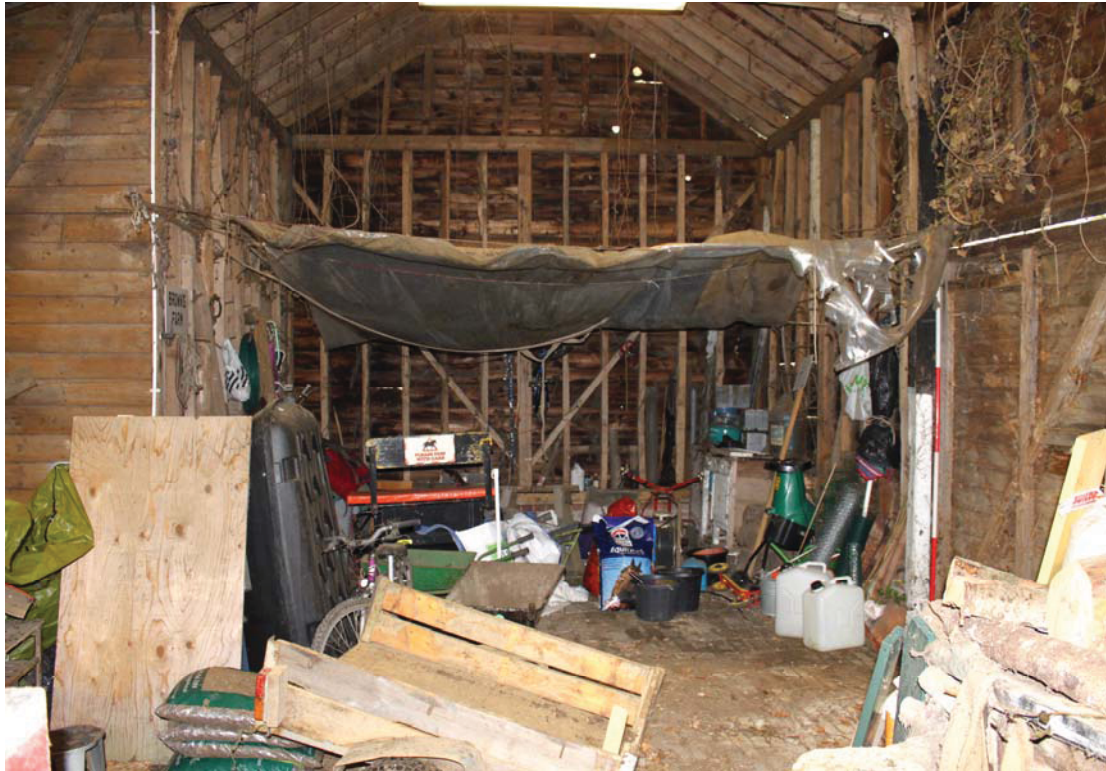
A2.5 Interior of barn (A) from east showing narrow softwood studs with nailed diagonal bracing. The central entrance bay and brick threshing floor lies in the foreground with the lean-to porch (B) to left and northern door to right.

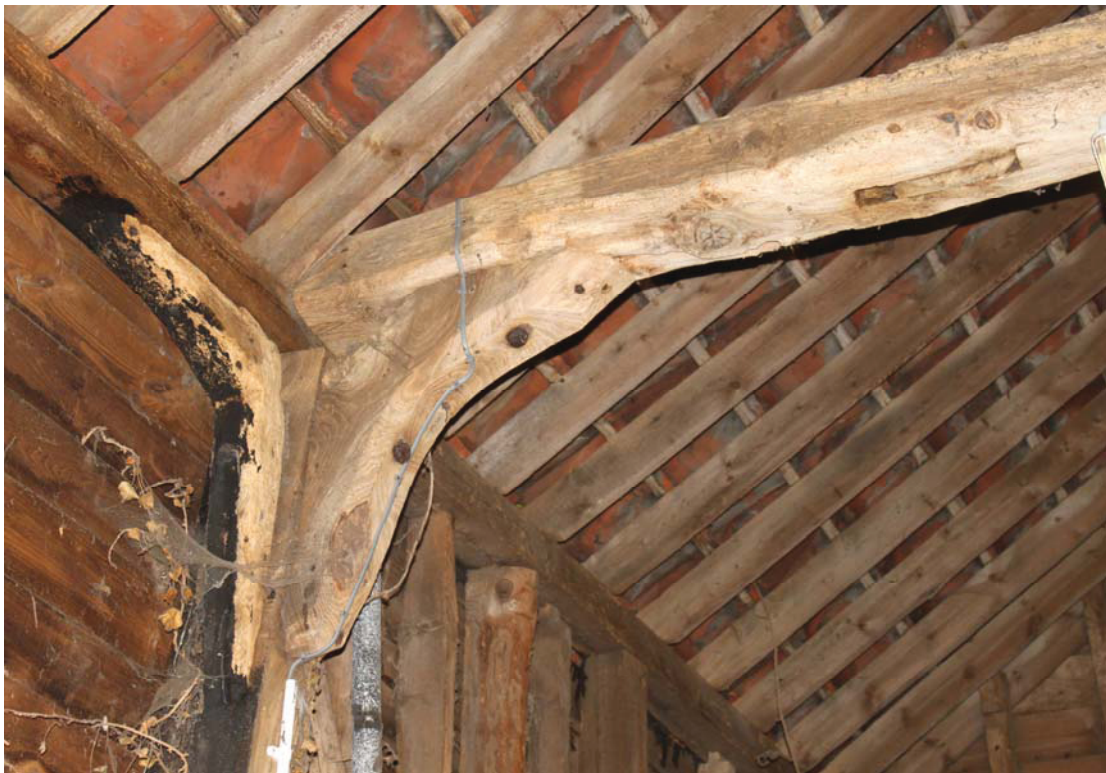
A2.6 Detail of original bolted knee-braces and re-used tie-beam in north-eastern corner of entrance bay. The empty arch-brace mortise in the underside of the tie-beam is shown to right

The framing consists almost entirely of uniform machine-sawn softwood and is characteristic of the late-19th and early-20th centuries, with nailed primary wall-braces and bolted knee-braces to the tie-beams (which are butted and strapped in all closed trusses rather than dovetailed). The storey posts are not jowled, and the original roof structure contains nailed collars with a ridge-board. The barn is shown on the first edition Ordnance Survey of 1882 but not the tithe map of 1840, and is unlikely to pre-date the former by more than a year or two. The many local barns of the 1850s and 1860s are stylistically earlier, with hardwood frames, tenoned wall braces and jowled storey posts, and a date of *circa* 1880 is suggested here. The tie-beams of the entrance bay and the ceiling joists of the vehicle shed (C), however, were re-used from one of more buildings of the 17th century or before: the oak tie-beams contain pegged mortises for traditional arch-braces (not reflected in the storey posts)

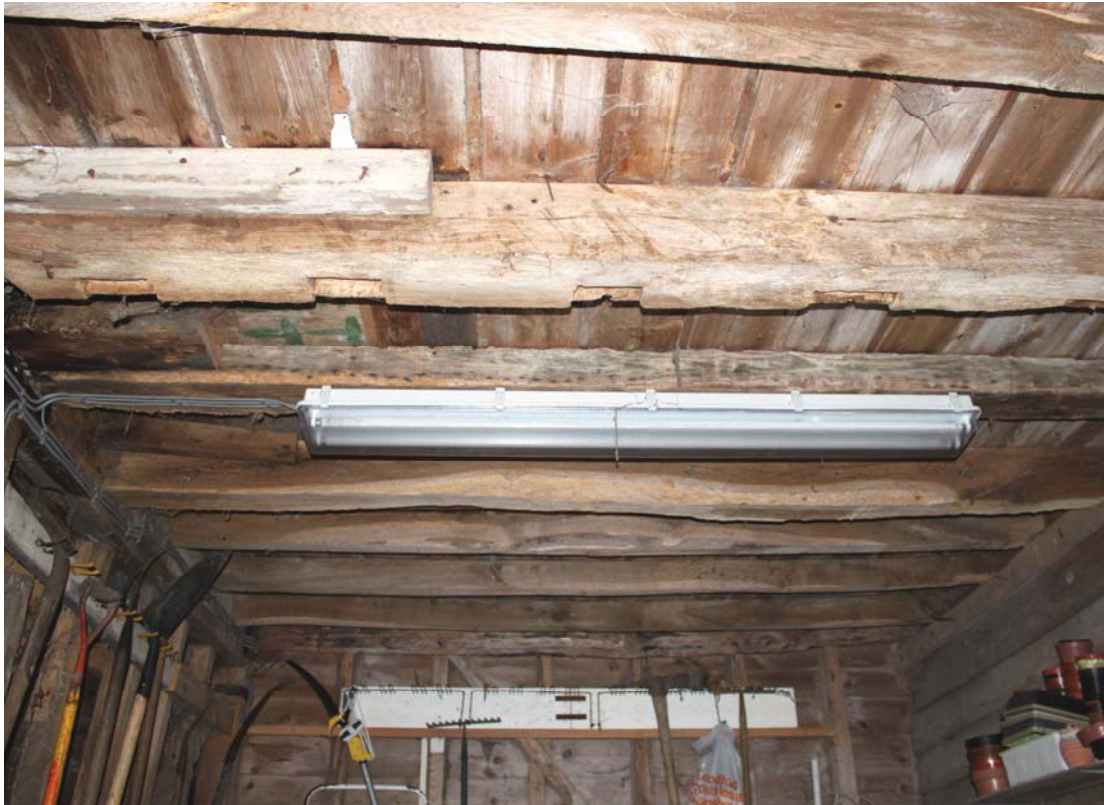
A2.7 Detail from north of re-used ceiling joists in vehicle shed (C). These substantial hardwood timbers were necessary to support the weight of the granary above.

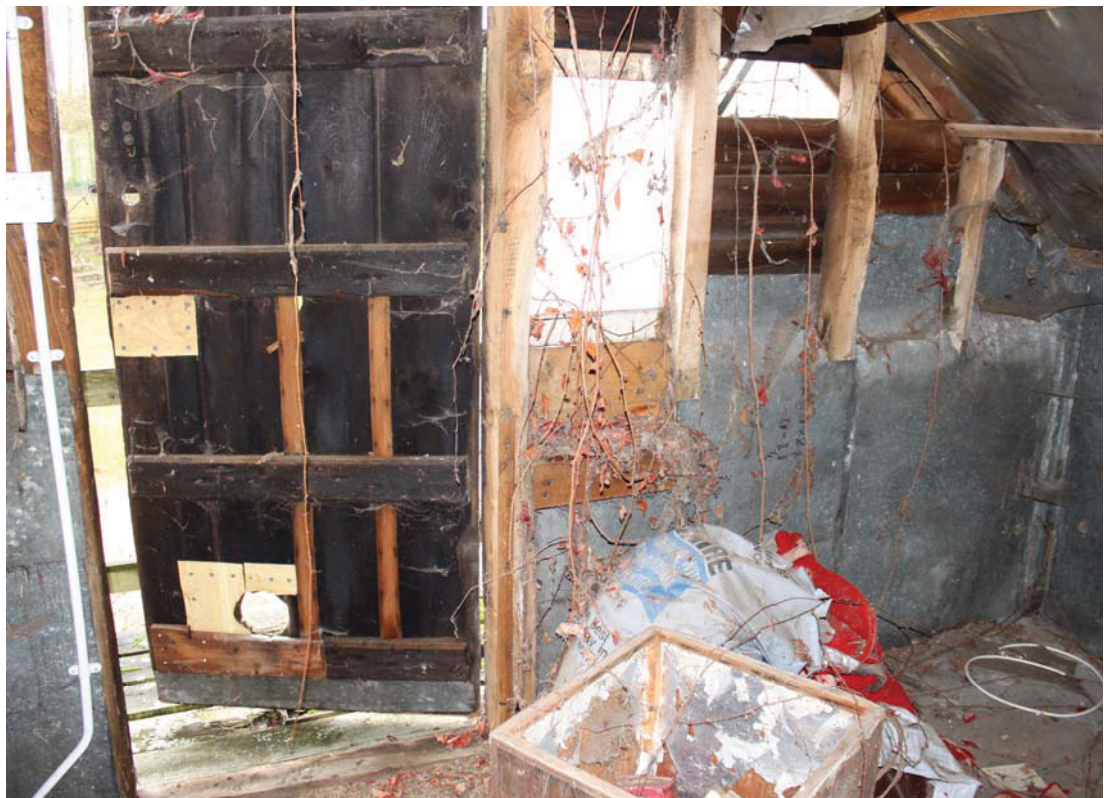
A2.8 Internal eastern gable of first-floor granary above vehicle shed (C) showing cat hole at base of door and 20th century zinc lining.

The narrow eastern bay is divided from the barn by an original boarded partition and contains a ceiling of re-used axial joists with double-doors in its northern elevation. Given its orientation towards the site entrance, and the width of its (renewed) doors, this space of 2.75 m (9 ft) in length was probably designed as a vehicle shed for a trap or cart. The upper storey formed a granary reached by a recently renewed external stair. The original door in its eastern gable contains a circular cat hole of standard design at its base – such features were commonly provided in granary doors to permit the farm cats to control vermin. The space is lined with zinc sheeting but contains no evidence of boarded bins.

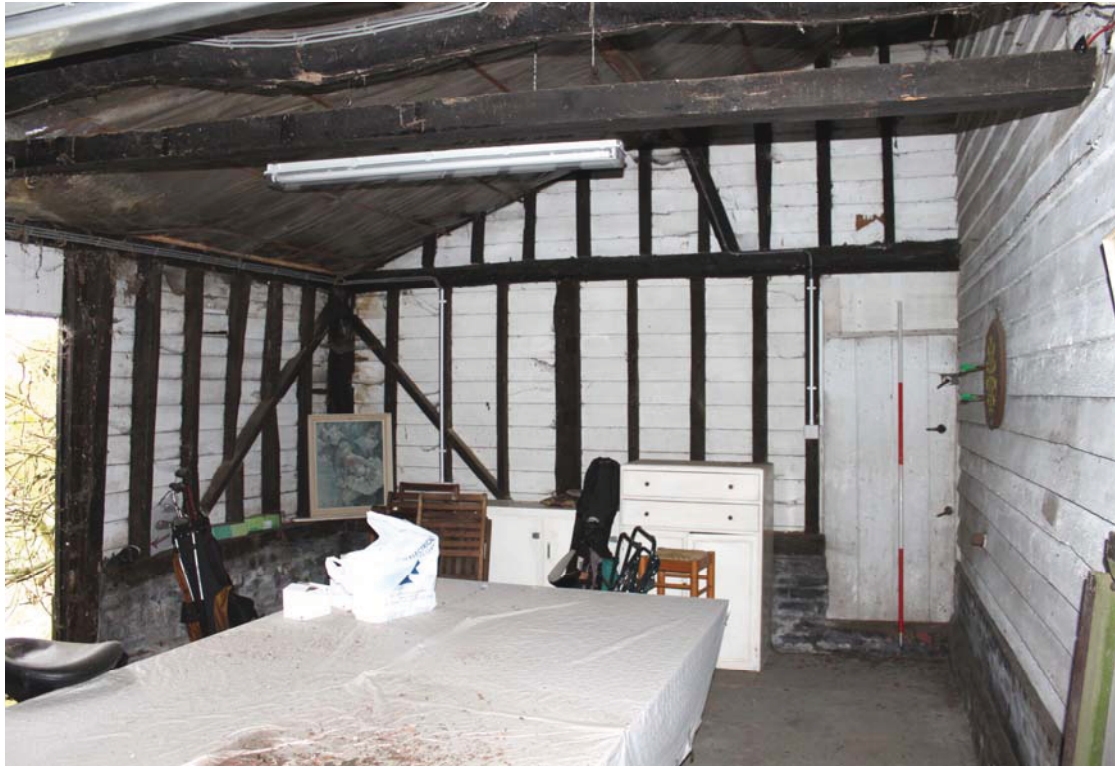
A2.9 Interior of south-eastern shed (E) from west showing external southern entrance to left and door to barn porch to right.

The eastern bay of the lean-to (E) forms an enclosed shed of 6.7 m in length (22 ft) entered by double-hung doors from the demolished southern yard and linked to the barn by a door in the corner of its porch. This shed was probably designed as a bullock shed with detached loose boxes in the yard but it has already been converted into a domestic games room and no evidence of mangers or hay racks survives. The space is too large for the pair of working horses a farm of this scale might have required, and its smaller counterpart to the west (D) would have been a more likely candidate as a stable but for the height of its manger and rack. The latter is likely to have accommodated a small number of dairy animals while the larger shed housed fat stock.

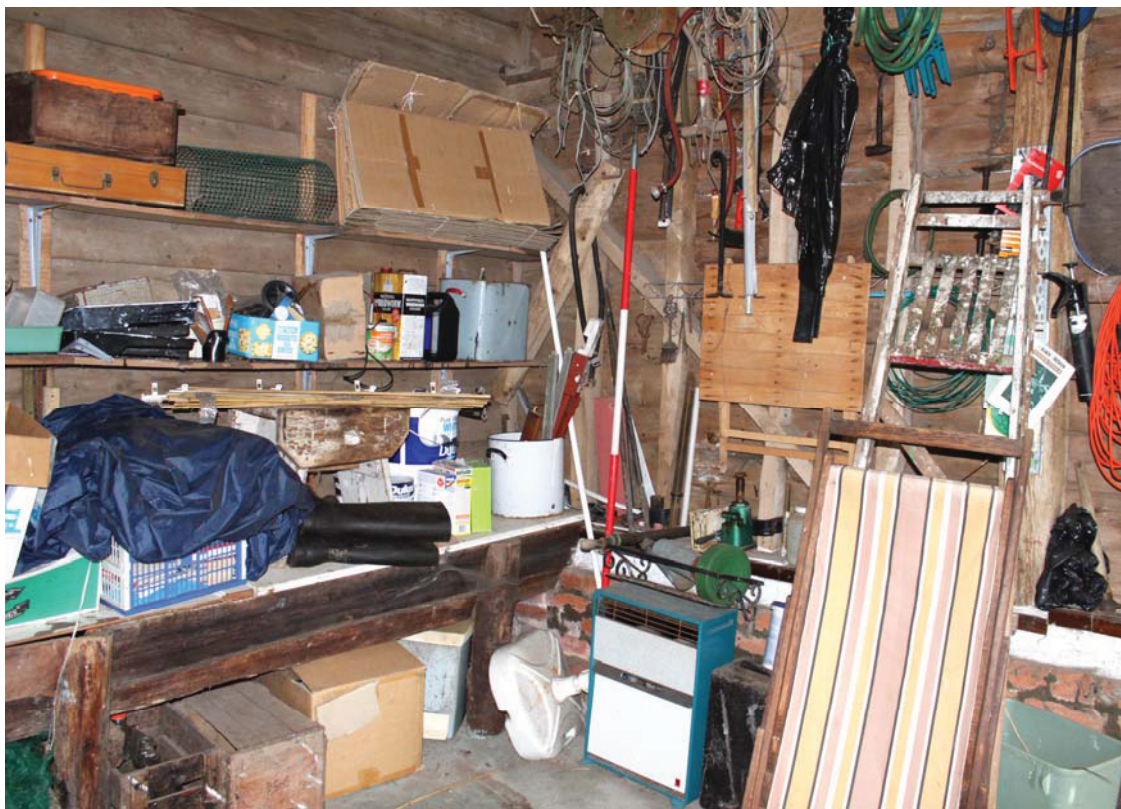
A2.10 North-eastern internal corner of cow shed (D) showing low boarded cattle manger beneath modern shelving against barn wall to left and the diagonal rail of a missing hay rack in centre (to left of half-metre scale rod).

The western bay of the southern lean-to (D) retains a low boarded manger against its northern wall, as shown in figure 6, flanked by nailed diagonal rails that supported a missing hay rack. The height of these features, with the top of the manger just 73 cm (29 ins) above the ground and the bottom of the rack 1.1 m (45 ins), indicates they were used by cattle rather than horses (a horse rack is normally at least 2 m high). The southern wall of the shed consists of 20th century boarding with large windows and dates only from its late-20th century conversion into a workshop; the absence of any brick plinth from this section of wall demonstrates that it was formerly open and apparently adjoined the open-sided yard shelter shown on the Ordnance Surveys.
