**‘Barn’ & Coach House,  
Rushford Hall,  
Euston, Suffolk  
EUN 032**

**Historic Building Record**

# **‘Barn’ and Coach House, Rushford Hall, Euston, Suffolk**

## **Historic Building Record**

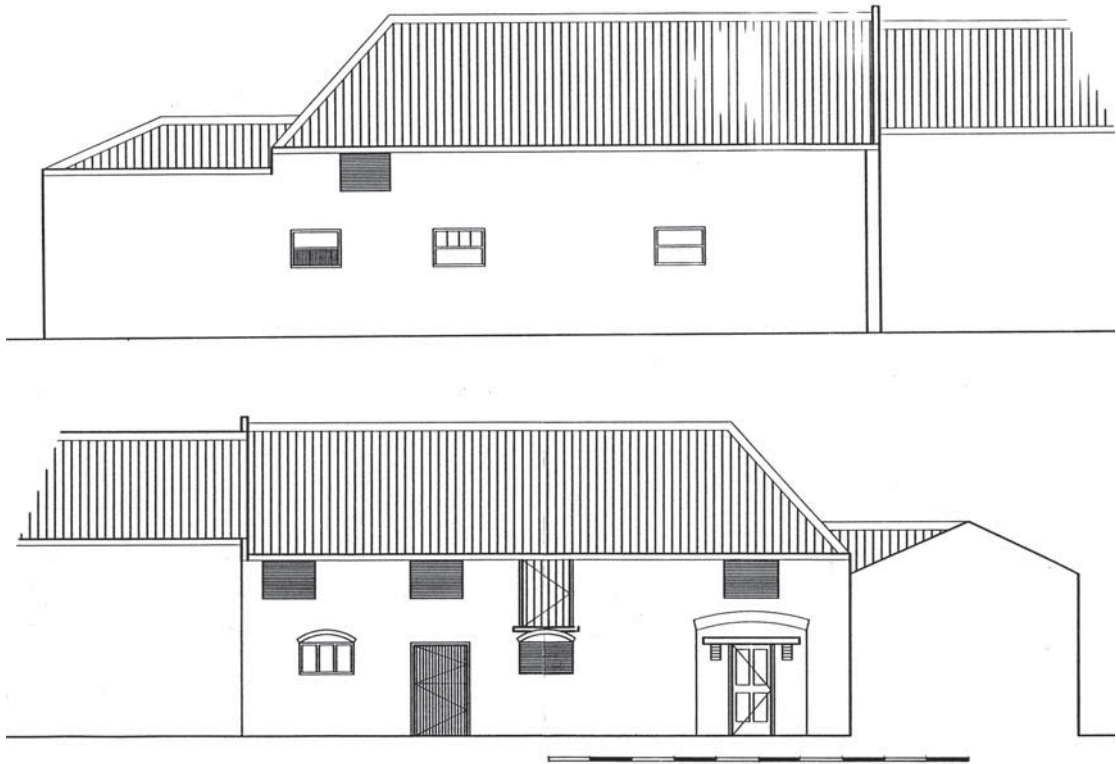
**Figure 5**  
**External northern (top) and southern elevations of the 19<sup>th</sup> century stable and former coach house (scale in metres, omitting brick dressing). Drawn by Brown & Co. of Norwich. The arch of the coach house door is shown to the right. The left door was moved from the left-hand window to the centre of the new range in the mid-19<sup>th</sup> century when the early-19<sup>th</sup> century stable was extended.**

The hay loft above the ground-floor stable is now reached by an external loading door at the eastern end of the southern elevation, but this appears to have originated as a window and the original door lay to the west of the same façade (and was later converted into a window). These alterations probably occurred when the coach house extension was built in the mid-19<sup>th</sup> century. There is evidence of a boarded partition between the central tie-beam of the loft, and

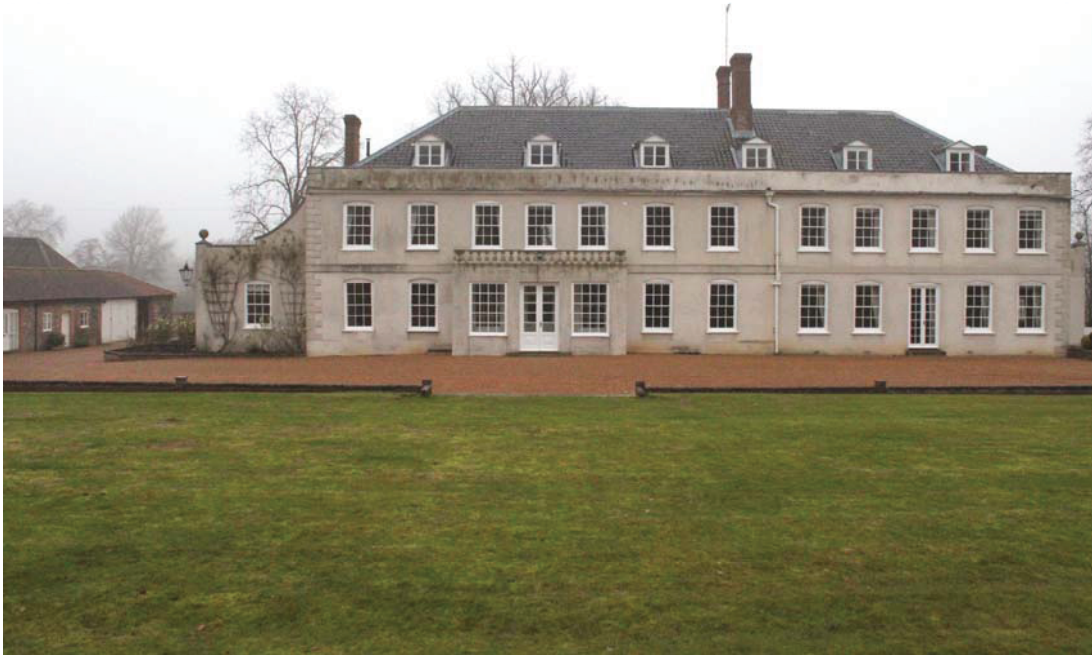
A2.1 General view of site from south showing façade of Rushford Hall with modern coach house (6) and hipped gable of earlier coach house (2) visible to left

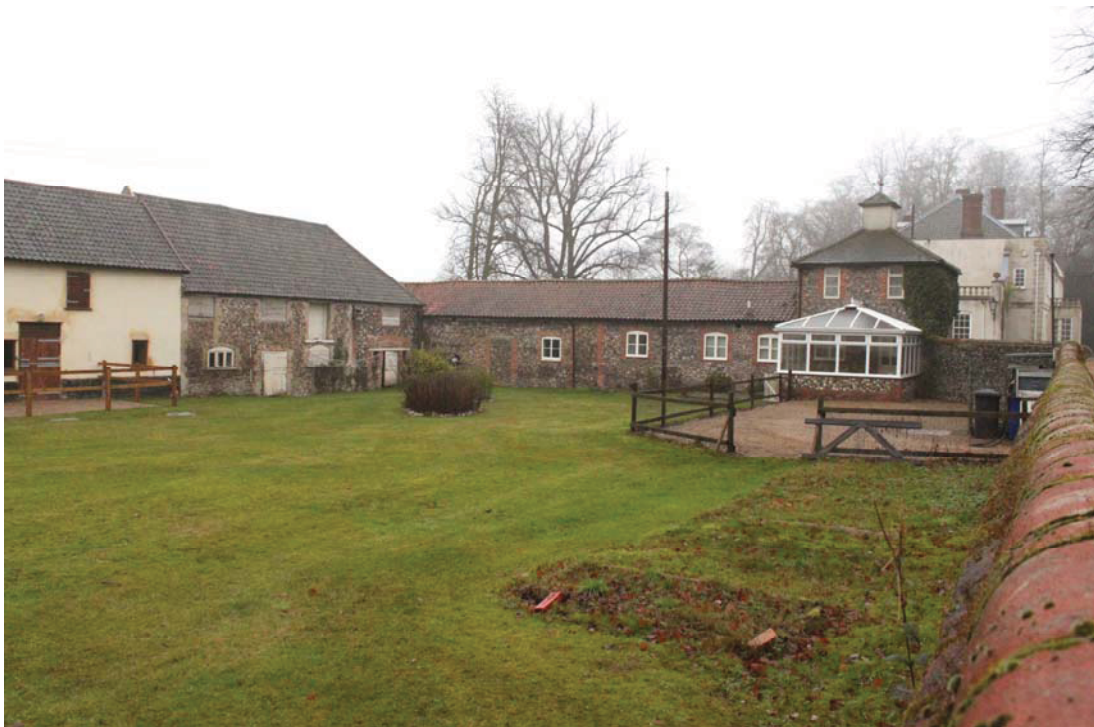
A2.2 General view of former stable yard from west showing from left to right: clay-lump mid-19<sup>th</sup> century stable, early-19<sup>th</sup> century flint rubble stable with later coach house to right (1 & 2), single-storied modern coach house (6), converted single-storied shed and probable granary (with turret clock), Rushford Hall (in rear) and yard wall to north of drive.

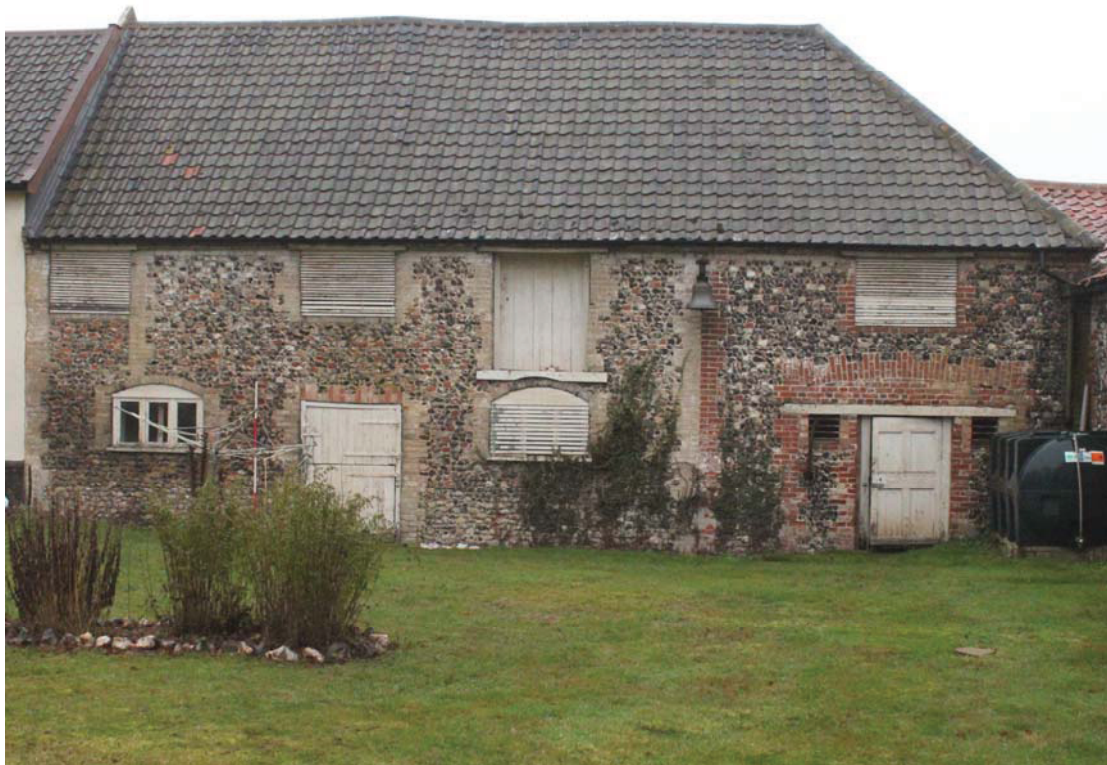
A2.3 Southern exterior of flint stable (1 to left) and later coach house subsequently converted into a game store (2 to right). Note blocked arched doorway of coach house and original first-floor loading door of stable to extreme left.

The eastern section of the two-storied range is a matching extension of 5.2 m in length (17 ft) with dressing of red brick as opposed to the gault brick of its earlier neighbour. A wide brick arch above the present southern entrance suggests it was designed as a coach house, but it appears to have been converted into a game store during the late-19<sup>th</sup> or early-20<sup>th</sup> century. Nails were hammered into the sides of its tall-sectioned ceiling joists to serve as hooks and a copper with an internal chimney (now truncated at eaves-level) was built in the centre of its rear (northern) elevation. There is no other evidence to suggest the building was used as a wash house or brew house, which seems unlikely given its distance from the house, and the hot water may have been required to de-feather and prepare game for the kitchen. The copper tub has been removed but its brick base and grate remain. A pair of rear doorways on both sides of this feature presumably opened into the missing lean-to shed mentioned above, but has since been converted into windows. A yard bell which projects from the junction between the two phases is cast with the date 1831 and may commemorate the construction of the coach house, but a date in the 1850s or 1860s is more probable. Its fabric appears integral with the much altered single-storied range to the east of the yard.

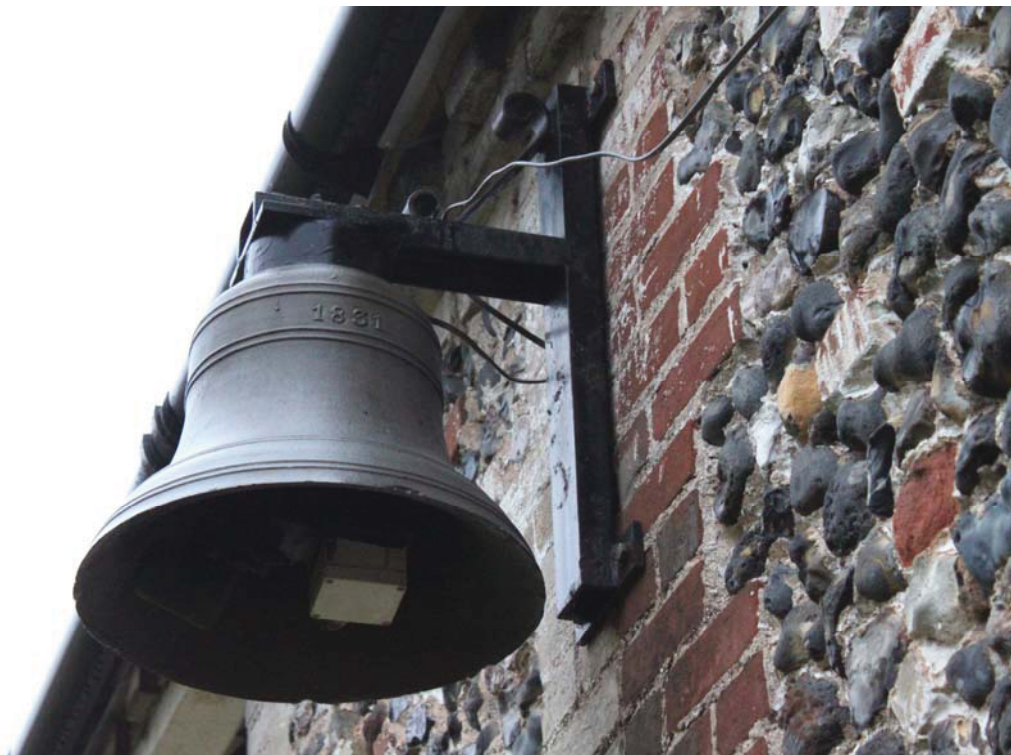
A2.4 Detail of clock bell with cast date 1831 to southern elevation of stable (1) and coach house (2).

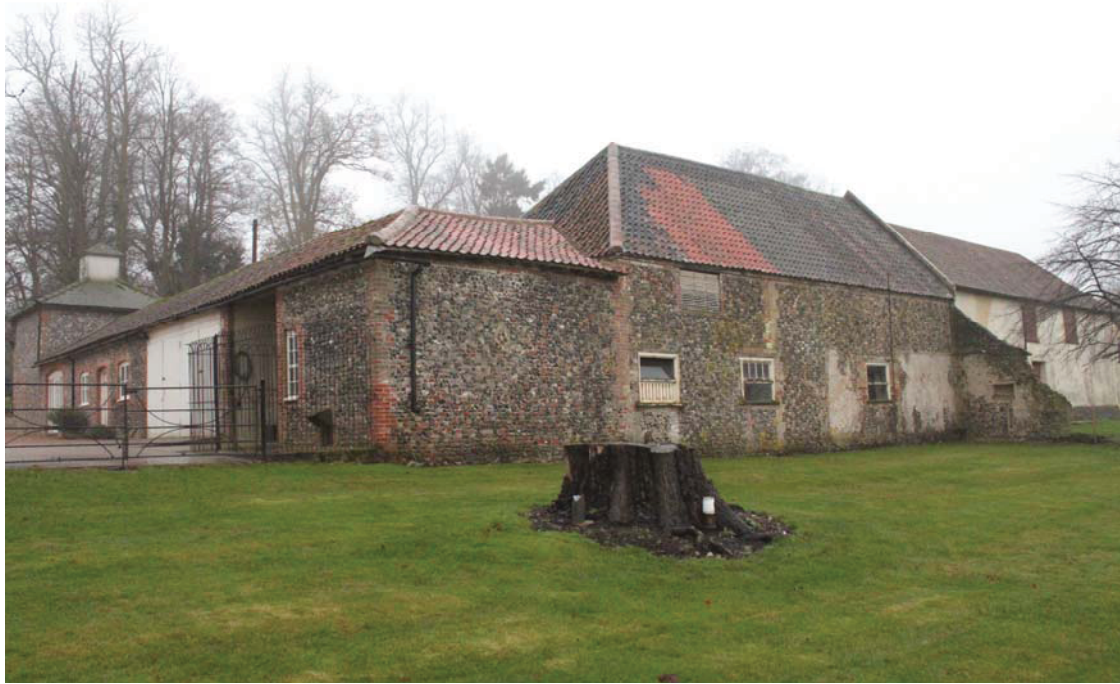
A2.5 General view of former stable yard from west showing from left to right: converted single-storied shed and probable granary (with turret clock), single-storied modern coach house (6), single-storied tack room now converted into kennel (at corner), early-19<sup>th</sup> century flint rubble stable with later coach house to left (1 & 2) – showing remains of lean-to rack room to right – and clay-lump mid-19<sup>th</sup> century stable to extreme right.

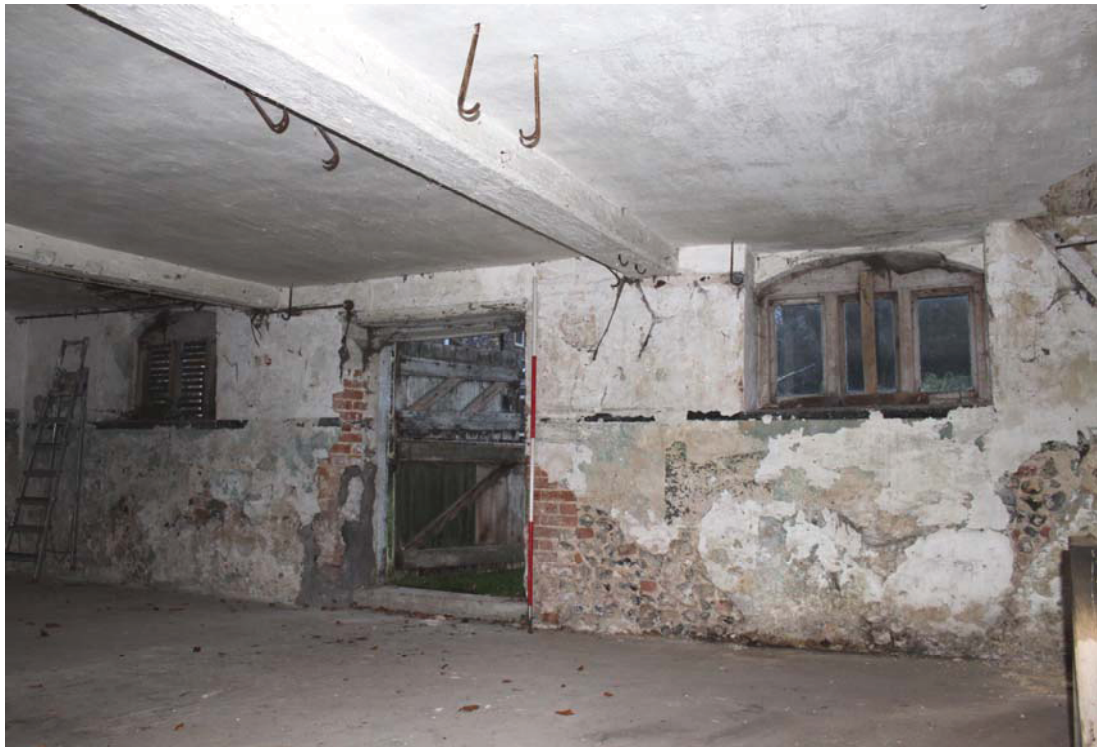
A2.6 Southern interior of stable (1) showing central yard door flanked by windows and showing diagonal strut of former hay rack against western elevation to right.

The ground floor is entered by a central door flanked by louvered windows to the southern yard. A blocked rear door immediately opposite (now a window) opened onto a lean-to shed that probably operated as a tack room and the diagonal strut of a hay rack against the western gable still survives at the end of the southern internal elevation. The render and part of the western gable of the demolished lean-to also survive against the northern external elevation, and the historic Ordnance Surveys suggest a lean-to continued to the north-eastern corner of the complex. This layout is typical of stables in the 18<sup>th</sup> and 19<sup>th</sup> centuries when horses were often stalled against both gables rather than the rear wall (as was more usual in earlier examples). A number of horizontal wooden struts against the western gable may relate to a manger or shelf, but no other fixtures or fittings remain. The internal walls are painted in green with a dark band at a height of 1.5 m to imitate wainscot boarding.

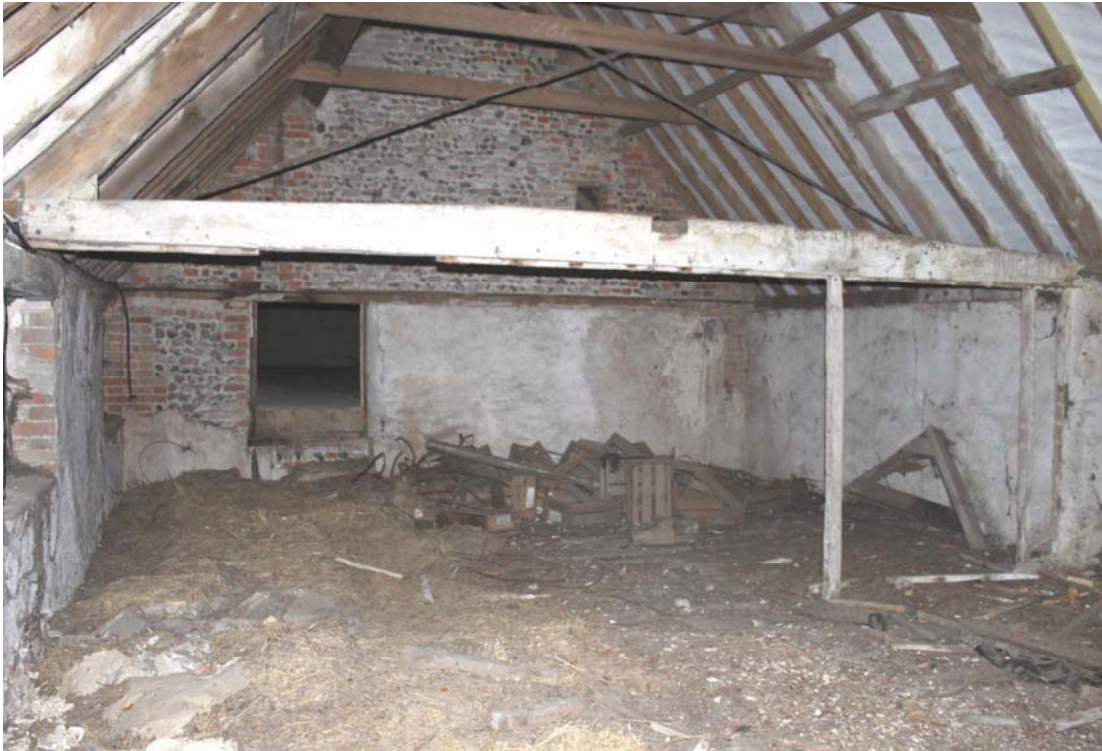
A2.7 Interior of stable loft (1) from east showing central tie-beam with remains of lateral partition and fragment of original roof structure of staggered butt-purlins to right. The secondary door in the western gable opened onto the loft above the clay-lump stable (4).

this too may be an addition of the mid-19<sup>th</sup> century. The western gable adjoins a clay-lump stable range of the mid-19<sup>th</sup> century but appears to retain part of a well-finished red-brick wall that may relate to an earlier building on the site; the roof scar of a slightly narrower structure can still be seen. The two lofts are now linked by a secondary door. A dentil cornice extends along the northern and southern elevations, and returns along the former eastern gable which was presumably hipped (now visible from the loft of the coach house extension).

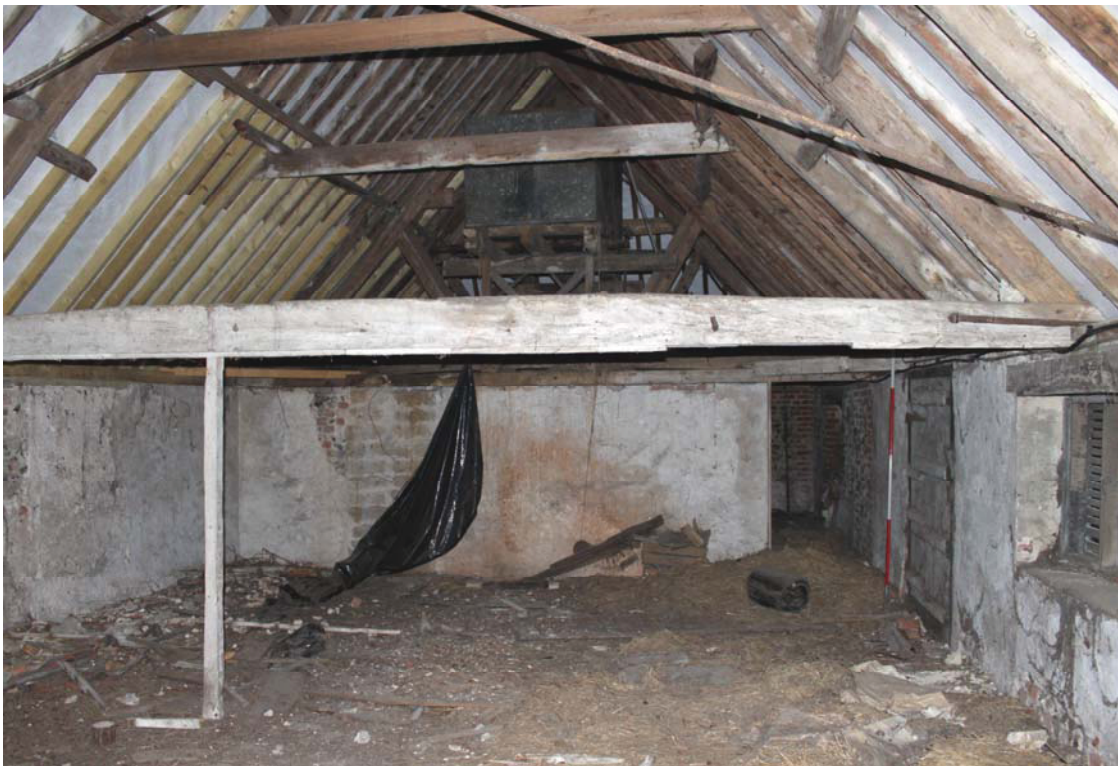
A2.8 Interior of stable loft (1) from west showing later door to coach house loft (2) and external loading door to right. The eastern gable shows a section of clay-lump repair to the left.

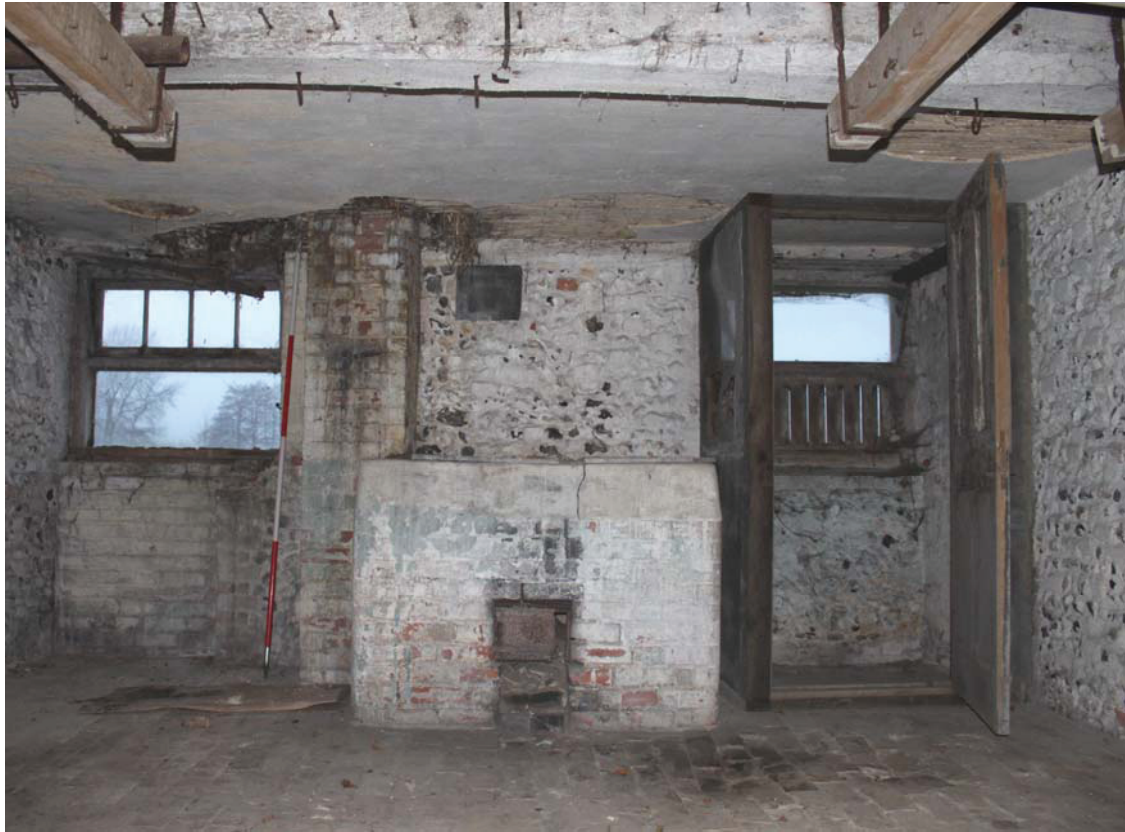
A2.9 Northern interior of coach house (2) showing later copper between blocked original doors (now converted into windows).

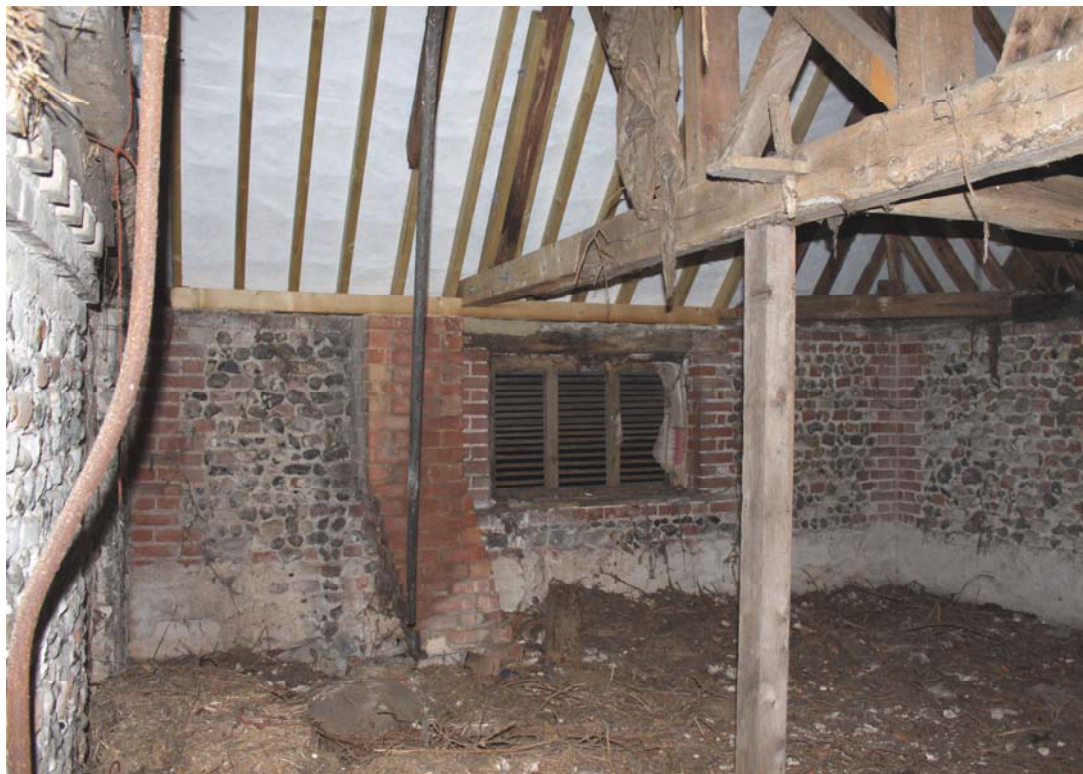
A2.10 Northern interior of coach house loft (2) showing original window and secondary chimney of copper with dentil cornice of original external gable to stable (1) to left.
