**‘Barn’ & Outbuilding,
Rose & Crown Inn,
Long Melford, Suffolk
LMD 185**

Historic Building Record

**‘Barn’ and Outbuilding,
Rose & Crown Inn,
Bridge Street,
Long Melford, Suffolk**

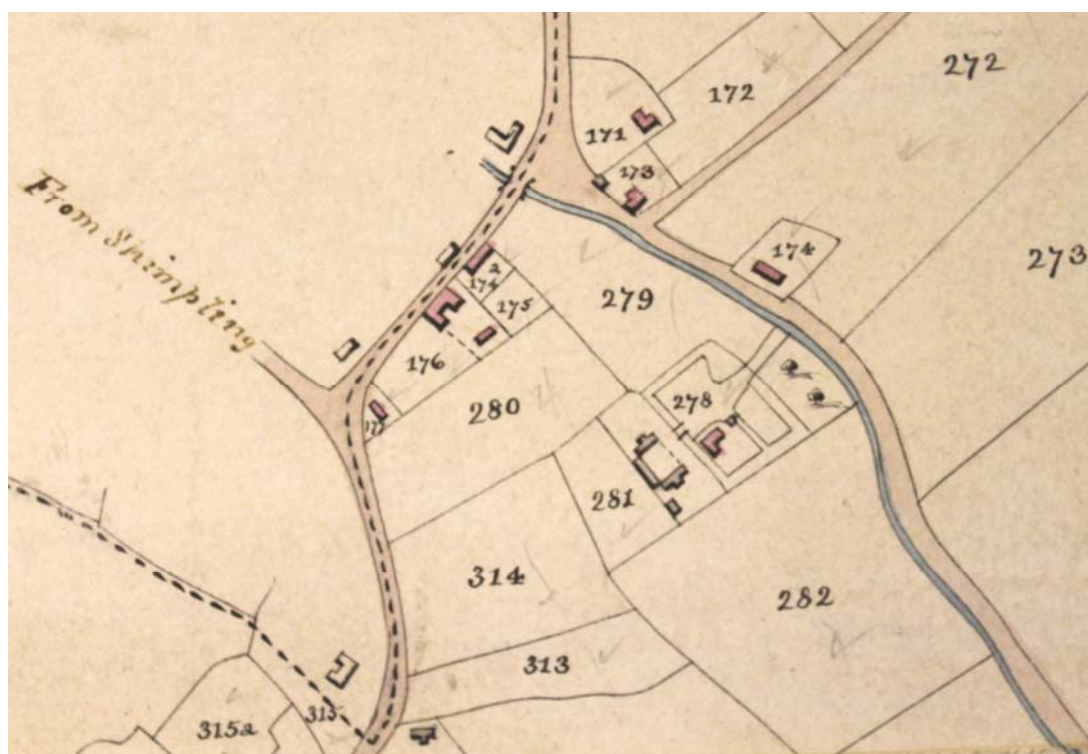
Figure 2

Bridge Street as depicted on the Long Melford tithe map of 1839, showing the Rose & Crown with a narrow rectangular outline (no. 174a). The present stable and sheds had not yet been built. Nothing now survives of the large ‘U’-shaped structure in the northern yard of Rose Cottage to the west (176) and the modern A134 now by-passes the road bend on the east.

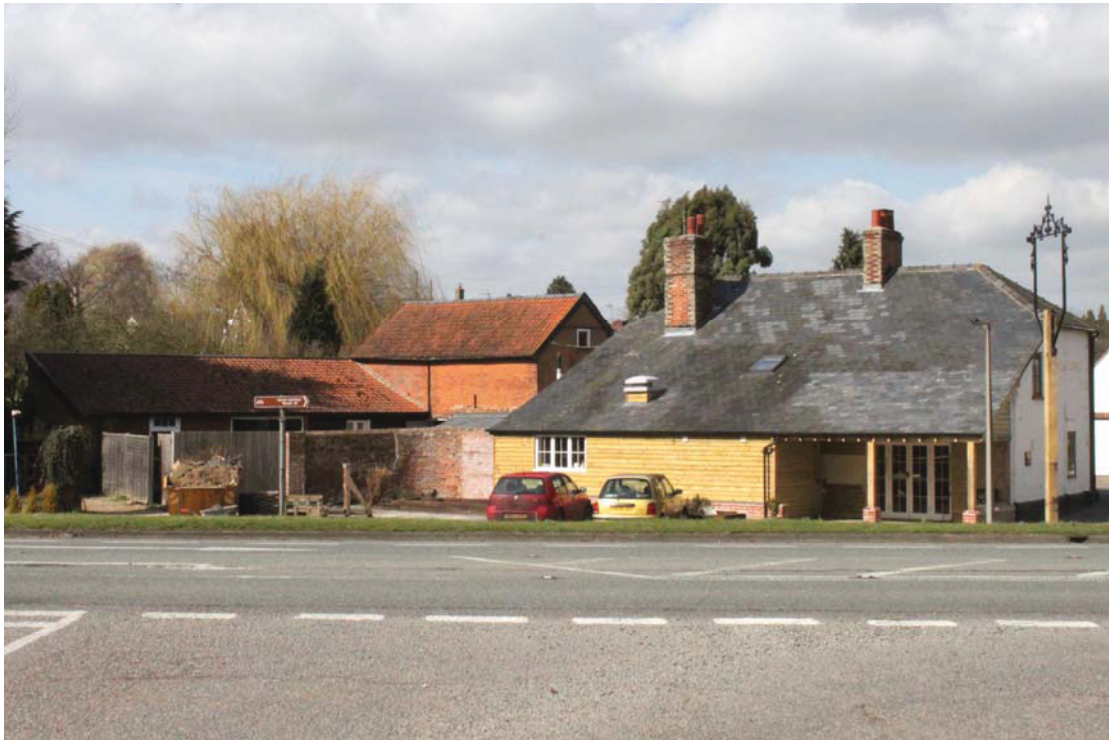
A2.1 General view from modern A134 to south-east showing red-brick stable (1) and single-storied range of sheds (2-4) to left & rear elevation of Rose & Crown Public House (5) to right

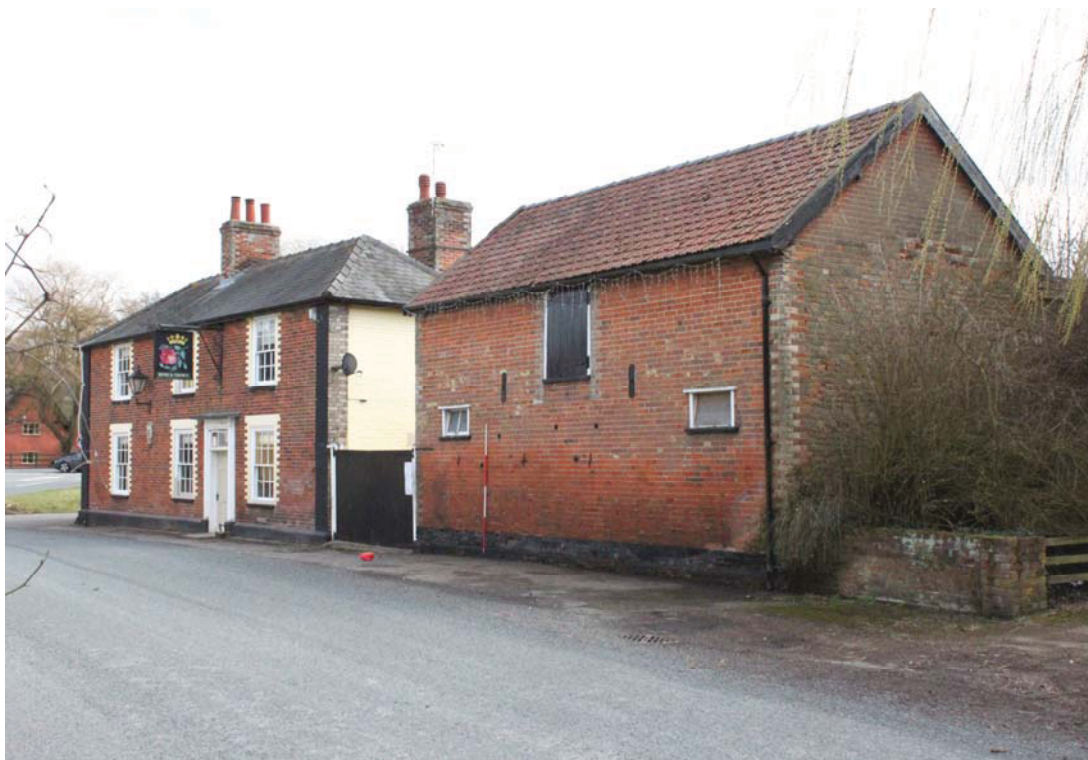
A2.2 General view of site from old road to north-west showing stable (1) to right with Public House (5) to left.

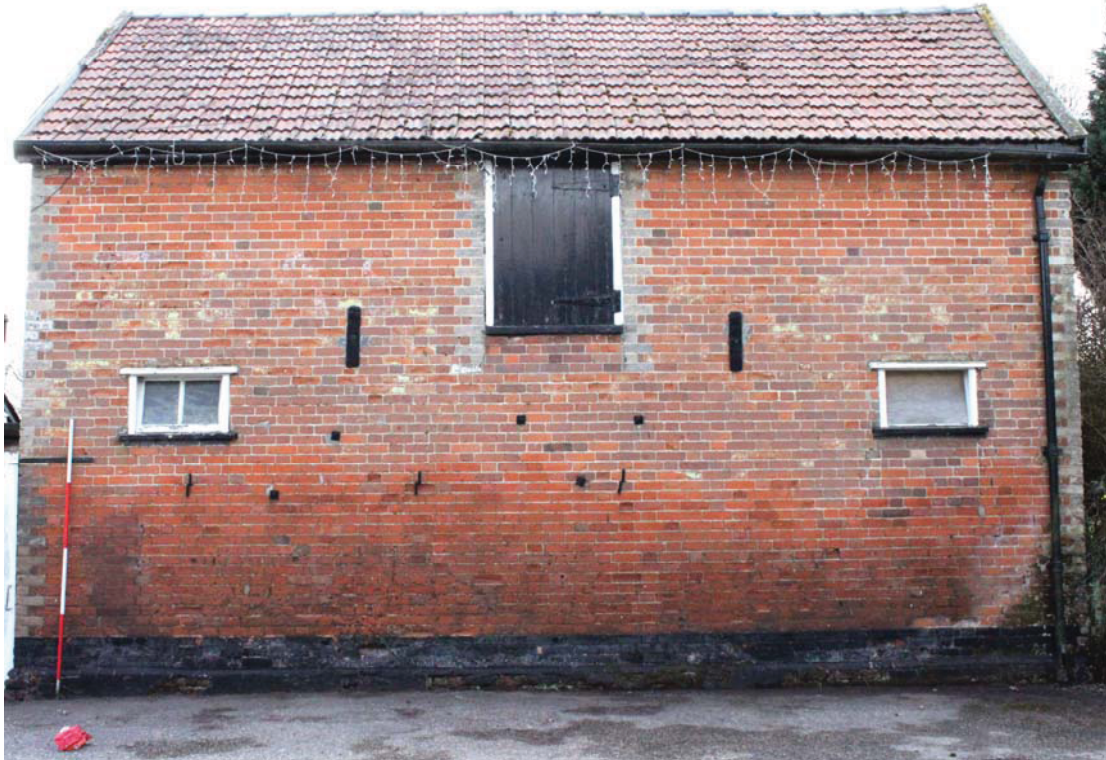
A2.3 Northern roadside facade of stable (1) showing original hay loft door with gault brick dressing in centre and evidence of blocked secondary ground-floor window or hatch to right.

The general layout and appearance of the stable remains largely intact, but its ceiling and roof structure are 20th century replacements. The present ceiling consists of mid- to late-20th century softwood joists supported on two secondary brick piers and with clearance of 2.3 m (7.5 ft) it lies approximately 0.3 m above the original ceiling (as indicated by the reduction in the height of the external loft door). The brickwork of both roof gables has also been rebuilt, and the treble tiles and softwood clasped-purlin structure of the roof are additions of the early-20th century. The original stable (and range of sheds) may have been roofed with slate to match the inn, or with pantiles. 20th century windows have been inserted into the lower storey of the western gable and the upper storey of the eastern gable, while the original ground-floor window to the east has been reduced in width as described above. Small secondary windows have also been inserted at both ends of the northern façade, and the western example was formerly of greater depth but has been reduced in height: six courses of inserted brickwork are visible beneath its present sill.

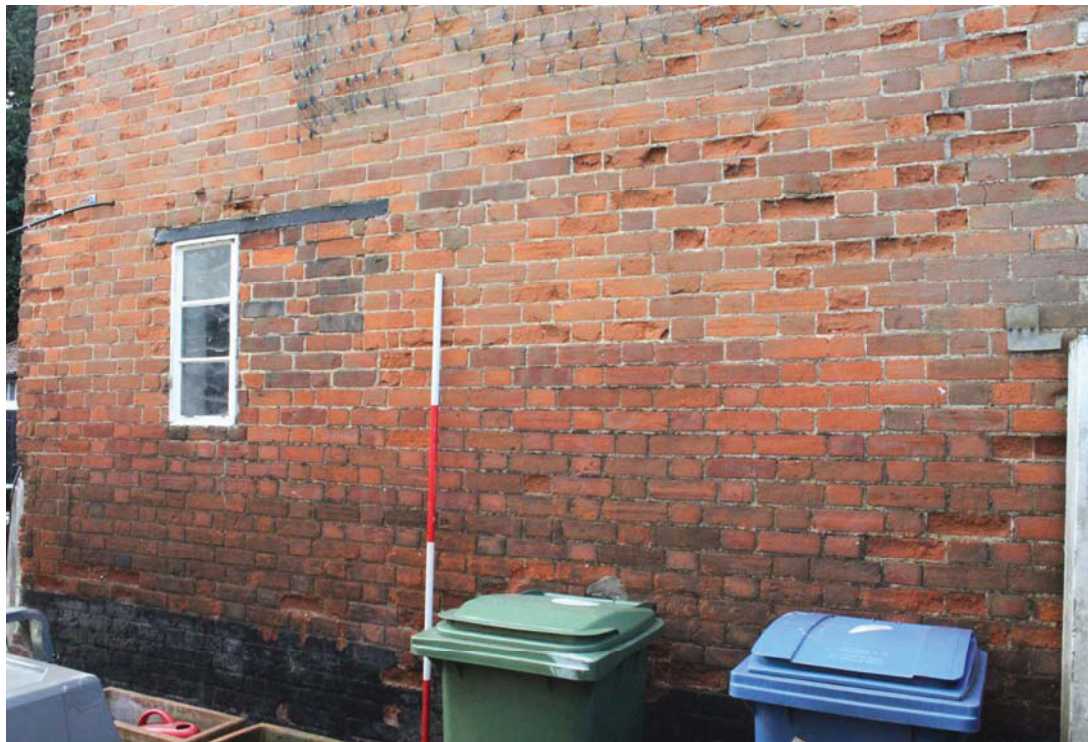
A2.4 Exterior of eastern gable showing partly blocked original window to left with numbered brick immediately beneath.

The stable was entered by a single door in the approximate centre of its rear elevation and lit by a single window in its eastern gable. The doorway remains in use but the window has been reduced in width (its original proportions are defined by quarter bricks). A brick beneath this window is inscribed externally with the horizontal numeral '5', which probably identified a manufacturing batch. The front (northern) elevation was entirely featureless on the lower storey, in the characteristic manner of stables which typically possessed hay racks and mangers opposite their yard entrances. The central first-floor loading door to the hay loft has been reduced in height, as indicated by the continuation of its gault brick dressing beneath its present sill and by four courses of secondary brickwork. No trace of the hay rack now survives, but the boarded manger which spans the entire width of its roadside elevation is almost certainly original to the building and is a particularly fine example of its kind. Rising to 0.9 m (3 ft) above the concrete stable floor it retains some seven or eight tethering rings and a number of internal divisions (it was partly hidden at the time of inspection), while its timber-work has been reinforced with iron plates and straps to produce a surface of unusual character. No other historic fixtures or fittings remain.

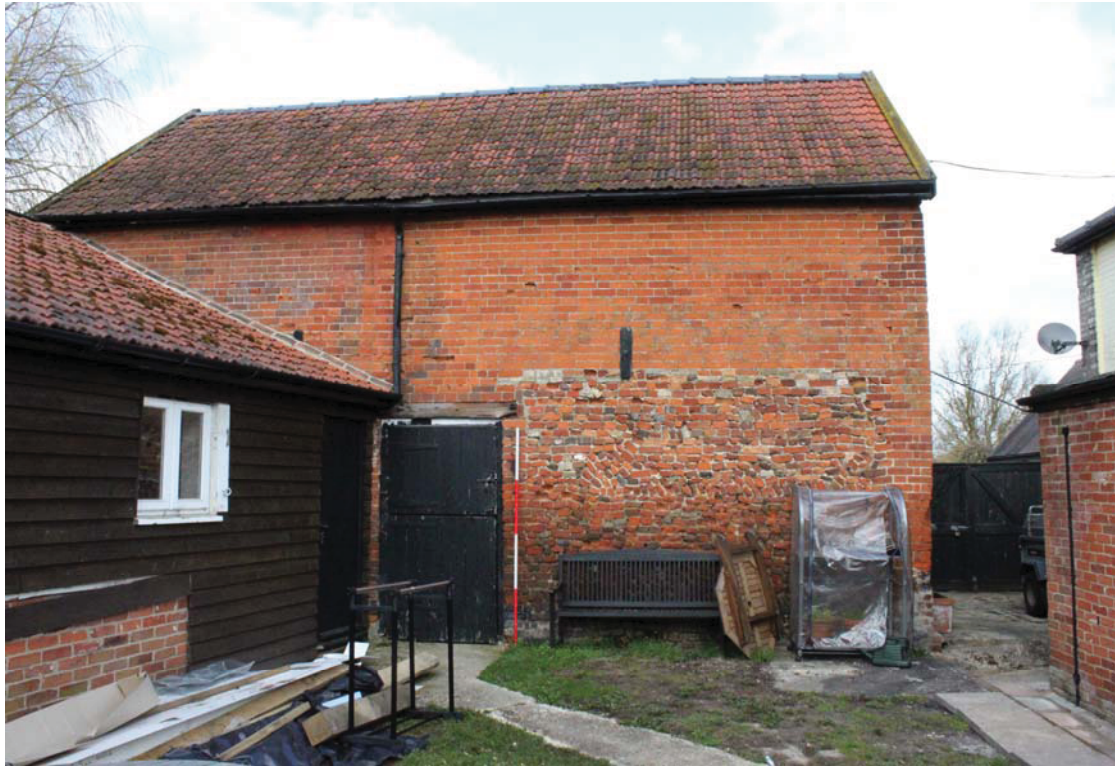
A2.5 Southern exterior of stable showing original central entrance with recently converted northern shed (2) to left and western gable of Public House (5) to right.

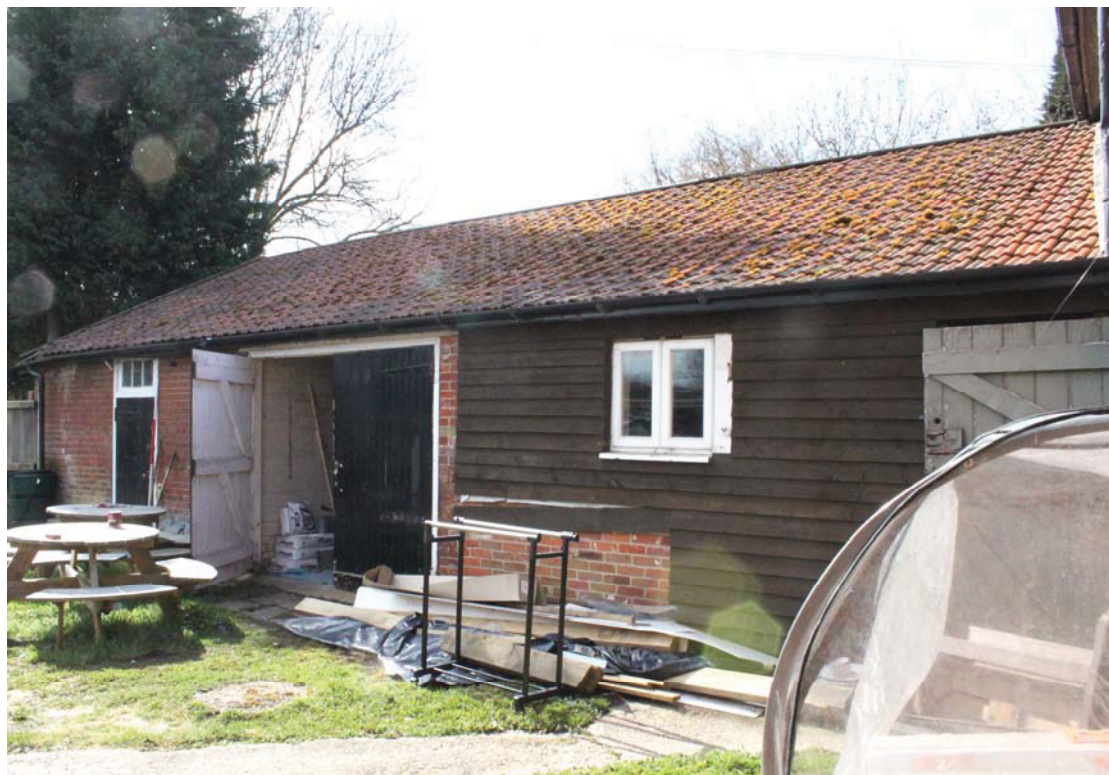
A2.6 Eastern exterior of pentice sheds seen from north-east, showing the vehicle shed (3) in centre, the enclosed southern shed to the left and the modern façade of the northern shed (2) to right.

extends to 3.6 m in width (12 ft) and is divided into three sections. The northern compartment adjoining the stable (2) has been heavily modernised in recent years and its eastern elevation consists of modern brick and boarding; it may have been an open shelter shed in the 19th century, but no conclusive evidence survives. The narrow central shed extends to just 2.75 m (9 ft) in length and contains double doors to house a cart or trap, while the southern shed of 5.2 m in length is entered by a single door with a glazed light above and contains evidence of a boarded shelf at the southern end of its western elevation. This shed may have served as a barrel store but could have readily operated as a harness shed.

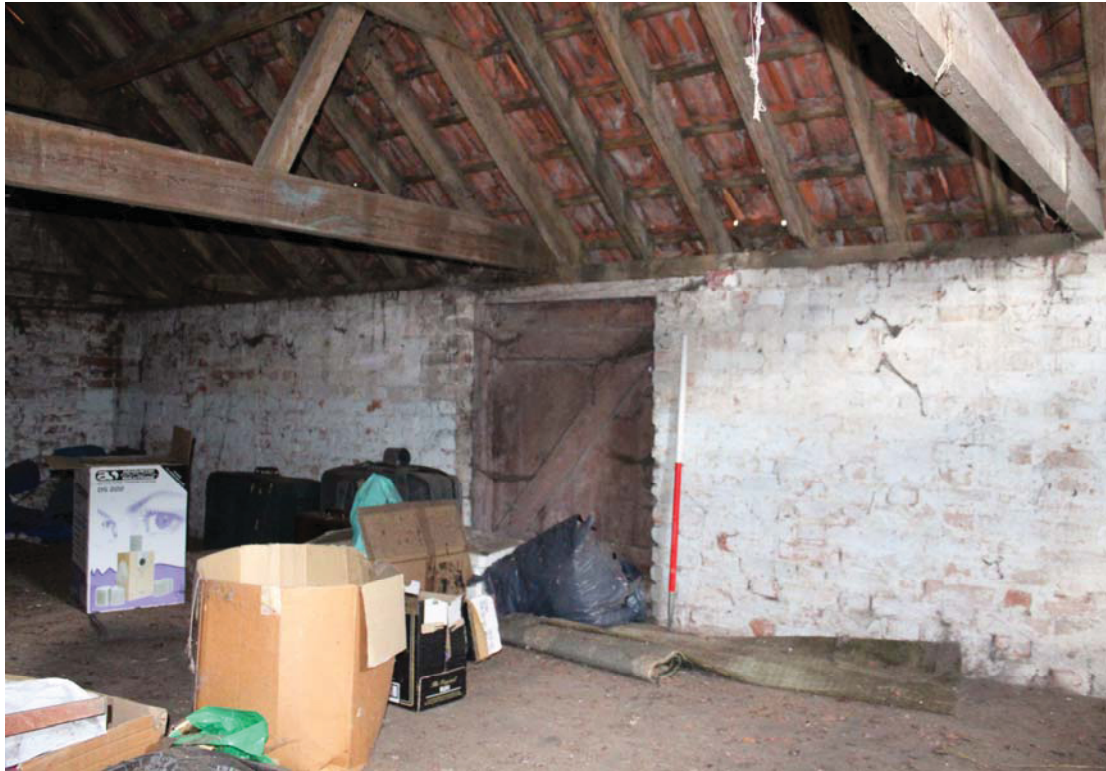
A2.7 Internal northern elevation of hay loft above stable (1) showing external loading door in centre and softwood clasped-purlin roof structure.

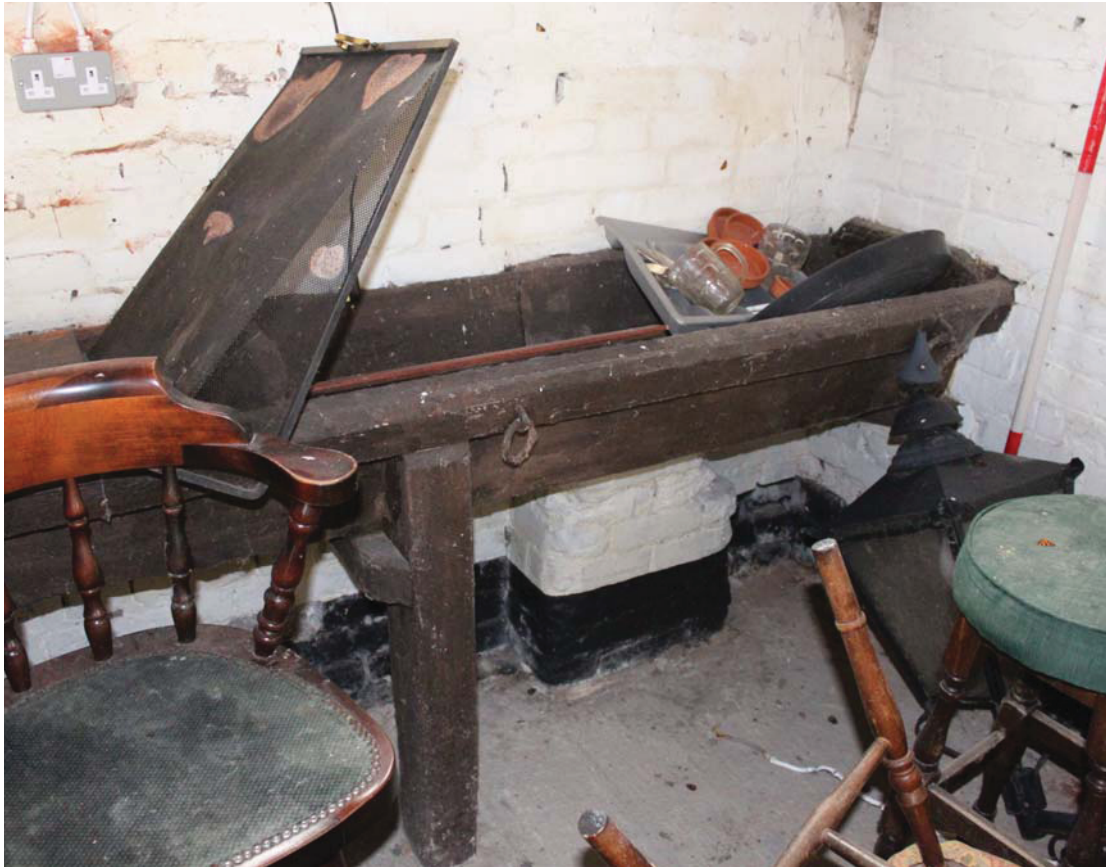
A2.9 Eastern end of original manger against northern stable interior (1) showing tethering rings and boarded construction.

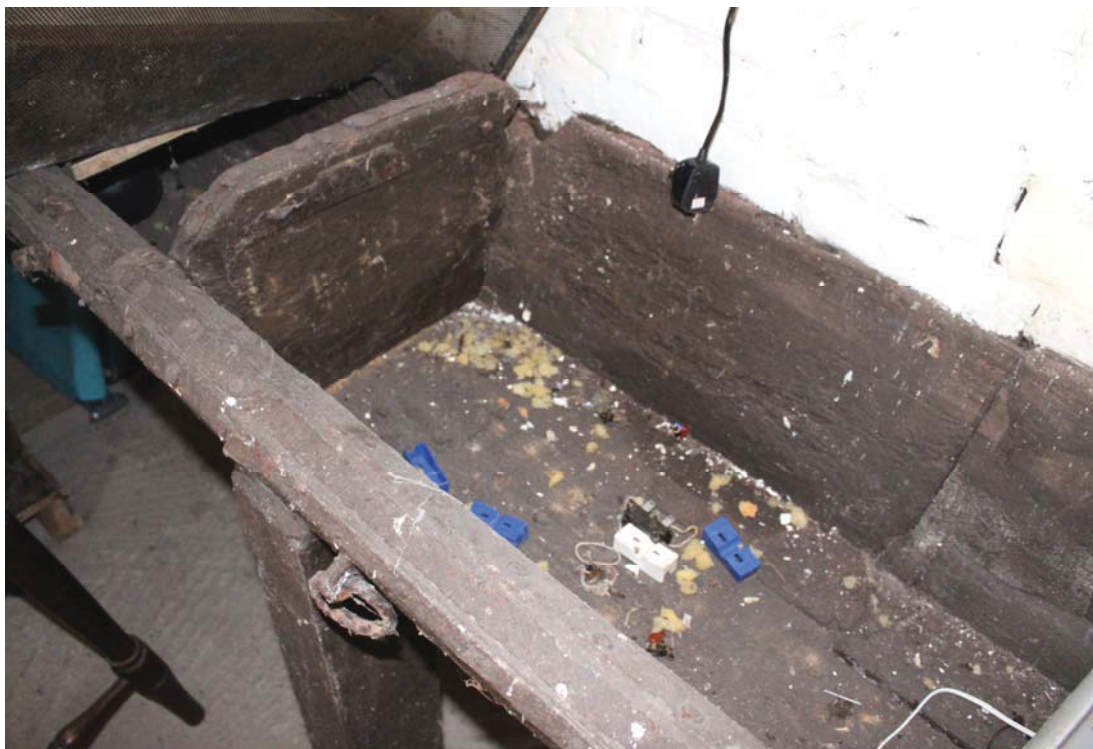
A2.10 Detail of boarded manger against northern interior of stable (1) showing internal division of trough to left.
