ARCHAEOLOGICAL MONITORING REPORT

SCCAS REPORT No. 2009/298

Barns at Vale Farm, Sutton SUT 216

An archaeological monitoring was carried out on land at Vale Farm, Sutton (TM 3194 4534); SUT 298.

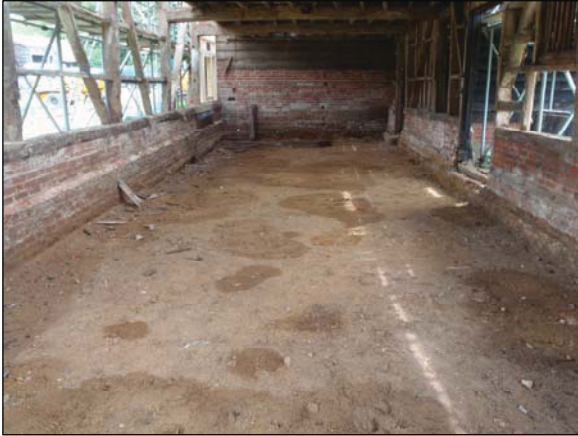
Plate 1. Room 1 looking NE

Room 1: The ground level in this room had been reduced by c. 0.4m prior to the archaeological monitoring. The ground reduction had revealed the orange brown shelly sand which was geological natural deposit 0122; however, without widespread hand cleaning of this surface archaeological cut features would not have been visible.

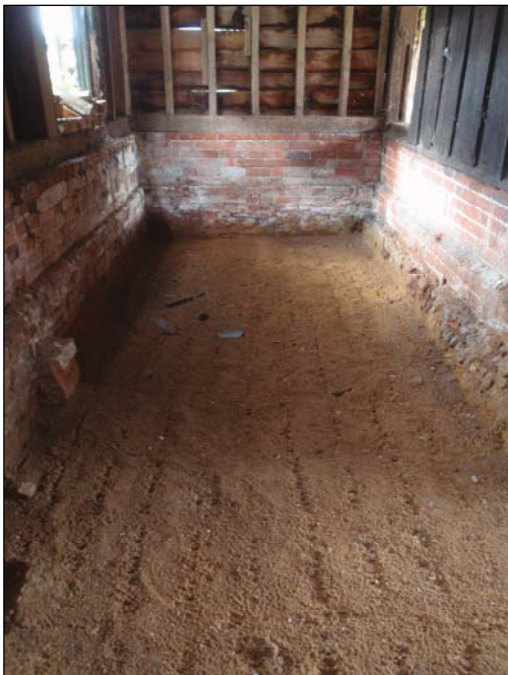
Plate 3. Room 2 looking SE

Room 2: The ground level in this room had been reduced by 0.4m to 0.5m below the floor level. This revealed the light orange brown shelly sand geological natural 0122. The condition of the revealed surface prevented identification of potential features cutting the natural.

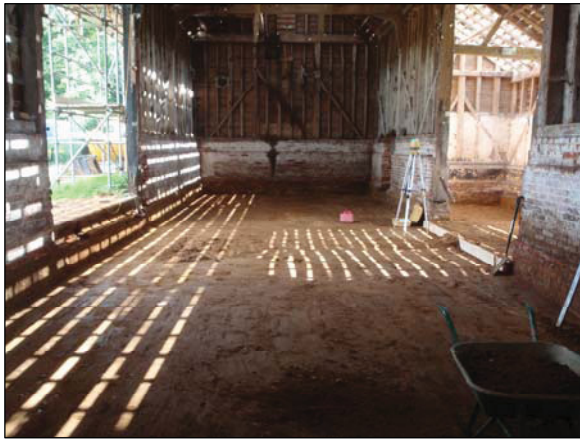
Plate 5. Room 3

Room 3: The ground level in this large room was 0.43m to 0.45m below the former floor level. Remnants of the tarmac floor to this room were evident in places. The ground reduction had revealed the light yellow brown and orange brown shelly sand natural 0122, and in places a 0.1m thick deposit of mid brown shelly sand & CBM rubble make-up, 0123. The brick foundations of the barn were revealed in two places; along the NE end of the room where they were 0.55m deep below the floor level, and along the NW side where they were 0.6m deep below the floor level.

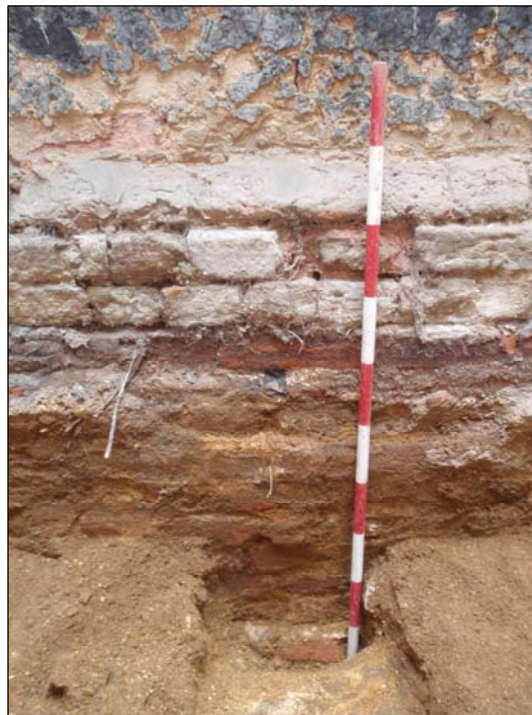
Plate 7. Room 4 foundation

Room 4: The ground level had been reduced by c. 0.4m, revealing a 0.1m thick deposit of mid brown shelly sand and CBM rubble, 0123, over the geological natural 0122. No features were seen cutting the make-up layer 0123.

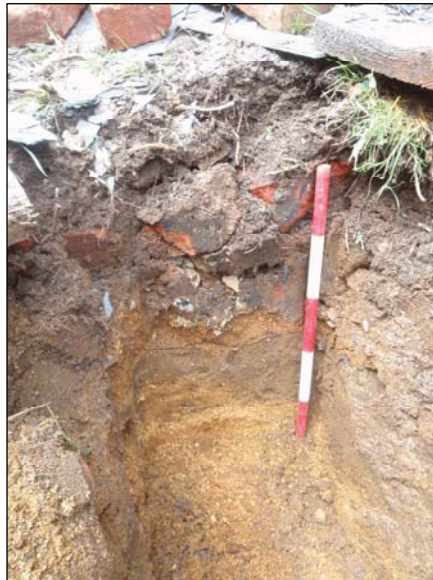
Plate 8. Test pit section

A test pit was excavated just outside the barn, in the middle of the southeast side. This revealed a deposit sequence that was typical for the area. At a depth of 0.53m below the ground level (BGL) the natural orange brown shelly sand natural 0110 was seen. This was overlain by 0.09 to 0.17m of mid brown silty sand subsoil, 0105. Over the subsoil was a 0.25m thick deposit of re-deposited natural and CBM rubble, 0104. The sequence was sealed by a 0.1m thick deposit of grey brown sandy silt topsoil, 0103.

A test pit excavated outside the barns revealed a buried soil horizon 0104 that was overlain by a rubble filled horizon. This indicates that the ground was prepared and levelled prior to the construction of the barn. Evidence for ground preparation was evident within the barns also, where the demolition rubble layer directly overlay the natural geology. It is not clear whether this demolition rubble was imported to the site or whether the rubble is the remains of older buildings that were demolished when the barn was built.

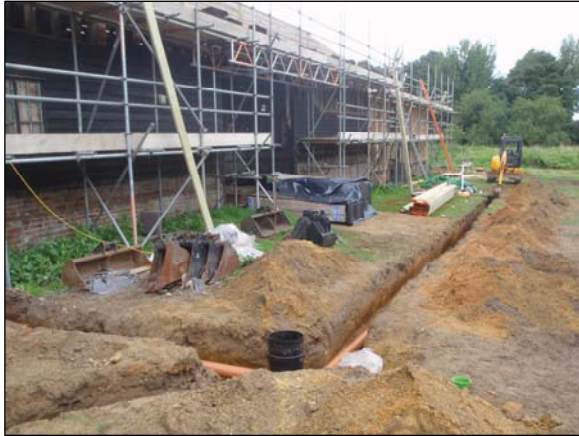
Plate 9. Drain run to NW

A straight drain run measuring 22m long by 0.3m wide was monitored. This was parallel to the NW side of the barn, and had three side branches leading to individual rooms. The drain was excavated to a maximum depth of c. 0.7m BGL at the SW end of the drain run. The natural was a light orange brown shelly sand deposit 0110, that was overlain by a 0.08m thick subsoil deposit of mid brown silty sand with 20% shell, 0105. Three features cut this deposit along the length of the drain run. The first, and eastern-most was 0102, that had steep to vertical sides and a flat base. It was 1.48m wide by over 0.35m by 0.46m deep. Feature 0102 held a mid brown sandy silt with frequent shelly crag fill, 0101.

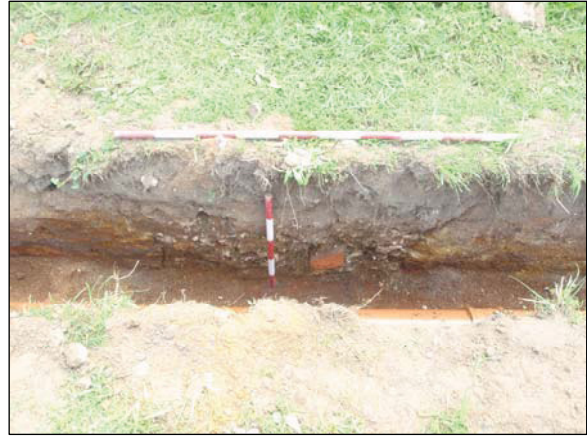
Plate 10. Feature 0107

A couple of metres to the SW there was a similar feature 0107. Feature 0107 had steep to vertical sides and a flat base, and was 0.95m wide by 0.46m deep. It held a dark brown shelly sand and mortar fill, containing occasional bricks, 0106. Feature 0107 was only visible in one side of the drainage run, indicating that only the edge of the feature was hit by its excavation.

A number of possible foundations were recorded in the drainage runs outside the farm buildings. The most complete of these, flint foundation 0113, matches the line of a SW range of farm buildings shown on the late 19th century historic maps, which once extended further NW than the current range. Others features to the NW of the barn, 0107 and 0109, may be the remains of robbed-out foundations. They were similarly

aligned to the standing buildings, and contained similar bricks. No buildings are shown on the late 19th century historic maps in this position, so it is possible that the features represent an earlier phase of farm building. Alternatively, the features may be the remains of robbed-out drains.

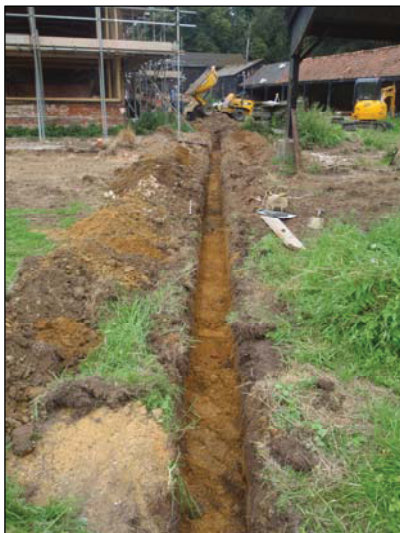
Plate 11. Drain run to SW

Along the SE side of the barn a second drain run was monitored. This one was approximately 50m long and 0.45m wide, and had various side branches leading to the barn. The majority of the drain was shallow and not affecting the archaeological horizon.

Features were seen in the SW extent of the drain run where it was deeper. The deepest part of the trench was the SW end, at 0.4m deep. Here, there was a shallow NW-SE aligned linear feature 0112, that had moderate concave sides and a flat base, 0.45m wide and 0.1m deep. It held a mottled mid brown and grey clay sand fill 0111.

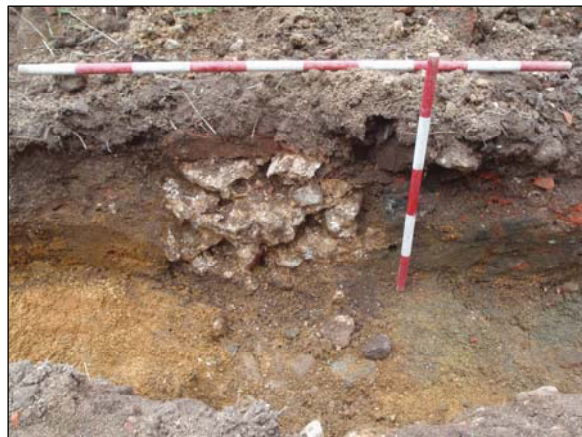
Plate 12. Foundation 0113/0114

Further to the NE a NW-SE aligned flint and mortar foundation was recorded. This was held in a vertical sided foundation cut that was 0.4m wide and over 0.3m deep, 0114. The foundation, 0113, was made of flint cobbles and light pink mortar, and was capped with a course of bricks.
