**The Granary,
Squirrells Farm,
Great Bricett, Suffolk
BCG011**

Historic Building Record

OASIS REF: Suffolkc1-76364

March 2010

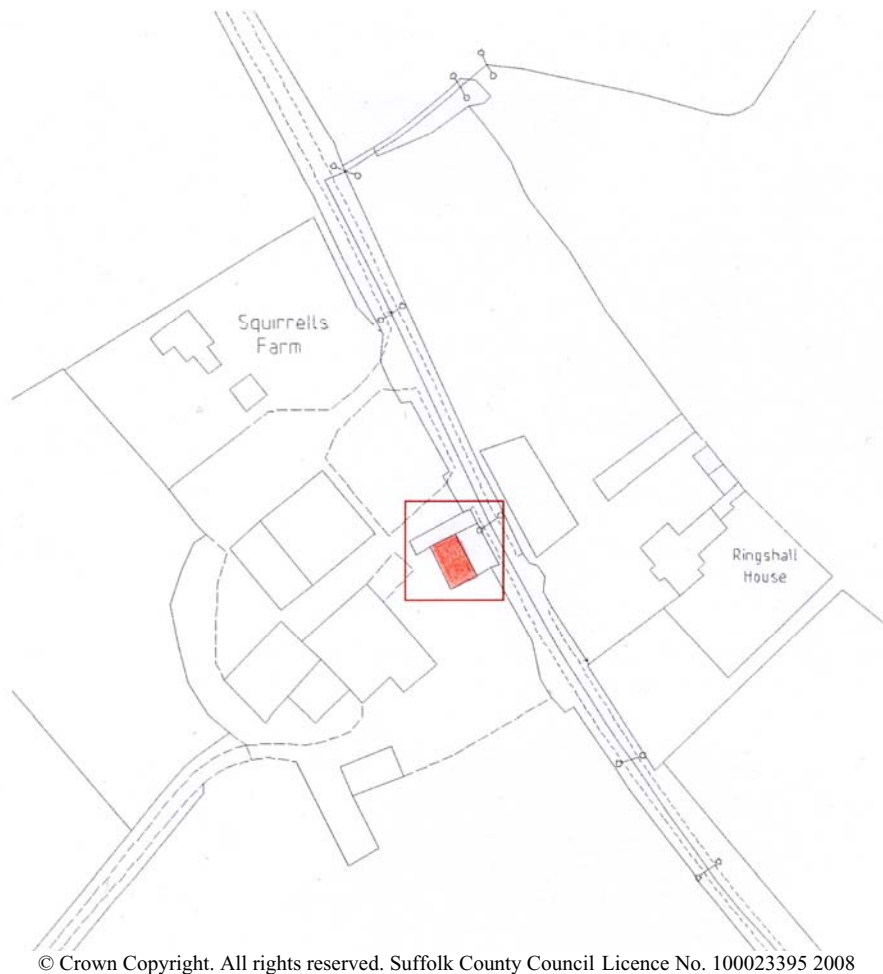
Figure 1

Current Ordnance Survey Site Plan

Enclosing the granary and attached 20th century lean-to sheds in a red square and shading the granary itself in red. The remaining farm buildings to the west date from the 20th century, and the farmhouse to the north (marked ‘Squirrells Farm’) is a brick building of the 1980s. The original grade II-listed farmhouse is now ‘Ringshall House’ in separate occupation to the east of Offton Road, which divides the parishes of Great Bricett to the west from Ringshall to the east.

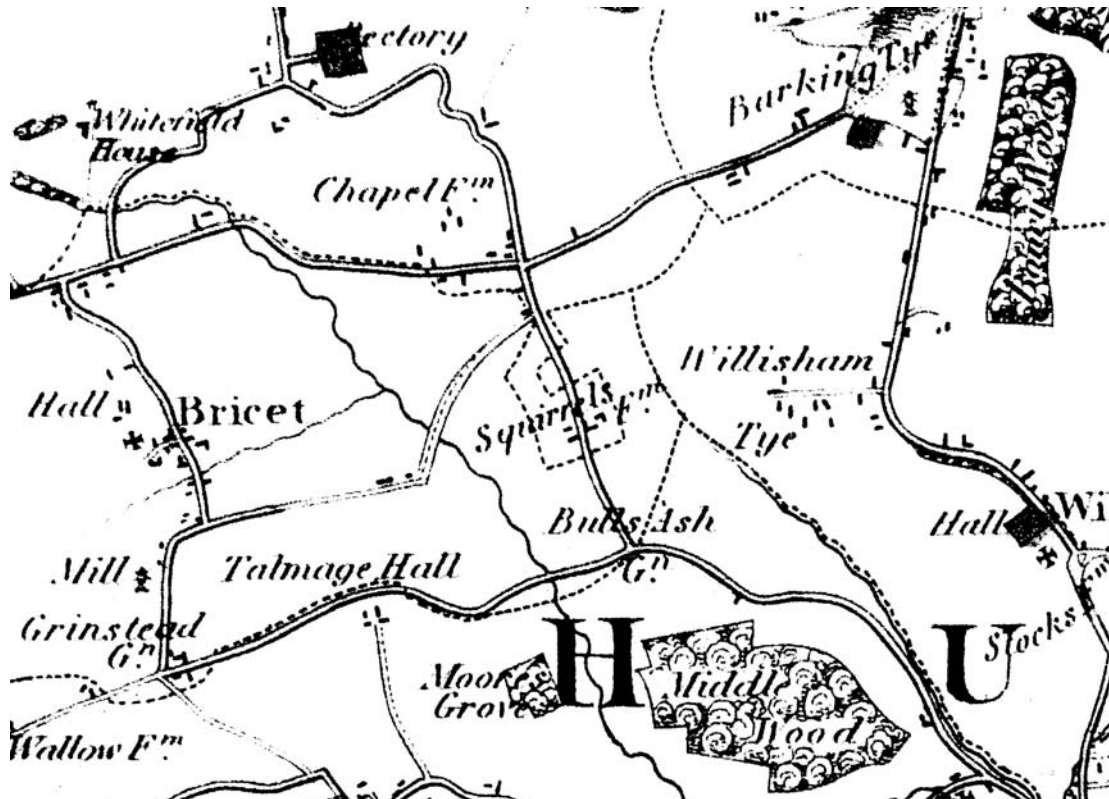
Figure 2
 Bryant's Suffolk map of 1825, which shows Hill Farm as 'Squirrels F(ar)m', and was used to rename the site in recent years.

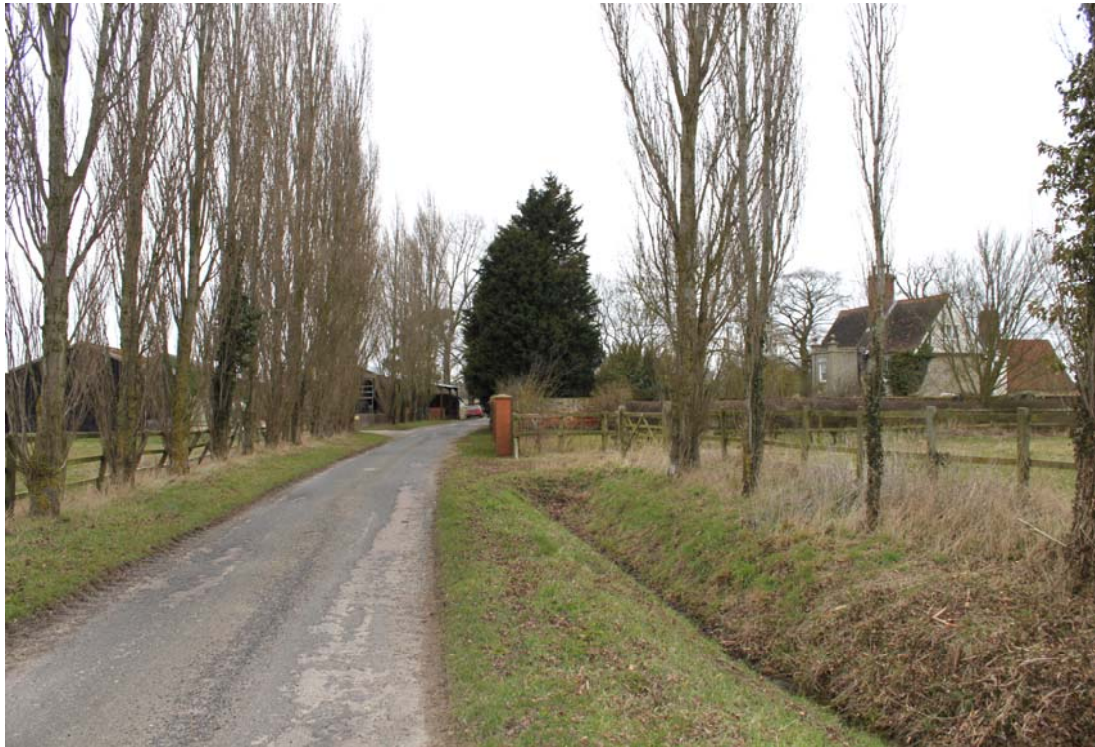
Illus. 1. General view of site from Offton Road to south showing Ringshall House on right and roadside granary with 20th century barns to left. The road divides the parishes of Great Bricett to the left and Ringshall to the right.

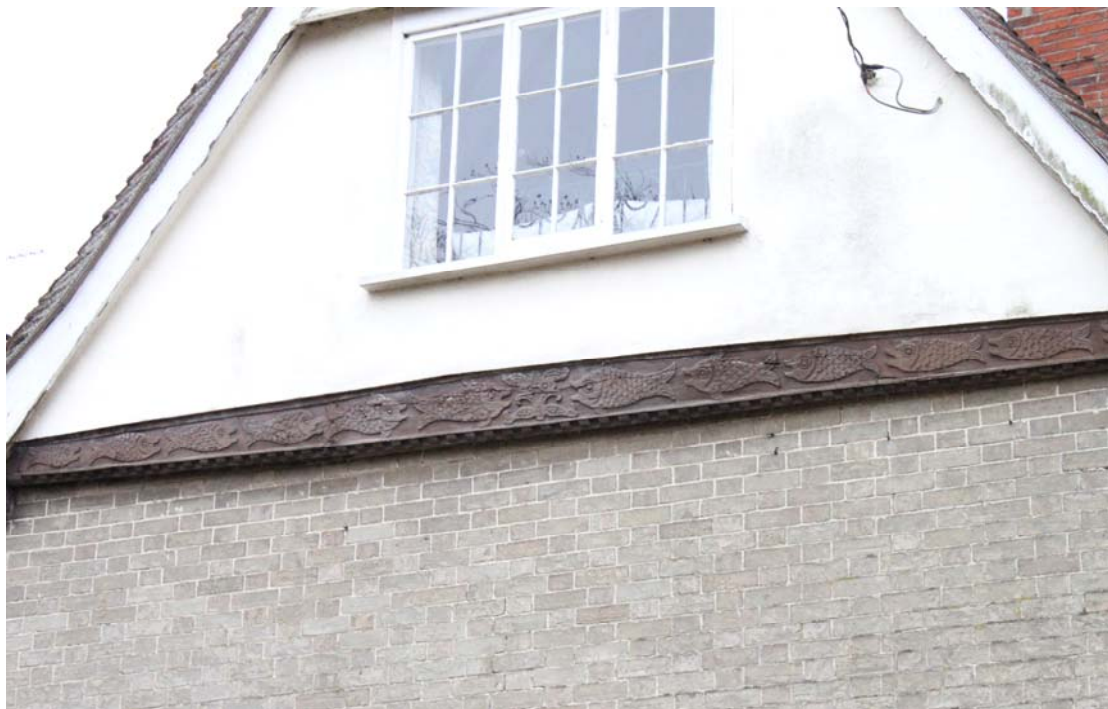
Illus. 2. Detail of the highly unusual and ostensibly authentic early-17th century northern tie-beam of Ringshall House, carved with fish. A similar tie-beam with drop finial survives to the south. Included for site context.

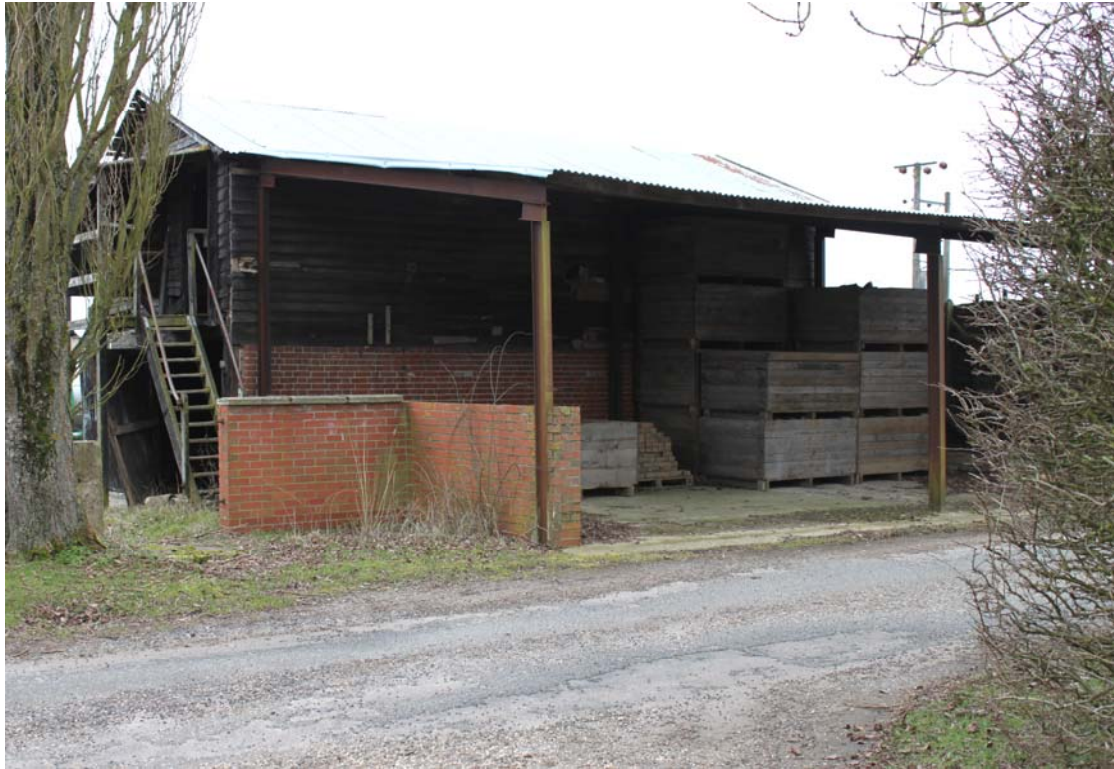
Illus. 3. Exterior of granary from east showing 20th century lean-to vehicle shelter adjoining road in foreground.

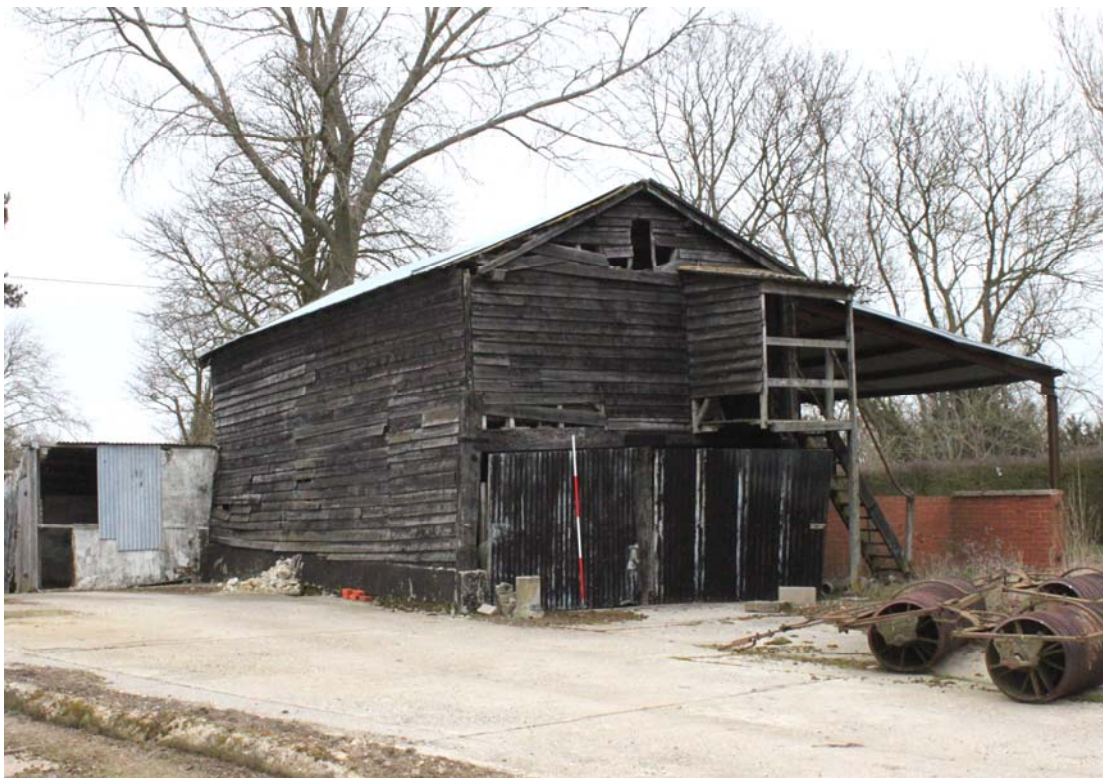
Illus. 4. Exterior of granary from south-west showing rebuilt external stair against southern gable and roadside vehicle shelter to right. Note corrugated iron vehicle doors to ground floor of gable.

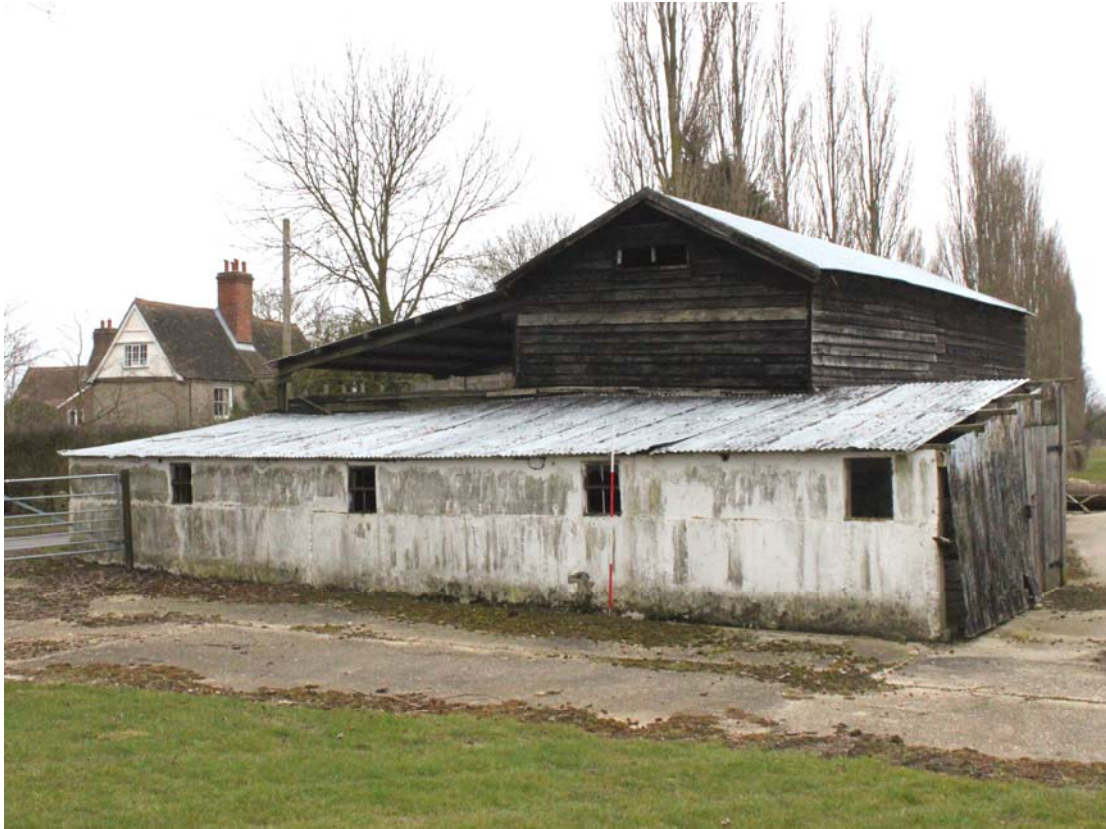
Illus. 5. Northern external gable of granary showing the adjoining 20th century lean-to piggy the proximity of Ringshall House on the opposite side of the road.

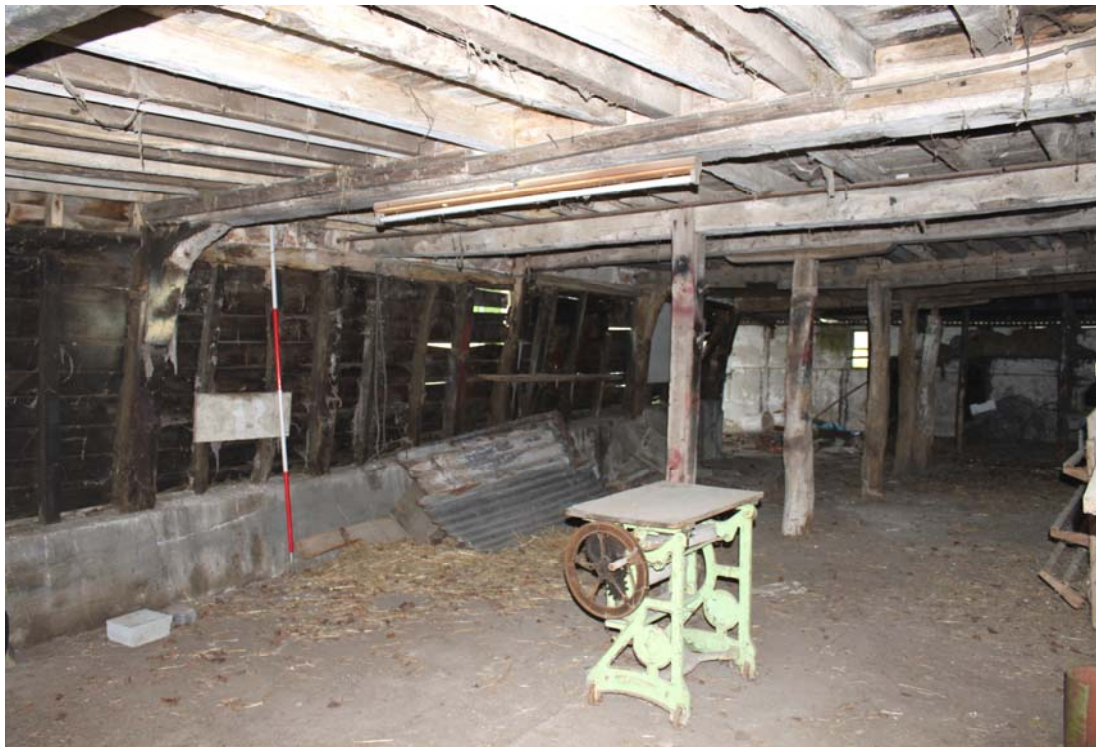
Illus. 6. Interior of lower storey from south-east, showing the Sampson posts in the centre of each binding joist (and the mid-rail of the northern gable) with the studwork western elevation to the left.

The ground storey is now entered by 20th century vehicle doors of corrugated iron in the southern gable, and forms a single space interrupted by an axial series of Sampson posts in the centres of the binding joists. The mid-rail of the northern gable is also supported by a central Sampson post, and the southern gable is depicted as an open elevation on the Ordnance Survey of 1904. These posts and both gables relate to the second phase of construction. Given its open and solid side-elevations the building probably served as an implement shelter rather than a cart lodge in the normal sense, but the original early-19th century building may well have been open to the east in the normal manner.

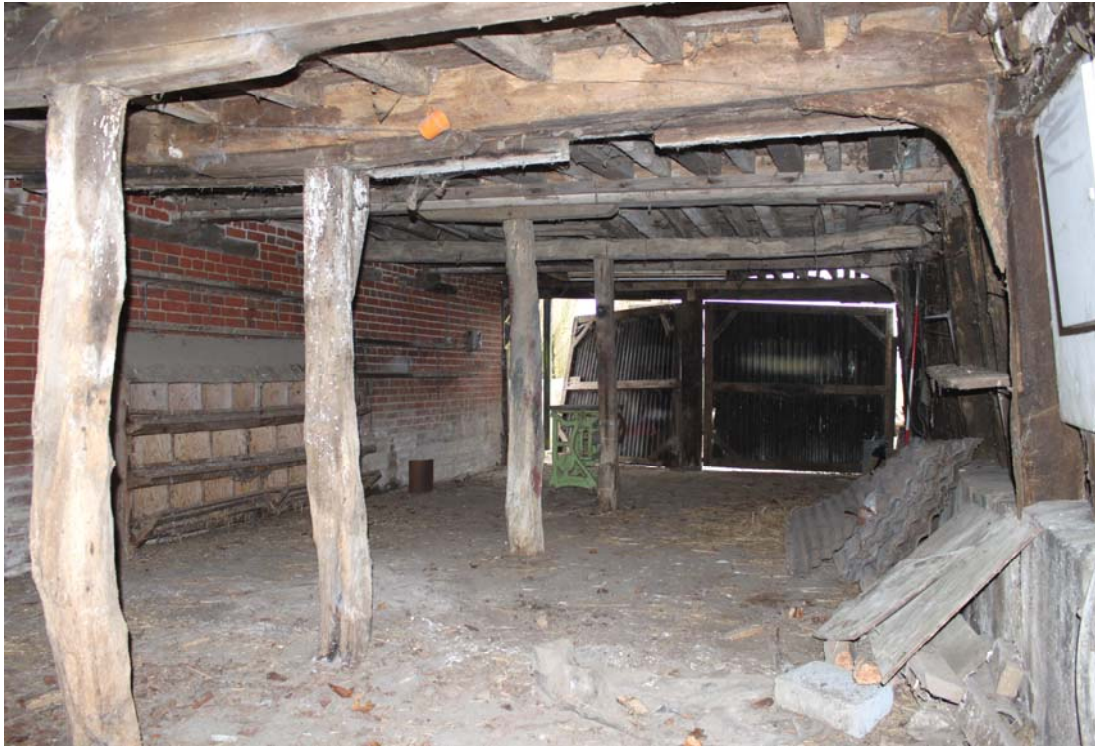
Illus. 7. Interior of lower storey from north showing axial Sampson posts and brick eastern elevation to left. The original ceiling joists of the northern bay shown here are tenoned to the binding joists.

walls were raised, and the western elevation has been much altered and retains few original studs, but its timbers are re-used and of much larger section than those of the upper storey. The pine binding joists are neatly chamfered with curled stops, and the original common joists are fully tenoned in a manner not normally associated with the mid- or late-19th century and in marked contrast to the nailed roof timbers. However, the building does not appear on its present site in the tithe survey of 1838, and it seems likely that the lower storey originally stood several metres further south (immediately opposite Ringshall House) but was moved as part of major redevelopment of the site to form the core of the new granary.

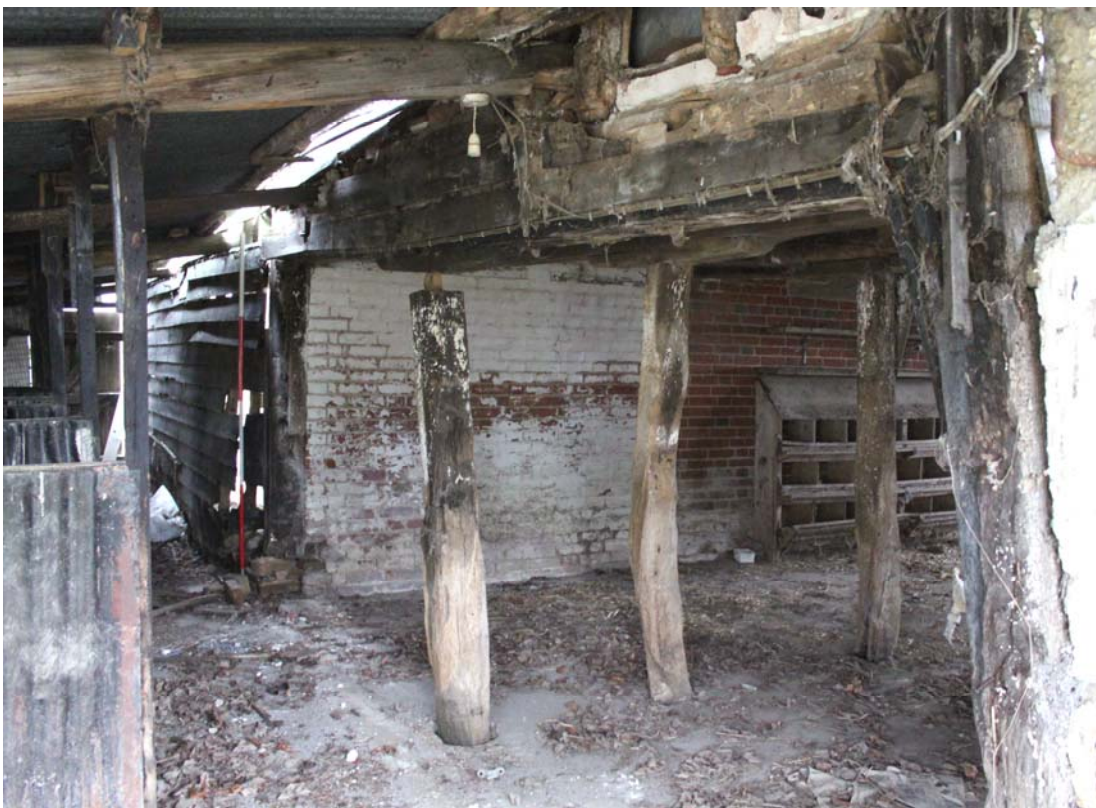
Illus. 8. 29. Northern external gable of granary seen from lean-to piggery to northwest. The gable is entirely open on the lower storey with a central Sampson post.

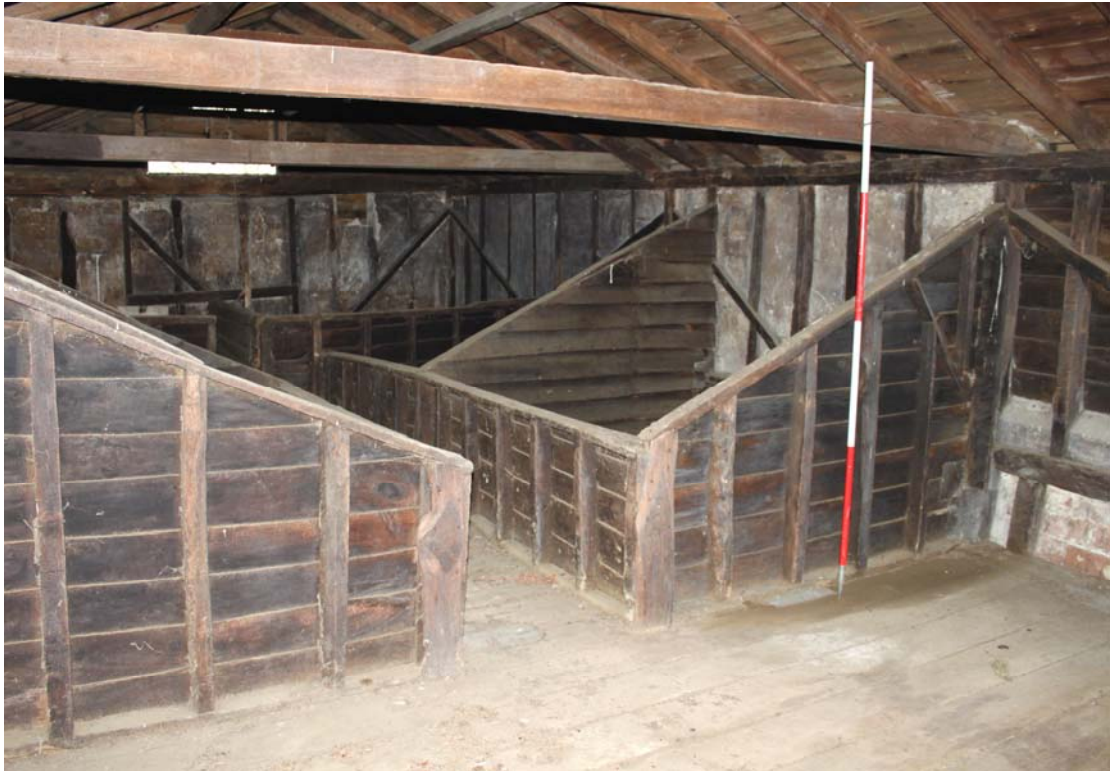
Illus. 9. Complete boarded grain bins seen from the south-western corner of the first-floor granary, showing the axial passage. The original roof plate and storey post are visible above the floor to the right. The walls were raised to accommodate the bins.

The grain floor is reached by an external stair at the eastern end of the southern gable, but this is a replacement of the mid-20th century. The interior contains an exceptionally complete series of boarded grain bins with an axial passage. Each of the six bins (two abutting the northern gable and two at the same end of each elevation) is 2.1 m wide (7 ft) and the passage is 0.65 m in width (25 ins). The southern end of the grain floor appears not to have contained additional bins but formed an open space – possibly for milling or simply to afford room to manoeuvre grain sacks. A wooden chicken coop rests against the eastern internal elevation of the lower storey but it is not clear whether this is *in situ*.

The historic interest of the granary at Squirrells Farm lies chiefly in the exceptionally well-preserved boarded grain bins on its upper storey. Apart from a small aperture in the north-western corner these remain completely intact and are among the finest examples of their type in the region. Granaries and bins of this kind were once commonplace but very few now remain in anything resembling their original condition.

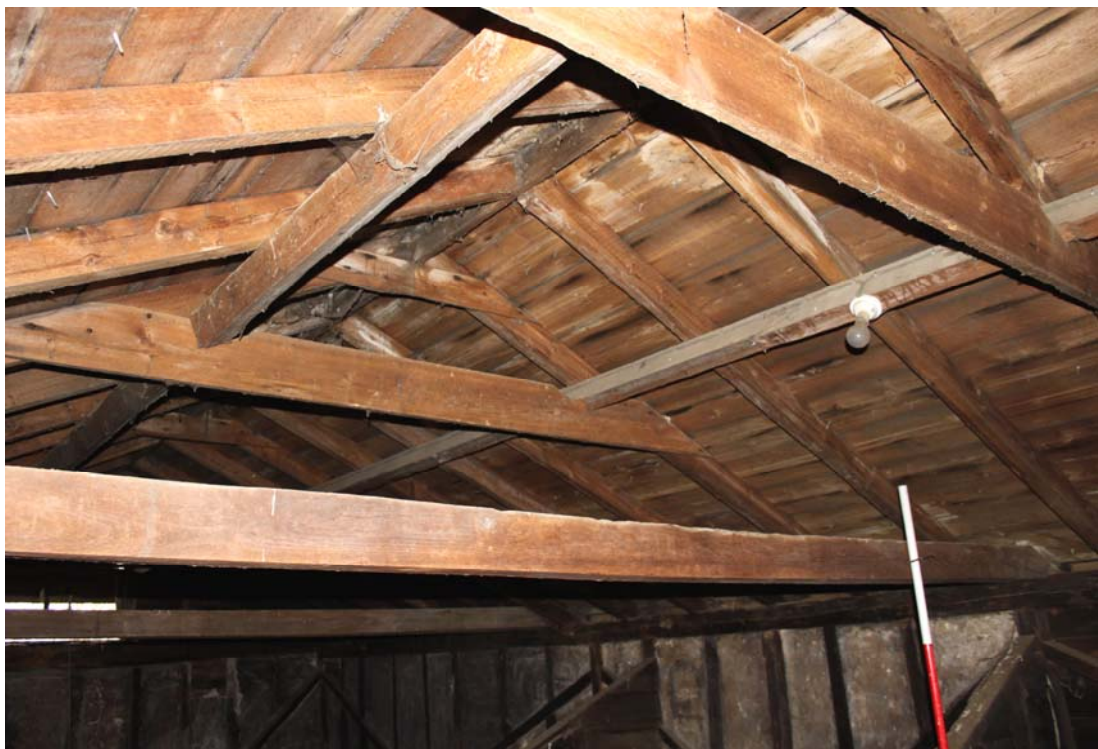
Illus. 10. Detail of softwood clasped-purlin roof structure seen from south-eastern corner of granary

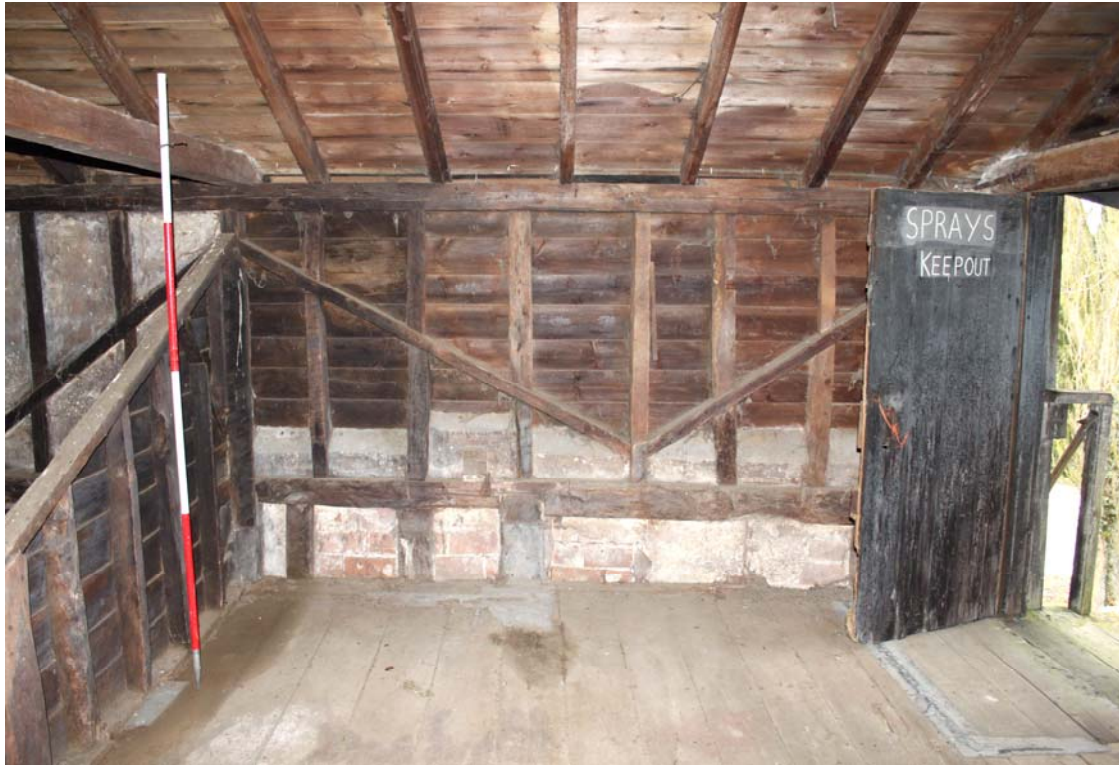
Illus. 11. Southern end of eastern internal elevation on grain floor, showing entrance in southern gable to right and the extent to which the original walls were raised in height (from the original roof-plate immediately above the floor to the present plate).

The walls contain evidence of two separate phases of construction. The storey posts of both the eastern and western elevations rise to just 2.7 m or 9 ft (35 cm or 14 ins above the ceiling), where they are tenoned to a former roof-plate. Mid-rails are tenoned and pegged to the extant storey posts of the western elevation at a height of 1.95 m (6.5 ft), and the three original binding joists are secured by bolted knee-braces. The walls were subsequently raised by 1.2 m (4 ft) and the present roof was added. The narrow sections of the studs used to form this 'lift', coupled with the machine-sawn softwood of the clasped-purlin roof structure, suggests a date of *circa* 1860-80, but the ceiling and lower walls are more typical of the early-19th century. The ground storey of the eastern elevation was rebuilt in red brick when the

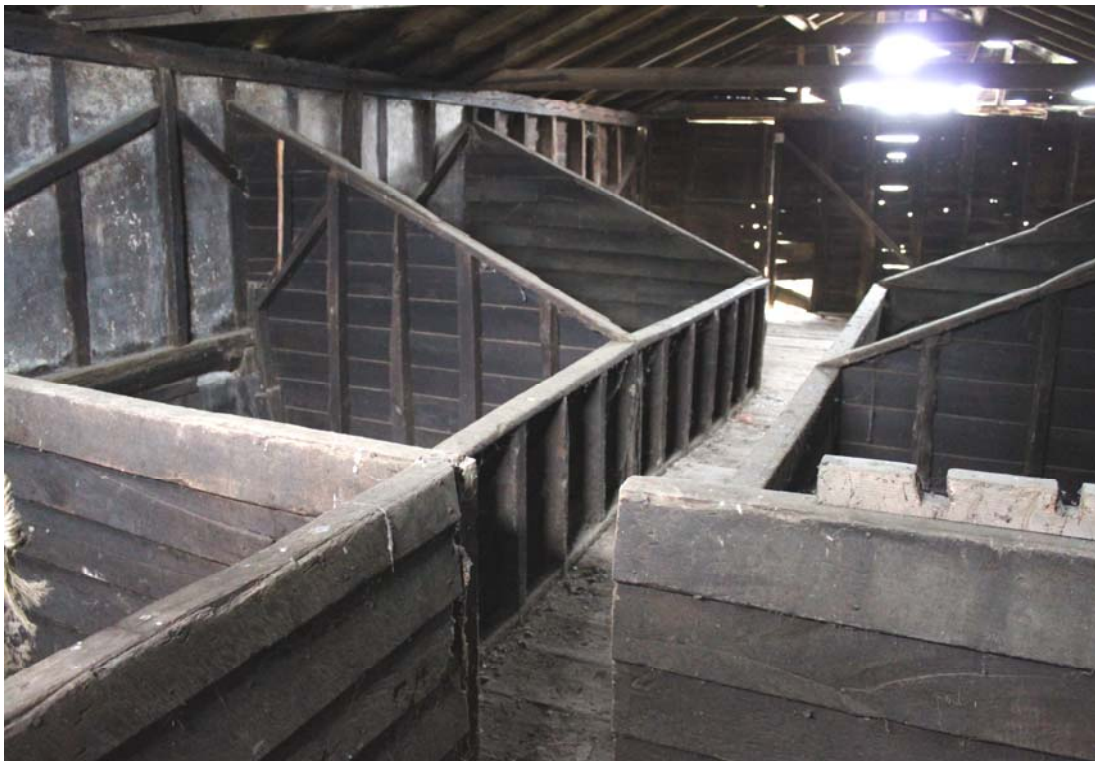
Illus. 12. The intact grain bins seen from north-western corner of the upper storey (the narrow gap in the foreground is a recent insertion).

In its present form the granary remains largely complete, although the early-19th century lower walls have been extensively mutilated. Much of the original ceiling survives intact, albeit with additional Sampson posts and several secondary softwood joists supported on nailed clamps (rails). The common joists of the northern bay are the best preserved. The second binding joist from the southern gable rests on the western mid-rail and is also an insertion. Much of the external cladding and the roof covering was renewed in the 20th century, and the corrugated iron vehicle doors of the southern gable are modern. The external granary steps were replaced in the mid-20th century and a narrow aperture has been cut into the boarded front of the north-western bin but the granary floor is otherwise complete.
