ARCHAEOLOGICAL MONITORING REPORT

SCCAS REPORT No. 2010/111

East Lane pillbox and groynes, Bawdsey BAW 153 and BAW 164

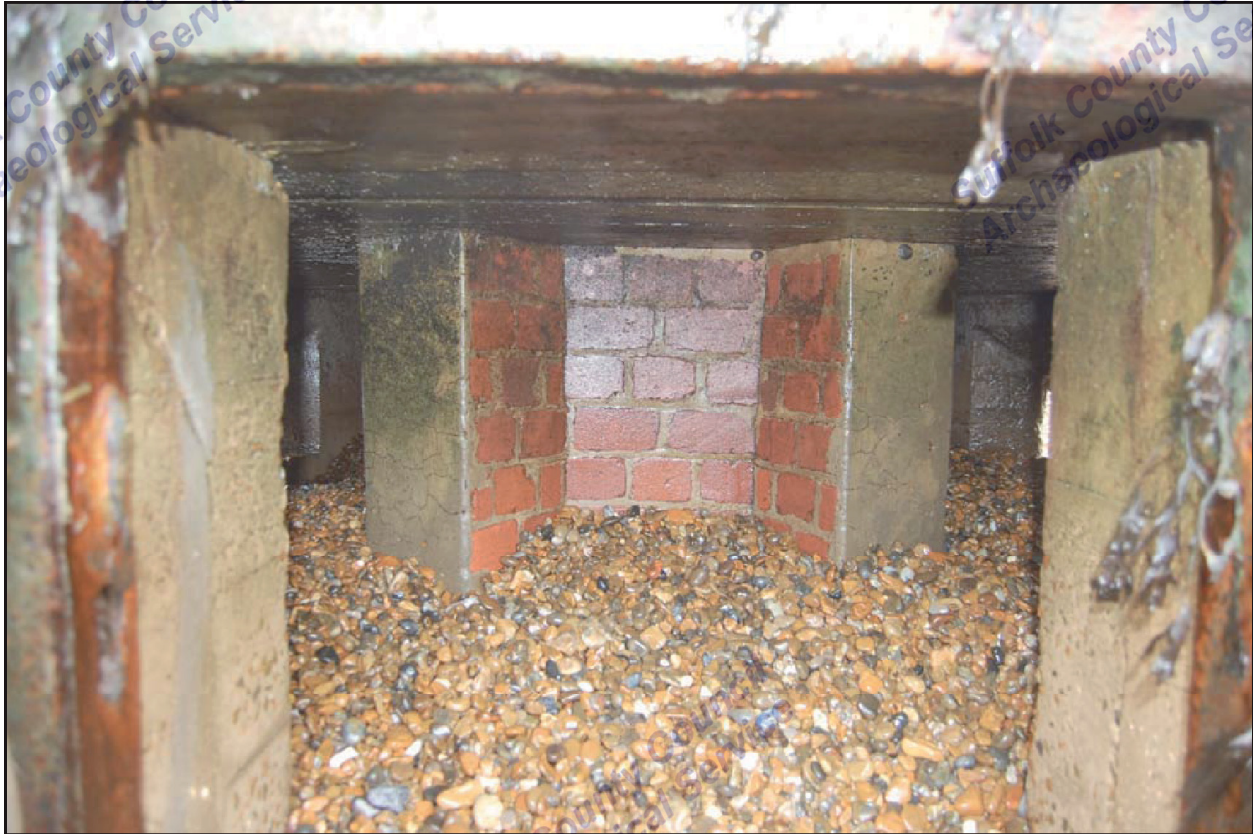
Plate 3. BAW 153, internal structure

Although it was not safe to enter the pillbox, an internal structure was visible (Plate 3). It was built of brick and appeared to function as structural reinforcement. The shape in plan was of a half hexagon, with the open side of the hexagon facing the doorway. This is fairly typical for the Type 22 style and it is likely that a further wall, aligned NW-SE in this case, would have run SE from this structure (Matthews, 2010).

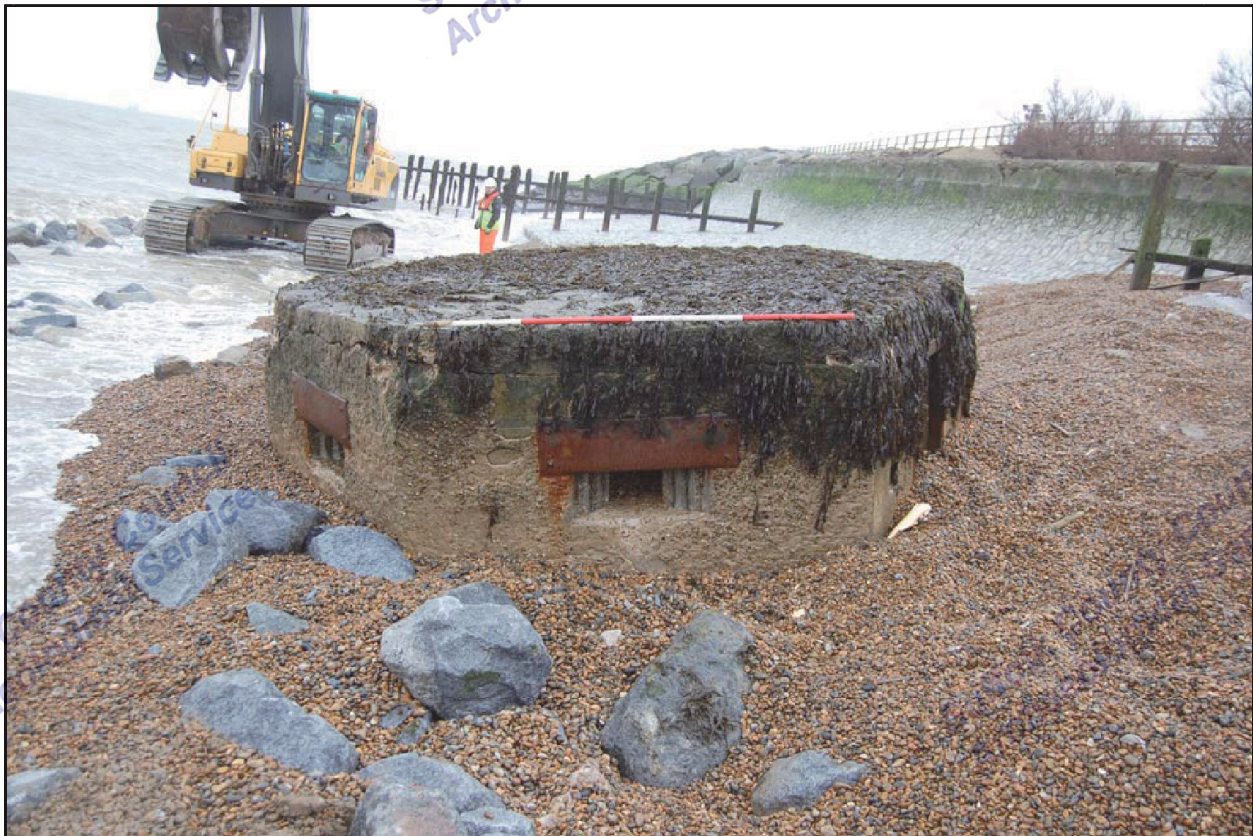
Plate 4. BAW 153, pillbox, facing south

The survey revealed that the pillbox was of the MoD FW3/22 variety, known more commonly as a Type 22, with a hexagonal shape as shown on Figure 3 and Plate 4 (Matthews, 2010). The roof was made up of a flat concrete slab, which was 0.21m thick. The walls were c.0.4m thick. There was one entrance, which in this case was facing north-west and measured 0.62m across x >0.68m tall (Fig. 3 and Plate 1). It was enclosed by a metal frame, which was 0.07m thick. Left of the doorway was a further small window/opening, measuring 0.17m across x 0.31m tall. The remaining five elevations were identical to one another, with a single window, (or 'rifle loop') in each (Fig. 3 and Plate 2). Each loop measured 0.64m across x 0.24m tall and had three layers of concrete shuttering on each side, measuring 0.065m wide x 0.065m deep (Fig. 3). Beyond the shuttering, the wall ran at an approximately 45° angle. Centrally above each window, a metal plate was attached with 4 rivets. This measured 0.92m across x 0.22m tall x 0.01m thick.

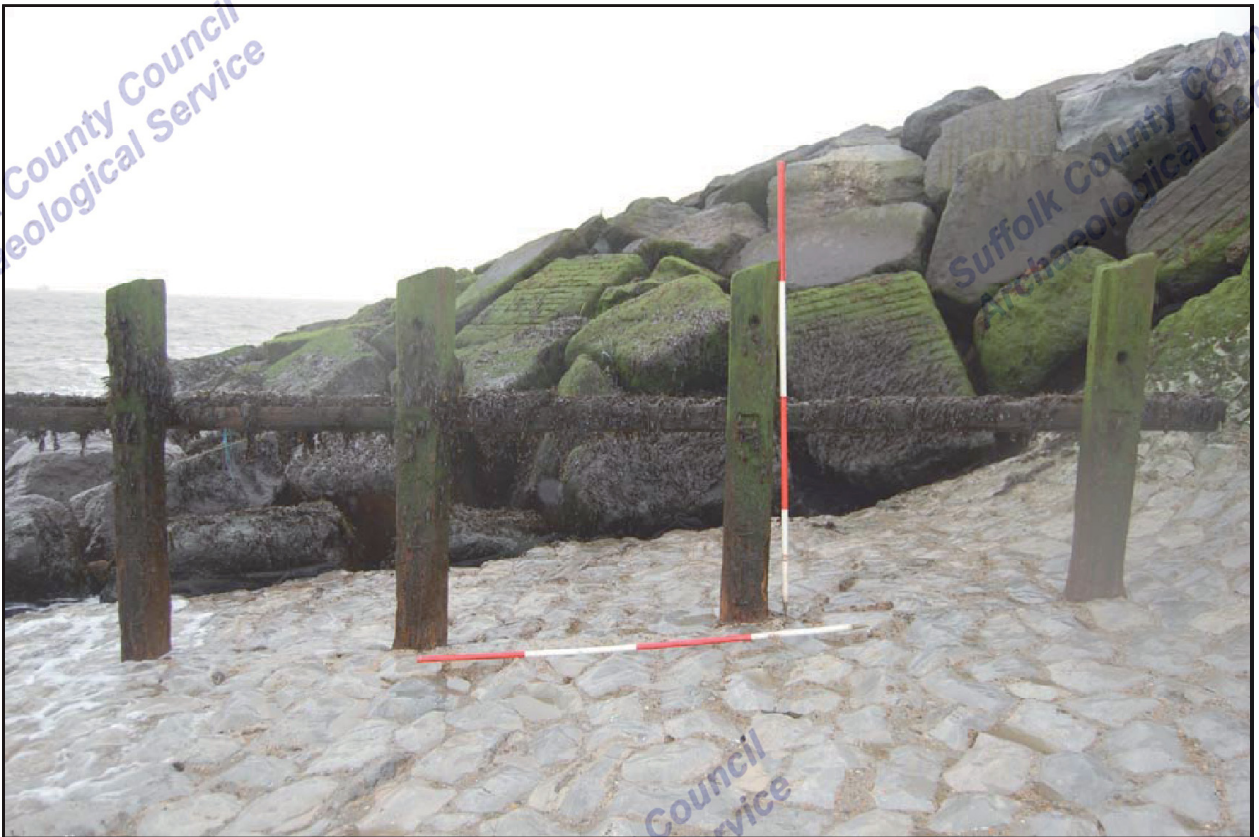
Plate 5. BAW 164, Groyne 1, facing south

The structures were made up of timber uprights that were roughly square in plan, measuring c.0.2m x c.0.2m (Plate 7). Horizontal timbers ran the length of each structure (Plate 5). The surviving timbers would have originally supported horizontal boards to trap sediment, although none survived. The tallest vertical uprights were always present

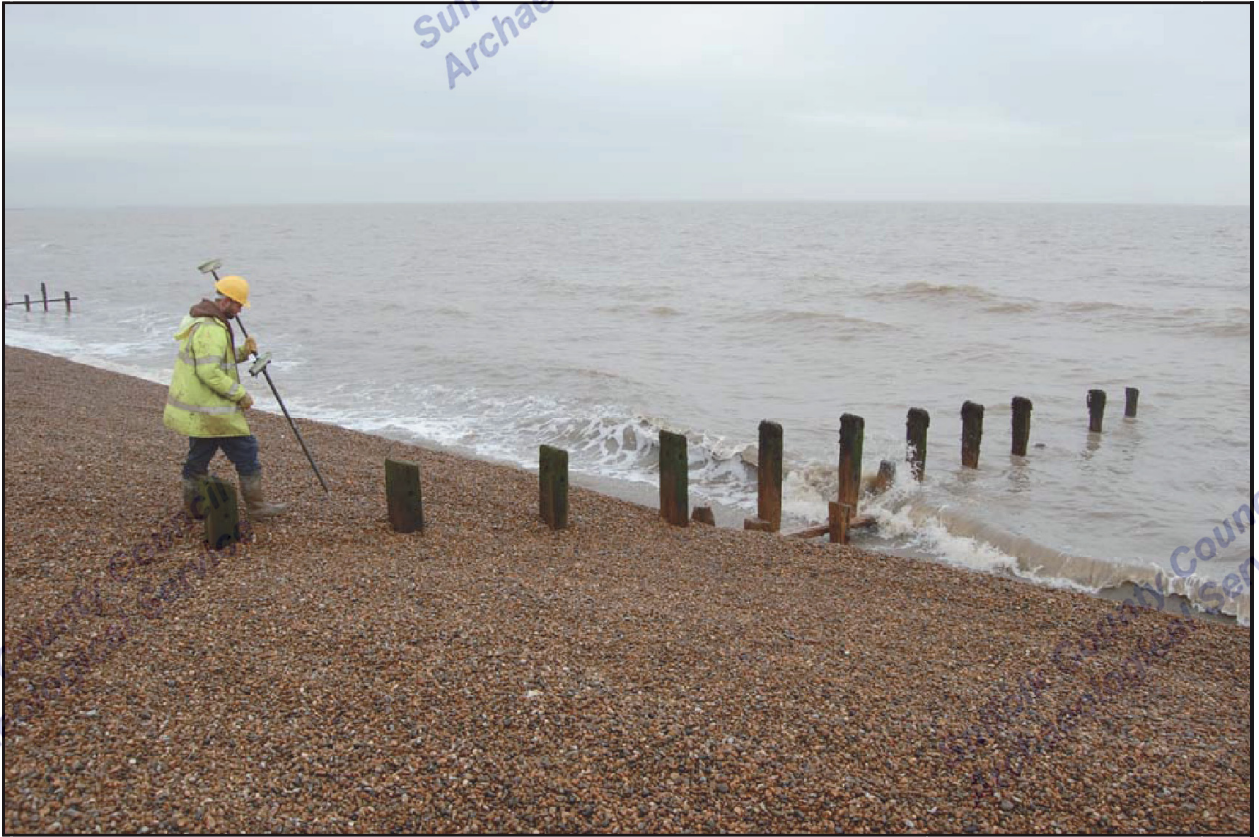
Plate 6. BAW 164, Groyne 5, facing north-east

on the northern side of each groyne and were c.1.2m apart. Shorter uprights were also present on groynes 4-6, and these were generally on the southern side of each groyne (Plate 6). The groynes were fixed together using large metal bolts (Plate 8). The base of the uprights were sharpened to a point and capped with a metal 'shoe' so that they could be easily driven into the ground (Plate 9). Groynes 5 and 6 were not within the development area, but were recorded to prove that those that had already been removed would probably have been consistent with the six structures that were intact.

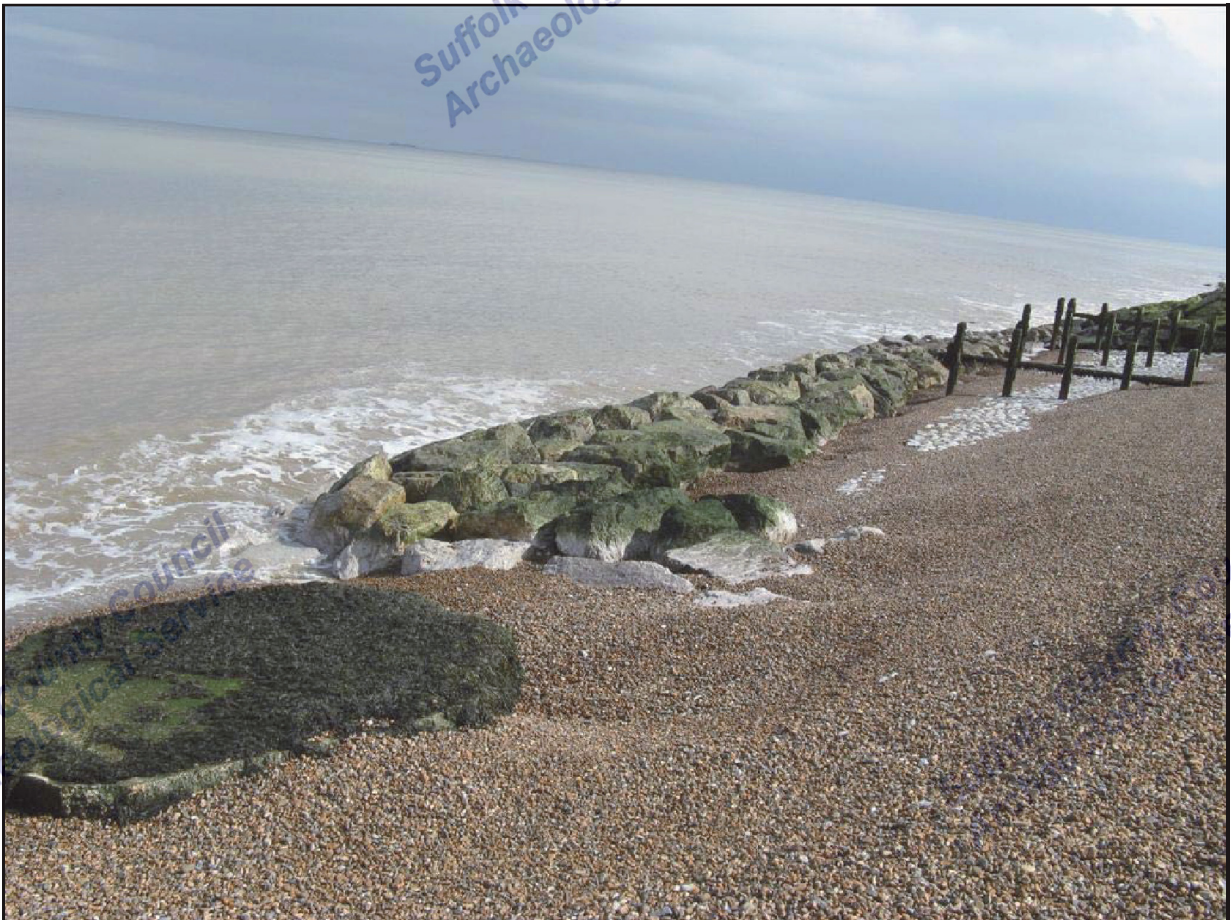
Plate 10. BAW 153 and 164, after completion of new sea defences, facing south-east (Courtesy of the Environment Agency)

As part of the sea defence works gravel was banked up around the structure to just below the height of the metal window plates (Plates 10-12).

The completion of the sea defence works involved the removal of many of the groyne structures and the partial burial of the remainder (Plate 10).
