ARCHAEOLOGICAL EVALUATION REPORT

SCCAS REPORT No. 2010/083

**Lowestoft Sixth Form College,
Rotterdam Road, Lowestoft
LWT 174**

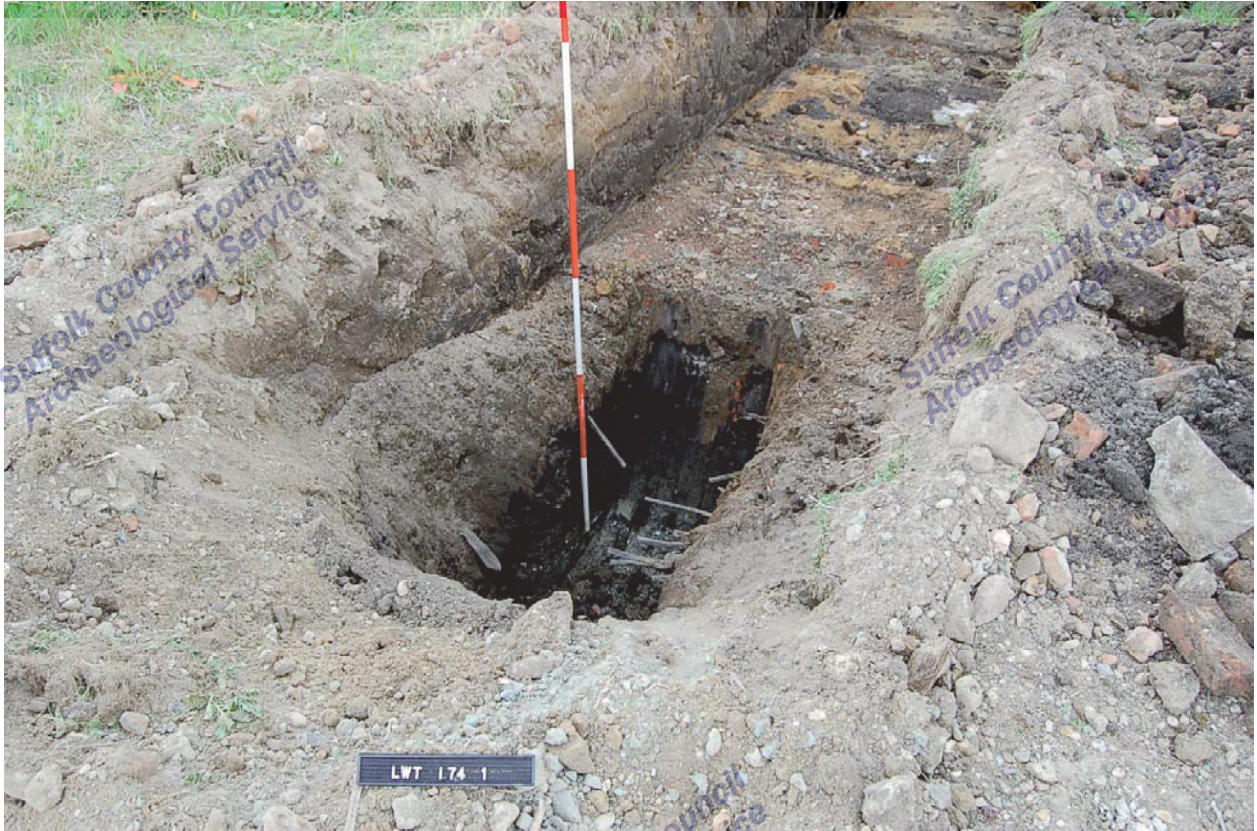
This trench was 30m long, 1.8m wide and up to 2.25m deep, orientated north-south. The stratigraphy encountered consisted of up to 1.5m of made ground, consisting of assorted construction debris, broken up tarmac, large kerbstones, plastic, metal and soils/sands, above 0.35m of a dark grey/black organic-rich silty deposit which appeared to be contaminated with hydrocarbons. Due to the loose nature of the overlying deposit, it was not certain that any modern inclusions visible in this layer were from it, rather than having just fallen in during excavation. This layer sealed a dark greenish grey silty clay deposit 0.35m thick, which overlay mid greenish grey patchy clay with chalk lumps and fragments, interpreted as a natural geological layer. The greenish tint to the lower deposits is suggested to be a result of chemical leaching from the upper made ground layer. No finds or features of archaeological relevance were observed in this trench.

Plate 1. Trench 1 northern end showing test pit, facing south (2m scale)

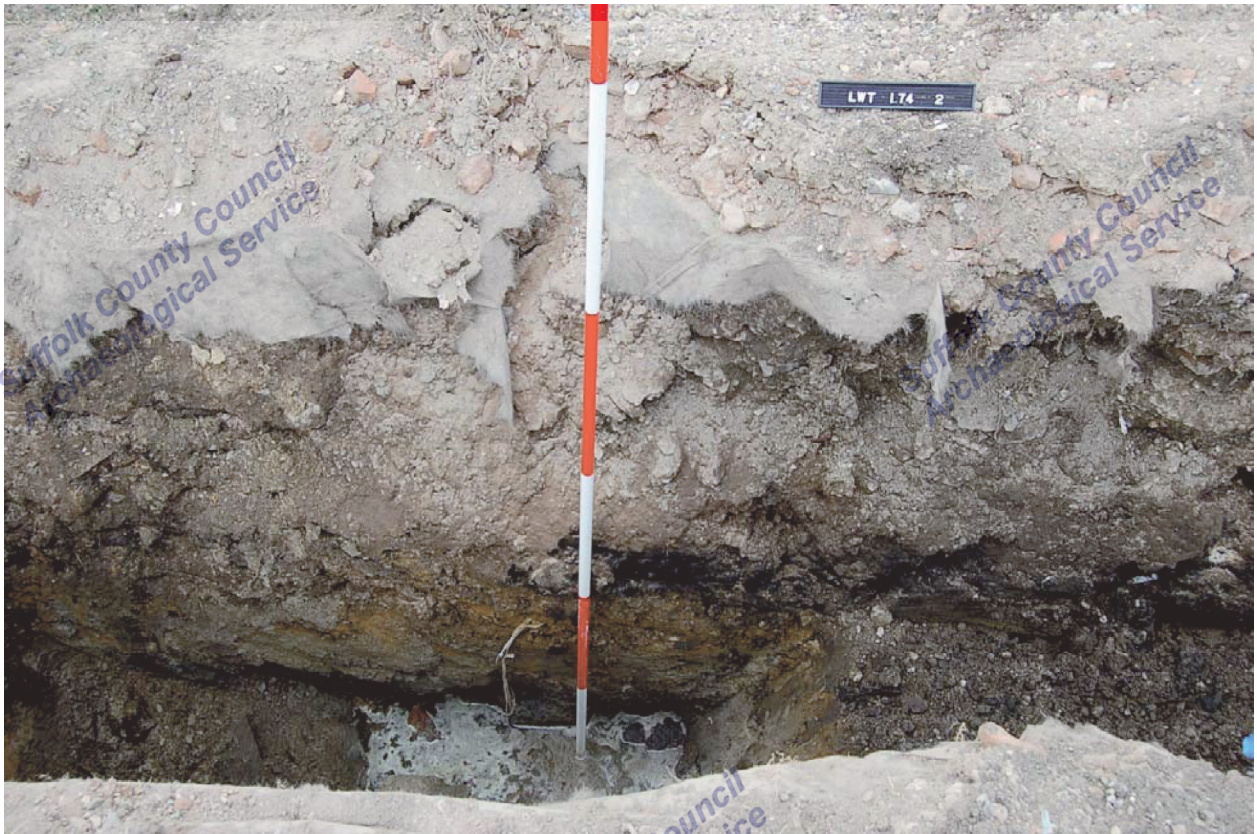
This trench was 28m long, 0.6m wide and up to 2.4m deep, orientated east-west. The stratigraphy encountered consisted of up to 2.4m of made ground, as in Trench 1. It was not possible to fully breach this deposit in order to record the depth of true natural deposits due to the quantity of large concrete blocks, kerbstones and the like within the deposit, although it should be noted that in this trench the dumping deposits are deeper than anywhere else on the site and it seems likely that there has been truncation of the natural geology at this point. No finds or features of archaeological relevance were observed in this trench.

Plate 2. Trench 2 sample section (facing south, 2m scale)

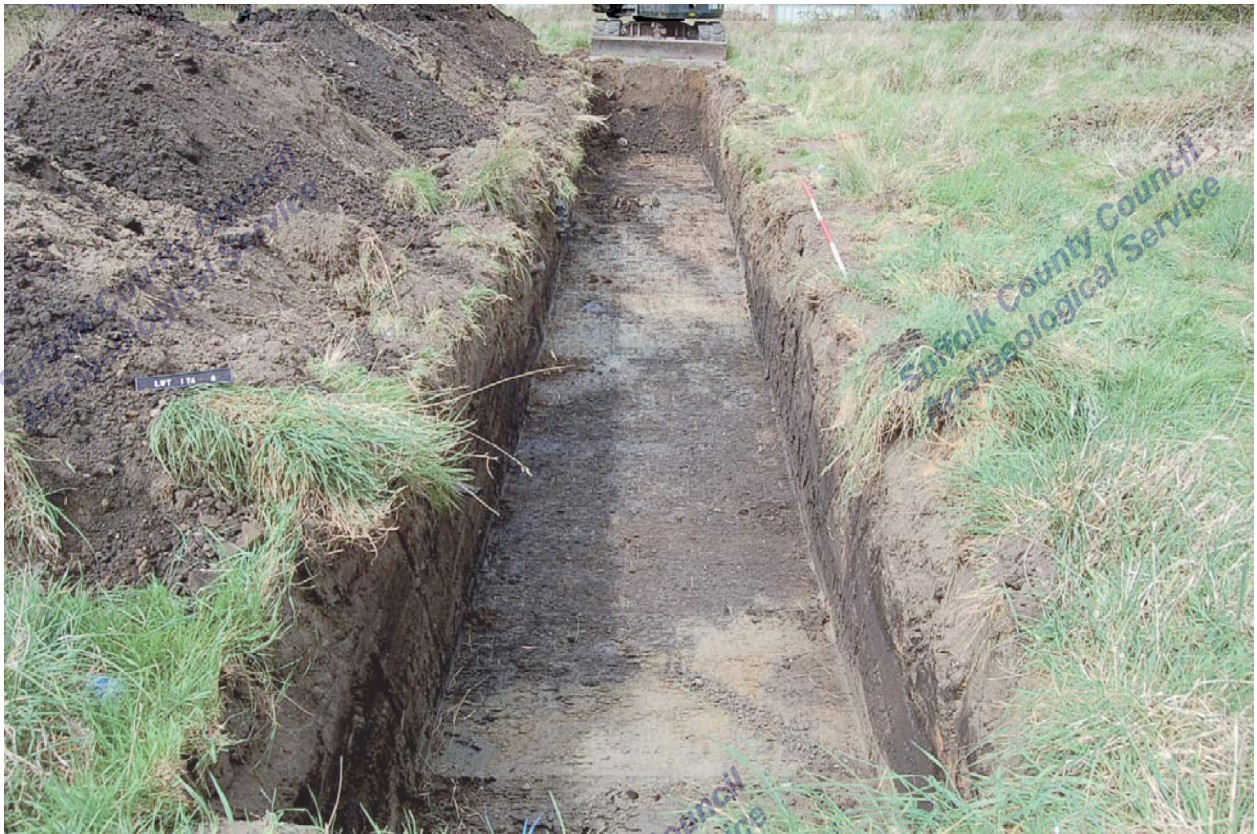
This trench was 15m long, 1.8m wide and up to 1.5m deep, orientated northwest-southeast. The stratigraphy encountered consisted of 0.38m of mid greyish brown silty fine sand topsoil above 0.42m of black organic-rich silt. This layer sealed a dark grey silty sand 0.4m thick which overlay 0.3m of pale grey/yellowish brown mottled silty sand (interpreted as a natural layer). The base of a suspected natural water channel was visible within this trench, and hand excavation supported this. The feature was very shallow, with irregular sides and base, and contained a similar dark grey silty sand to the overlying deposit. Modern truncations were noted in the north-western third of the trench, containing large concrete rubble and brick fragments. No finds or deposits of archaeological relevance were observed in this trench.

Plate 3. Trench 6, facing north-west (2m scale)
