Moat Survey at The Vicarage, Hoxne HXN 041

Archaeological Monitoring and Excavation Report

SCCAS Report No. 2011/039

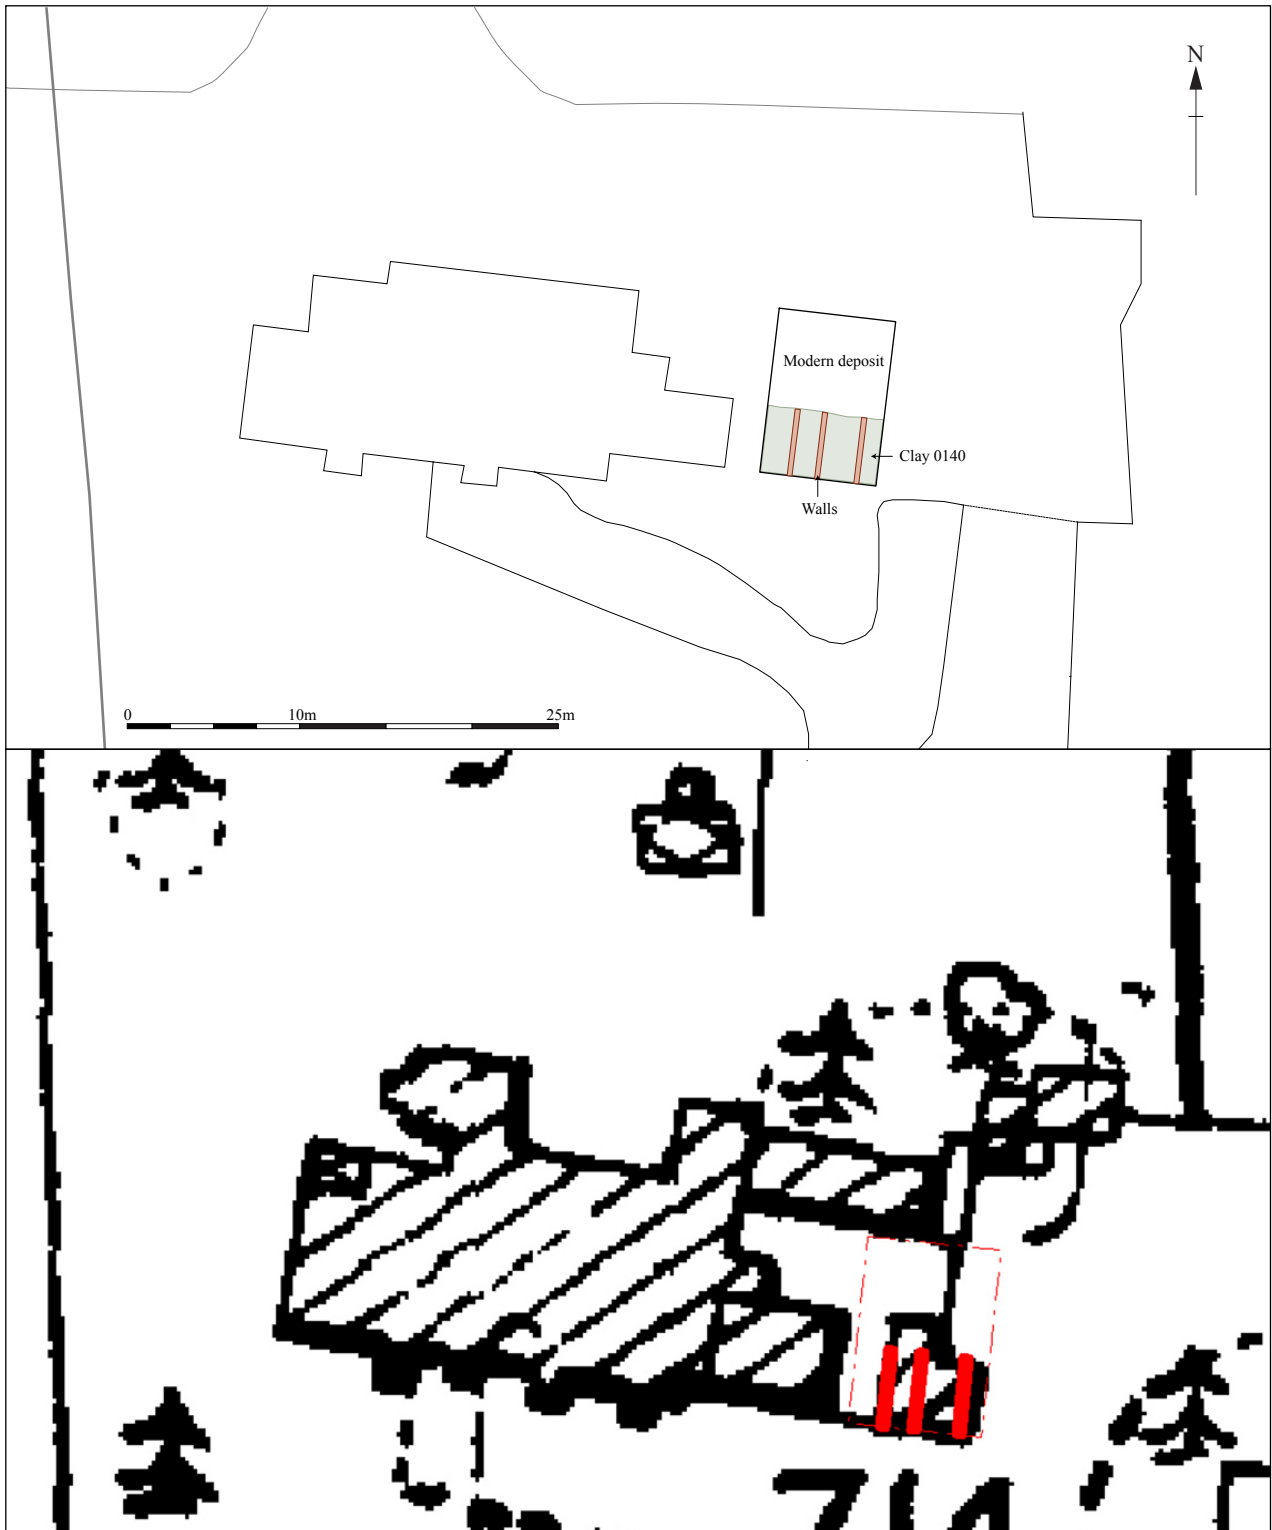
Figure 6 . Plan of the Cart Lodge strip and overlay onto the 2nd Ed. Ordnance Survey map c.1904

The cart lodge stripping work involved the removal of soil in order to level the area and create space for a slab foundation. In the southern half of the stripped area, up to 0.45m of material was removed. This uncovered three wall foundations on a north-south alignment, which ran for 4m from the southern edge of the strip and which were approximately 0.3m wide (Fig. 6). These align very closely with a series of small out-buildings shown adjoining the house on the first and second edition Ordnance Survey map of 1885 and 1904 (Fig. 6).

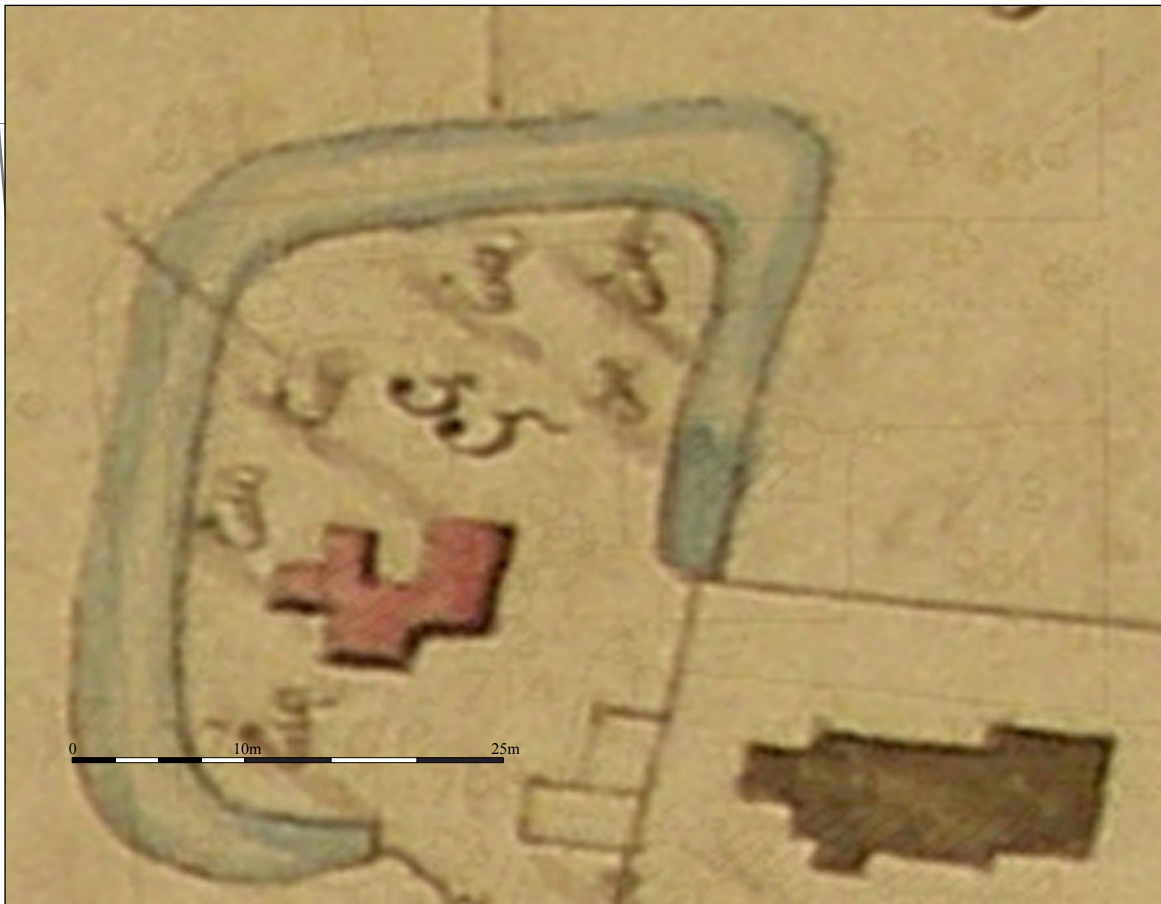
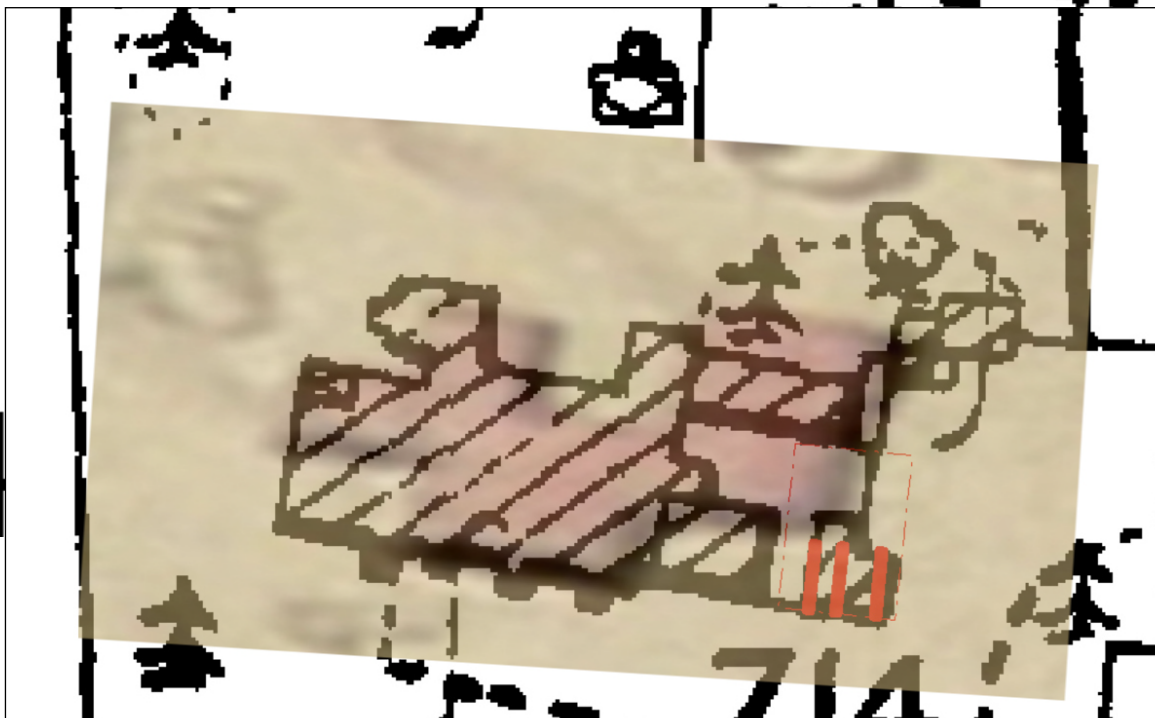
Figure 7 . Plan of the Cart Lodge strip against the the plan of the Vicarage as depicted on the tithe map of 1840

Tithe map 1840 before Rev. Edward Padget's alterations, showing the kitchen range on the east end of the building

Overlay of the tithe map and 2nd Edition OS and cart lodge. Showing the clay layer 0140 lies within the angle at the south end of the kitchen

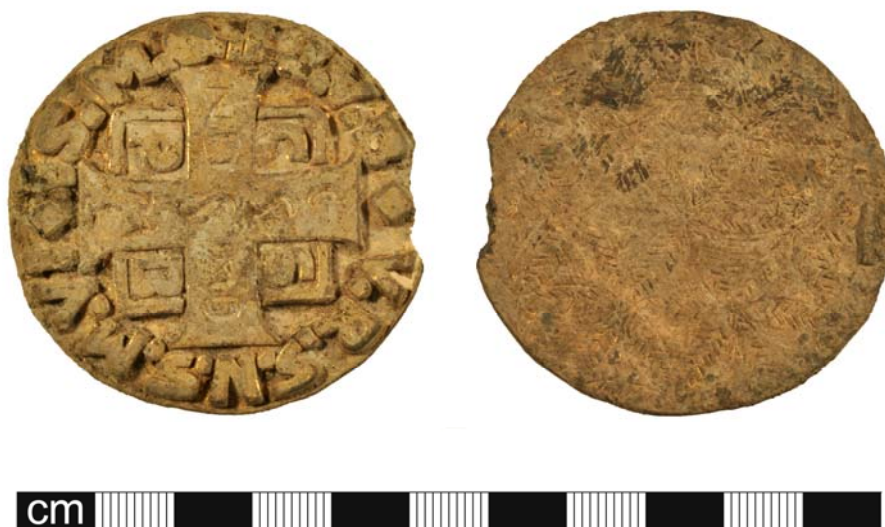
Plate 1. Jubilee medal of St Benedict struck in 1880 to mark the 1400th anniversary of the Saint

A single small find was recovered (SF1001). It is a ?brass medal (diameter 52mm), the reverse of which has a moulded decoration of a cross, with initials around the diameter. It is a jubilee medal of St Benedict. This type of medal was struck in 1880 to mark the 1400th anniversary of the birth of St Benedict. The cross has letters signifying pious entreaties, in particular against evil and the devil. Presumably the medal was dropped and lost near the church.

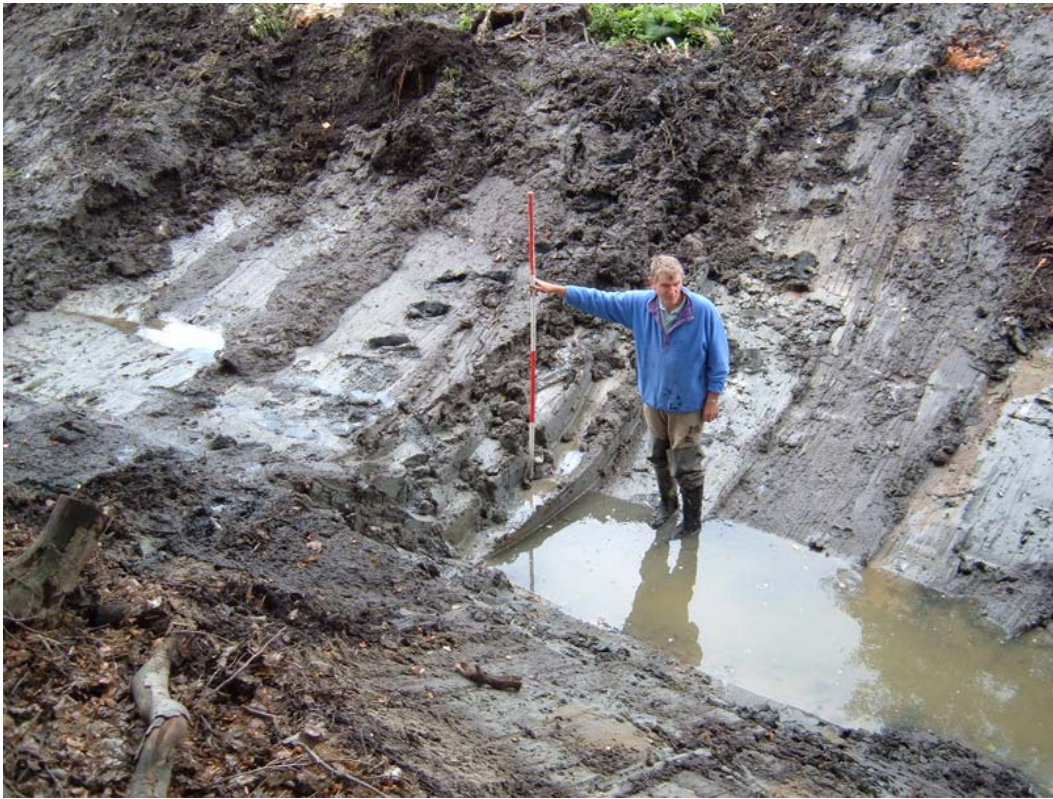
Plate 2. Monitoring the moat de-silting. Recording the west arm of the moat at the change of moat depth at Section 4. Photographed from the moat platform looking west

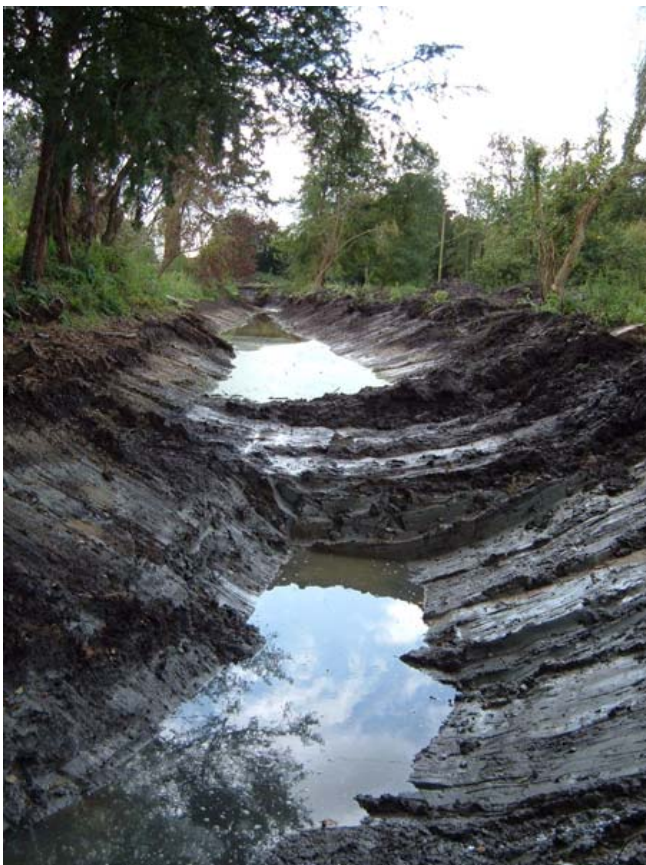
Plate 3. Change in depth on the western arm of the moat. Photographed from the NW corner looking south

The north-west corner of the moat was 3.2m deep. This was notably deeper than the rest of the circuit and the change in the moat depth was by way of a vertical drop immediately adjacent to where profile 4 was recorded. This sudden change in depth was the result of the moat (the NW corner at least) being previously cleaned out by a machine which effectively cut a cross-section through the underlying natural clay. The channel width in and approaching the NW corner narrowed to 7.6 – 8.4m wide and the moat base was recorded at a lower 33m – 33.11mOD. Here, in contrast to elsewhere around the moat the inner bank was noticeably higher than the outer and the ditch's inner side (S4 and S5 Fig. 6) was stepped to accommodate a low revetment wall running around the inside bank of the moat, whereas the opposing sides sloped smoothly. The revetment wall was constructed of lower courses of bricks beneath bonded large flints. Some of the structure had partially collapsed, although the surviving extent was still over 19m long and was recorded in profile 5. The first edition OS map (1886) (Fig. 7) shows a footbridge in this location and creation of the revetment, the deepening of the moat and siting of the footbridge, are all thought to be associated and possibly related

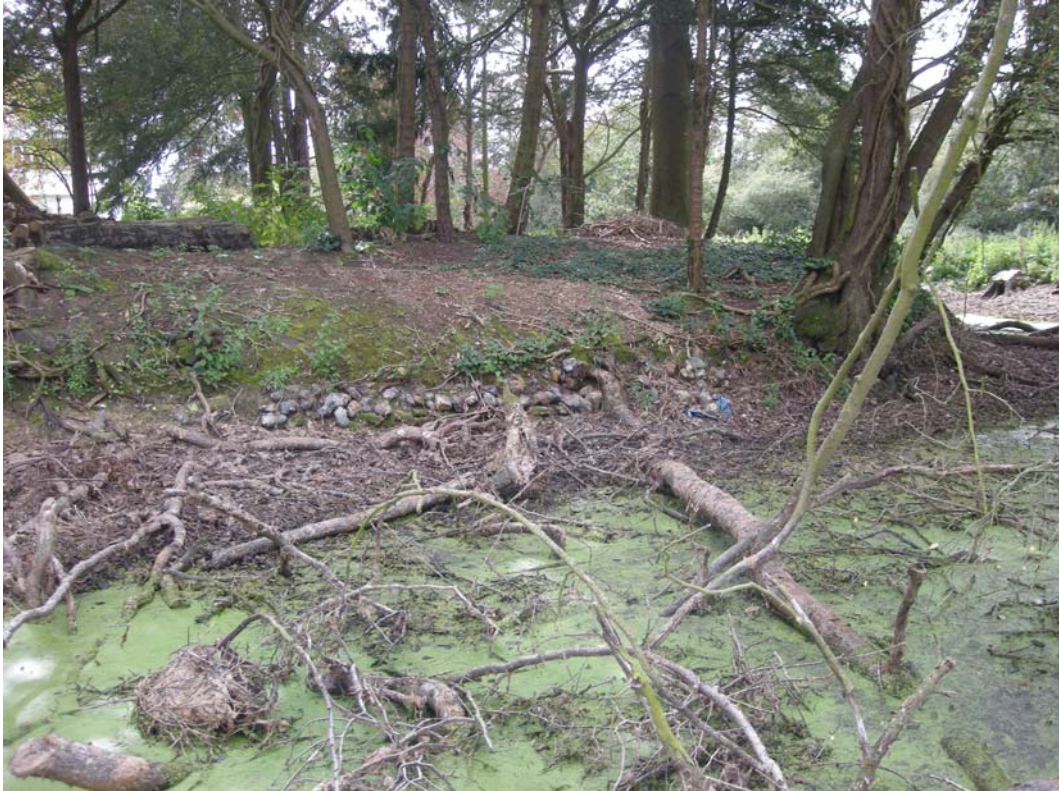
Plate 4. Remains of flint-built revetment wall and raised inner bank around the north west corner of the moat. Photographed prior to de-silting from the north bank looking south west

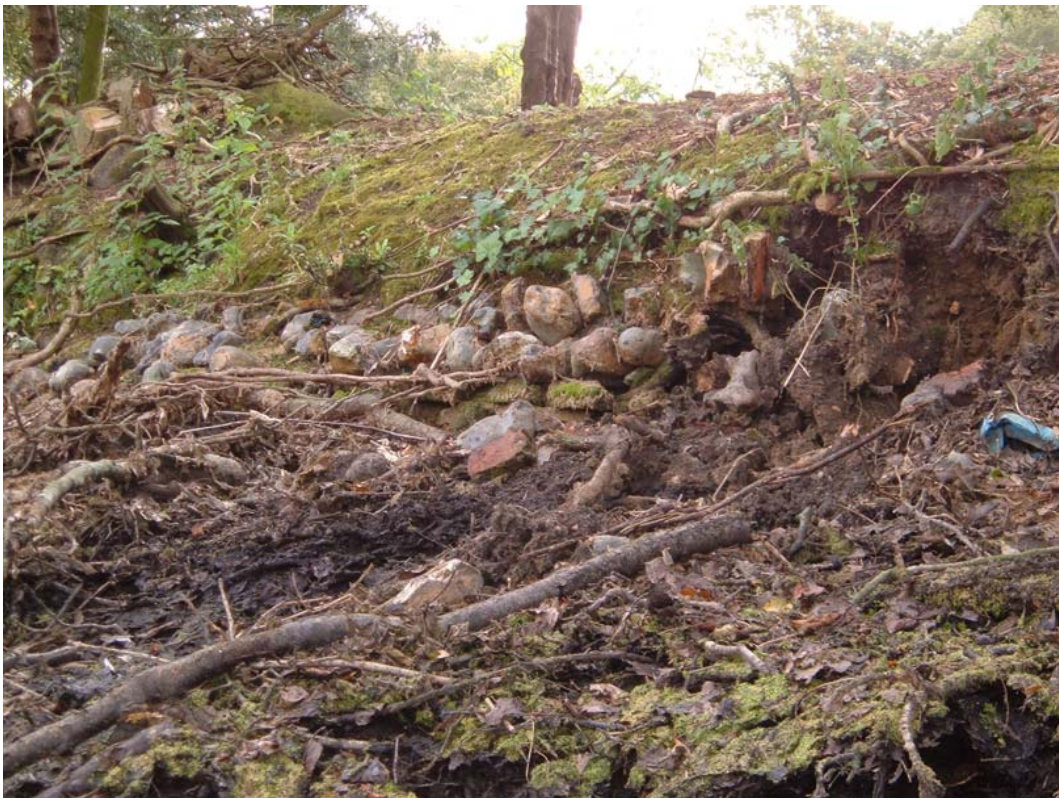
Plate 5. Detail of revetment wall

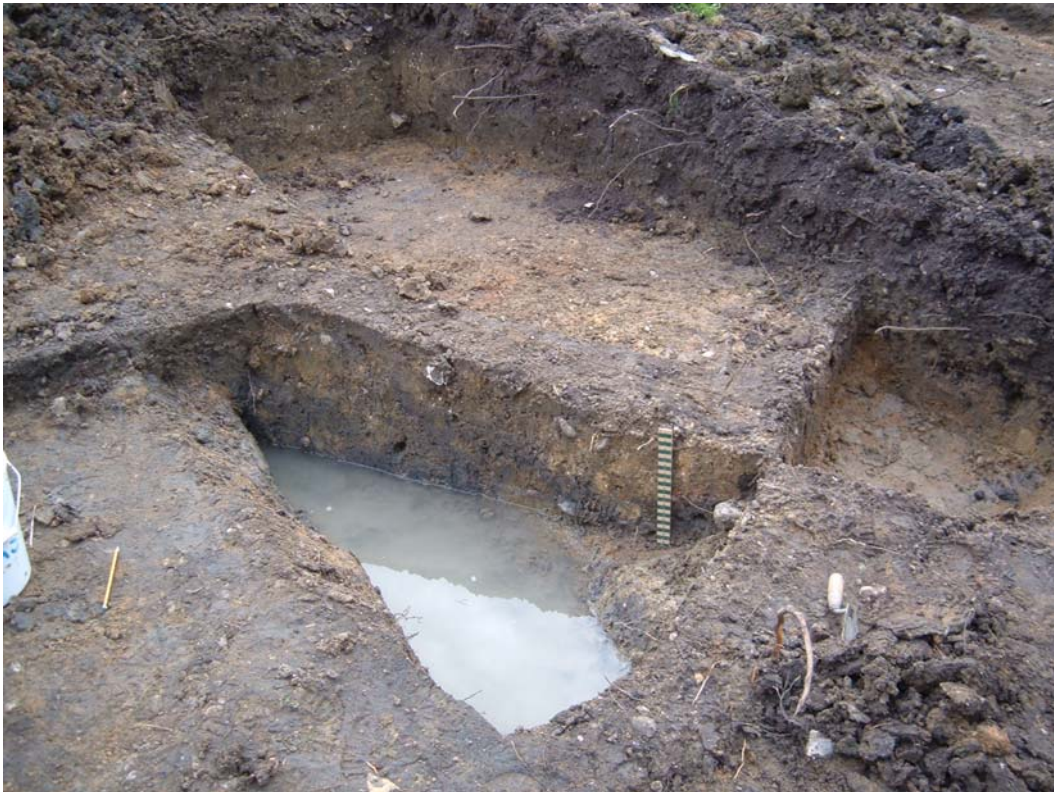
Plate 7. Early medieval building slot 0019 in the foreground cut by later medieval clay-filled pit 0022. Photographed from the north edge of the excavation looking south.

Pit 0022 was a small, irregular pit alongside pit 0017 which also cut slot 0019. The profile was somewhat irregular, being stepped on its SE side and fairly straight on the NW side. Its two fills, 0023 and 0024, produced no finds but contained burnt and unburnt clay, the remains of an oven or hearth structure, and charcoal. This was re-deposited material and there was no indication that the oven had been sited here. Similar material was also found in the adjacent pit 0017 suggesting that the two may have been infilled at the same time or were related features.
