## **ARCHAEOLOGICAL MONITORING REPORT**

SCCAS REPORT No. 2010/108

### **Outbuildings at Bentley Hall, Bentley, Suffolk BTY 033**

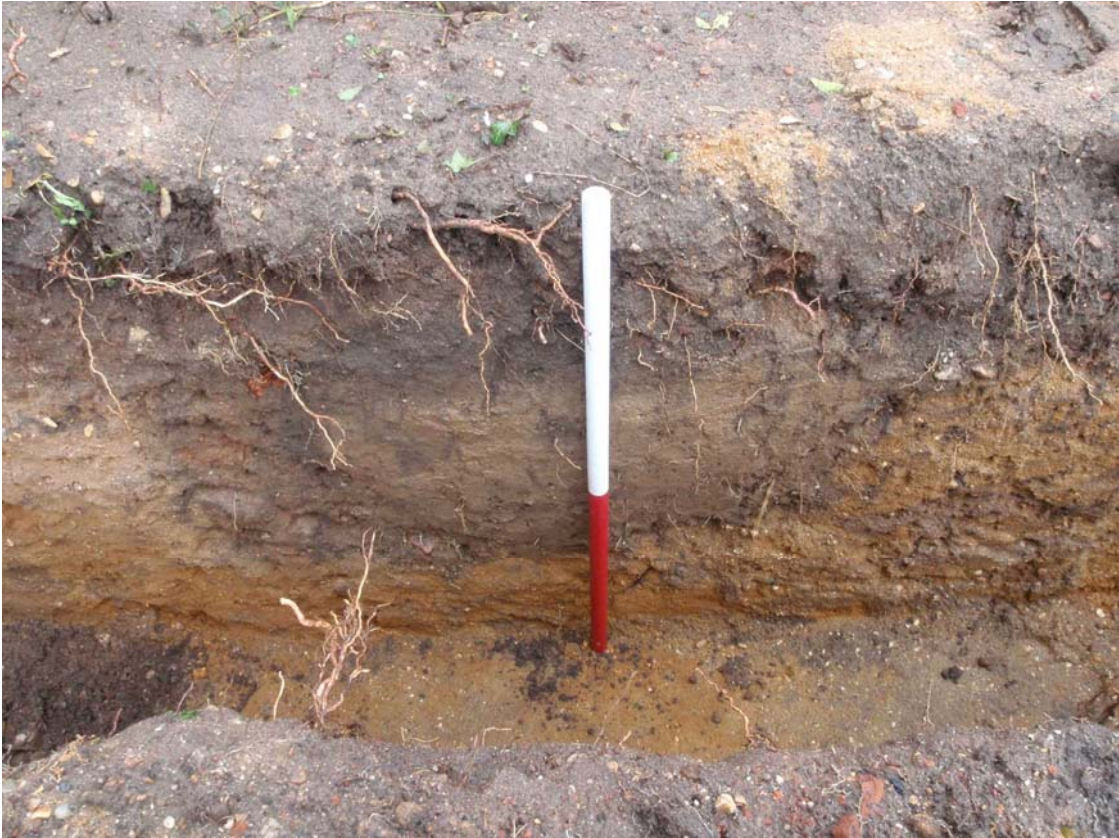
Pit 0004 measured 1.00m N–S x >0.50m E–W x 0.40m deep, with steep to vertical sides breaking gradually into a flat base. Its lower fill 0003 was loose, mid brown silty sand containing moderate pebbles and occasional small to medium fragments of brick and roof tile. Upper fill 0002 was compact, light greyish brown slightly sandy silt containing occasional pebbles and flecks to small fragments of charcoal.

Plate 1. Pit 0004 in section, looking east (1m scale)

Post-medieval pit 0004 was located close to the Hall but its precise date and function are unknown. Post-medieval cut feature 0006 also cannot be dated precisely. Its form and the nature of its fill suggest that it might have been a robbing trench, although it should be noted that it was considerably deeper than the foundations of the Hall, as can be seen on Figure 3, Section S1.

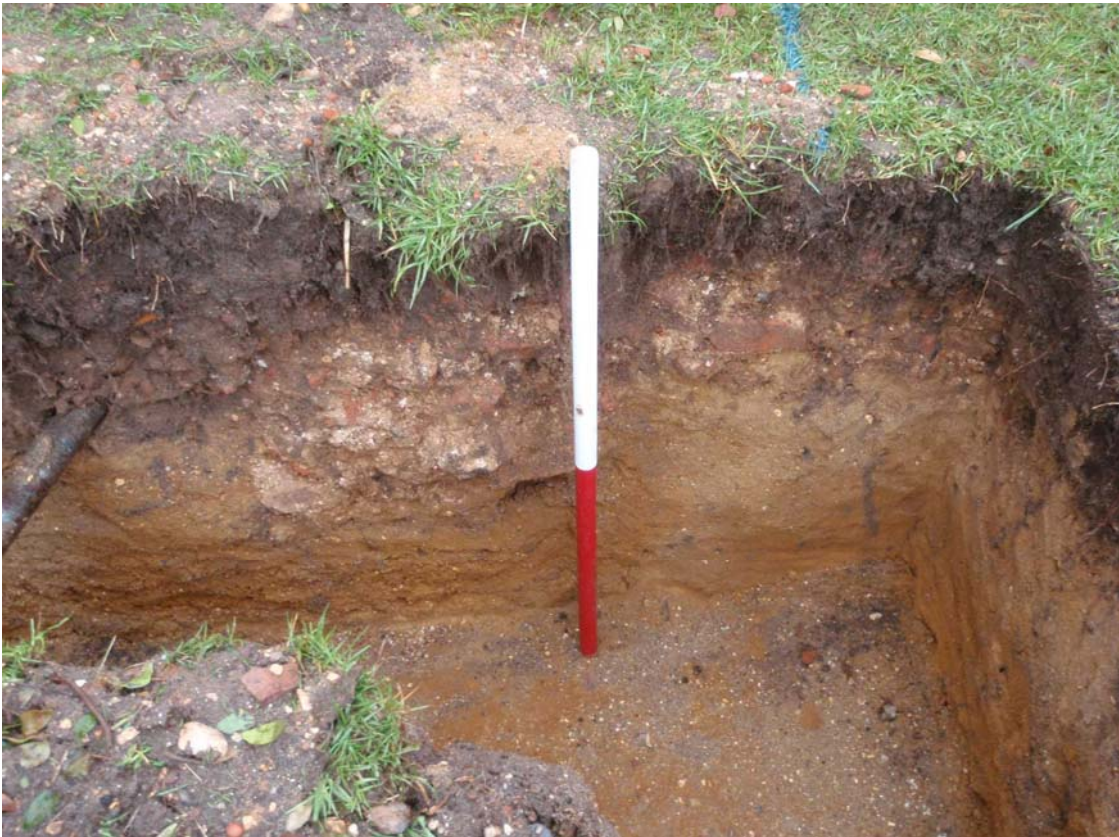
Cut 0006 measured >0.90m N–S x >0.50m EW x 0.44m deep. It had vertical sides, with a stepped profile to the south, breaking sharply into a flat base. The single fill 0005 was a mixed deposit of crushed, off-white mortar and brick rubble (50:50).

Plate 2. Cut 0006 in section, looking east (1m scale)

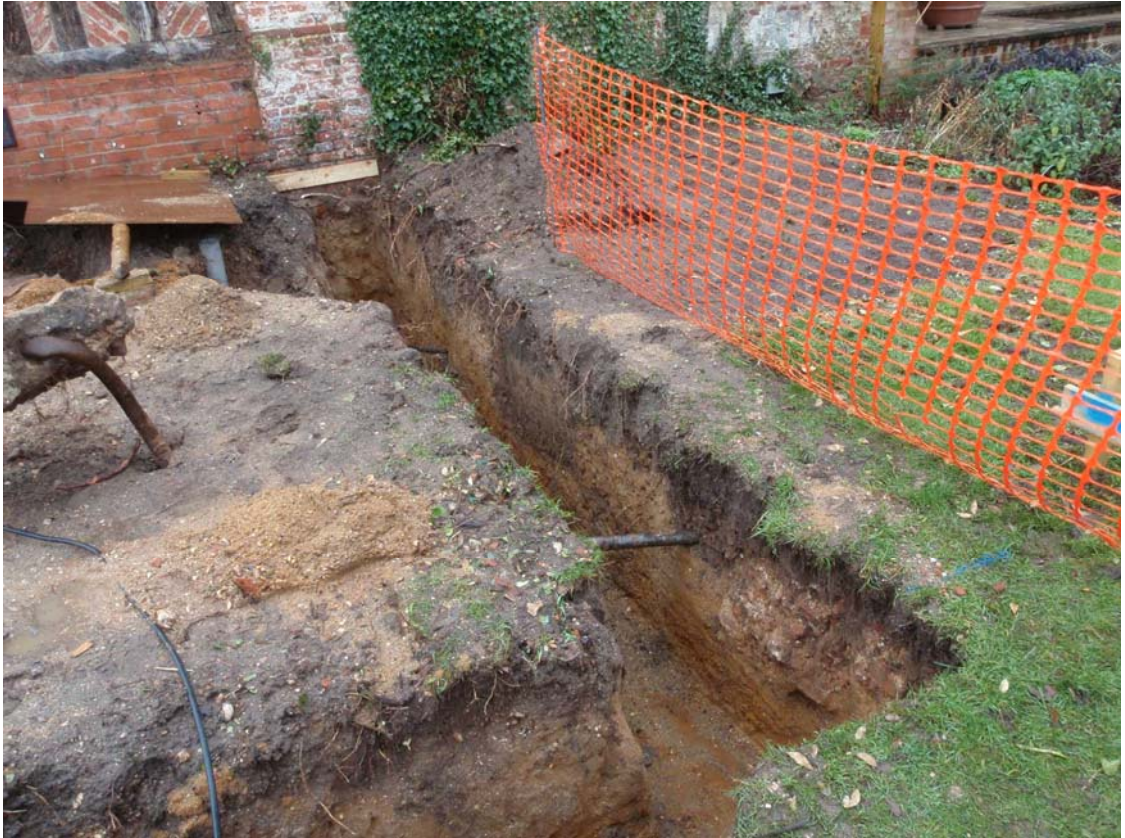
Plate 3. View of the trench recorded as Section S1, looking northeast (1m scale)

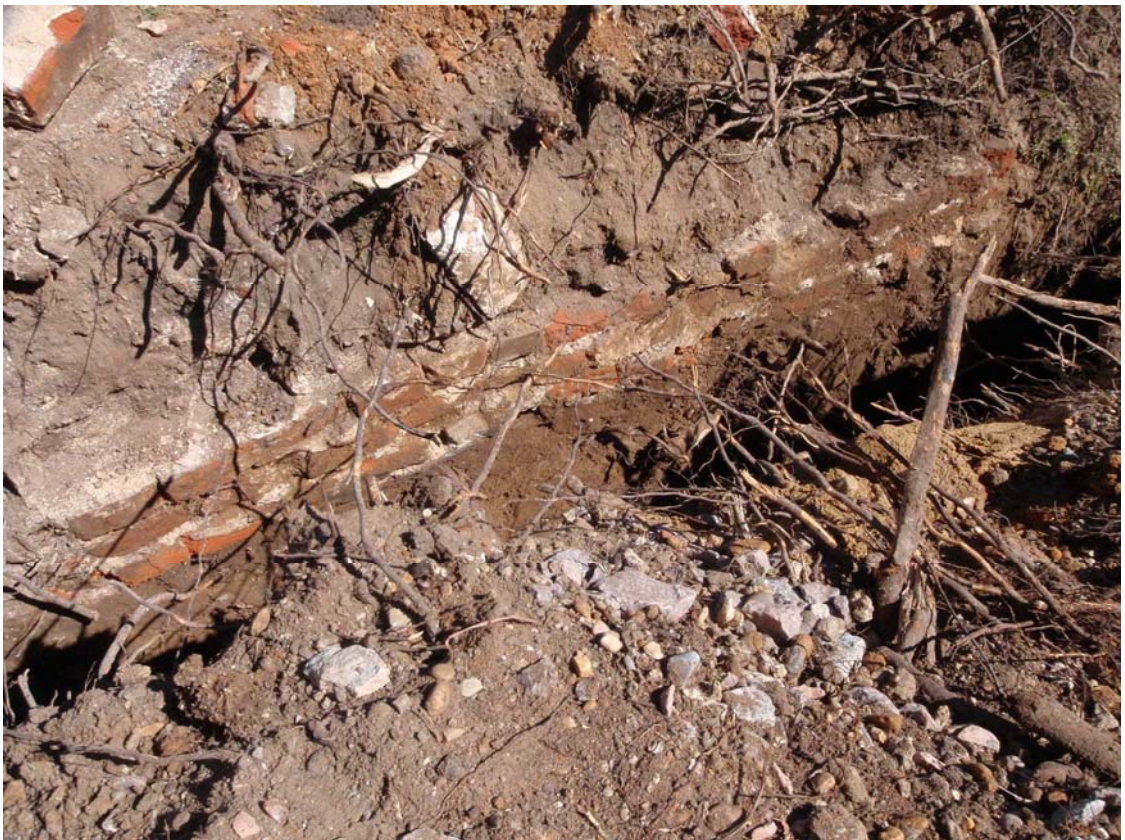
A brick foundation (0015) was exposed in the west-facing section of one of the north–south trenches (see Figure 2 for location). The foundation ran the length of the trench, apart from 1.2m at the south end of the trench where the foundation had been destroyed by the cut for some modern water pipes. 0015 was observed also in the south-facing section of the east–west trench on the north side of the garage block.

Foundation 0015 survived to a maximum of four courses (0.32m) and was constructed of red, hand-made bricks (un-frogged) measuring 240 x 110 x 65mm; the bricks were laid in an informal pattern of random headers and stretchers, and bonded with soft, light grey lime mortar. The foundation was only 0.24m (one header) wide.

The cut for the foundation had partially truncated subsoil layer 0013, and the foundation was sealed by garden soil 0012.

Plate 4. Brick foundation 0015, looking southeast

North–south foundation 0015 is assumed to have been of 18th- or early 19th-century date, based on brick form and dimensions, although it is possible that the bricks were reused at a later date. Given the narrow width of the foundation it was probably the footing for a garden wall rather than a building. The wall was demolished prior to the dumping of garden soil 0012, indicating a change of land use in this area of the site.
