**The Barns,  
Barningham Park,  
Bardwell, Suffolk  
BAR 077**

**Historic Building Record**

# The Barns, Barningham Park, Bardwell, Suffolk

## Historic Building Record

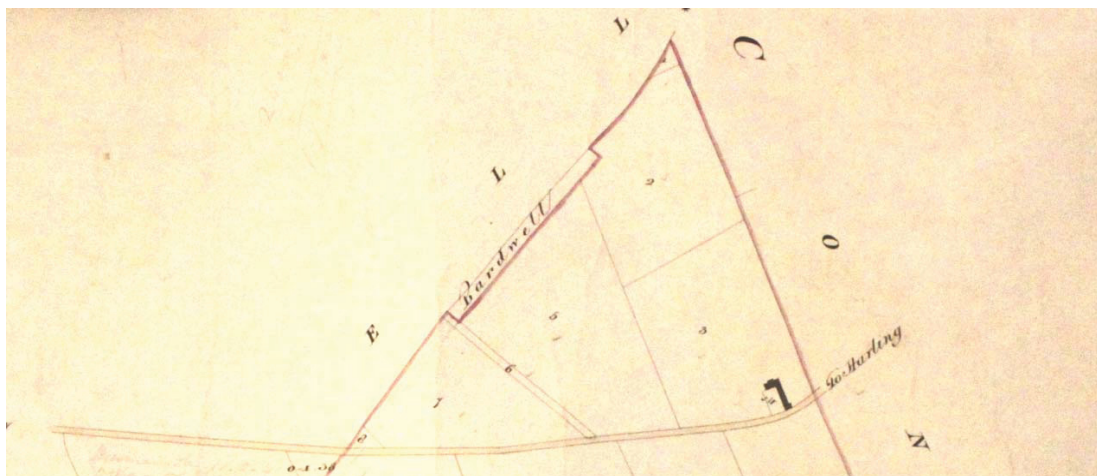
Figure 3

The same area on the 1843 Barningham tithe map showing the new arable fields with the L-shaped Barningham Barn to right and the track to Barningham Park to left.

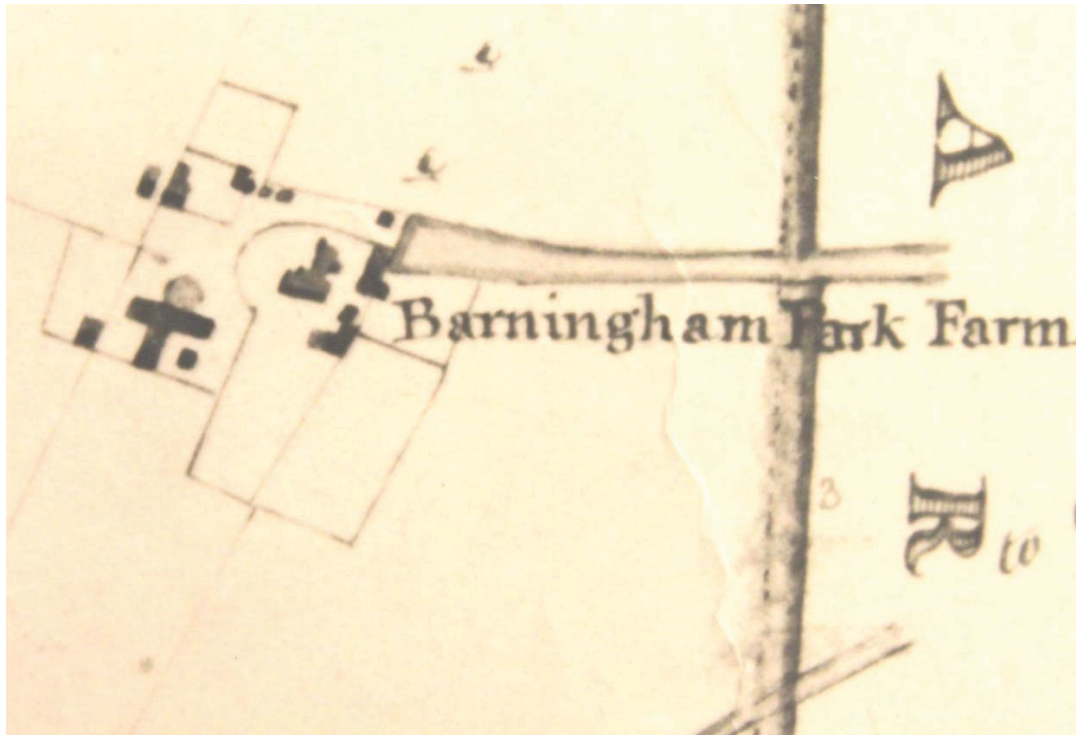
**Figure 4**

The Bardwell enclosure map of 1831, showing the boundary with Barningham and the 'private road' to the right. The listed southern barn (Barn 2) is shown as a T-shaped structure adjoining a circular pond to the north, but the site of the northern barn (Barn 1) was occupied by a pair of yards and a scattered group of small outbuildings.

The Bardwell enclosure map of 1831 (figure 3) shows the southern barn as a T-shaped building abutting a pond to the north, but the northern barn (now known for planning purposes as Barn 1) is conspicuous by its absence. A scattered group of small outbuildings occupied its site. This enclosure map related chiefly to former common land further south in the parish and shows the present linear field system in the vicinity of the farm. The property belonged to the Euston estate of the Duke of Grafton, whose forebear had purchased a manorial estate in Bardwell in 1734, and it remains in the same ownership today. The 1831 changes did involve the addition of some new land to the estate, however, and the exchange of scattered lands with neighbouring owners to create a more unified holding, and may well have occasioned the need for a second barn at Barningham Park. 16<sup>th</sup> century documents refer to a manorial park at Bardwell which may well have been located on the heathland and have given its name to the modern farm. (possibly a park for conies (rabbits), which it was fashionable to hunt, rather than deer)

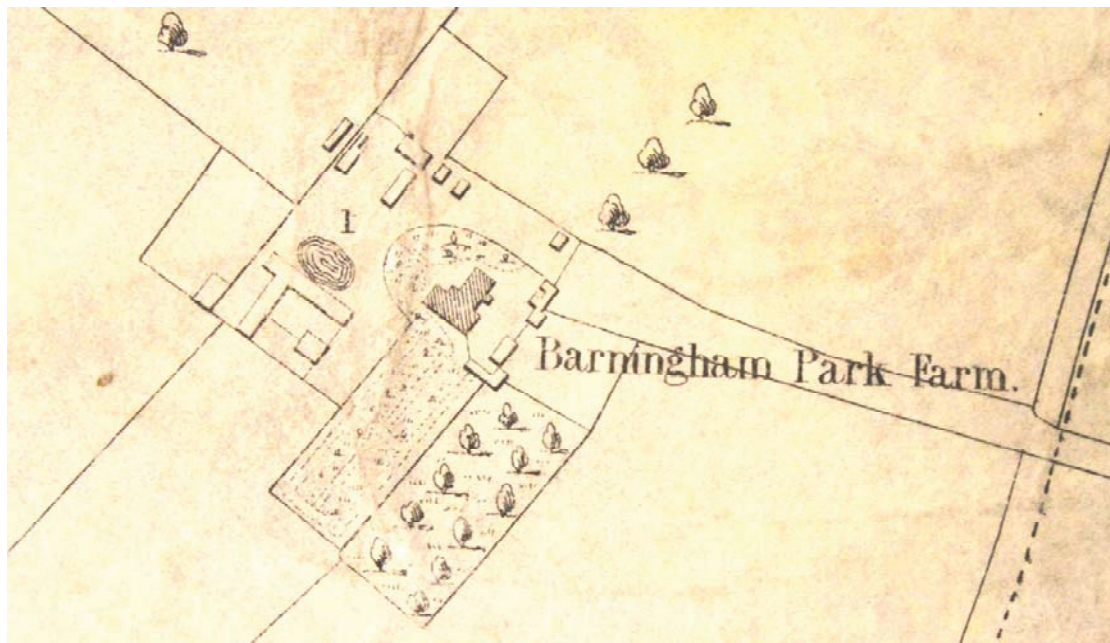
**Figure 5**

Bardwell tithe map of 1839 showing a similar layout in more detail. A new linear shed has been added to the northern group of buildings since 1831. The broken line of the Barningham boundary to the right follows the course of an 'Ancient Road' as described on the apportionment. 'Barn Pightle' adjoins the southern barn to the south-west and 'Stackyard' on the west.

At the time of the Bardwell tithe map of 1839 the northern barn had still not appeared, although an additional structure had been erected since 1831 on the approximate site the eastern cow-shed range of Barn 1. The Duke of Grafton owned approximately 1,100 acres in the parish (and more in neighbouring parishes) divided into two main holdings: Barningham Park of 363 acres (tenanted by William Cooper) and Bowbeck Farm of 637 acres. These farms were very large by the standards of the day and included arable fields of between 20 and 40 acres with approximately 22% of pasture land. Several field names reflect the Breckland-edge site, such as Heath Field, The Brect and Breaky Meadow, but most derive only from their size (i.e. ‘Six-and-thirty Acres’, ‘Six-and-twenty Acres’, etc.). The farm premises (plot 1 on the map) are named on the apportionment as: ‘Site of Barningham-park, farmhouse, offices, yards, gardens, yards, orchard and drift’. An ‘office’ at this period often referred to a malting (which may explain the unusual number of detached outbuildings to the north) and the drift is the farm lane. An additional track which crossed the present farm lane to the east was named as ‘Ancient road’ and was followed by the parish boundary, suggesting a medieval origin although no trace of it now survives. A corner in this road, some 150 m north-east of the farm, was named as ‘Park Corner’ with ‘Park Field’ further to the north.

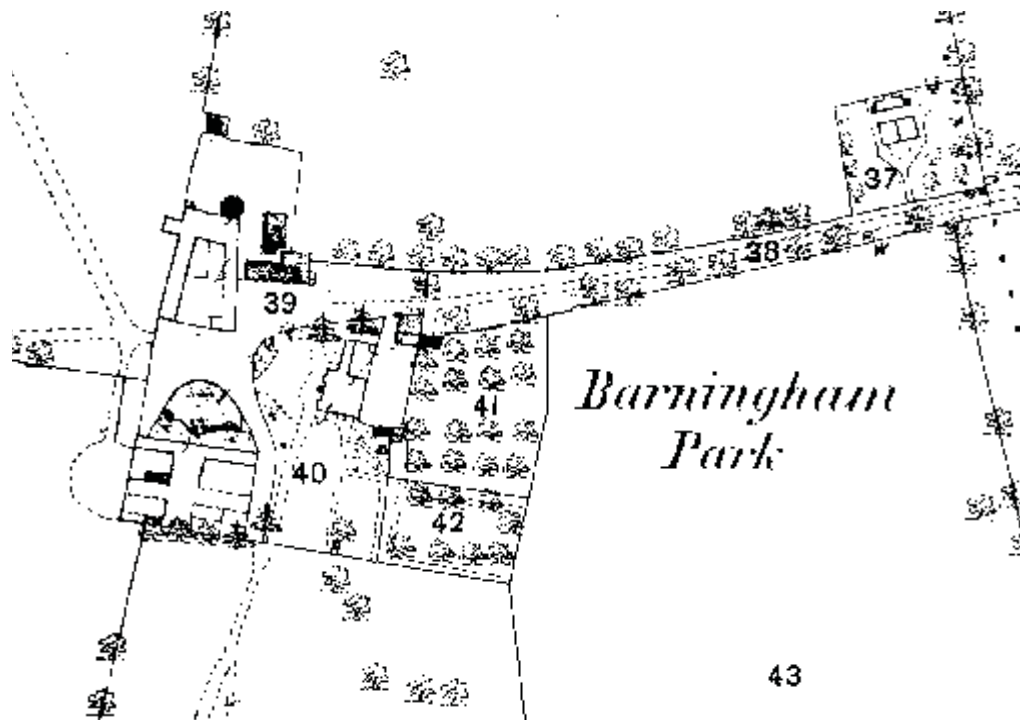
Figure 6

First edition 25 inch Ordnance Survey of 1883

Both barn complexes are shown much as they remain today, with Barn 1 having been built since 1839 and the yard sheds added to the east and west of Barn 2. The circular feature adjoining the north-eastern corner of Barn 1 was probably a horse mill. The dotted parish boundary with Barningham parish is shown to the right.

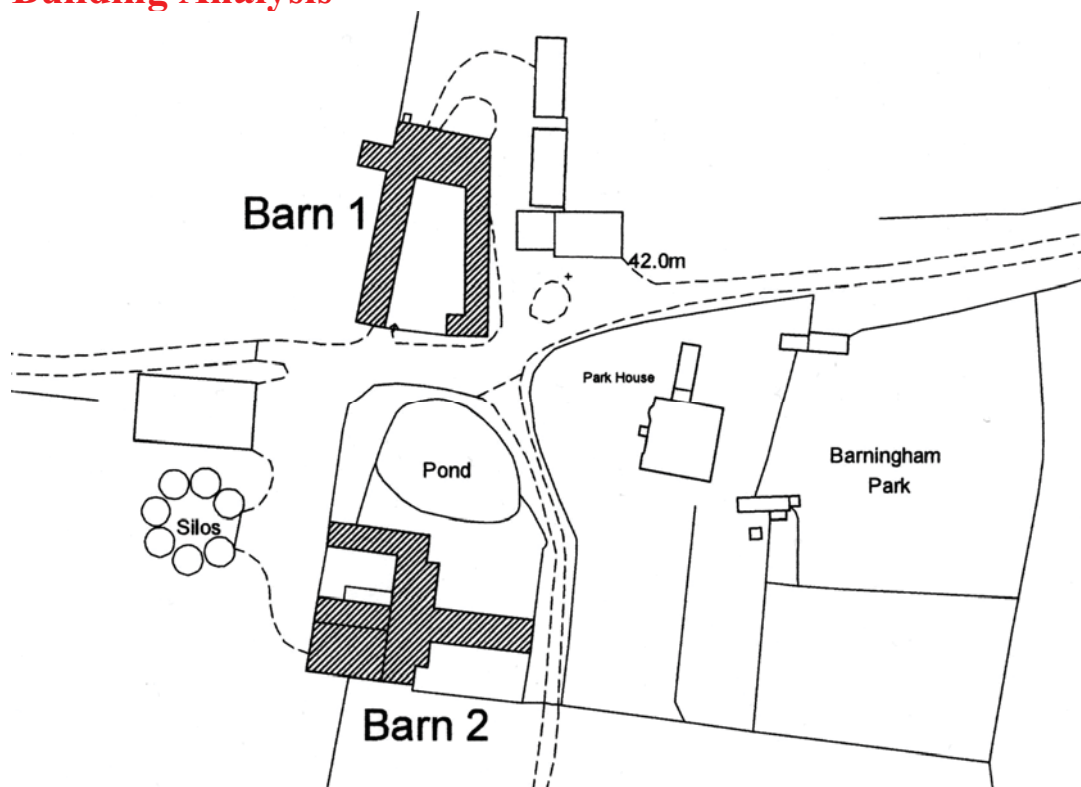
**Figure 8**  
**Plan of site showing Park House to right with the two historic farm complexes known for planning purposes as Barn 1 and Barn 2 to the west. Park House and Barn 2 are listed at grade II. The un-shaded buildings to the east of Barn 1 are additions of the 20<sup>th</sup> century.**

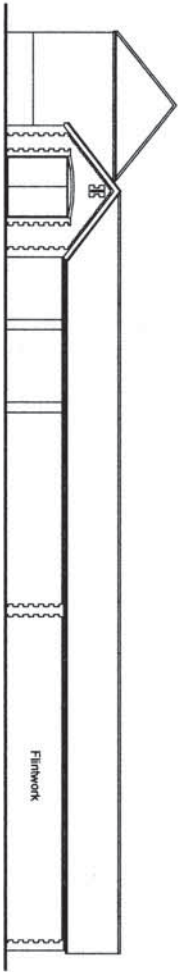
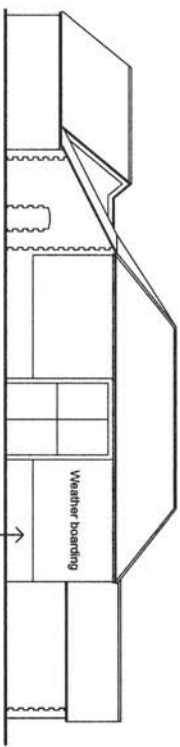
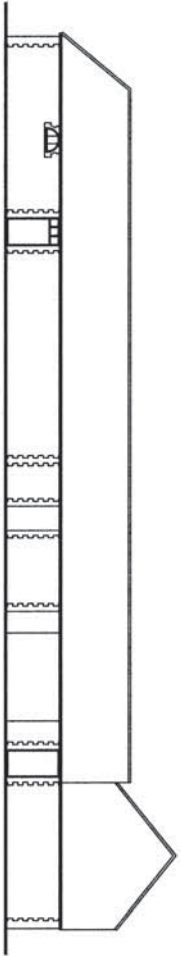
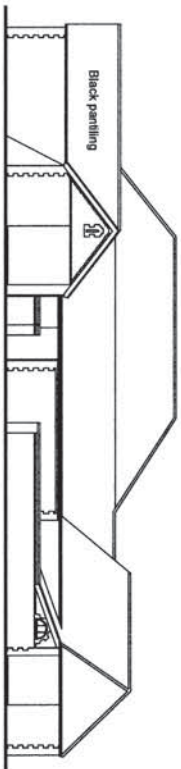
**Figure 11 (page 14)**  
**Elevations of Barn 1 (Drawn by Bidwells Building Consultancy)**

West Elevation

North Elevation

East Elevation

South Elevation

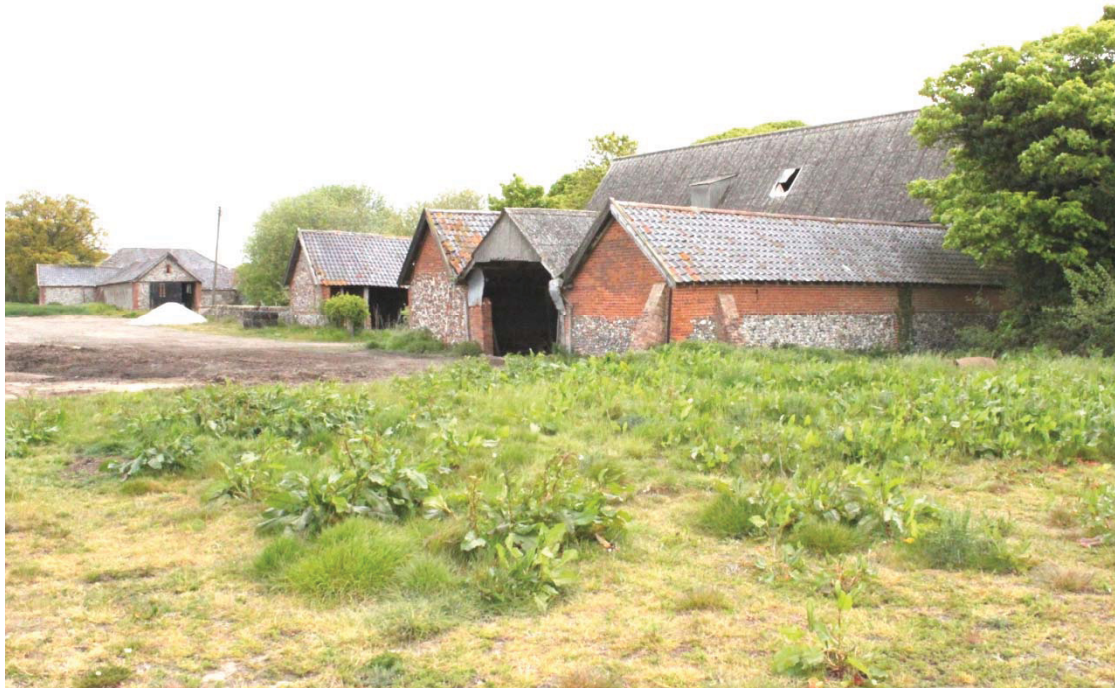
**Illus. 1. General view of site from south-west showing Barn 2 to right and Barn 1 in rear to left.**

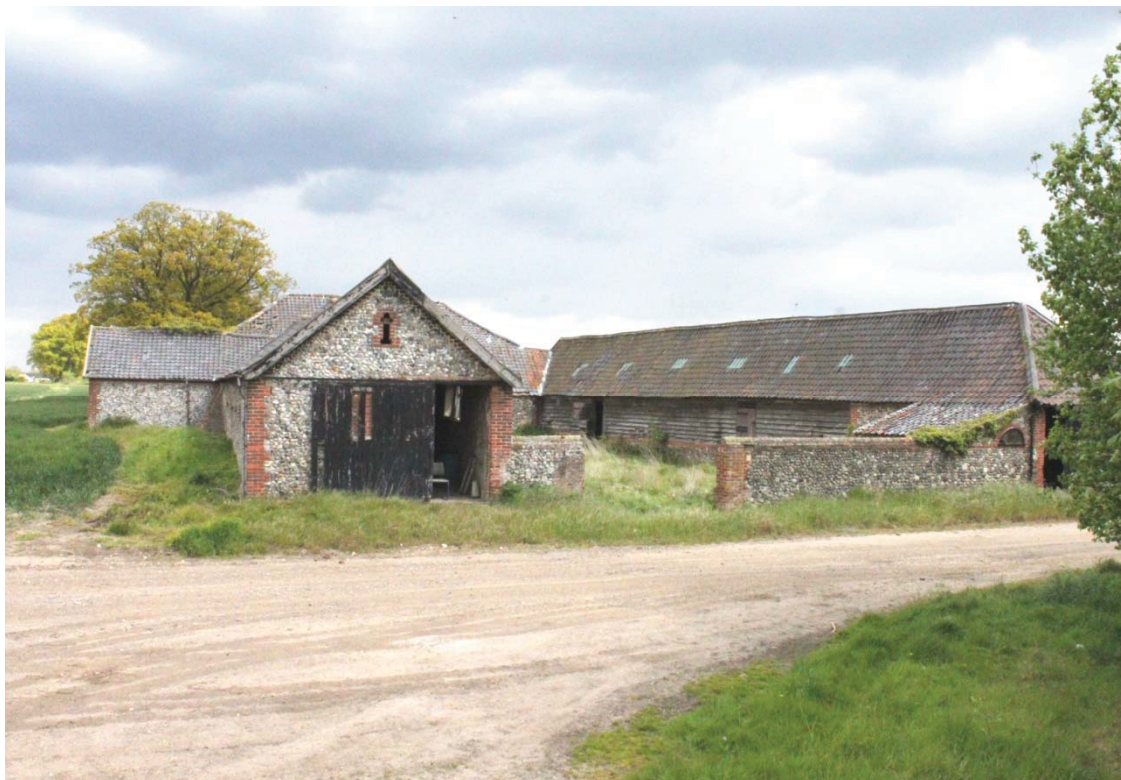
**Illus. 2. Exterior of Barn 1 from south showing hipped roof of main barn (1) in rear with gable of stable (7) to left and cow shed range (3-5) to right.**

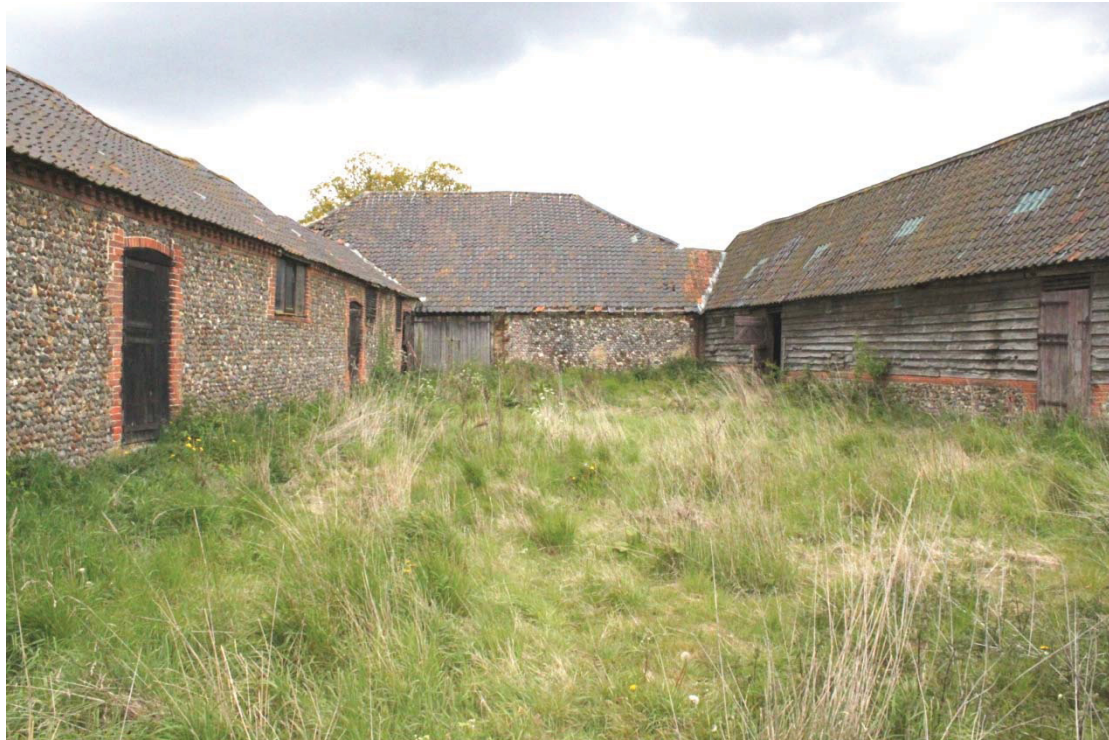
**Illus. 3. Yard of Barn 1 from south showing hipped main barn (1) in centre with western stable range (7-9) to left and eastern cow-house range (3-5) to right. The latter was converted from an open-sided shelter shed.**

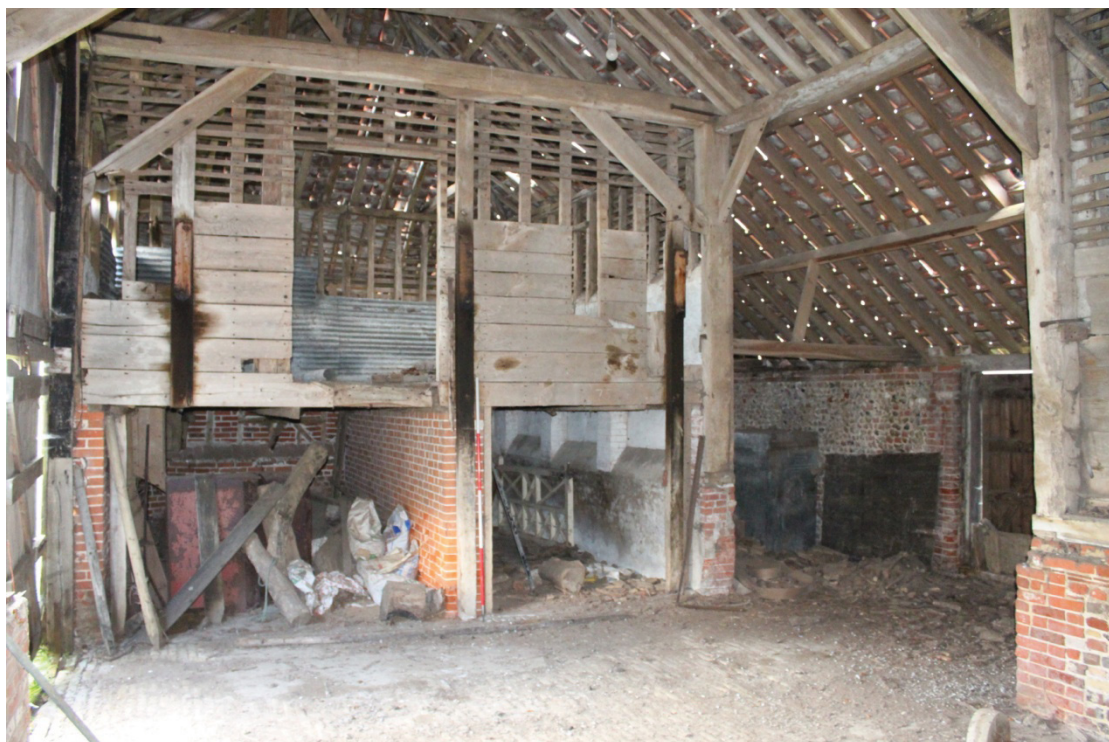
**Illus. 4. Interior from west of main barn (1) of Barn 1 showing the early-20<sup>th</sup> century inserted grain floor to the east of the central bay which retains an original brick threshing floor. The lean-to shed (1a) adjoining the yard is visible to the right. Note the unusually late straight braces to the tie-beams.**

A grain floor of tall-sectioned softwood joists supported on piers of red brick was inserted into the barn's eastern bay during the early-20<sup>th</sup> century (or possibly the late-19<sup>th</sup> century). This was a common development which reflected the increasing use of local barns as grain stores and cattle feed mills rather than threshing barns with the advent of machinery during the second half of the 19<sup>th</sup> century. A pair of iron belt-drive wheels survives on the internal eastern gable of the loft. The lean-to shed (2) adjoining the barn's eastern gable probably contained the mechanism of a horse mill shown to the north on the Ordnance Survey of 1883, and possesses an external door to the south and a blocked window-like aperture to the north. The eastern yard range seems at first sight to contain a pair of original cow sheds with boarded 19<sup>th</sup> century cattle stalls and an impressive brick floor with a raised standing to the east and an axial drain and passage to the west, but has in fact undergone considerable alteration. A pair of blocked original doors can be seen in the fabric of the eastern wall (their outlines dressed in red brick and blocked with flint), each of which adjoins the corner of an internal partition that now survives only above the tie-beams. The range was evidently divided into four compartments (the northernmost entered from the lean-to shed (2) against its northern gable) rather than two as at present, and was almost certainly open to the west as the existing flint plinth of the weatherboarded studwork is not keyed to the original plinth of the adjoining enclosed feed shed to the south (5). It probably formed the open-sided shelter-shed of a horse yard that was converted in *circa* 1870 to form a pair of cow sheds. These changes may well have coincided with the addition of the yards to the southern barn and the introduction of cattle to the site. The feed shed was extended by a lean-to brick store (6) before 1883 – as it is shown on the Ordnance Survey – and subdivided with cement blocks in the mid-20<sup>th</sup> century to form a chemical store (5b). A number of small, square stone blocks of uncertain origin have been incorporated in the external fabric at this end of the complex.

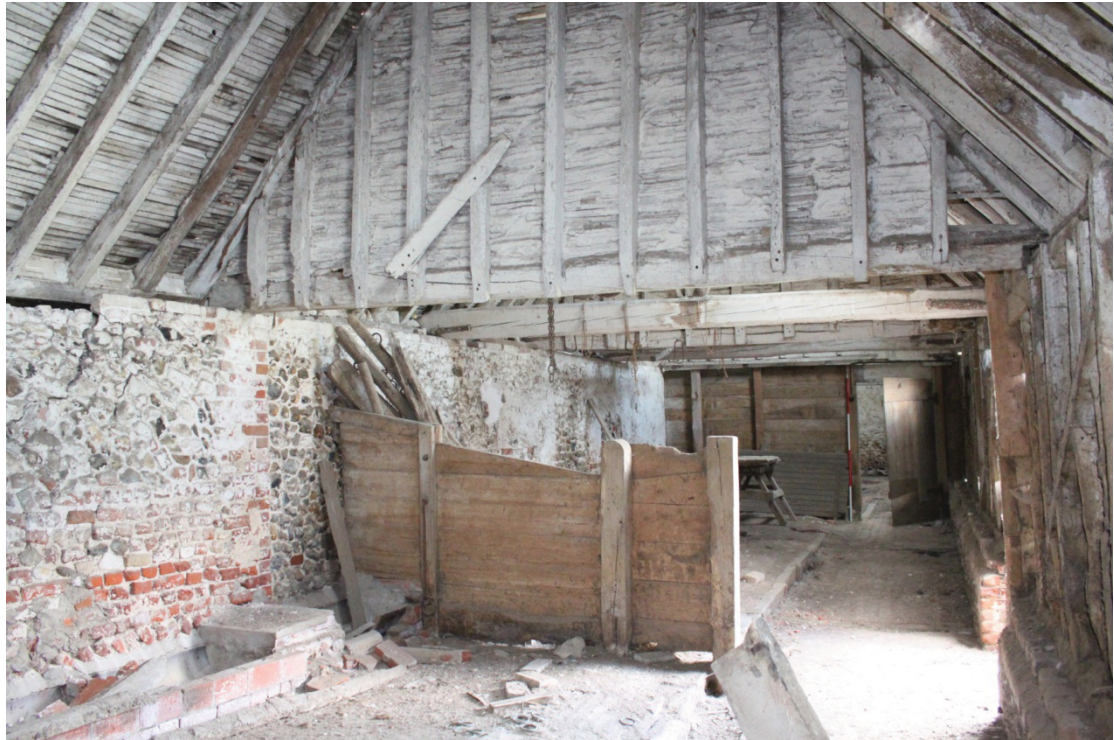
**Illus. 5. Interior of northern cow-shed (3) of Barn 1 from north showing low secondary brick manger to left and door to southern shed (4) in rear. The two blocked doors of the eastern elevation are visible to the left, and the two associated lateral partitions still survive above the tie-beams.**

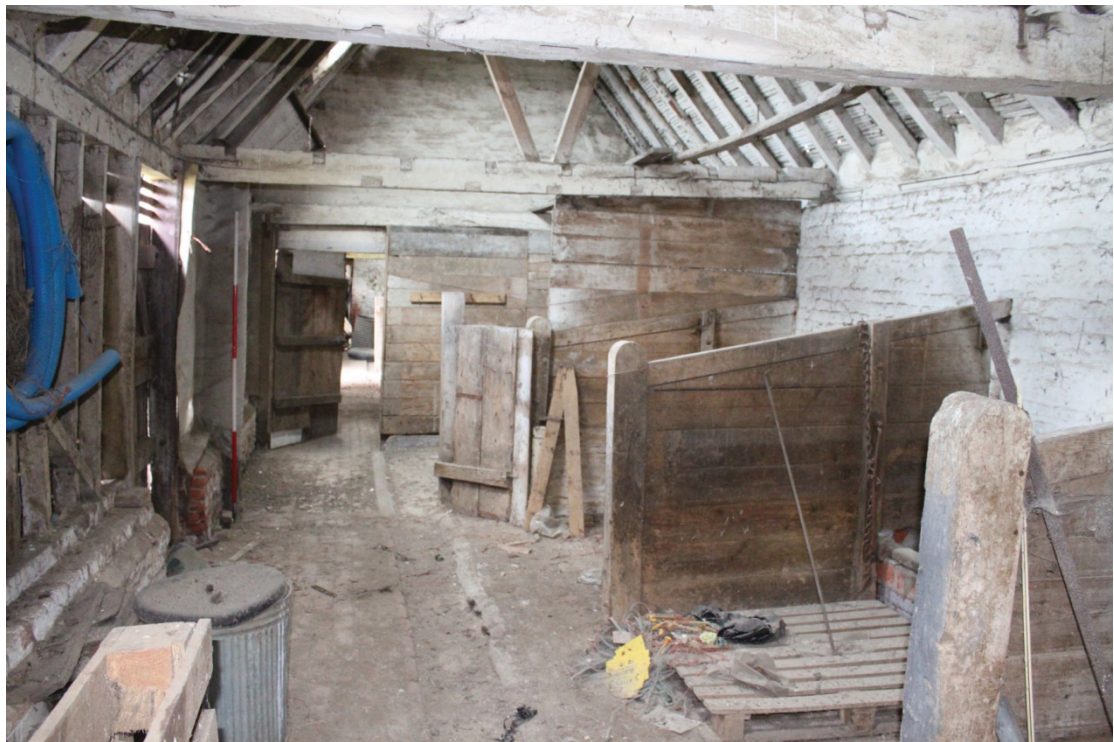
**Illus. 6. Interior from south of southern cow-shed (4) of Barn 1 showing 19<sup>th</sup> century boarded stalls to right and door to northern shed (3) in rear. Note the brick floor with axial drain and yard elevation of boarded studwork to left (replacing an original open arcade).**

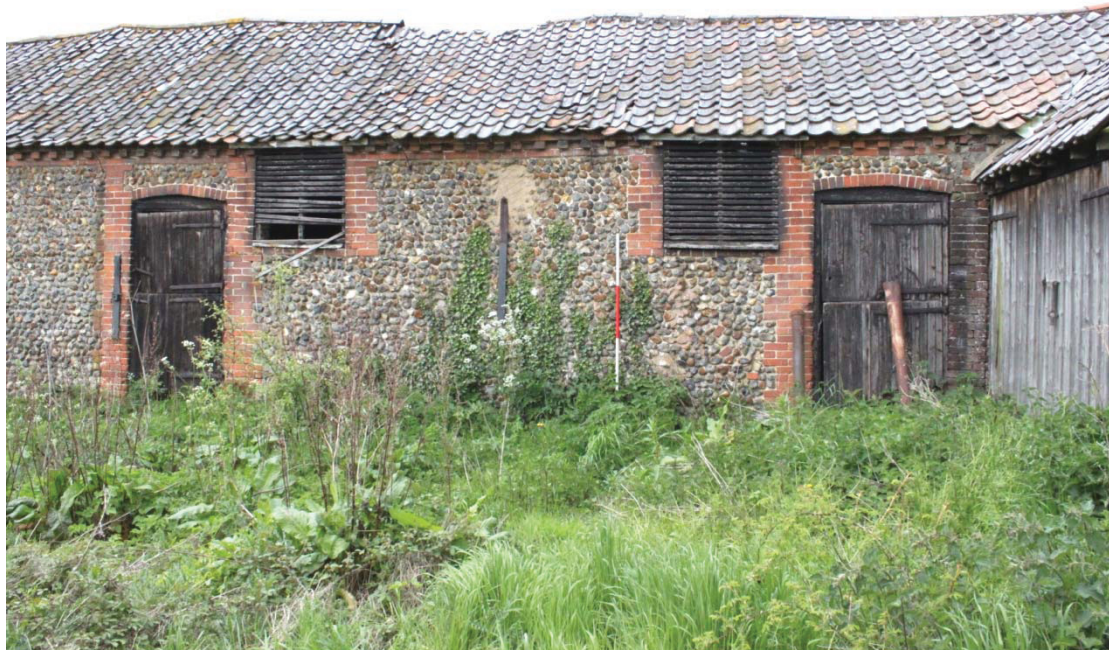
**Illus. 7.** The original double-hung doors and louvered windows in the eastern exterior of the northern stable (9) which was originally divided in two. The secondary doors of the main barn (1) of Barn 1 are shown to the right.

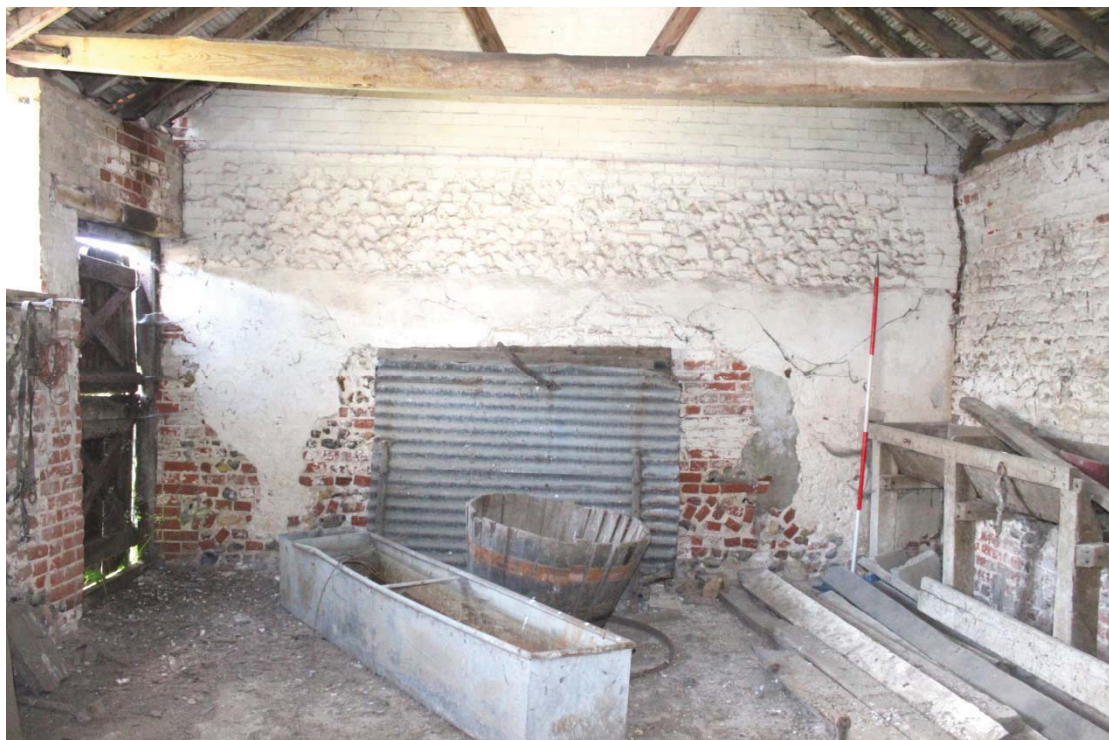
**Illus. 8.** Internal southern gable of northern stable (9) of Barn 1 showing its yard door to the left and an original boarded manger to right. Circular apotropaic marks are incised in the barn adjacent to the entrance and above the manger.

the yard door and manger. Concentric circles of this kind were traditionally used in East Anglia as superstitious devices to protect animals and crops from evil spirits – in much the same way as hag-stones or suspended horse shoes.

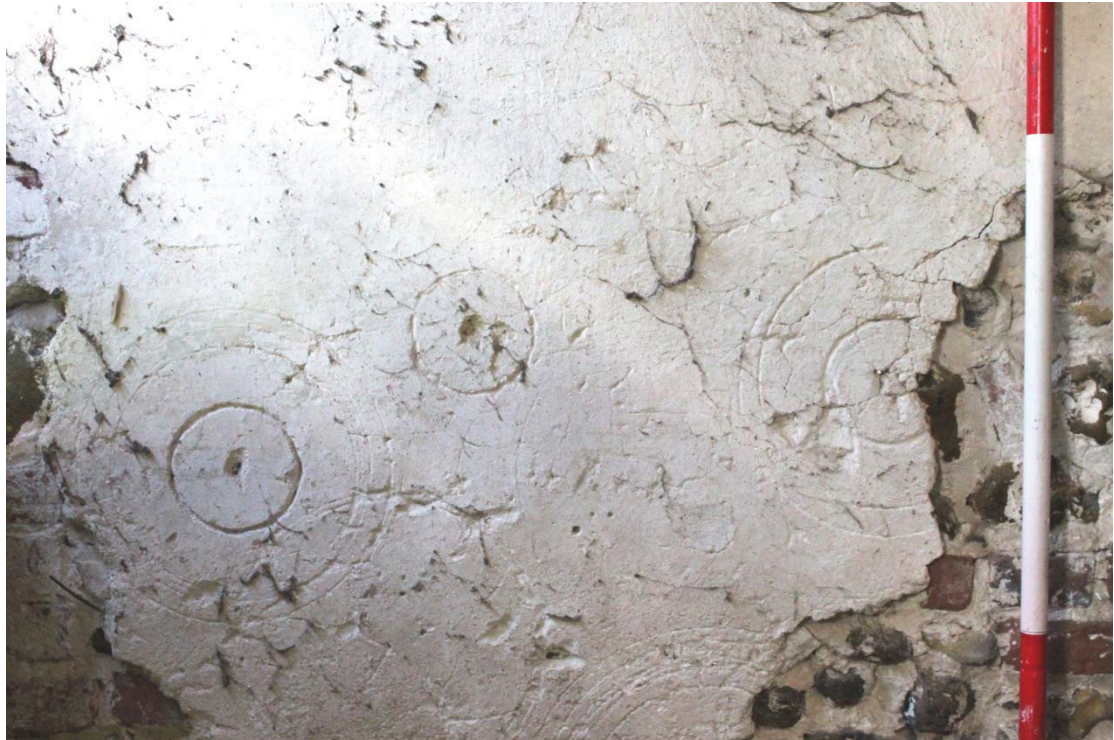
**Illus. 9. Detail of circular apotropaic marks incised in lime render to eastern side of southern interior of stable (9) in Barn 1 (adjacent to entrance door to left).**

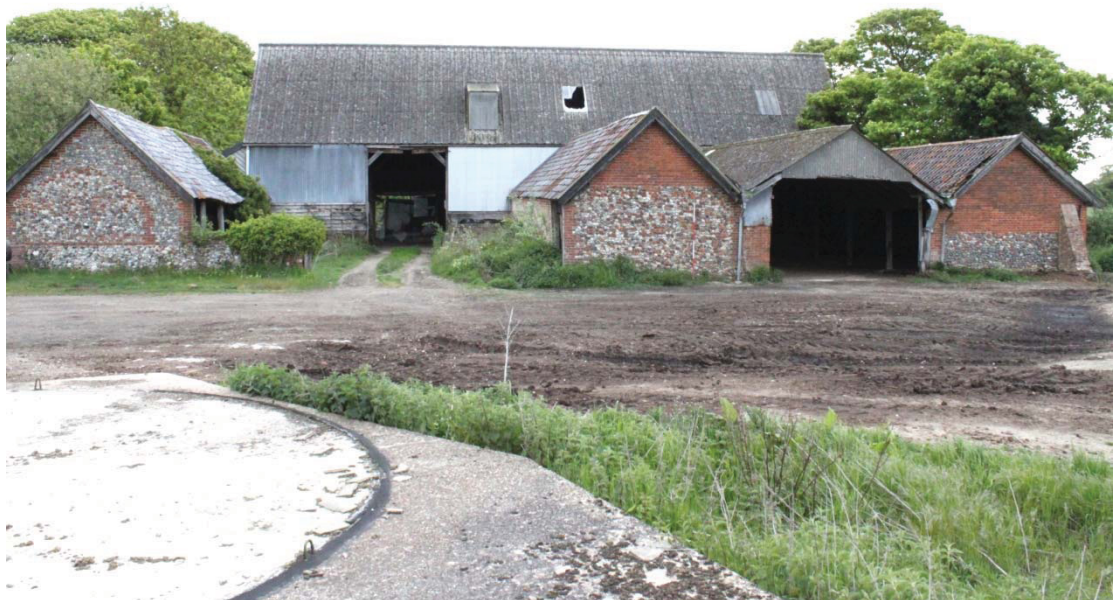
**Illus. 10. Western exterior of grade II-listed Barn 2 showing main barn (1) in rear (originally thatched but now with a corrugated asbestos roof) and sheds 3, 4 & 5 from left to right in foreground. The roof over the cattle yard between sheds 4 & 5 to the right is an addition of the mid-20<sup>th</sup> century.**

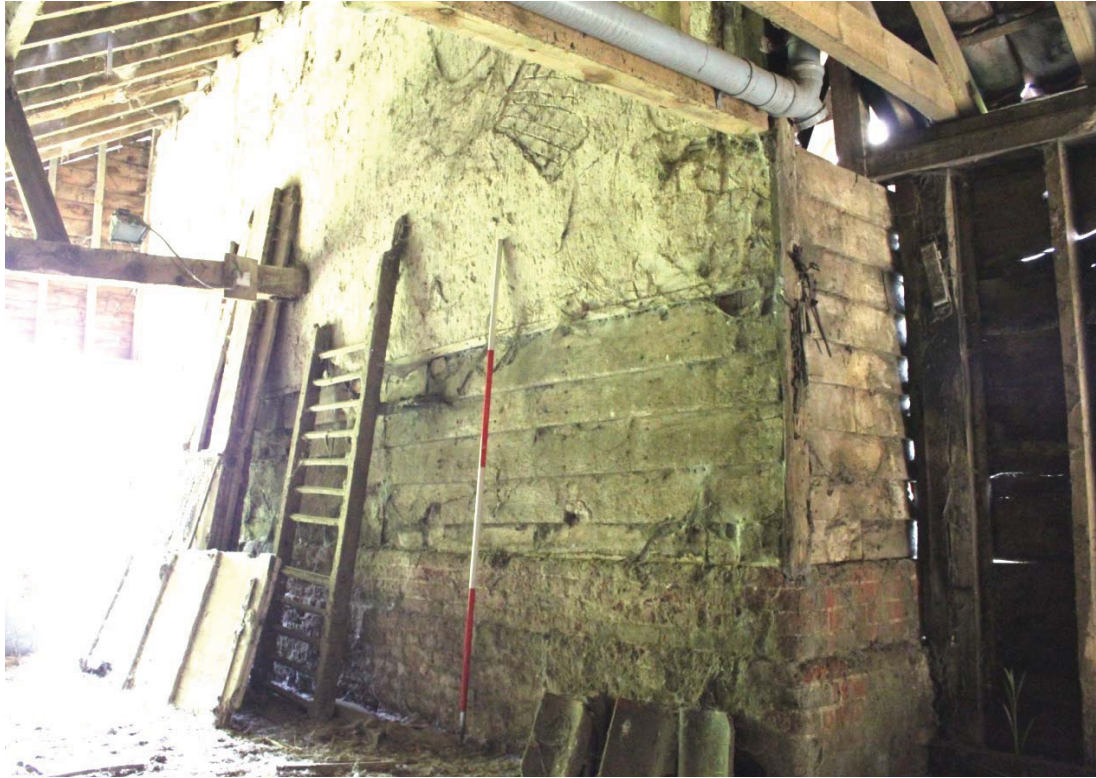
**Illus. 11. Northern external gable of main barn (1) of Barn 2 seen from adjoining open shed (3a) to north-west, showing the original two-tier cladding of render above weatherboarding.**

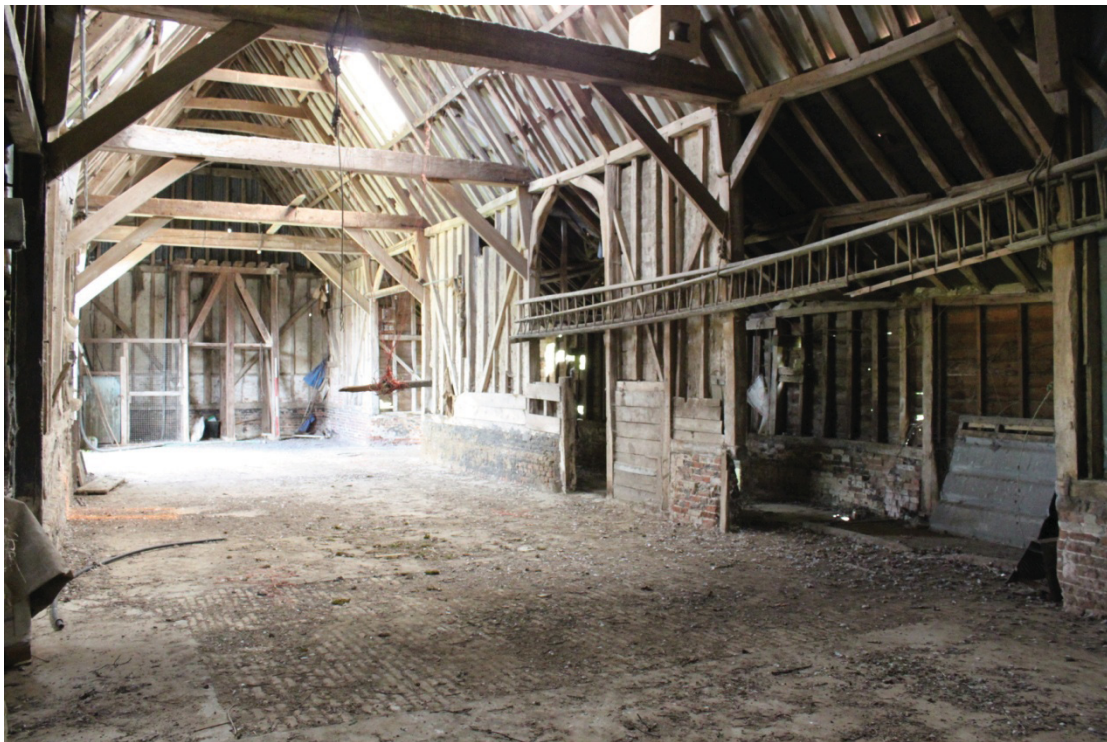
**Illus. 12. Eastern interior of main barn (1) of Barn 2 showing the two original threshing bays B & E from left to right with an intact brick threshing floor in the foreground. The central doorway is a later insertion. The northern (left-hand) storey post of bay E to the right bears the carved date and initials shown in illus. 14.**

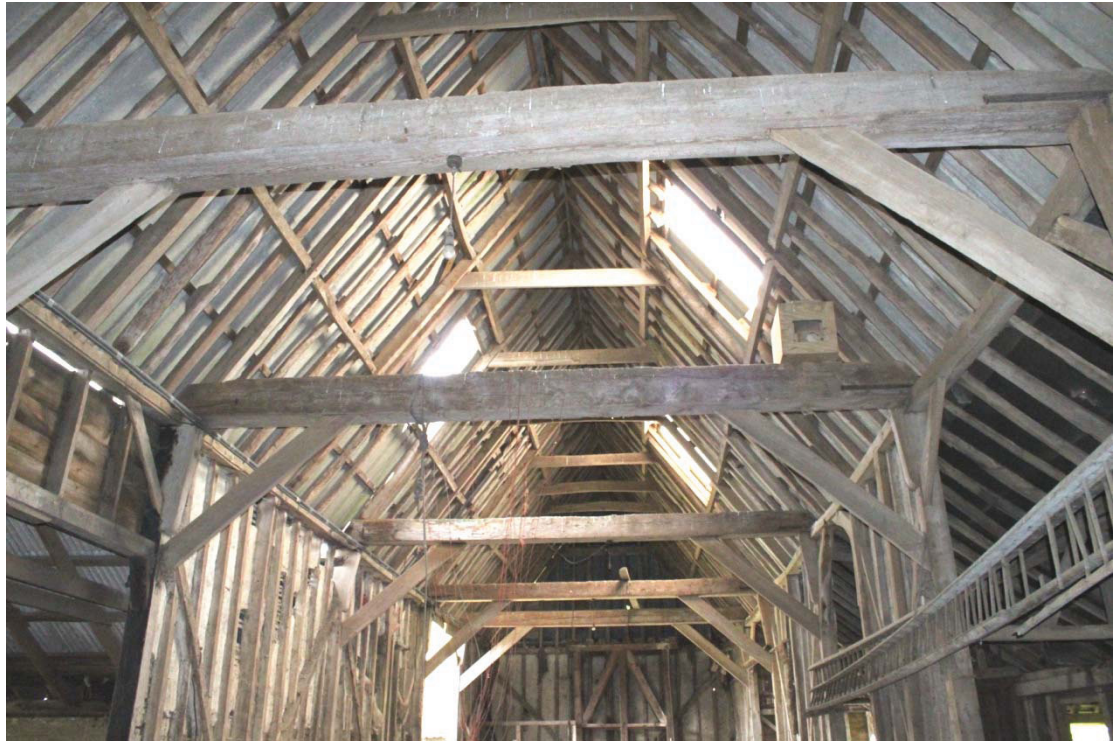
**Illus. 13.** Detail from south of roof of main barn (1) of Barn 2 showing intact horizontal tie-beams and braces with two tiers of linear butt-purlins above. The roof is steeply pitched for thatch.

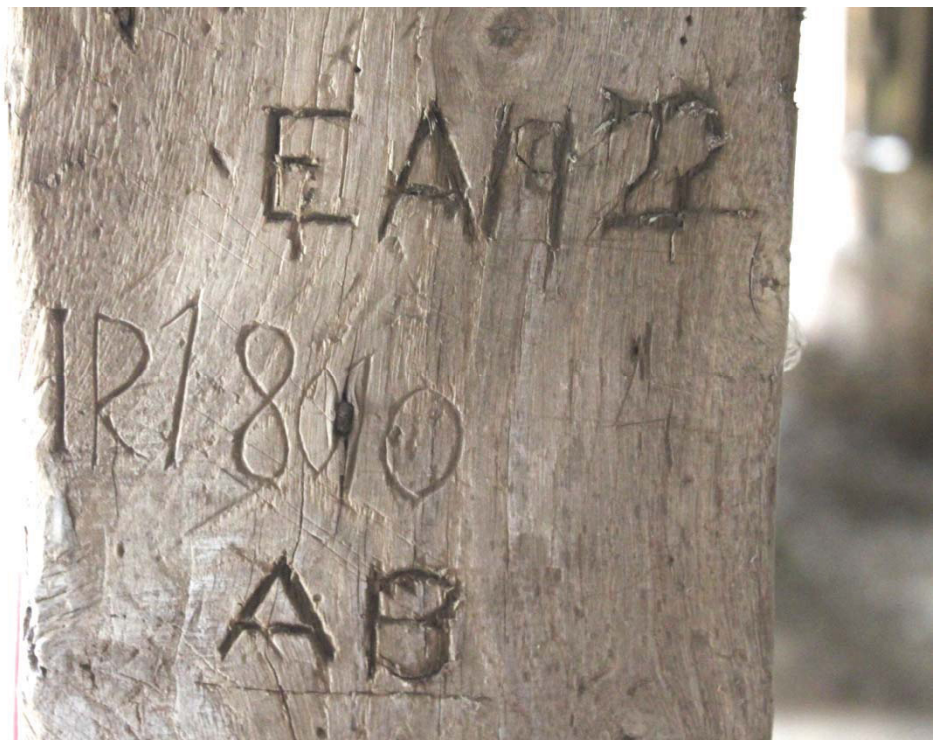
**Illus. 14.** Carved date and initials to southern edge of north-eastern storey post of threshing bay E in main barn (1) of Barn 2. Originally 1810 but altered to 1800 by inserting a narrow second zero. This is contemporary with the initials I R (probably representing J R), while 'E A' was carved in 1922. The barn's structure suggests it was built in or very shortly before 1810.

The barn is dated to the early-18<sup>th</sup> century in the Schedule of Listed Buildings but its framing is in fact typical of the many barns that were rebuilt in Suffolk around 1800 in response to the cereal boom of the Napoleonic wars. The high prices of grain caused by restrictions on imports from the continent made it profitable to plough the Brecklands and Sandlings in the county for the first time in centuries. A very similar barn on the neighbouring farm to the east (now known as Barningham Barn in Coney Weston) is not shown on the 1798 enclosure map, which labels the fields surrounding Barningham Park as ‘sheepwalk’ (i.e. rough grazing), and the barn here is almost certainly dated by the inscription ‘I R 1810’ carved into the north-eastern storey post of the southernmost of its two narrow threshing bays – which also preserves an original brick threshing floor. This date appears to have been altered to read 1800 by squeezing an additional ‘0’ into the narrow gap between the ‘8’ and the following ‘1’, and it is unclear which of the two was originally intended. ‘Foundation’ inscriptions of this kind are often found in local barns and may well have been associated with a ritual of some form. Despite its later date and the loss of its thatch the barn still merits listing at grade II in my view, although many similar ‘Napoleonic barns’ in the county remain unlisted. A secondary aperture in the eastern elevation of bay D appears to be a mid-19<sup>th</sup> century insertion designed to give access to the new eastern cattle yard of the same period.

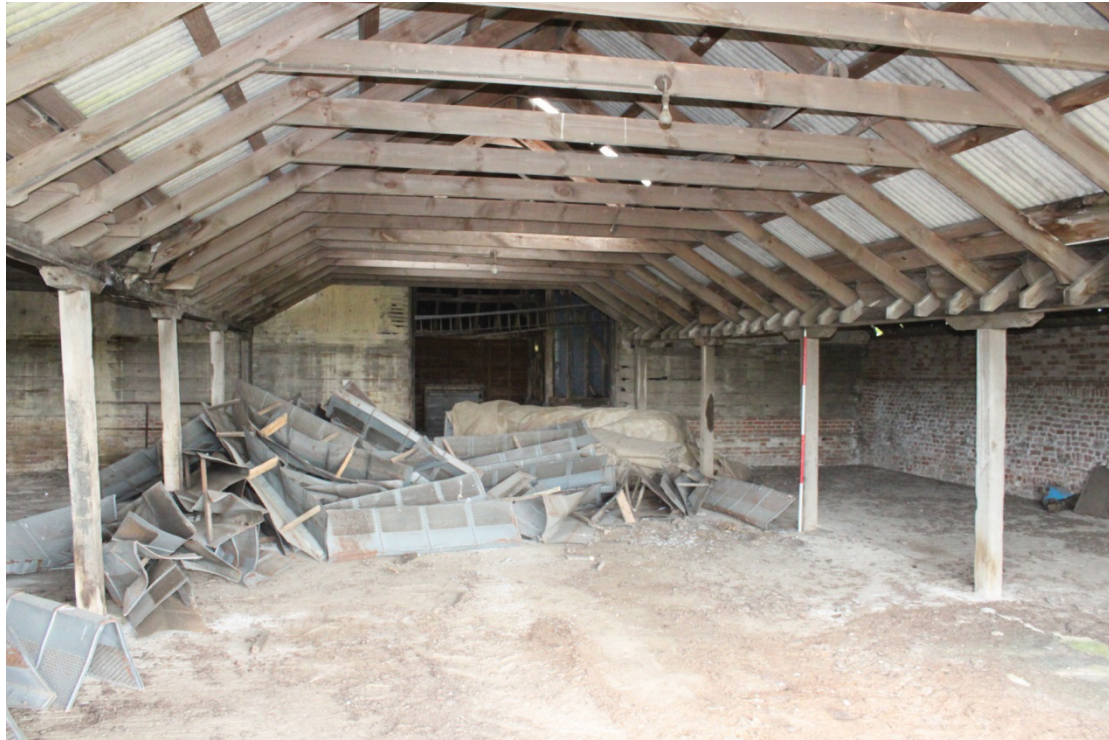
**Illus. 15. Interior of 20th century covered cattle yard of Barn 2 from west showing open shelter-sheds 4 and 5 to left and right respectively. The southern entrance in bay E of the main barn (1) is visible in the rear, flanked by original two-tier cladding.**

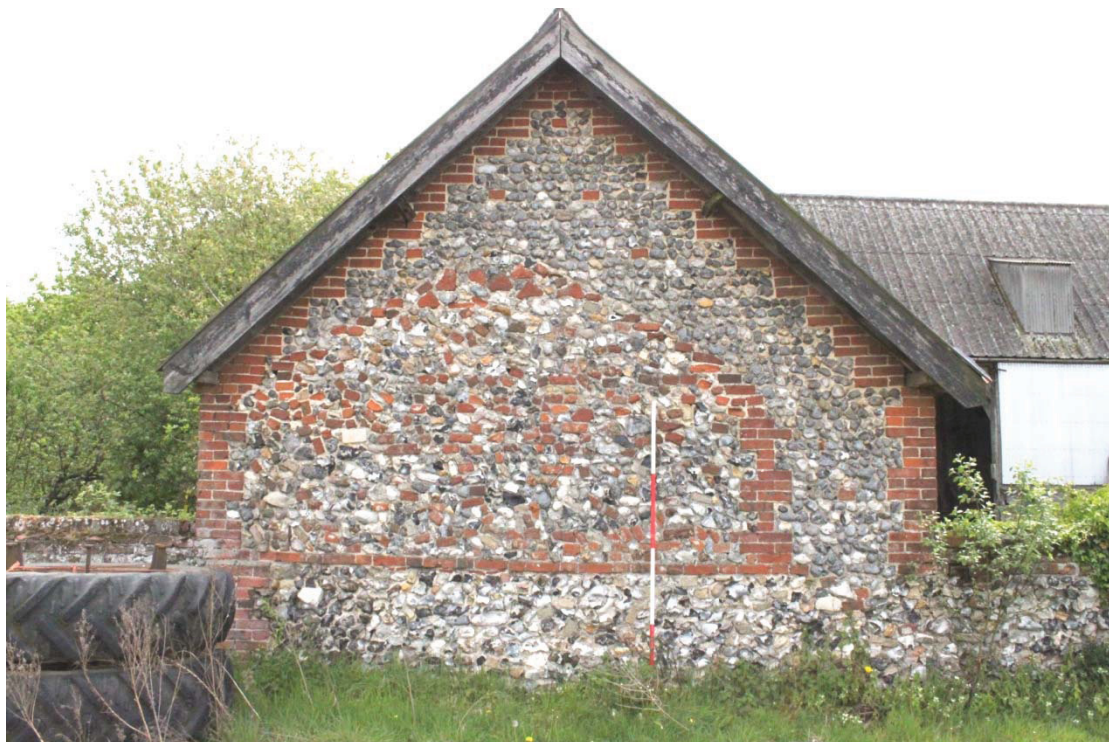
**Illus. 16. Detail of western external gable of shed 3 of Barn 2 showing the outline of the narrower, earlier shed (as shown on the tithe map) which was incorporated into the present building.**
