**The Cartshed,  
Stone Farm,  
Blaxhall, Suffolk  
BLX 018**

**Historic Building Record**

# **The Cartshed, Stone Farm, Station Road, Blaxhall, Suffolk**

## **Historic Building Record**

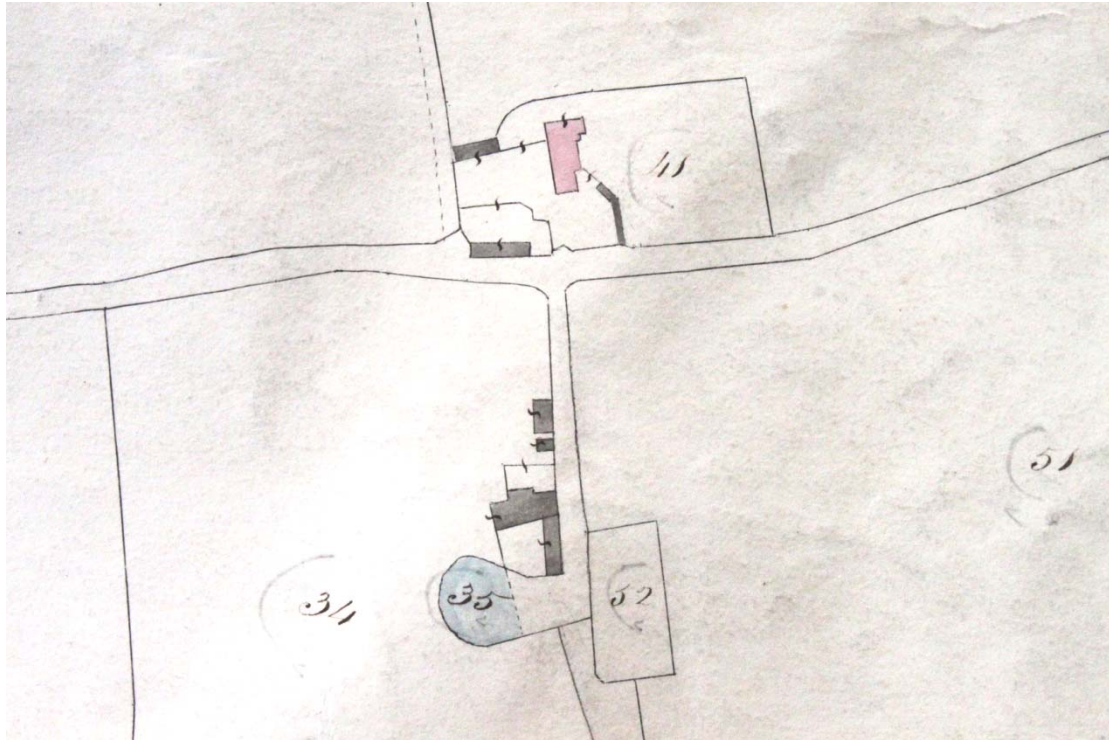
**Figure 2**

**Stone Farm on the Blaxhall tithe map of 1841 showing the farmhouse in red to the north of the road and a barn to the north of the pond. Neither the cartshed nor farm complex to the east of the farm track had been built at this time.**

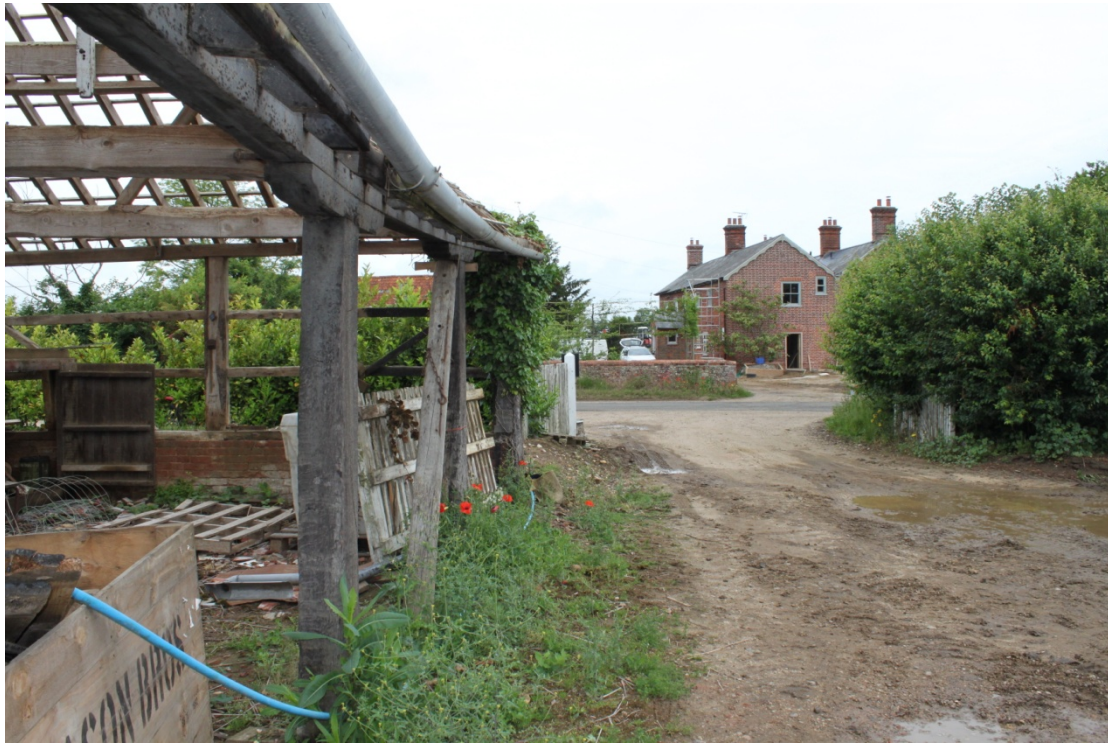
**Illus. 1. General view of site entrance from south showing cartshed to left and farmhouse on opposite side of Station Road in rear to right.**

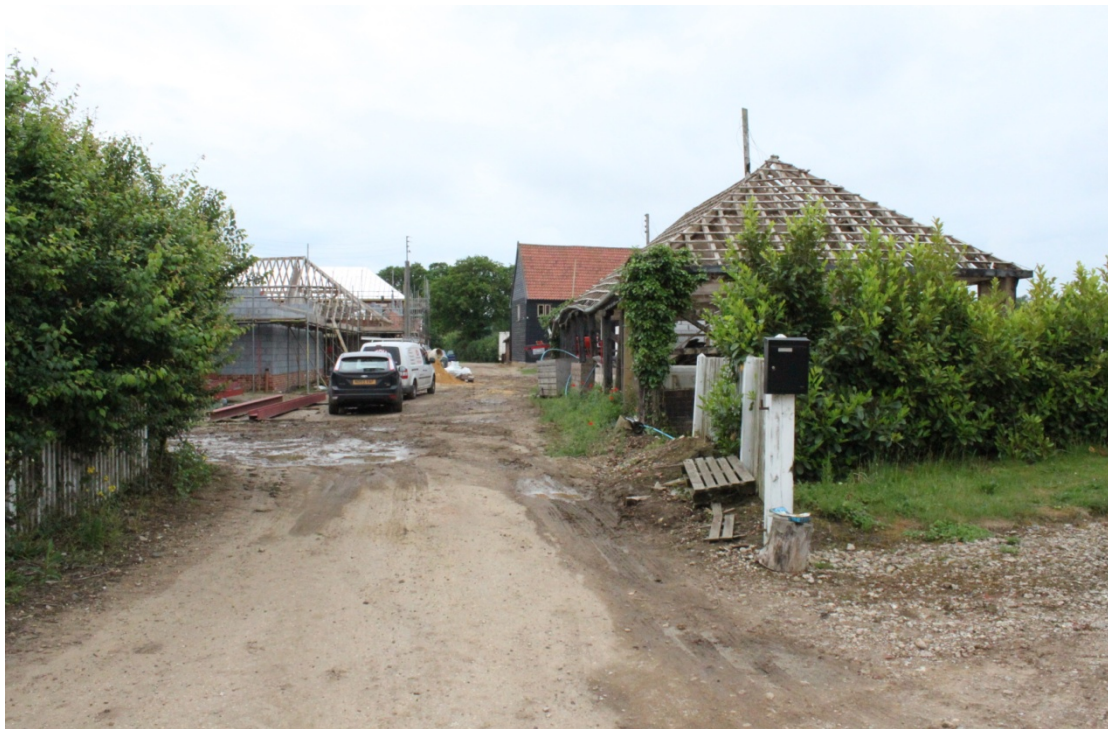
**Illus. 2. General view of site entrance from north showing cartshed to right and farm complex currently undergoing conversion in rear.**

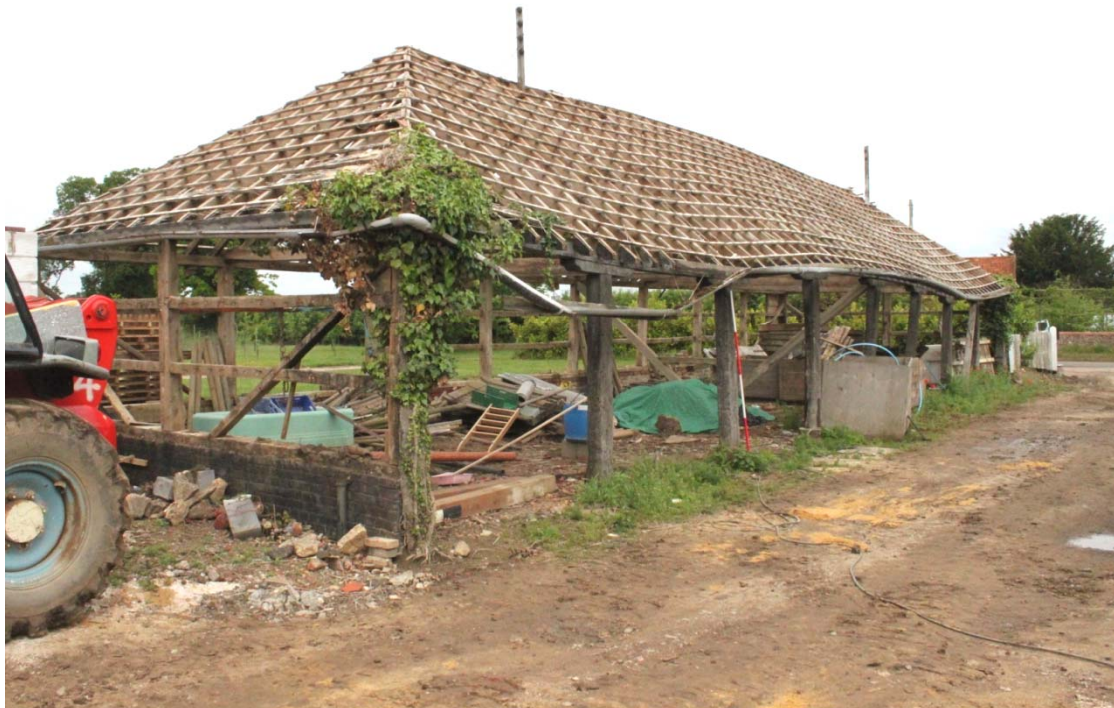
**Illus. 4. Exterior of cartshed from south-east showing open eastern elevation and site entrance to right with southern gable to left. The building had been entirely stripped of its external cladding and tiles prior to inspection.**

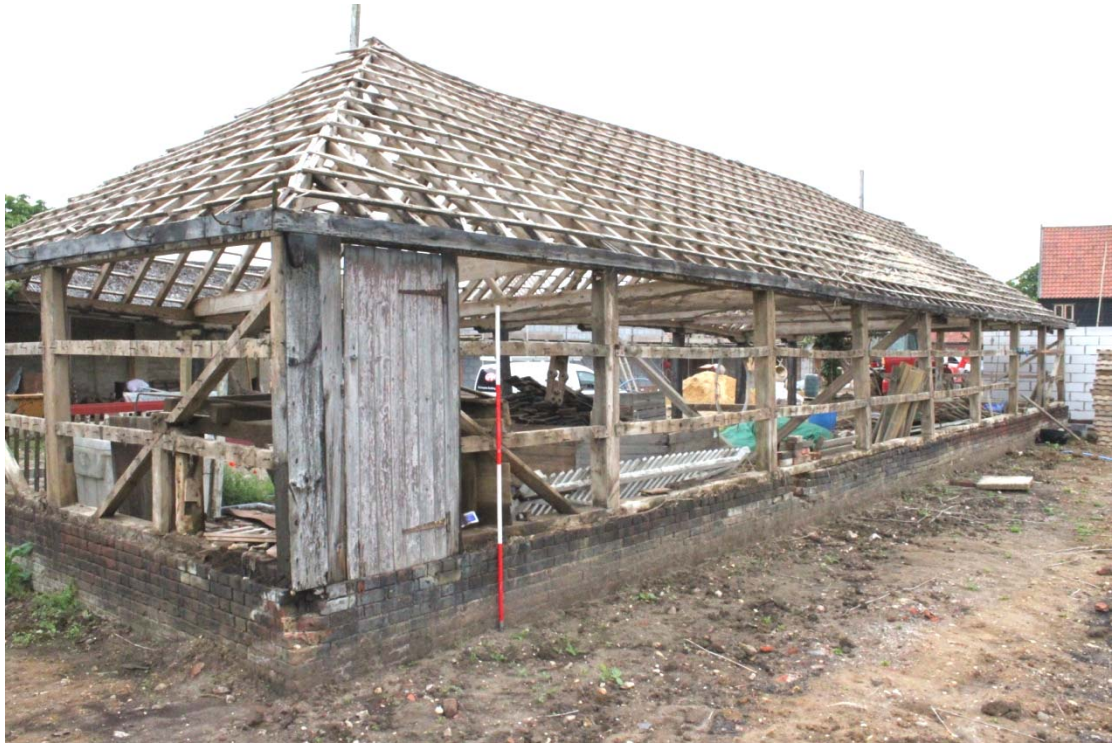
**Illus. 5. Western exterior from north-west showing northern gable and door to left (re-used as cladding) with post-and-rail construction fully exposed. The converted barn is visible to the right.**

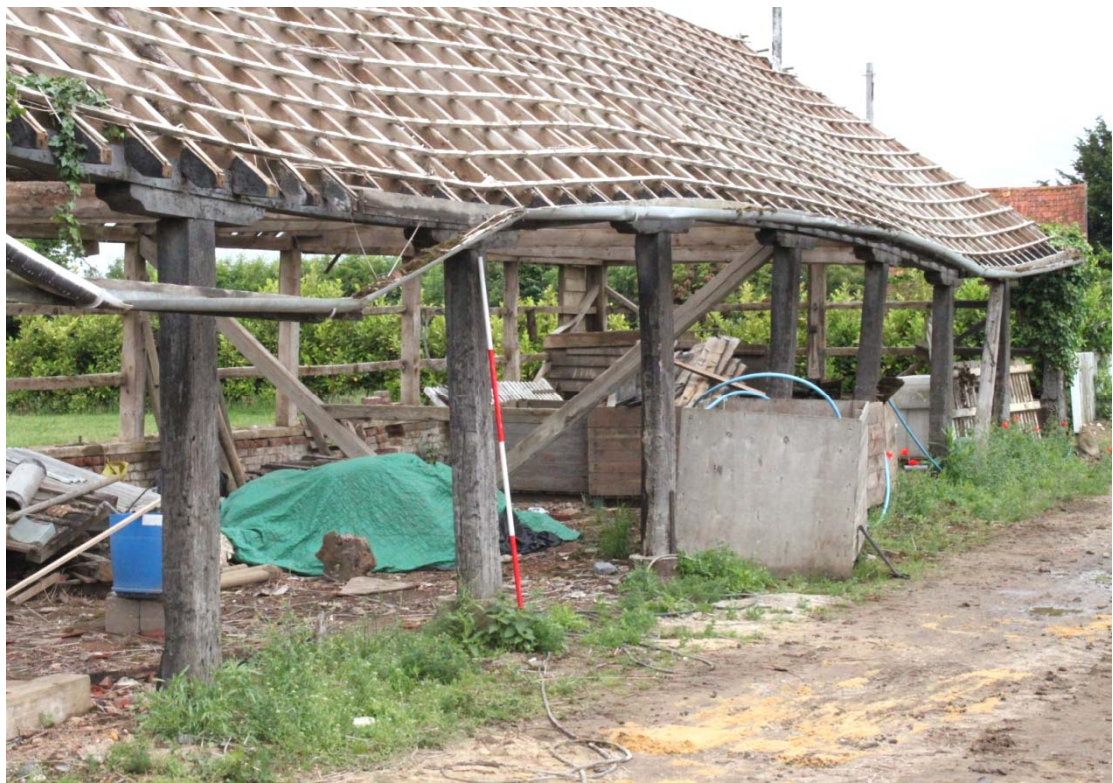
**Illus. 6. Open arcade of the eastern elevation seen from south-east showing the undulating roof and the shaped lintels of the arcade posts.**

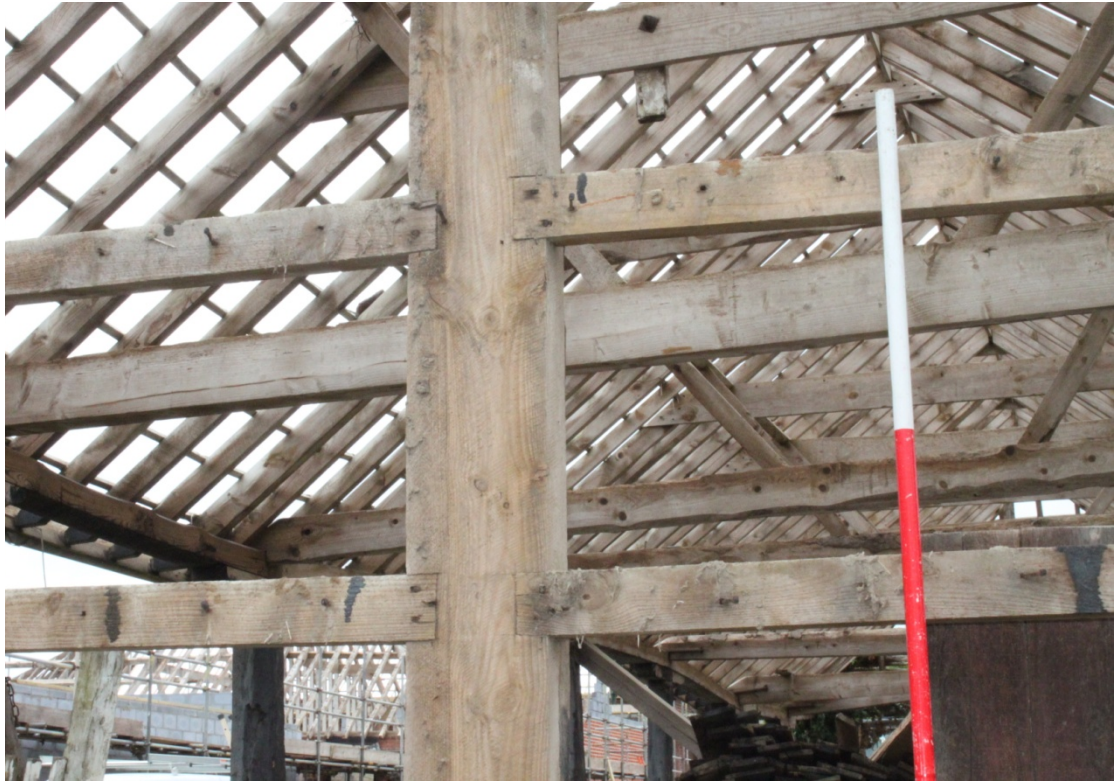
**Illus. 7. Construction detail of northern external gable showing softwood horizontal rails nailed to central post.**

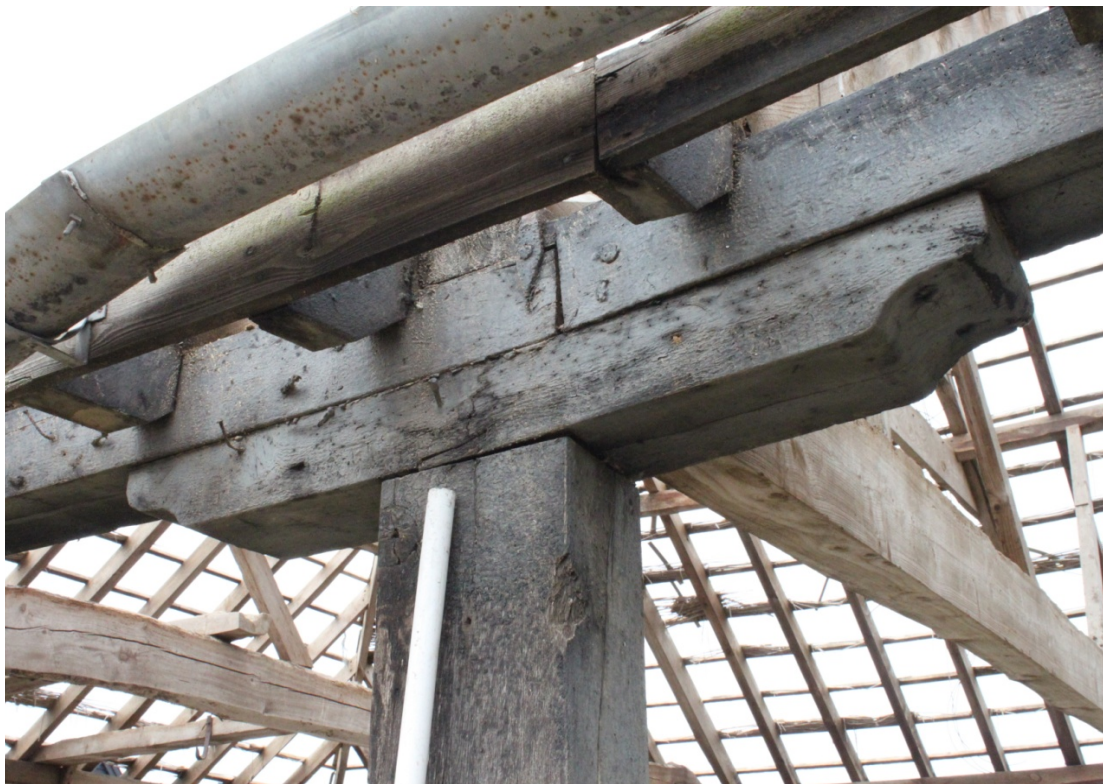
**Illus. 8. Detail of shaped lintel to arcade post of eastern exterior showing scarf joint in roof-plate and original grey pigment.**

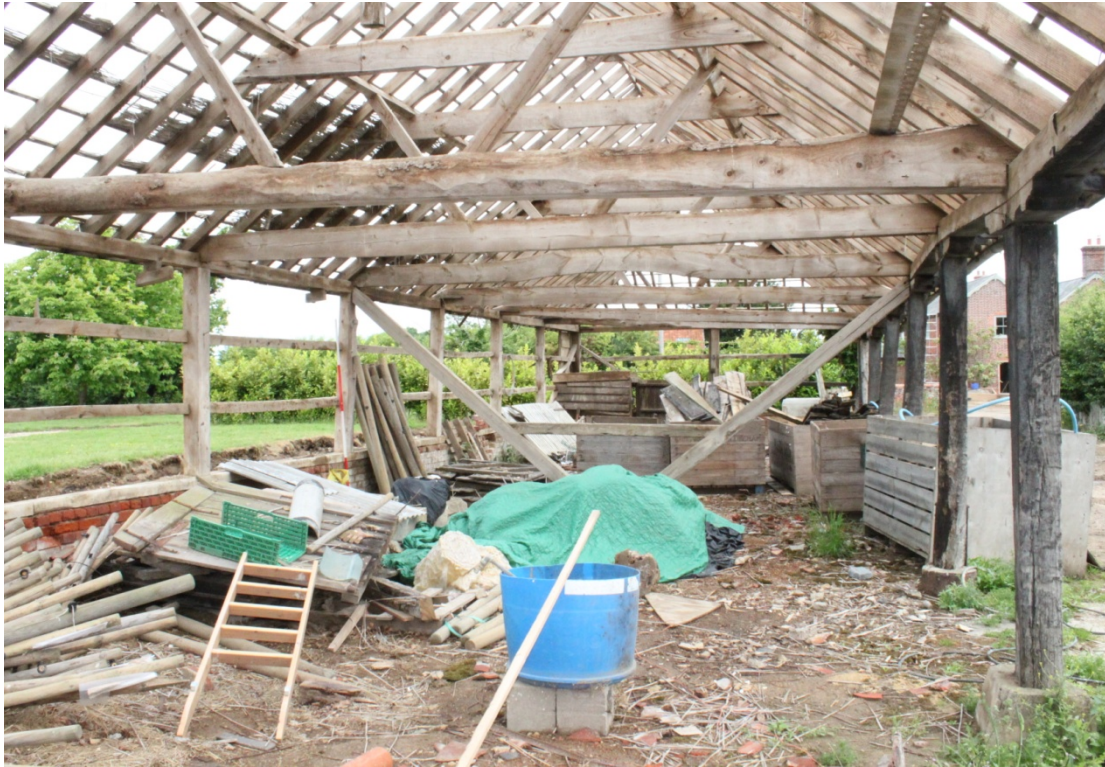
**Illus. 9. General view of interior from south showing open arcade to right and enclosed western elevation to left. The diagonal braces are modern insertions.**

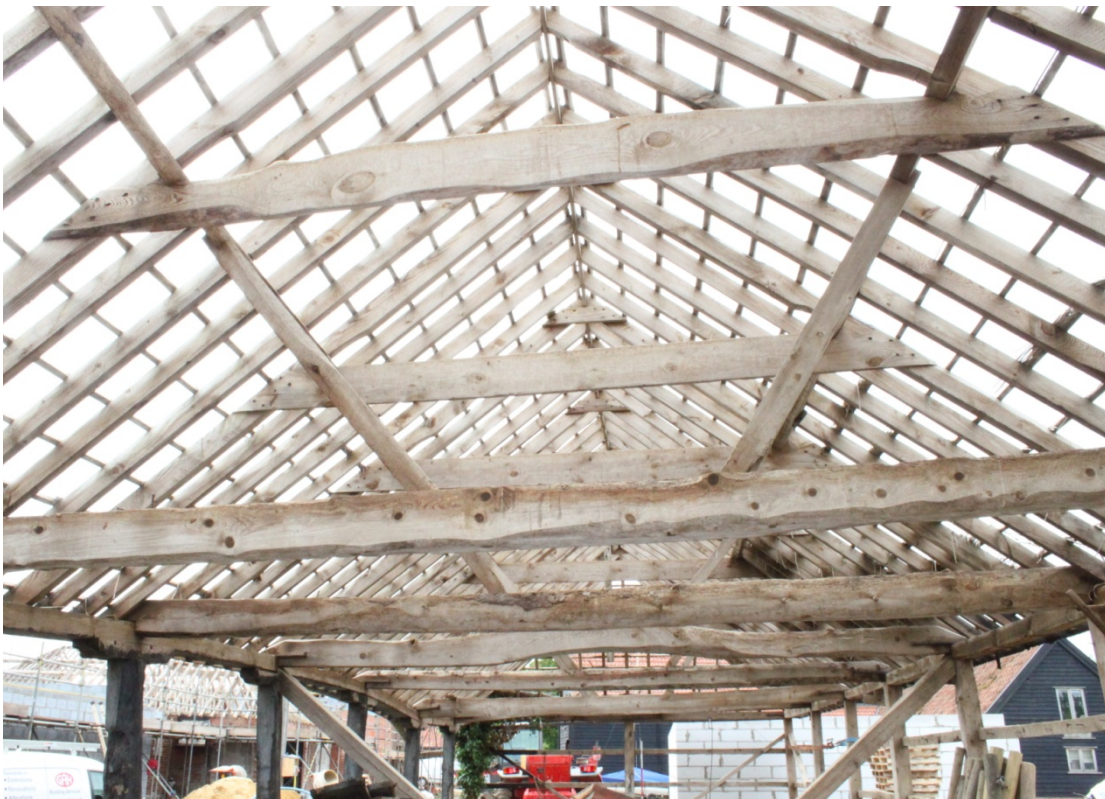
**Illus. 10. Internal roof structure seen from north showing clasped-purlins with nailed deal roughwood collars and tie-beams. The tie-beams are secured to the roof-plates with original iron straps.**
