**Barn at Moat House,
Park Green,
Wetheringsett,
Suffolk
WCB 064**

Historic Building Record

June 2010

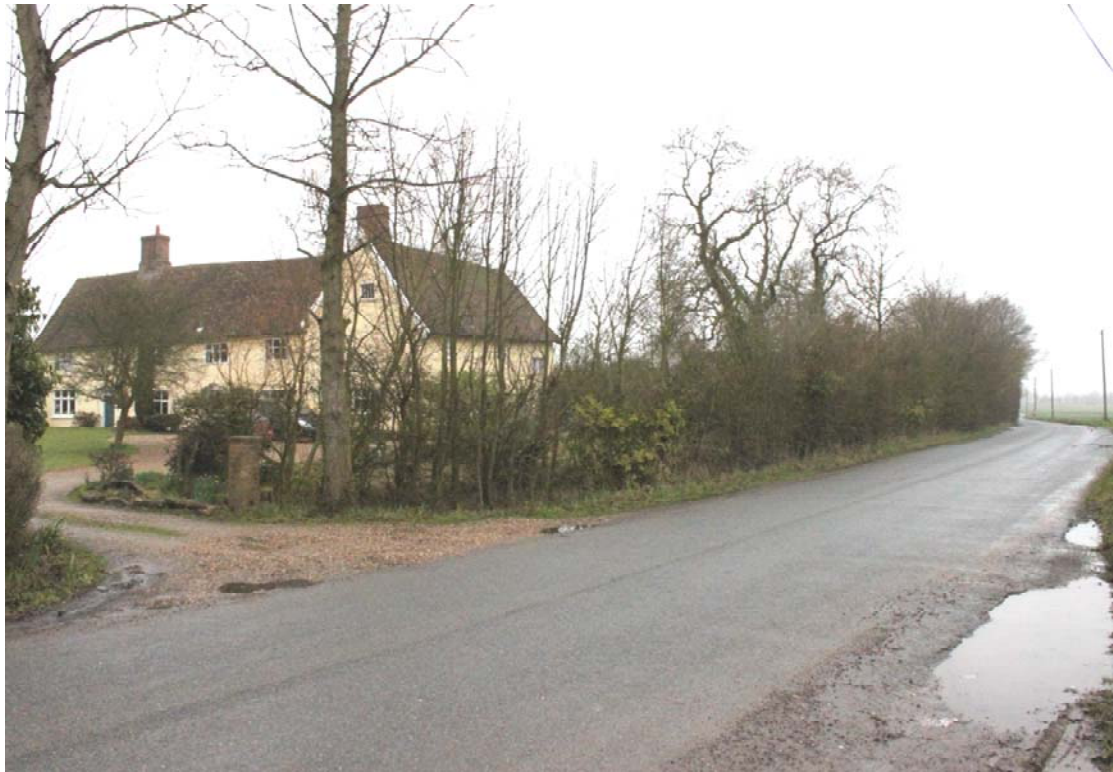
Illus. 1. General view of site entrance from Town Lane to east showing Moat House to left and the former Brockford Green to right. The road did not exist until the green was enclosed in the mid-19th century.

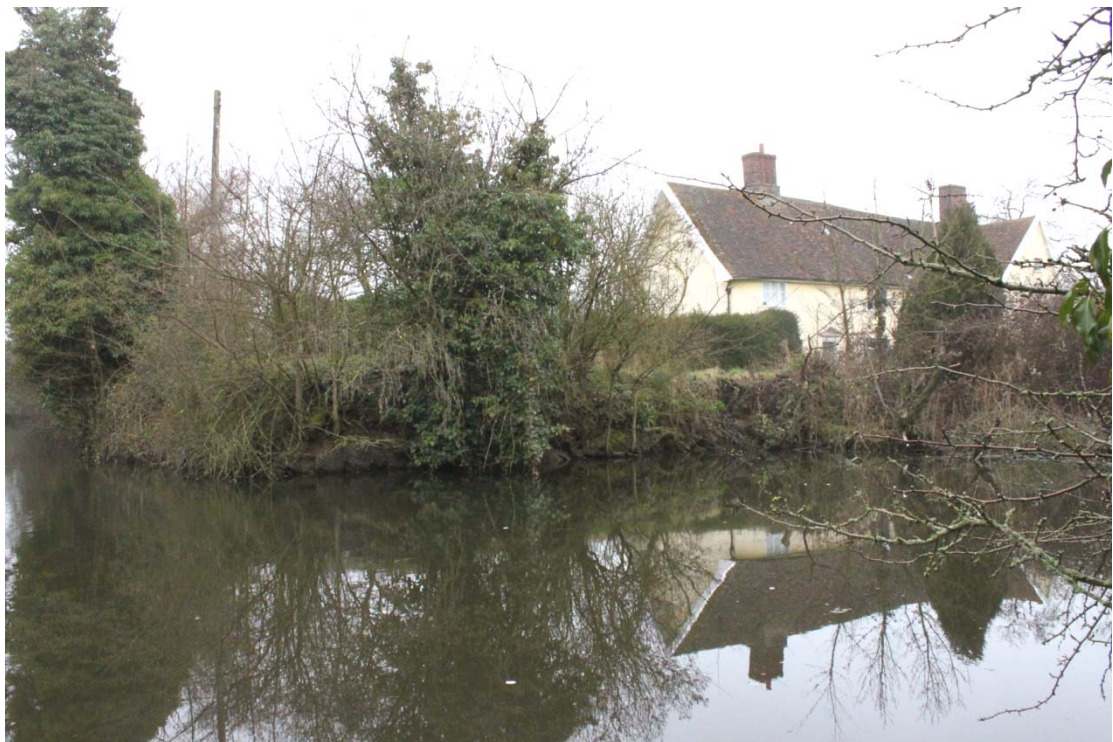
Illus. 2. Exterior of Moat House from south-east showing the well-preserved moat in the foreground (included for site context).

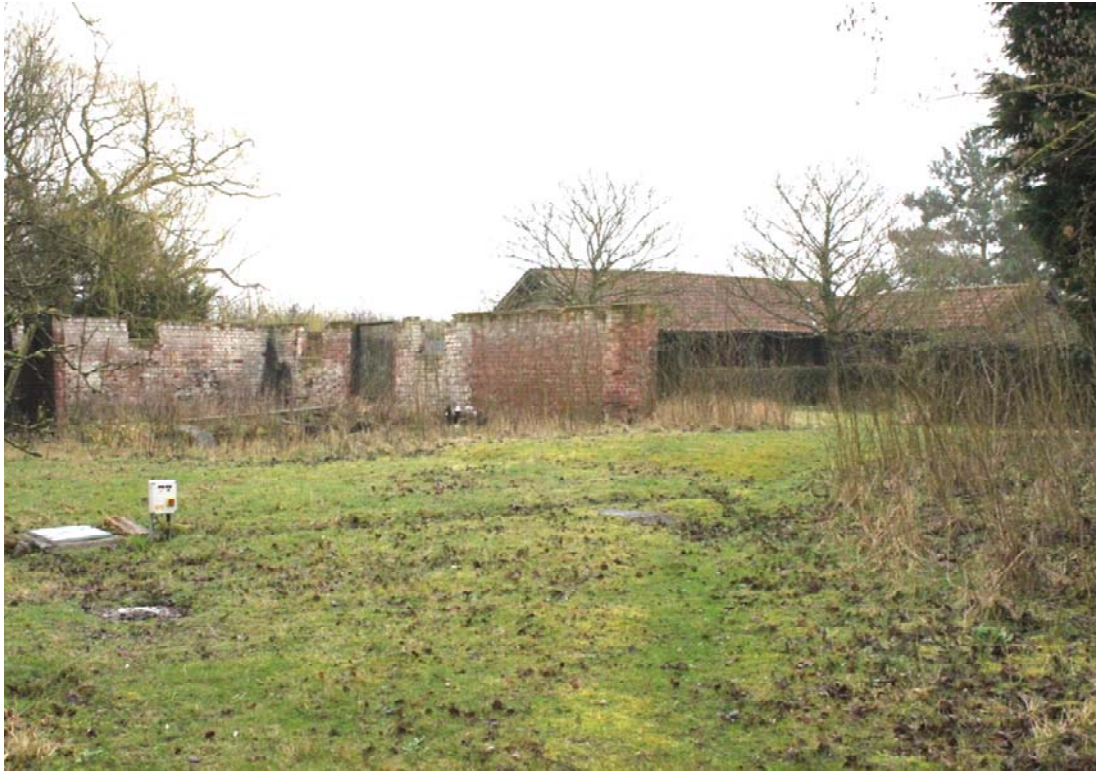
Illus. 3. General view of farm yard from north-west showing the ruined mid-19th century brick stable (3) to left & the site of the demolished barn to the right. The shelter sheds (1 & 2) are visible in the rear.

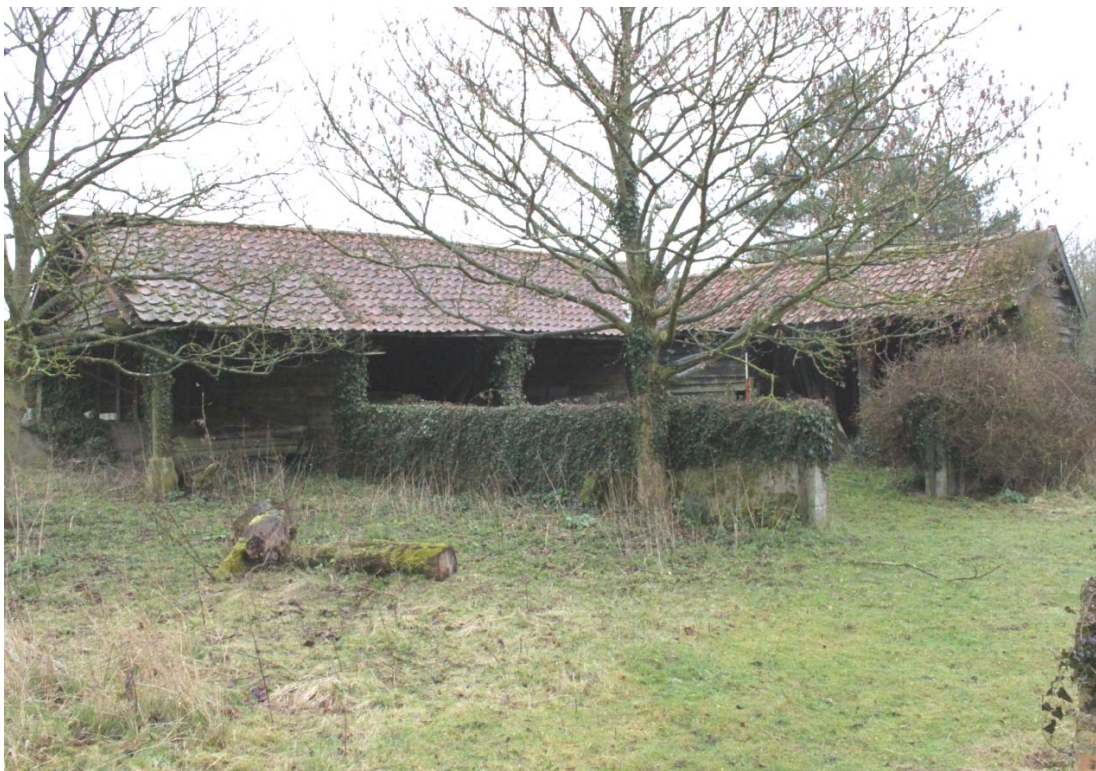
Illus. 4. Exterior from north-west showing the brick yard wall in the foreground with the truncated northern shed (1a) to the left

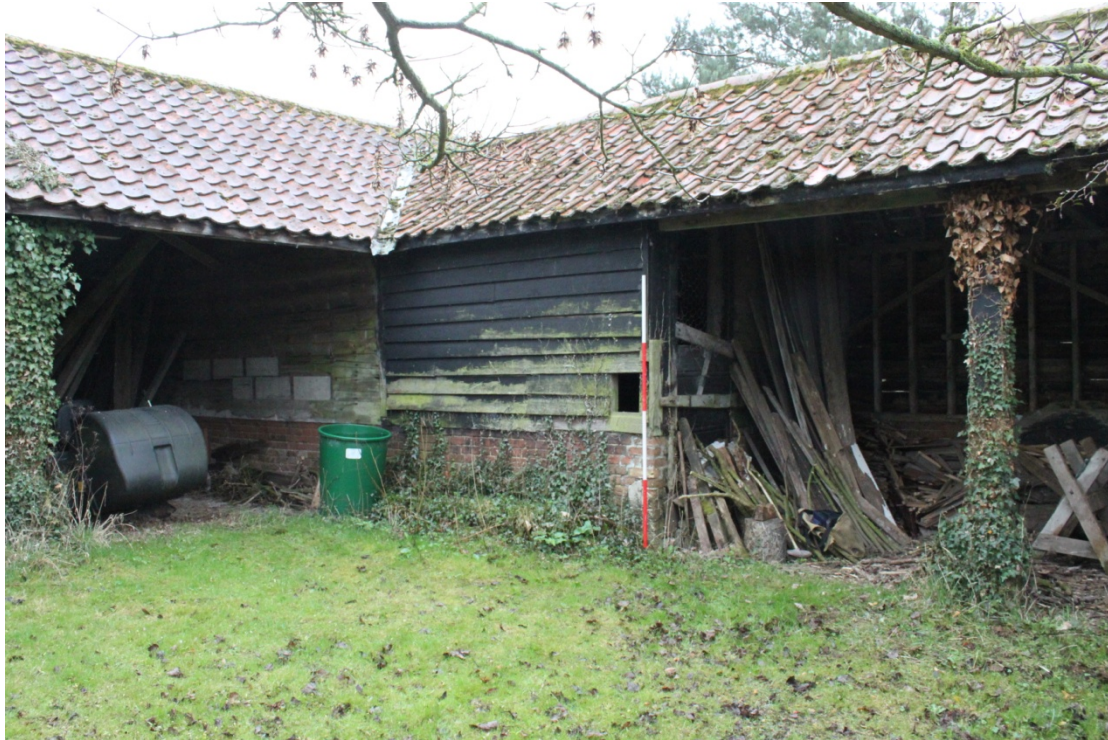
Illus. 5. Exterior from north-west showing the junction of the two integral wings with the open shelter-sheds (1b & 2a) to left and right respectively and the enclosed loose box or feed store (2b) in the centre.

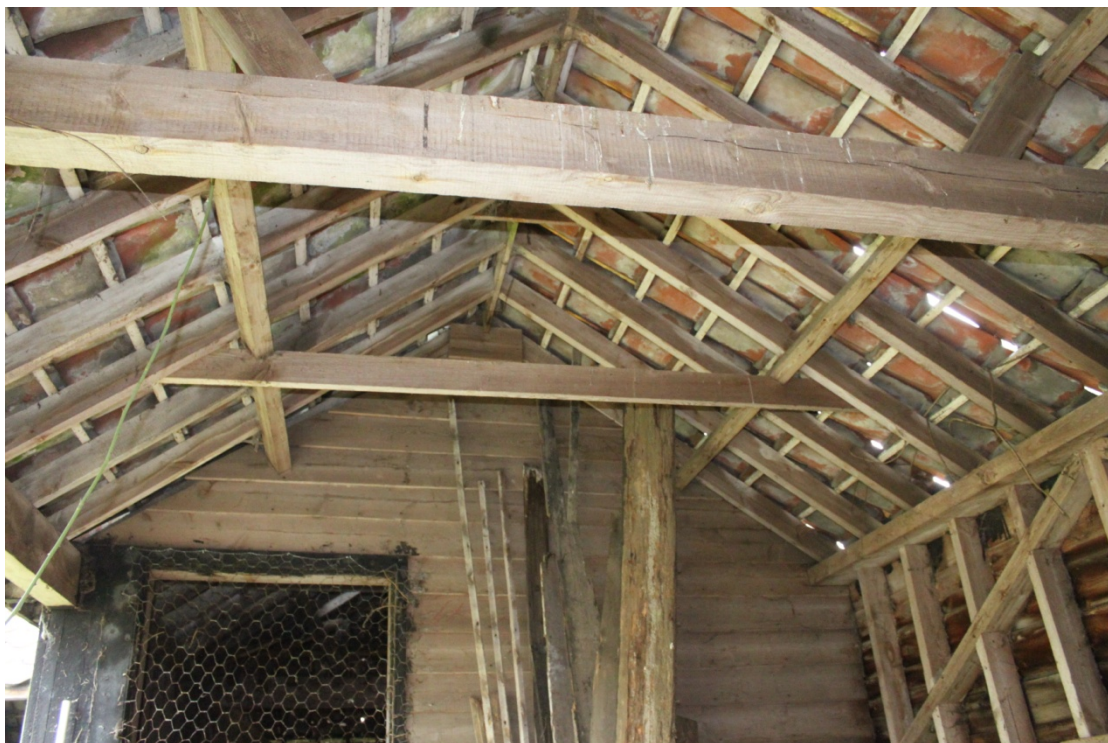
Illus. 6. Softwood roof structure of open shed (2a) from west showing its clasped-purlins with nailed collars & the door and boarded partition to the enclosed shed (2b).

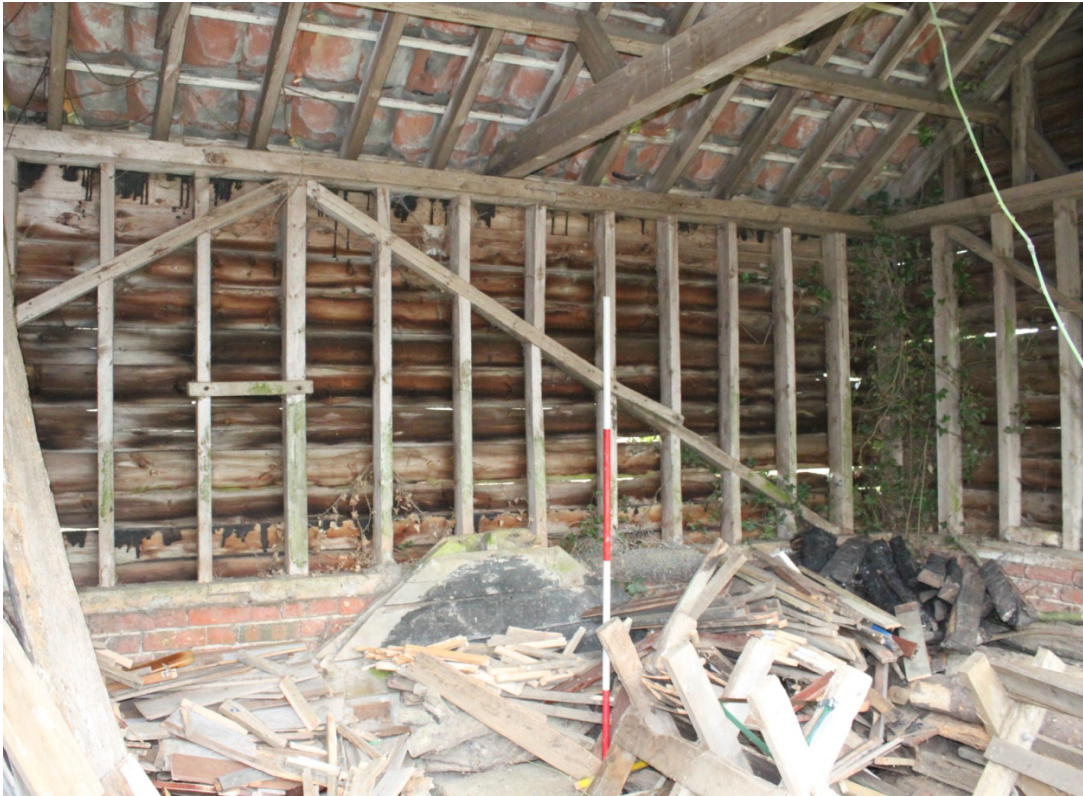
Illus. 7. Southern interior of the western open shelter-shed (2a) showing the diagonal primary stud bracing and brick plinth with the western gable to the right.

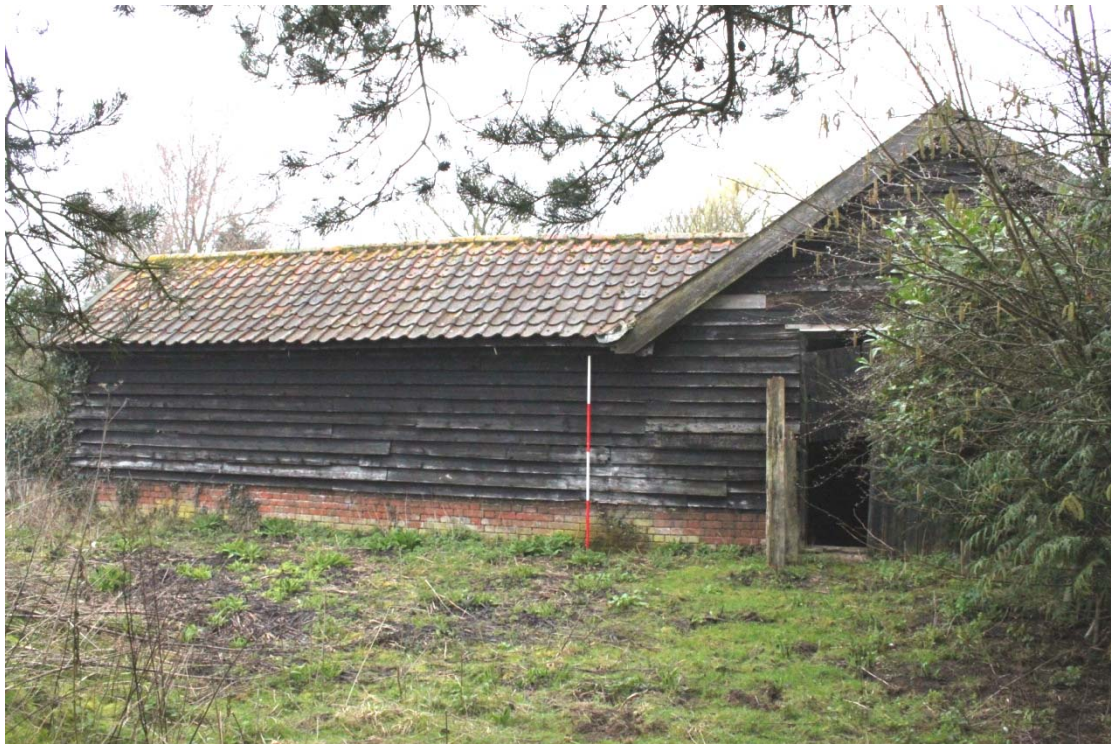
Illus. 8. Southern exterior showing the entrance to the enclosed loose box or feed store (2b) to the right.

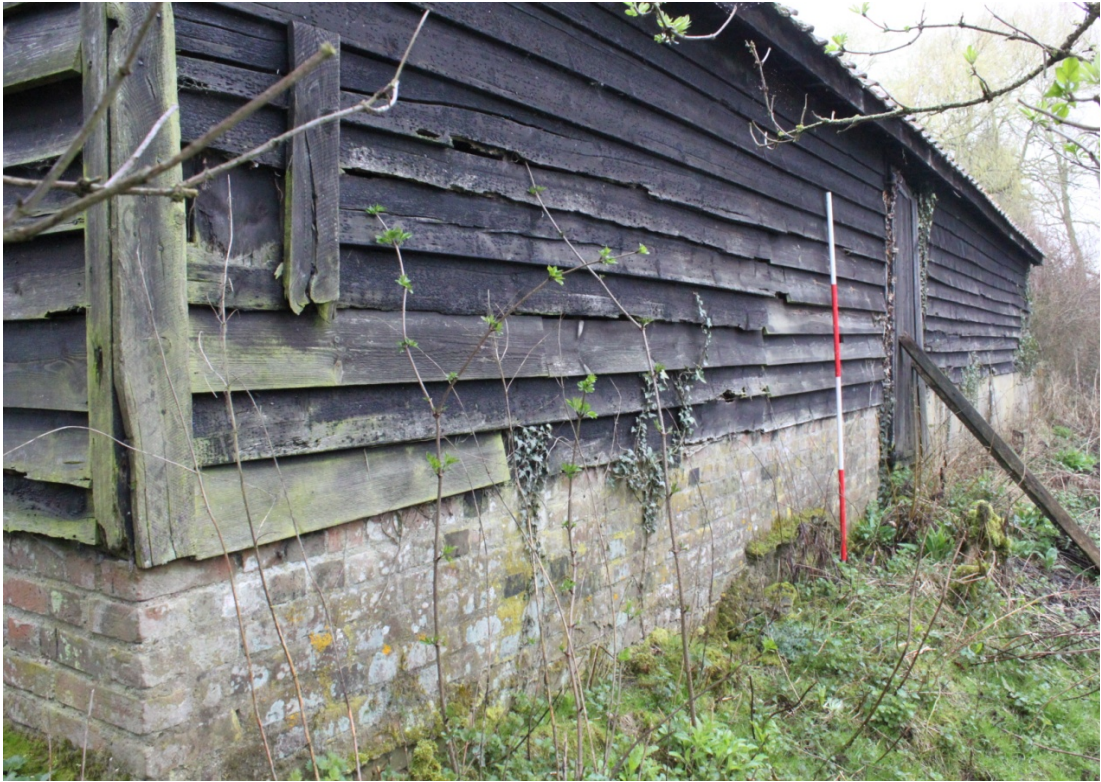
Illus. 9. Eastern exterior showing the rebuilt brick plinth and the external door to the open shed (2b).

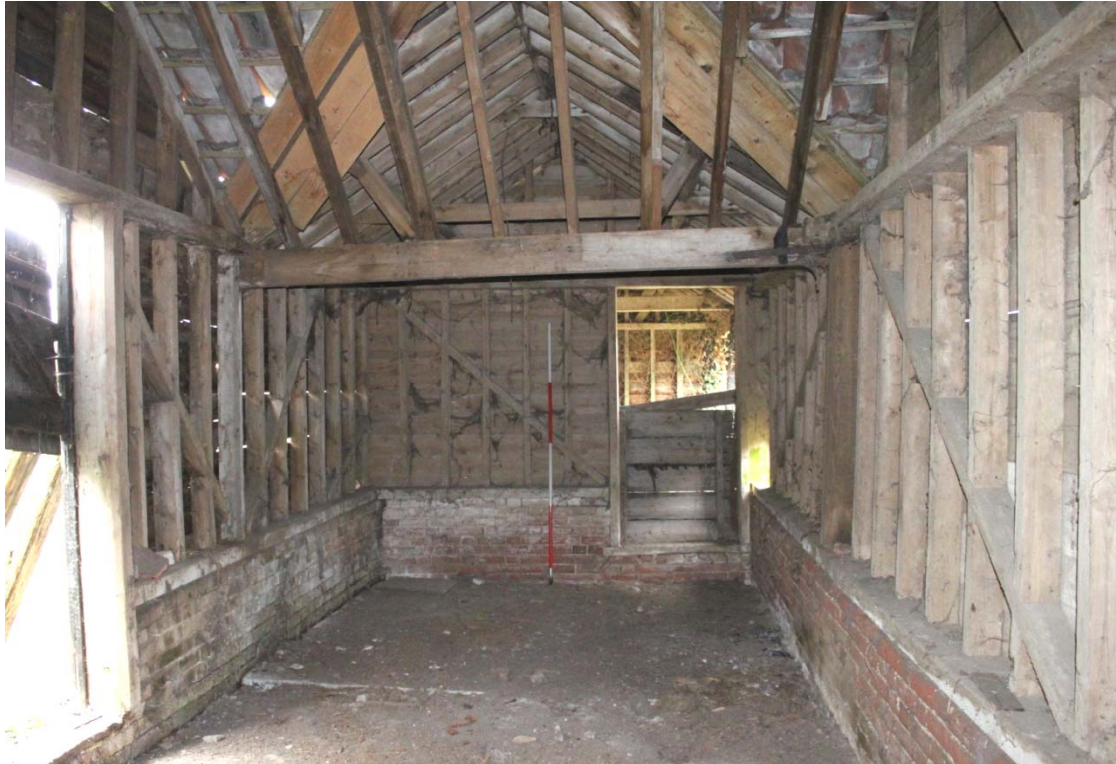
Illus. 10. Interior of enclosed feed store or loose box (2b) from the east showing the external door to the left and the door to the open shed (2a) to right.
