**Green Farm,  
Wetheringsett,  
Suffolk  
WCB 065**

**Historic Building Record**  
Oasis ID: suffolkc1-80567

# **Barns at Green Farm, Town Lane, Wetheringsett, Suffolk**

## **Historic Building Record**

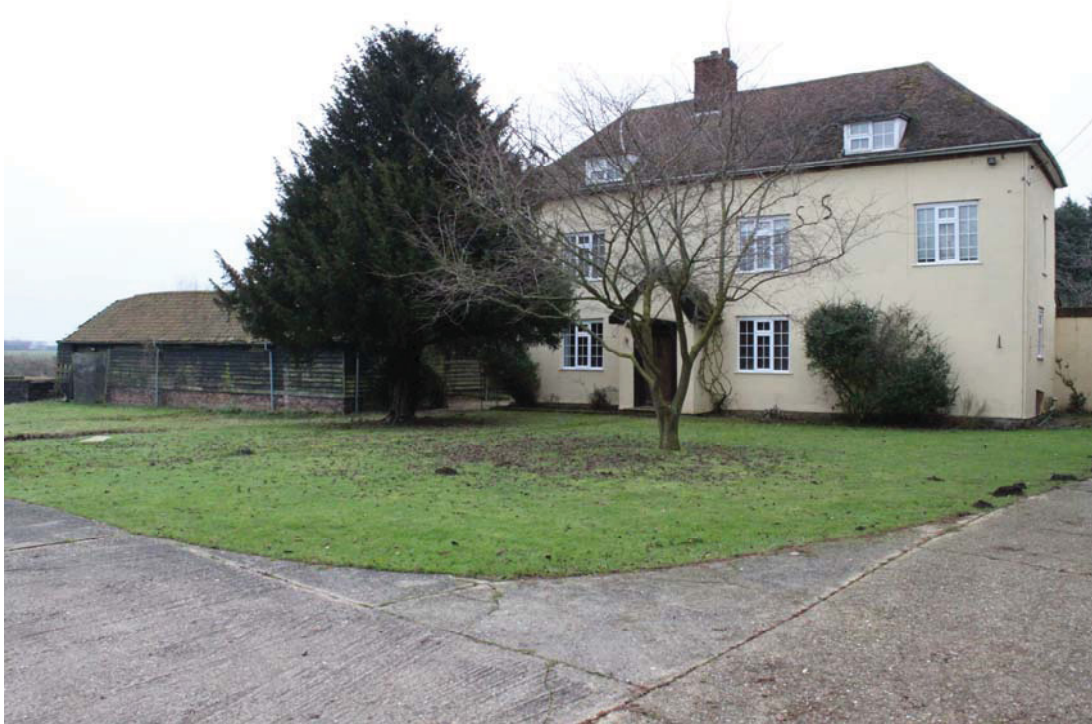
A2.1 Northern facade of brick farmhouse bearing initials S.C. and date 1779 in modern render. Showing 20<sup>th</sup> century shelter shed (2) and fragment of Brockford Green to left.

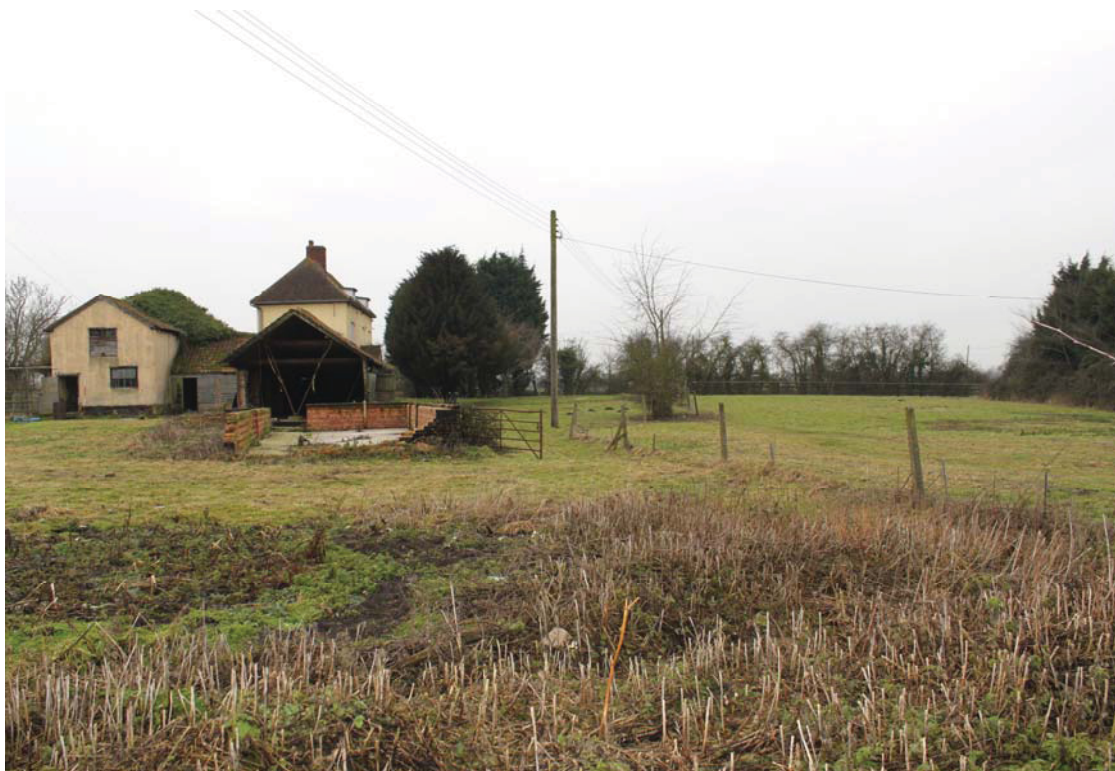
A2.2 General view of site from east showing stable to left and remaining fragment of medieval Brockford Green to right.

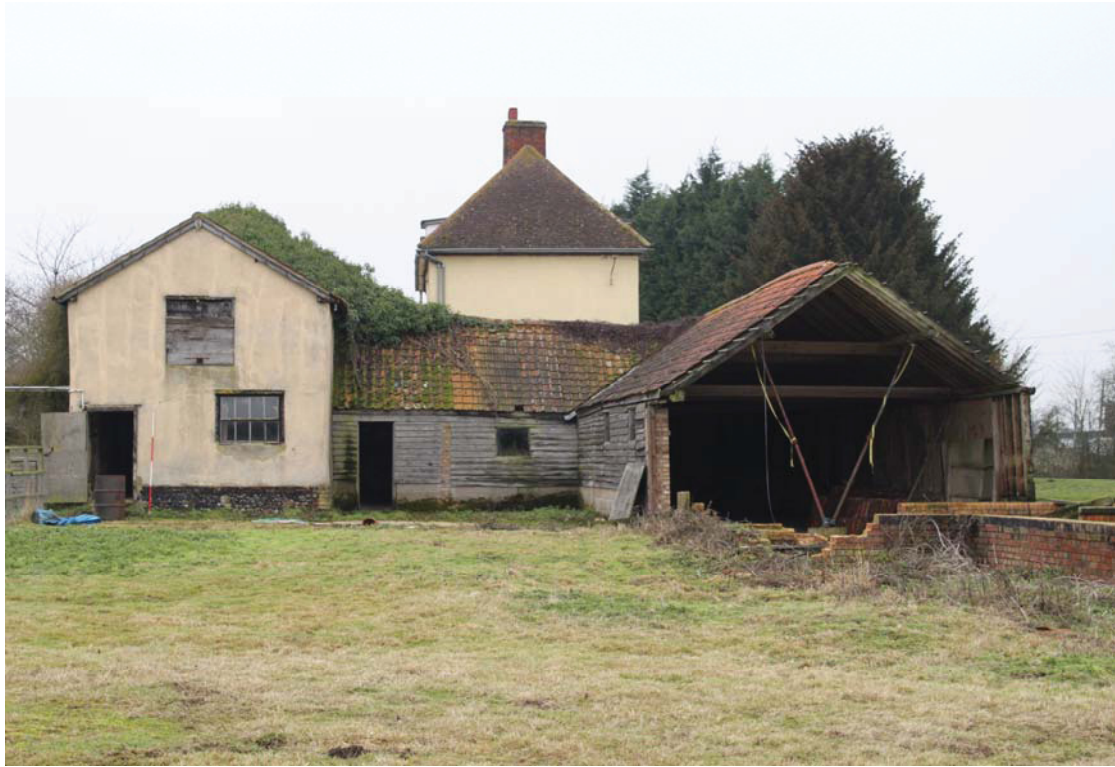
A2.3 General view from site of demolished barn to east showing clay-lump stable (1) to left with farmhouse (4) and enclosed 20<sup>th</sup> century shelter shed (3) in centre. The brick plinth of the demolished 20<sup>th</sup> century animal shed (3) is visible to right. The ground-floor door and window of the stable are secondary but the hay loft door above is original.

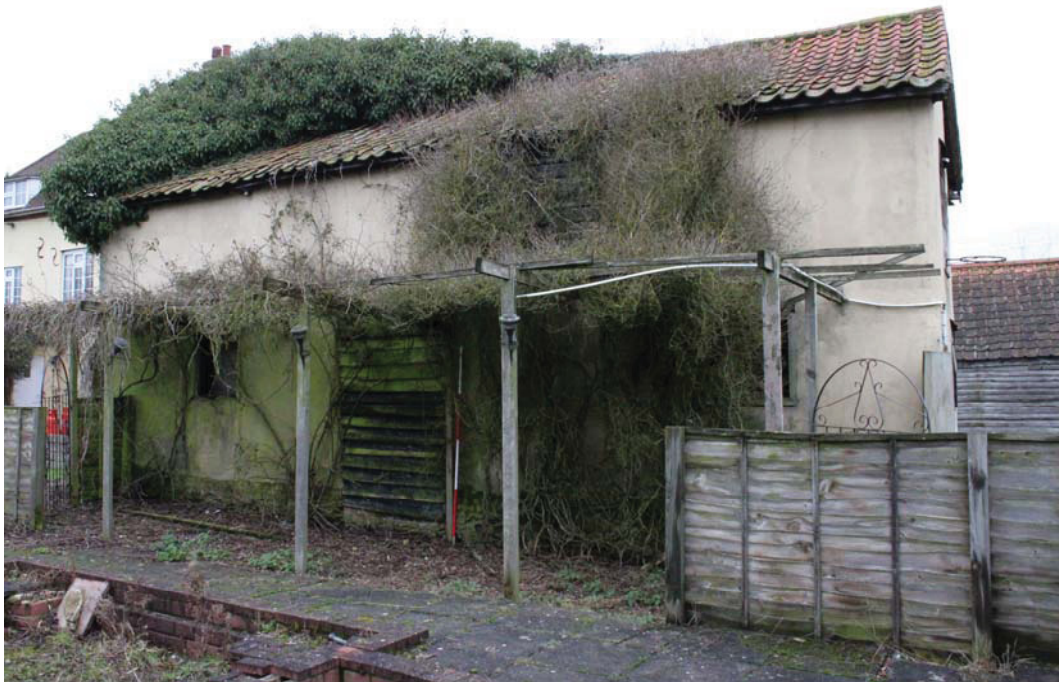
A2.4 External southern elevation of stable (1) showing modern render with original central door flanked by ground-floor windows to right and left. The left window (obscured by vegetation) is also original.

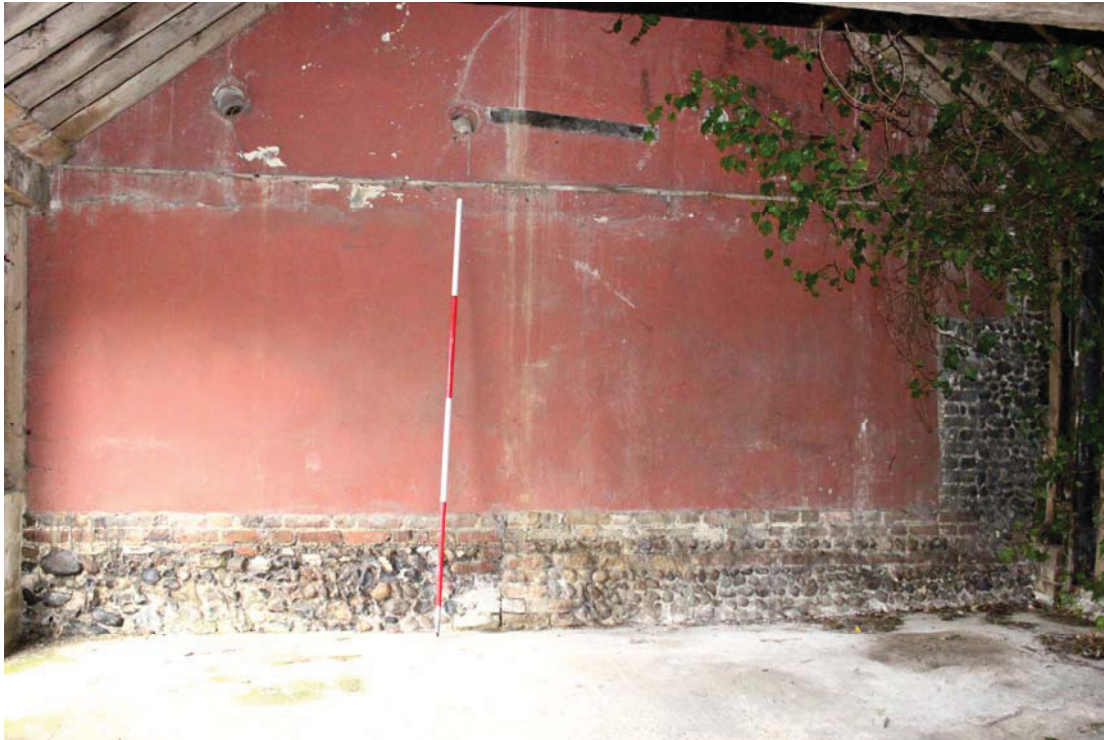
A2.5 Northern exterior of the stable (1) within the later shelter shed (2). Note the change in height of the flint plinth to right, and the abuttal of two corners in the centre. The series of pipes which penetrate the painted clay-lump wall adjoining the internal hay rack is visible above.

missing hay rack is unique in my experience. A total of six horizontal red-clay pipes, each 19 cm in diameter (7.5 ins) pierces the 30 cm (12 in) depth of the wall at intervals of 1.1 m (3.5 ft) and at a height of 2 m (6.5 ft) above the floor. They are spaced equally from the western gable but terminate 3 m from the eastern gable where an area may have been partitioned from the body of the stable to form a tack room. Each pipe remains open at both ends, and was presumably intended to ventilate the hay in the rack to prevent rot.

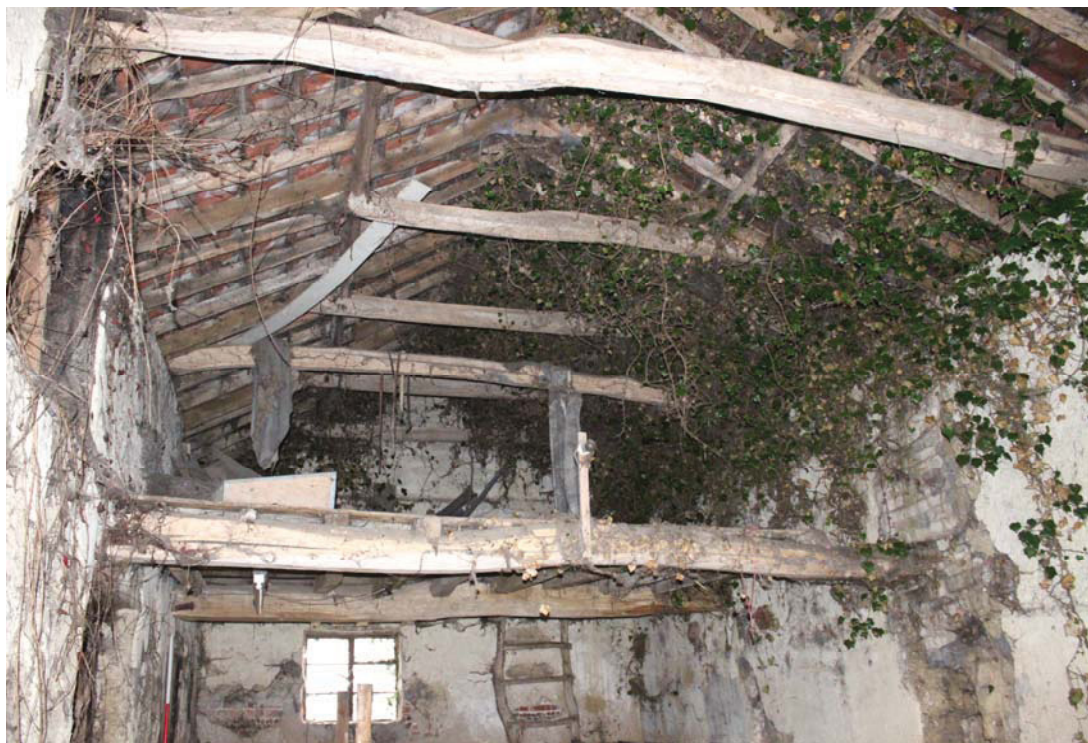
A2.6 Stable interior from east showing original roof structure and remains of original hay loft to west (joists removed from foreground). The window in the western gable is a secondary insertion.

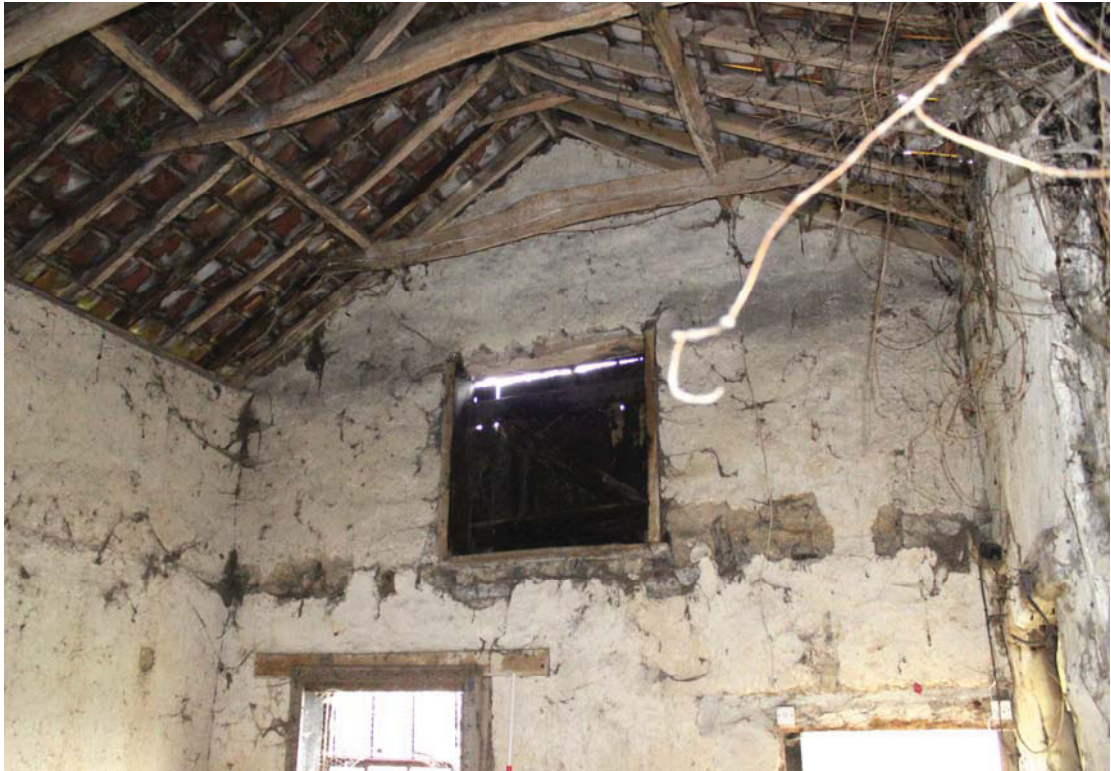
A2.7 Interior of eastern gable showing original loft door scars of removed ceiling joists. Groups of circular apotropaic marks have been incised into the internal daub to the left and right of the door and to the northern elevation visible to the left (see A2.8 below). Similar marks lie to the east of the loft window in the southern elevation (top-right).

Two features of the stable are of particular historic interest. Several groups of well-preserved incised apotropaic (evil-averting) circles survive on the internal walls of the loft. These were intended to protect the contents of the building from harm, and focus on the original apertures through which evil spirits might enter: to the left of the southern window and to both sides of the loading door in the eastern gable. Several also cluster at the eastern end of the northern elevation. Most appear to be concentric circles, but at least one example to the left of the gable contained 'petals' in the form known as a 'daisy-wheel'. While such features are not uncommon in agricultural buildings the row of pipes which penetrates the wall behind the

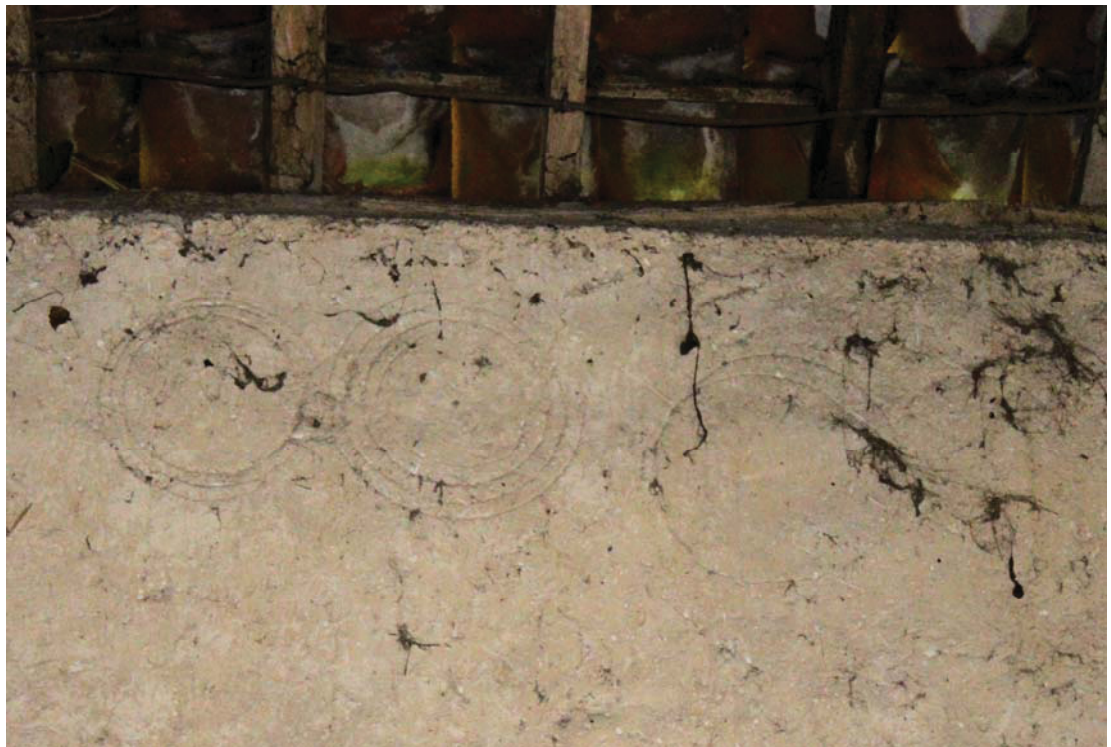
A2.8 Detail of incised concentric apotropaic circles at the eastern end of the northern internal elevation, showing pantiles and rafters above.

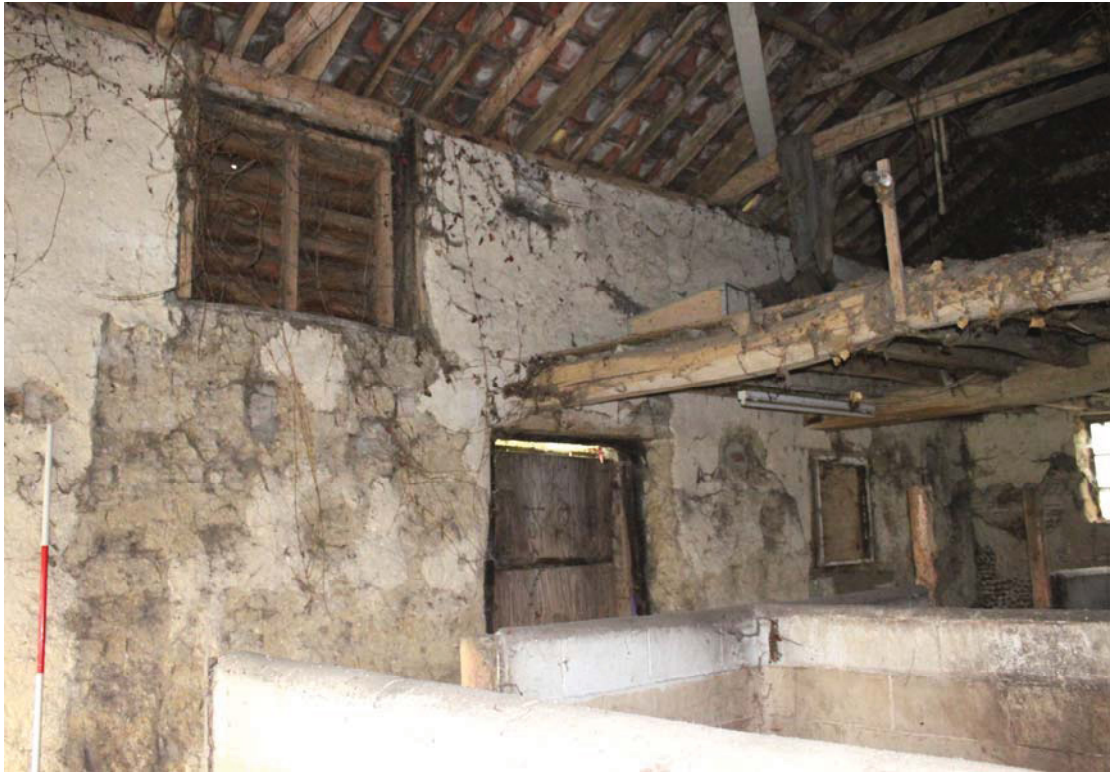
A2.9 Internal southern elevation from north-east showing 20<sup>th</sup> century block-work cattle or pig stalls in foreground. Note clay-lump wall fabric. The door and loft window are original features, but the hay loft has been removed to the left.

A series of calf or pig stalls of cement blocks with ground-level troughs was inserted in the mid-20<sup>th</sup> century, reached by a corridor against the southern elevation, and the eastern end of the hay loft was removed. The floor was also largely renewed, although some 19<sup>th</sup> century floor bricks still remain, and windows were inserted in both gables together with a new door to the east. Despite these alterations, and other minor repairs, the profile and layout of the stable is substantially original, and the building is relatively well preserved for its size; while two-storied clay-lump structures of this height and scale were once common in the region, most have decayed beyond recognition.

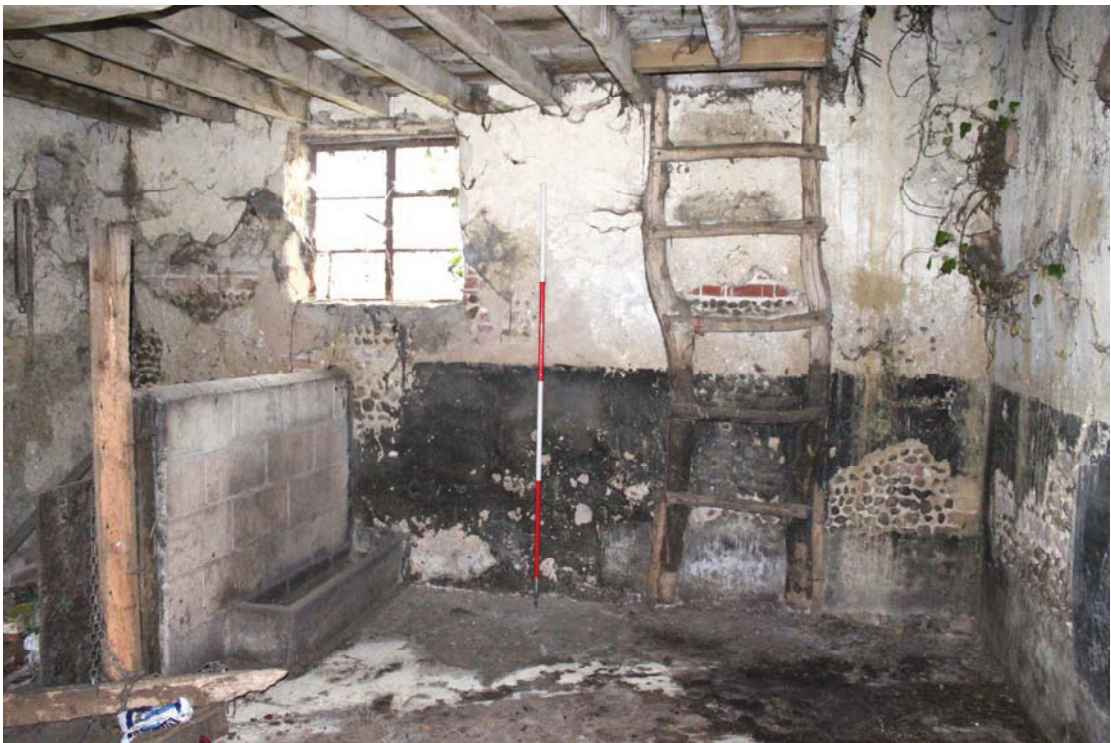
A2.10 Interior of western gable showing loft ladder and inserted window with position of removed hay rack against northern elevation to right. The wall of a 20<sup>th</sup> century stall with low feeding trough is visible to left.

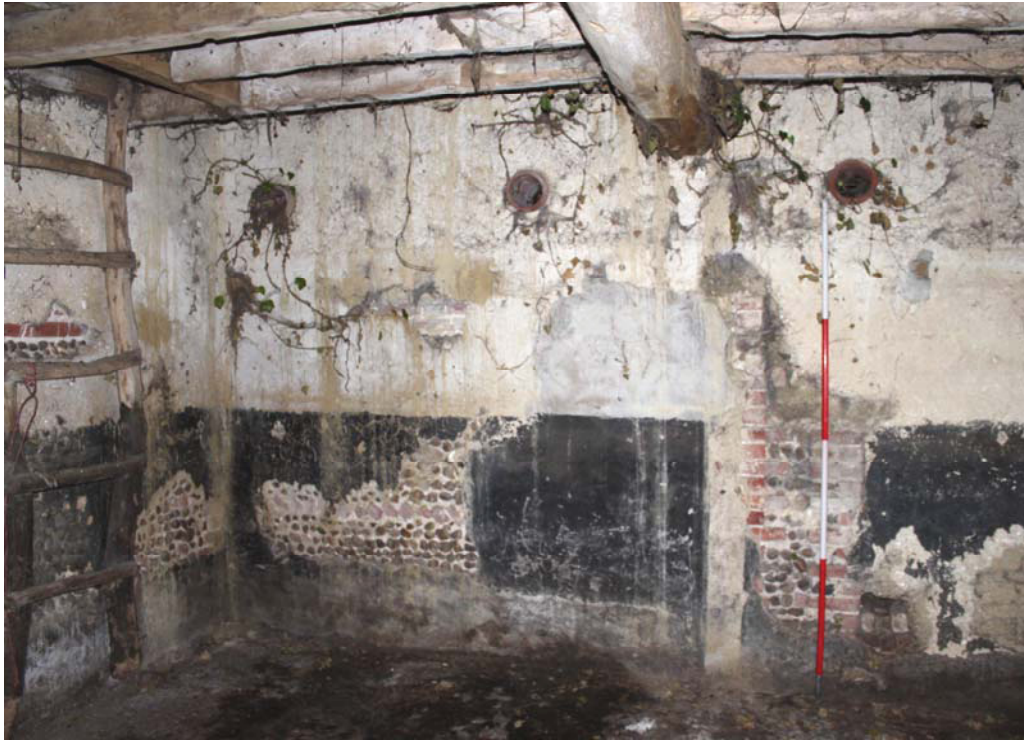
A2.11 Western end of northern internal elevation showing pipes penetrating wall behind position of former hay rack. Note tall flint plinth to left, terminating in brick dressing to right with clay lump fabric beyond. These features were probably retained from an earlier structure on the site.

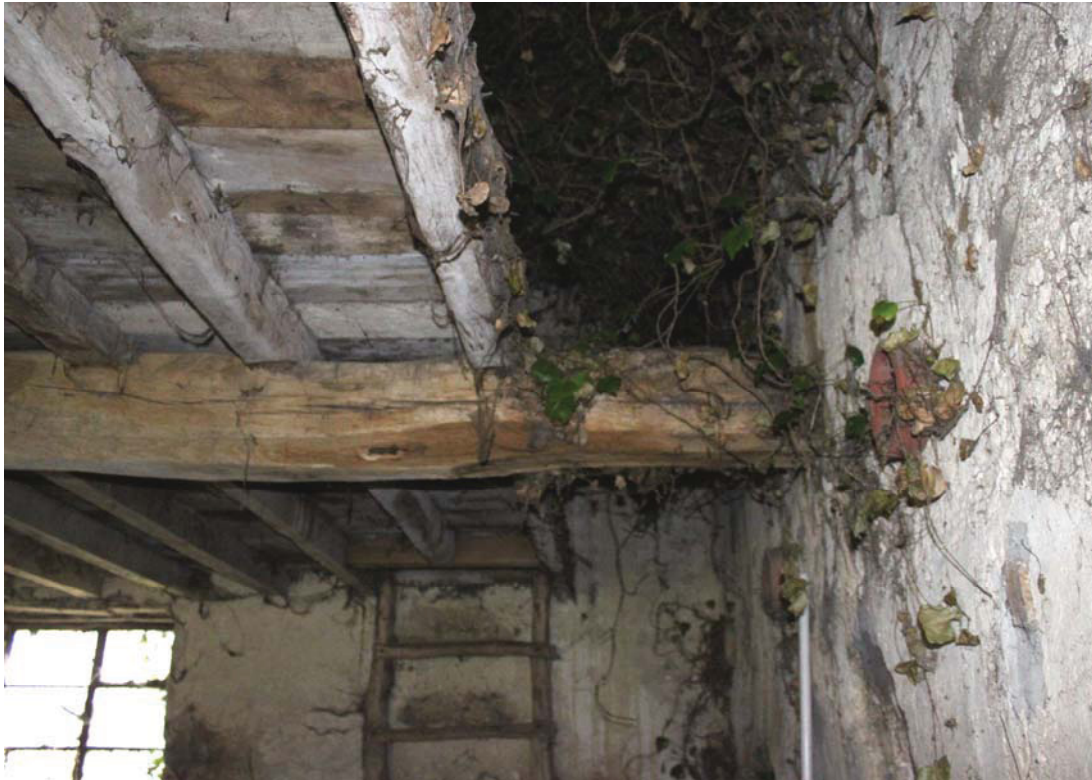
A2.12 Detail of original original loading aperture above former hay rack (seen from east). Note the pipes which penetrate the northern elevation to the right
