## **ARCHAEOLOGICAL EVALUATION REPORT**

**SCCAS REPORT No. 2010/160**

# **Kennings/Sixt Hire Centre, Duke Street Ipswich, Suffolk IPS 634**

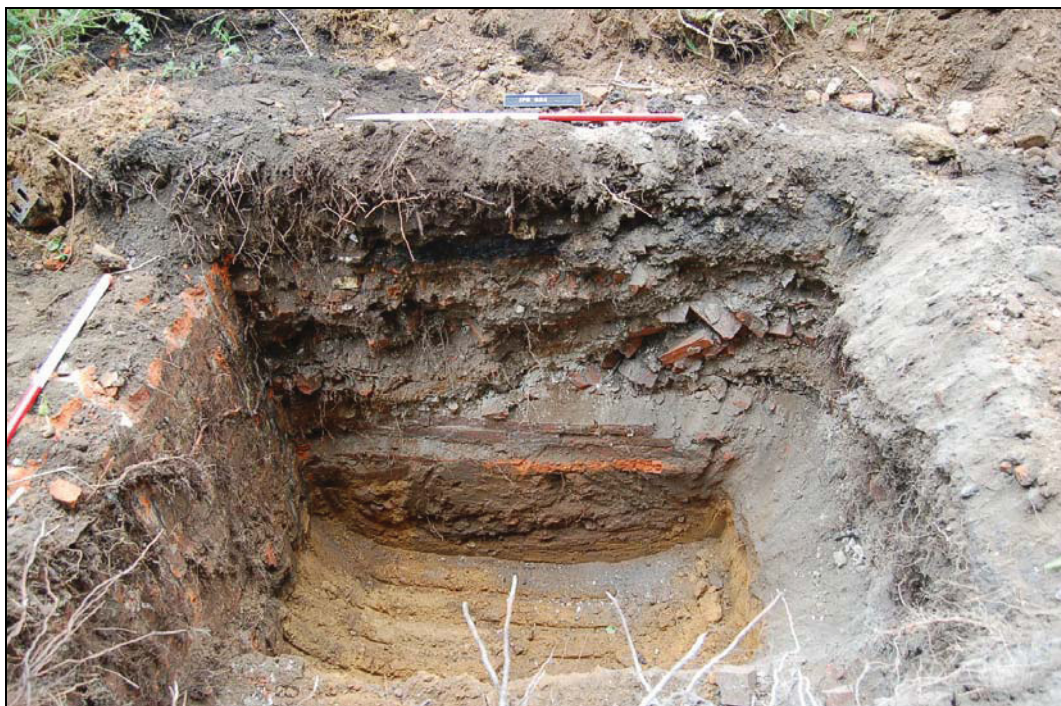
A single test-pit was excavated in the area of Trench 3, to ascertain the nature of the bulk of the higher terraced area towards the southern corner of the site. This was 3m long, 1.6m wide and up to 2.3m deep, orientated east-west. The stratigraphy encountered consisted of 0.3m of mixed dark brown loamy silts (an imported topsoil) filled with modern detritus such as plastic, bottle glass, broken brick and metal fragments. This sealed approximately 1.4m of demolition rubble and early 20th century waste, amongst a mixed grey/brown ashy/silty soil above natural yellow/brown silty clays at a depth of c 1.7m below ground level. Two segments of intact walling were noted, at the western and northern edges of the test pit: a significant thick wall (believed to be a rear wall to a roadside terraced building) along the western edge, and 4 courses of intact brickwork (including the foundation course) possibly relating to a wall alongside the access road to Siloam Place present on the first edition Ordnance Survey map of the site (refer to figure 10 in Rolfe & Breen, 2010).

Plate II. Trench 3, facing north (2 x 1m scales)

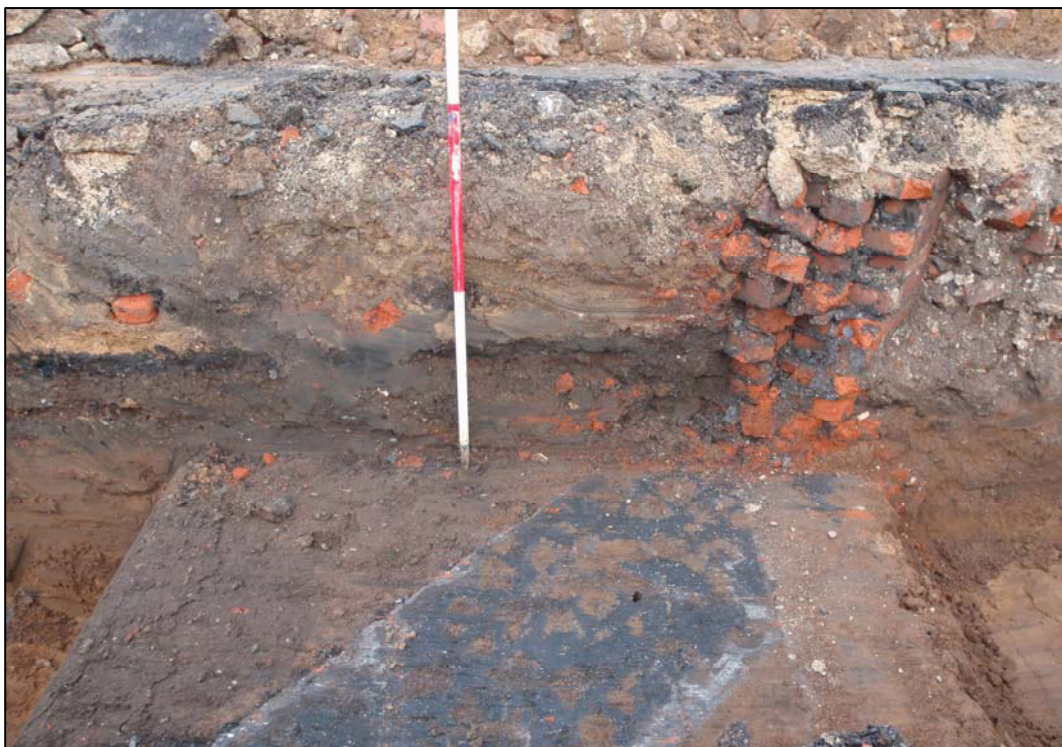
Wall 0003 was the width of three bricks and was built on a foundation of dark grey concrete mixed with red-brick fragments (Plate IV). Eleven courses of brickwork were extant, the upper surface of which was coincidental with the base of the concrete surface. This foundation lay at a depth of just over 1m. This was a substantial footing and was not removed from the trench.

Plate IV. Trench 4, wall and footing 0003, camera facing north (scale: 0.5m divisions)

It is likely that Wall 0003 is in fact a rebuild along the line of the front wall of the terrace to create a substantial boundary wall, hence it's more substantial nature and the substantial footing of concrete with rubble inclusions. Wall 0008 is coincidental with buildings on the opposite side of the street (unnamed until the 3rd Edition where it is marked as 'Siloam Place' - figure 5) and the two cuts, 0005 and 0007, are likely to relate to drainage for these buildings and the former terrace.

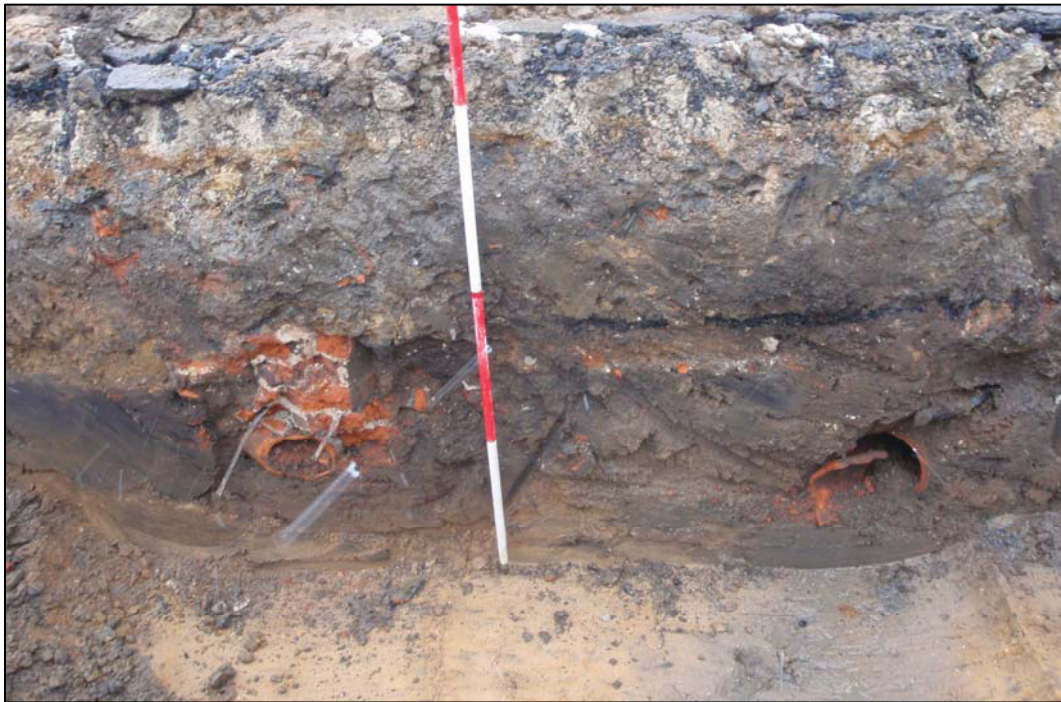
**0007:** A linear feature, 0.65m wide with a grey sandy fill. A service trench associated with a c. 0.3m diameter, red clay drainage pipe which was situated just above the level of the natural (Plate VI). Presumably 19th century in date. Cuts Ditch 0004.

Plate VI. Trench 4, showing Wall 0008 and the pipe in Cut 0007, camera facing north

**0008:** A wall constructed of soft, frogless, red-brick. The wall consisted of five extant courses of brickwork running on a similar alignment to wall 0003 but with no obvious foundation. It marked the western extent of the layer of black gavel and possible bitumen. A red ceramic pipe ran through this wall close to the base. The pipe, which had originally connected with that in Cut 0007, was mortared into the wall and appeared to be contemporary.

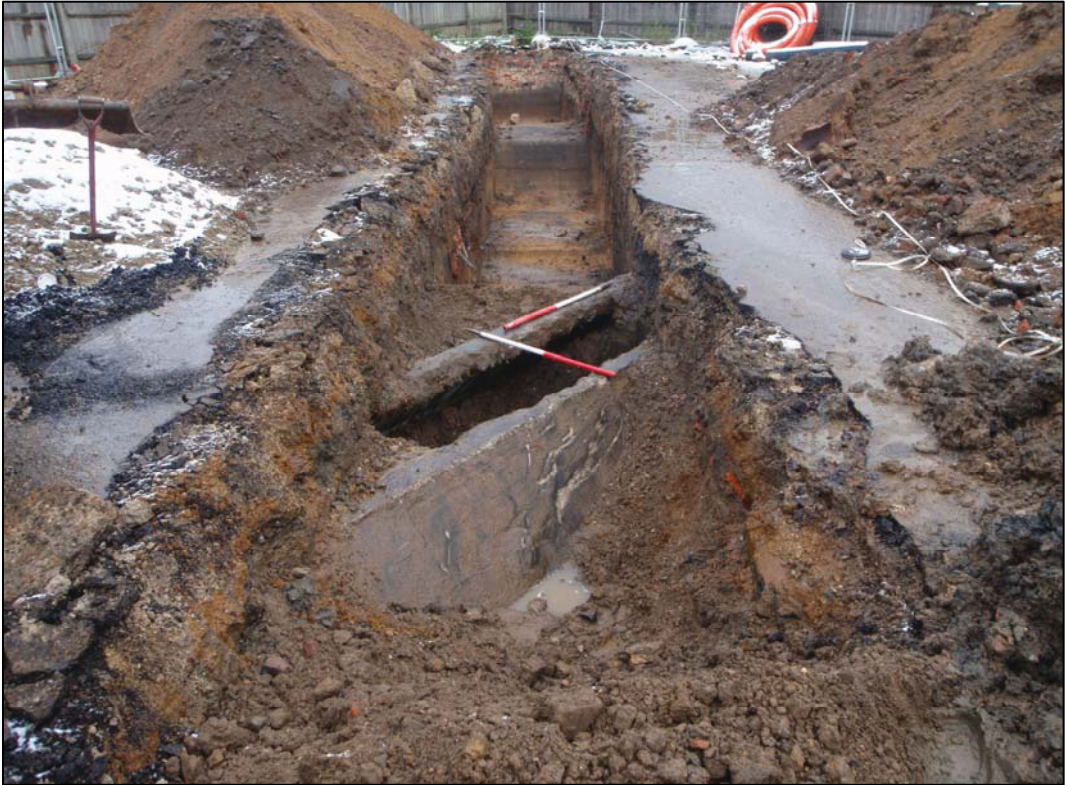
**0009:** A large concrete structure standing within a significantly larger cut; interpreted as a Second World War air-raid shelter (Plates VII, VIII & IX). The structure, which measured approximately 2.9m in width, was aligned north-west to south-east and ran across the width of the trench. The walls were initially vertical before sloping inwards at an angle of 45 degrees and continuing up to a flat top (see figure 3 for a representation of the probable profile). The whole structure stood within a cut that on the north-eastern

Plate VII. Trench 4, showing air-raid shelter in foreground, camera facing east

The air-raid shelter is of local history interest and will be severely damaged if not completely destroyed by the proposed reduction in levels. Although there is no question of it being preserved *in-situ* it should be preserved by record. The proposed method would be to expose the entire structure liable to be affected by the development and make a basic record through measured plans and photography. Once this was complete the concrete of its structure could then be broken up and removed, this work should also be monitored. There is the potential for contemporary graffiti to be present on the internal walls of the shelter, which may be worthy of recording.

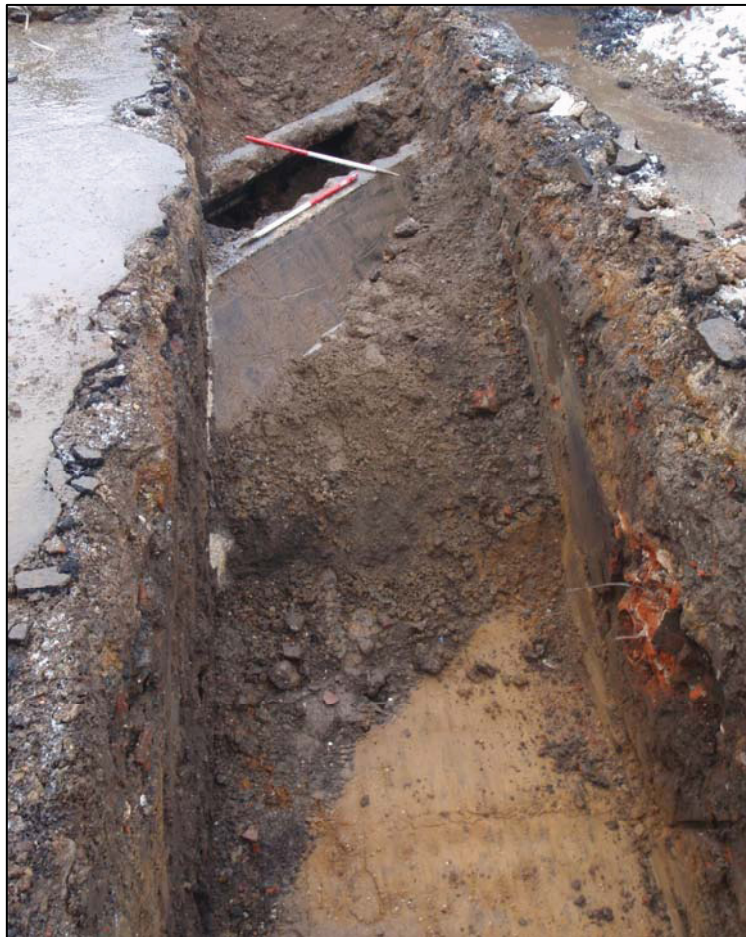
Plate VIII. Trench 4, air-raid shelter and cut, camera facing west

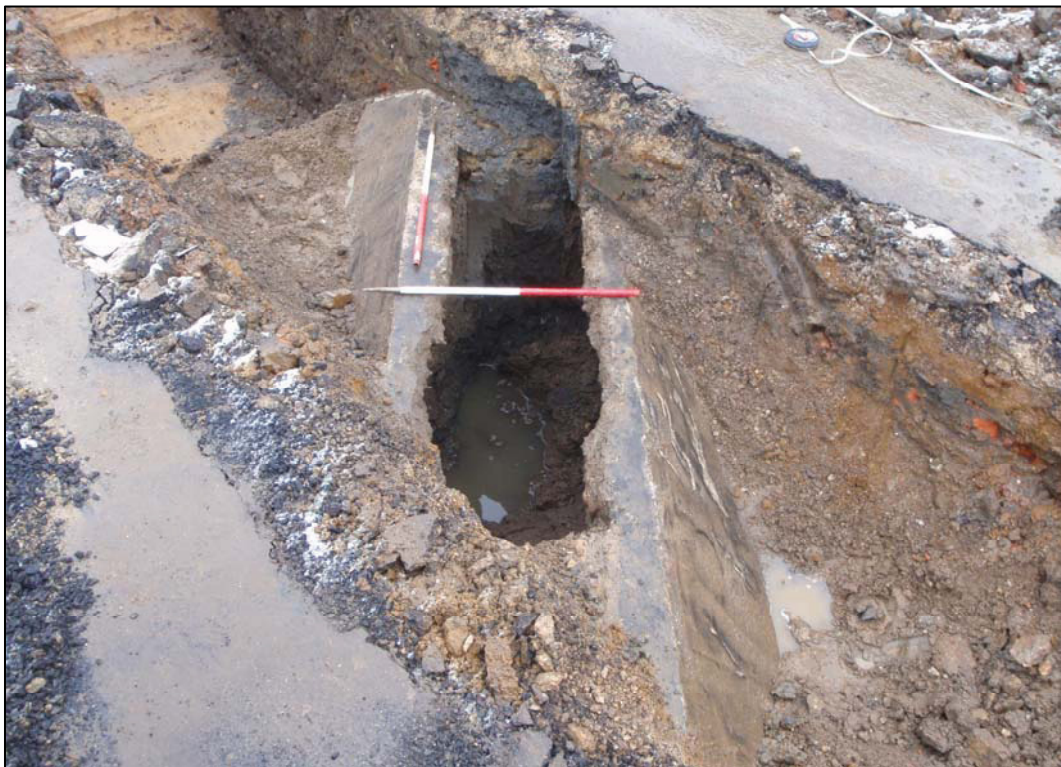
Plate IX. Trench 4, air-raid shelter, camera facing south-east

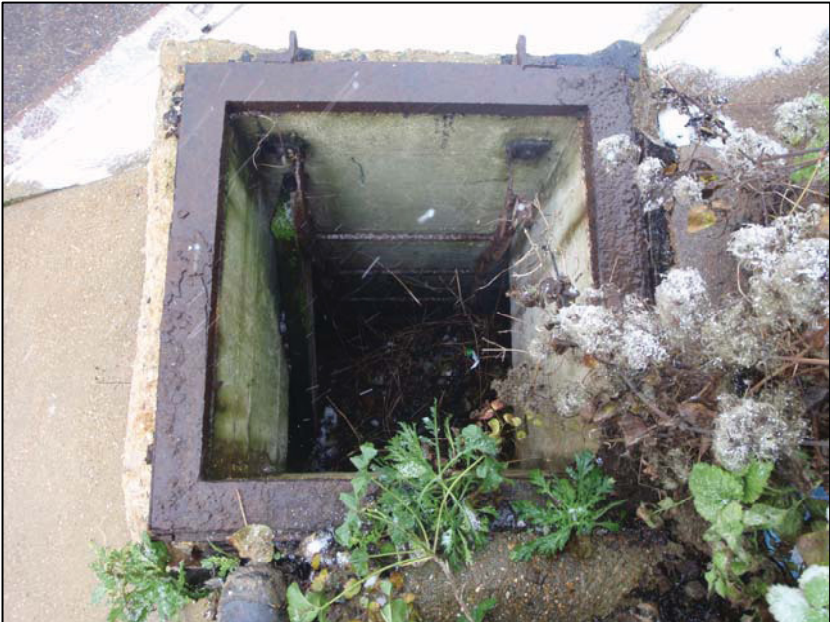
Plate X. View down manhole, camera facing north-west

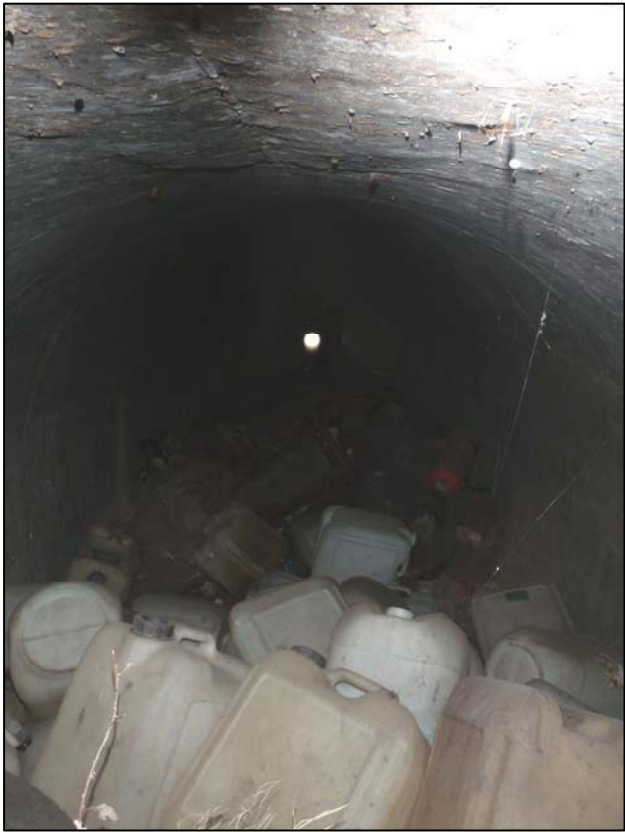
Plate XI. View from the manhole into the shelter, camera facing south-east
