HISTORIC BUILDING ASSESSMENT

SCCAS REPORT No. 2010/165

Pontin's Holiday Centre, Pakefield Gisleham GSE 067

M. Sommers
© September 2010
www.suffolkcc.gov.uk/e-and-t/archaeology

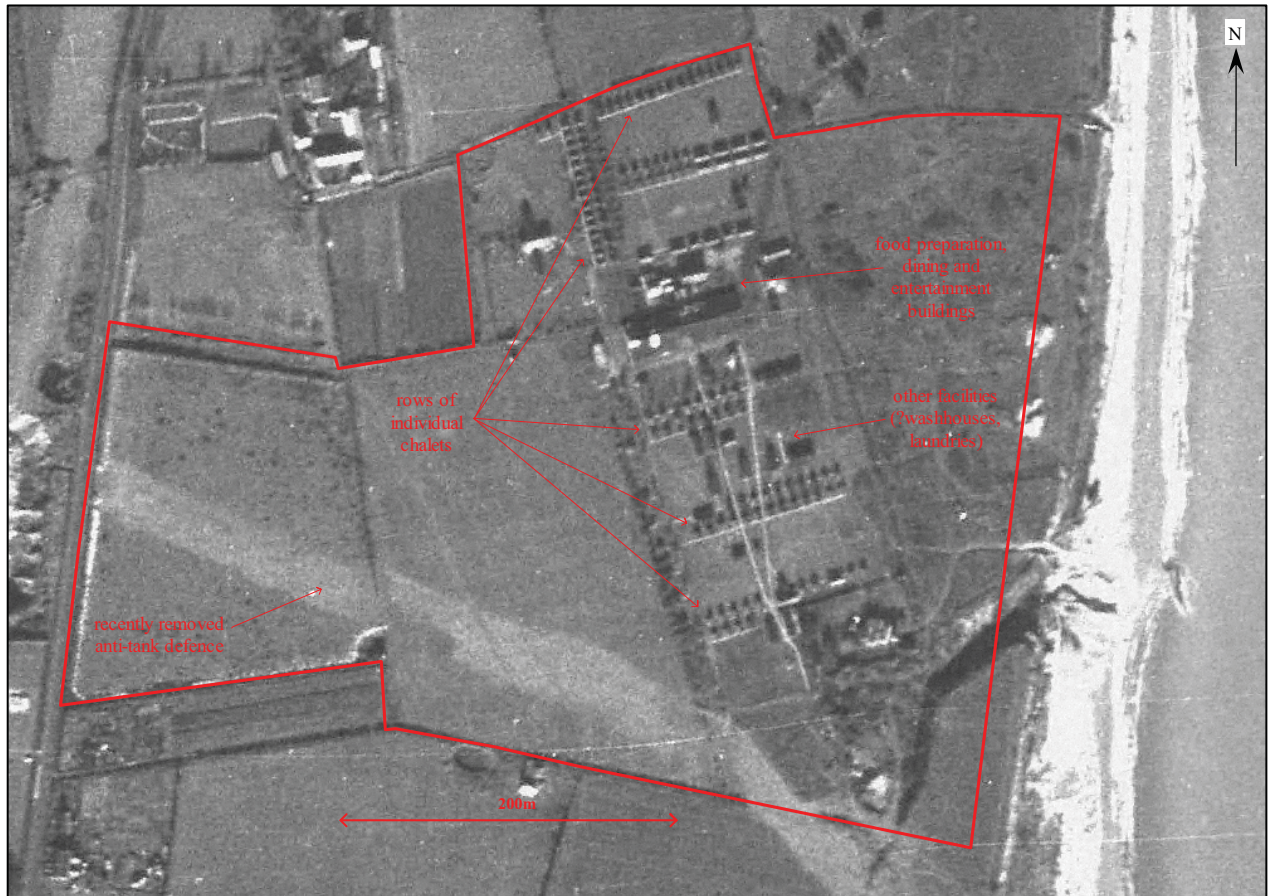
Figure 3. An aerial photograph of the site from 1945

There are no readily available plans of the pre-war camp at Pakefield but its arrangement immediately after the war can be seen in aerial photographs taken by the RAF in late 1945 (Fig. 3). Although the resolution of the image is low, lines of individual chalets on perpendicular alignments can be discerned. There is a group of slightly larger buildings amongst the rows of chalets to the south, which are possibly washhouses and laundries. A large building with other nearby buildings, that are clearly

not chalets, are located just north of the centre of the camp which are likely to be for food preparation, dining and entertainment. North of this area lines of what appear to be larger huts are visible. These are probably chalets but of a slightly larger design (either with two rooms or as semi-detached pairs) although it is possible they are further washhouses and laundries or even staff accommodation.

This building is coincidental with the large building visible on the 1945 aerial photograph and therefore potentially early but has clearly been greatly enlarged. The earlier structures may be extant within and on the north side of this large block but this was not clear (some steel framed 'Crittall' type windows present). This was the focal building of the camp until the major rebuild of the early 1970's.

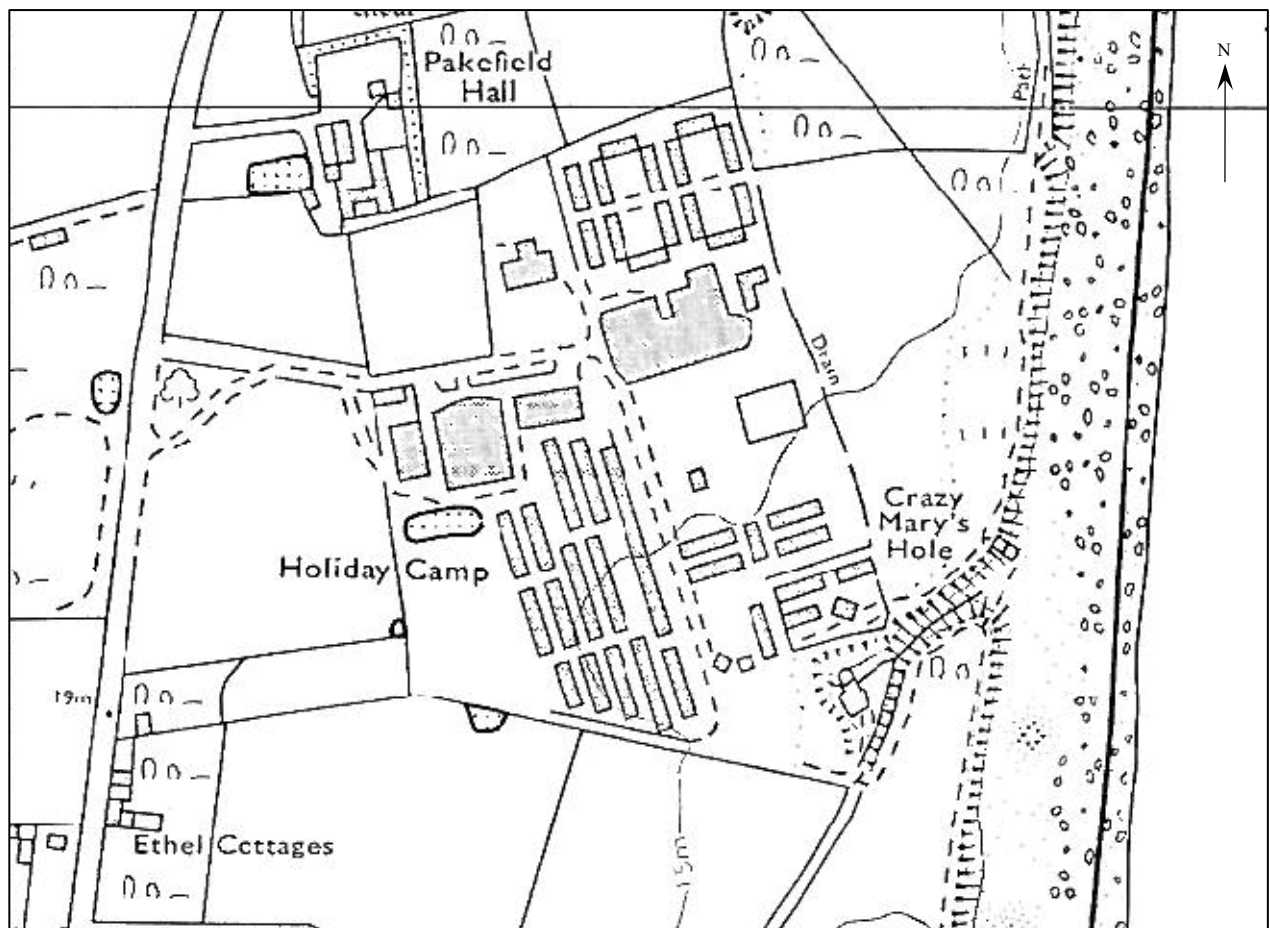
Figure 5. Ordnance Survey 1:10000 sheet of 1974 (un-scaled extract)

By the 1974 map (Fig. 5), however, it can be seen that the camp has changed considerably. All the original rows of chalets have disappeared and have been replaced with continuous blocks of chalets running on similar alignments as the original rows. A large group of chalets have been built to the southwest of the main entertainment/service buildings and three new, large entertainment buildings have been built immediately to the north of this new area of chalets, with a pond to the south. The original entertainment/service buildings have been extended (although due to the mapping convention it is possible that this actually represents a larger group of buildings rather than one large structure). The service building noted to the northwest also remains but appears to have been extended.

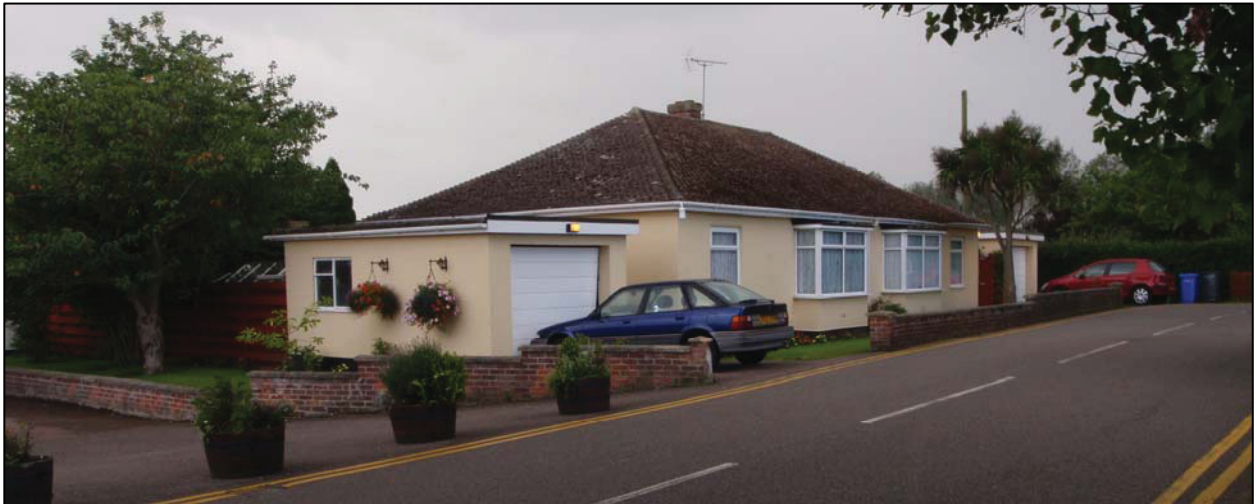
Building 1

Building 1: A pair of semi-detached bungalows with garages built for staff accommodation. Rendered brick with tiled roof. Constructed as part of the major rebuild in the early 1970s.

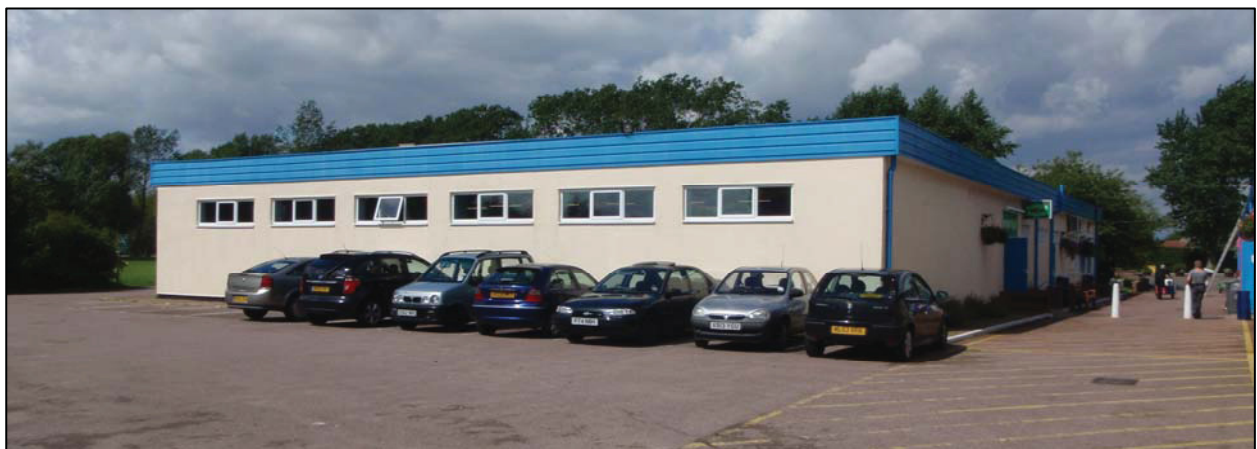
Building 2 (camera facing north)

Buildings 2, 3 and 4: Entertainment buildings constructed as part of the major rebuild in the early 1970s. Steel framed structures with brick and breeze block walls rendered and painted cream with blue detail. Building 2 houses the games rooms, Building 3 houses the main reception, amusement arcade, a café and the ballroom. Building 4 houses a large indoor swimming pool (this structure maybe a later rebuild or has been extensively refurbished since its original construction).

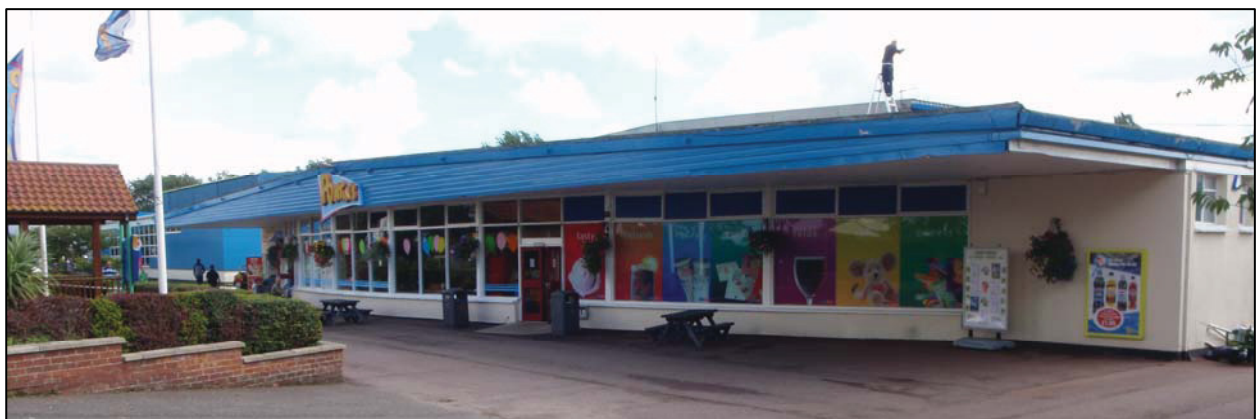
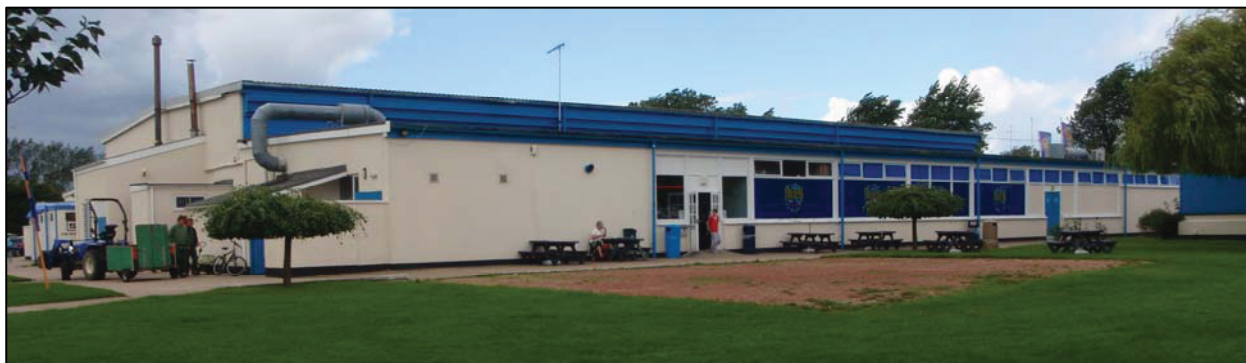
Building 3 (front – camera facing southeast)

Building 3 (side and rear – camera facing northwest)

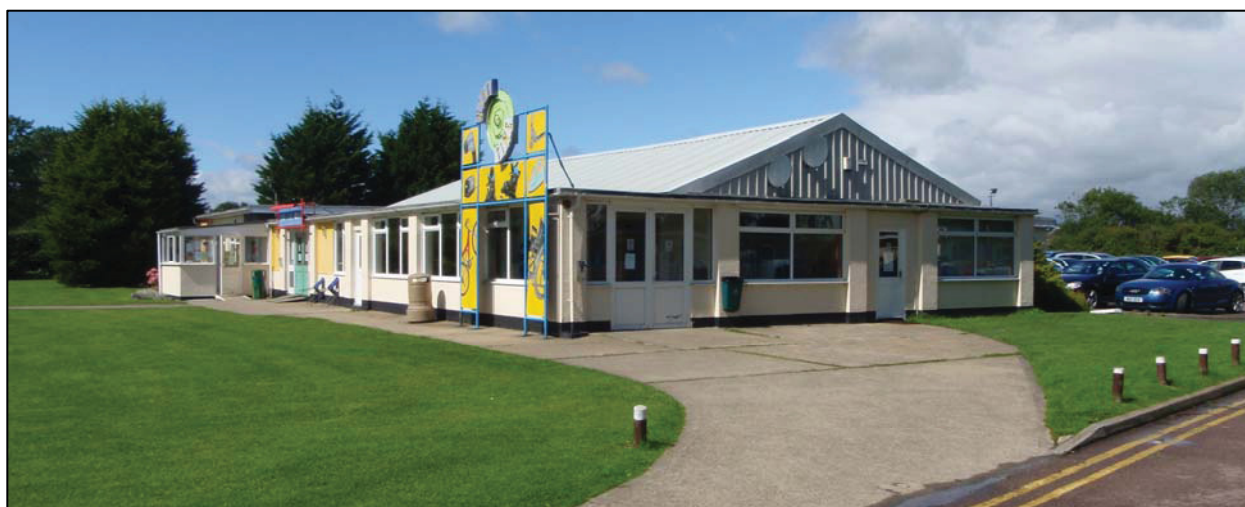
Building 5 (camera facing northwest)

Building 5: The hire centre and children's crèche. A steel framed shed with corrugated sheet cladding surrounded by brick and breeze block extensions rendered and painted cream with blue detail. Possibly one of the earliest structures on the site as it is coincidental with a building visible on the 1945 aerial photograph but has clearly been extensively rebuilt and refurbished.

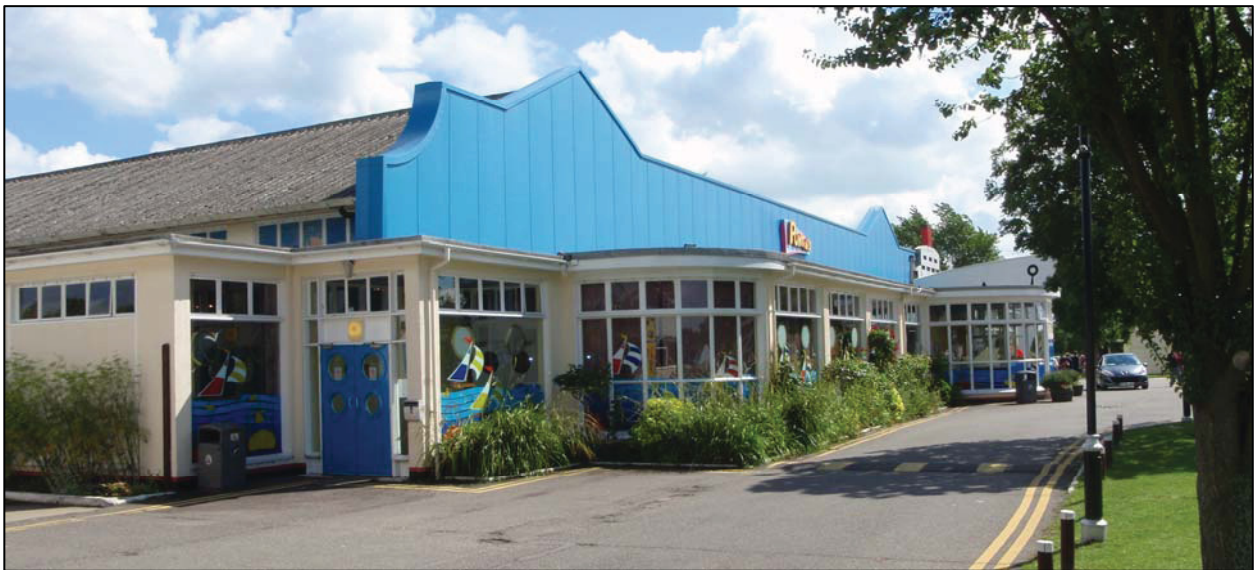
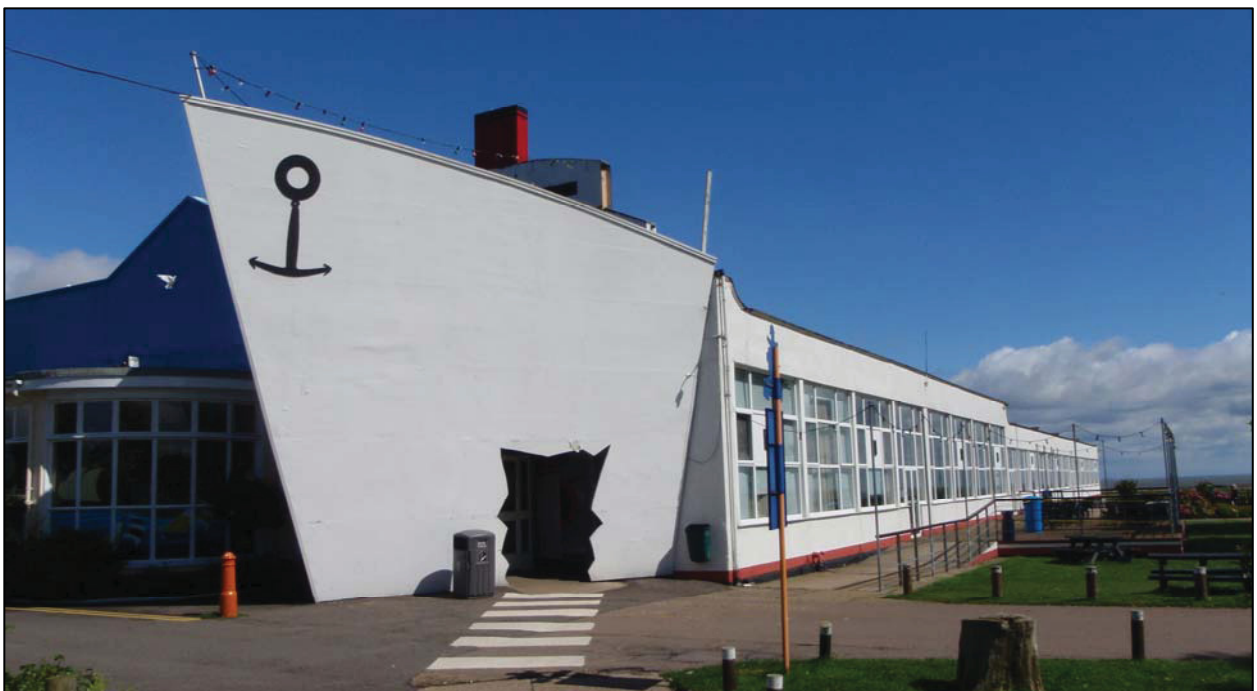
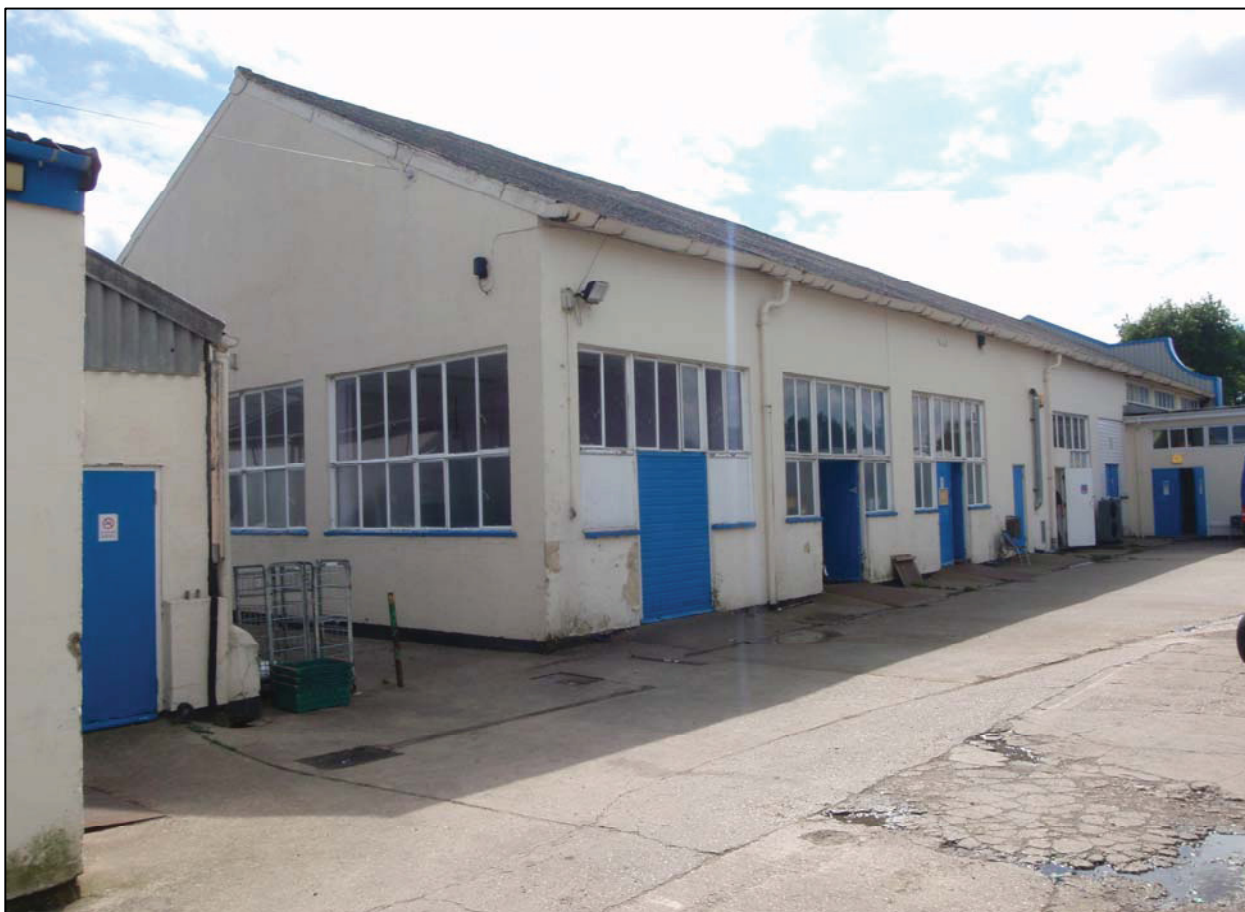
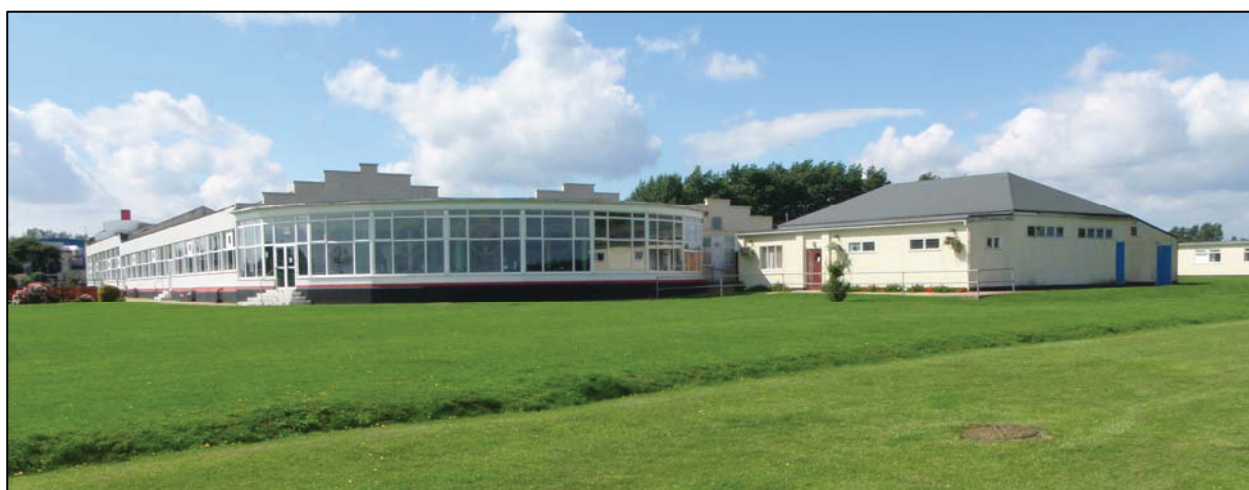
Building 6: An entertainment building housing the Prince's Bar, The Queen Vic public house and the SS Victoria Restaurant. Also incorporates the main kitchens and other service buildings (laundry etc.). Comprises a series of connected, presumably steel framed, sheds with brick and breeze block walls rendered and painted cream with blue detail. The southern side has been styled to suggest an ocean liner. The eastern end has three stepped gables although these are partially hidden behind later extensions.

Building 6 (front – camera facing southeast)

Building 6 (south side – camera facing northeast)

Building 6 (north side showing part of the service area – camera facing southwest)

Building 6, eastern end with the stepped gables visible (camera facing west). Building 7 to the right

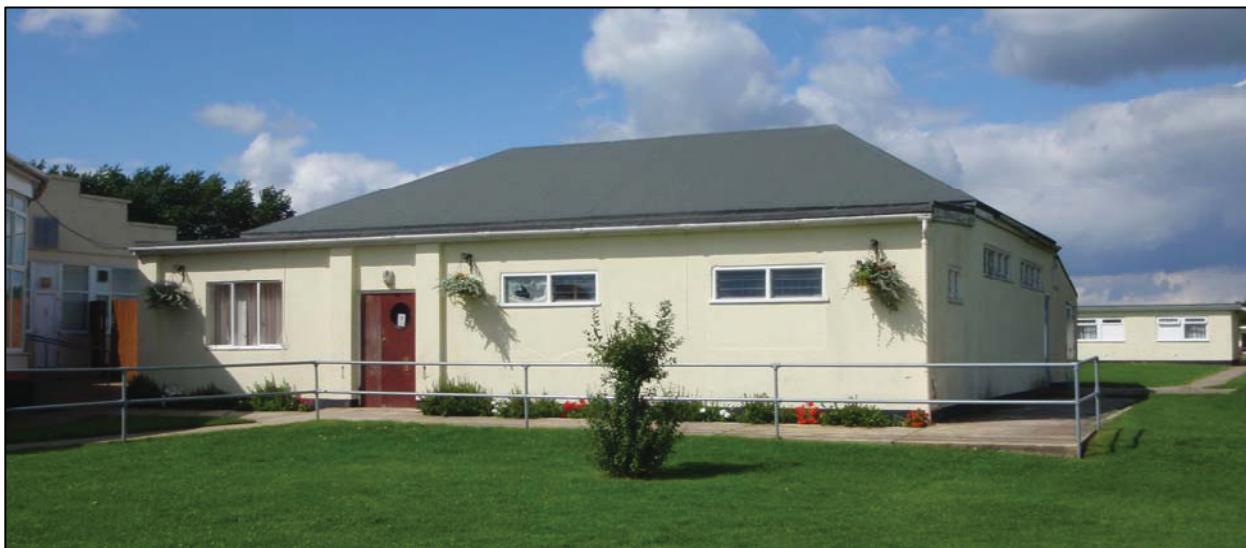
Building 7 (camera facing northwest)

Building 7: Maintenance building. Brick and breeze block construction painted cream with white detail and blue and brown doors. Timber roof structure covered in roofing felt. Probably an early structure as it is coincidental with building on the 1945 photograph. Does not appear to have been extensively altered structurally but was clearly once an entertainment building housing a children's play area (painted design featuring animals on the interior). Possibly the best preserved of the early camp buildings but is of little architectural merit.

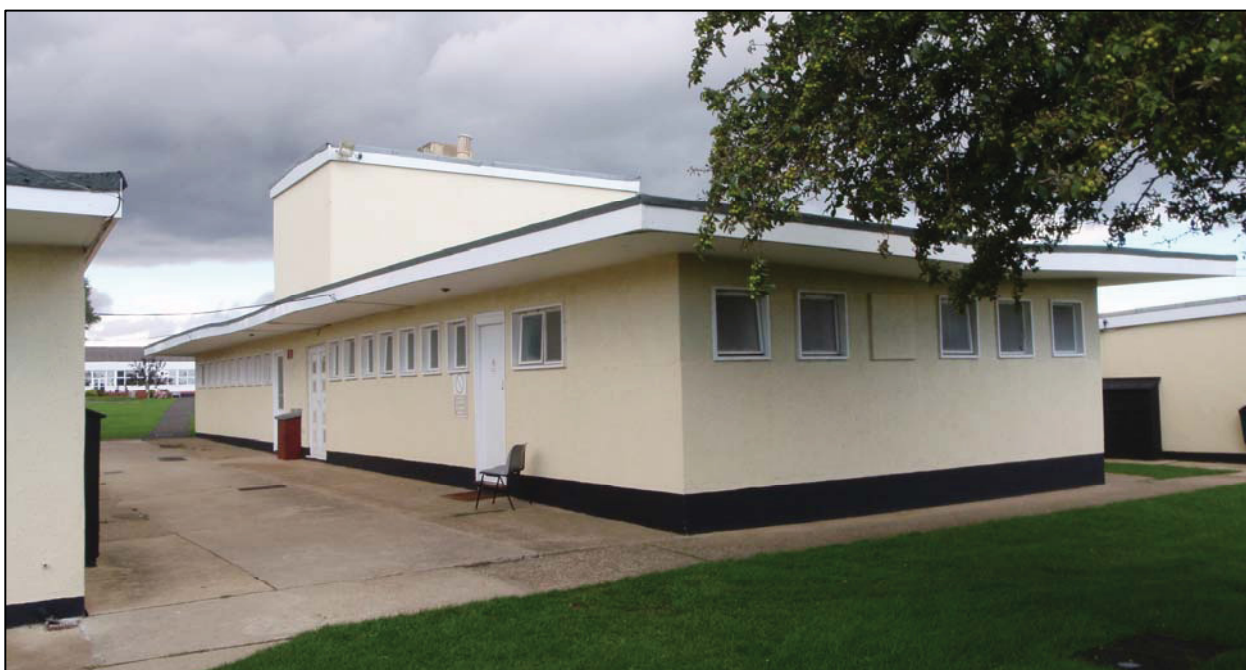
Building 9 (camera facing north)

Building 9: A prefabricated hut painted cream with white detail. Situated within the walled enclosure around the lighthouse. Appeared to be a private dwelling associated with the coast surveillance station.

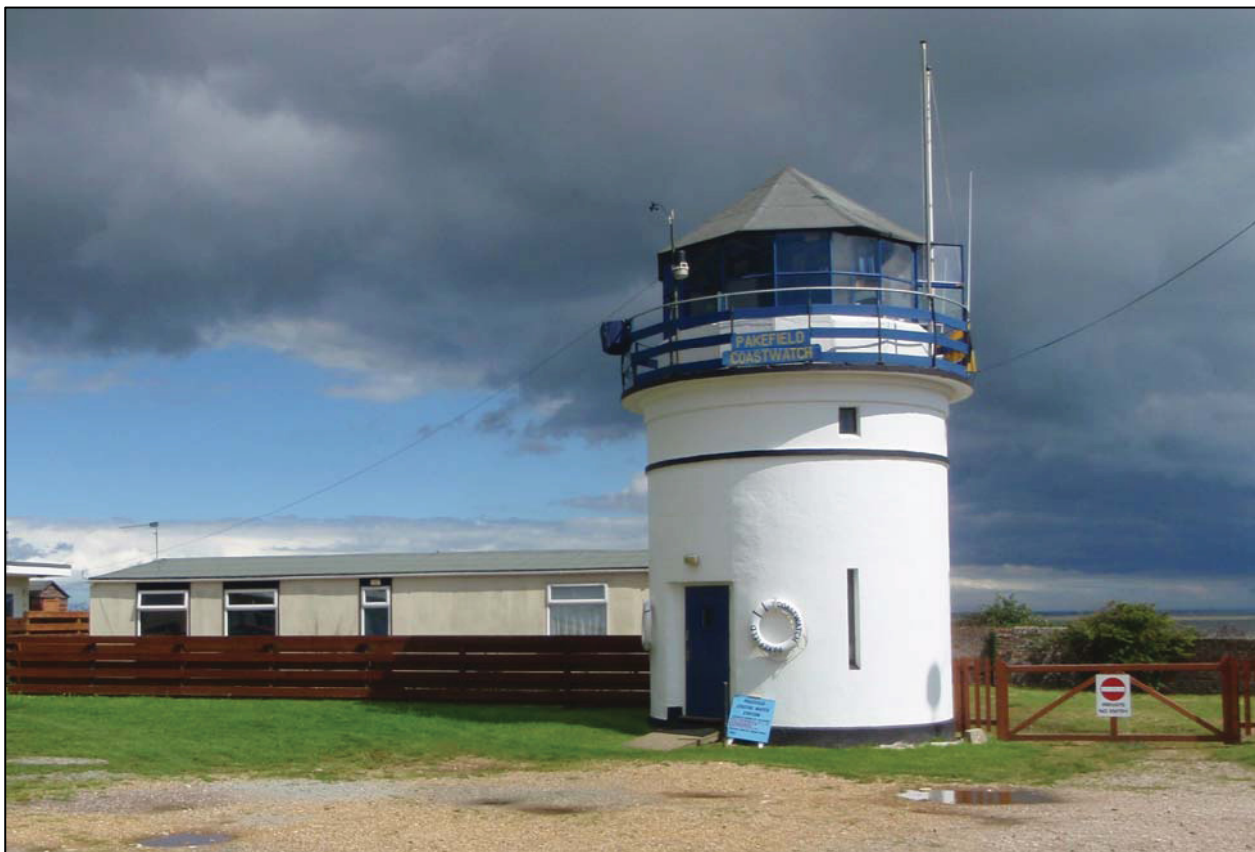
The existing lighthouse is made up of a circular tower, rendered and painted white, with a single doorway at the base facing northwest (and so was entered from the now demolished cottage?). There are narrow slits for windows on the ground floor with small square windows higher up. It has a conical, slate roof covering the glazed lantern where the light was once situated (see Building 10 in Section 4). It is not on the List of Buildings of Special Architectural or Historical Interest.

The lighthouse and the now demolished cottage were situated within a roughly rectangular area enclosed by a brick wall of which a large proportion still stands.

Buildings 9 and 10, the lighthouse (camera facing northeast)

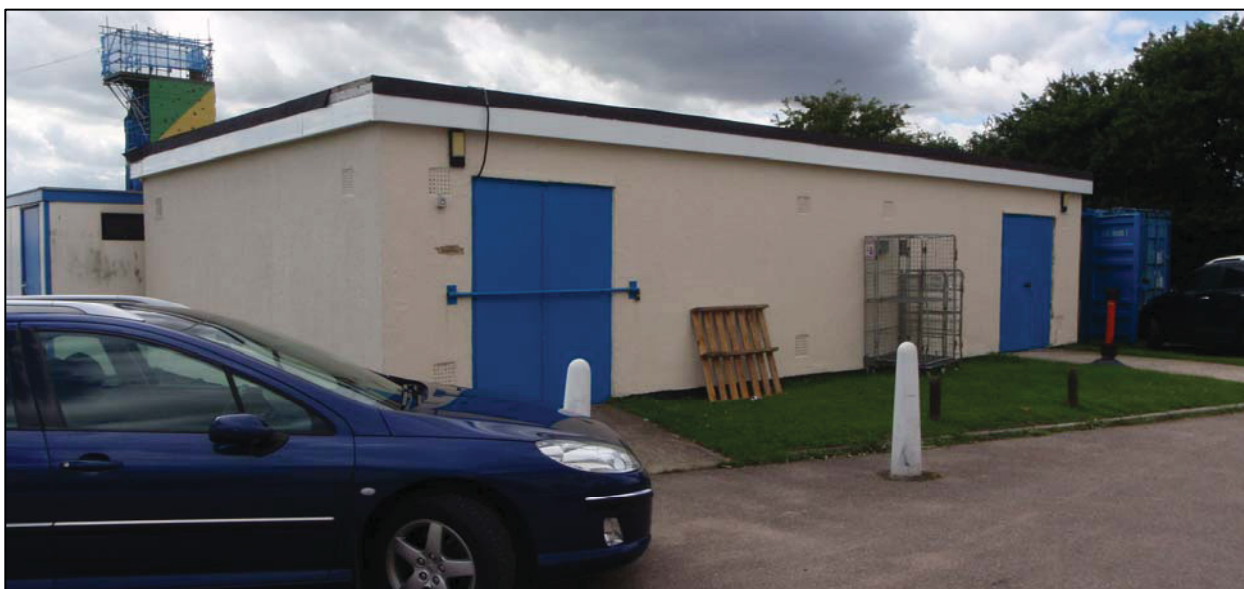
Building 11 (camera facing southwest)

Building 11: A storage shed to the rear of Building 2. Brick and breeze block construction with a flat roof. Rendered and painted cream with blue doors. Post 1970's, appears on a map of 1992.

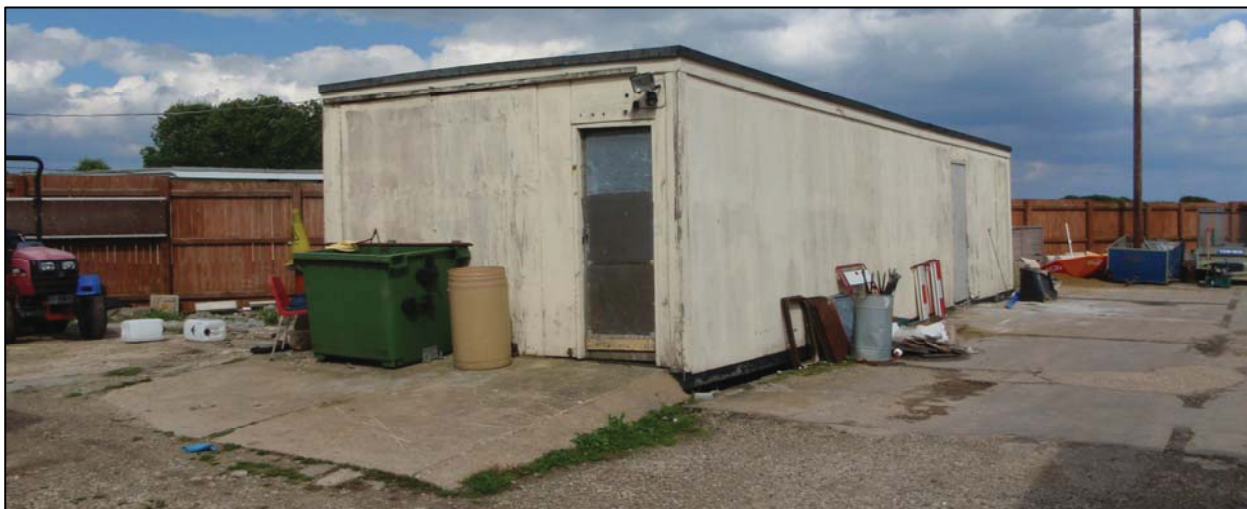
Building 12 (camera facing northeast)

Building 12: Timber framed shed clad in plywood, painted cream, with a flat roof covered in roofing felt. Of unknown age but probably relatively modern.

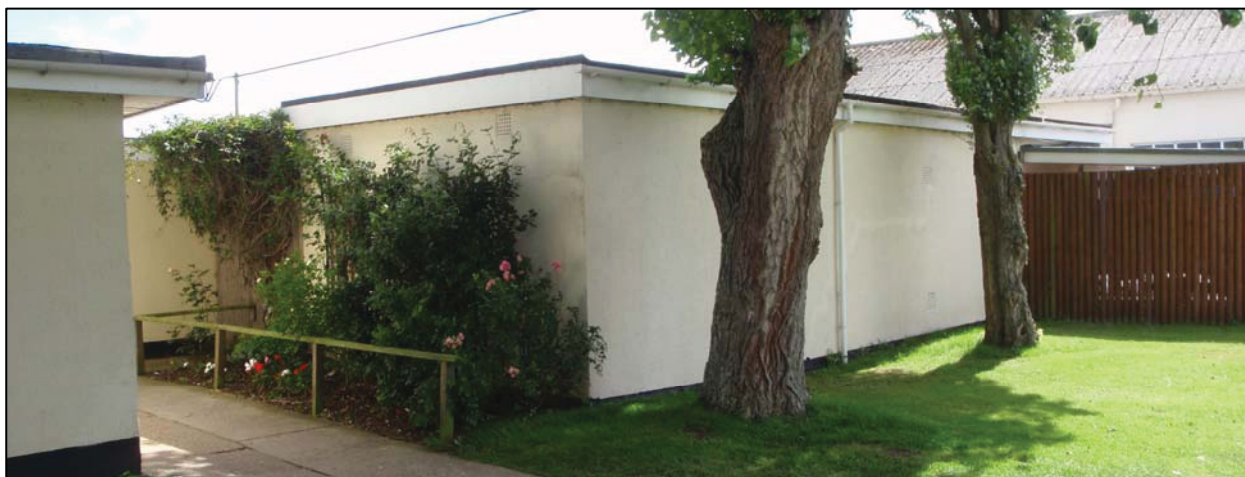
Building 13 (camera facing southeast)

Building 13: Rectangular brick and breeze block storage shed with a flat roof. Rendered and painted cream with white detail. Probably constructed as part of the major rebuild in the early 1970s.

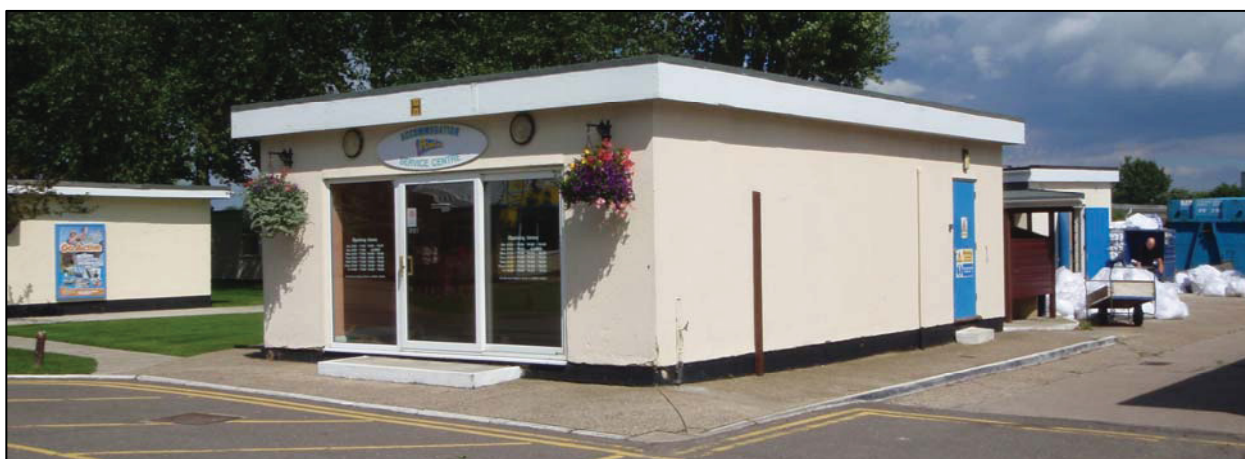
Building 14 (camera facing northeast)

Building 14: Rectangular brick and breeze block structure with a flat roof. Rendered and painted cream with white detail. Probably constructed as part of the major rebuild in the early 1970's.

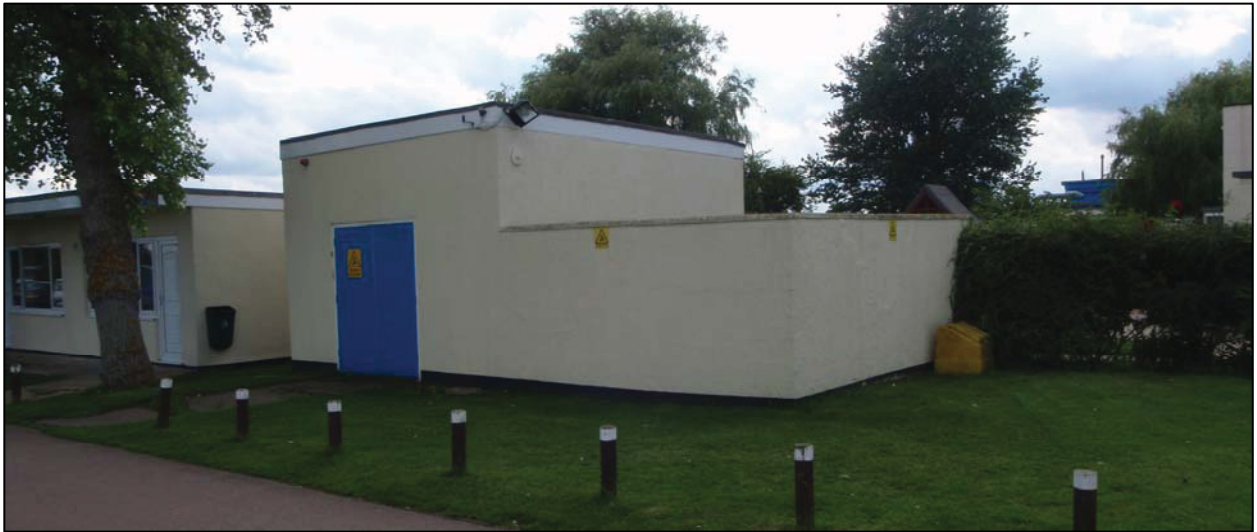
Building 15 (camera facing southwest)

Building 15: Rectangular brick and breeze block structure with attached open yard. Rendered and painted cream with white and blue detail. Houses a small electric substation. Probably constructed as part of the major rebuild in the early 1970's.

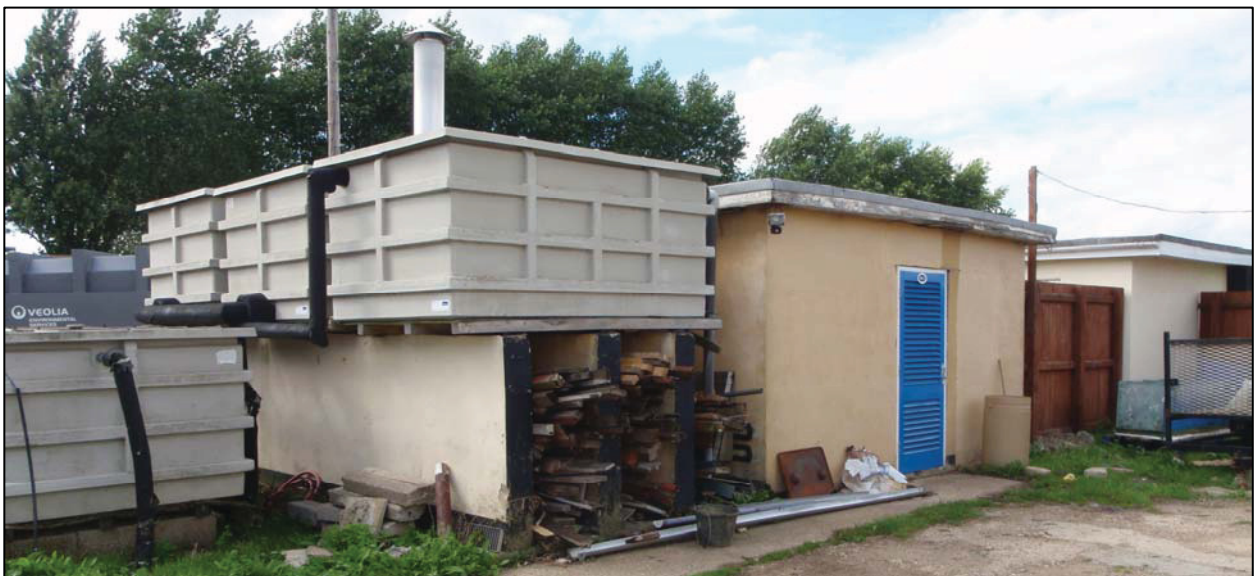
Building 16 (camera facing northwest)

Building 16: Service building. Brick and breeze block construction with flat roof. Walls are rendered and painted cream. Probably constructed as part of the major rebuild in the early 1970's.

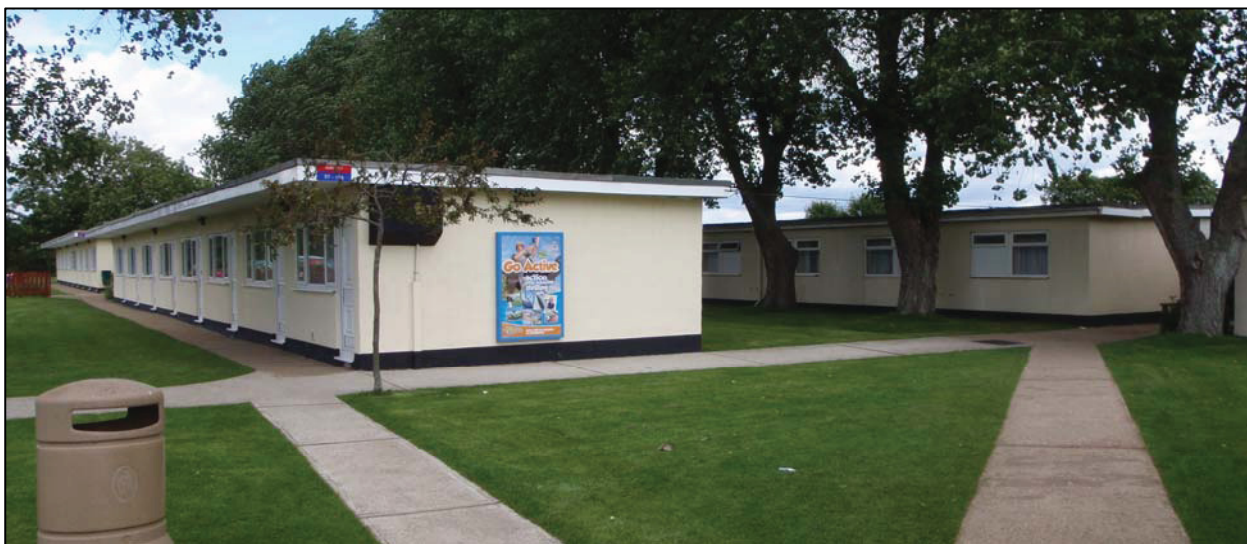
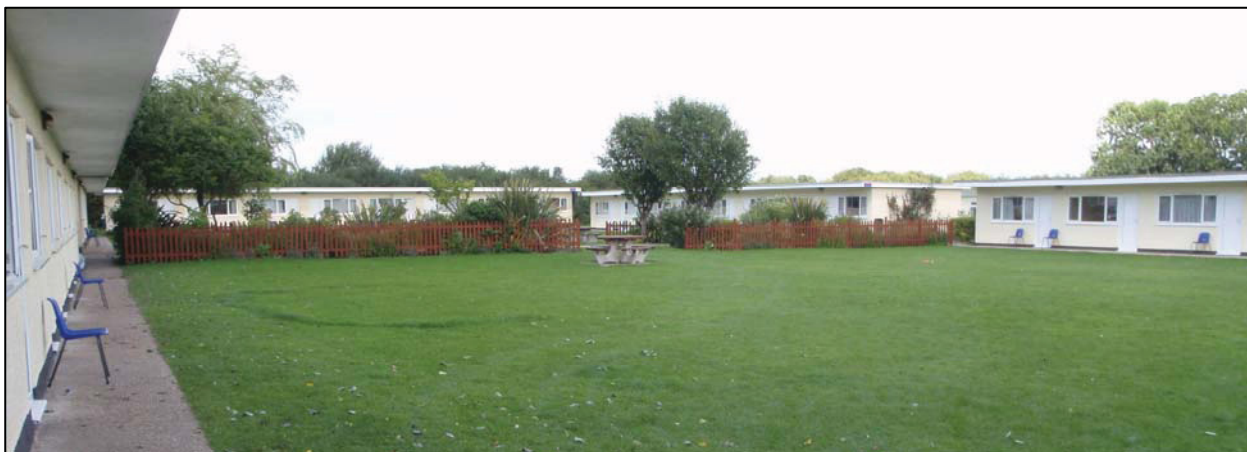
Buildings 17 to 24: A series of eight identical blocks, each containing eight chalets. As a group they are named by Pontins as 'Surf City'. Buildings 17 and 18 front onto a car park to the west whilst Buildings 19 to 24 are arranged around a rectangular area of grass with flower beds and a main pathway running approximately east to west across the centre. They are constructed of brick and breeze blocks, which are rendered and painted cream with white detail. They are situated in an area of former individual chalets and run on similar alignments to the former rows. Constructed as part of the major rebuild in the early 1970's.

Building 18 with Building 17 beyond. The back of Building 24 is visible to the right (camera facing north)

Buildings 24 (left), 20 21 and 22 (camera facing north)

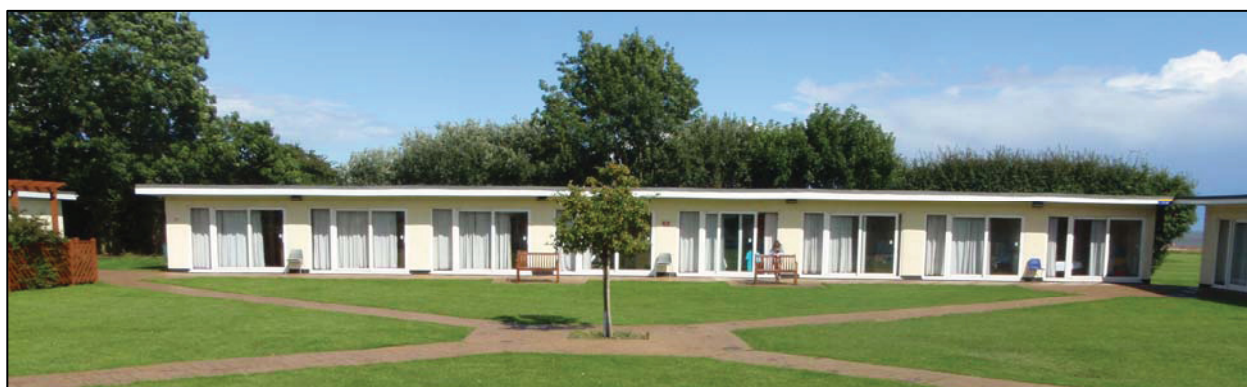
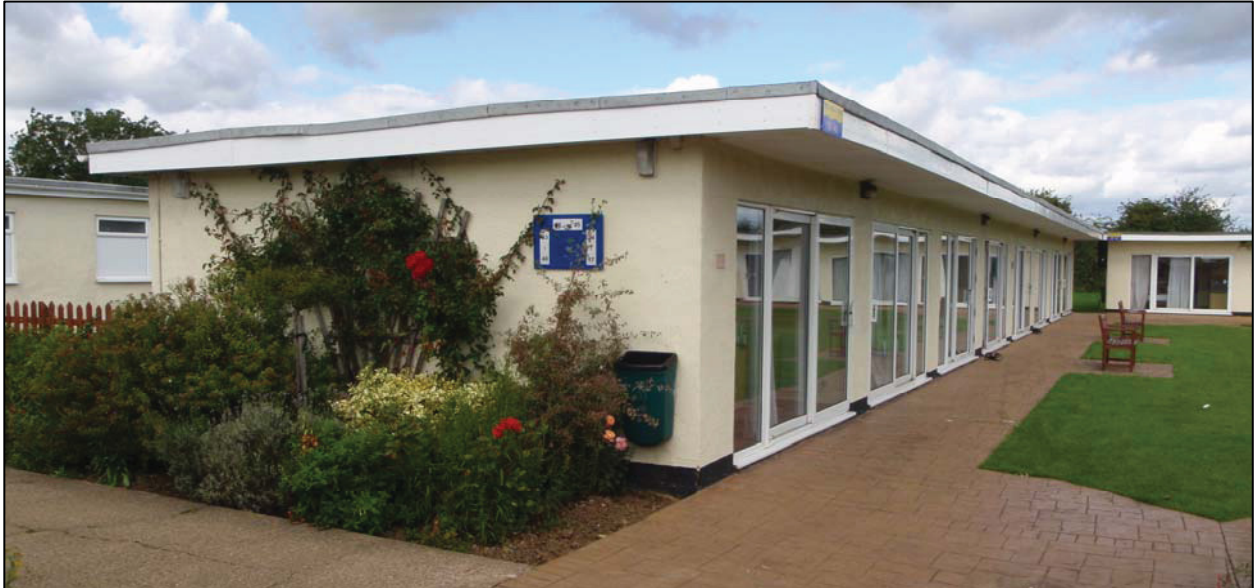
Buildings 25 to 30: A series of six identical blocks each containing eight chalets which as a group are named 'Club Savannah Land' by Pontins. They are arranged around a rectangular area of grass with flower beds and a main pathway running approximately east to west across the centre which incorporates a pergola (Building 60). They are constructed of brick and breeze blocks, which are rendered and painted cream with white detail. In basic appearance they are virtually identical to Buildings 17 to 24 but with full height windows that also allow for access. Constructed as part of the major rebuild in the early 1970's.

Building 28 (camera northeast)

Building 25 (camera looking northwest)

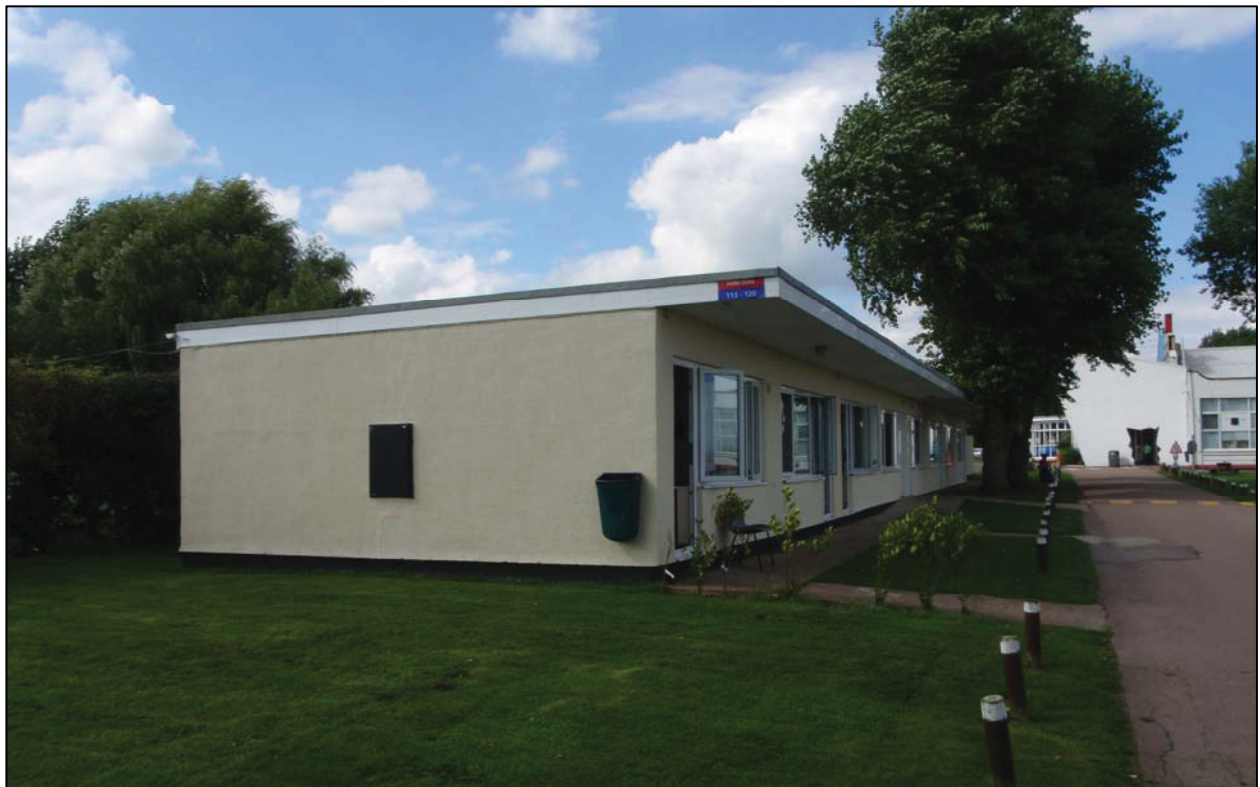
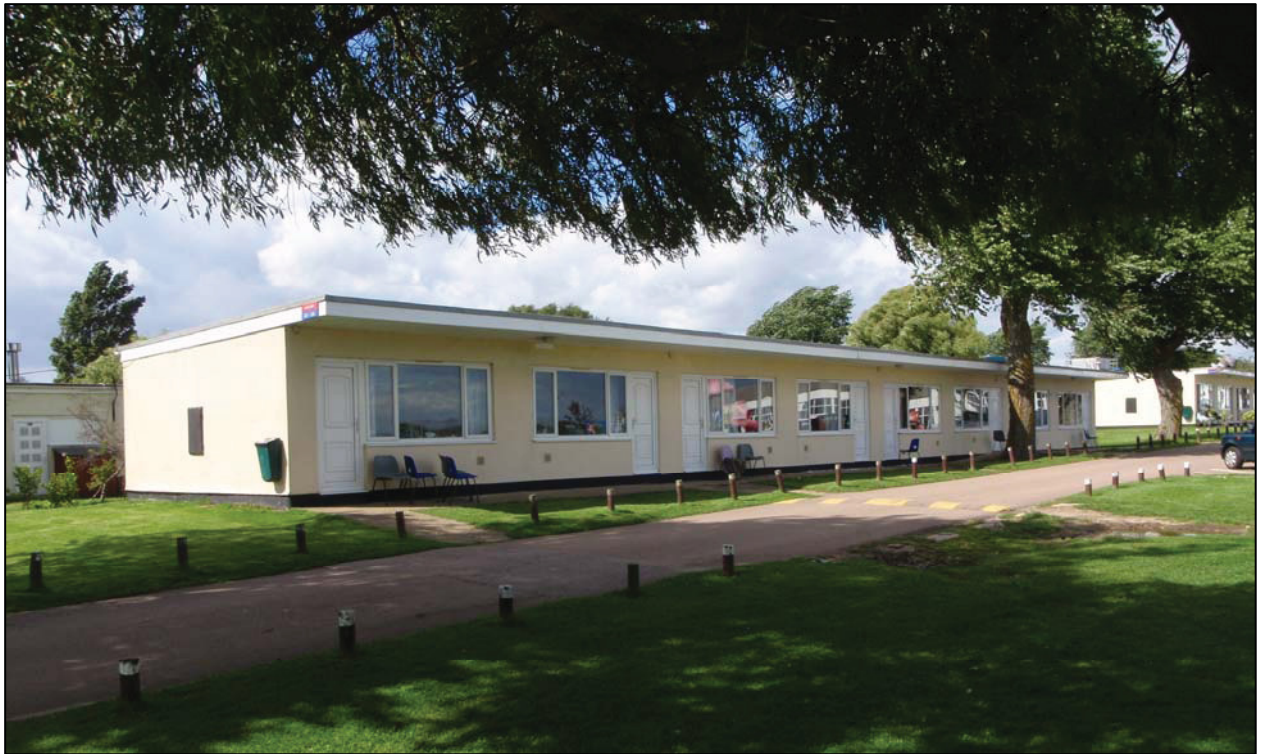
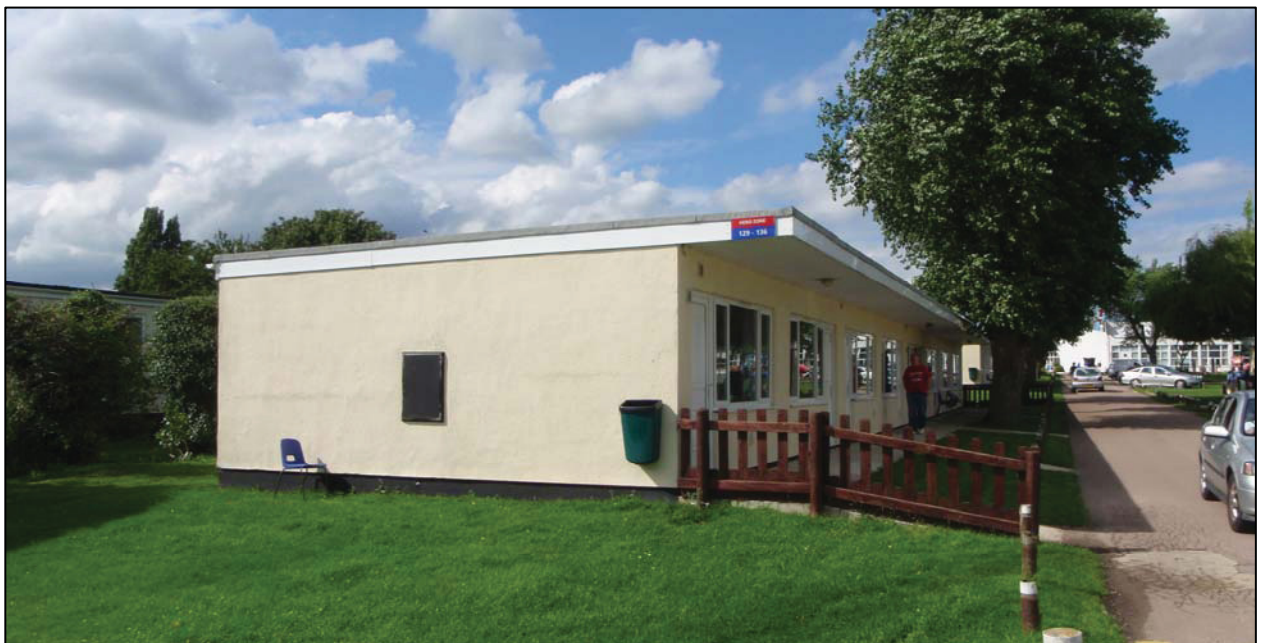
Buildings 31, 32 and 33: These comprise three similar blocks, each containing eight chalets running along the west side of the main north-south route through the camp. They form part of a group of chalets named by Pontins as the 'Hero Zone'. They are constructed of brick and breeze blocks which are rendered and painted cream with white detail. They run along the line of a former row of individual chalets but they are not on the 1974 map and are therefore later additions to the major rebuild in the early 1970s.

Building 31 (camera facing northwest)

Building 32 (camera facing northwest)

Building 33 (camera facing northwest)
