HISTORIC BUILDING ASSESSMENT

SCCAS REPORT No. 2010/165

Pontin's Holiday Centre, Pakefield Gisleham GSE 067

M. Sommers
© September 2010
www.suffolkcc.gov.uk/e-and-t/archaeology

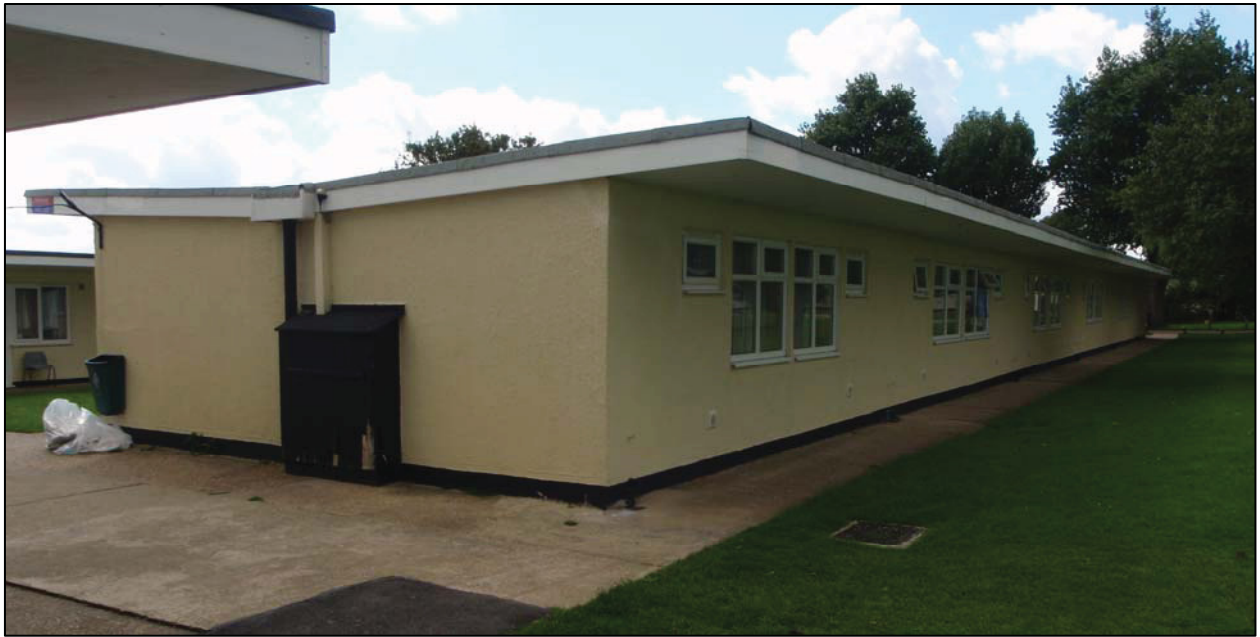
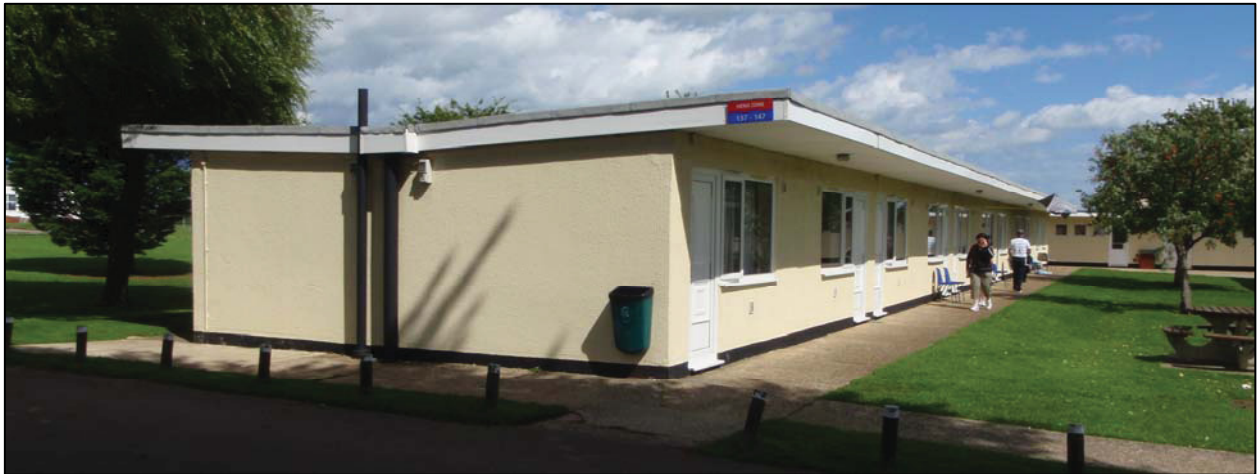
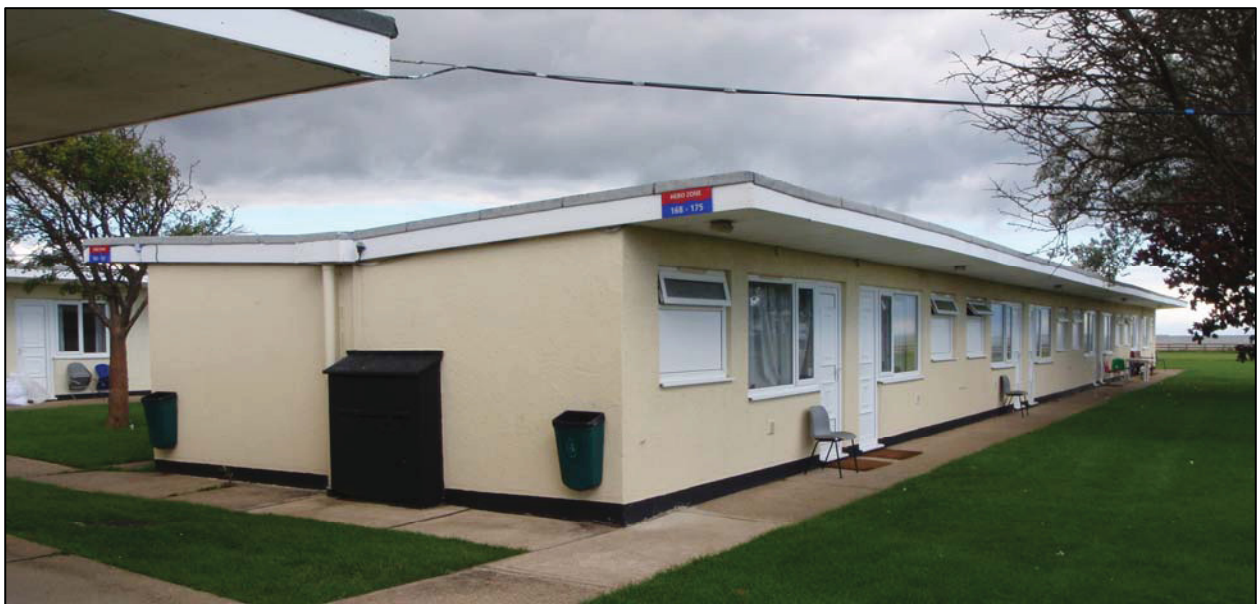
Buildings 34 to 37: Comprise a further four blocks of the 'Hero Zone'. Buildings 32, 35 and 36 each contain eight chalets whilst Building 37 contains sixteen, smaller chalets in a back-to-back arrangement. All four blocks are of identical proportions and it seems likely that all four blocks originally contained sixteen chalets but alterations have been undertaken to create the larger chalets. All four blocks are constructed of brick and breeze blocks which are rendered and painted cream with white detail and were constructed as part of the major rebuild in the early 1970s. They are arranged symmetrically either side of Building 8

Building 34 showing what is now the 'back' of the row (camera facing southwest)

Building 34 showing the 'front' of the row (camera facing northeast)

Building 37 (camera facing northeast)

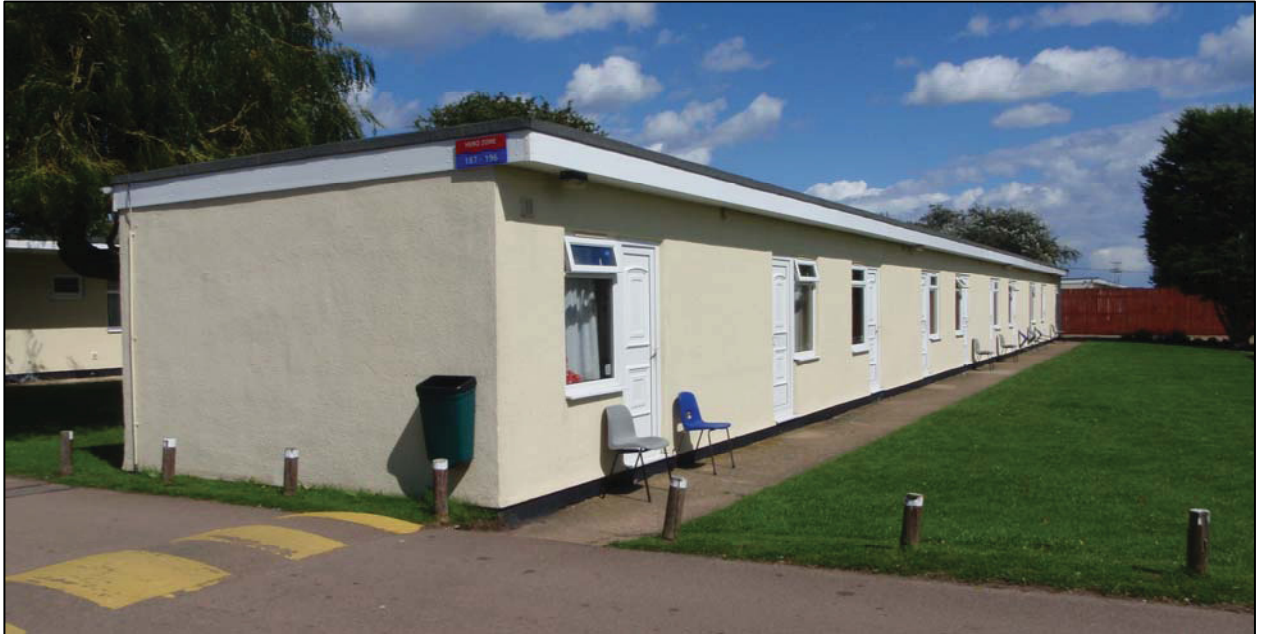
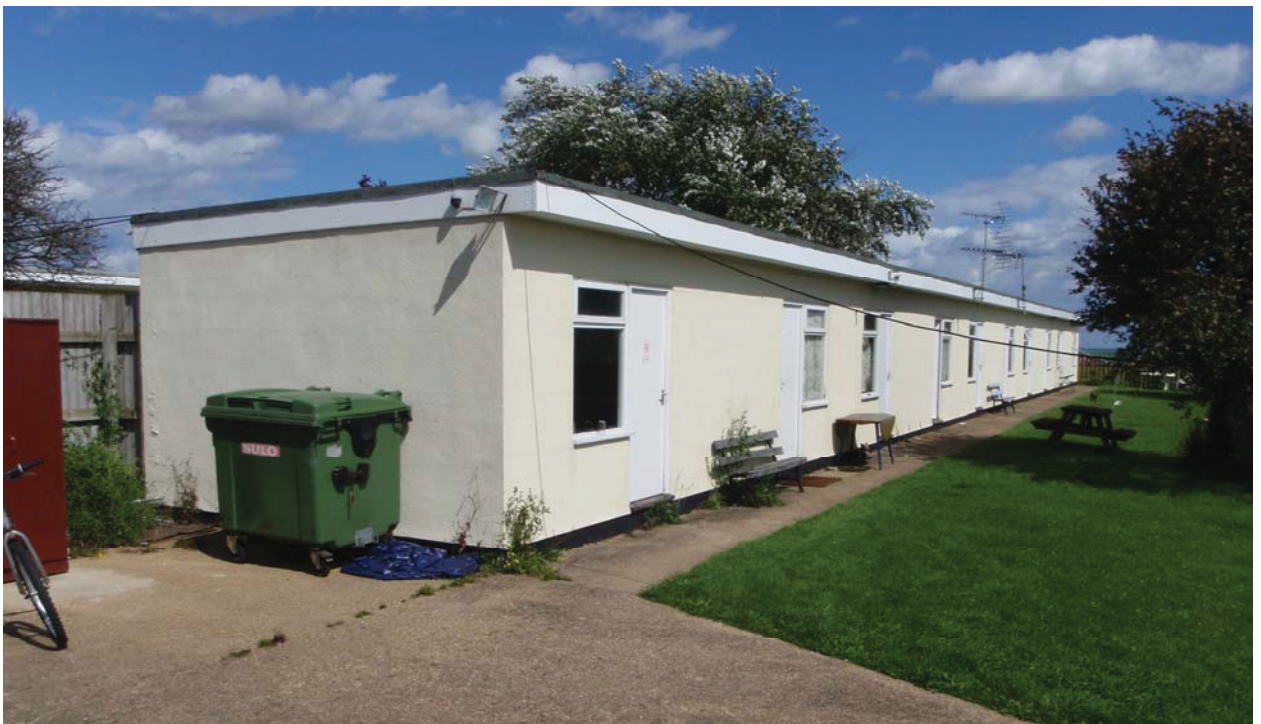
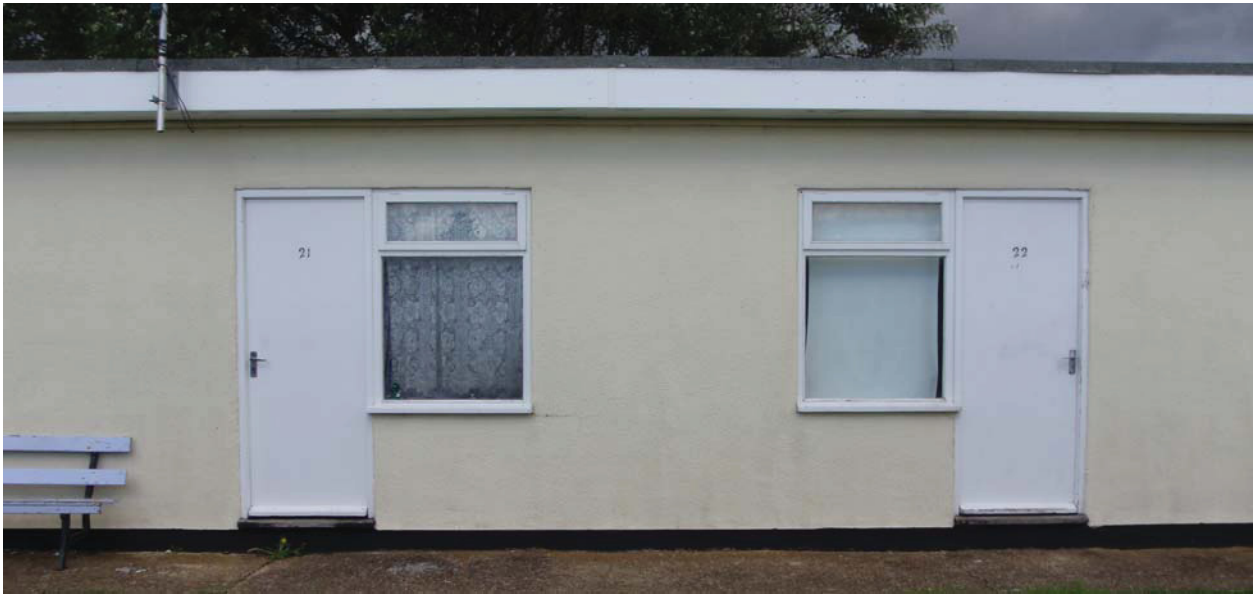
Buildings 38 and 39: Two identical blocks adjacent to Buildings 36 and 37 but which are of a slightly different design. Each building comprises a single row of eight chalets but they have a much smaller overhanging roof than all previously described chalets. Building 38 is part of the 'Hero Zone' whereas Building 39 is for staff accommodation. All the chalets that are for public use have uPVC windows and doors which have been fitted as part of a modernisation scheme within the camp. The staff accommodation on the other hand does not appear to have been modernised to such an extent and Building 39 retains wooden window frames and doors. These buildings do not appear on the 1974 map indicating they are slightly later despite their simpler appearance.

Building 38 (camera facing northeast)

Building 39 (camera facing northeast)

Building 39 showing the wooden doors and window frames (camera facing north)

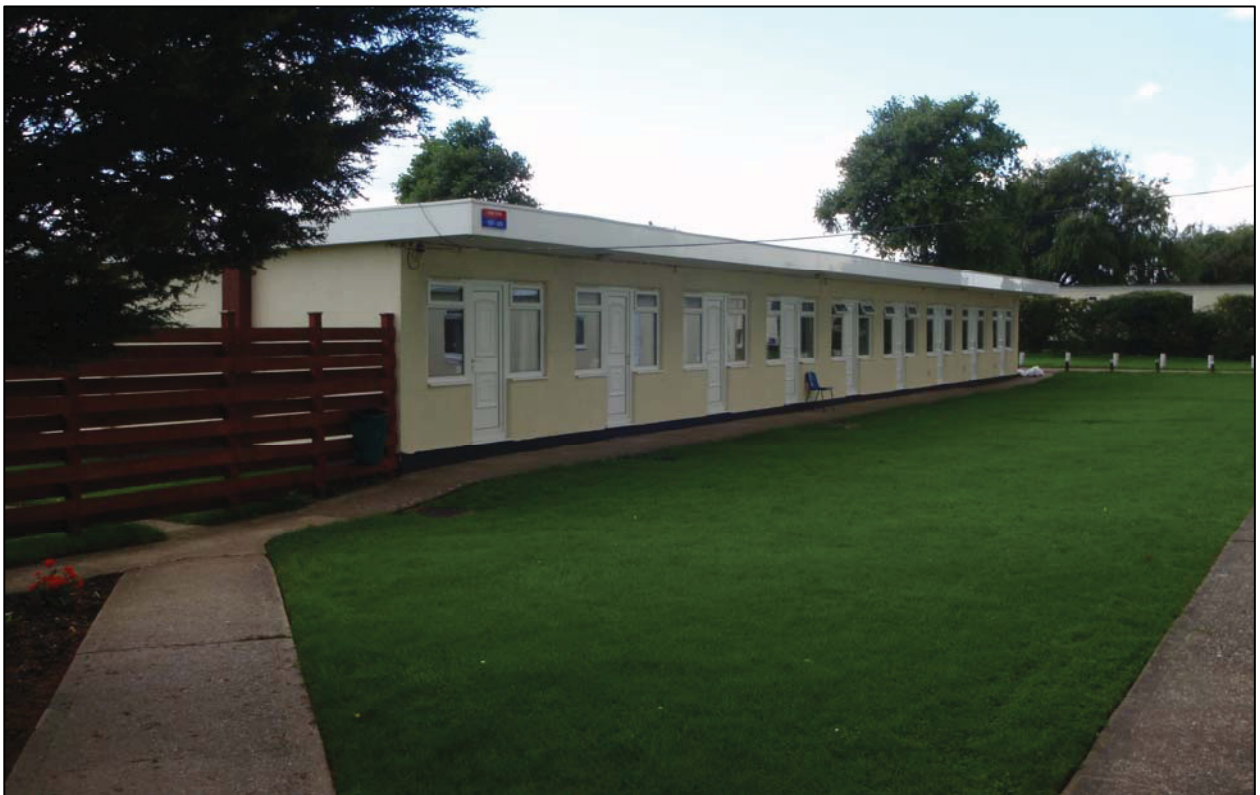
Building 40 (camera facing southwest)

Building 40: This is situated in the southwest corner of the 'Hero Zone'. It is not shown on the 1974 map indicating that it is later in date. It comprises eighteen chalets in a back-to-back arrangement with those facing north being for public use whilst those facing south are for staff accommodation. It is built of brick and breeze blocks which are rendered and painted cream with white detail. It also has uPVC fascias. The chalets for public use have uPVC doors and window frames whilst the staff row retains the wooden doors and frames.

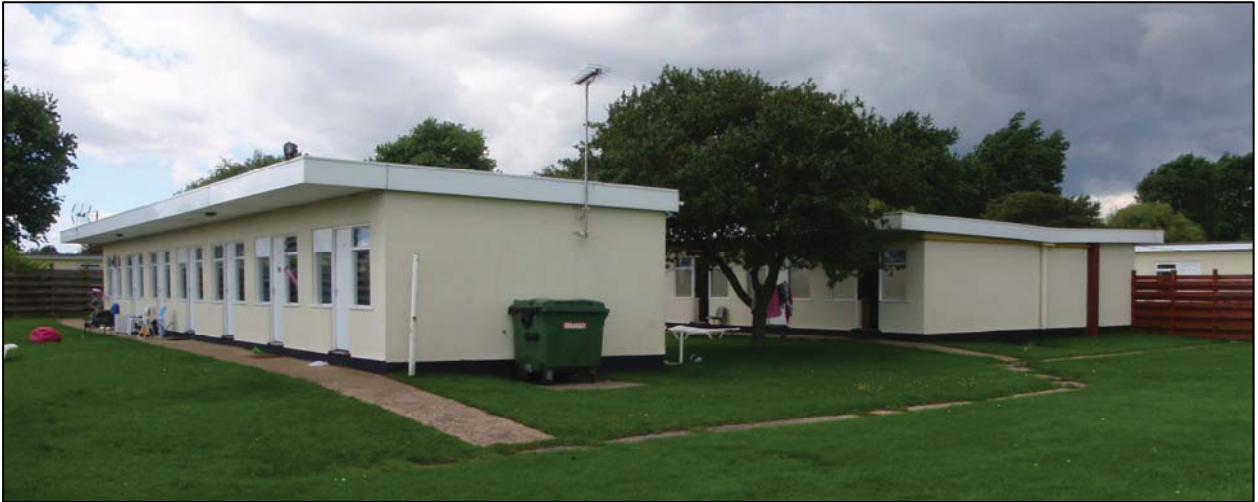
Building 41: This is situated southwest of the 'Hero Zone'. It is not shown on the 1974 map indicating it is later in date. It comprises seven chalets facing south which are for staff accommodation. It is built of brick and breeze blocks which are rendered and painted cream with white detail. It also has uPVC fascias but wooden doors and frames.

Building 41 with Building 40 to the right (camera facing northwest)

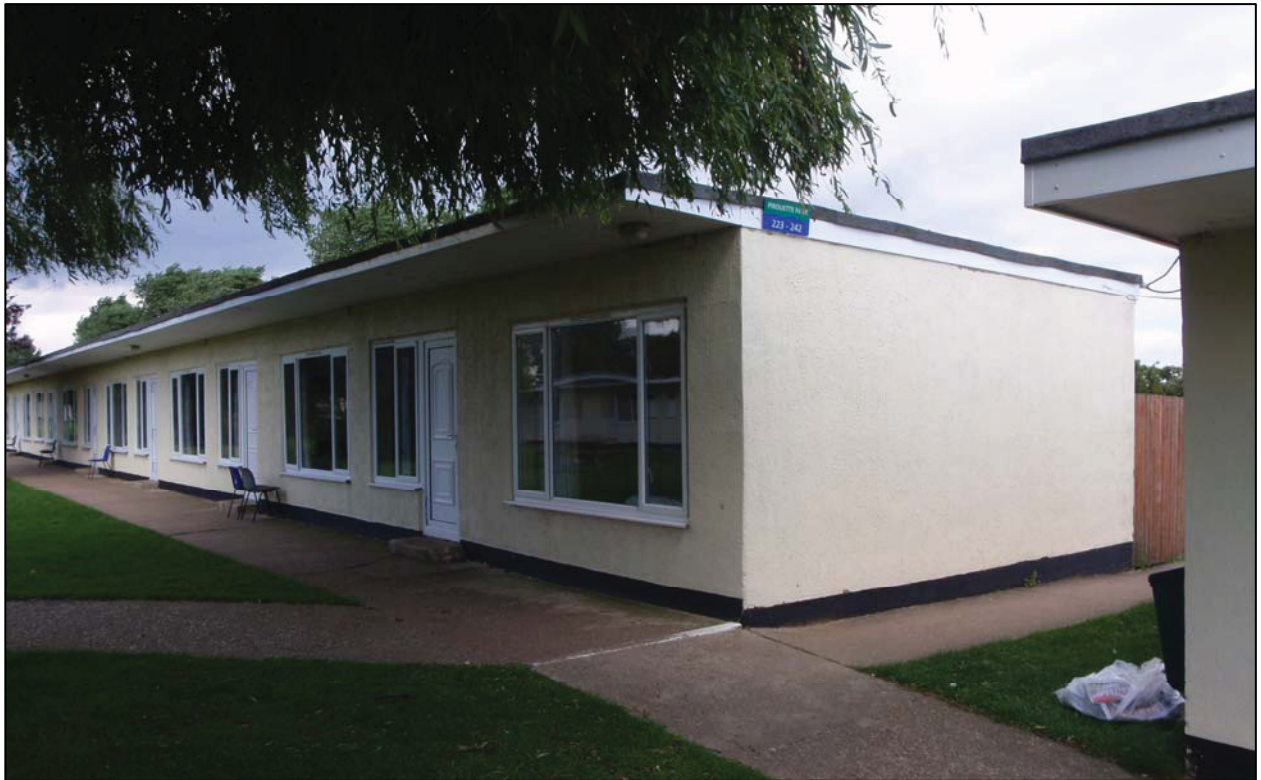
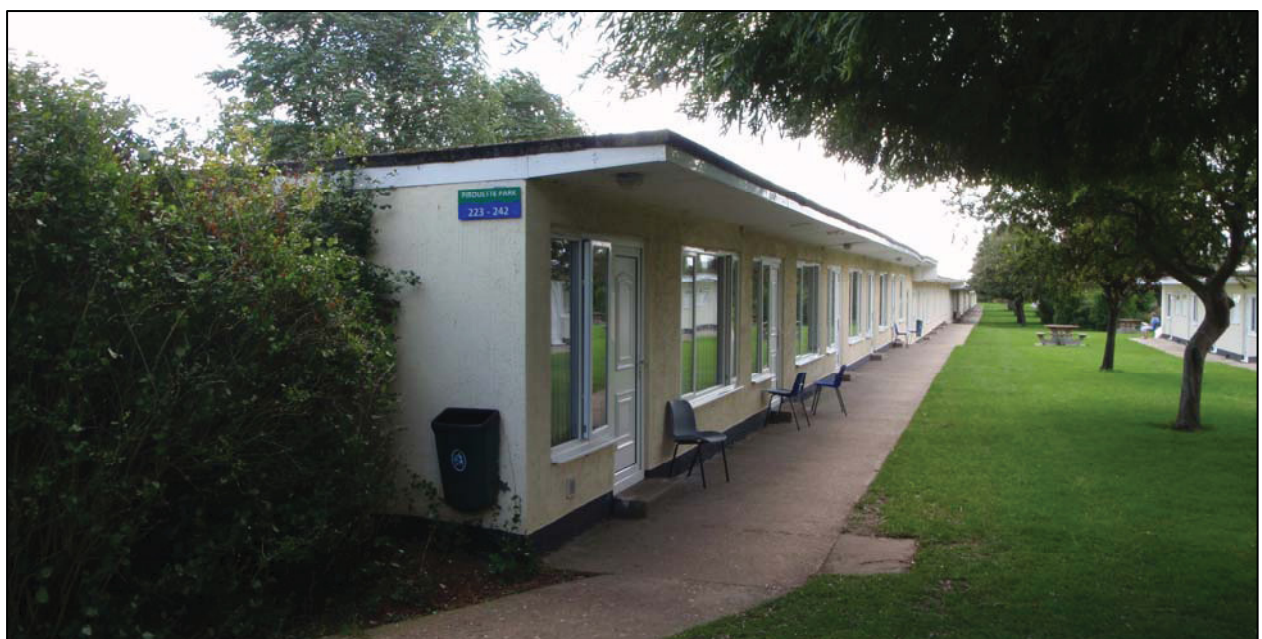
Building 45: This building comprises a long unbroken row of twenty chalets facing west. It is built of brick and breeze blocks which are rendered and painted cream with white detail. It forms part of a group of chalets named by Pontins as 'Pirouette Park' and was constructed as part of the major rebuild in the early 1970s. There is clear evidence for a number of doors having been sealed up and their associated concrete steps having been removed suggesting that originally this row was divided into a larger number of chalets. The ground on which this row is built rises slightly to the north and has resulted in the structure stepping up twice along its length.

Building 45, the southern end (camera facing north)

Building 45 (camera facing southwest)

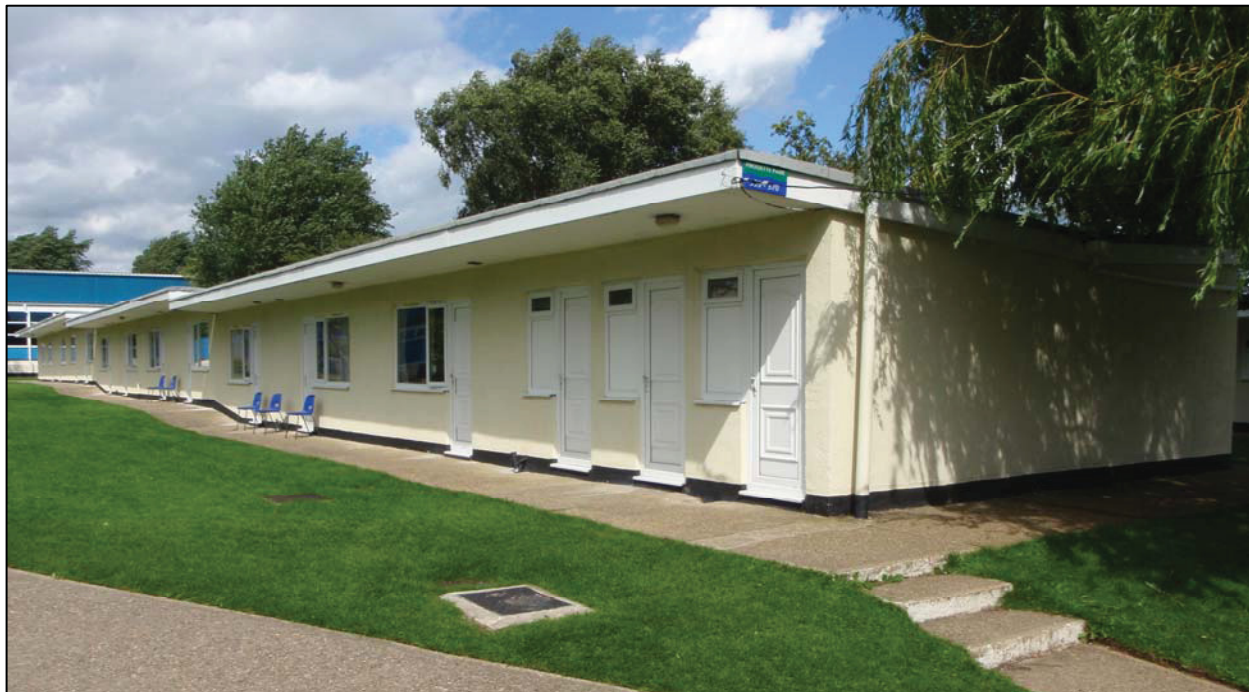
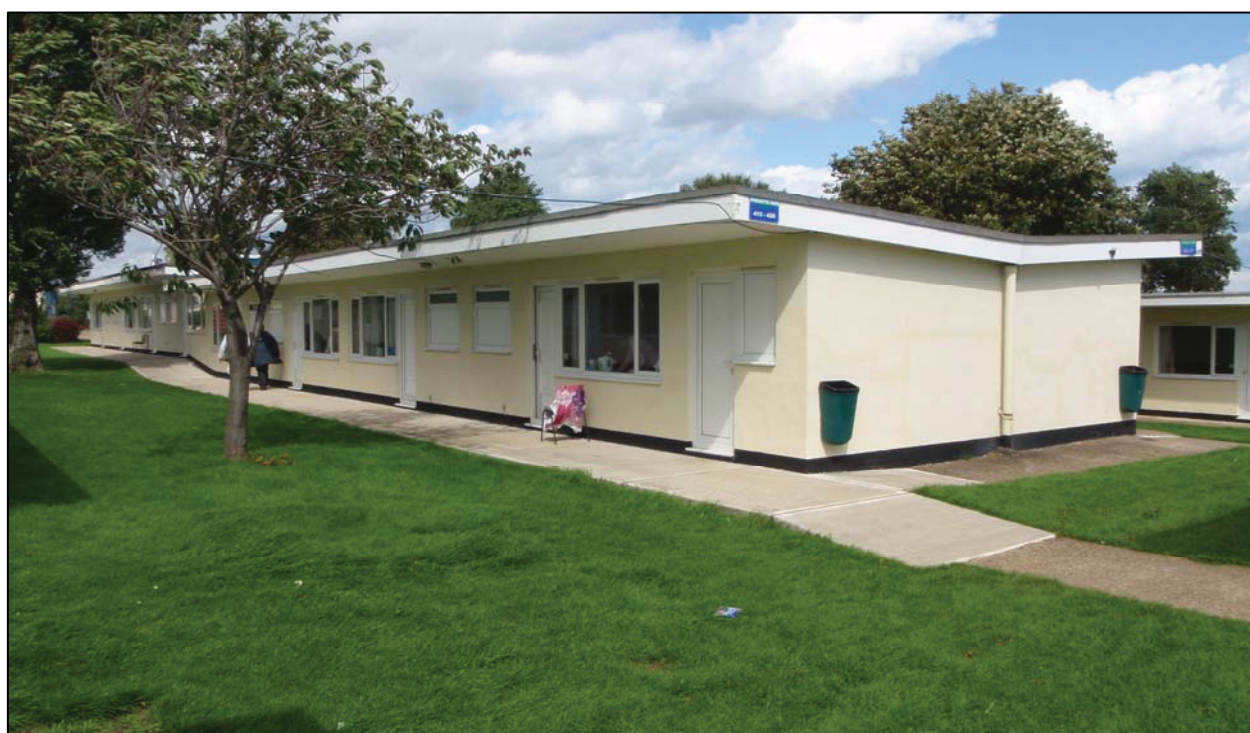
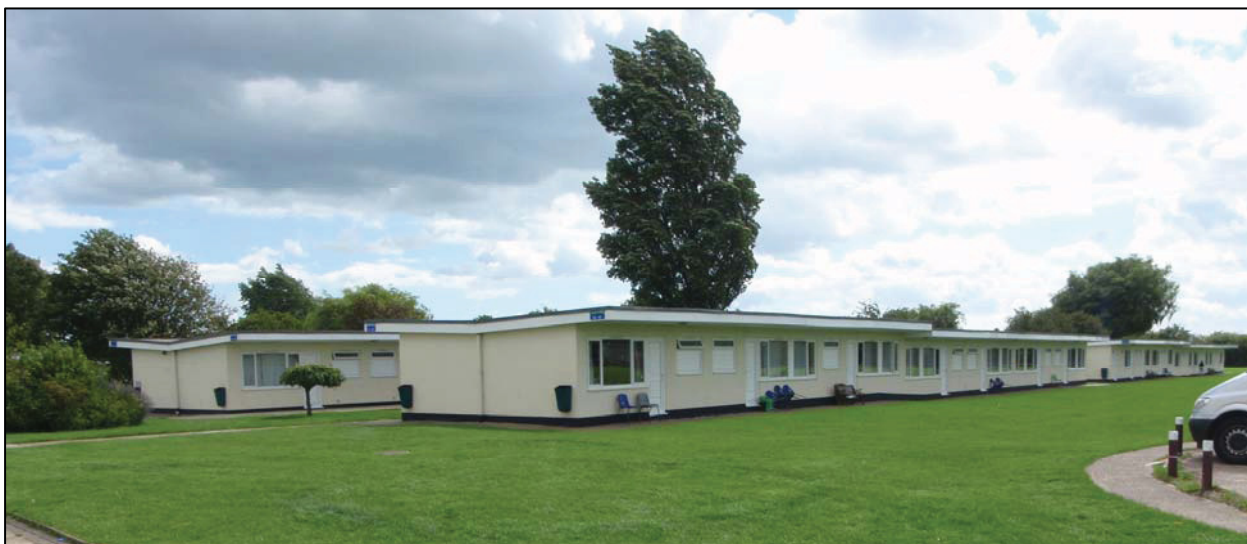
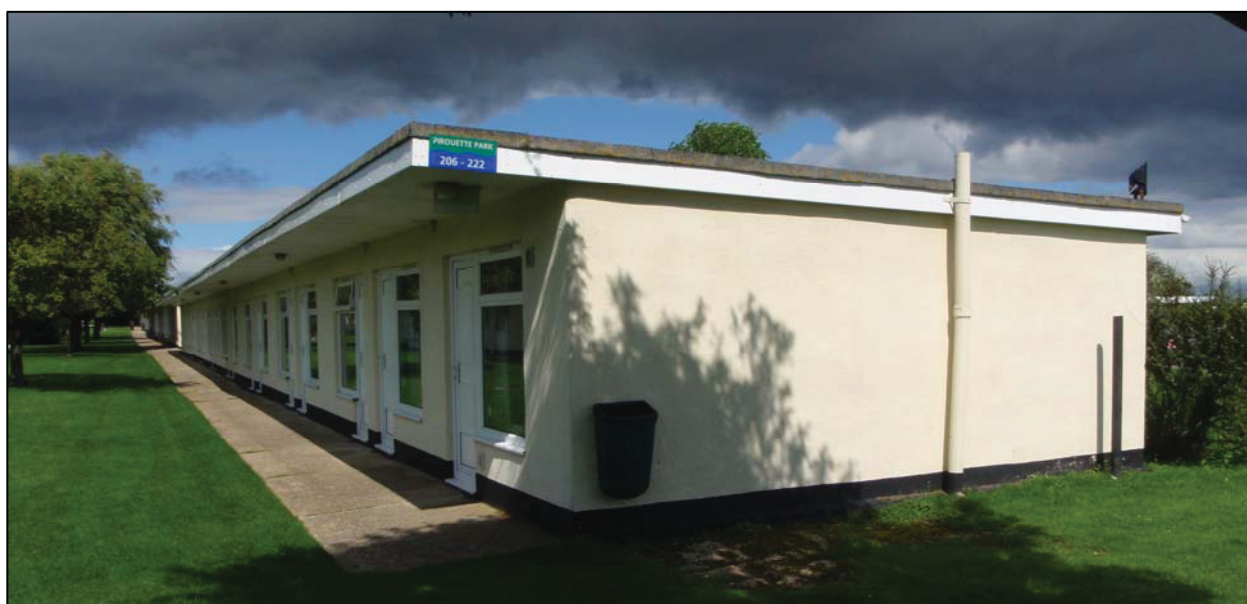
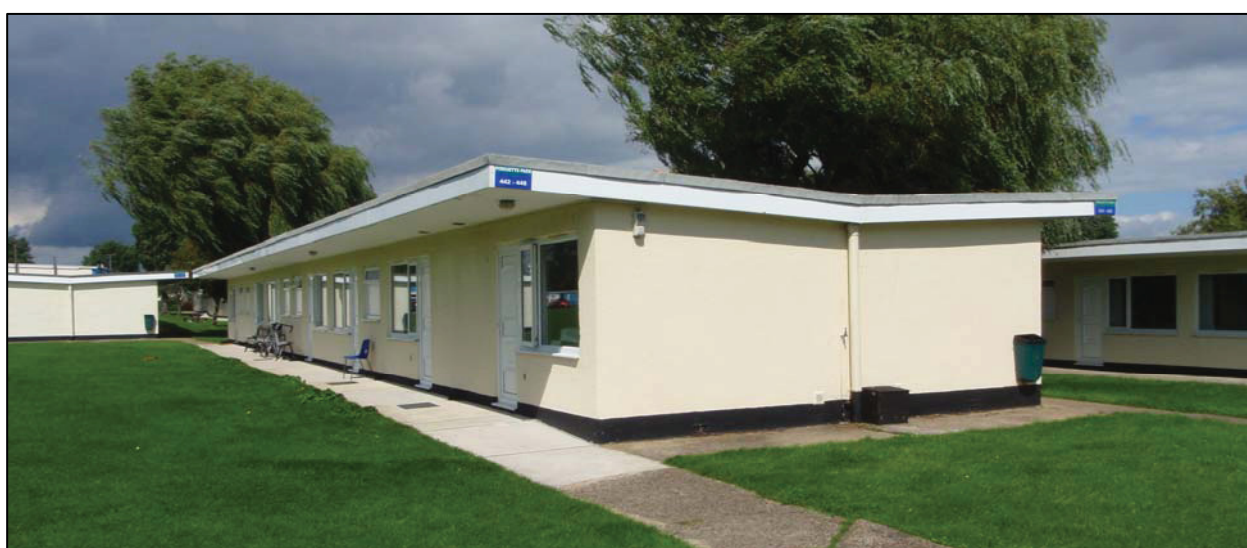
Buildings 46 to 58: These comprise a group of thirteen separate blocks of chalets of varying lengths that make up a group named by Pontins as 'Pirouette Park'. All chalets, except those in Building 54, are arranged back-to-back and are of a very similar design to each other and those elsewhere in the camp. Building 54 is similar to Building 45 and acts as southern extension of that building. Buildings 46 to 53 are built on slightly sloping ground and utilise steps in the structure similar to Building 45. All blocks in 'Pirouette Park' are built of brick and breeze block which has been rendered and painted cream with white detail. All were constructed as part of the major rebuild in the early 1970's.

Building 47 (camera facing north)

Building 48 (camera facing north)

Buildings 48, 49 and 50 (camera facing southeast)

Building 54 (camera facing north)

Building 58 (camera facing north)

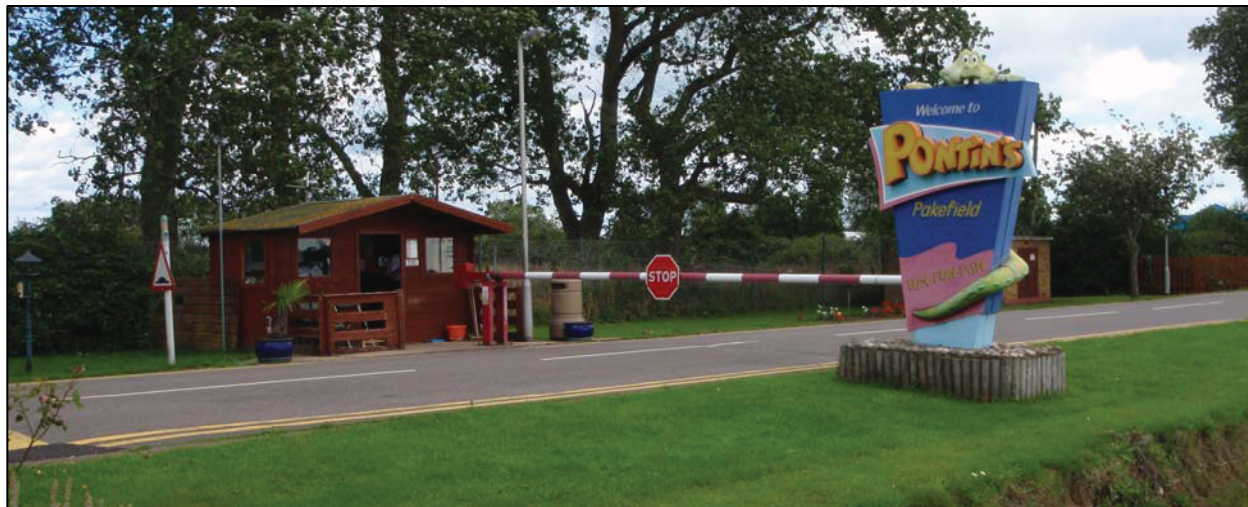
Building 59 (camera facing northeast)

Building 59: A wooden shed at the entrance to the camp to house the camp gatekeeper. Not dissimilar to one of the early chalets but is of modern construction.

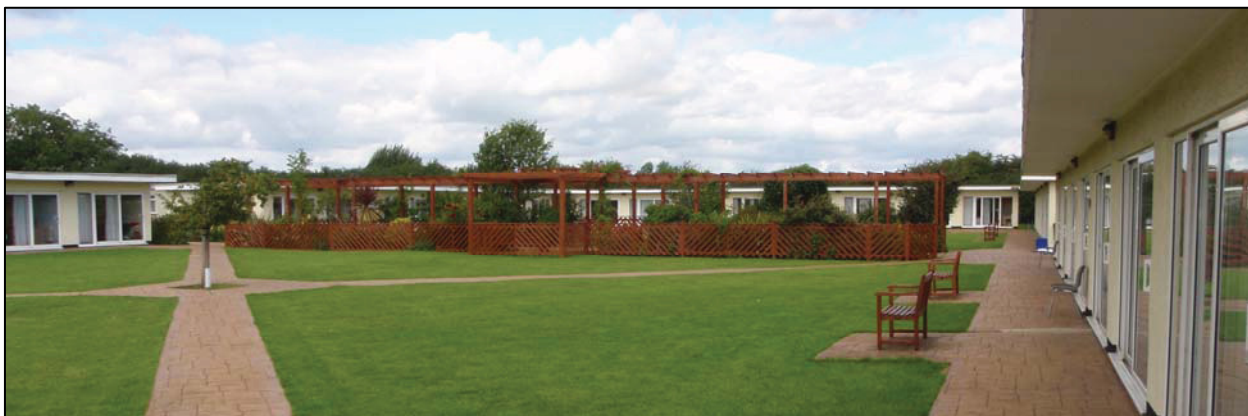
Building 60 (camera facing north)

Building 60: A timber pergola running across the area of 'Club Savannah Land'. Modern construction.

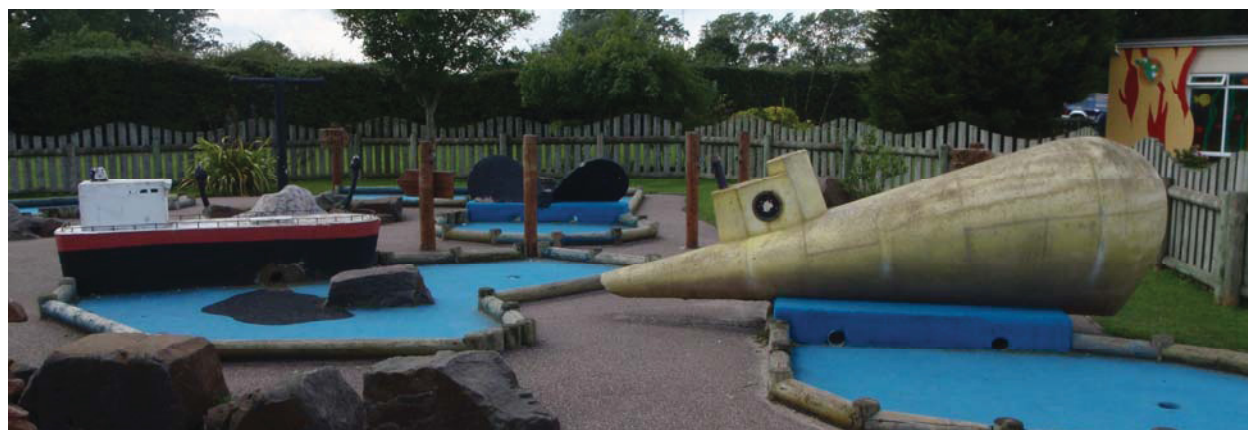
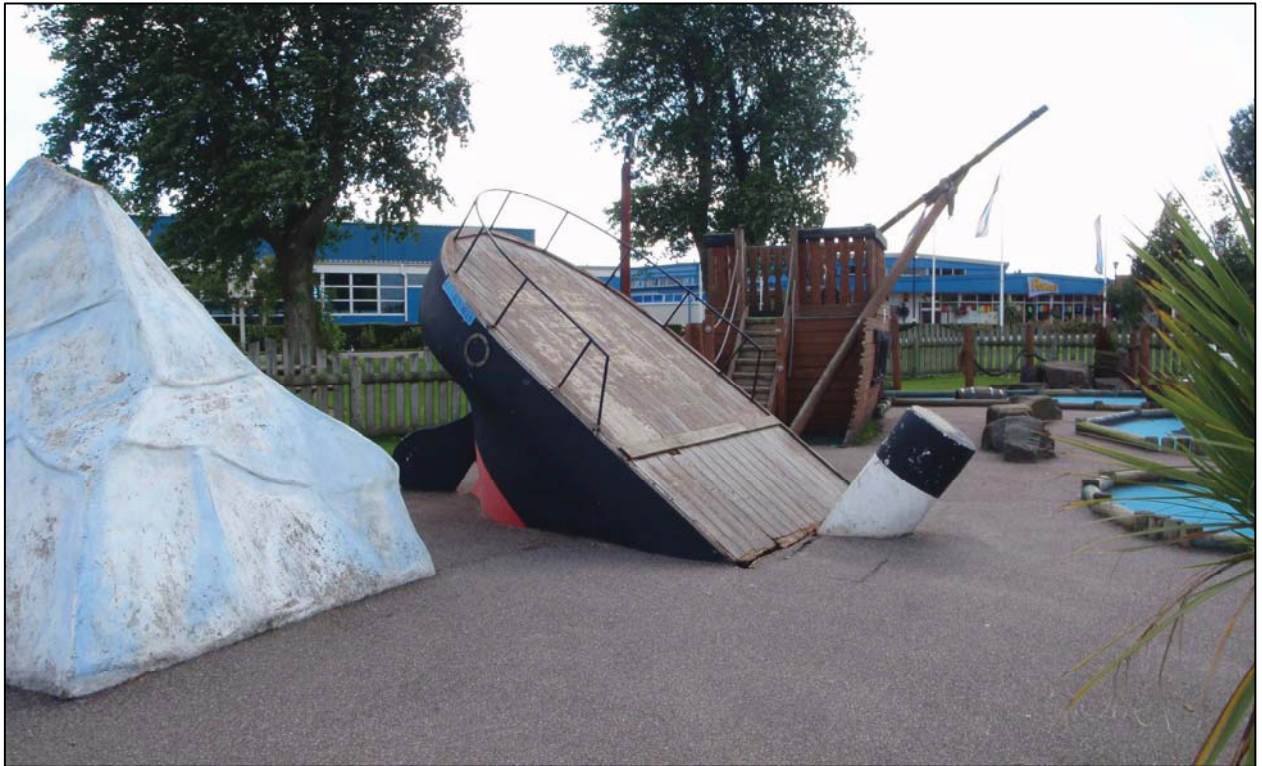
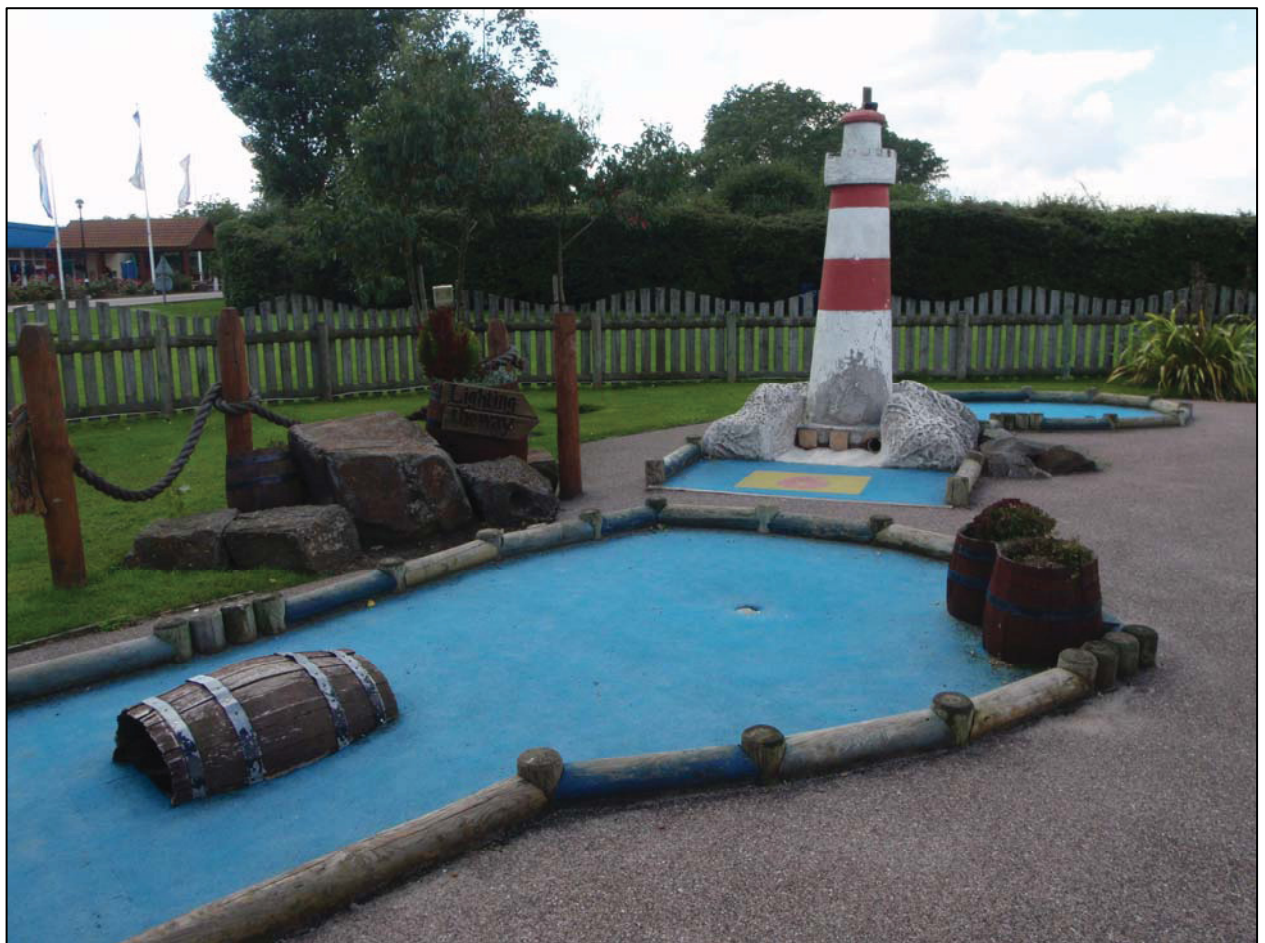
Building 61: The crazy golf course featuring a number of small structures of timber, concrete and brick construction with a nautical theme. Date unknown.

Building 61 (camera facing east)

Building 61 (camera facing southeast)

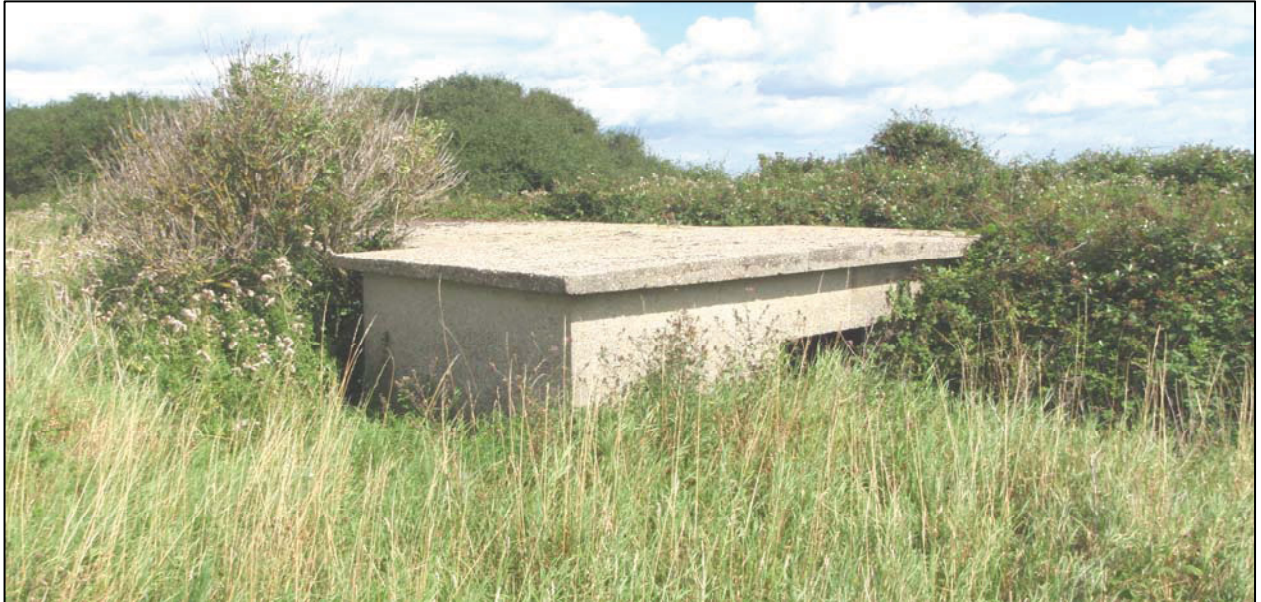
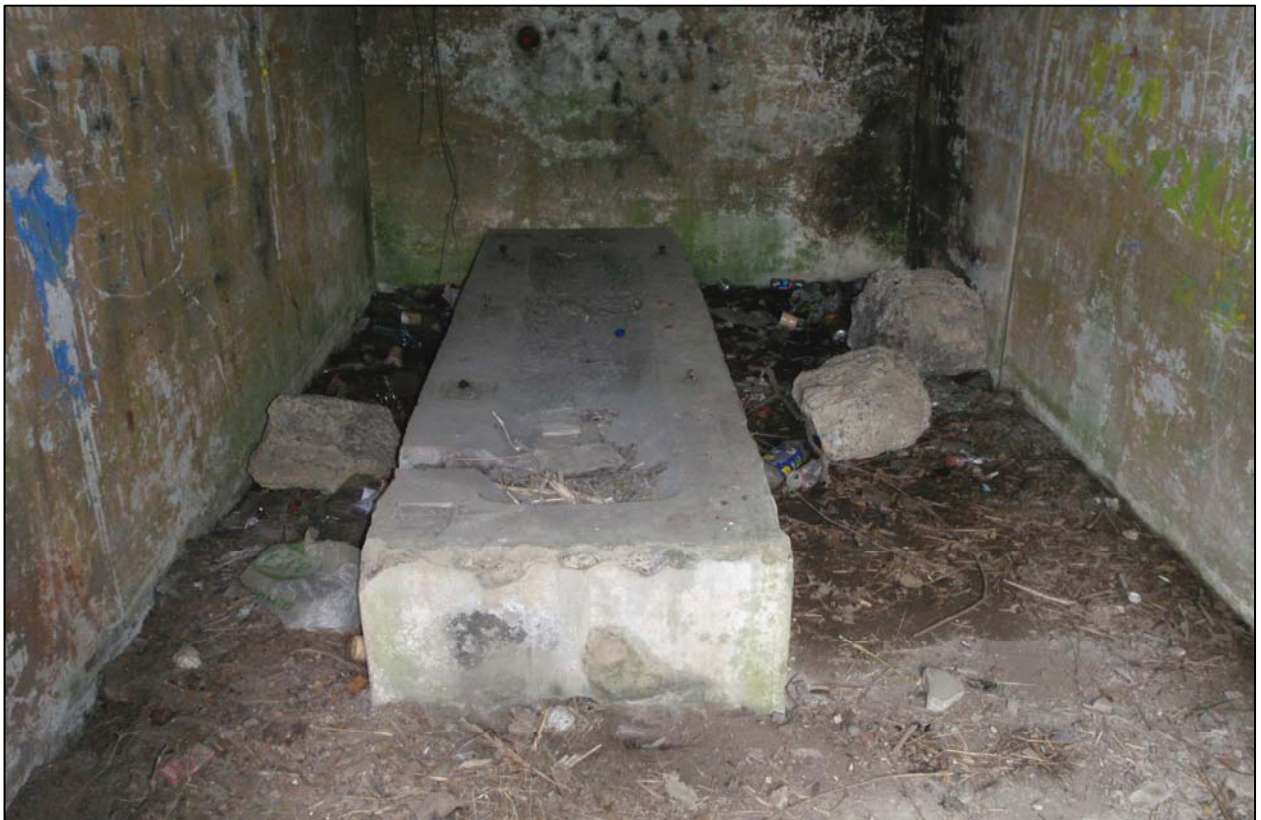
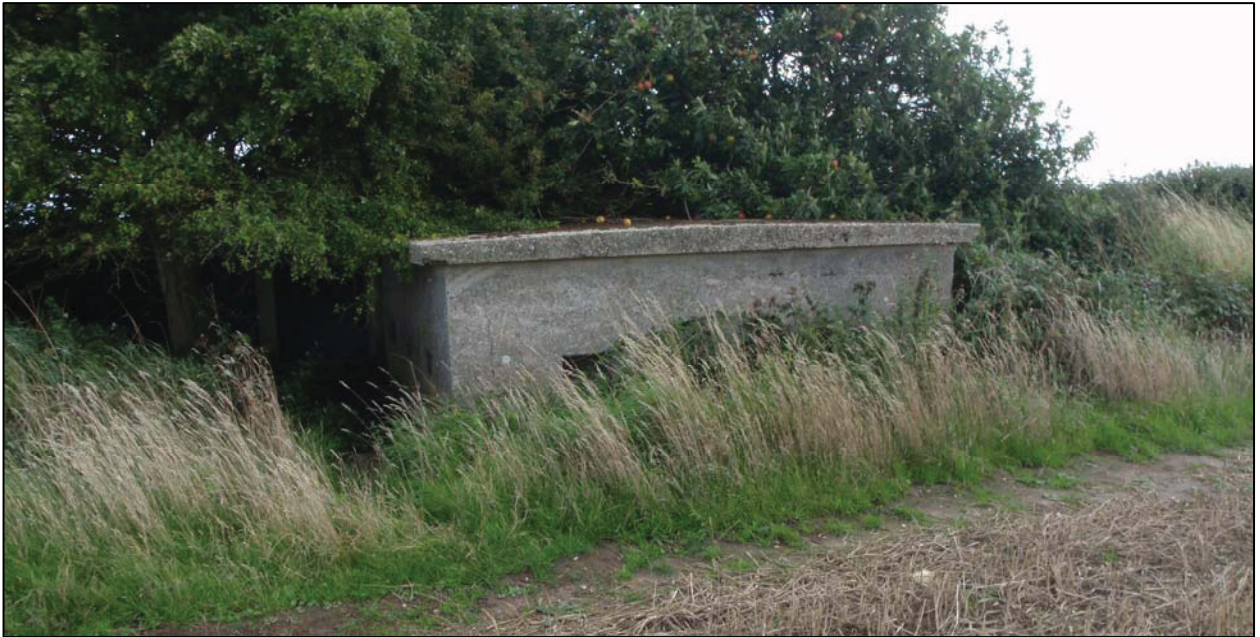
Building 62 (and Building 65): These two buildings are generator houses, both of which are built to an identical design. They comprise a rectangular chamber, in which the generator would have been housed, and an enclosed corridor at one end. The corridor runs across the end of the building and a little way along each side before exiting alongside the structure. There is also an opening across the corridor to allow the generator itself to be installed or removed. Both are partially sunken into the ground so slightly less than half of the structure is visible. A concrete bed on which the generator sat is present within both structures. Both structures date from the Second World War and are associated with Building 64.

Building 62 (camera facing northeast)

Building 62, interior showing machine bed for the generator (camera facing north)

Building 65 (camera facing east)

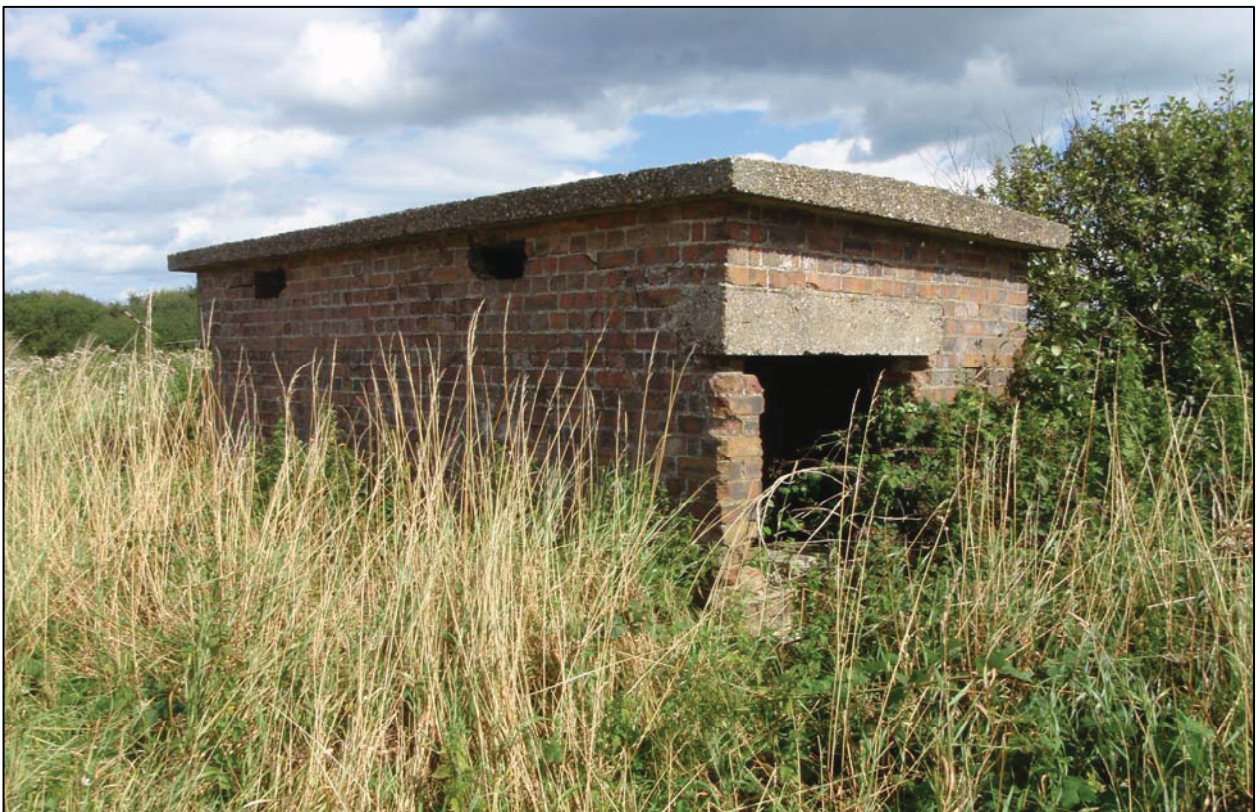
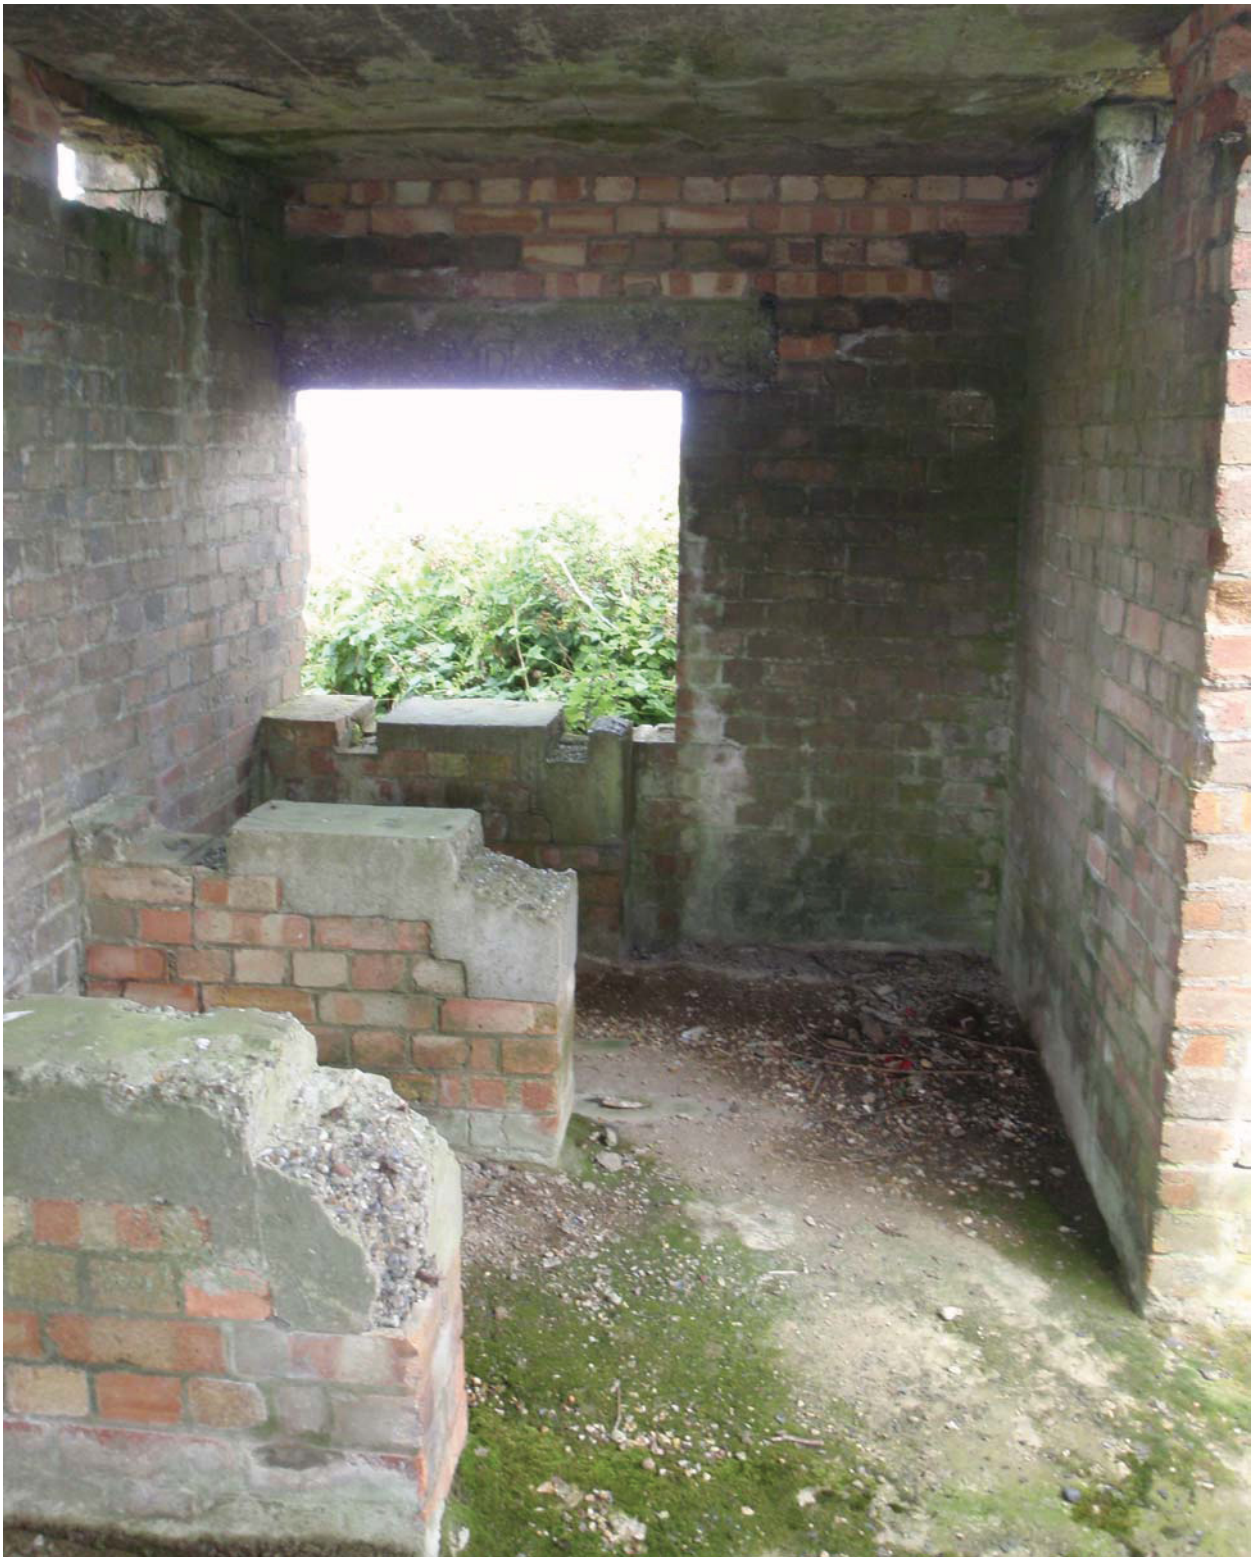
Building 63: A small rectangular, brick built structure with a cast *in situ* concrete slab roof. It is aligned north-south with an entrance on the east side and openings in the northern and southern end walls which are adjacent to the west wall. A series of brick and concrete piers are present inside and outside the structure. These are in line with the end wall openings and slots in the top surfaces suggest they may have supported rails, an arrangement that would allow something (a pair of searchlights?) to be moved in and out of the building.

Building 63 (camera facing northeast)

Building 63, interior (camera facing north)
