HISTORIC BUILDING ASSESSMENT

SCCAS REPORT No. 2010/165

Pontin's Holiday Centre, Pakefield Gisleham GSE 067

M. Sommers
© September 2010
www.suffolkcc.gov.uk/e-and-t/archaeology

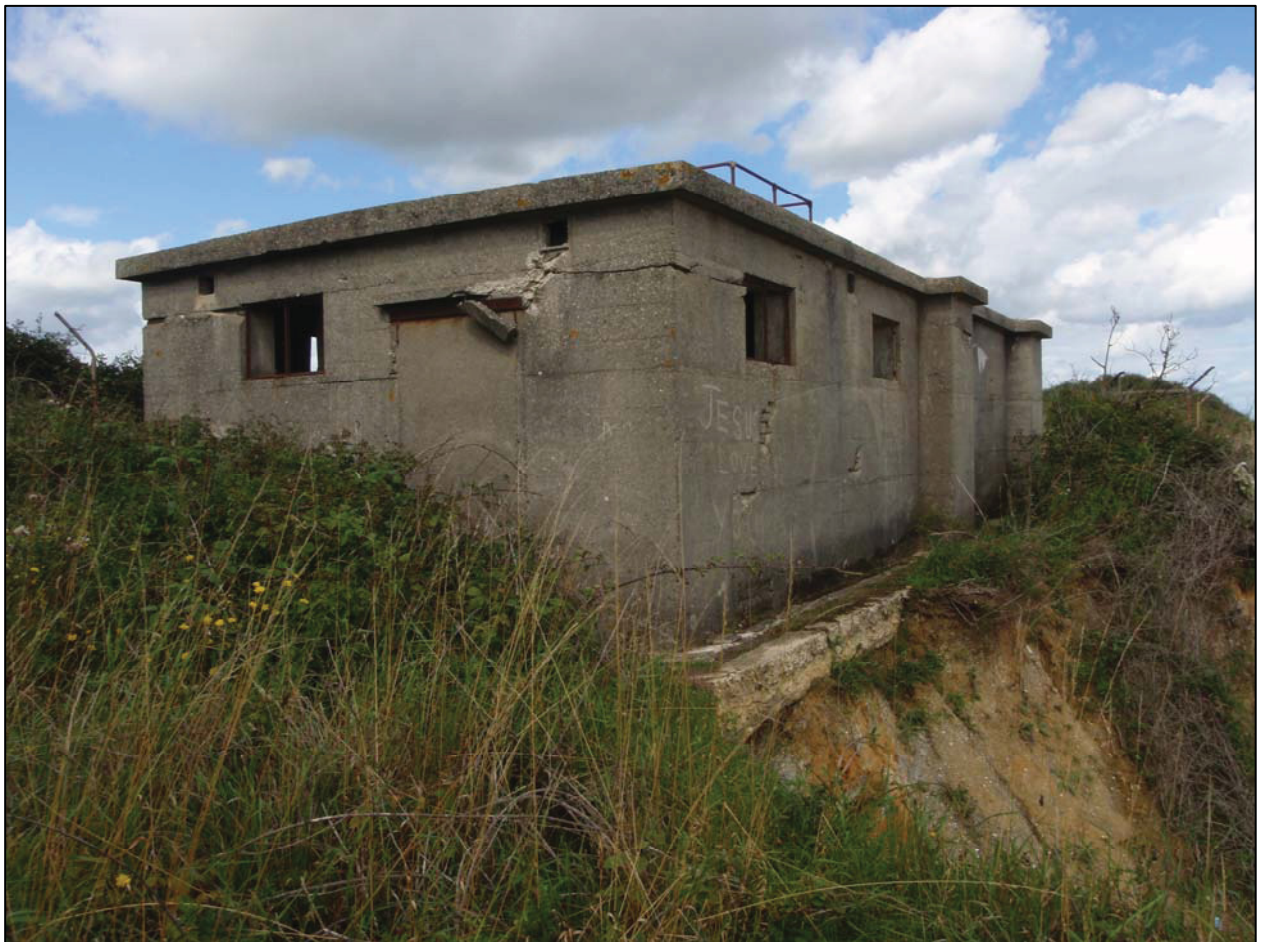
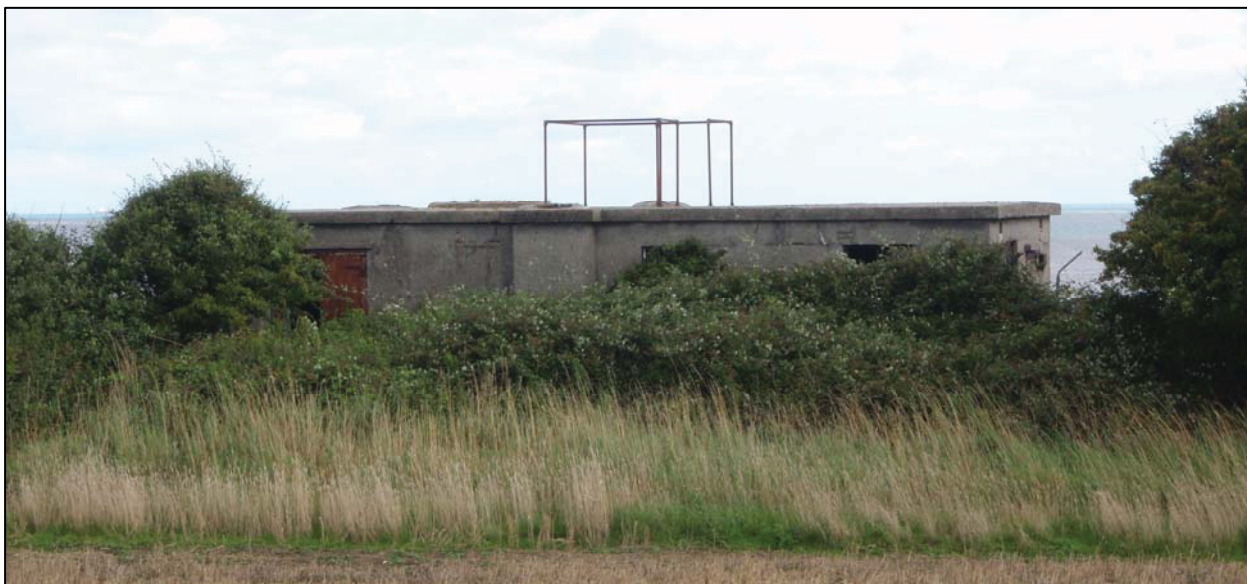
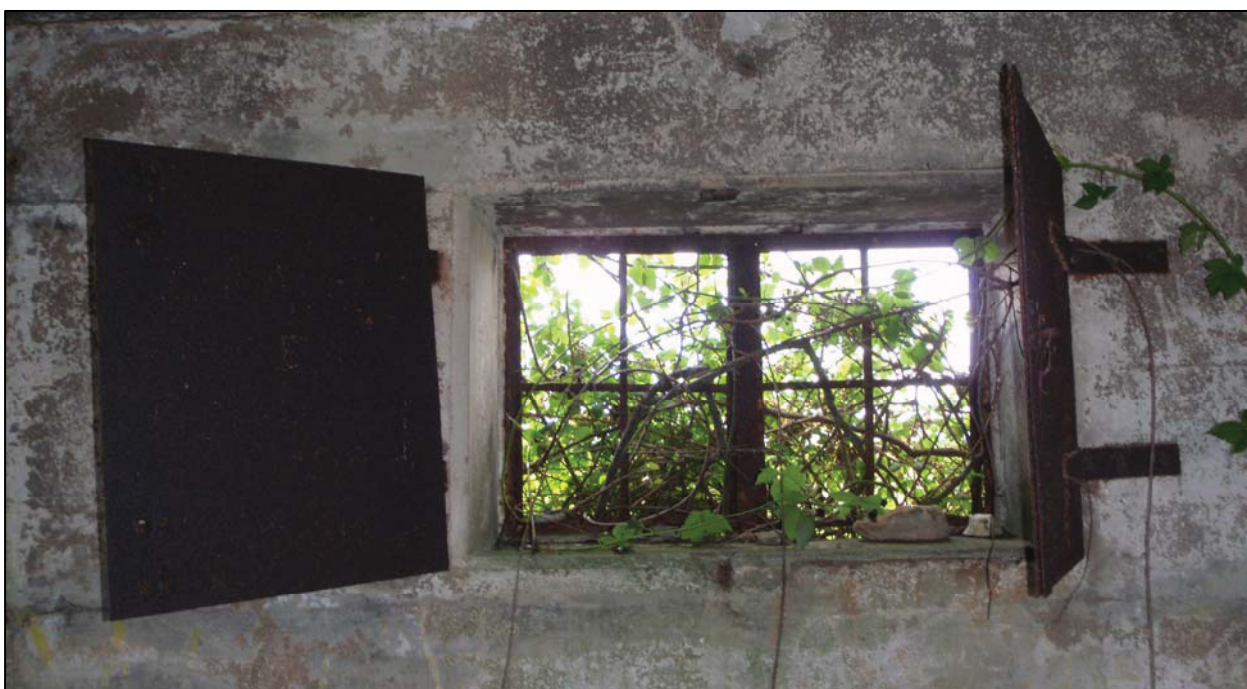
Building 64: This comprises a rectangular concrete structure, single storey, with three chambers. There are windows on all four walls (although some now blocked) with steel shutters mounted on the inside of the building. One entrance with steel doors (one *in-situ*) is located in the western wall and opens into the northern chamber. A further entrance was situated on the southern wall but this is now blocked. The interior is bare but there are marks on the walls where electrical cables once ran and slots in the floor for further cabling. The floor is concrete with evidence for wooden battens which presumably supported

Building 64 showing the blocked southern door and the erosion undermining the southeast corner (camera facing northwest)

Building 64 (camera facing east)

Building 64, window with steel shutters and metal frame (camera facing west)

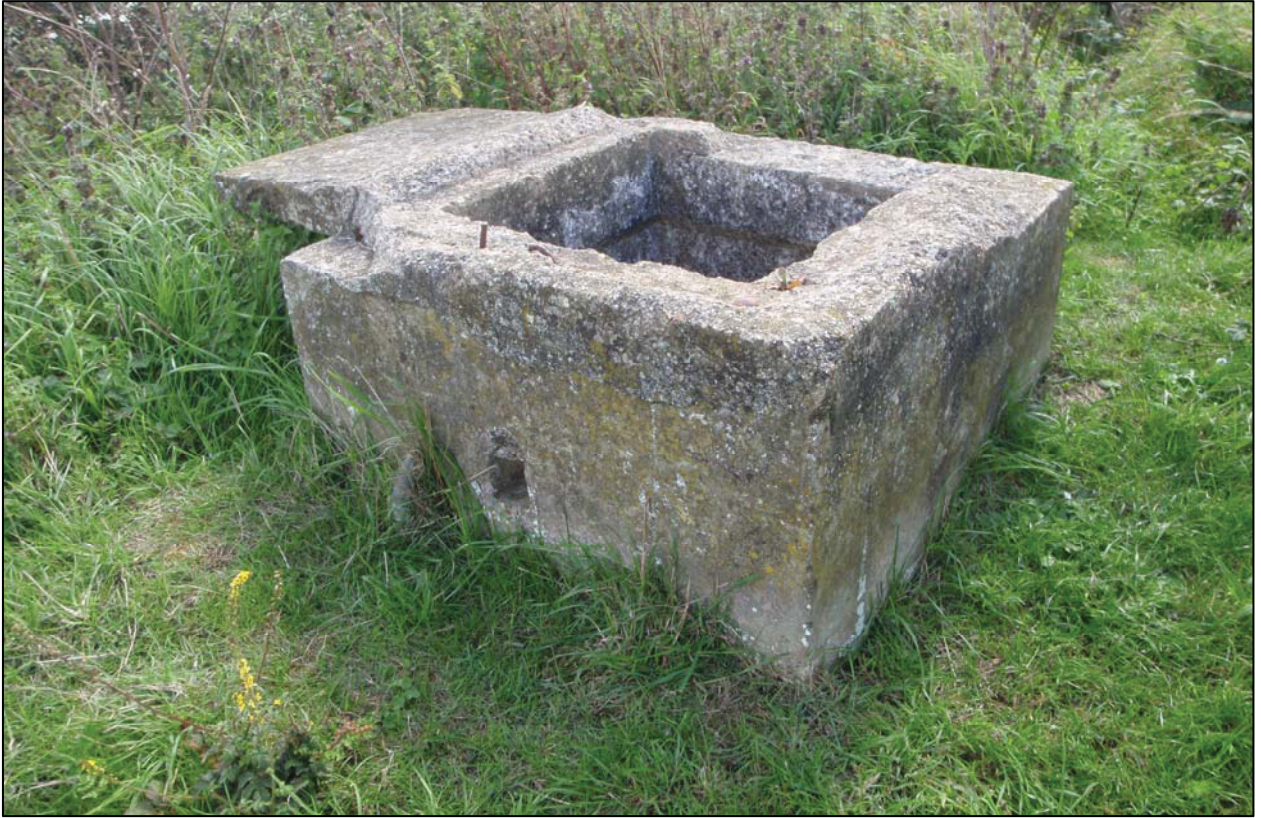
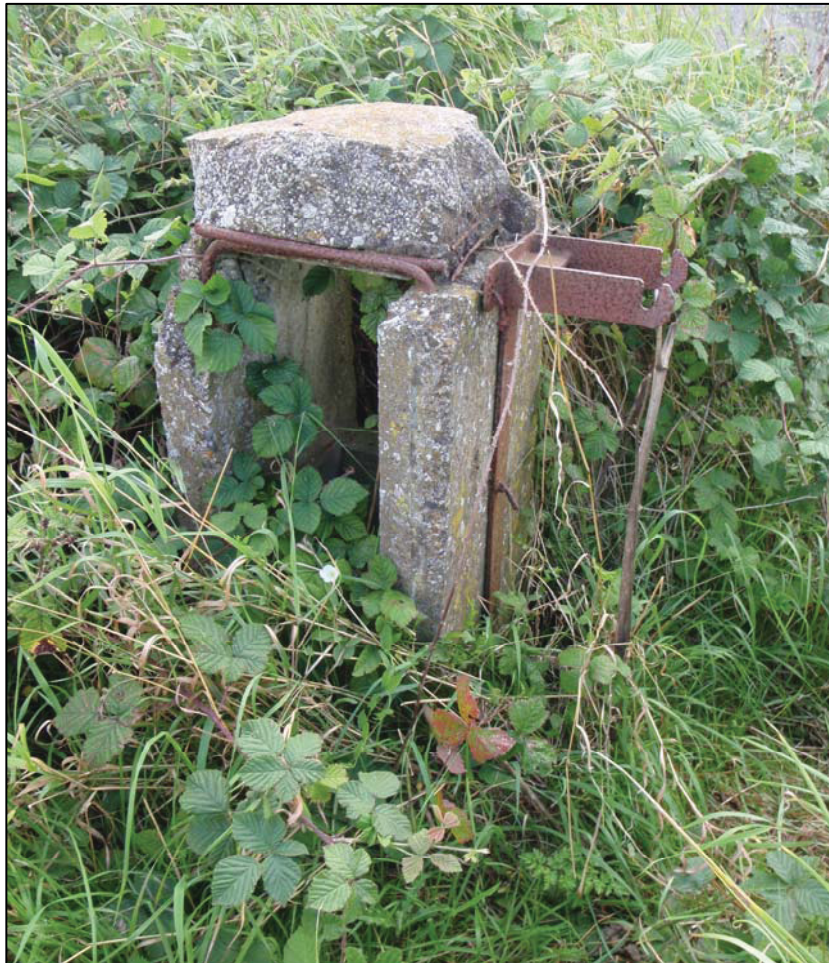
Within the complex a subterranean Royal Observer Corps (ROC) station has been constructed (Building 66). ROC stations were built countrywide during the late 1950s and early 1960s to provide shelter for monitoring the fallout after a nuclear attack.

At this site it would appear that the main block of the radar station was initially used by the ROC prior to the construction of the underground shelter. The floor has received a screed of concrete and in the surface of this 'ROC 1952' has been crudely marked.

Building 66, the entrance (camera looking southeast)

Building 66, the air vent (camera facing southeast)

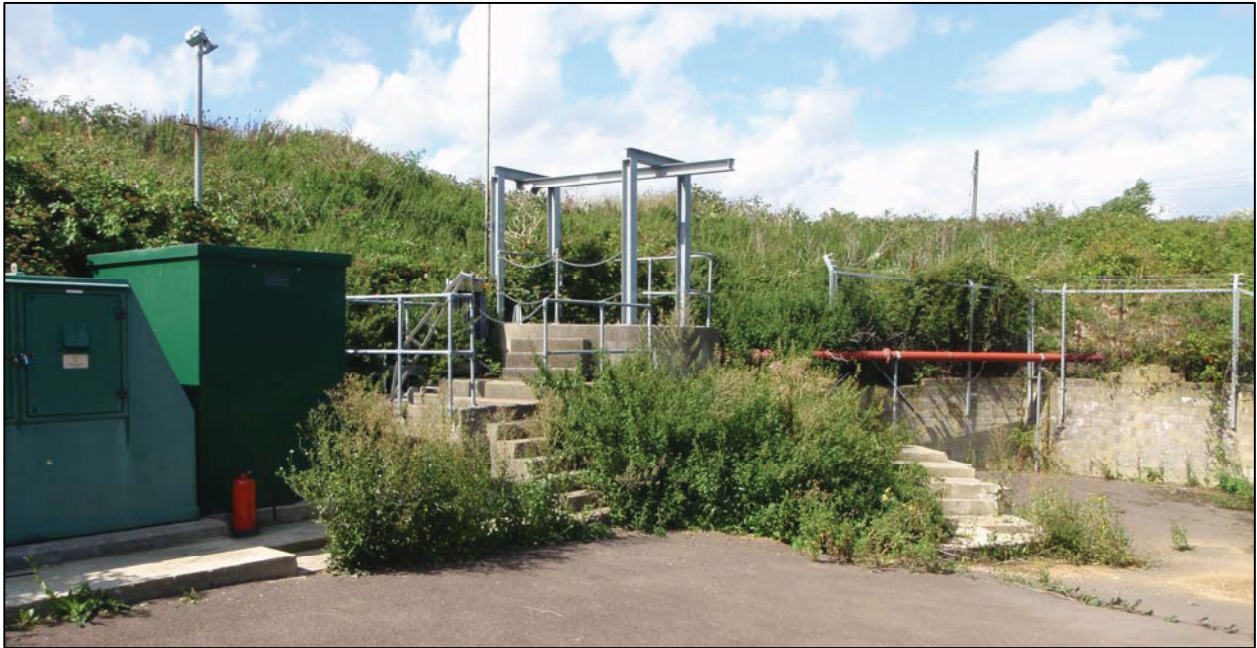
Building 67 (camera facing northwest)

Building 67: An Anglia Water fenced compound with concrete structure.
