**Fox & Goose Cottages,
Tostock (Elmswell Parish),
Suffolk
EWL 027**

Historic Building Record

1 & 2 Fox & Goose Cottages, Tostock (Elmswell Parish), Suffolk

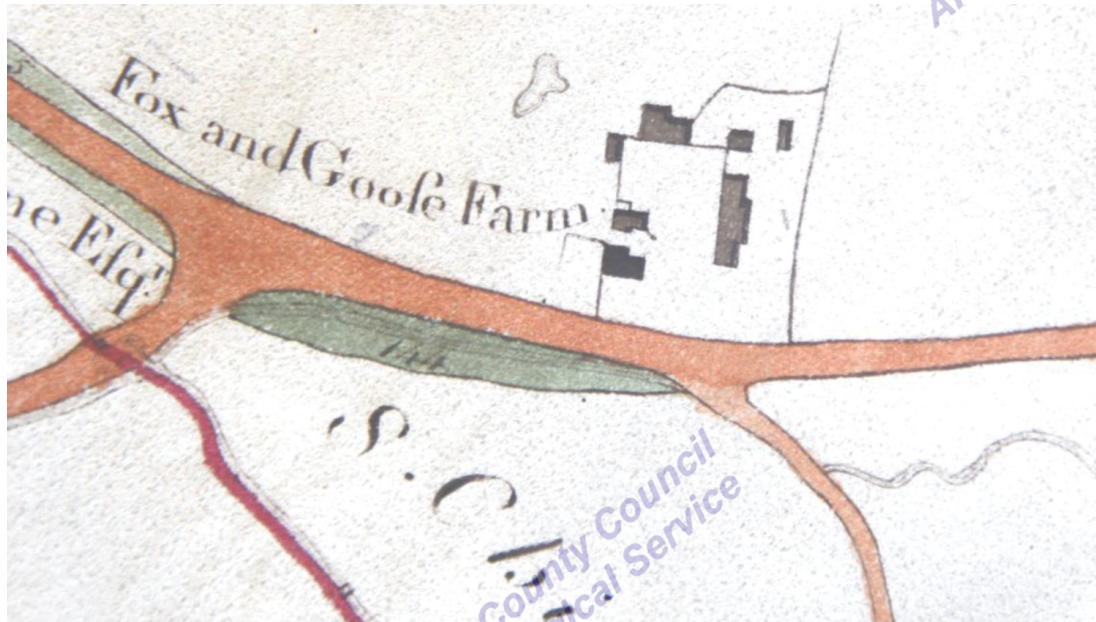
Figure 2

The Cottages as depicted on the 1814 Elmswell enclosure map when they formed a farmhouse in the south-western corner of a large farm yard known as Fox and Goose Farm. The L-shaped profile of the building is largely unchanged, with a narrow shed projecting from the western end of its northern elevation.

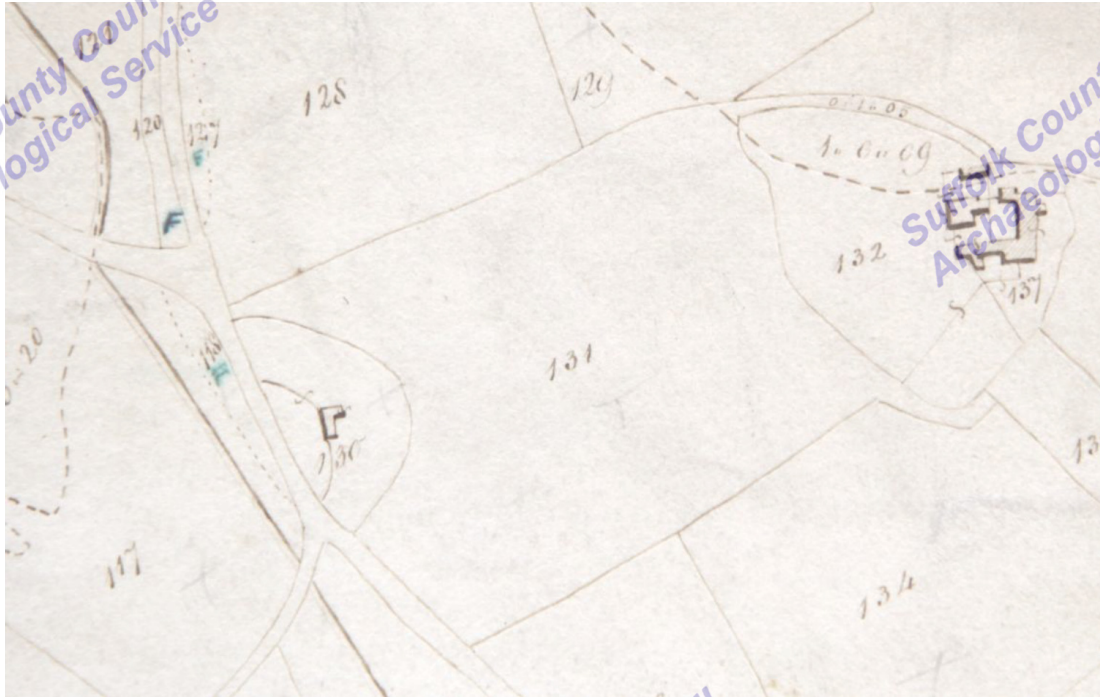
Figure 3

The Elmswell tithe map of 1843, showing the new farmhouse to the right (i.e. Elmswell New Hall) and the old house (Fox & Goose Cottages) now devoid of its farm buildings to the left. The direction of north lies towards the top right-hand corner. The curved feature to the rear of the house was a new plantation designed (presumably) to screen the old house from the new.

The situation had changed dramatically by the time of the Elmswell tithe survey in 1843 (figure 2). The farm was owned by Sarah Spark and extended to 112 acres in the parish with (probably) more extending into Tostock and Norton – a substantial holding for the period. The old farmhouse (i.e. Fox & Goose Cottage) had been stripped of its farm buildings and replaced by a new house and yard at Elmswell New Hall. Sarah Spark was not in residence, and the land was leased to John Howlett while the 'mansion and pleasure grounds' were occupied separately by Mary Browne (whose address was given as 'New Building' in White's Suffolk Directory of 1844). The new farm buildings behind the mansion formed part of Howlett's farm, as did the old farmhouse which was described as a 'house, garden and plantation'. There is no indication that it was either sub-divided or used as an alehouse, but these changes had occurred by 1884 when the western half of the building (ostensibly) was labelled 'Fox and Goose' on the first edition Ordnance Survey and the internal partition was clearly shown (figure 4). A similar situation existed in 1904 (figure 3). Many new public houses were established during the mid-19th century and often consisted of no more than small cottages in this manner. The original building, however, is a typical farmhouse of the early-17th century that would have been entirely appropriate to a holding of 112 acres or more: it was converted into cottages only after its replacement with a new farmhouse in *circa* 1820. Many similar new farmhouses were erected in Suffolk at the same period as local farmers benefitted from the high cereal prices during and immediately after the Napoleonic wars (which restricted grain imports from the continent). Few farms were established on entirely new sites during the 17th century, however, and it is likely that the site occupies that of a medieval predecessor.

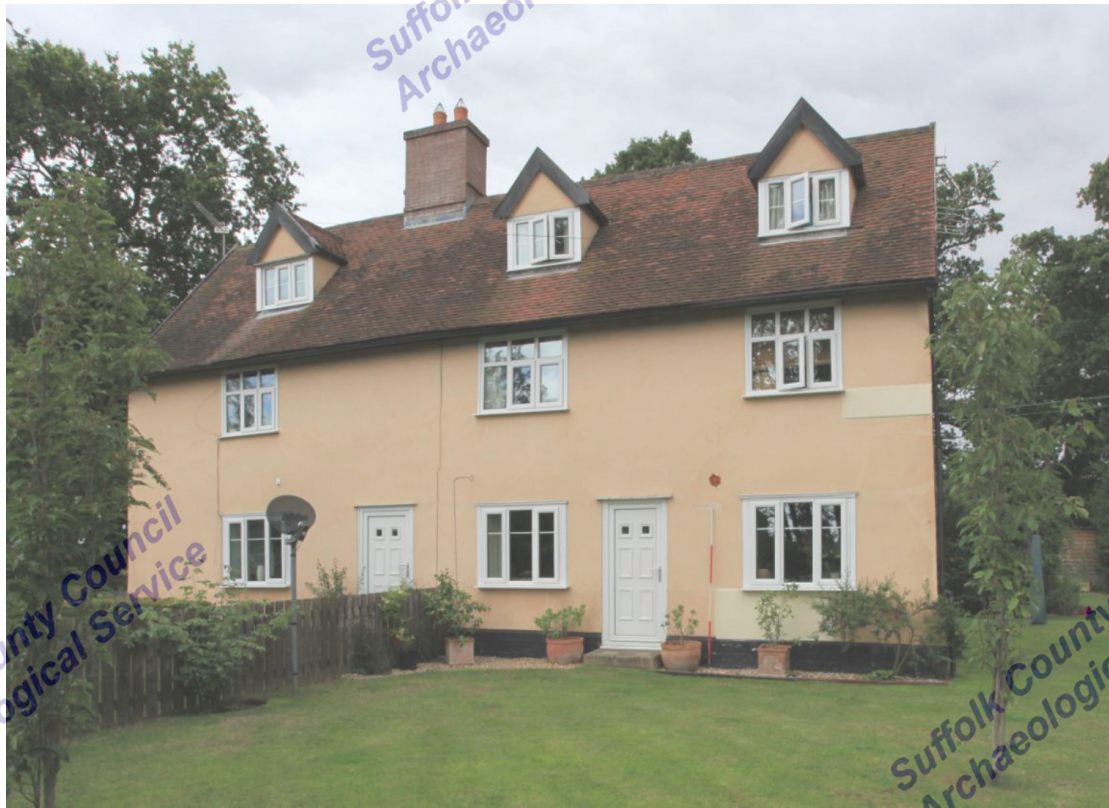
Illus. 2. Southern exterior showing no. 1 to left and no. 2 to right (the 17th century parlour and hall bays respectively).

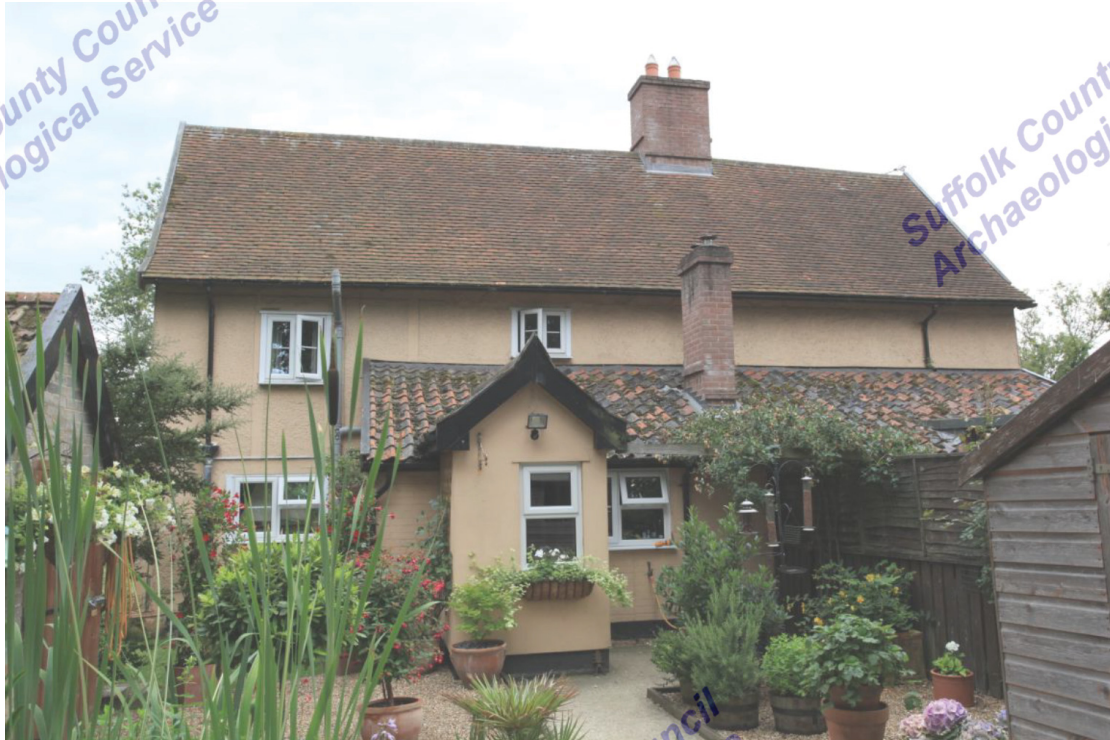
Illus. 3. Northern external rear elevation from garden of no. 2 showing panelled roughcast pargeting with 20th century lean-to kitchen extensions and detached brick shed dated 1875 to left.

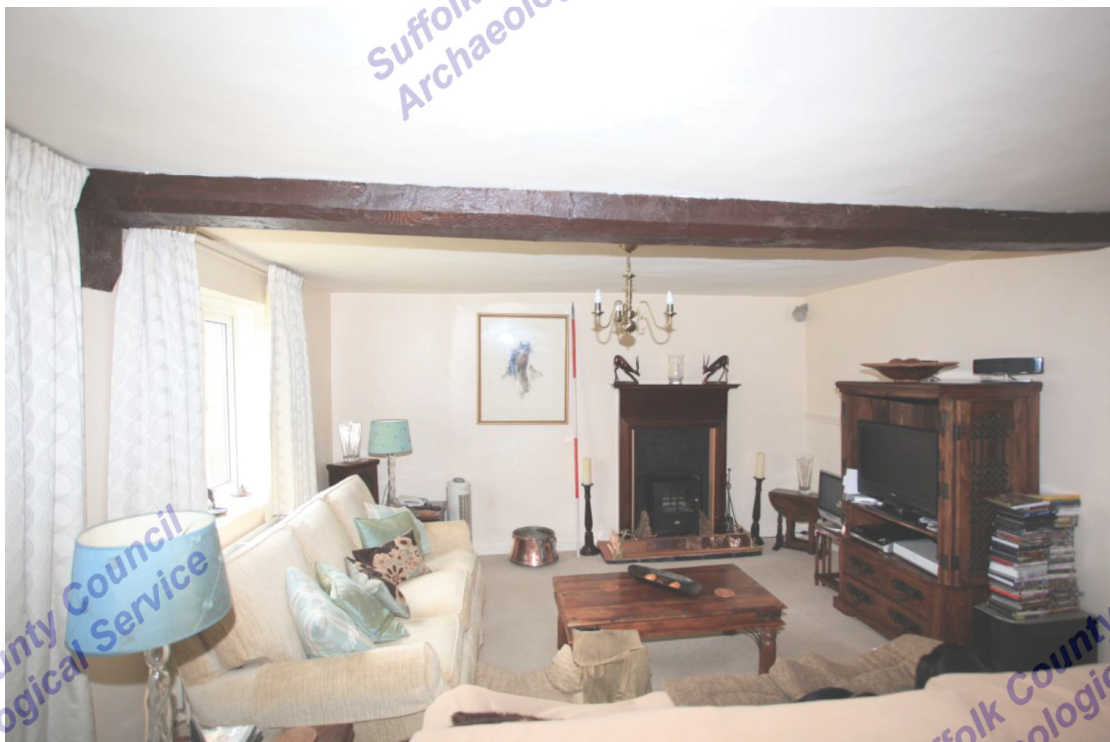
Illus. 4. Living room of no 2 from east showing 20th century fireplace and chamfered binding joist (2) spanning width of 17th century hall. Much of the 17th century fabric, including an 'inglenook' fireplace, is hidden behind modern render.

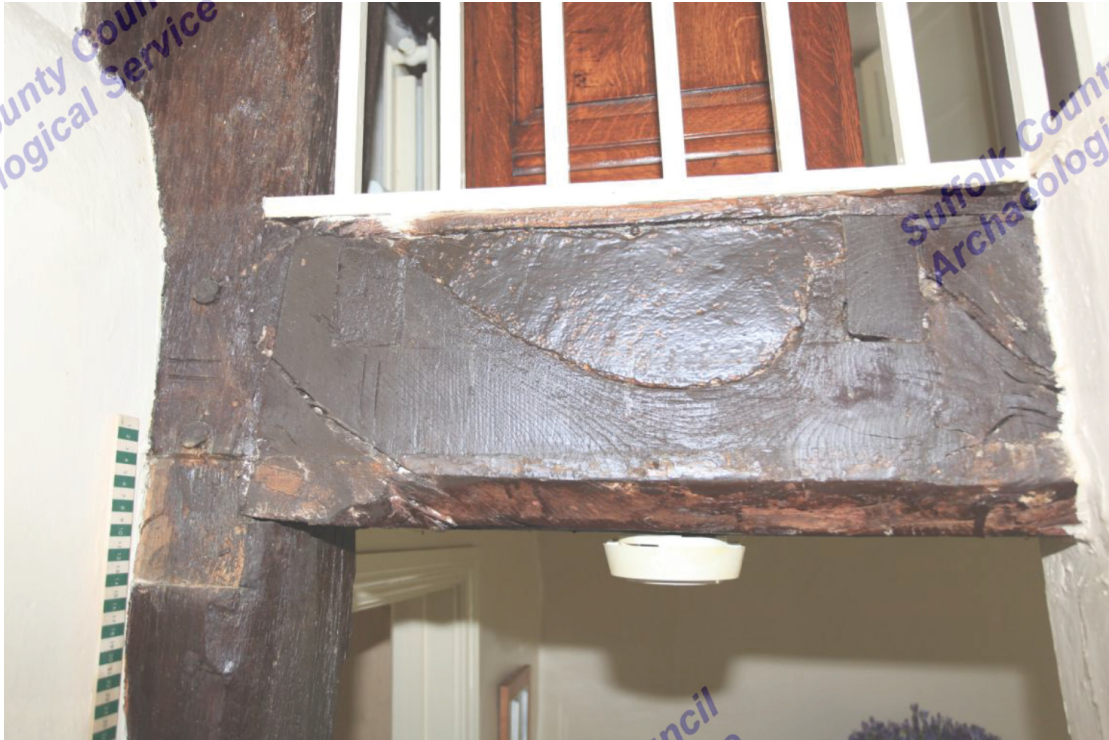
Illus. 5. Detail from west of chamfered binding joist above stair in living room of no. 2 showing carpenters' numerals and the mortises of the tall-sectioned common joists that were removed to accommodate the stair. The original joists probably survive elsewhere but are hidden by render.

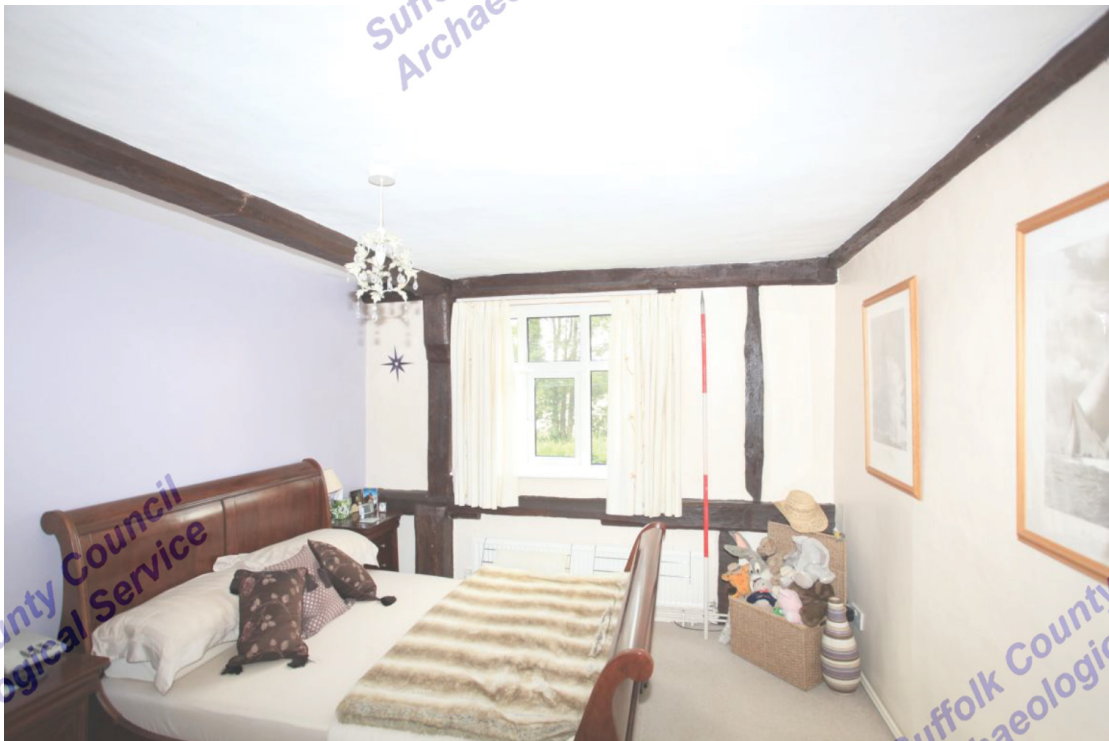
Illus. 6. Southern interior of western bedroom (9) in no. 2 showing the original roof-plate below the window with the mid-17th century heightening of the wall above.

The internal framing of the upper storey is largely exposed, particularly in the hall chamber (no. 2) and reveals evidence of a significant heightening of the walls in the mid-17th century. The original roof-plate (which supported the rafters) lies 3 m (10 ft) above the present internal floor (and 66 cms or 26 ins above the ceiling) and belonged to a 1½ storey building with its first floor contained partly within the slope of its roof. The current roof-plate lies 1.3 m (4.5 ft) above its predecessor and the walls were raised to increase headroom by the simple expedient of adding short additional posts and studs above the original plate. The high quality of the secondary carpentry, with shaped jowls to the posts and lamb's tongue stops throughout, suggests this occurred within a relatively short period: given the presence of face-halved scarf joints (rarely used before 1600) and tall-sectioned joists the original house can be dated to *circa* 1620 while the 'lift' is unlikely to have occurred later than 1650. Both plates incorporate well-made face-halved scarfs and several internally trenched braces are visible in the upper walls. It became increasingly fashionable to sleep upstairs as the 17th century progressed and many local houses were raised in much the same way. The chimney was probably rebuilt at the same time.

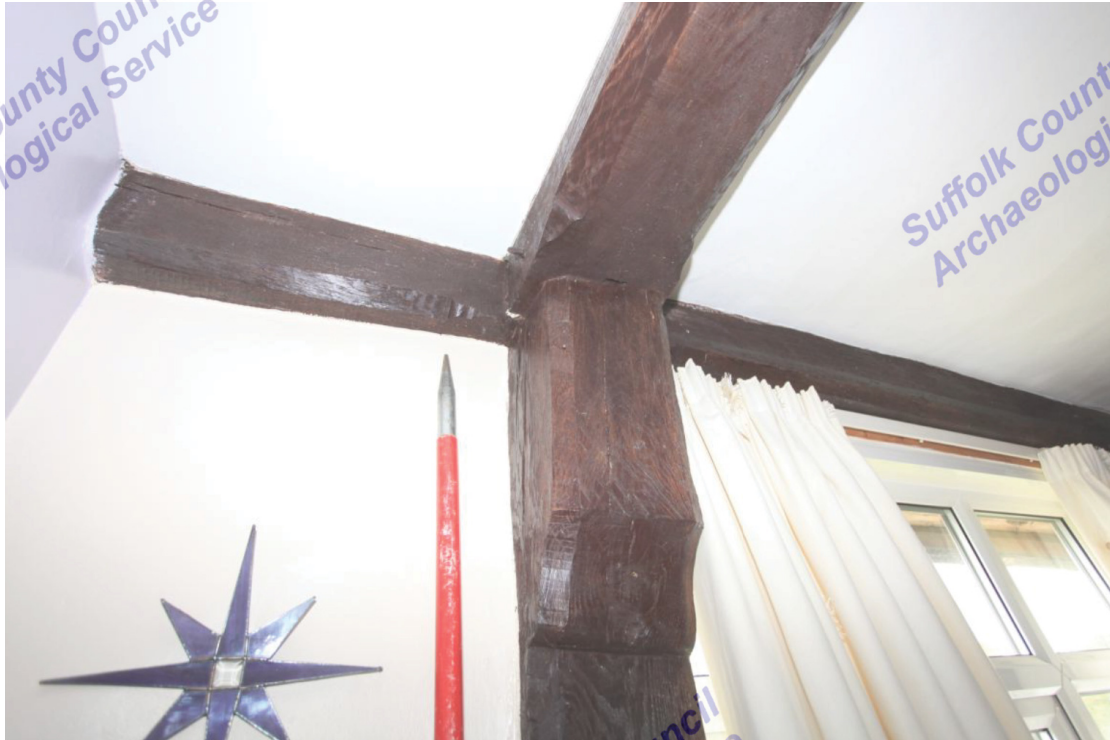
Illus. 7. Detail of finely shaped and chamfered jowl of upper storey post in southern elevation of no. 2 (9). This structure was added to the original house in the mid-17th century to increase its height.

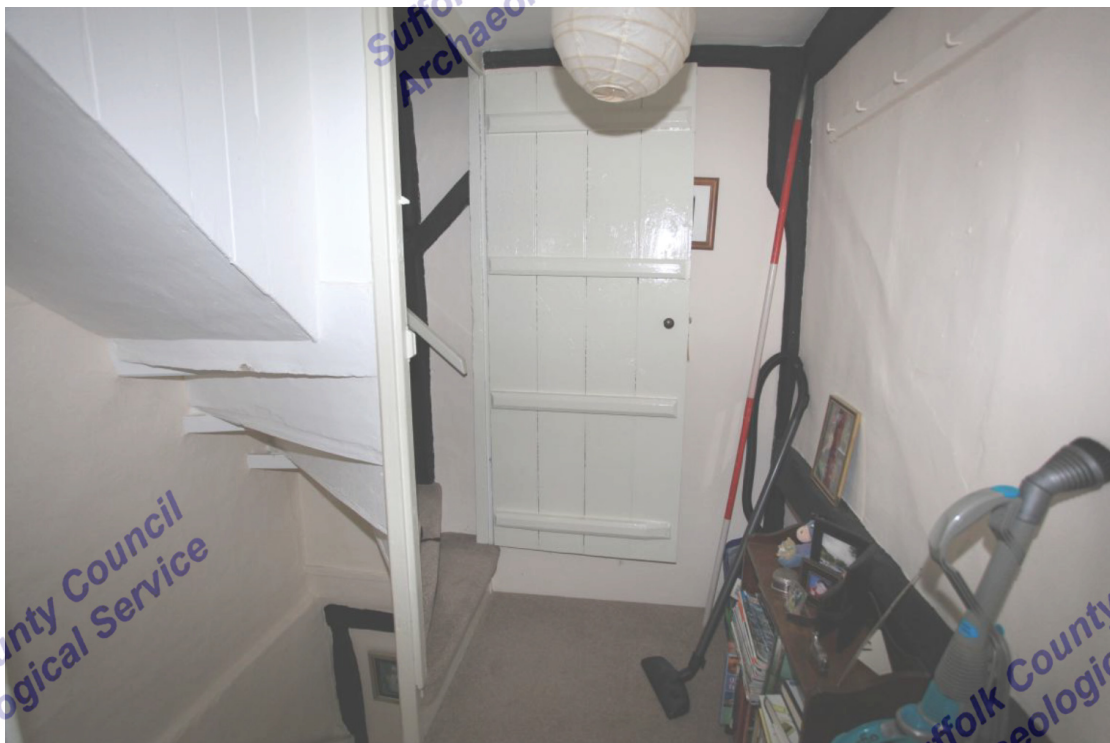
Illus. 8. Stair landing of no. 1 (5) from west showing door to attic stair with blocked access door to no. 2 in centre. The original roof-plate is visible to the right with the contours of the studs and brace of the second-phase wall visible in the render above.

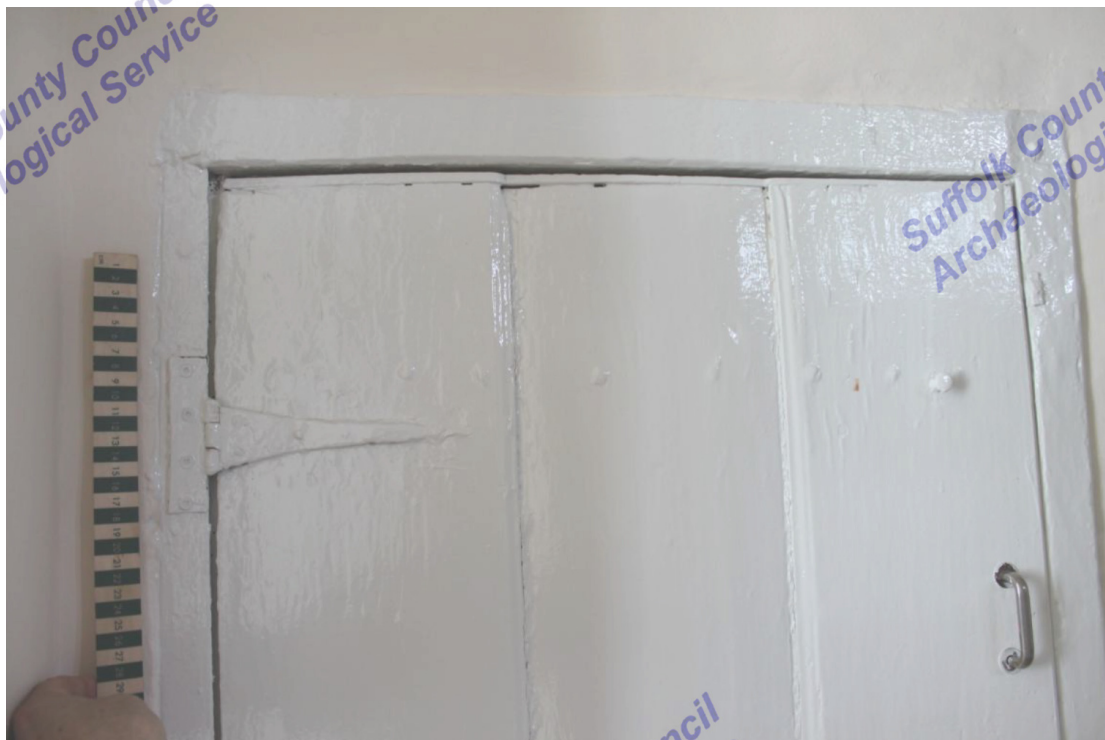
Illus. 9. Detail of 17th century moulded plank door and hinge to under-stair cupboard in lobby entrance of no. 1 (4).

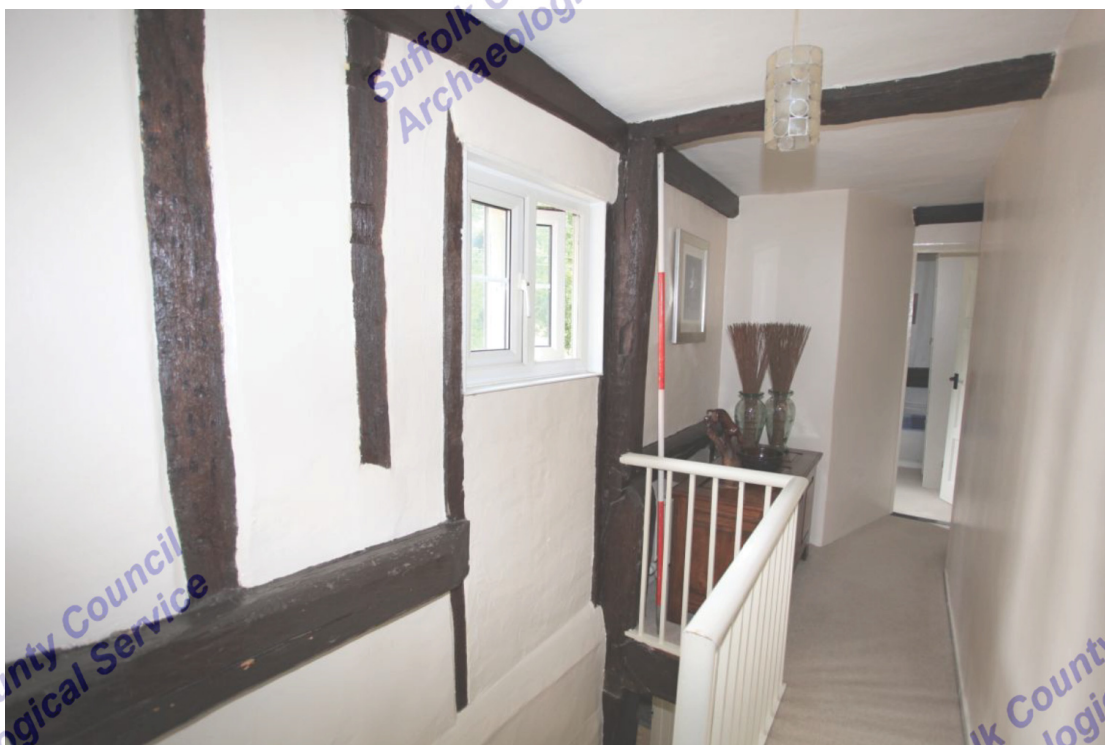
Illus. 10. Stair landing (8) of no. 2 from west showing original rear (northern) roof-plate below with raised wall above. The former has been cut to insert an external loading door of a kind often found in 18th and 19th century farmhouses.
