**Agricultural Buildings,
White Hall Farm,
Great Waldingfield, Suffolk
WGF 042**

Historic Building Record

September 2010

Agricultural Buildings, White Hall Farm, Valley Road, Great Waldingfield, Suffolk

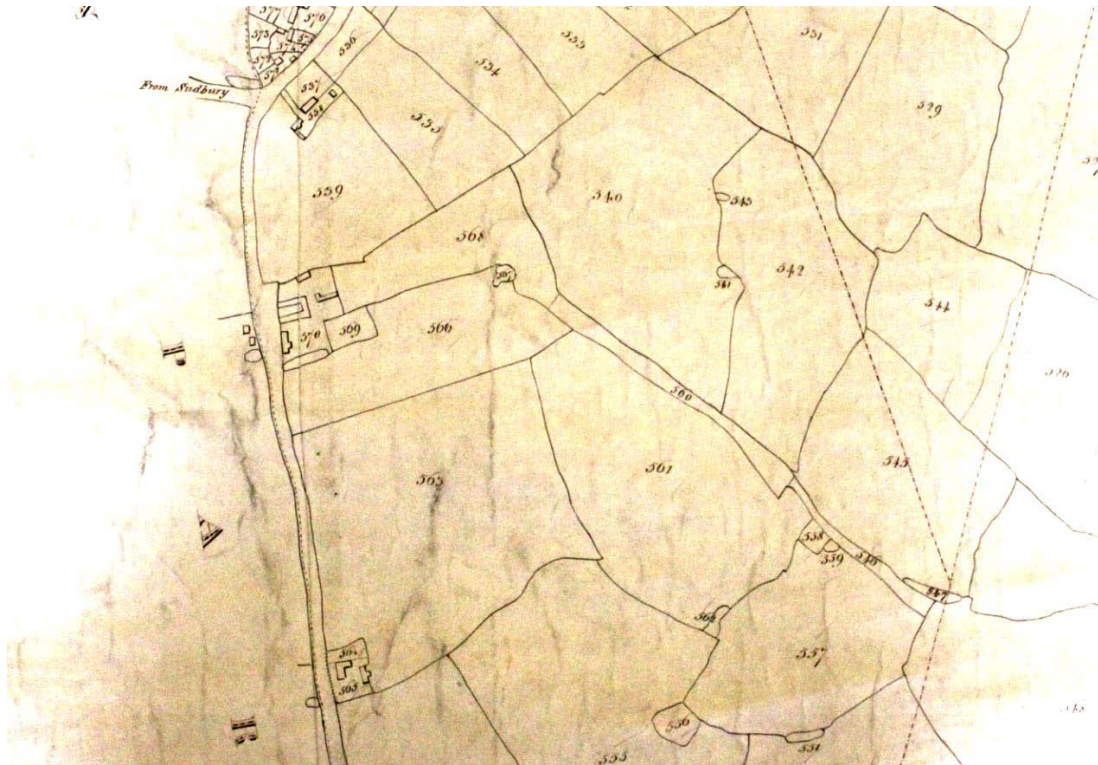
Figure 2
The Great Waldingfield tithe map of 1838 showing the southern edge of the village in the top left-hand corner and White Hall Farm (then known as Chilton End Farm) on the right-hand edge of Valley Road to the south. Copt Hall Farm is shown further south on the same side of the road. The area to the left of the road is blank as it lay in Chilton parish. Original in Suffolk Record Office.

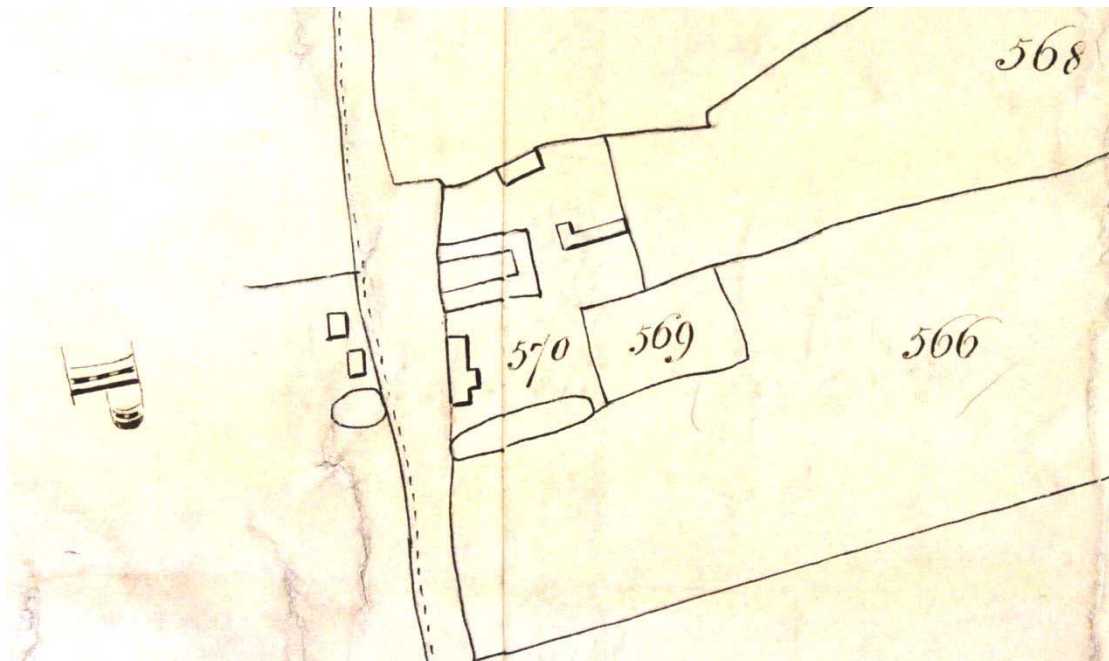
Figure 2a
Detail of the 1838 tithe map showing what appears to be a U-shaped farmhouse adjoining the road with a barn to the south (the latter with an eastern porch). The existing farm complex is conspicuous by its absence.

The title map shows what appears to be a U-shaped farmhouse forming a courtyard facing the road, with a roadside barn to the south and two smaller buildings to the rear. A pond and additional structures are indicated on the opposite side of the road. A long, narrow field to the east named as ‘Old Pasture’ (no. 568) opened onto a ‘drift’ or track leading in the direction of Newton Hall to the south-east, with a garden (569) and ‘Lawn Pasture’ (566) to the south.

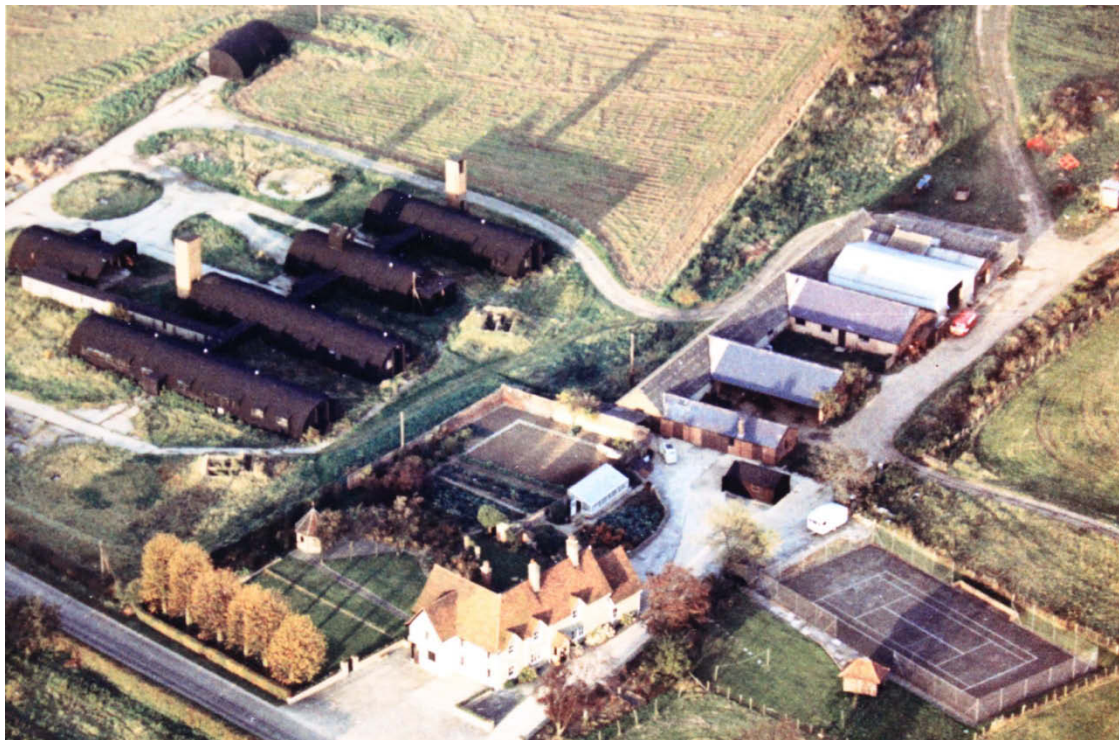
Illus. 1. Aerial photograph of 1960s taken from south-west showing WWII USAF airfield hospital complex to left, farmhouse bottom centre and farm buildings in rear to right.

The American heavy bomber base known alternatively as RAF Sudbury or Acton was built on the level land to the north-west early in 1944 and was the home of the 486th Bomb Group until the end of the war. A plan of the airfield in its published history labels the area immediately north of White Hall Farm as the 'sick quarters' and refers to it elsewhere as the 'sick bay' 'War Stories of the O.W. A History of the 486th Bomb Group', Wood & Bee, 1986, p.52). This complex of Nissen huts survived until 1971 when the present owner replaced them with a large grain store and the site was further altered when a housing estate was constructed to the north and north-east in the 1980s. Of the huts shown in aerial photographs of the 1960s in the possession of the owner only rectangular concrete floors now survive to the east and west of the grain store (illustrations 1 & 2 of Appendix 2 below).

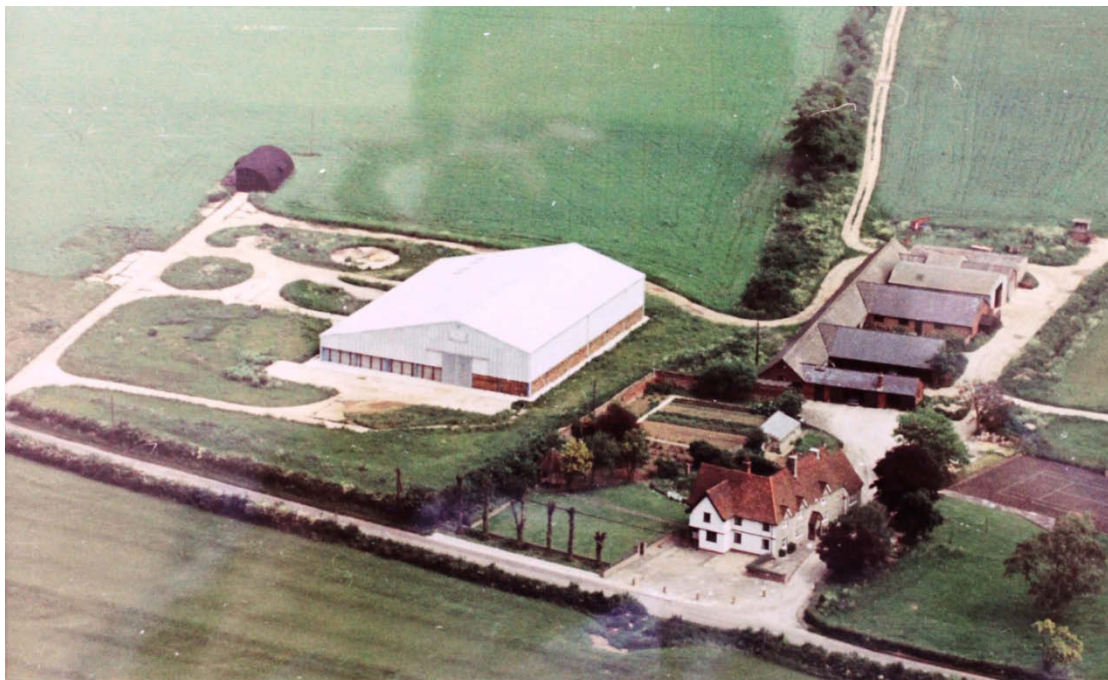
Illus. 2. Aerial photograph of early 1970s from south-west showing new grain store of 1971 on site of hospital complex to left and farm buildings in rear to right.

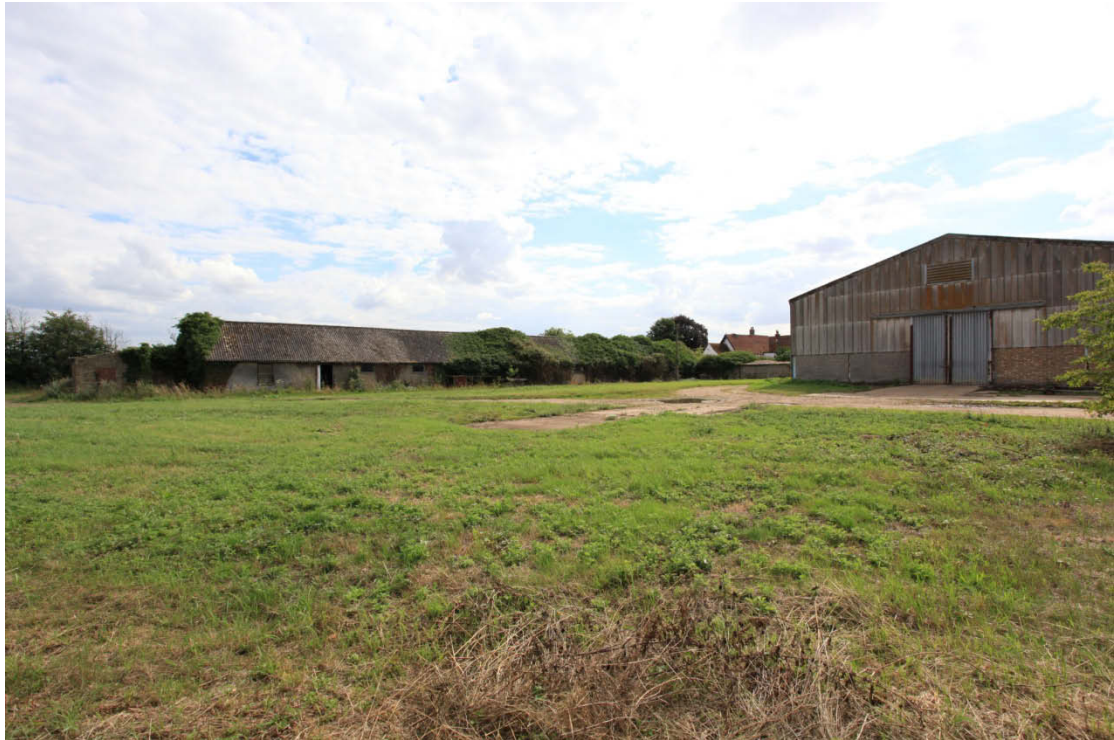
Illus. 3. General view of site from north-east showing single-storied linear barn (1) to left, farmhouse in centre rear and grain store of 1971 to right. The concrete floor of a WWII hospital Nissen hut is visible in front of the latter's entrance.

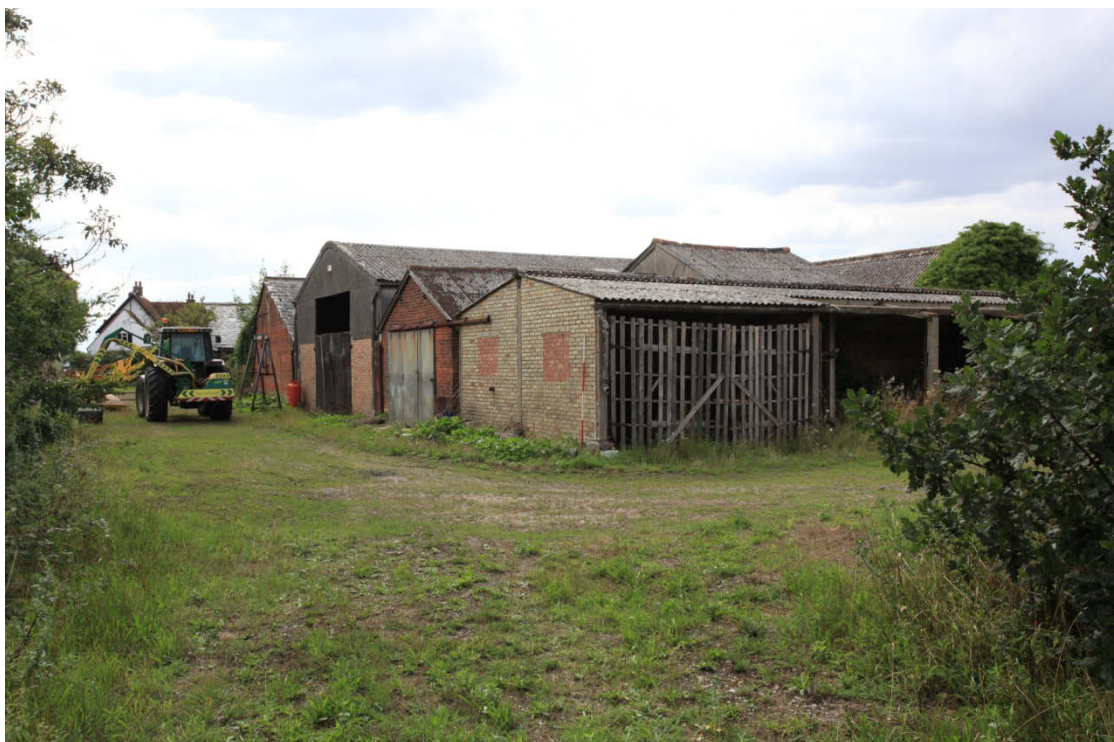
Illus. 4. Southern exterior of yard sheds from east showing farmhouse in rear to left & 20th century implement shelter (2) in foreground to right. Note the 20th century section of raised roof in the enclosed shed (3) above a grain silo.

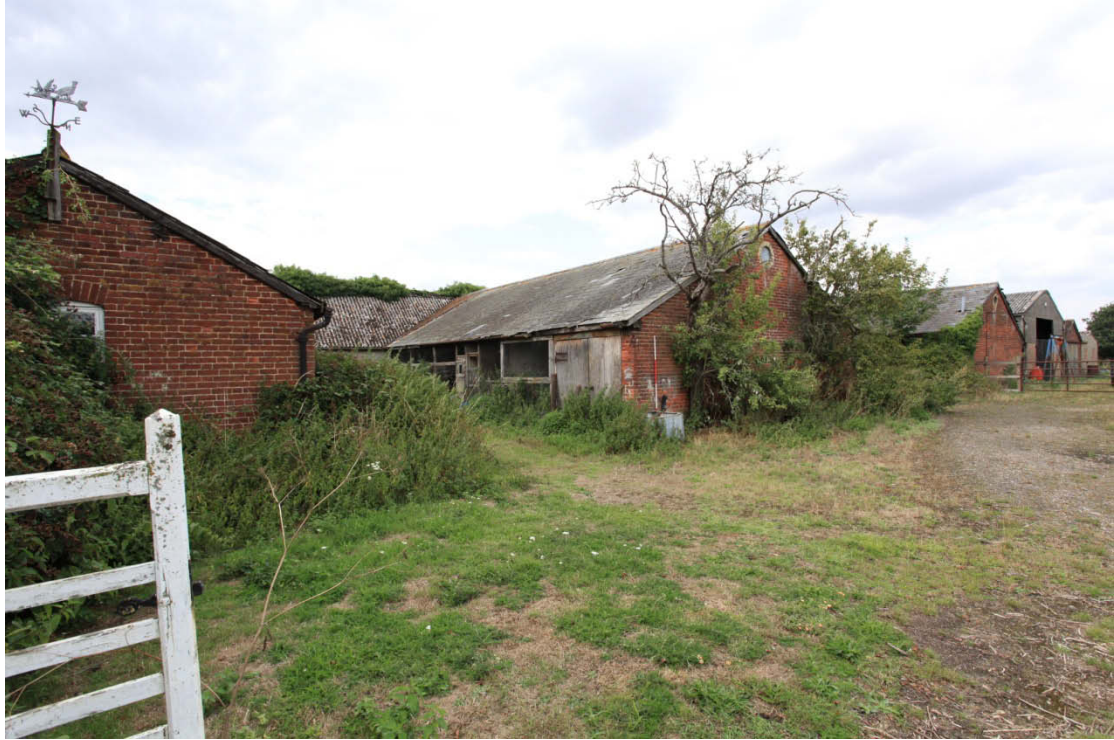
Illus. 5. Southern exterior of yard sheds from south-west showing cart shed (11) to left and the open-sided shelter-shed now converted into a poultry house (9) in centre.

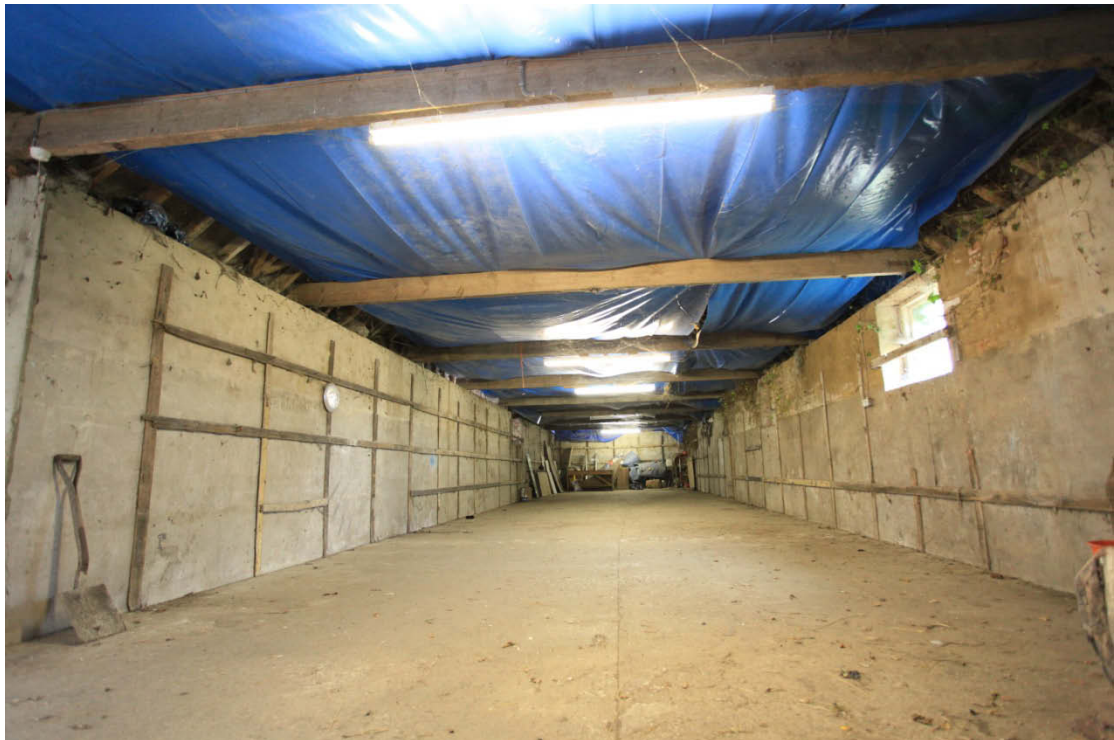
Illus. 6. Interior of linear barn (1) from east showing door to central yard (7) to extreme left and northern window to right. The internal walls have been cement rendered to operate as a loose grain store and the roof structure hidden by a tarpaulin to trap falling dirt and debris.

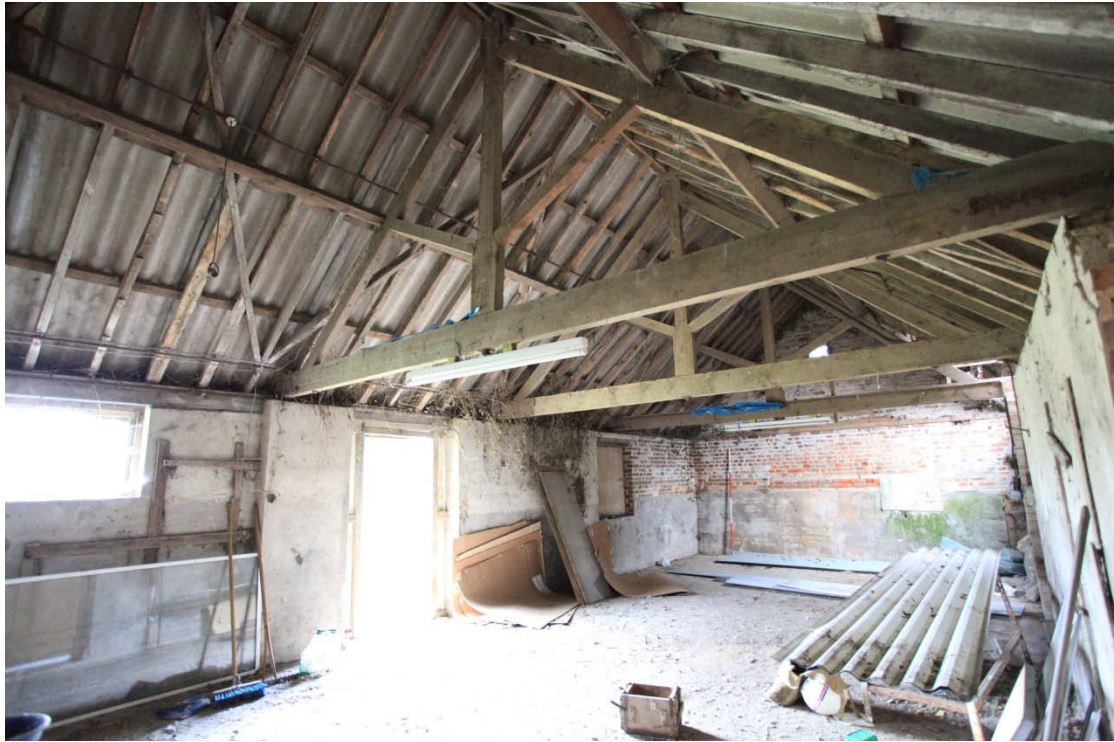
Illus. 7. North-eastern internal corner of linear barn (1a) showing northern door and window positions to left with red-brick eastern gable to right. The softwood king-post roof trusses are original to the building.

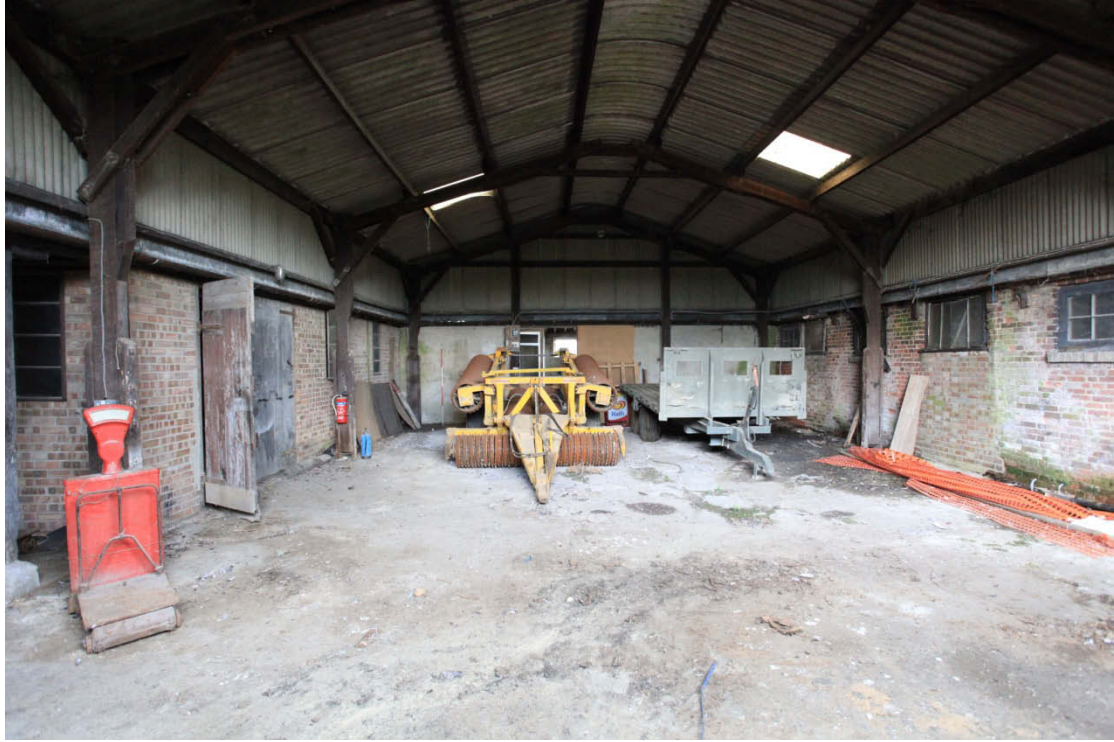
Illus. 8. Interior of eastern yard with 20th century roof (4) seen from the south and showing the enclosed shed with two blocked doors & original windows to right (3) and the open-sided shelter shed now partly enclosed to accommodate a grain dryer (5) to left.

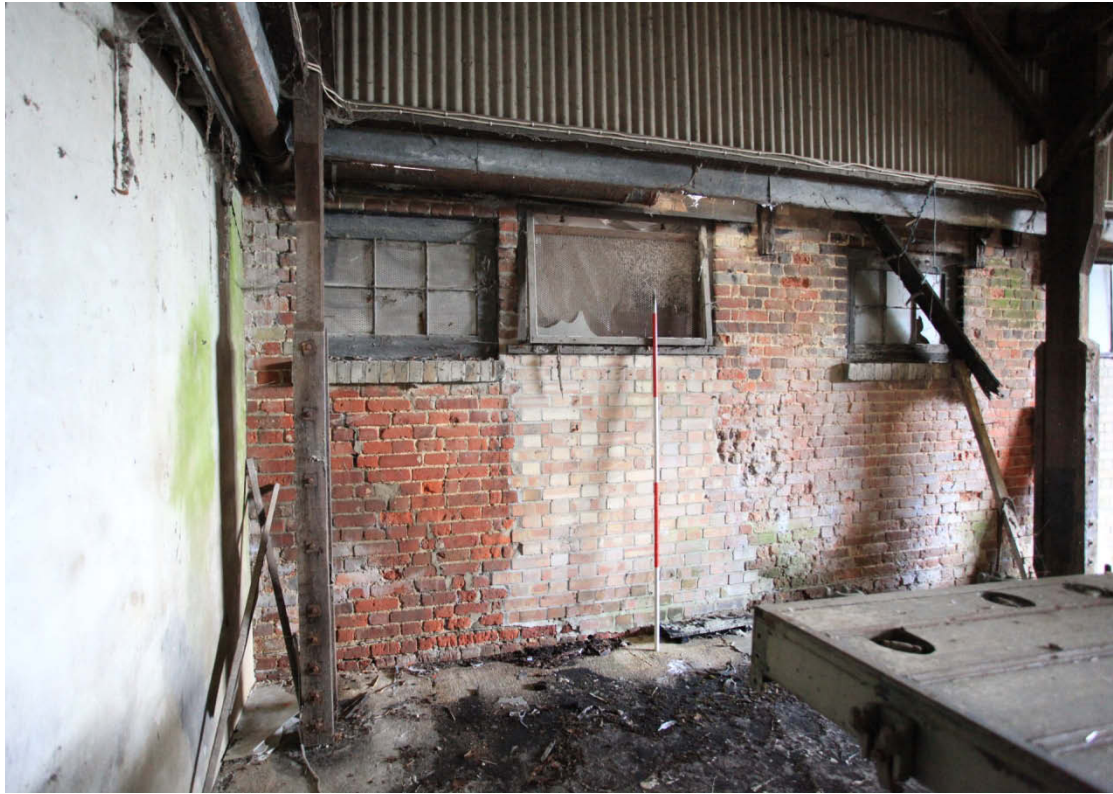
Illus. 9. Detail of blocked door & original windows at northern end of enclosed eastern shed (3) as seen from 20th century covered yard (4) to west.

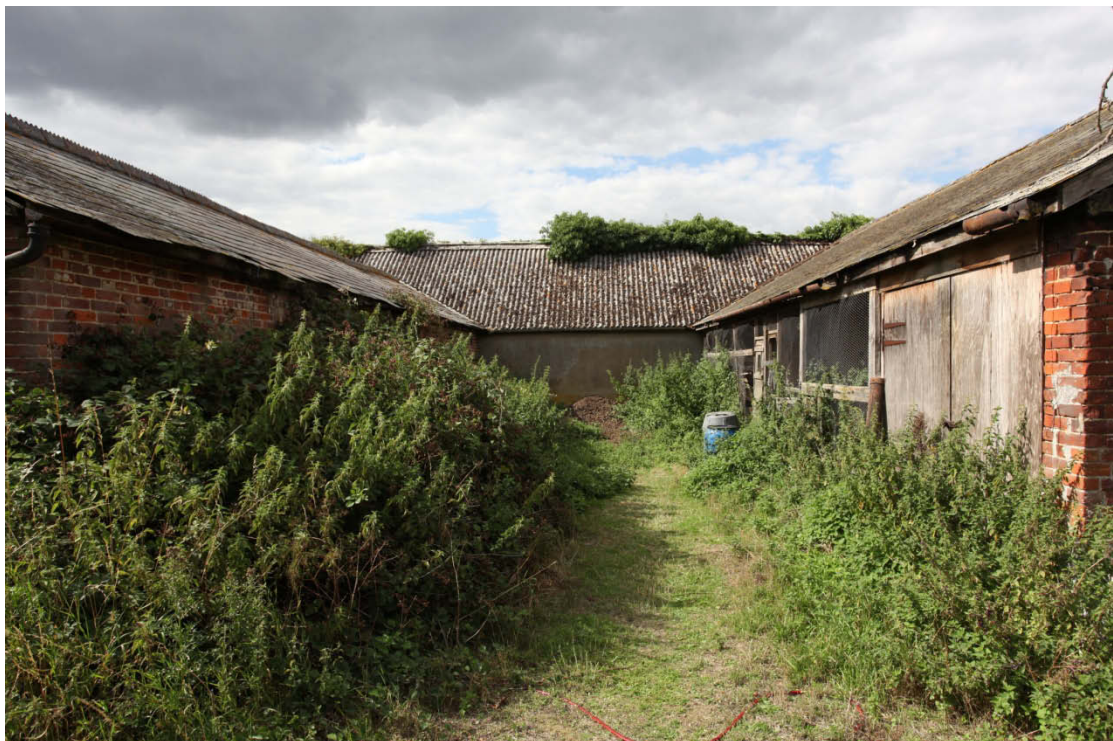
Illus. 10. Western yard (10) from south showing linear barn (1) in rear with cart shed (11) and open-sided shelter shed now enclosed to form a poultry house (9) to the right.
