**The ‘Cart Lodge’,
Lower Manor Farmhouse,
Battisford, Suffolk
BAT 017**

Historic Building Record

The ‘Cart Lodge’, Lower Manor Farmhouse, Valley Road, Battisford, Suffolk

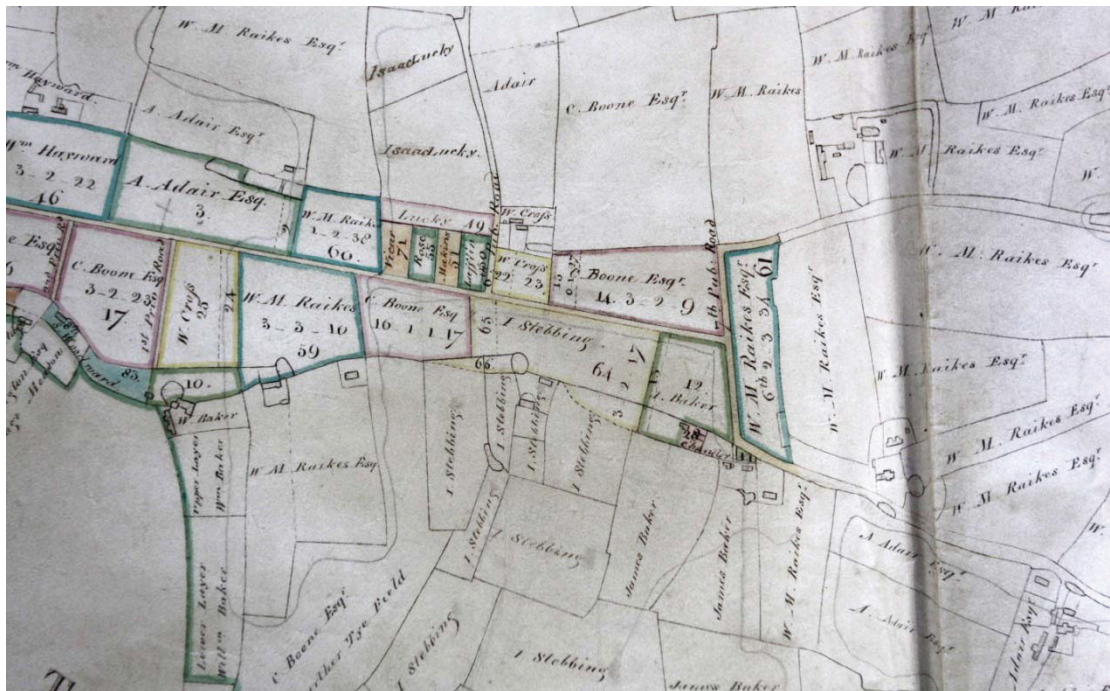
Figure 3

The Battisford Enclosure Map of 1812 showing the green now divided into small plots with Lower Manor Farm to the right. (Suffolk Record Office Ipswich, HD 1473).

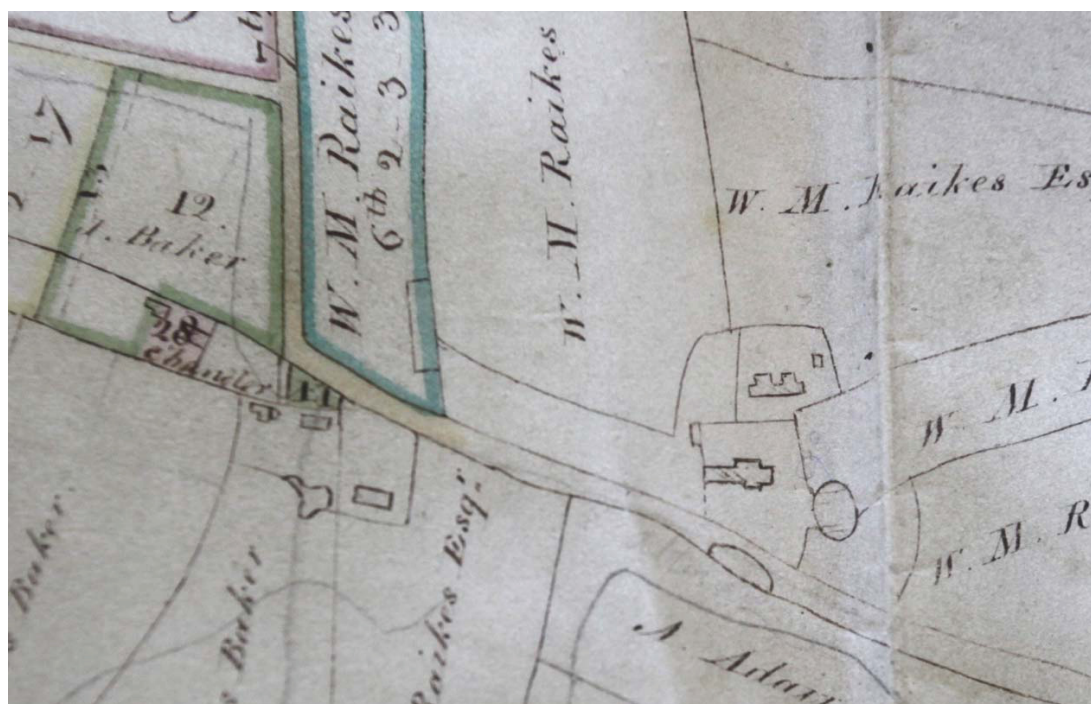
Figure 3a

Detail of the 1812 Enclosure Map showing Lower Manor Farm in the ownership of W. M. Raikes Esquire with the boundary of the tye picked out in green to the left. The ‘cart lodge’ had not yet been built but the barn is depicted with narrow projections to north and south; the northern projection coincides with the area of open framing and may represent a demolished aisle. The tithe map of 1842 shows an identical arrangement.

The maps of 1812 and 1842 (the latter in poor condition and not included here) show the same site layout, with the farmhouse north of the barn and the surviving pond. The shelter shed which forms the subject of this report had yet to be built. The outline of the barn is unusual, with a long, narrow projection from its northern elevation coinciding perfectly with the evidence of an open arcade in the timber frame and suggesting the presence of an aisle that had been demolished by 1885 as shown on the first edition 25 inch Ordnance Survey. The latter shows the shelter shed for the first time, and indicates a mid-19th century remodelling of the site. Most East Anglian farms were altered in similar ways during the 1850s and 1860s as it became fashionable to keep cattle in enclosed yards to maximise the production manure rather than abroad in the fields. The farmhouse had been divided into labourers' cottages (as was probably the case in 1842 given the lack of a separate tenant farmer on the tithe apportionment). While the link between the two properties clearly dates back to the beginning of the 19th century it may have extended much further back in time. It is possible, for example, that Lower Manor Farm marks the site of the demesne home farm of the medieval preceptory at St Johns. Alternatively it may have been built by the Greshams after the Reformation when they enclosed the medieval common in front of their new property.

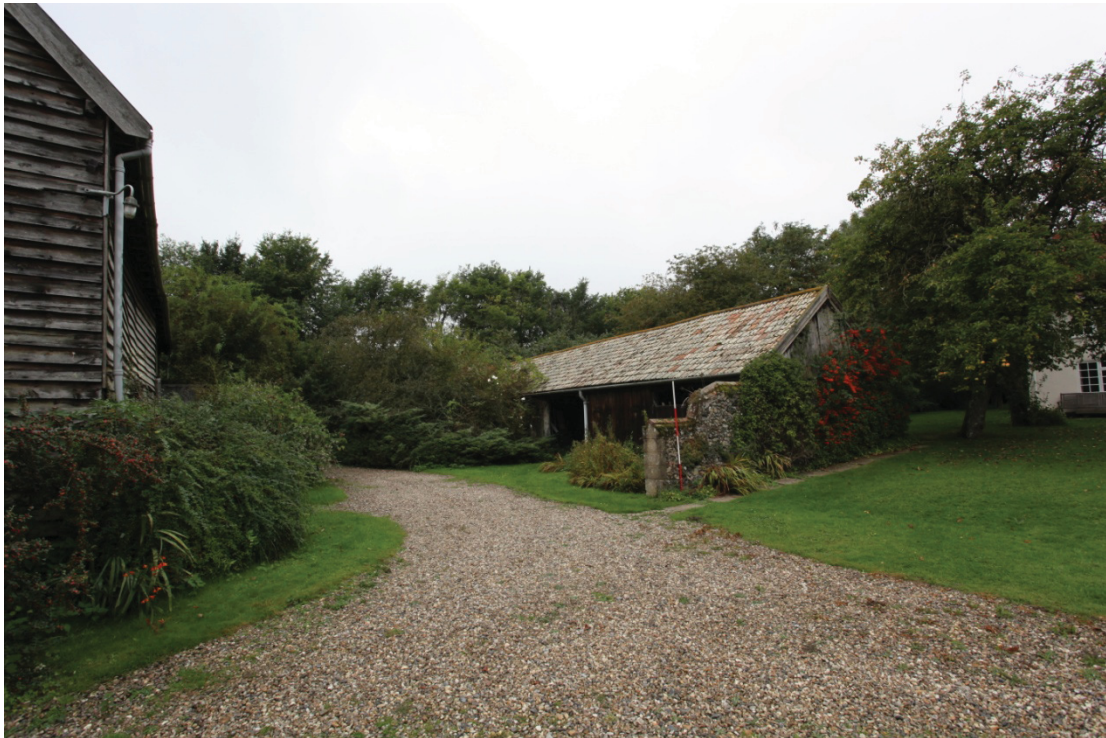
Illus. 1. Exterior of shelter-shed (1) from south-east showing 17th century timber-framed barn (3) to left and grade II-listed farmhouse (5) to right.

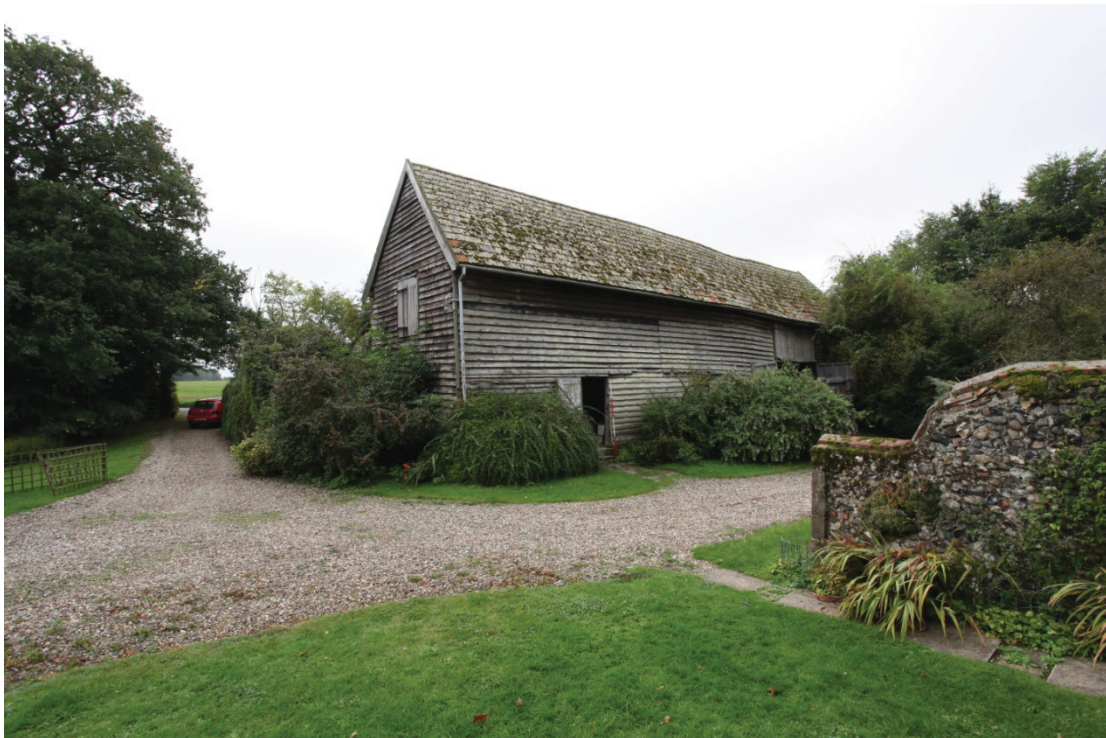
Illus. 2. Northern exterior of barn (3) from north-east showing yard wall adjoining shelter-shed (1) to right. This elevation of the barn was originally open-arcaded and may have formed a rare hay-house

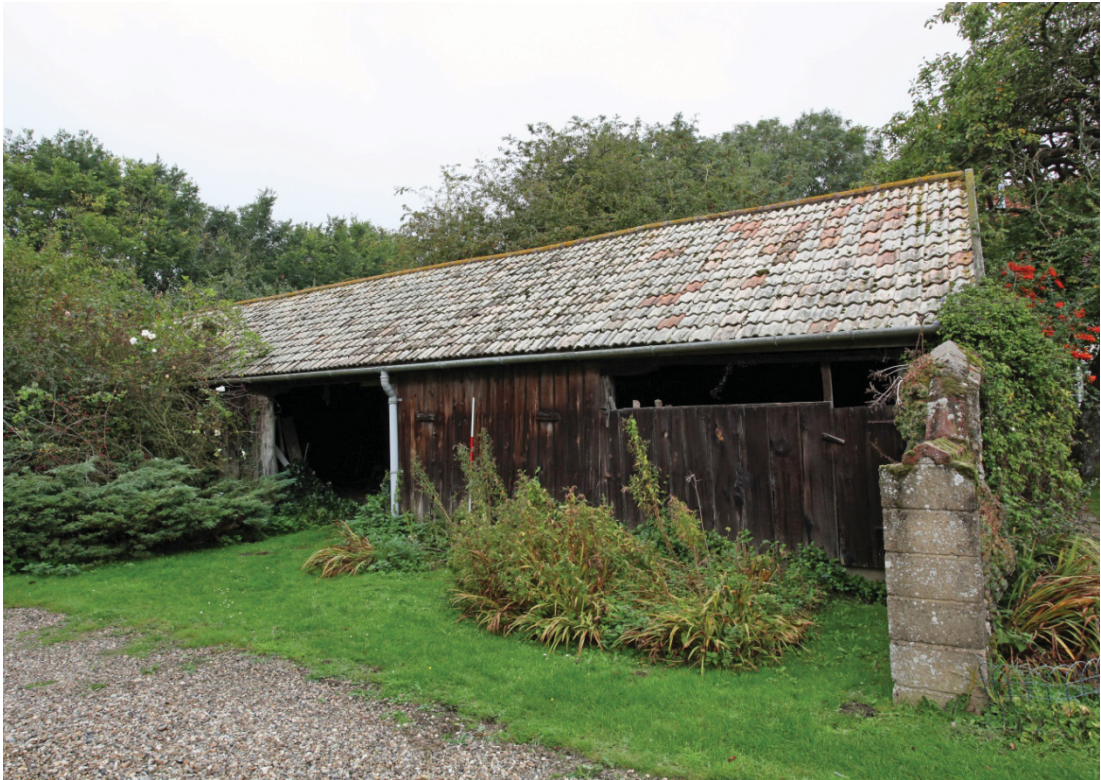
Illus. 3. Southern exterior of shelter-shed (1) from south-east showing 20th century boarded loose boxes to eastern section (1a) and pantiled roof.

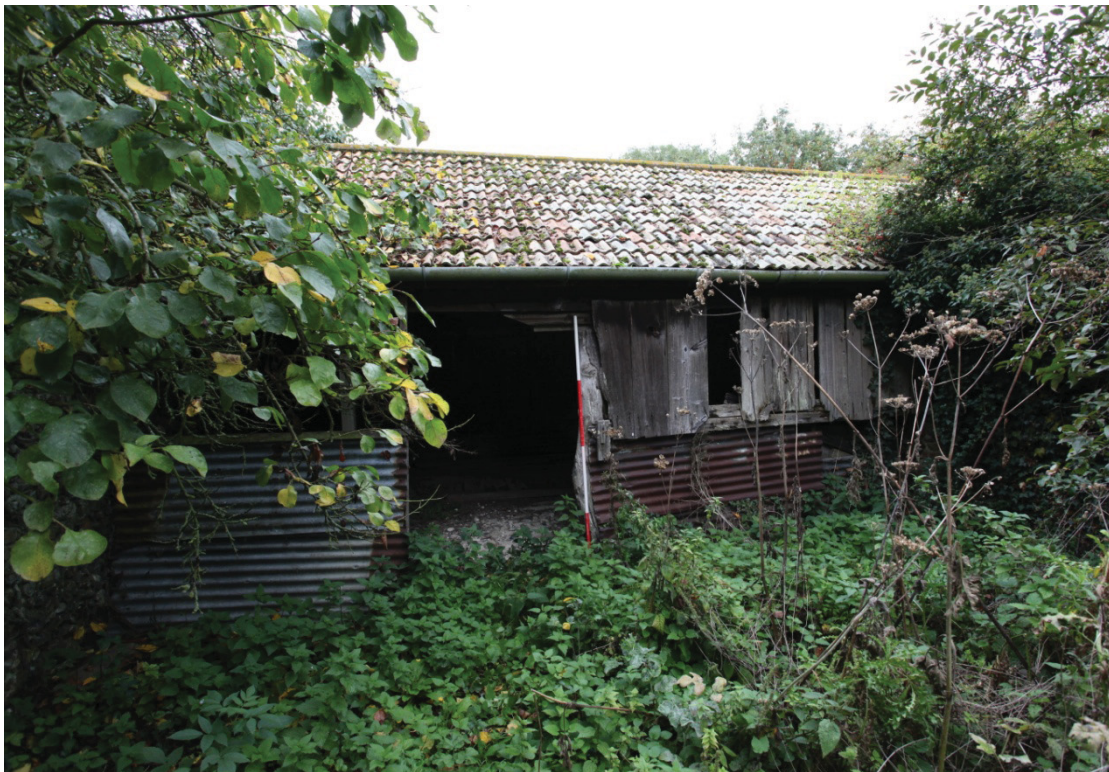
Illus. 4. Southern exterior of western section of shelter shed (1b) from western yard showing 20th century corrugated iron loose box (1a).

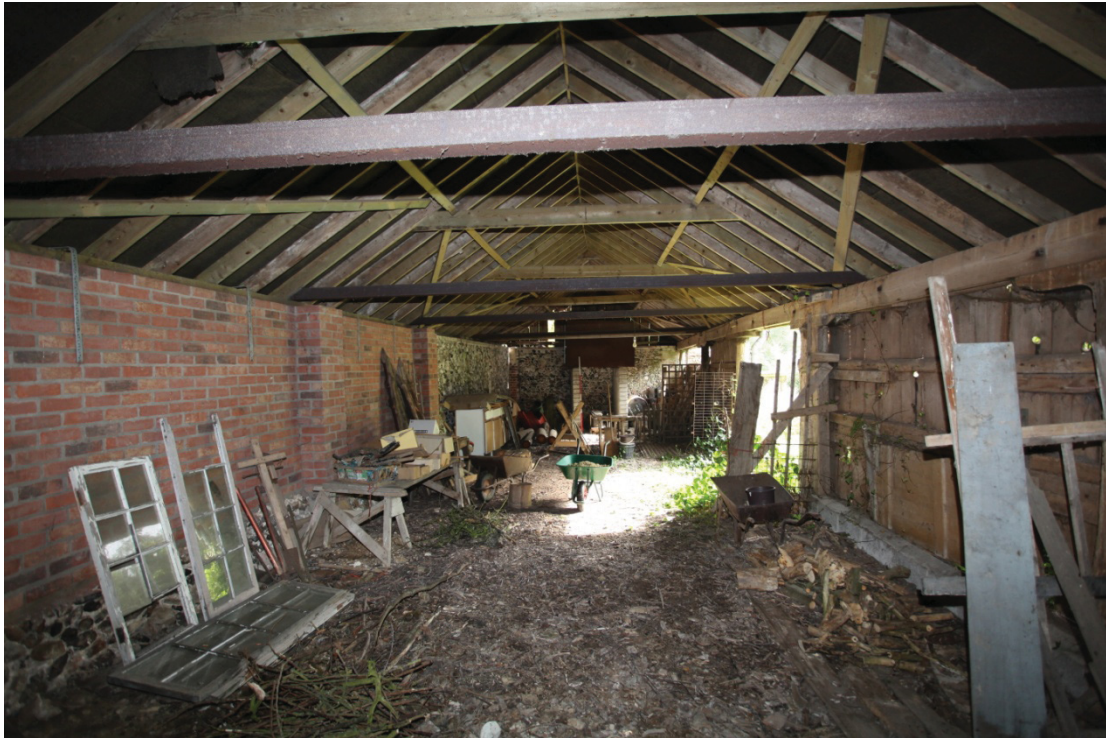
Illus. 5. Interior of eastern section of shelter-shed (1a) showing modern roof and northern brick wall to left (rebuilt after collapse in 1980s) with small section of original flint fabric and roof in rear.

The shelter-shed is understood from the present owner to have collapsed under the weight of snow in the early-1980s (presumably the severe winter of 1981-2) and has been largely rebuilt. With the exception of approximately 6 m to the east the rear (northern) elevation was

entirely renewed in modern red-brick and all but 3 m of the roof was also rebuilt in modern softwood. The upper part of the western gable was similarly renewed leaving only the eastern gable and internal partition chiefly intact. The southern roof has been replaced with two sections of tall-sectioned softwood bolted together and the arcade posts replaced with rough round-wood (i.e. tree trunks in the round).

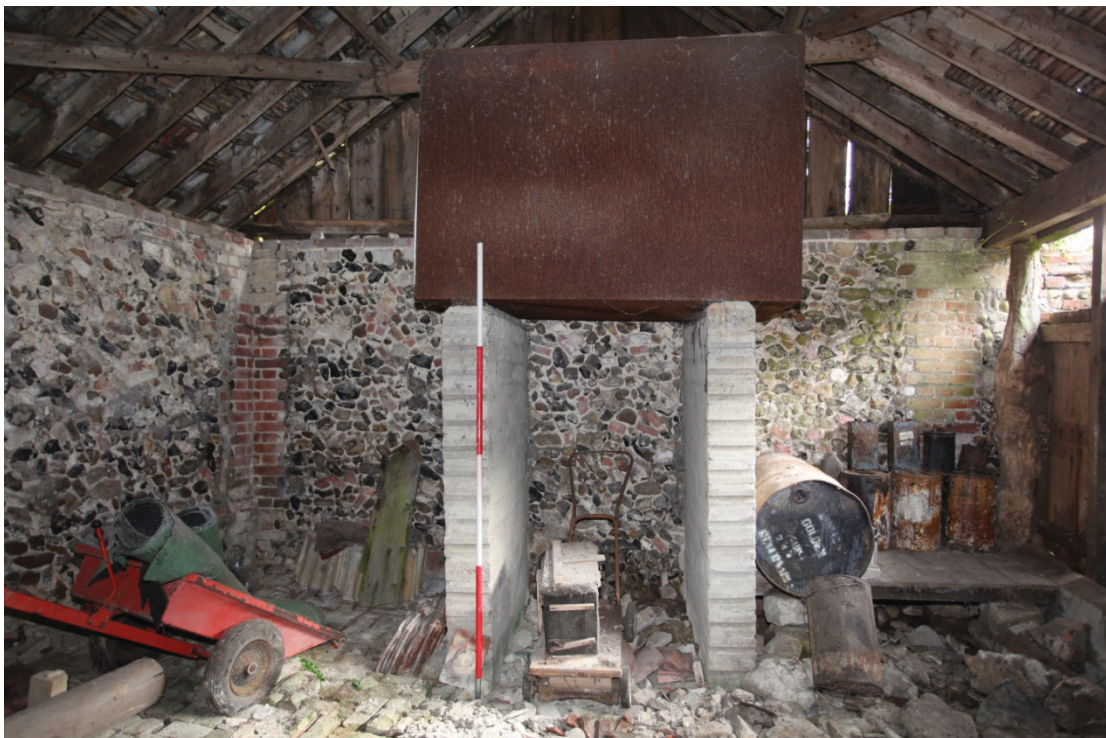
Illus. 6. Internal eastern gable of shelter shed (1a) showing original flint-rubble fabric with brick dressing to corners and contiguity with yard wall to right. The roof structure shown here is also original, with softwood joists and rendered laths against the pantiles.

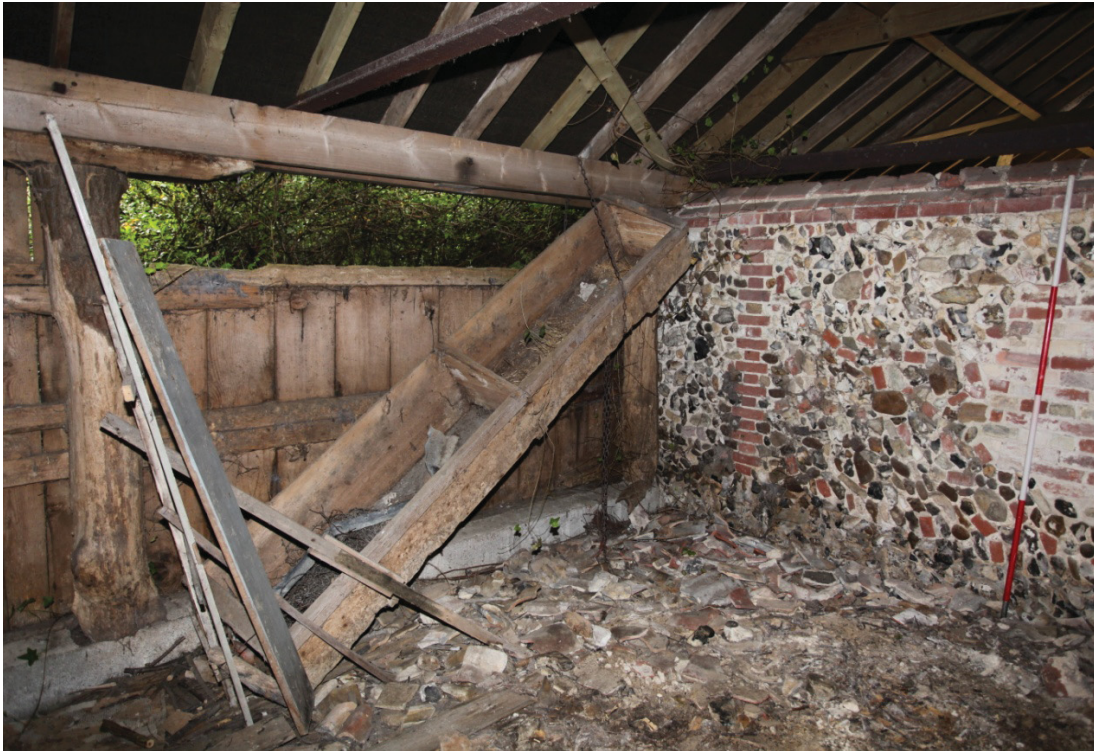
Illus. 7. Detail of boarded cattle trough hanging in south-western internal corner of eastern section of shelter-shed (1a), showing internal partition to right.

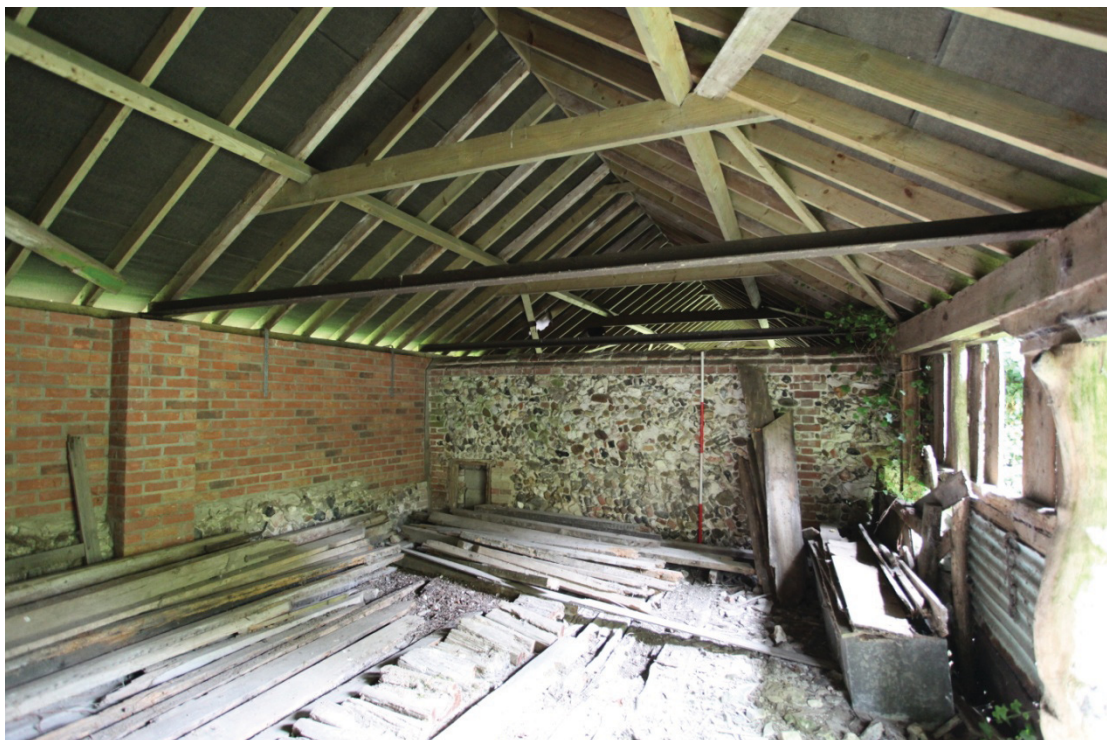
Illus. 8. Interior of western section of shelter-shed (1b) from west showing rebuilt northern elevation to left, open arcade adjoining southern yard to right and flint-rubble partition against the eastern section in centre. The small, blocked hatch or calf creep is visible to the left of this partition.

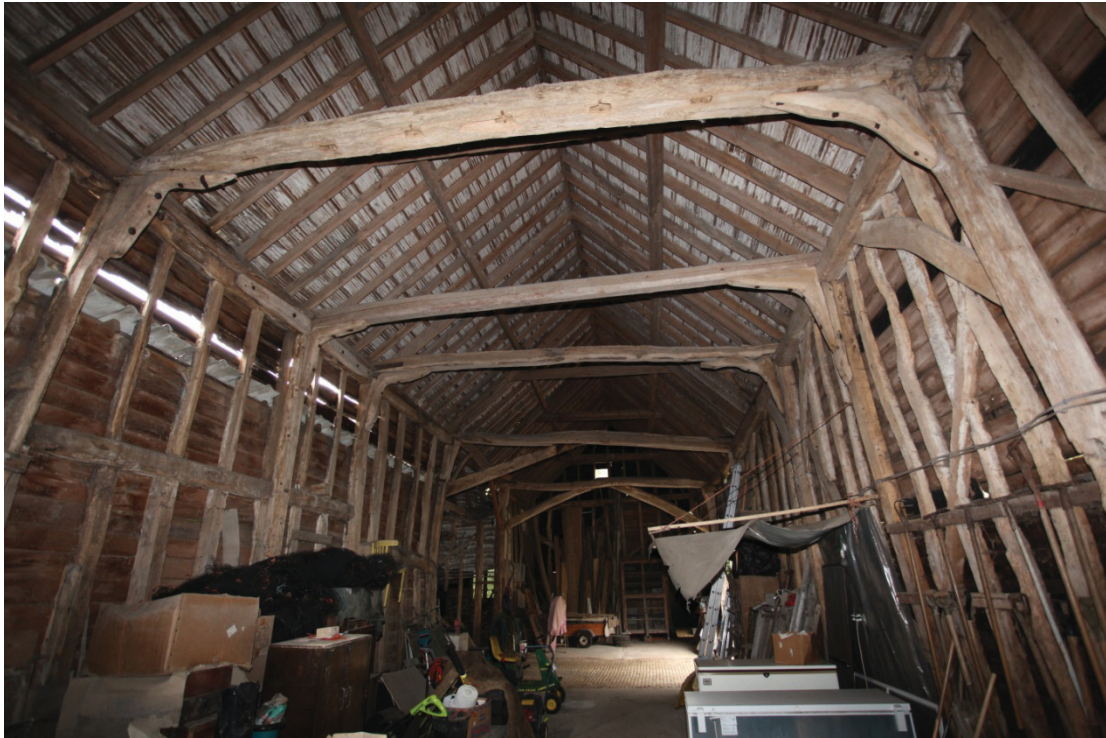
Illus. 9. Interior of barn (3) from east showing arch-braces of formerly open northern elevation to right with fully-framed southern elevation to left & tie-beam with empty stud mortises of original gable above. The roof is a late-19th century replacement that may be contemporary with the shelter-shed (1).

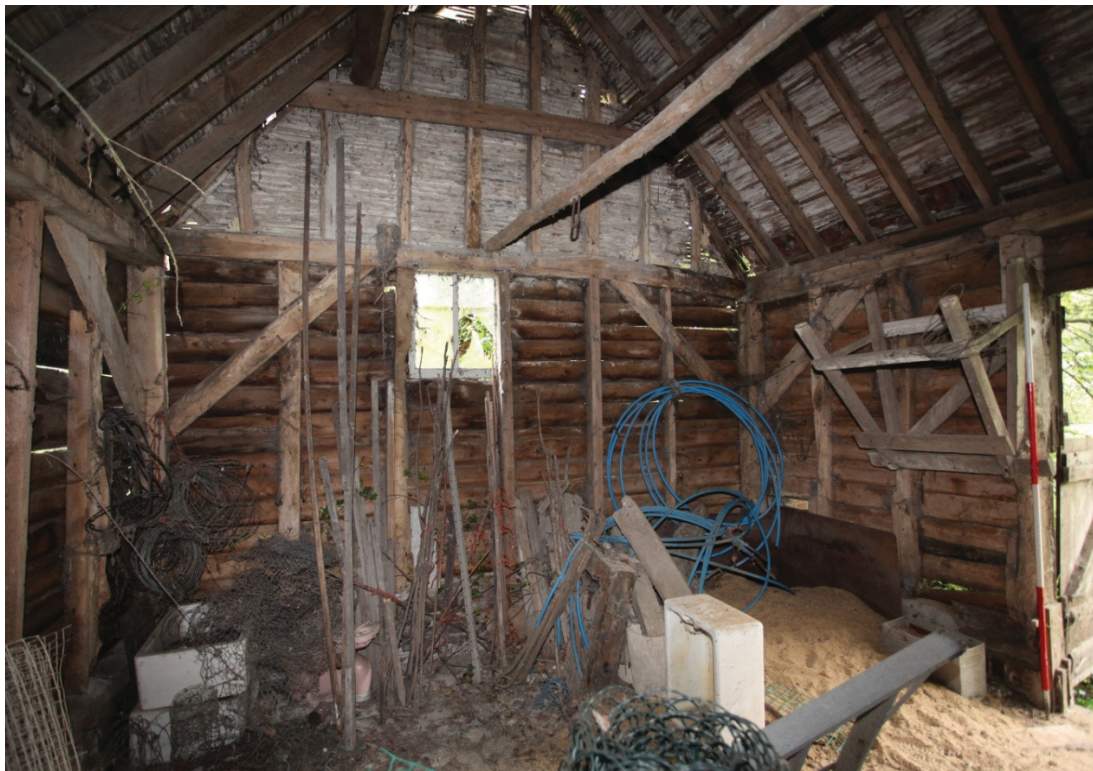
Illus. 10. Interior of unusually diminutive western shed (4) from east showing arch-braced tie-beam and roof-plates with central tenoned post.
