## ARCHAEOLOGICAL MONITORING REPORT

SCCAS REPORT No. 2010/116

### EDF Cable Trench, Leiston Abbey, Leiston LCS 155

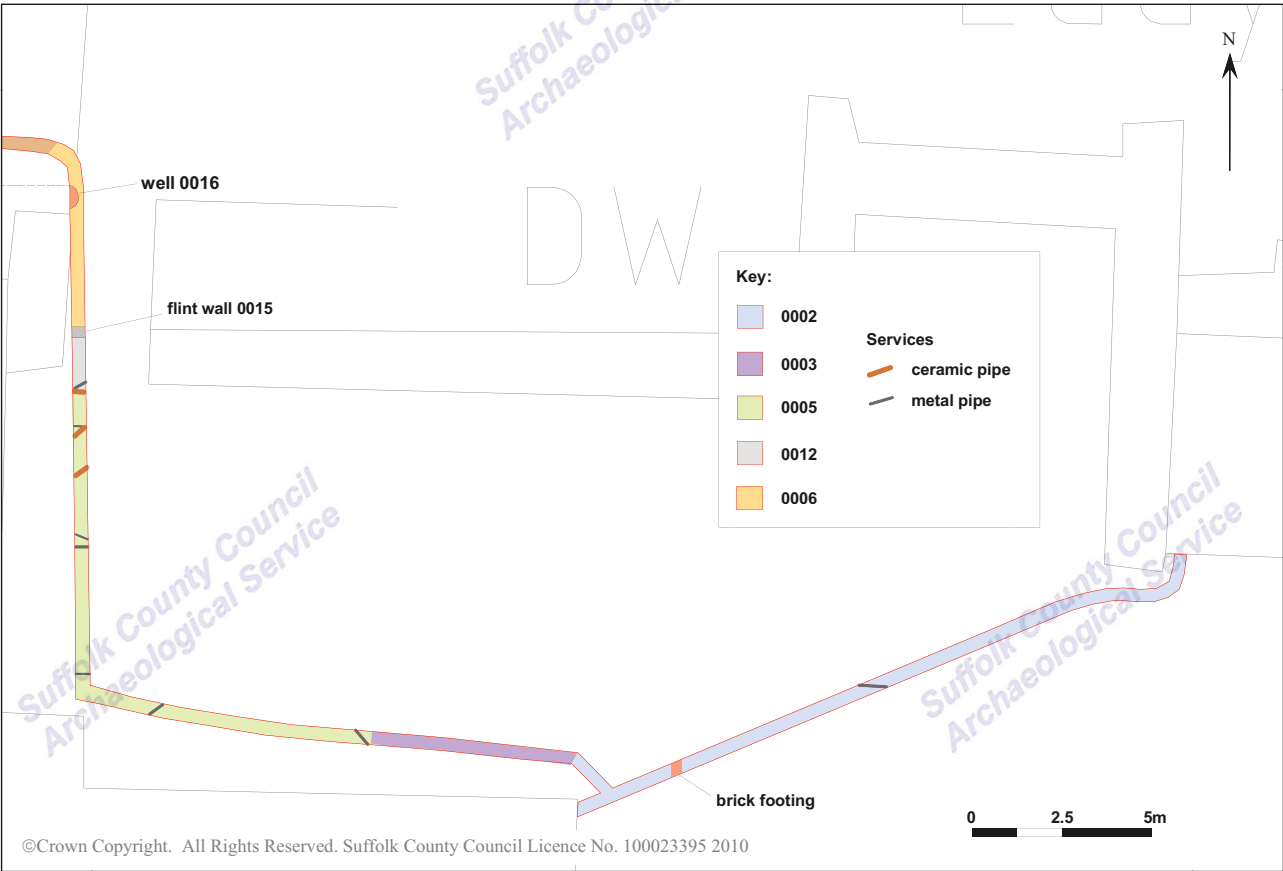
Figure 3: Detail of deposits and features in the eastern part of the trench

As the trench was quite shallow, much of the excavated material consisted of topsoil, which was a dark brown friable silty loam, c.0.15m - 0.2m thick where it was present, and various disturbed layers associated with episodes of construction and modern services. 0002 was the backfill of a known service trench and was very similar in character to the topsoil, but included regular post-medieval and modern artefacts. This layer was still evident in the base of the trench. 0003 was very similar to 0002 but lacked modern finds. It was clearly disturbed and contained ashy patches as well as CBM, mortar flecks, occasional charcoal lumps and tile. At the base of the trench, a compact mid yellowish brown silty clay sand, 0004, was revealed. This was a deposit observed through the majority of the base of the trench but it was not clear whether this represented a subsoil layer or the natural subsoil. 0005 was a mixed deposit, heavily disturbed by services, consisting of mid brown sandy silty clay with regular flints, CBM and mortar flecks to the full depth of the trench (0.4m).

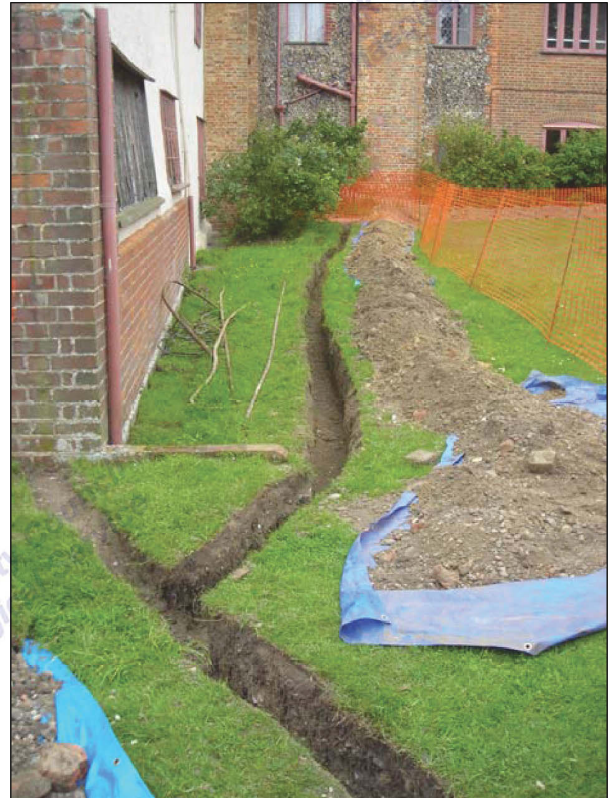
Plate 1. General view of the trench under excavation. Located within the church nave, looking west.

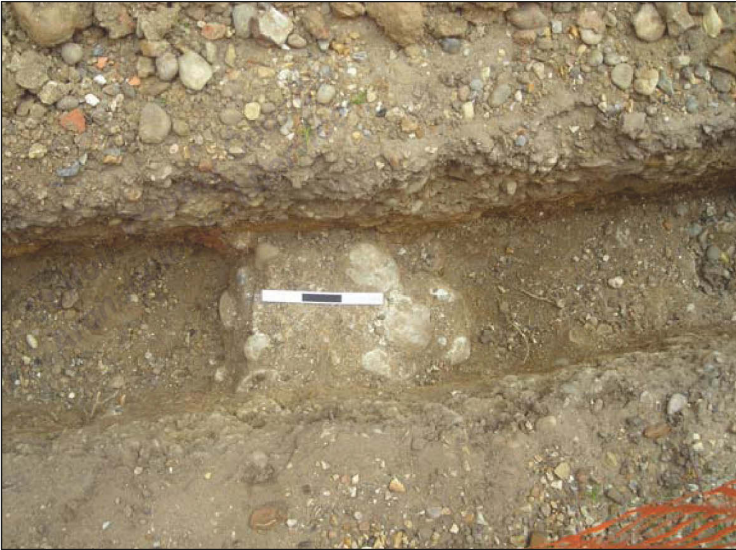
0015 was an east-west aligned section of bonded flint and mortar masonry (Plate 2). It measured 0.3m wide and the top was 0.23m from the ground surface. Whilst it was reasonably well faced on its north side, the south side was less even. For c.1m immediately south of this wall fragment, and at a depth of 0.36m, the base of the trench was extremely solid. Hand cleaning revealed fragments of flint and mortar set in a mid-pale yellow brown clay matrix, and this was allocated the context number 0012. 0015 and 0012 align with the north nave wall. It is likely that these represent the westerly continuation of this wall. This may explain the uneven southern side of 0015 as the result of cutting through part of the wall for construction of a modern footing, leaving the top of the nave wall footing exposed as 0012. A scar in the brickwork of the farmhouse to the west implies that a wall once extended over the location of 0012 (Plate 3).

Plate 2. Wall fragment 0015, looking approximately east. 0012 is adjacent to, and south of, the wall, but cannot be seen clearly in the photo.

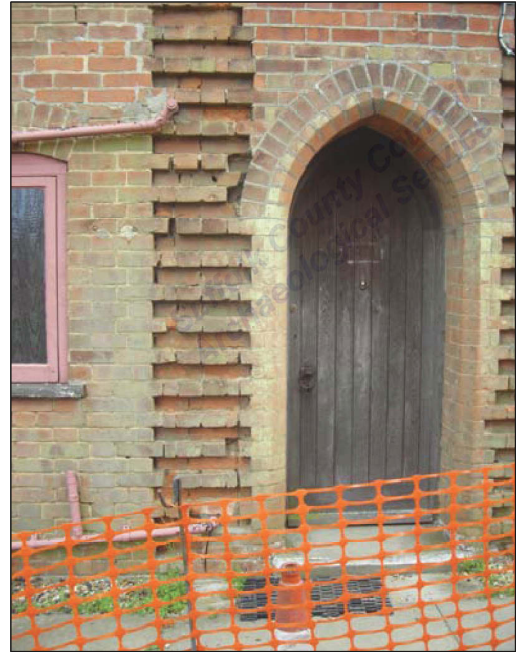
Plate 3. Signs of a former modern wall which would align with 0012, 0015 and the north nave wall.

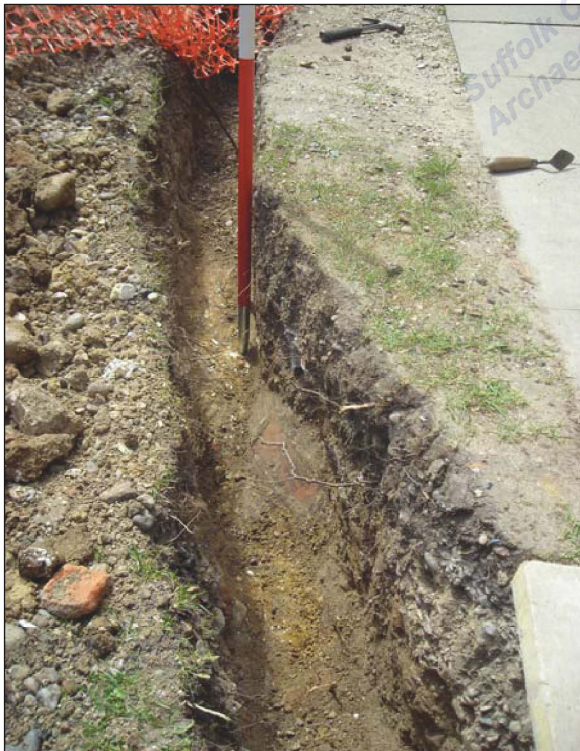
Plate 4. Brick capping of well 0016 visible in the western trench section. Looking south.

0016 was a probable brick capped well or pump, partially exposed in the western side of the trench (Plate 4). Two courses of bricks were visible creating a dome, on top of which was a metal plate, subsequently sealed by 0.26m of overburden 0006. The bricks were lined externally by a 0.12m thick mid grey brown clay layer which was itself cut into 0004, the clean trench base. No well or pump is represented in this location on the 1st-3rd edition Ordnance Survey maps and whilst the visible brick is clearly modern in origin, not enough of the feature was revealed to determine if it is entirely recent or an older feature, recently capped.

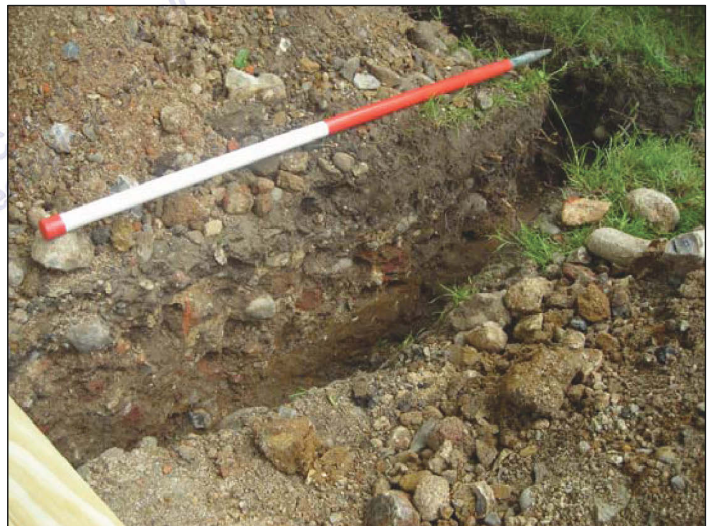
0010 was a mid-pale yellowish brown sandy clay with occasional chalk lumps, very compact in places, overlying 0004. Incorporated into this matrix under the gravel car park area and the north-south tarmac road west of the abbey complex was 0011, comprising dense demolition rubble, particularly CBM, and worked masonry fragments. The CBM was abraded, and of mixed date, including early brick, medieval floor tile and post-medieval brick. 0011 continued c.2m through into 0013 (Plate 7) which was a dark brown friable silty loam, essentially topsoil, to the full depth of the trench and overlying 0004.

Plate 7. Rubble layer 0011 merging into 0013 west of the tarmac road. Looking south west.
