ARCHAEOLOGICAL MONITORING REPORT

SCCAS REPORT No. 2010/098

Lorne Villa, 18 The Croft, Sudbury SUY 093

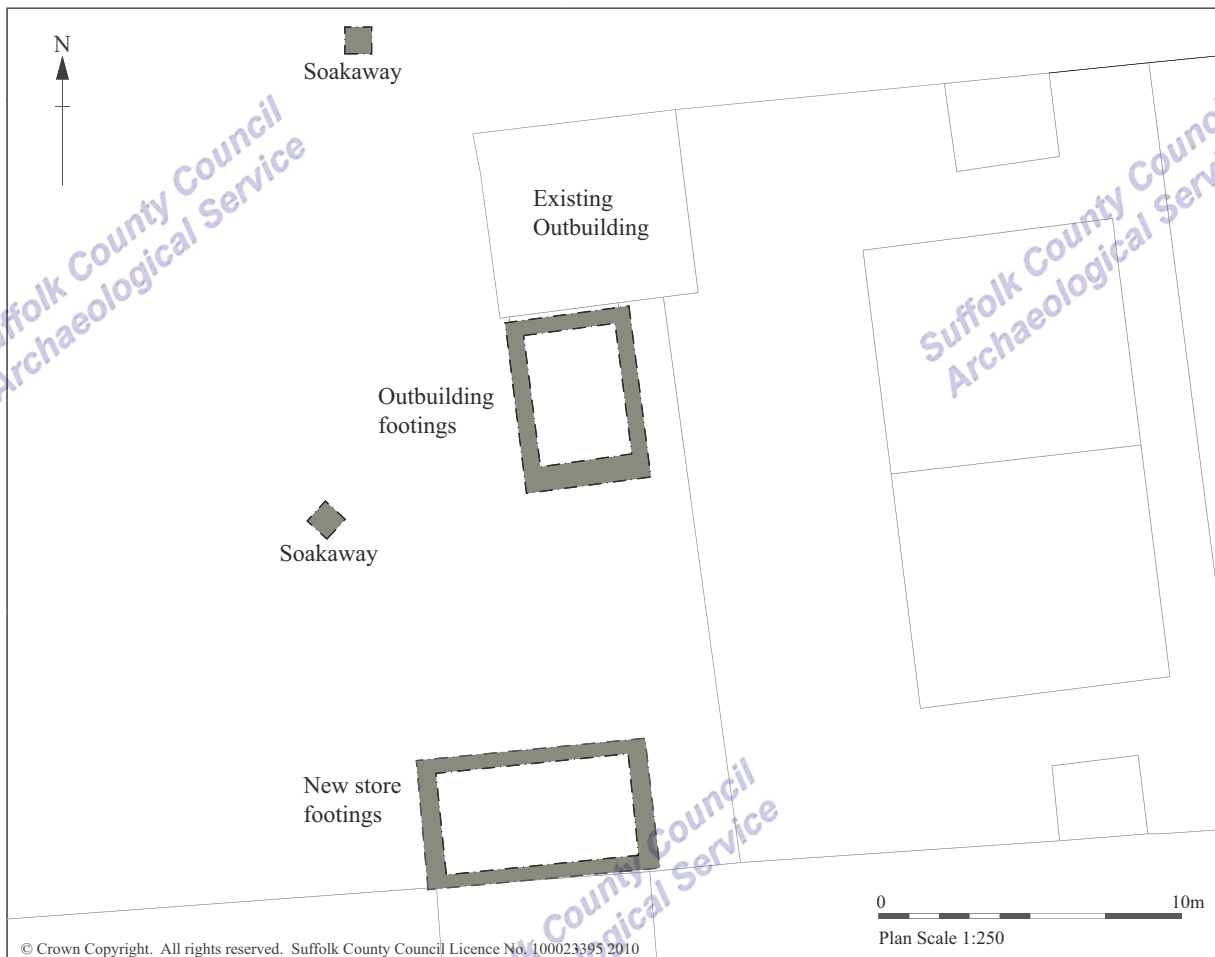
Figure 3. Location of footings and detail of extension area, showing kiln/oven 0211 below pit 0202

The outbuilding footings were excavated by the building contractor over a period of three days and by the time of the third visit were in part backfilled. This meant that observations could not be made of the entire footing area. Despite this, part of a brick structure, possibly a kiln or oven (0211), was identified on the west side of the footings trench (Fig. 3, Pl. 3), which had a thick deposit of heat-affected clay on its outside edge. Two post-medieval pits were also located here. A third pit was located in the south-east corner of the footing trench.

The exposed structure of the kiln/oven was 0.45m wide and was over 0.15m deep and the upper surviving surface was encountered approximately 0.40m below the ground surface. The visible inside edge had a slight curve, which indicated that it may have

been a large structure. A lime mortar render had been applied to the inside face of the kiln/oven, which was approximately 0.03m thick. Where exposed, the mortar and single skin of brickwork (0211) were ragged, suggesting that this was not the top of the kiln/oven and that it had been demolished. No finds were recovered from the kiln/oven, but the dimension of the bricks (9.68" (L) x 4.13" (W) x 2.75" (H)) indicates that they are 16th century. An area of crushed brickwork/burnt clay (0203) lay directly above the kiln/oven structure and was probably the damaged/truncated remnant of this structure.

Two pits truncated the kiln/oven, one to the north and one to the south. Pit 0206 was at least 1.25m long, but its shape in plan was unclear due to part of the footing having been backfilled. It was filled by 0204, reddish grey silty clay. No finds were recovered. Pit 0202 lay to the south of the kiln/oven and was at least 0.60m wide and filled with 0201, dark grey sandy loam.

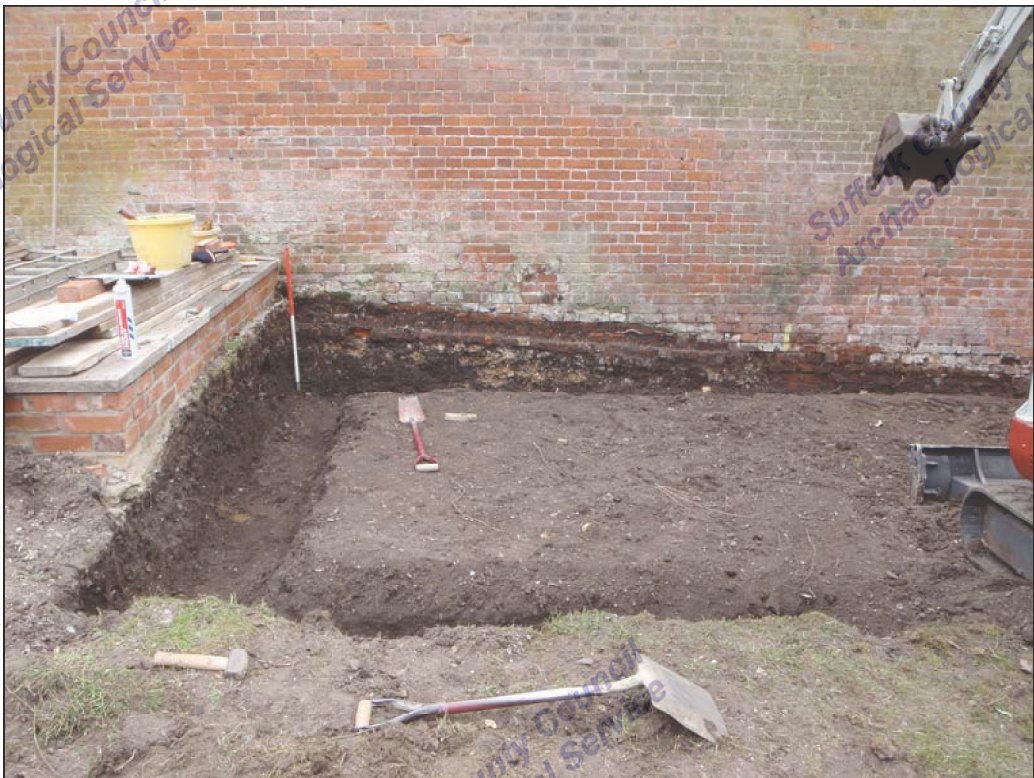
Plate 1. Store footings, east end, facing south

Observations were made of the groundworks (Fig. 3, Pl. 1) for the garden store during the first visit which consisted of reducing (using a Takeuchi TB016 mechanical excavator and a Thwaites 1 tonne dumper) the east half of the area to a level surface and the excavation of the footings trench. The store footings were excavated to a depth of between approximately 0.25m and 0.70m.

Deposit 0004 was the lowest observed layer in the footings trench of the garden store. It was dark brownish grey silty clay up to 0.50m deep with an upper lens of 0.16m thick (max) mid brownish yellow sandy peagrit. Towards the east end of the footings 0004 merged with 0003, the lowest of the observed deposits underlying the patio. Deposit 0003 was mid whiteish grey silty sand with a mixed lower half of silty clay and sandy peagrit. The sloping angle of this gritty deposit might indicate pit(s) underlie this sequence: where the fills of the underlying pits settle and sink, overlying deposits sink with them.

Overlying this was 0002, dark grey silty clay. Its total depth was 0.26m, which included an ash/fire rake-out deposit in the upper 0.06m. This ashy lens extended from the south wall outwards to the front (north) edge of the patio, where it became thinner and petered out.

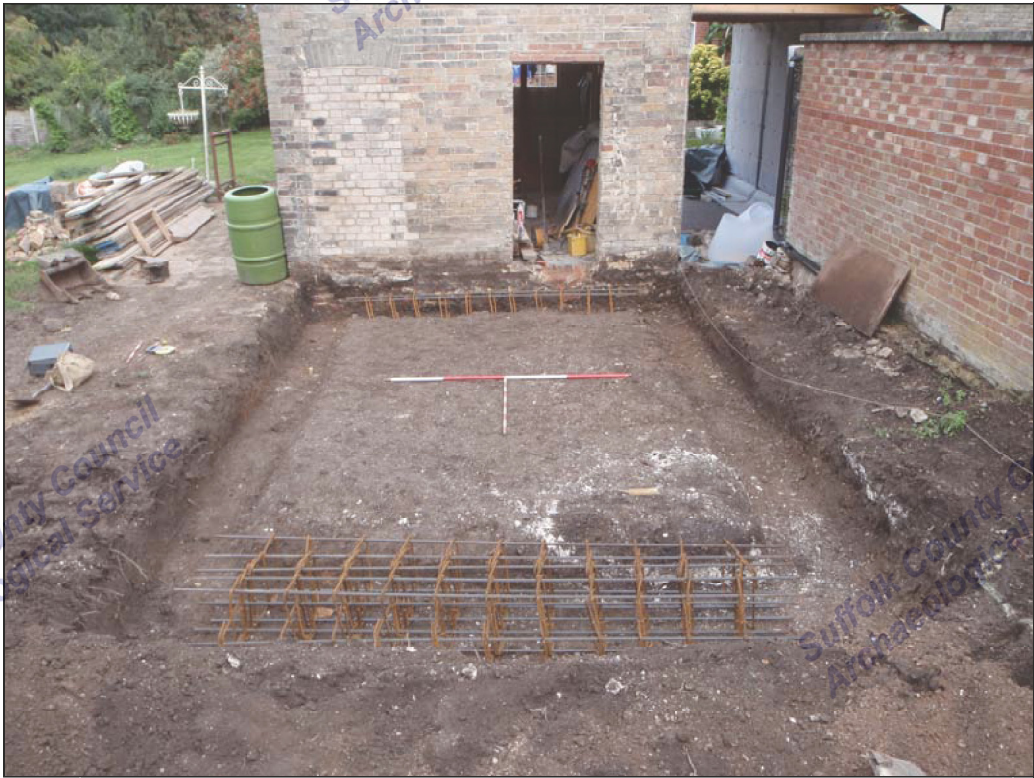
Plate 2. Extension footings, facing north

The second and third visits observed the reduction of the central area of the extension (Fig. 3, Pl. 2) by 0.40m and the excavation of the footings to a depth of approximately 0.70m.

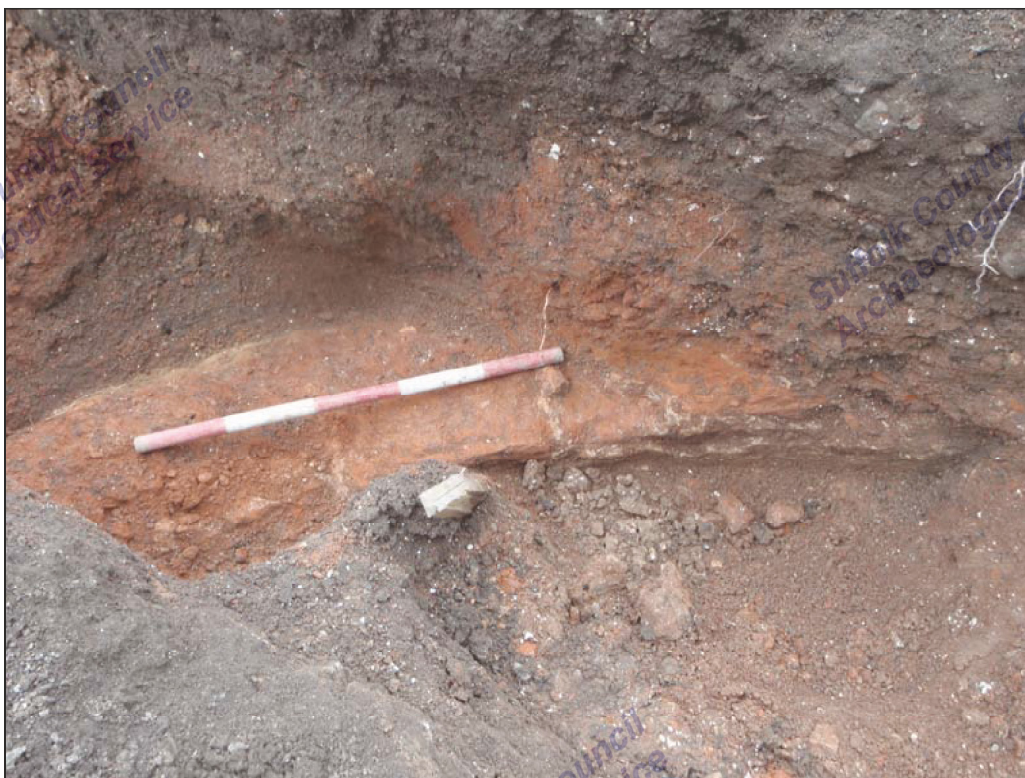
Plate 3. Kiln/oven structure 0211, facing south-west

Possibly the earliest feature identified was the remains of a possible kiln/oven in the west side of the extension footings. The dimension of the surviving brickwork suggests a 16th century date for the structure, although it is possible that they could have been re-used, and therefore put the kiln/oven at a later, post-medieval date. Regardless of the date, the presence of the structure is evidence for probable small-scale industrial activity in this location.
