ARCHAEOLOGICAL EVALUATION AND MONITORING REPORT

SCCAS REPORT No. 2010/197

New Boiler House, Hartismere High School, Eye EYE 099

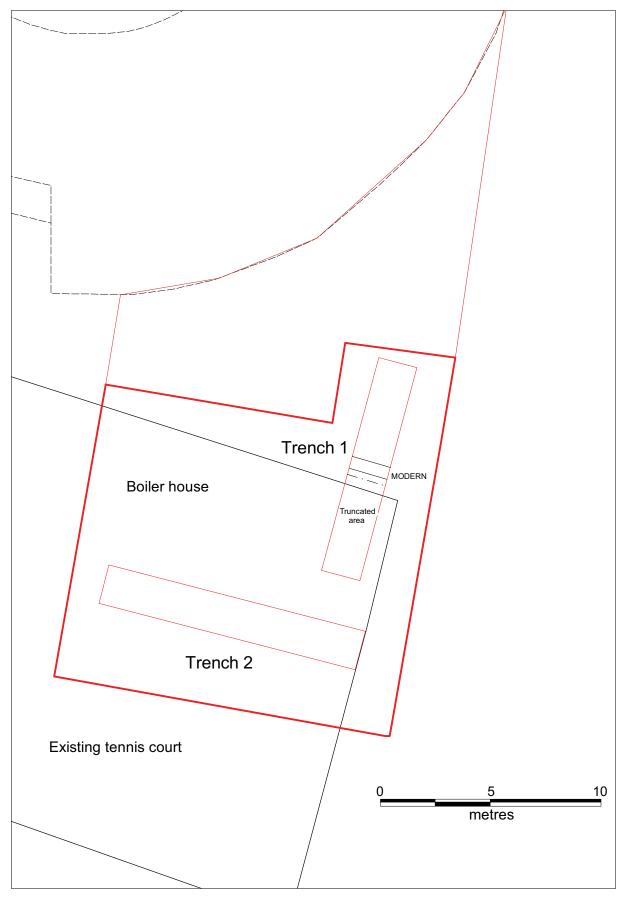
Figure 2. Evaluation trench plan

Two evaluation trenches within the proposed boiler room footprint (Fig. 2) were marked out by hand following a layout detailed in the project WSI. They were excavated by a mechanical digger, equipped with a ditching bucket, to the top of the subsoil surface or archaeological levels, under the supervision of an archaeologist. The two trenches totalled 22m in length and were 1.8m wide.

The depth of the trenching varied from 0.5m to 1.2m, depending upon the level of modern landscaping. Trenches and spoilheaps were thoroughly examined for archaeological material and cleaned as required to clarify the absence of archaeological features.

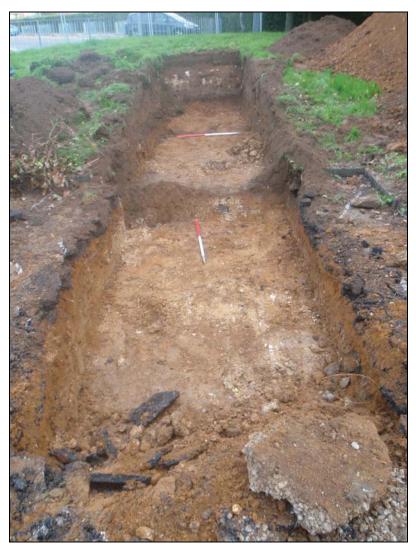
This trench measured 10m long, 1.8m wide, and was aligned north to south. The northern 6m was placed across an area of grass forming an artificially steep slope from the existing carpark down to the hardcourt playground. The southern c.4m of the trench was placed through this playground.

At the northern end the trench profile showed 0.75m of modern deposits overlying the former topsoil which was 0.25m thick. This is turn overlaid a 0.2m thick layer of mid brown silt, 0001, which sealed the natural subsoil of mid orange clay/silt and gravel. To the south the drop of the modern slope was seen to be caused by a rapid thinning of the modern deposits, with the topsoil and 0001 layer descending by only c.0.1m over the first 5m.

In the centre of the trench these layers were cut by a modern service trench and did not reappear to the south as the modern ground surface continued to descend until it met the existing hardcourt playground at a height of c.0.1m above the natural subsoil level, thereby removing the topsoil and majority of 0001.

The southern 4.5m of the trench, within the playground, saw the removal of 0.3m of modern tarmac and hardcore expose a truncated and disturbed subsoil surface at c.35m AOD. This was lowered by a further 0.2m until a clean undisturbed subsoil was exposed. The truncation had removed any evidence of the natural slope.

No archaeological features or deposits were seen at any point within the trench.

Plate 1. Trench 1 facing north

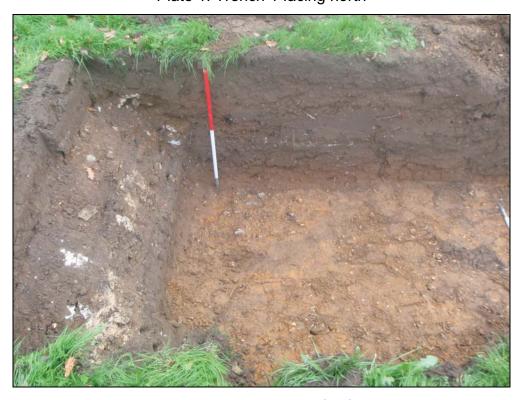
Plate 2. Trench 1 north end profile facing east

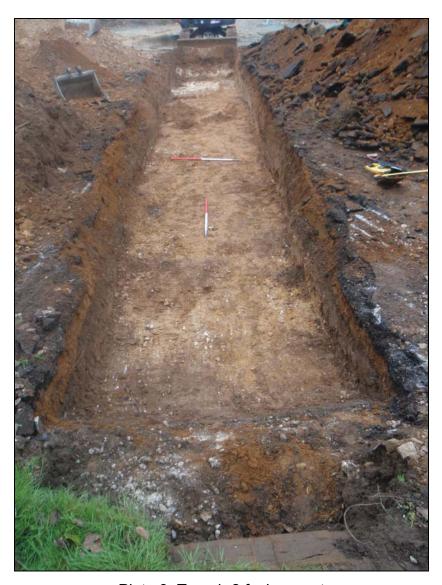
This trench measured 12m long and 1.8m wide and was aligned east to west within the hardcourt playground. The removal of 0.35m of tarmac and hardcore exposed a trace of the original topsoil, particularly along the southern side of the trench indicating the drop of the natural slope, and then 0.25m-0.4m of layer 0001, here a compacted brown silt/sand with fragments of chalk, gravel and scattered modern debris. This overlaid the undulating natural subsoil of mid yellow/brown chalky clay and gravel. Pockets of layer 0001, which infilled natural hollows in the subsoil surface, were removed by hand.

No archaeological features or deposits were seen at any point within the trench.

Plate 3. Trench 2 facing west

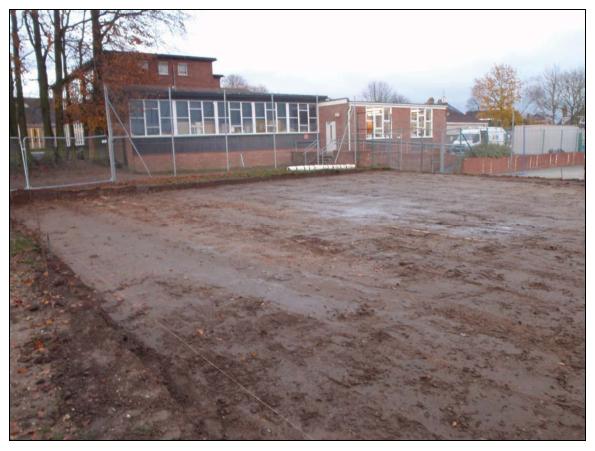
Three visits were made during the groundworks for a new playground and an access track. The site, an existing grass tennis court, was reduced to a level of 37m AOD to the north and 36.5m AOD to the south. This meant that up to 0.35m of modern topsoils, but generally less than 0.2m, was removed across the site. Across the majority of the site this meant that the topsoil was not fully removed. In the small areas where the topsoil was wholly removed a mid brown/orange silt/sand was exposed, presumably being a similar deposit to 0001.

The groundworks therefore were not deep enough to expose either the natural subsoil or potential archaeological horizon. It is possible that archaeological deposits remain *in situ* beneath the new playground although it is also unclear how much disturbance has been caused by landscaping of the natural slope.

Plate 4. Tennis court site strip, facing north-east
