## **ARCHAEOLOGICAL MONITORING REPORT**

**SCCAS REPORT No. 2010/137**

# **Land to Rear of 82 Guildhall Street, Bury St Edmunds BSE 295**

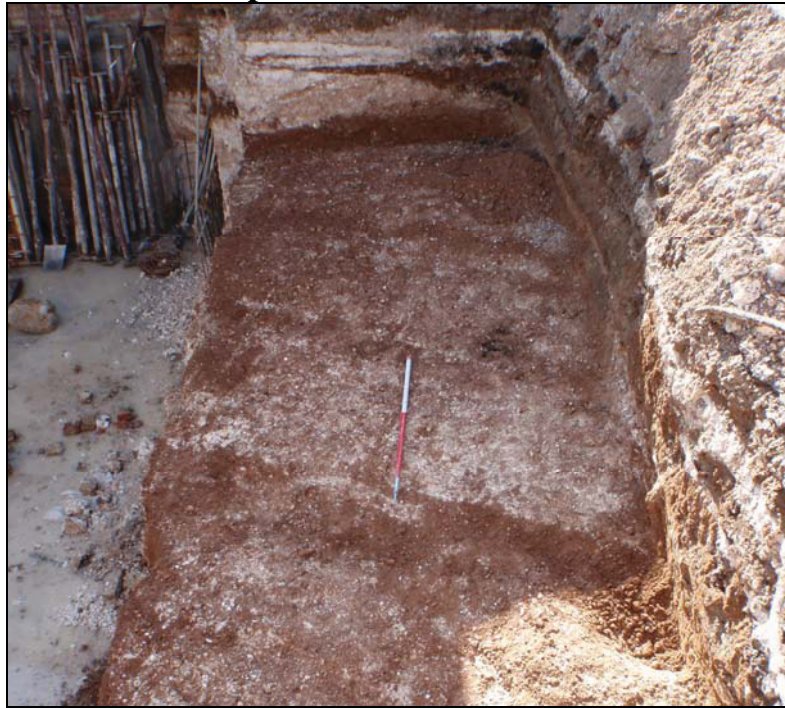
The earliest material on the site was soil layer 0024 that was sealed beneath the bank when the medieval town ditch was excavated. A small area was exposed by machine and an area measuring 3m x 1m was excavated by hand (Fig. 2 A and Pl. 1). This homogenous brown layer produced no finds although there were small flecks of charcoal. It was directly above natural chalk although it did fill a series of parallel shallow striations into the chalk. This layer is interpreted as a medieval plough soil that was buried by the bank created when the town ditch was excavated in the 12th century.

Plate 1. Facing south, parallel lines can be seen in the top of chalk below the soil beneath the town bank.  
The tail of the town bank can appear in the far section.

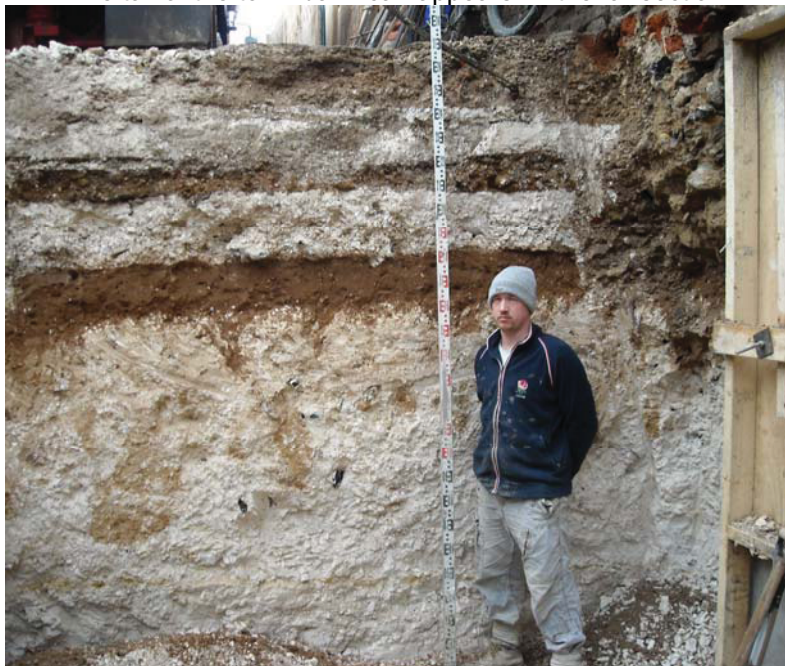
Plate 2. Facing west, buried soil can be seen sandwiched between natural chalk and the chalk cast up during the excavation of the town ditch.

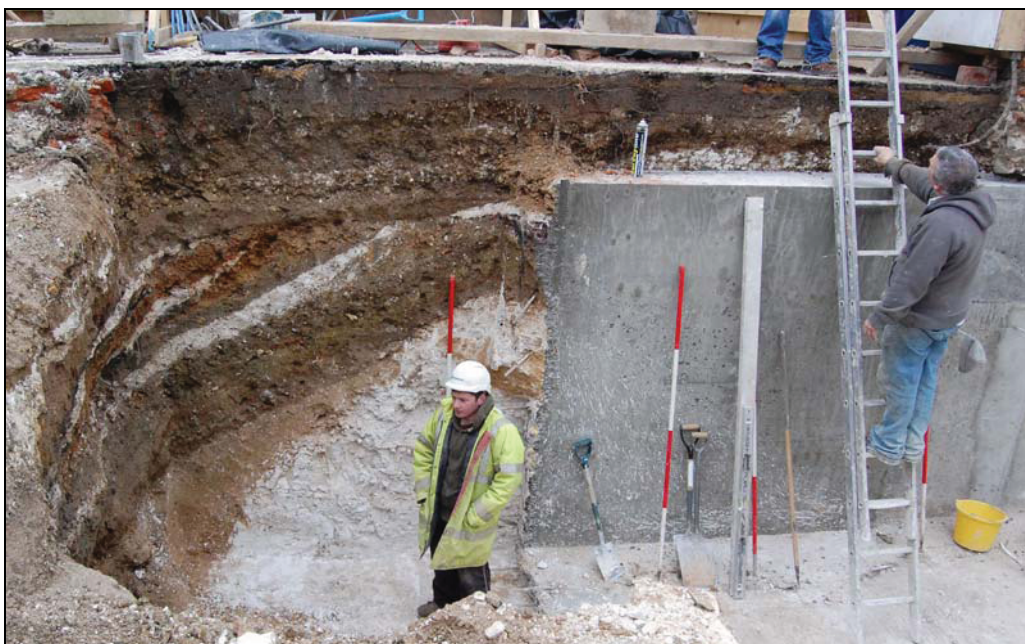
Figure 2 Plan A, Figure 3 and plate 3 show the ditch section 0039. The most complete section of the ditch was recovered on the north side of the plot. The section did not extend to the bottom of the ditch although a separate deep footing was excavated by machine to the top of natural chalk on the edge of the property. The ditch was cut at an angle of c.45 degrees from the top of layer 0024 for about 1.2m before dropping away at a steep angle of c.70 degrees; it was traced within the excavation to a depth of 2.2m and a further hole was followed to an approximate depth of 4m (suggesting a depth of c.5m from the modern ground surface). The lowest fill of the ditch was of fine silt with occasional flecks of charcoal. Layer 0036 also contained charcoal flecks within a green crumbly fill, possibly the remains of cess or similar organic fill. Above this a grey silt layer, 0035, contained oyster shell, animal bone, (not kept) and pottery, which is dated 16th to 18th century. Above this layer was chalk and further backfilling with general rubbish. The first layer above the ditch that does not slump in to the top is 0026 and this extends as far as the line of the former town wall. This layer, and chalk layers 0027 and 0028 that were above it, are likely to be successive surfaces of the enlarged St Andrews Street.

Plate 3. The south facing section through part of the town ditch. The gravel layer above the ditch is the old surface of St Andrews Street.

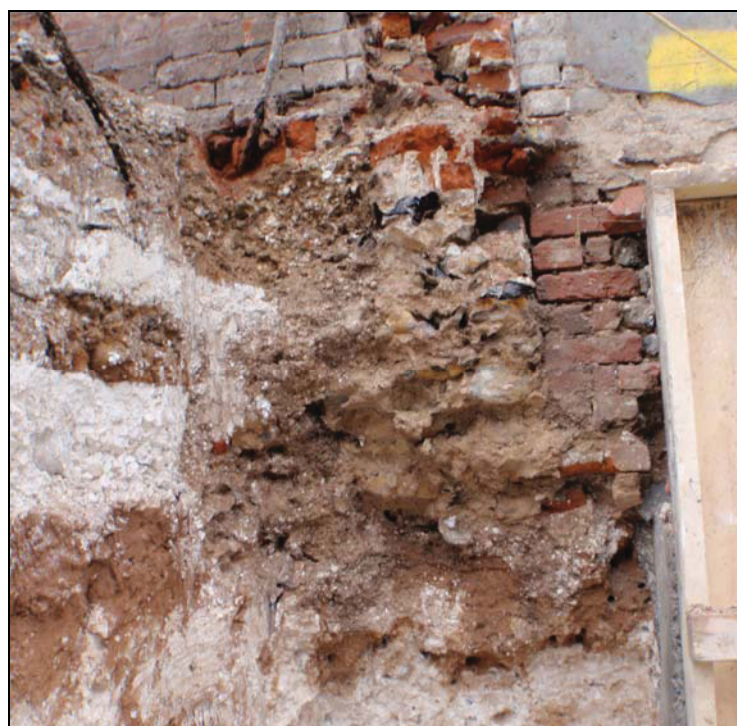
The line of the medieval town wall was maintained as a property boundary (Statham 1988) and the line would follow that of the wall indicated on Figure 2A and Pl. 4. The

evidence from this section reveals a foundation trench, 0031 and a wall foundation 0033. Although predominantly of flint and mortar both contained occasional brick fragments indicating that neither is likely to have been part of the original wall (possibly they relate to the buildings that were demolished before the stables were built). At the south end of the property a stub of earlier wall can be seen with no foundation trench (Pl. 5). It would appear to be separate to the stable wall that was built on top of it.

Plate 4. South facing section of wall and the footing trench that was dug into the bank on the north side of the site. The wall perpetuates the line of the original town wall.

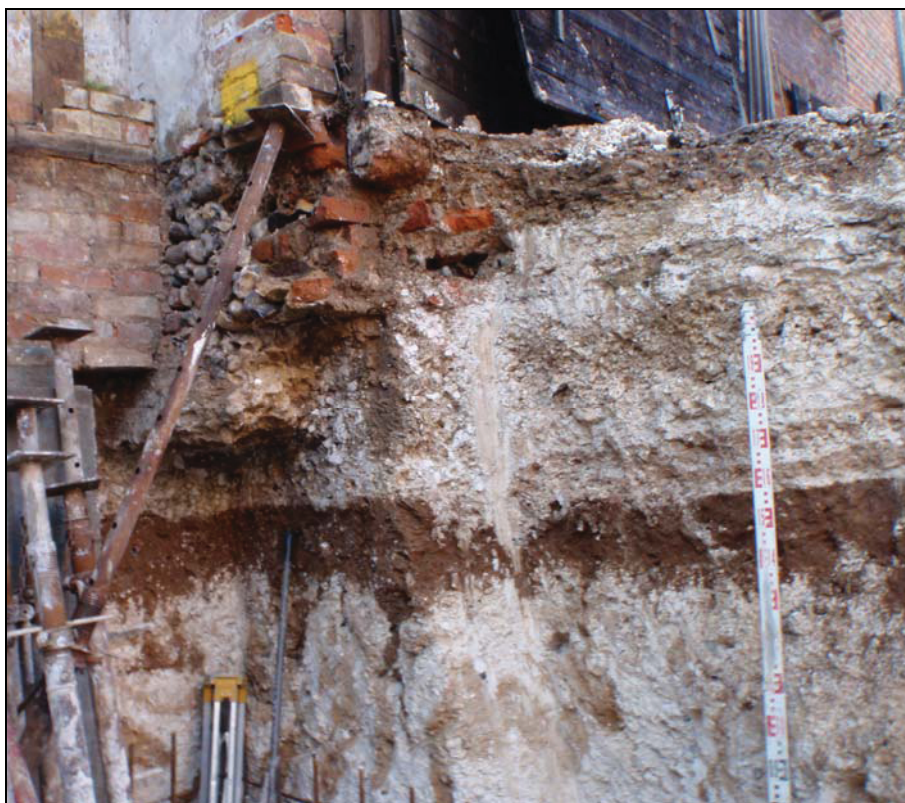
Plate 5. East facing section along the line of the old town wall. There is no footing trench with the flint and mortar wall, which may be the stub of the medieval wall.

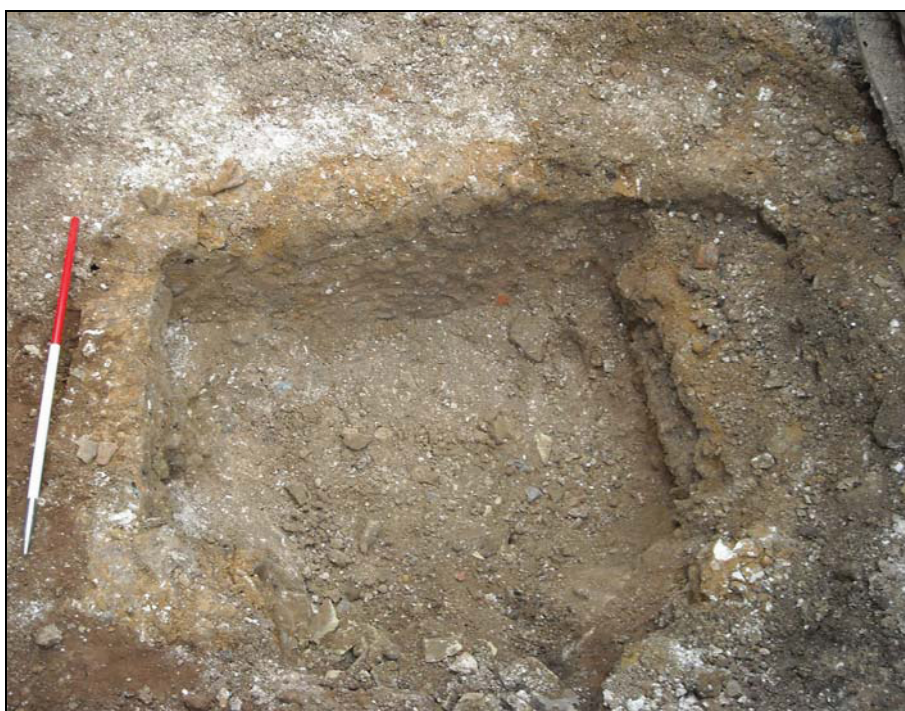
Built close to well 0017 and possibly replacing it was Well 0021 (Fig.2B and Pl. 6 and 7). It was c.95m wide and 2m in length and was unusual in being rectangular, with an apsidal south end. The western edge was supported by bricks, which were sampled and indicate the re-use of medieval bricks.

Plate 6. Flint-lined well 0021 looking east.

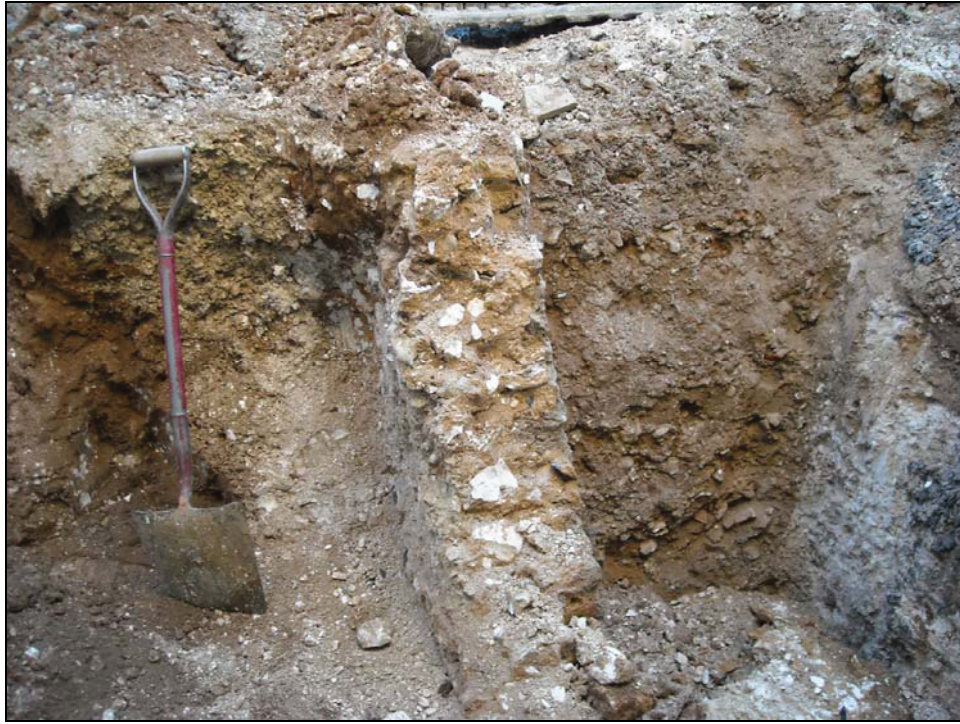
Plate 7. Section through well 0021 looking south. The fill of the well is on the right with part of a construction trench behind that was filled with clay.

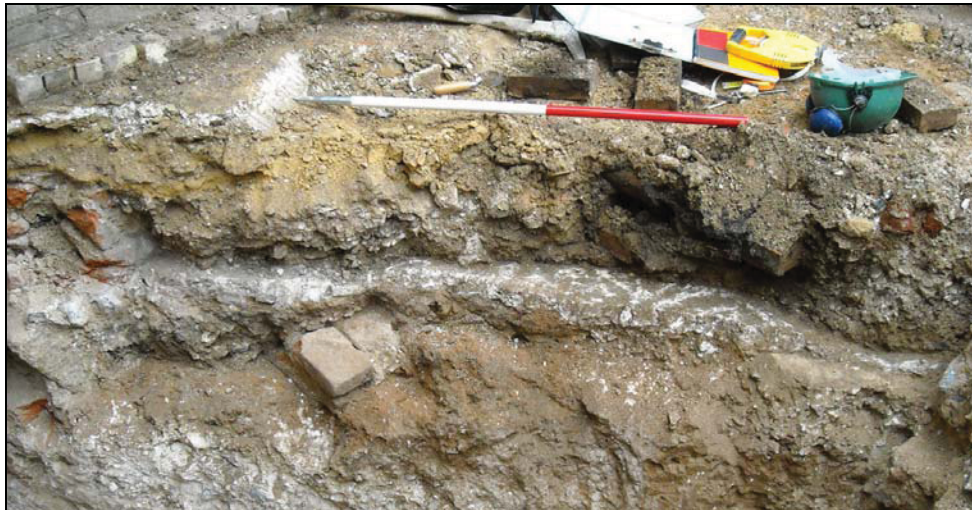
Ditch 0009 was replaced by a flint wall that was built in the ditch. It was constructed in two sections; the eastern length of the wall, 0007, was c.0.7m wide and this narrowed to 0.5m, 0006, to the west. The point at which the width changed had been removed by a later drain but aligned with this disturbance was an insubstantial alignment of unbonded bricks c.1.5m from the eastern wall 0002 and associated with cut 0016; these appear in Figure 2 (B), Figure 3 Section 2 and Plate 8.

Plate 8. Detail of Section 2 (Fig. 4). Unbonded bricks 0002 can be seen sealed beneath chalk floor 0005. The edge of wall 0007 can just be seen to the right and wall 0012 to the left with bricks from the stable floor 0010 visible at the top left. The scale is 1m.

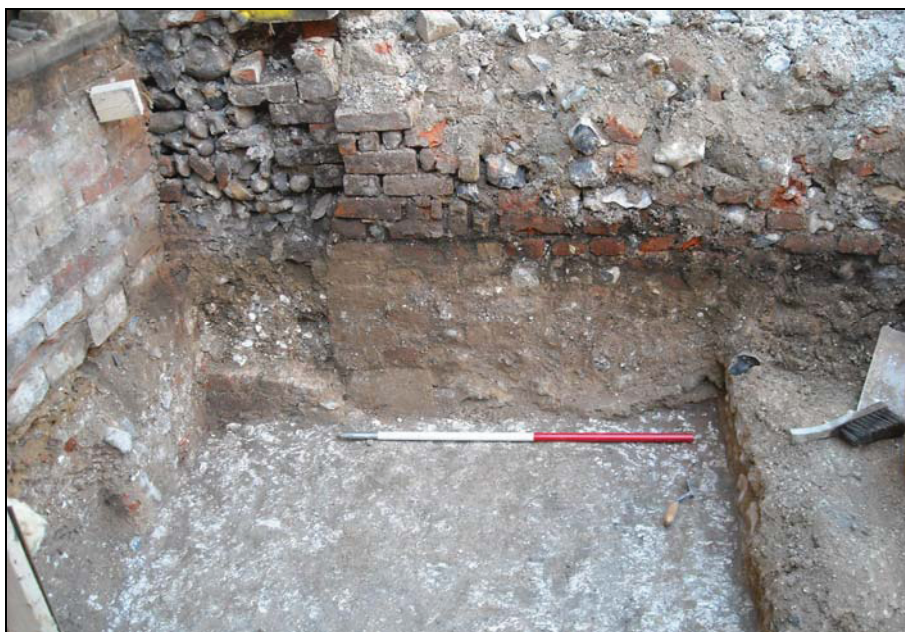
On the south side of the flint wall was a chalk floor, 0005, (Pls. 9 and 10) that was laid over a bed of loose mortar (Fig.2B, Figs. 3 and 4, Sections 2-4). It was c.0.5m thick and very evenly spread and overlaid bricks 0002. From the quality of the chalk surface and the spread surface beneath this was almost certainly an internal floor associated with a building that ran off wall 0007.

Plate 9. Chalk floor 0005 against the line of the town wall facing east with south facing wall 0007 to the right. The scale is 1m.

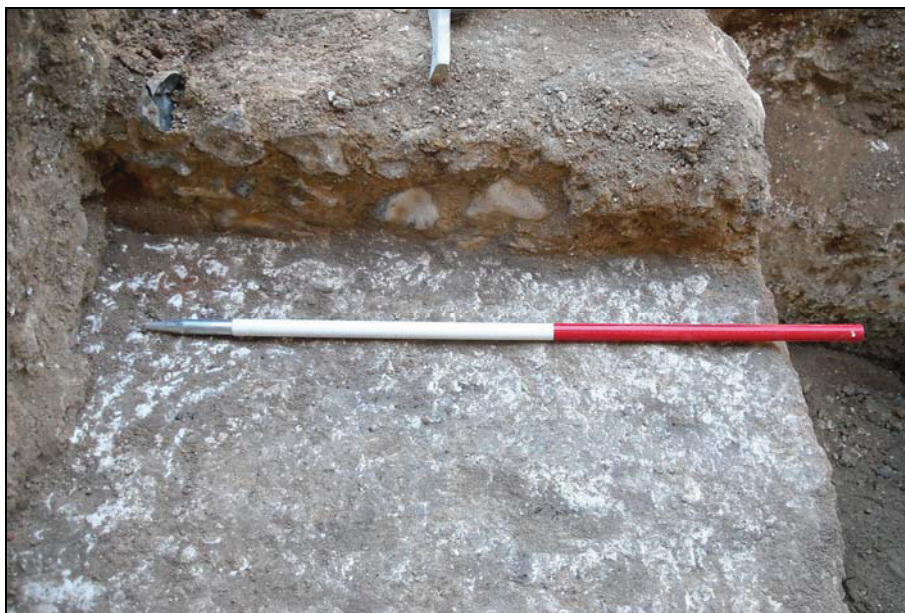
Plate 10. Chalk floor 0005 against wall 0007 facing south. The scale is 1m

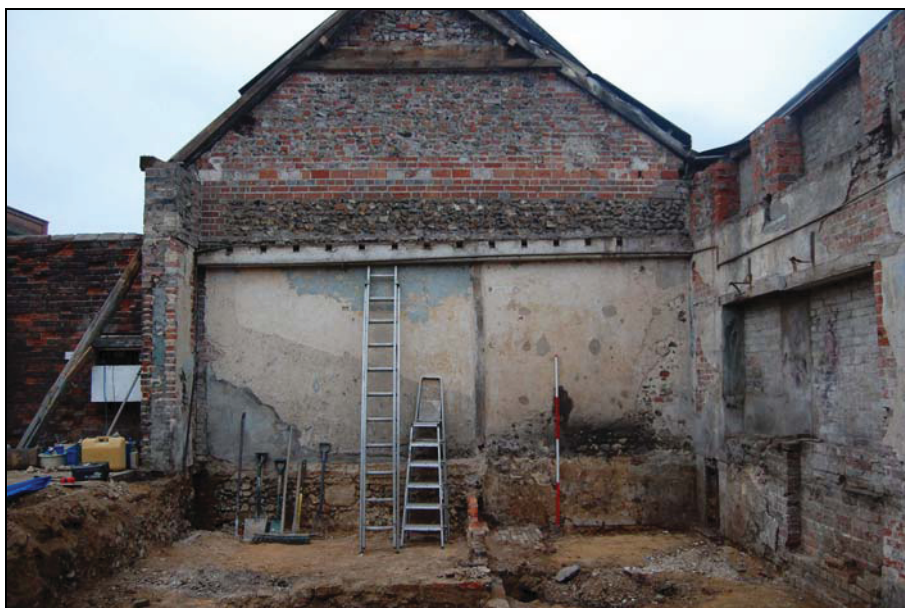
Plate 11. South facing stable wall showing height of the stable block and the collar roof which allowed more space in the hayloft. The scale is 2m.

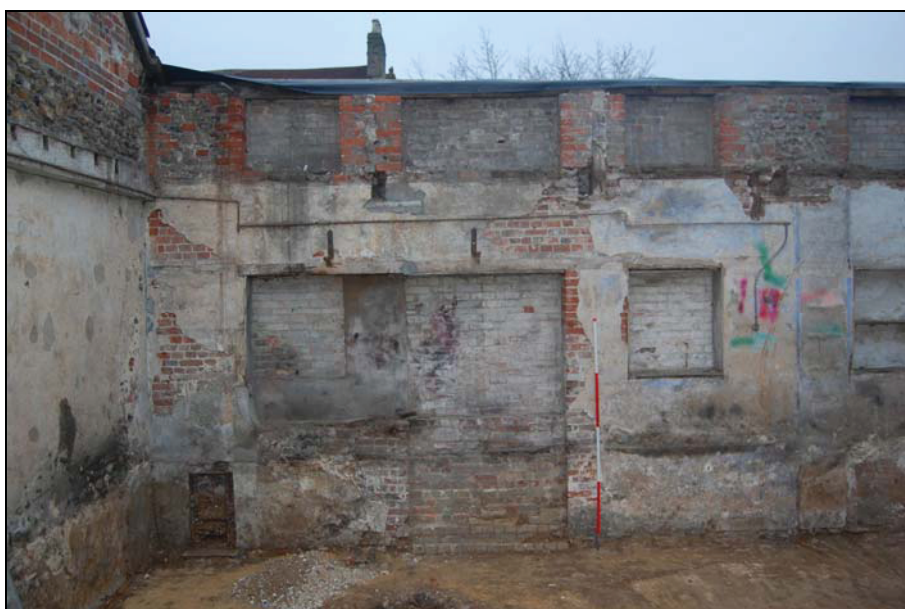
Plate 12. West facing stable wall showing fireplace to the left and bricked in entrance straight ahead. The scale is 2m.

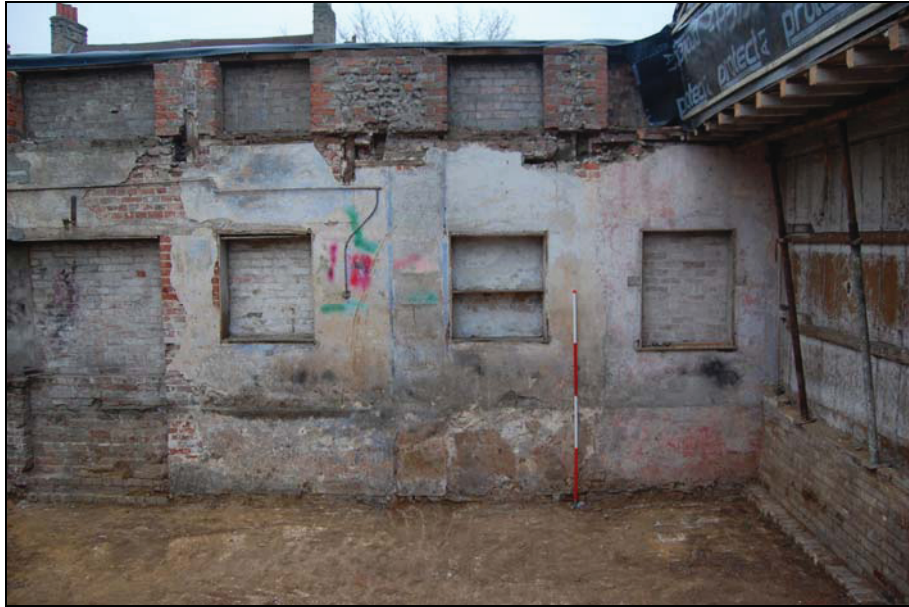
Plate 13. South end of east facing stable wall with bricked in openings prominent and 'watermark' where the floor level was raised. The scale is 2m.

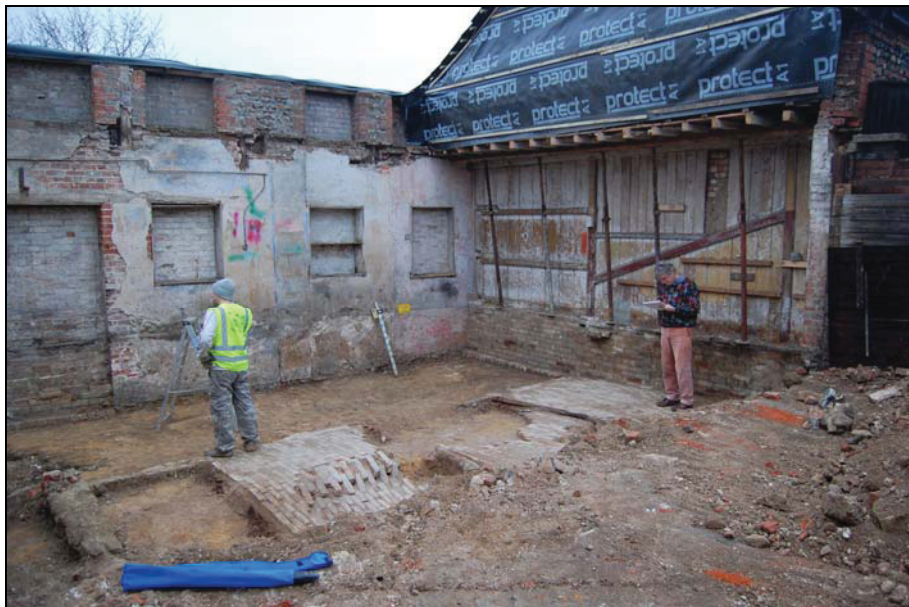
A partition wall was built on the south side, firstly with white bricks up to the level of St Andrews Street and subsequently of wood. Presumably coinciding with the sale of the property, the openings on the east wall were all bricked in and all access must then have been from St Andrews Street South. The arrangement to the present records the development in the 20th century of the motor car.

Plate 14. Subdividing south wall of the stable block with bricks to the level of the raised floor and a wooden partition above. The scale is 2m.

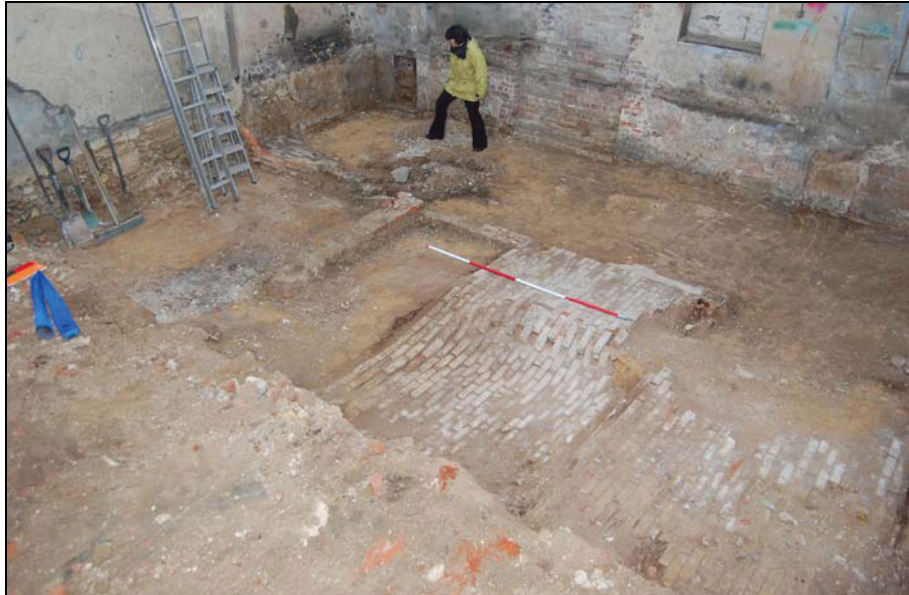
The third and last well to be built on the site was 0040 which partially straddled the old property line of the town wall. This well had a brick surround and contained brick rubble and rusty iron in the top of the backfill. It was responsible for substantial subsidence in the floor of the stable block, which was built over the top and it is clear that it must have been infilled during the 19th century.

Plate 15. Looking down into the stable with floor bricks still in place. A slump in the bricks in the centre of the photograph is due to the last well on the site 0040. The scale is 2m.

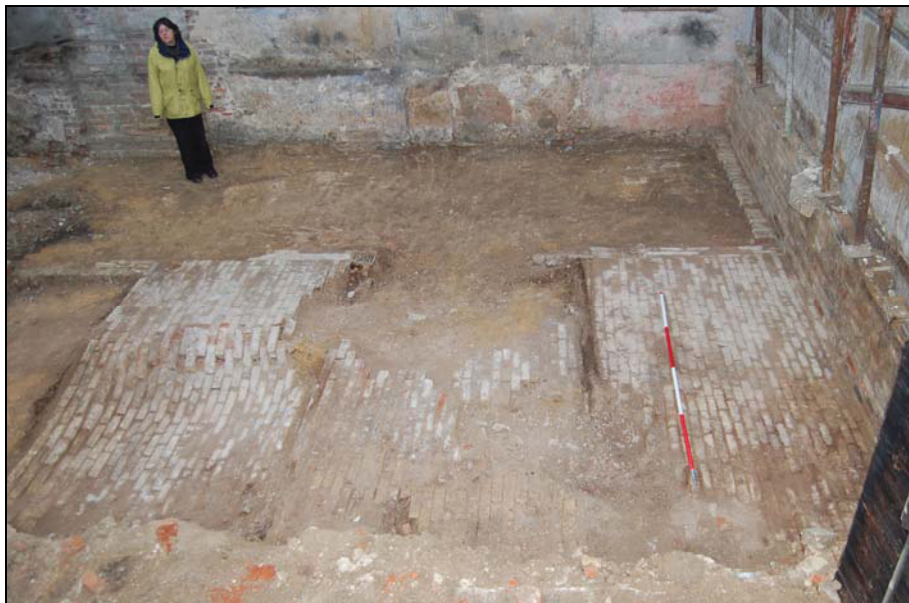
The plan of the stable indicates a series of stalls on the west side divided by wooden floor plates to support partitions. There was a smaller space adjoining the possible tack room in the north-west corner. A drain ran the length of the stable. It would appear from the standing building that there was a larger entrance at the south end of the stable block facing west, which was wide enough for a carriage. On a detailed OS map of Bury St Edmunds c. 1880 (not illustrated) angled retaining walls lead from the south end of the stable block onto St Andrews Street; this is presumably on an incline that accounts for the difference in floor level between the stable floor and St Andrews Street. The level of the stable block has since been raised and a lowered doorway for vehicular access remains. The whole stable block is separated from No.82 Guildhall Street by a north-south garden wall but with access from No.81 via the main house and through the adjoining wall to the rear.

Plate 16. Wooden ground beams can be seen dividing the stalling. The scale is 2m.

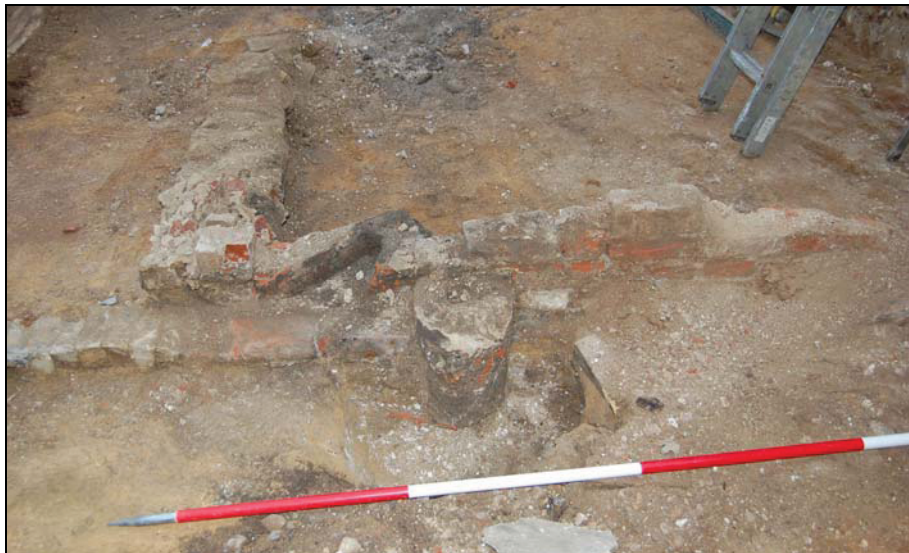
Plate 17. facing west, the base of the spiral staircase between the putative 'grooms' room and the 'tack' room.

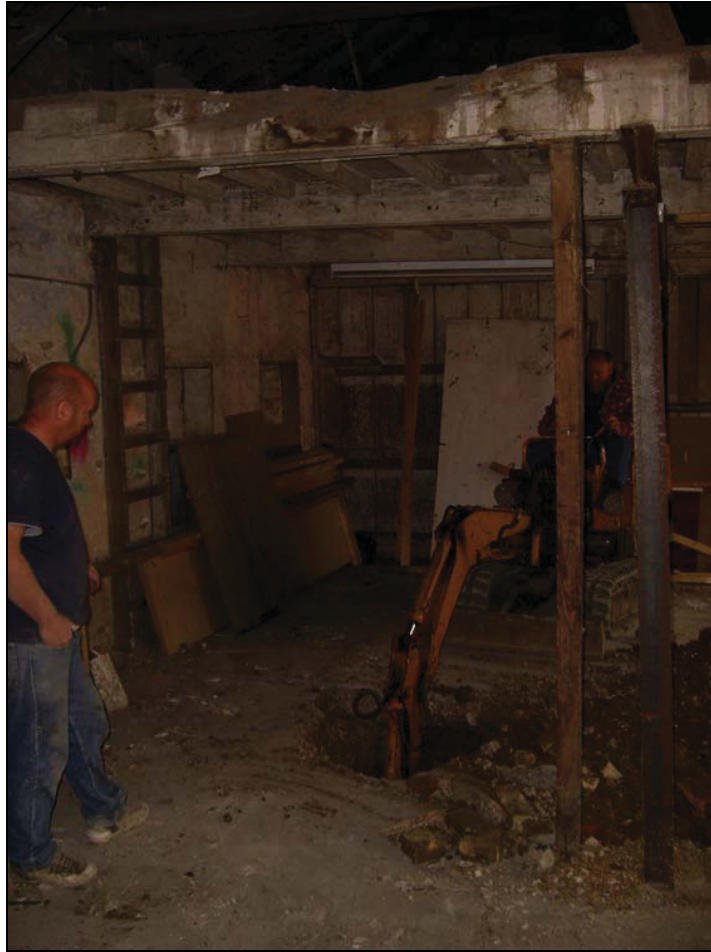
hayloft floor and the supporting tie beams can be seen against the east wall and also the remains of the fittings for a gas light below. The image of a ladder providing a second access to the hayloft along the east wall was made when the rendered surface of the wall was painted. The partial buried ladder was visible within the old garage, (Pl. 19).

Plate 19. Trial hole excavated in 2009. The ladder to the hayloft appears to the left of the frame.

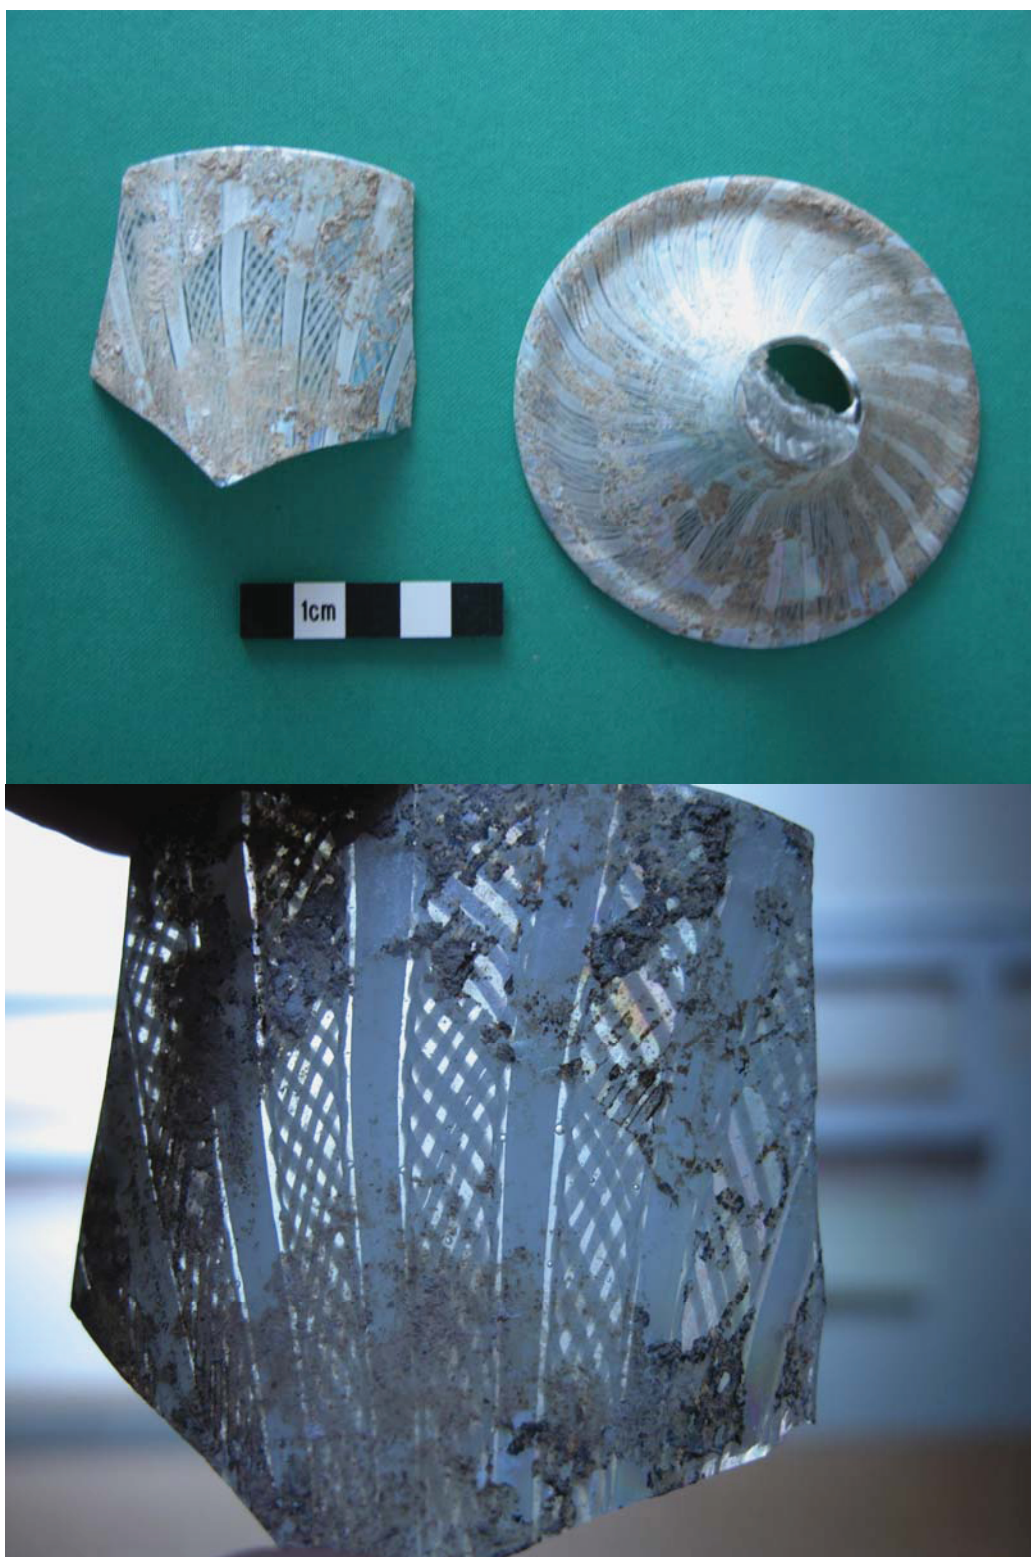
Two fragments of a highly decorated glass pedestal goblet were recovered from ditchfill 0003 (SF1001). The remains of the rim (diameter 140mm) and a complete pedestal base (diameter 94mm) were excavated. The vessel was made in *façon de Venise style* and is decorated with alternating *vetro a fili* and *vetro a retorti* strips (Pls. 20-21). It was probably made in Antwerp and dates to around the late 16th century.

Plate 20. Fragments of a glass goblet SF(1001). The vessel was made in *façon de Venise style* and is decorated with alternating *vetro a fili* and *vetro a retorti* strips. It was probably made in Antwerp and dates to around the late 16th century.
