ARCHAEOLOGICAL SURVEY REPORT

SCCAS REPORT No. 2010/156

Bridge at Sibton Abbey, Sibton

SBT 034

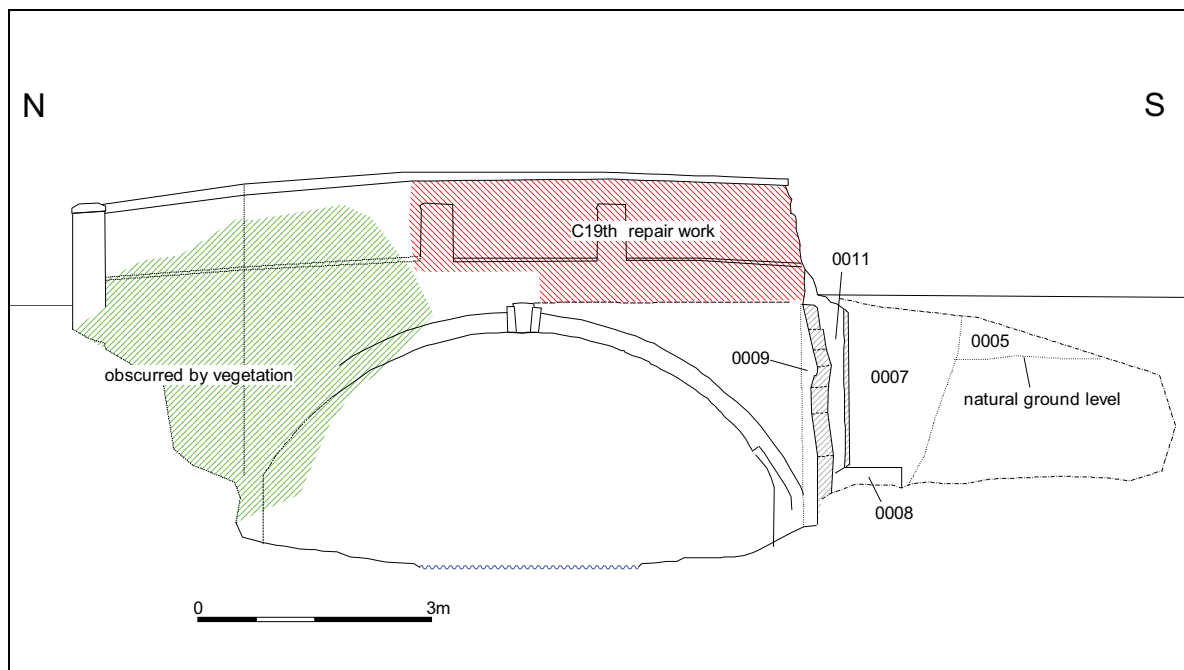
Figure 4. Sibton Bridge, west elevation

side. The areas of repair can be identified in the appearance, bonding and size of the bricks and are shown on the elevation drawings (Figs. 4 and 5).

The original structure was built in plain brick made from fine sandy textured clay with grog inclusions which were fired orange-red to purple red and measured $9\frac{1}{4}" \times 4\frac{1}{4}" \times 2\frac{1}{4}"$. The bricks are laid generally in Flemish bond but the pattern varies as required by the shape of the arch or engineering demands. The bricks are bonded with a white lime mortar and there are traces of mortar on the brick face in several places (Pl. 3) suggesting that it once may have been rendered, possibly to create the illusion that it was made of stone. In the more recent past the west elevation has received a concrete render in a misguided effort to consolidate and protect the fabric.

bridge has collapsed before. It was constructed from a mix of re-used brick salvaged from the original and a red-buff coloured brick which measure a standard 9"x 4¼"x 2½" and are moulded with a shallow square frog suggesting that they date from around the middle of the 19th century (Plate 8). The bricks are bonded with lime rather than a mortar based on Portland cement which would be expected in this application had it post-dated the end of the 19th century. The repair included the parapet wall (0012) and the start of the repair can be seen as a row of brick headers just above the crown of the arch. The wing was constructed without deep foundation but off a simple stepped footing, the base of which comprised a single course of dry-laid, un-bonded bricks, laid on the river bank. In an attempt to ameliorate the design against further collapse a projecting wall (0009) was added in front of the wing to funnel the river through the arch, with the angle between the projecting wall and the wing in-filled with brick rubble. Later a concrete apron was added to the base of the projecting wall in an attempt to stop it being undermined.

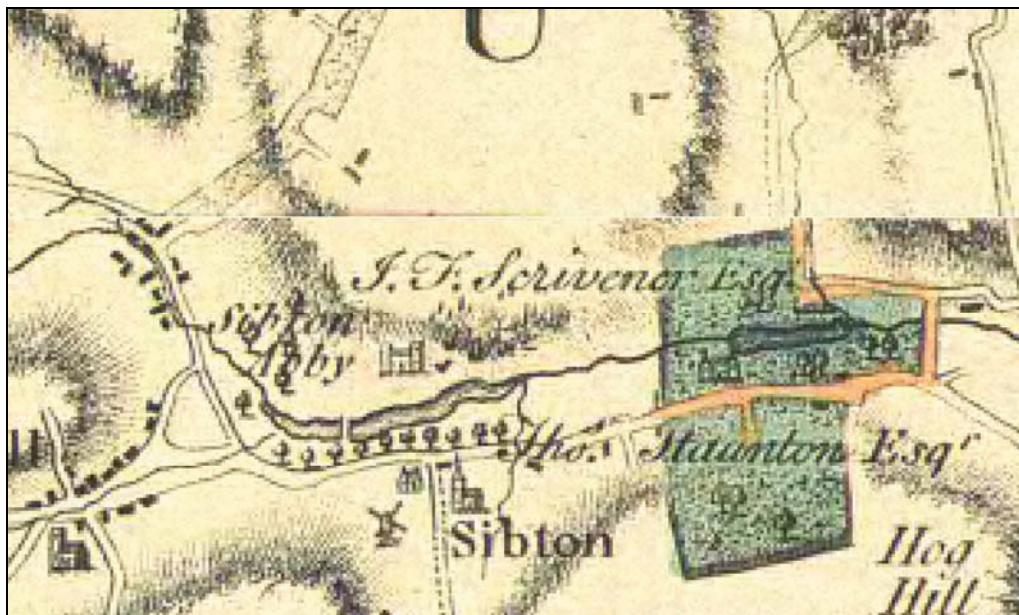
Figure 8. Hodskinson's Map of Suffolk 1783 showing the great house at Sibton Abbey. Note an increase in width of the river in front of the house.

The current bridge was built in 1770 by John Freston Scrivener Esq. to replace the previous bridge which was built as part of Sibton Abbey. The bridge would have been visible from the house which the Scrivener family had had built on the site of the abbey during the first half of the 17th century. Hodskinson's map of Suffolk published in 1783 (Fig. 8) shows the river swollen to a wider body of water as it passes through the park, and the elegant new bridge would have been designed to contribute to this enhanced vista as well as providing access to the house. There are vestiges of a render on the surface of the brickwork of the bridge and it may have been finished to look like stone.

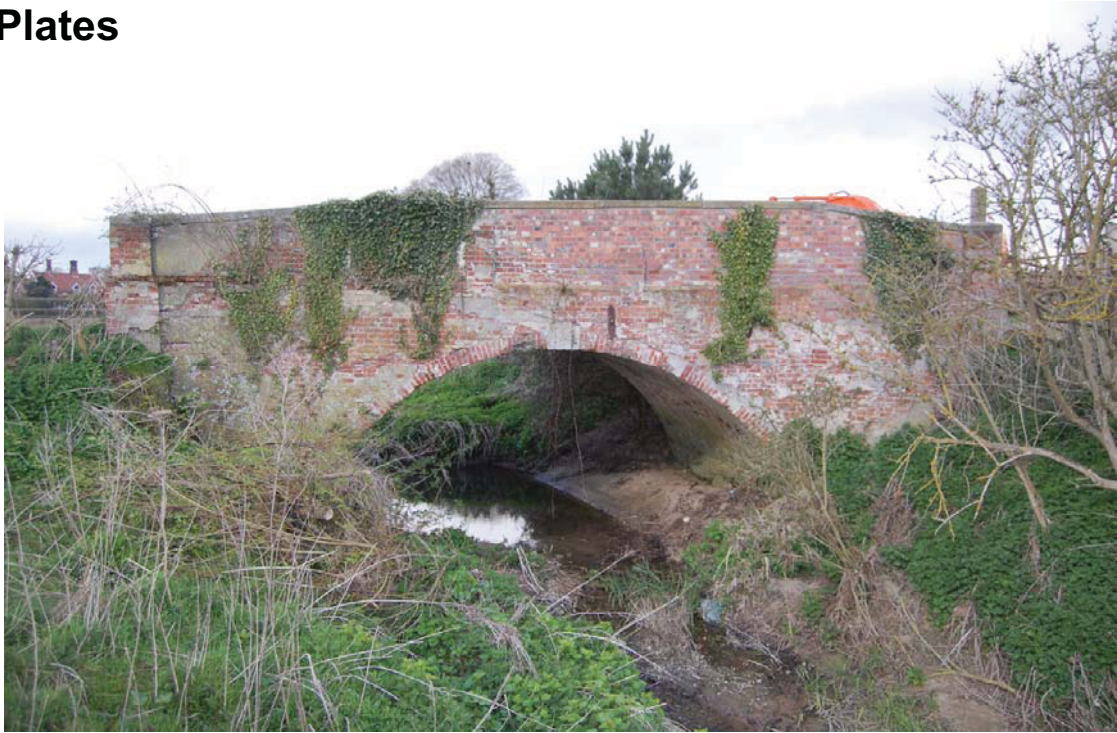
The current bridge is a brick-built, single segmental arch with a span of 6.15m (20' 2" ft), and the arch springs from a low abutment of five brick courses high and rises 2.98m above the current water's surface (Pls. 1 and 2). It does not cross the river at right angles but at a slight angle to it. The width of the bridge between the parapets is 3.83m (12' 4"ft), the parapet walls are 1.4m (4' 3"ft) high and splay at the entrance to the crossing. The bridge is constructed entirely in red brick apart from coping stones along the top of the parapet walls and the keystones which are cut from a pale oolitic limestone. The keystones are inscribed 'JS' after John Scrivener and dated 1770 (Pl. 3). Most of the surviving fabric originates from this date but there have been several phases of repair to the parapet and the replacement of the upstream wing on the south

Plate 1. The 18th century bridge to Sibton Abbey over the River Yox, from the east

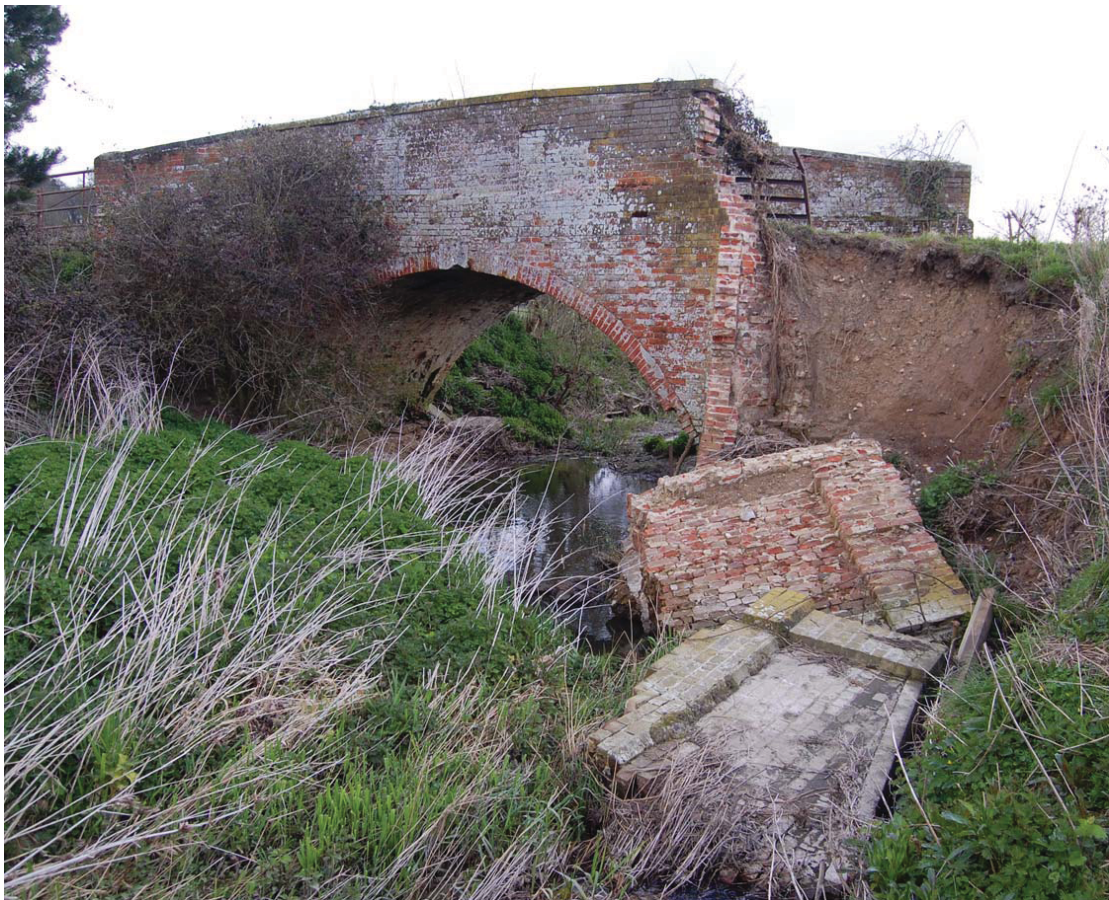
Plate 2.
View from the west showing the collapsed parapet and wings. The slumped bank is shown in the foreground on the left prior to its removal.

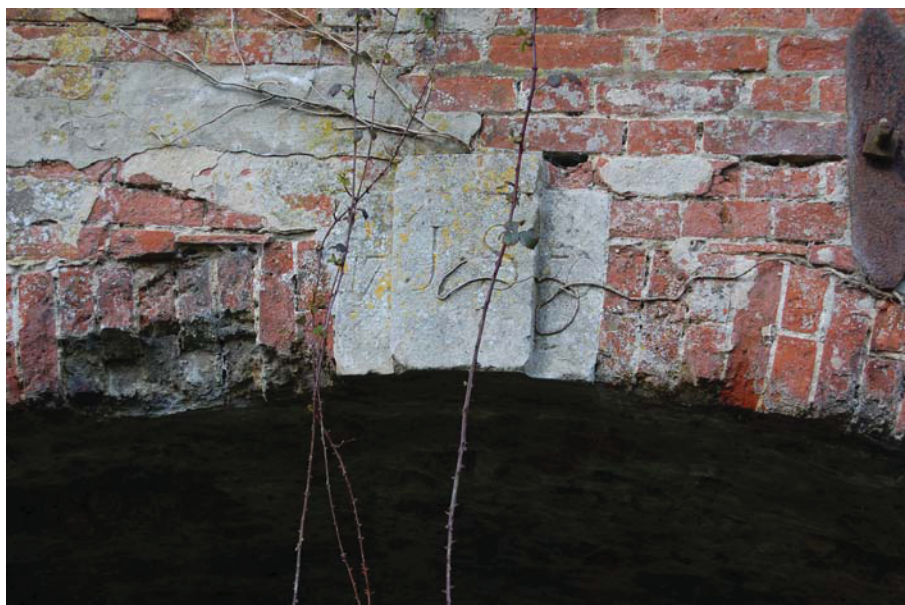
Plate 3.
Commemorative keystone inscribed 'JS 1770'. Note remains of a lime render on the surface of the bricks pre-dating the concrete screed.

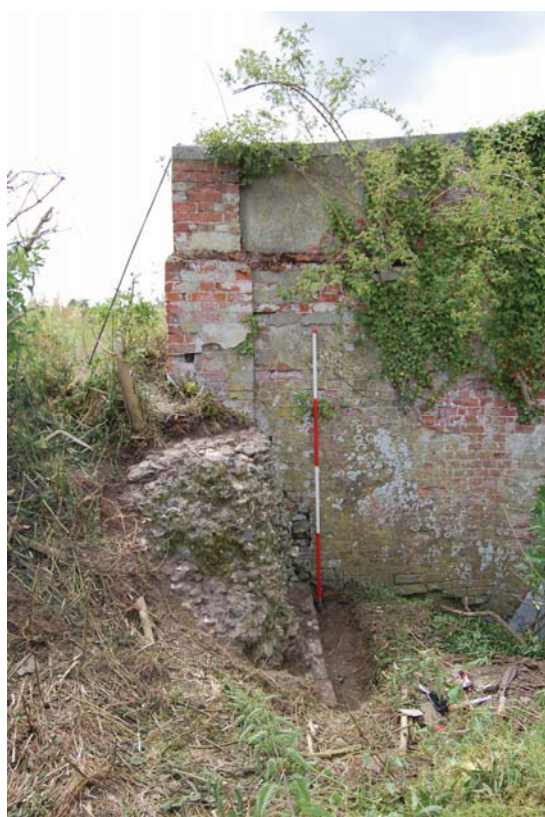
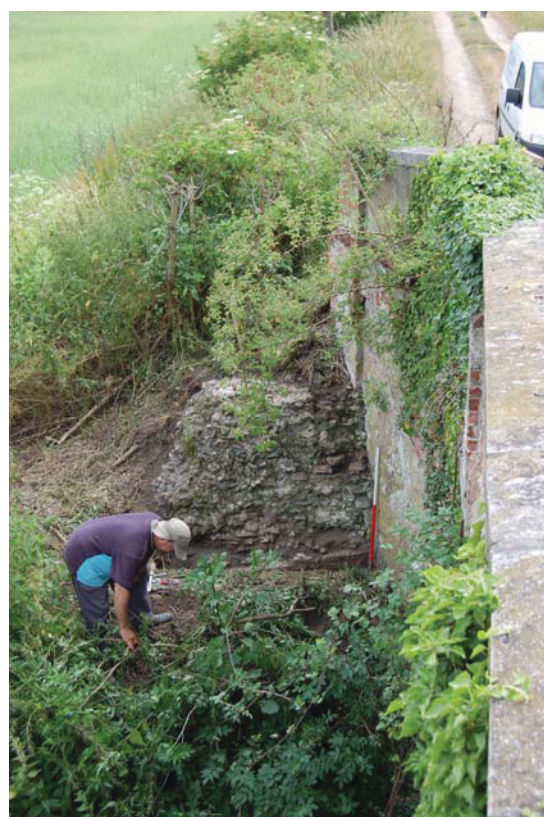
The remains of a flint-built abutment (0002), part of the former bridge, exist on the south bank. The remains lie alongside the east side and are partly buried by the current bridge with the top of the abutment truncated at 0.6m below the level of the current trackway. The abutment consists of a 1.20m thick wall part buried in the bank and set 1.55m back from the abutment of the current bridge and river edge. The fragment has lost almost all of its facing masonry and appears as a rough block of bonded flint, but at its base at least three courses of the former brick facing, remain intact (0003). The bricks were plain, handmade in a red–purple firing sandy clay with burnt flint inclusions and measure 10"x 5⁵/₈"x 2", and were laid in English-bond. Brick and roof tile were also laid in bands within the core to help stitch the flintwork together. The abutment face is best preserved where overbuilt by the current bridge (0004) and rises vertically for a height of 1.1m, at which level there is no indication of the start of an arch. The

Plate 4 and 5. The flint-built core of the medieval bridge abutment on the east side of the 18th century bridge. The remains of the brick facing can be seen next to the bottom of the ranging pole. The picture on the right shows the sloping side of the causeway aligned with the abutment edge.

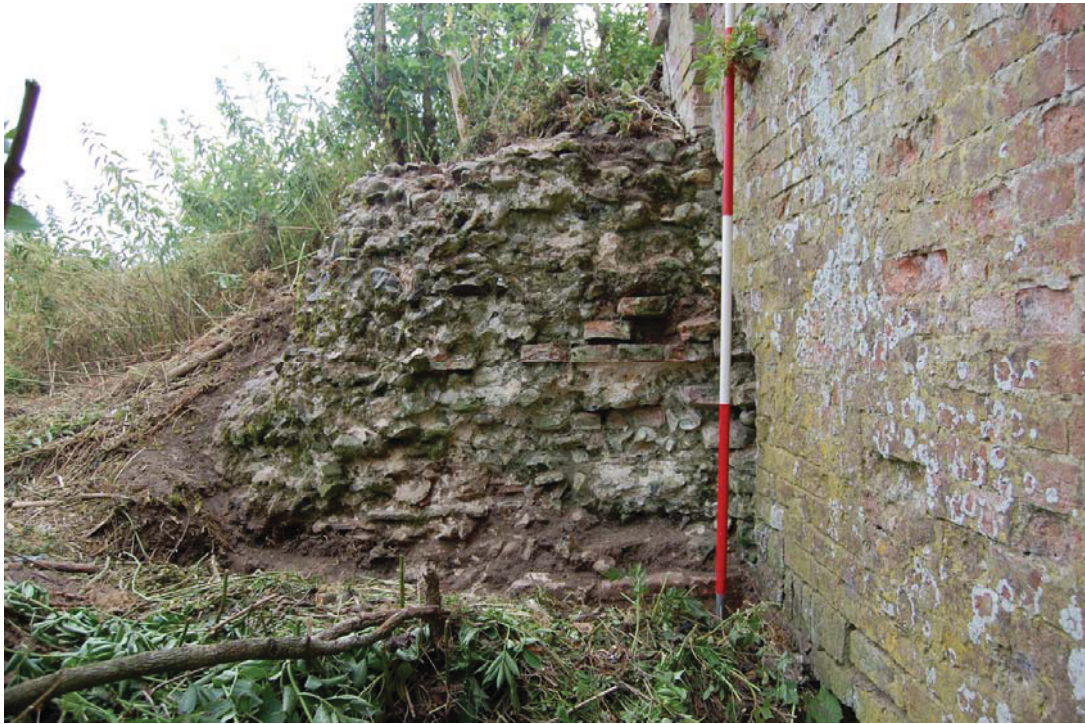
Plate 6

The medieval bridge abutment projecting from the east side of the bridge looking from the north bank

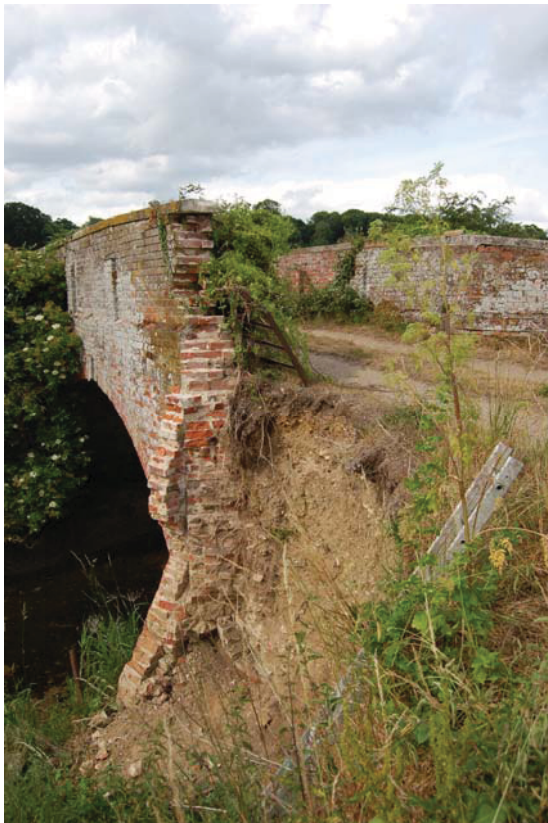
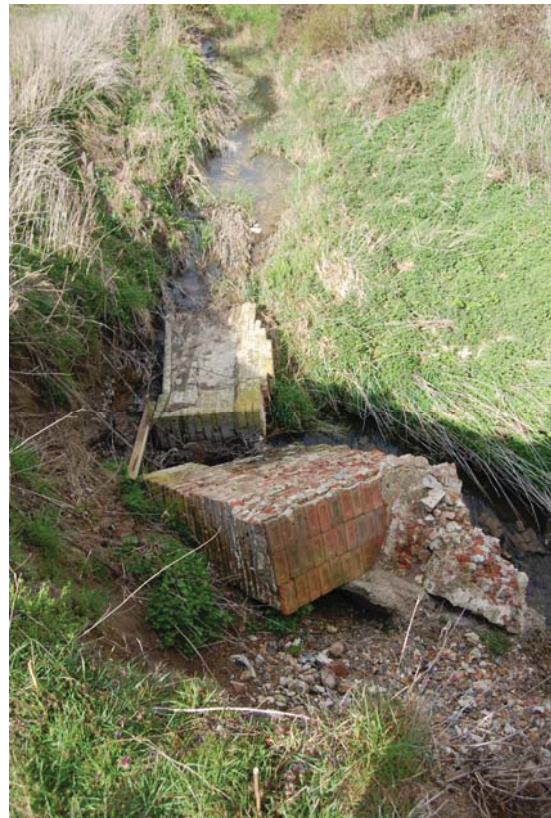
Plates 7 and 8

Truncated south end of the west parapet and the detached parapet and bridge wing lying in the river. Note the absence of mortar on the base and between the joints of the 19th century frogged bricks at the base of the collapsed section. Photographed prior to the removal of the slumped bank.

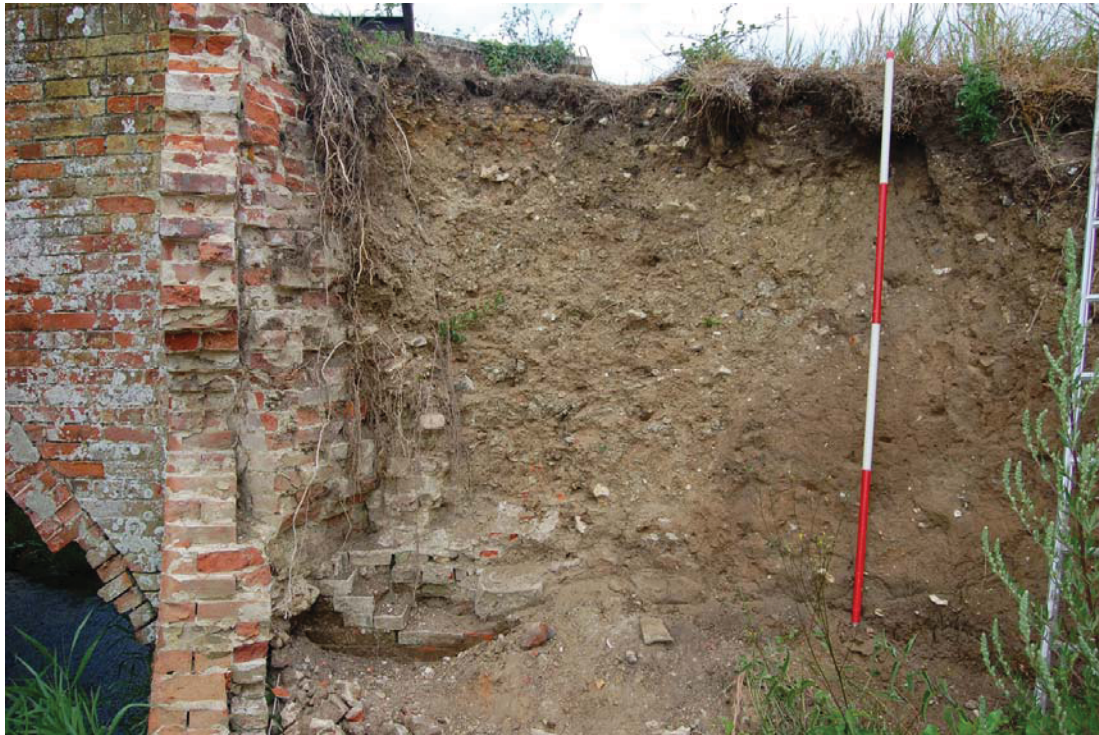
Collapse of the wing exposed the soil behind the south abutment (Section 0010 Fig. 6); this showed the soil profile of the causeway (0005) and where it, and the river bank, were cut back to construct the bridge (0007). At the base was a short stub of a bonded brick wall (0008), which is the return of the abutment wall which extends back from the bridge to secure the abutment into the bank. The

wall is a continuation of the line of the west face of the arch, the top of the wall stub is truncated (or unfinished) and it is unclear if the wall once extended to the full height of the bridge and is the remains of the original 18th century wing and parapet. Once the bridge was completed, the 'construction pit' (0007) was backfilled with spoil containing fragments of brick rubble and building flint from the earlier bridge and re-deposited clay silts from the river bed; and these lay in banded tip lines.

Plate 9.
Section through the causeway showing the construction cut for C18th century bridge. The C18th abutment where the bridge is keyed into the bank is at the base of the section. The projecting wall on the left was added to the bridge in the 19th century when the parapet and wing were rebuilt after a previous collapse.

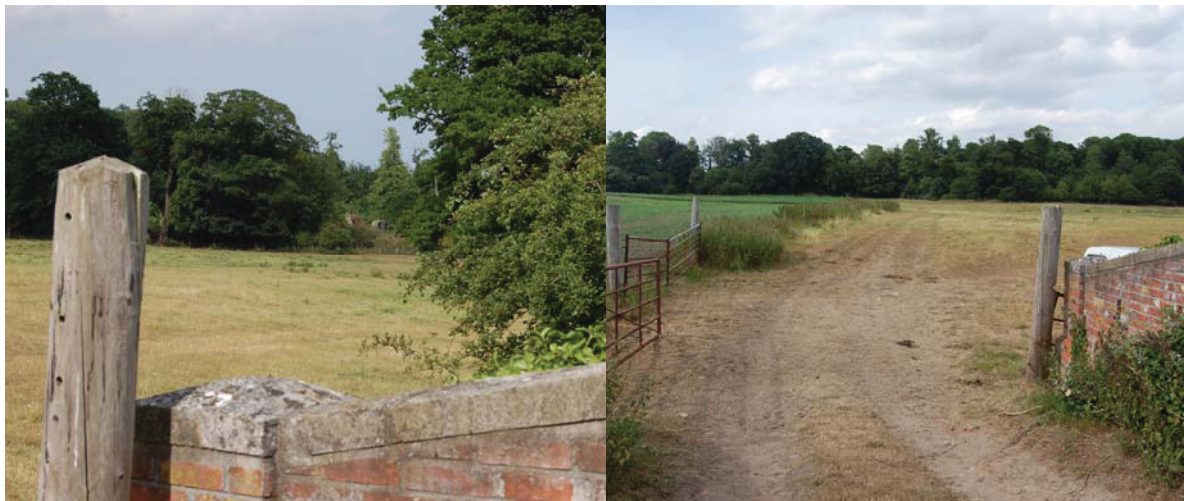
Plate 10 and 11.
Left: View of the remains of Sibton Abbey taken from the bridge. *Right:* General view of the north side of the river. The topography shows no indication of an approach to the medieval or former roadway.
