**The Stable Block,
Dalham Hall,
Dalham, Suffolk
DAL 027**

Historic Building Record

OASIS ref Suffolk c1-862249

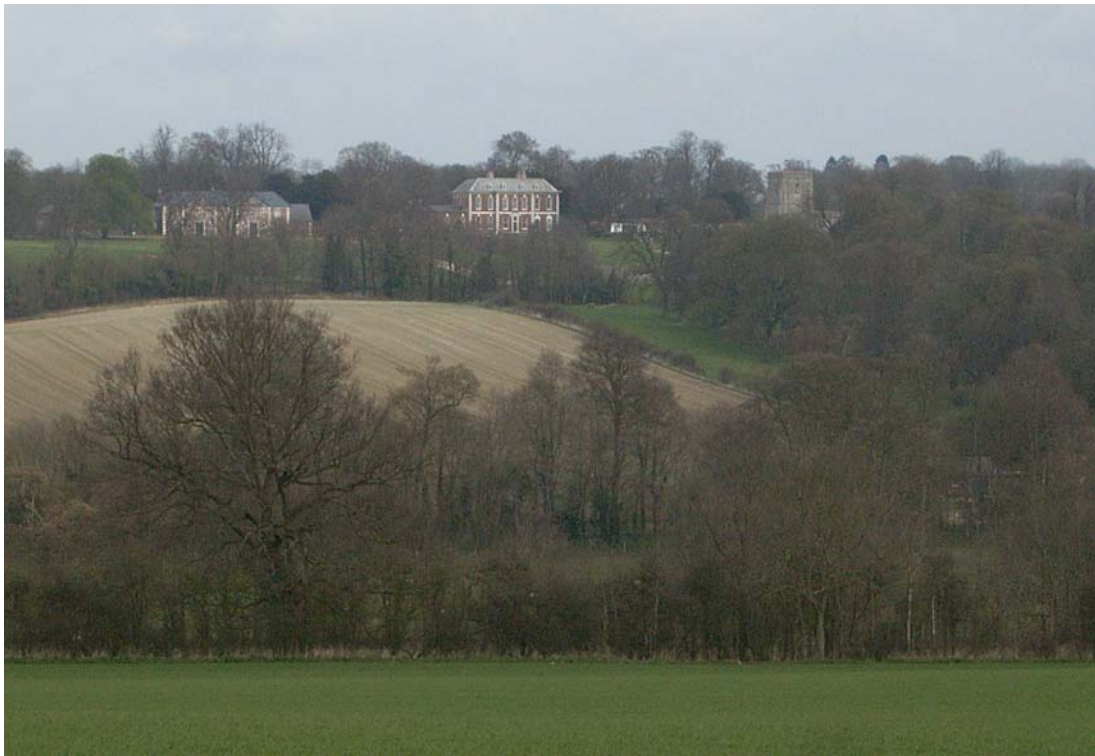
A2.1 General view of site from south-west showing the highly conspicuous position of the buildings in the landscape: Dalham Hall lies between St Mary's church on the right and stable block to the left.

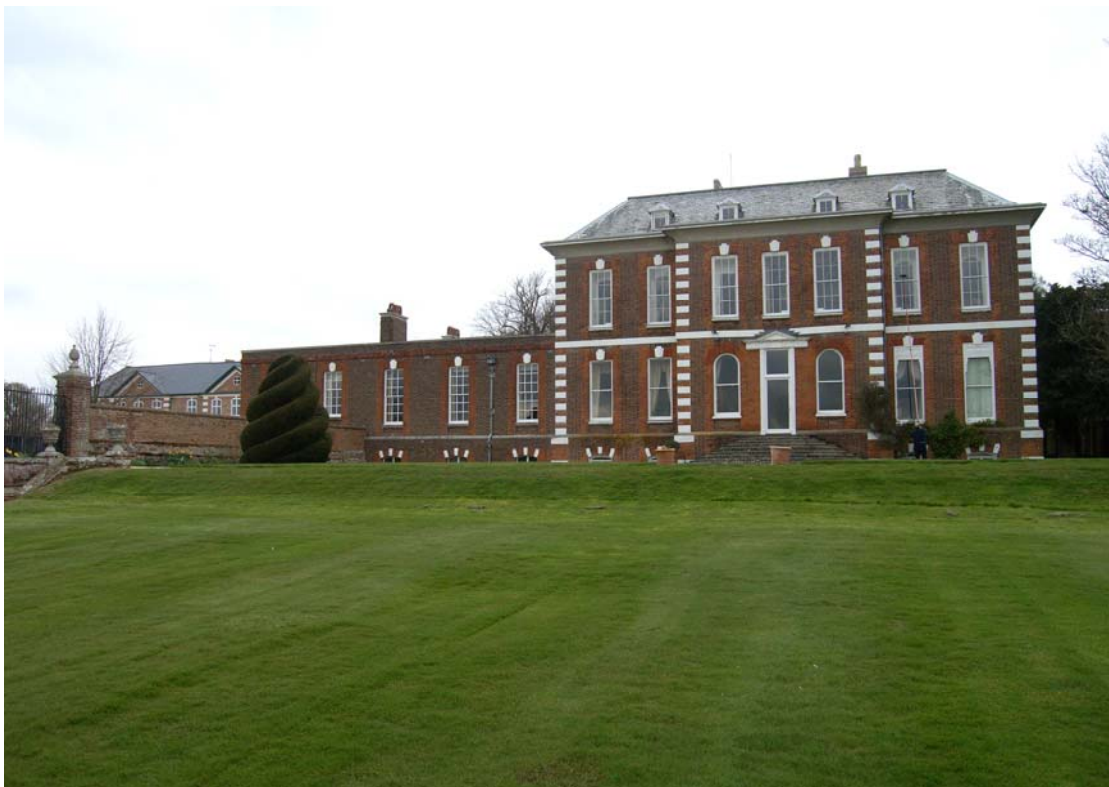
A2.2 Southern facade of Dalham Hall showing the proximity of the stable block (visible in the rear to left)

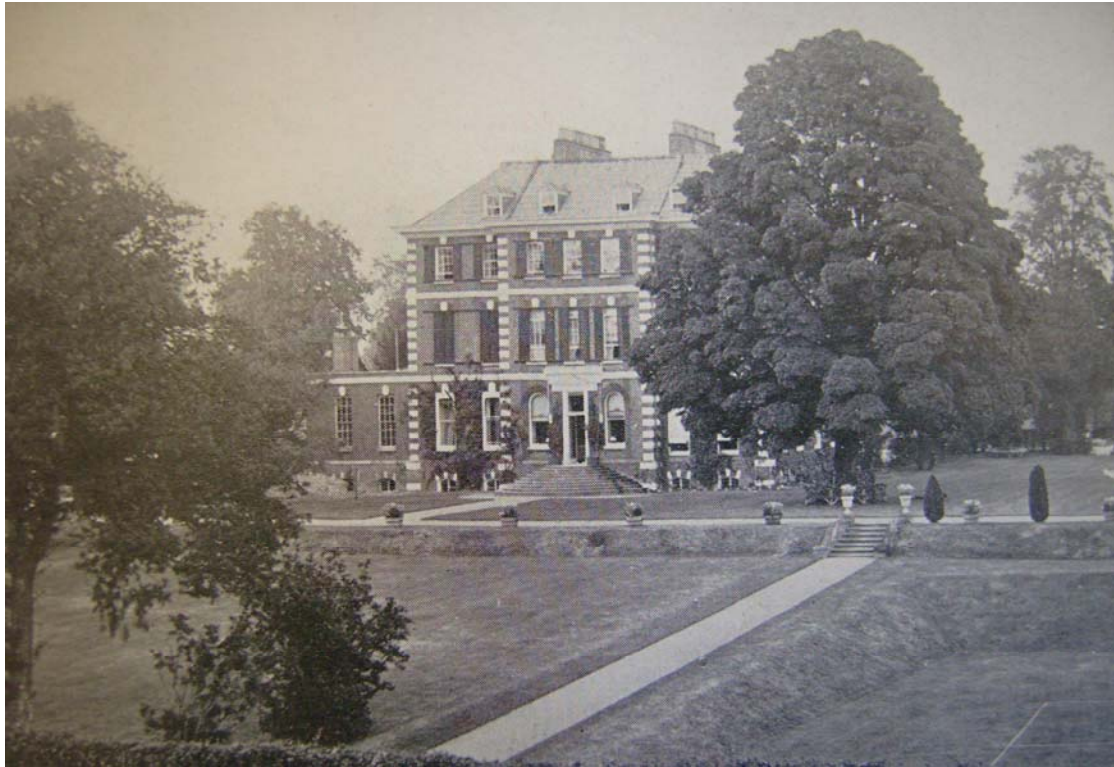
A2.3 Southern facade of Dalham Hall before the loss of its upper storey to fire in 1954
(West Suffolk Illustrated, 1907)

Dalham Hall is a substantial Queen Anne brick mansion built in 1704/5 for Simon Patrick, Bishop of Ely (Pevsner). The grade II-listed structure lies on an eminence which commands fine views across the valley of the River Kennet to the south, and is surrounded by parkland between the 14th century parish church to the south-east and an impressive contemporary or slightly later stable block to the north-west (illus. A2.1). The site represents a fine and largely intact example of an early-18th century seigneurial landscape, although the upper storey of the hall was removed after a fire in 1954 (Schedule of Listed Buildings, and see A2.3).

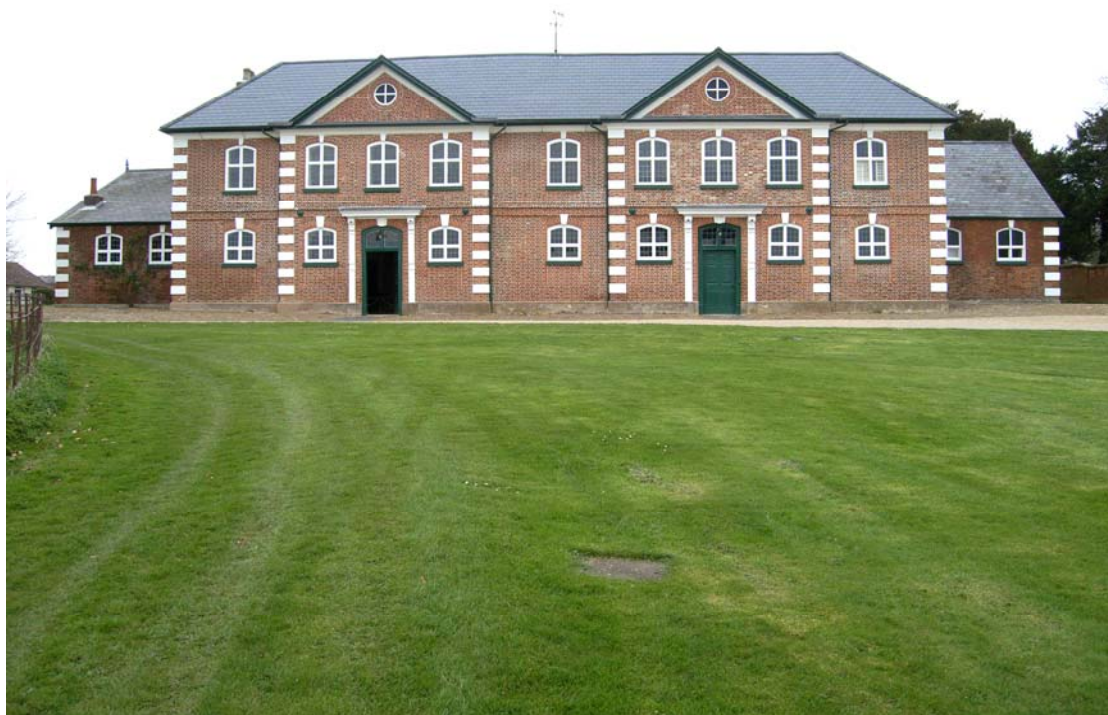
A2.4 Southern facade of stable block showing projection of tack room and gardener's store from western gable to left

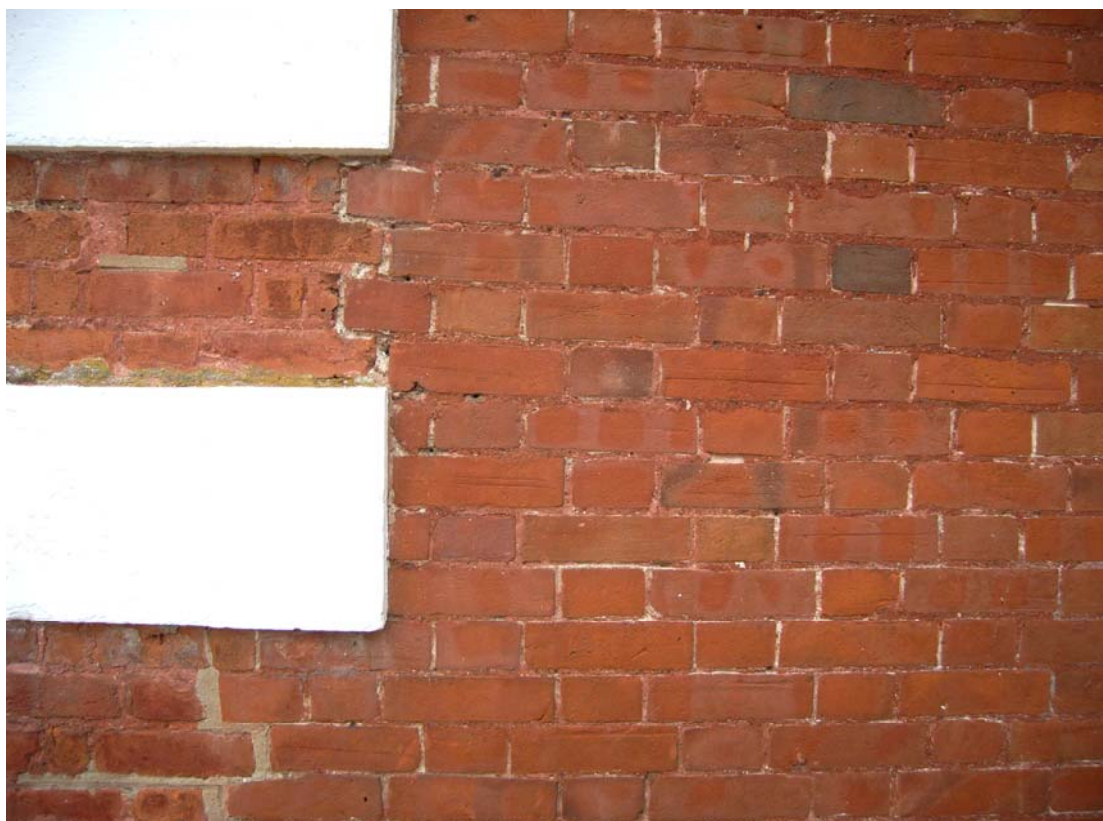
A2.5 Detail of original reddled brickwork to exterior of eastern gable, showing stucco quoins of south-eastern corner to left

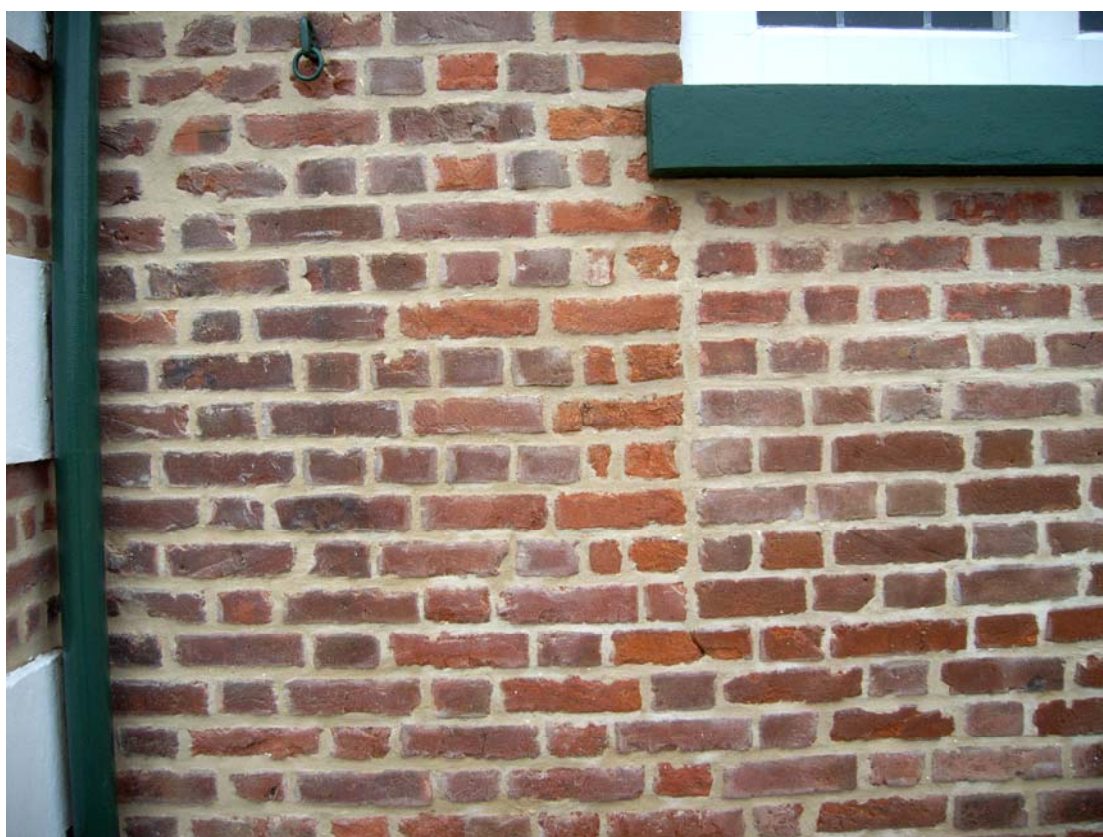
A2.6 Detail of recently re-pointed brickwork to southern facade, showing vertical joint of blocked original window to right and projection of eastern pediment to left

The southern façade is largely original, with the exception of its ground-floor windows which were reduced in height during the late-18th or 19th century; they were initially identical to those of the upper storey but straight joints in the brickwork beneath their present sills reveal the extent of their truncation. This brickwork has recently been subjected to particularly unsympathetic re-pointing which has destroyed the 'reddened joints' mentioned in the listing description of 1984. The brickwork would have been reddled in this way from the outset and much of its historic integrity has been lost accordingly, although a section survives on the eastern gable. The listing also refers to a plaintiled roof instead of the present slate. A substantial section of the ground-floor wall at the western end of the rear elevation has been rebuilt in brickwork of early-20th century appearance, which alteration probably relates to the date of 1906 cast into an adjoining rainwater hopper. The stalls may also belong to this period, shortly after the estate's acquisition by the Rhodes family.

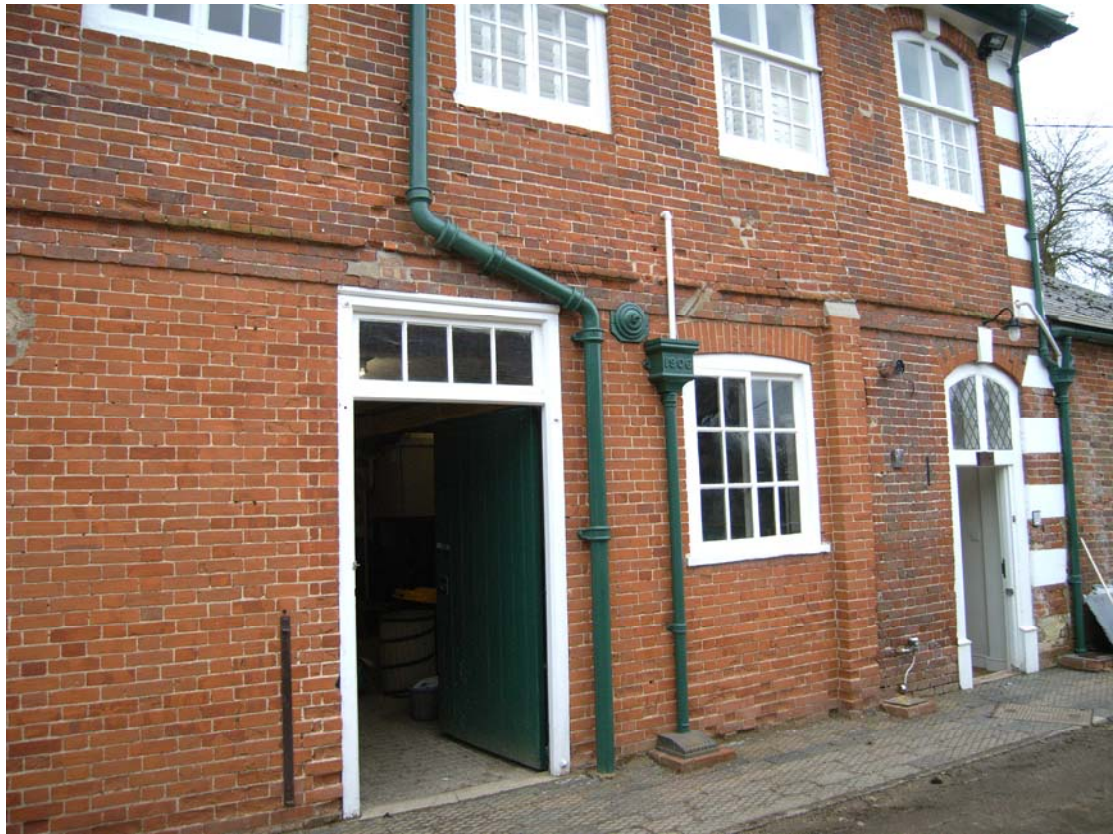
A2.7 Area of Edwardian brickwork to ground storey at western end of northern elevation (the rainwater hopper dated 1906) with original doorway and brickwork to right and single-storied projection of gardener's store beyond

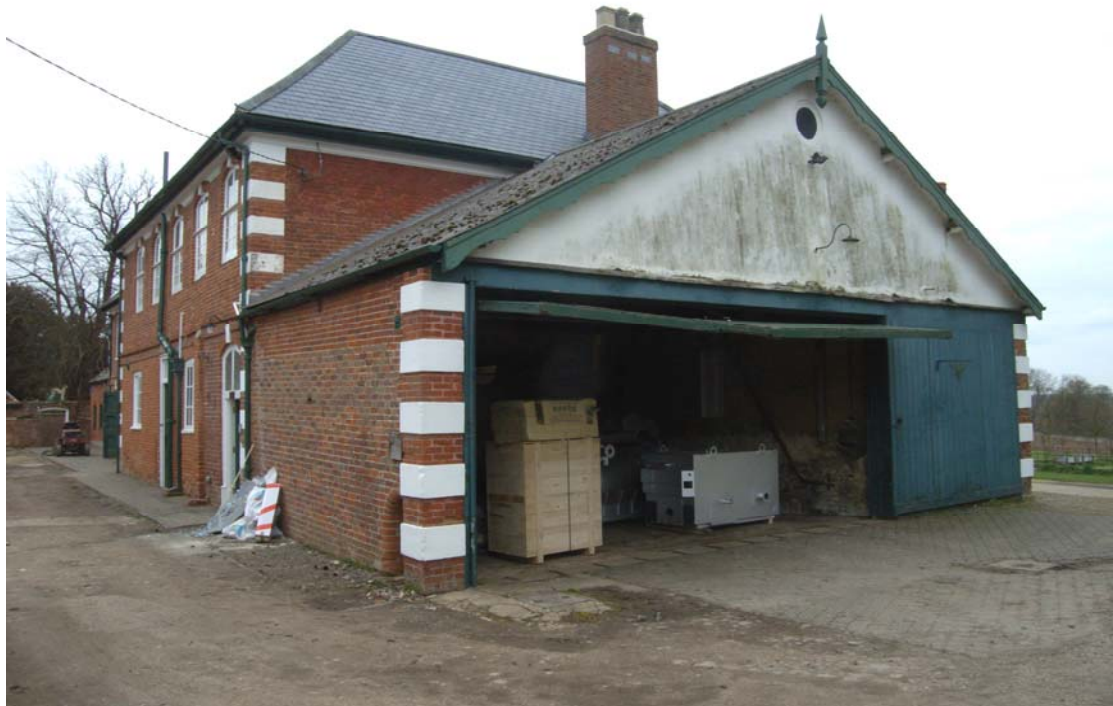
A2.8 Exterior of single-storied projection from western gable showing earlier brickwork in lower courses of northern elevation to left.

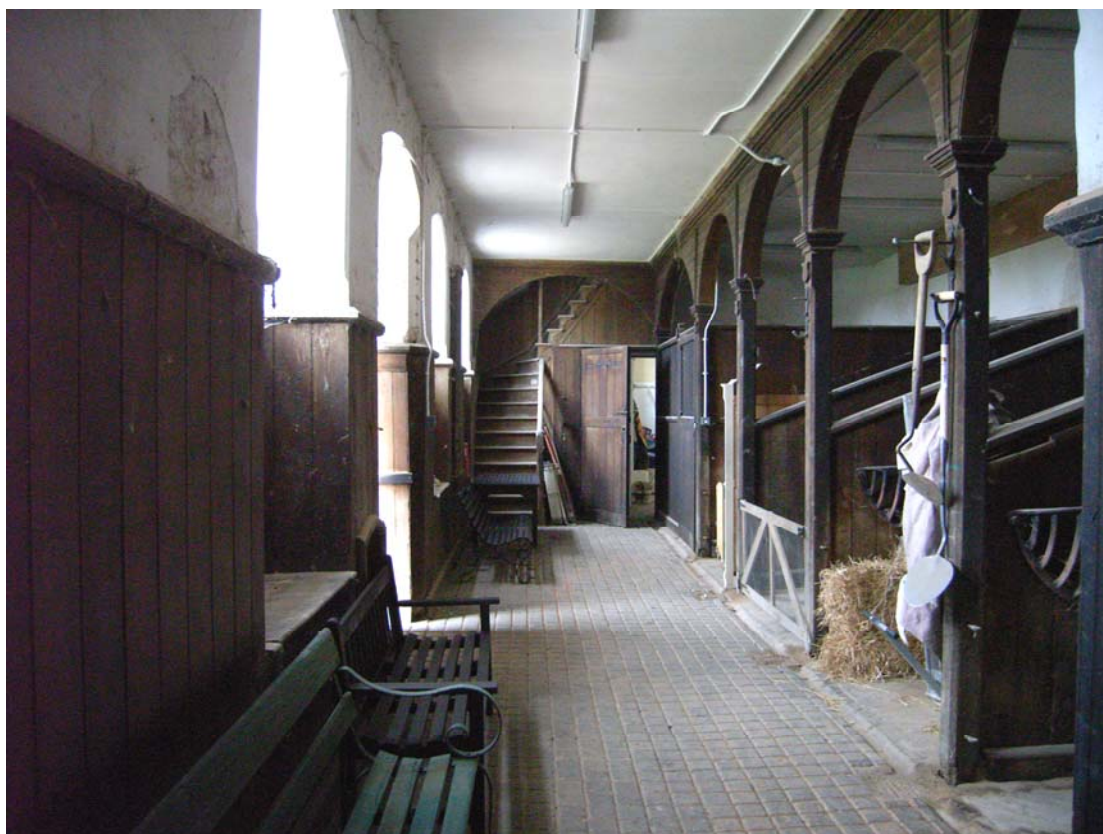
A2.9 Interior of stable from east, showing southern elevation to left and entrance door to tack room in rear.

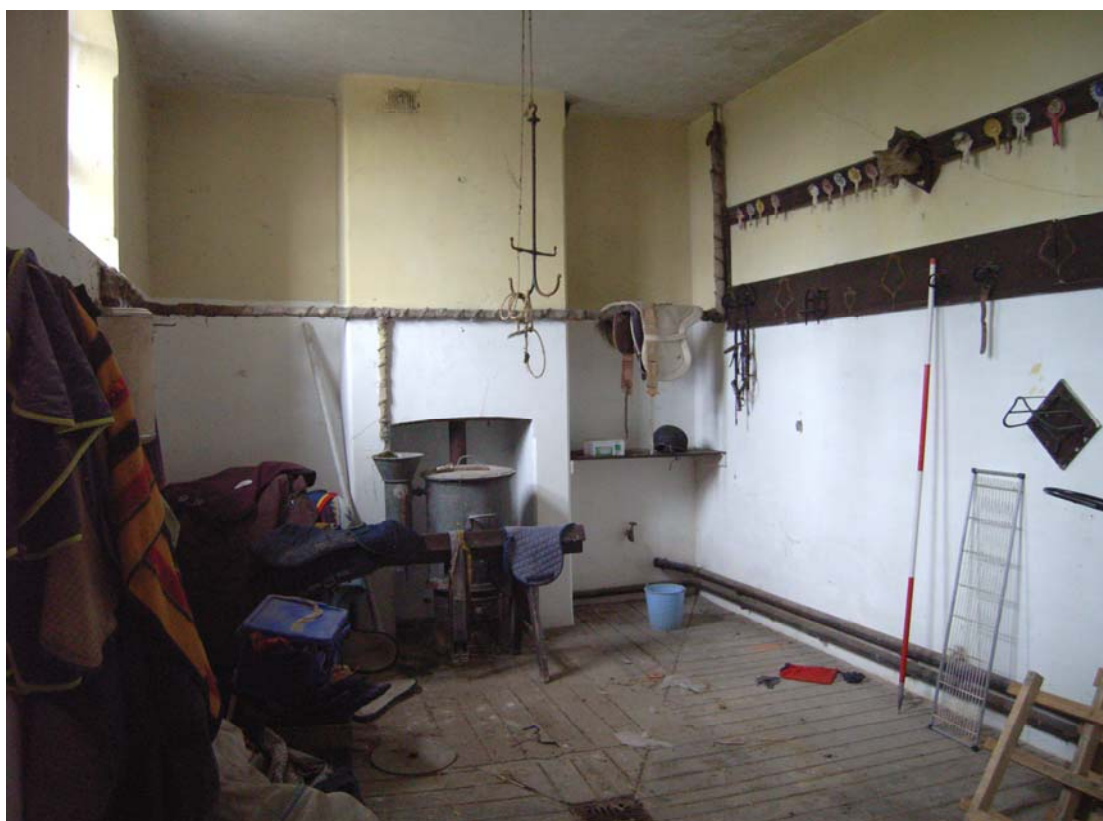
A2.10 Interior of tack room from east showing chimney against western gable and southern external elevation to left.

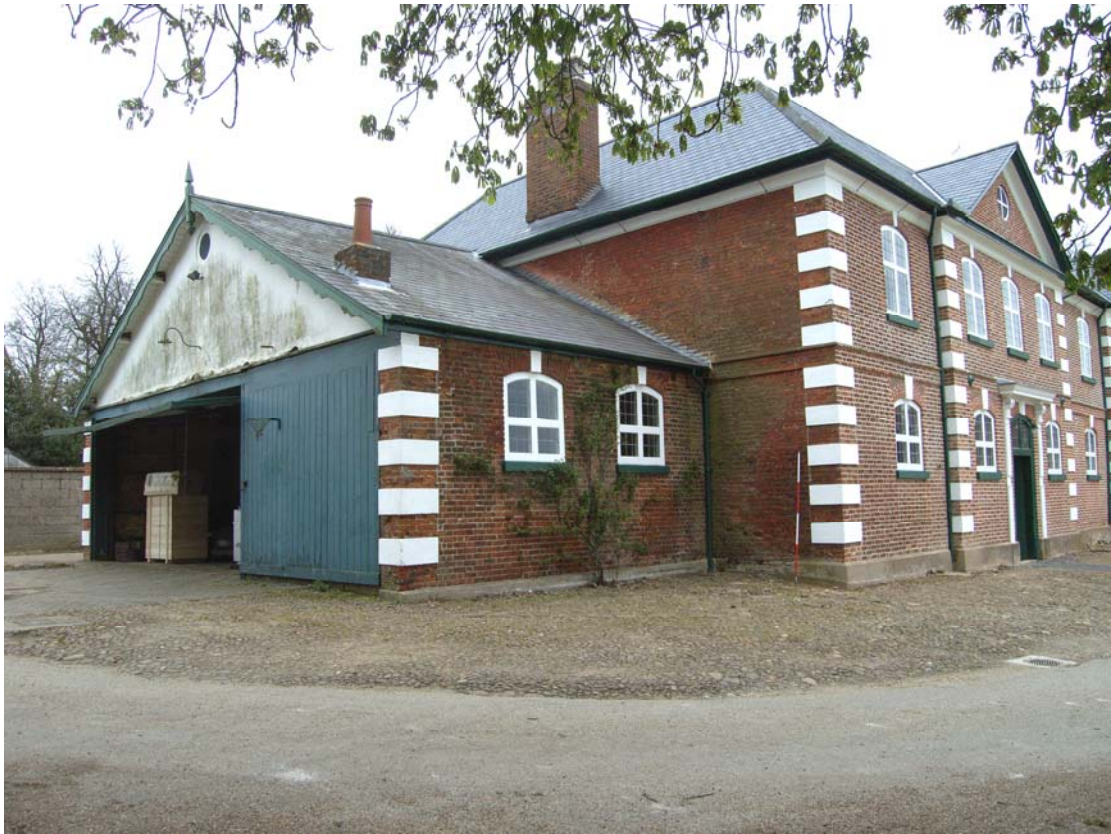
A2.11 Exterior of single-storied tack room & gardener's store projection from south-west showing scar of steeply pitched earlier roof above tack room on western gable of main block.

store by a 20th century garage-type ‘up-and-over’ door in its western gable. Both spaces are now spanned by a slate roof of late-19th century pre-fabricated king-post trusses, but the scars of at least two earlier roofs are visible on the gable of the original structure (shown in red in figure 6, and see photos A2.11 & 12). The external brickwork of the tack-room’s southern elevation is of late-18th or early-19th century appearance, and contains two shallow windows which reflect the secondary ground-floor fenestration of the main façade. This structure possessed its own narrow roof structure before its replacement by the present king-post trusses. The shallow-pitched roof which formerly existed to the north may have belonged to an original axial wing, but precise analysis is impossible. The northern elevation of the gardener’s store is of late-18th or early-19th century appearance to a height of 2.4 m but was raised to its present height of 3.2 m in the late-19th century – presumably when the present roof was built. This secondary brickwork does not resemble that associated with the rainwater hopper of 1906, and neither phase is keyed to the main range. The roof-scar within the gardener’s store seems to have belonged to a demolished structure which stopped short of the northern elevation, and this is consistent with the outline of the building in 1808. The additional ‘step’ in the south-western corner of the same outline suggests that the two structures were of differing lengths, but figure 4 indicates that the modern arrangement existed by 1884.

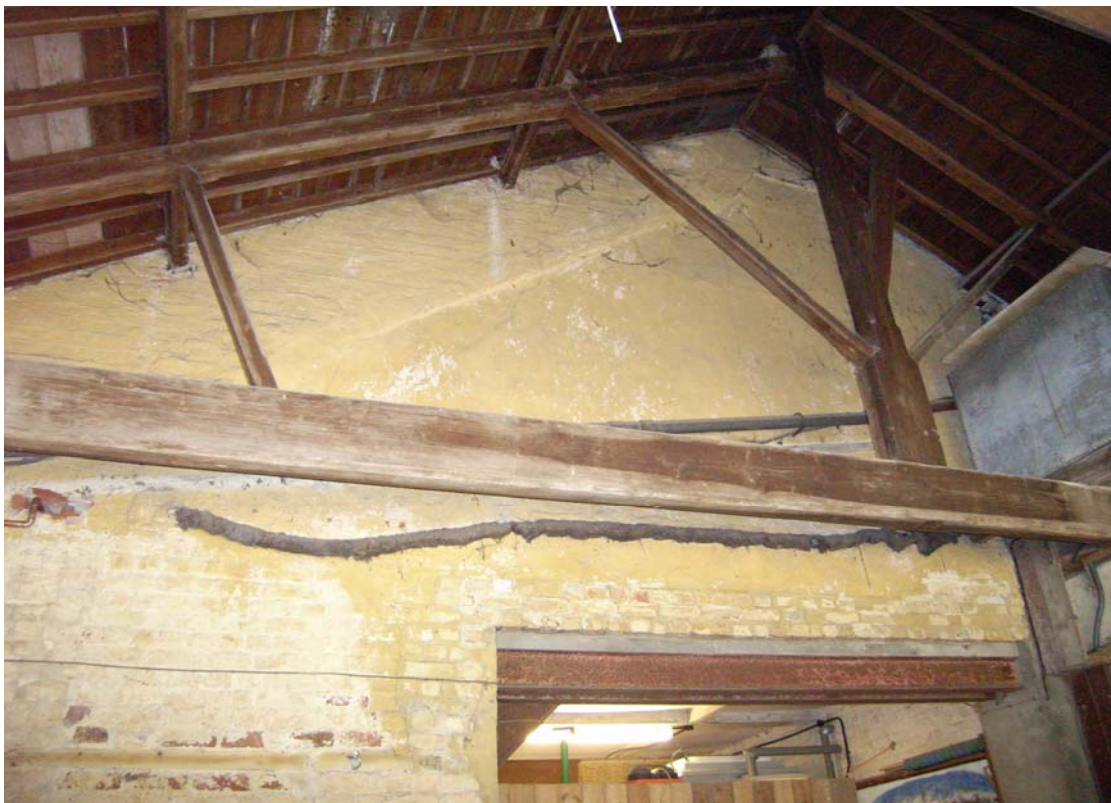
A2.12 Detail of western gable in gardener's store showing scar of earlier low-pitched roof beneath present king-post structure (the tack room lies under the galvanised tank to the right).
