**Farm Buildings at
Abbey Farm,
Hoxne, Suffolk
HXN 053**

Historic Building Record

OASIS ID: Suffolkc1-86862

November 2010

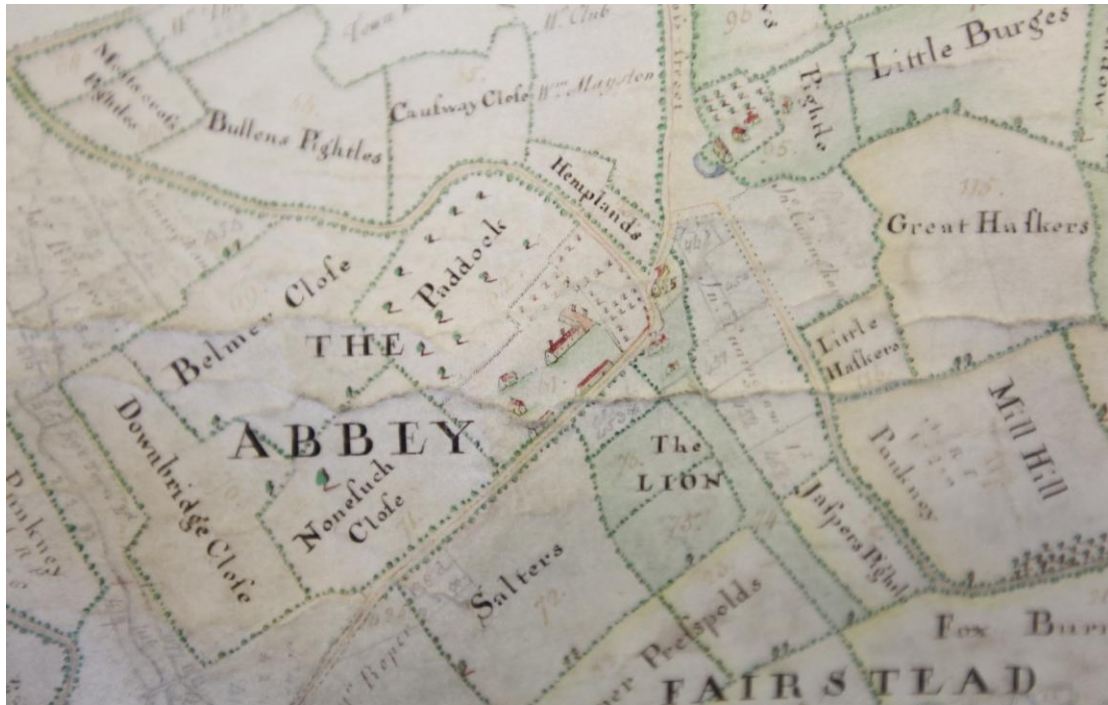
Figure 2. A map of the estates of Charles, Lord Maynard of Hoxne Hall drawn by T. Skynner and dated 1757. Kindly drawn to my attention by Hoxne local historian Mr. Stephen Govier. The direction of north is shown to the left (SRO HB 21/280/2).

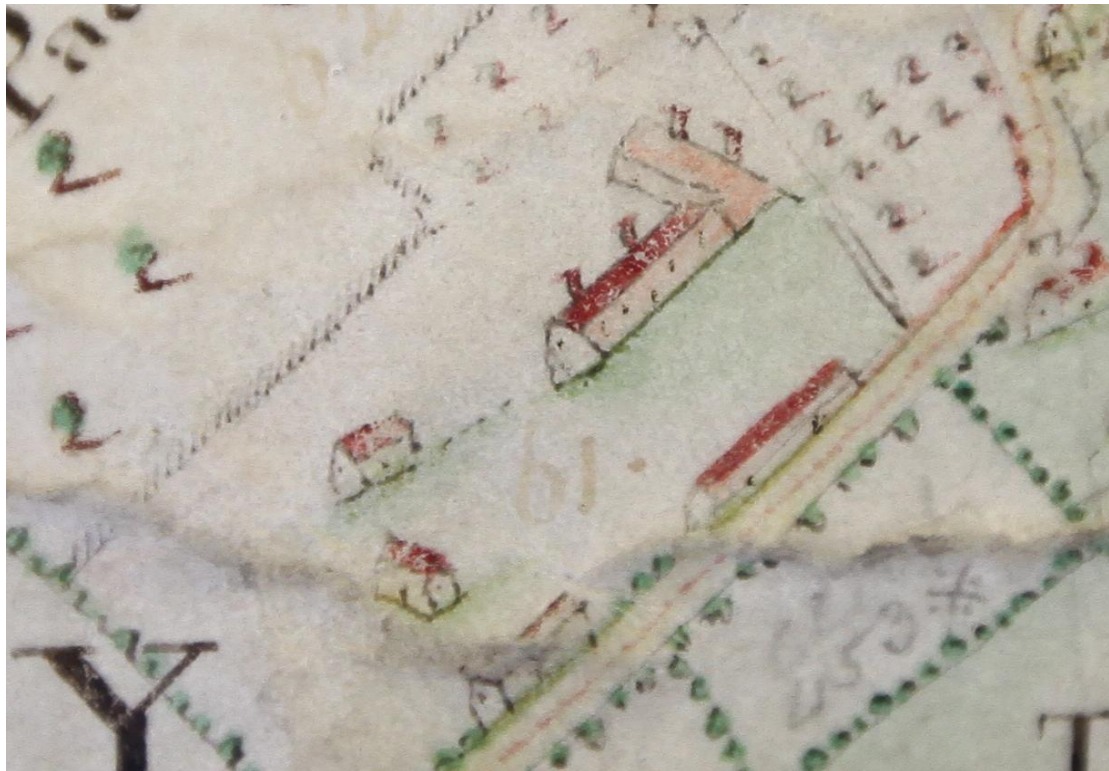
Figure 2a. Detail of the 1757 map showing the L-shaped farmhouse and a group of four detached buildings effectively forming a courtyard to the north-west. The longer of the two buildings adjoining the road coincides with the listed flint boundary wall while the smaller survives as a fragment to the south of the modern site entrance. The northern 'barn' (G) is clearly shown at right-angles to the other outbuildings with what appears to be a door to the north and a first-floor window in its western gable.

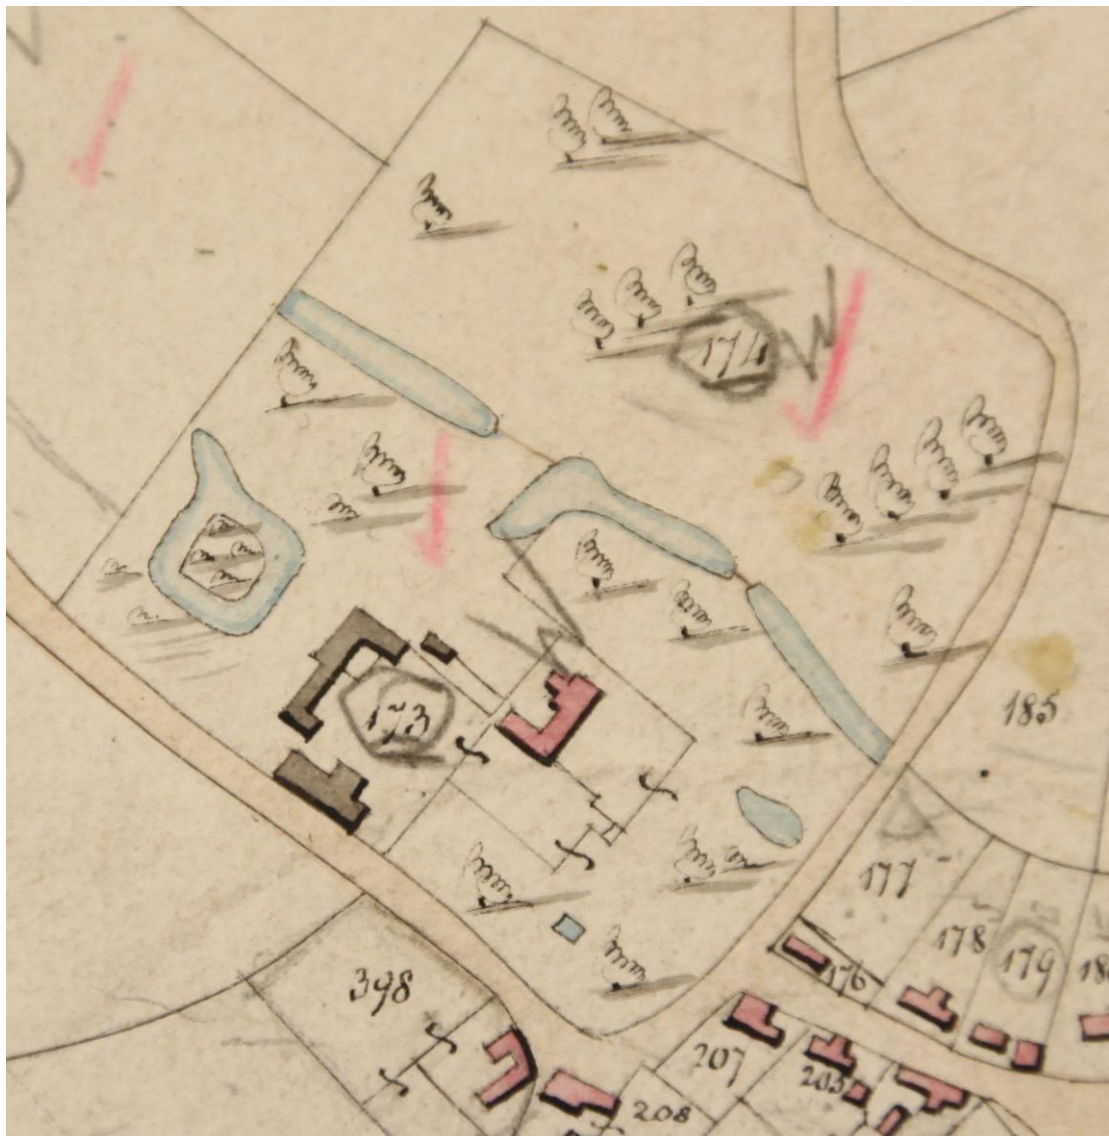
Figure 3

The site as depicted on the Hoxne tithe map of 1843 (Suffolk Record Office). The long range adjoining the present flint boundary wall had been demolished since 1757 and the 'barn' (G) considerably extended. The water features such as the small moat to the north were not surveyed in 1757. The site (173) was described only as 'Abby farm yards' in the schedule, 'Paddock' to the east (174) and 'Nonsuch close' to the north (172)

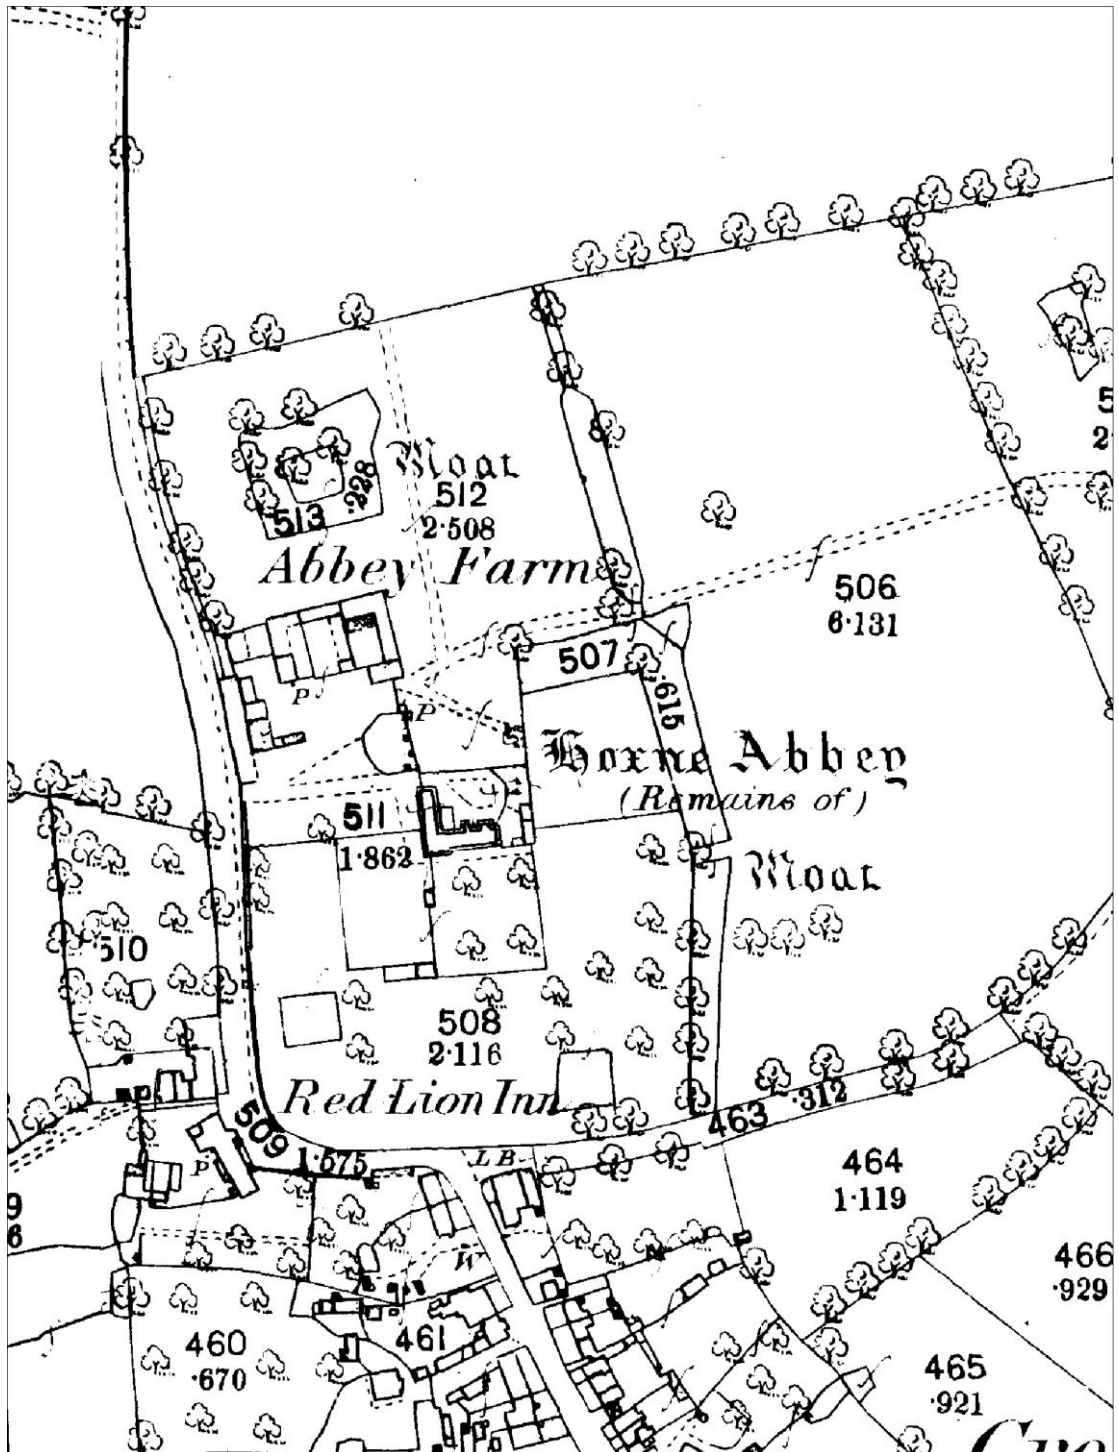
Figure 4.
Abbey Farm on the First Edition 25 inch Ordnance Survey of 1886. See detail below

time in their present form on the first edition 25 inch Ordnance Survey of 1886 (figure 4 below). With the exception the minor modifications shown in 1904 (figure 5) they remained largely unaltered until the 1960s and later when the present owner made a series of modifications which included the removal of the ceiling and southern elevation from the 'barn' (G) and converted the 19th century buildings into office and storage accommodation.

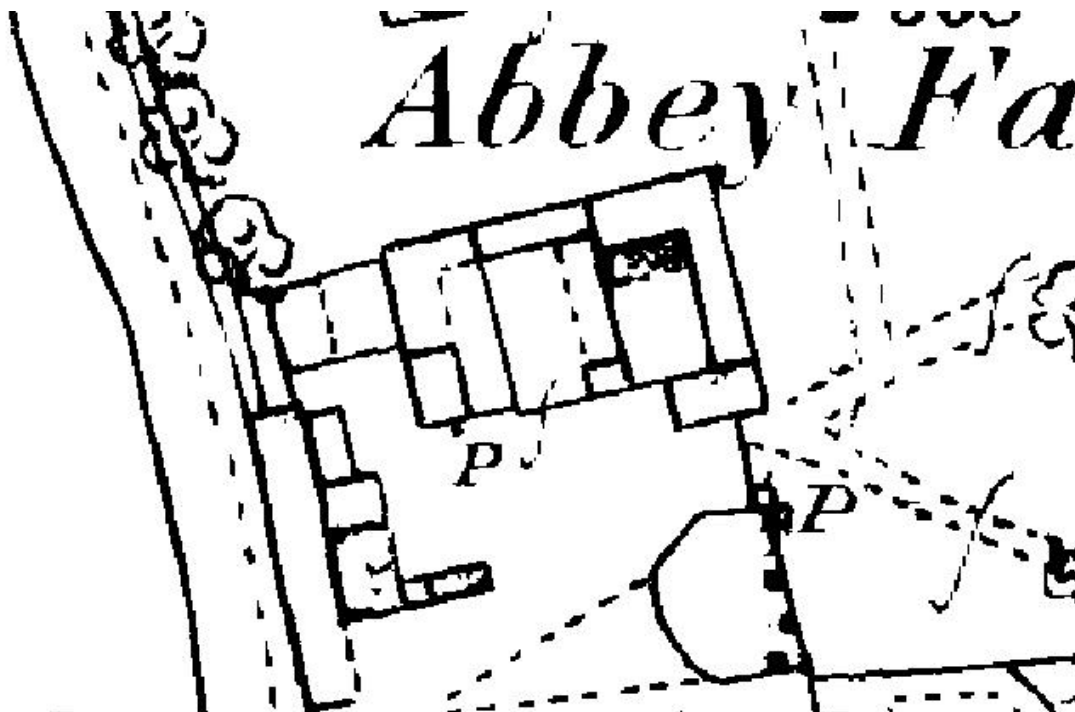
Figure 4a. Detail of First Edition 25 inch Ordnance Survey of 1886. The outline of the farm complex is shown much as it remains today, with the open-sided elevations of the cart lodge (C) and the two shelter sheds (D & F) indicated by broken lines. The long range adjoining the road to the west was demolished to accommodate the present site access, leaving only a small fragment to the south (now converted into offices).

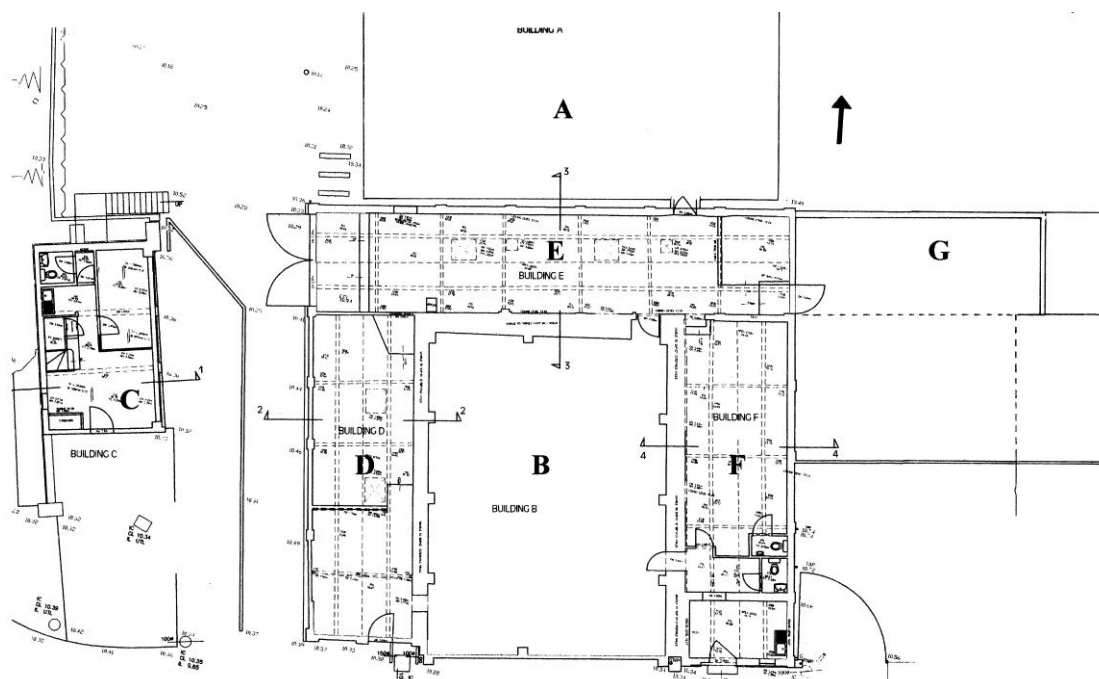
Figure 6

Block plan of the site identifying each historic building with a number for ease of reference in the text and photographic record. Adapted from a site plan by Anna High Consultancy Ltd.

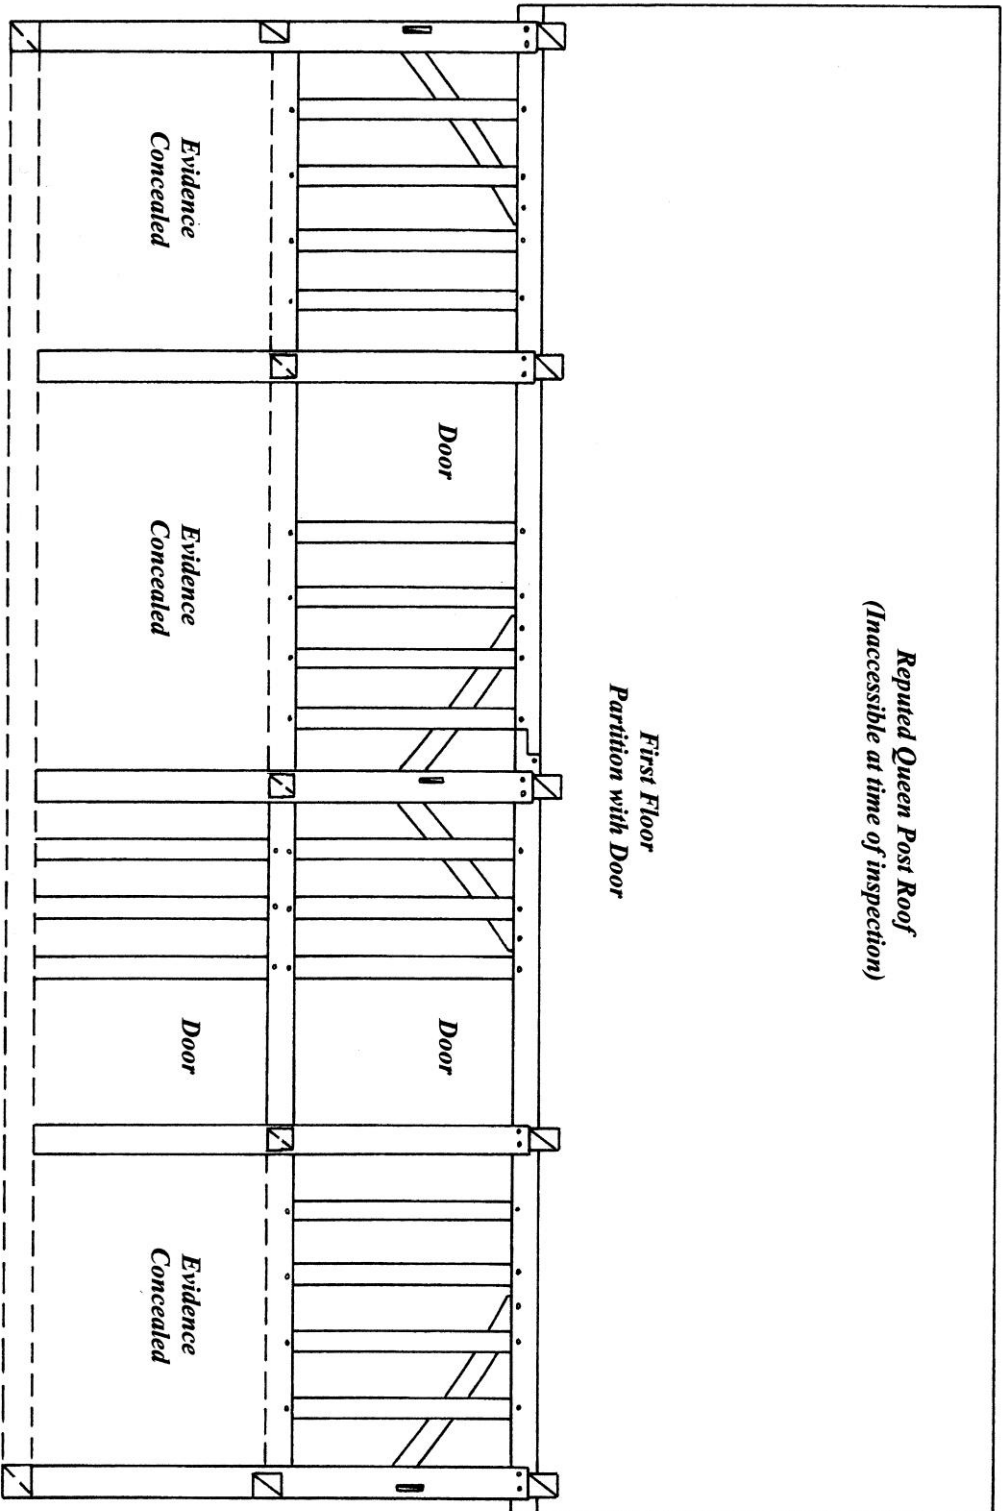
*Reputed Queen Post Roof
(Inaccessible at time of inspection)*

*First Floor
Partition with Door*

**Figure A. Abbey Farm, Hoxne
Reconstruction of Northern Internal Elevation of 'Barn' (G)**

The northern elevation can be partly reconstructed on the basis of the pegged mortises in its internally exposed roof-plates, mid-rails and storey posts as in figure A, despite the concealment of any intact studwork behind modern boarding (internally) and weatherboarding (externally). The lower storey (beneath the mid-rails) has been rebuilt in 20th century Fletton brick and the original ceiling has been removed leaving empty mortises in the storey posts, and all but a small section of the southern elevation has been cut out to form a single storage area with a 20th century lean-to shed which covers a formerly open yard. This mutilation occurred during the 1960s shortly after the owner acquired the farm.

The upper storey was divided by a central partition into two chambers linked by a door adjoining the southern elevation (as indicated by the pattern of empty stud mortises in the central tie-beam). Each chamber was entered by an external first-floor loading door in the northern elevation, at least one of which lay immediately above a ground-floor door. Each of the three doors was approximately 1.1 m in width (3.6 ft). The southern elevation contained only a narrow gap of approximately 0.75 m (2.5 ft) in the penultimate western bay (as indicated by the empty mortises of its roof-plate), which gap may have accommodated either an additional but narrow doorway or a shallow oriel window in the late-16th century fashion. There is no evidence of this elevation on the ground-floor. The mid-rail of the eastern gable is obscured and an adjoining lean-to shed was inaccessible but a central window lay beneath the tie-beam. The western gable also contained a central first-floor window and part of its window sill is exposed in the adjoining shed (E); this sill projects beyond the plane of the wall and was probably designed to penetrate the external render with which the frame was originally clad. A wide central gap in the mortises of its mid-rail is separated by a single mortise from another gap at its southern end, indicating the presence of an oriel or framed window alongside a door. More evidence of the building's appearance is likely to survive behind its boarding. A pair of binding joists has been re-used as posts in the southern elevation and lean-to: these contain mortises with diminished shoulders for tall-sectioned joists and (in once case) stud mortises for a first-floor partition (but not a ground-floor partition) and may well represent all that remains of the original ceiling.

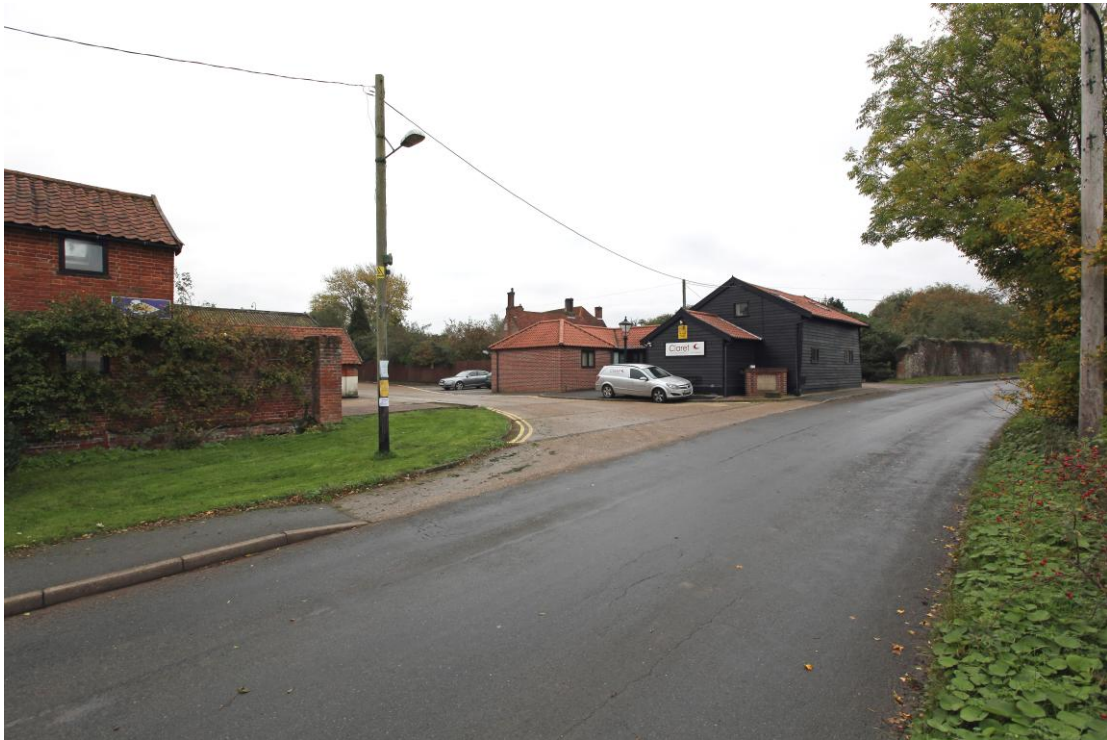
Illus. 1. General view of site entrance from Abbey Hill to north-west showing granary (C) to left with farmhouse and previously converted timber-framed & weatherboarded building in centre & flint boundary wall in rear to right.

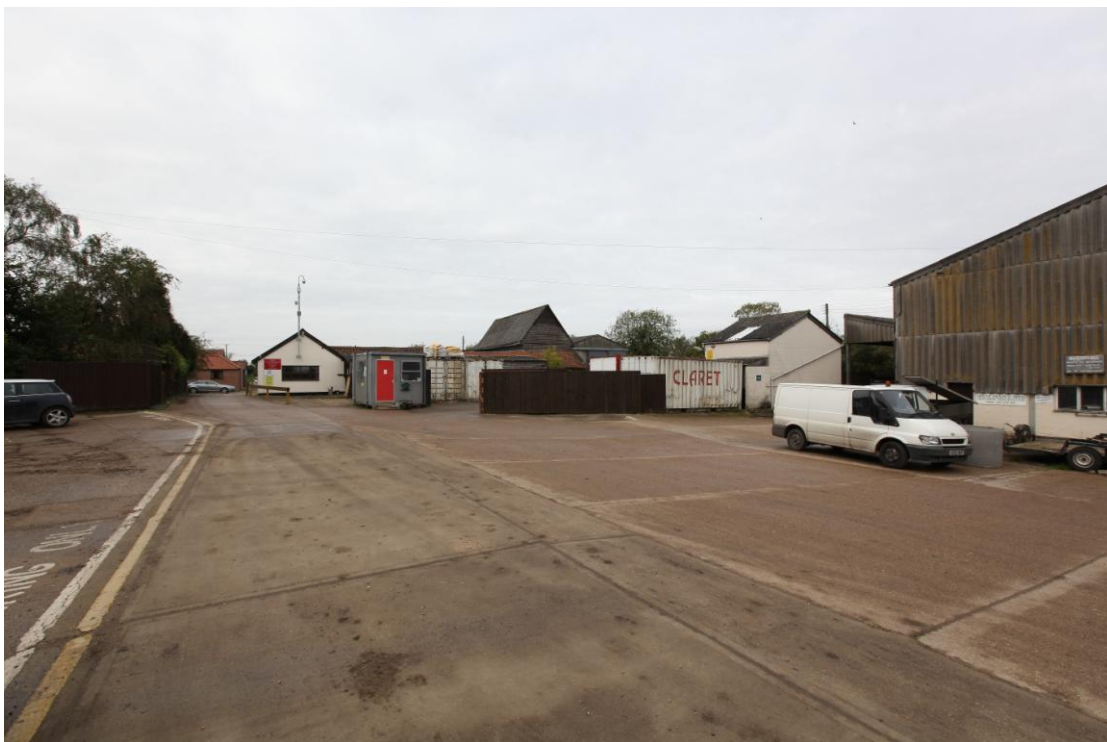
Illus. 2. General view of site from east showing 20th century grain store to right and steeply gabled roof of 16th century 'barn' (G) in centre.

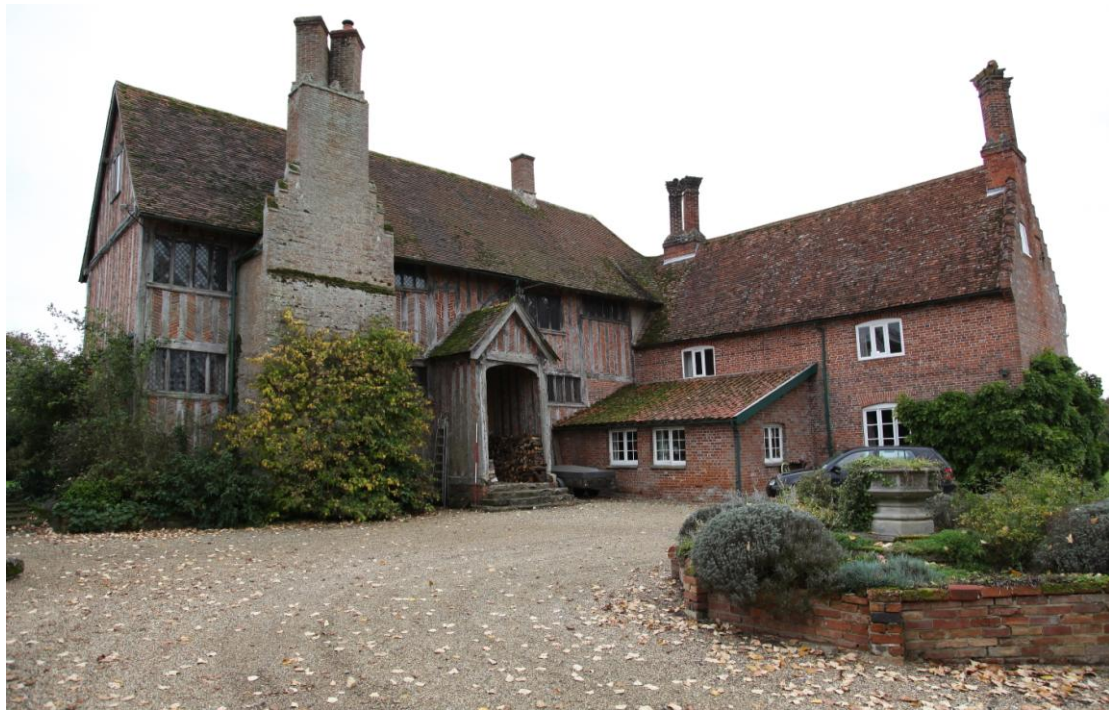
Illus. 3. Abbey farmhouse from rear (north-east) showing 18th century brick wing to right & truncated two-storied porch to cross-passage (with evidence of blocked door to missing porch chamber above). The parlour to the left has been demolished. Included for site context.

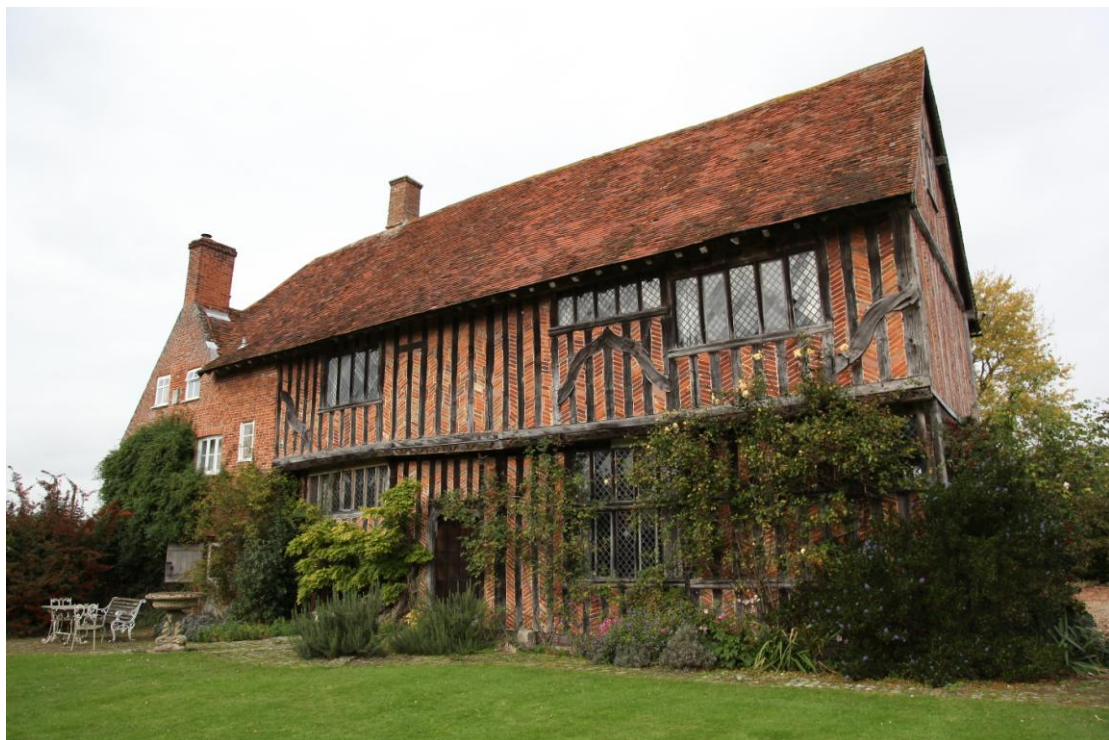
Illus. 4. Much restored jettied southern facade of late-16th century Abbey farmhouse showing position of two-storied porch to cross-passage in centre (with blocked door to porch chamber) with position of missing parlour to right. The 'serpentine' bracing is typical of the final quarter of the century. Included for site context.

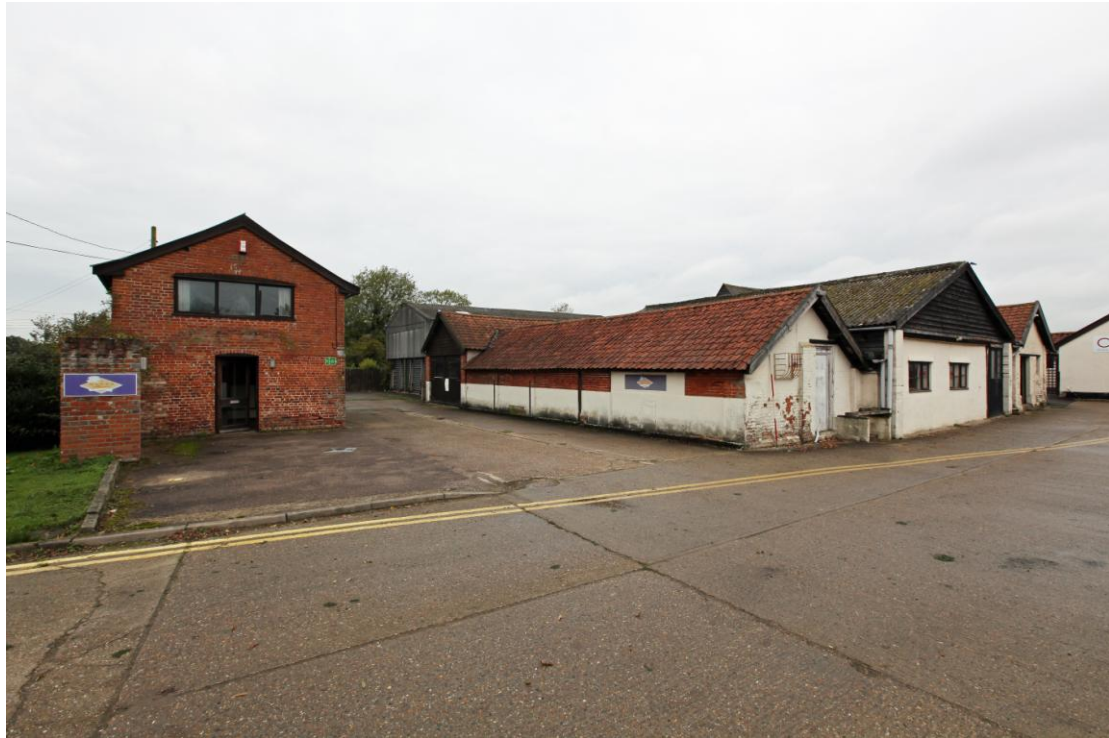
Illus. 5. Exterior of yard complex from site entrance to south-west showing roadside granary (C) to left and covered yard (B) to right (flanked by shelter sheds (D & F) to left and right respectively).

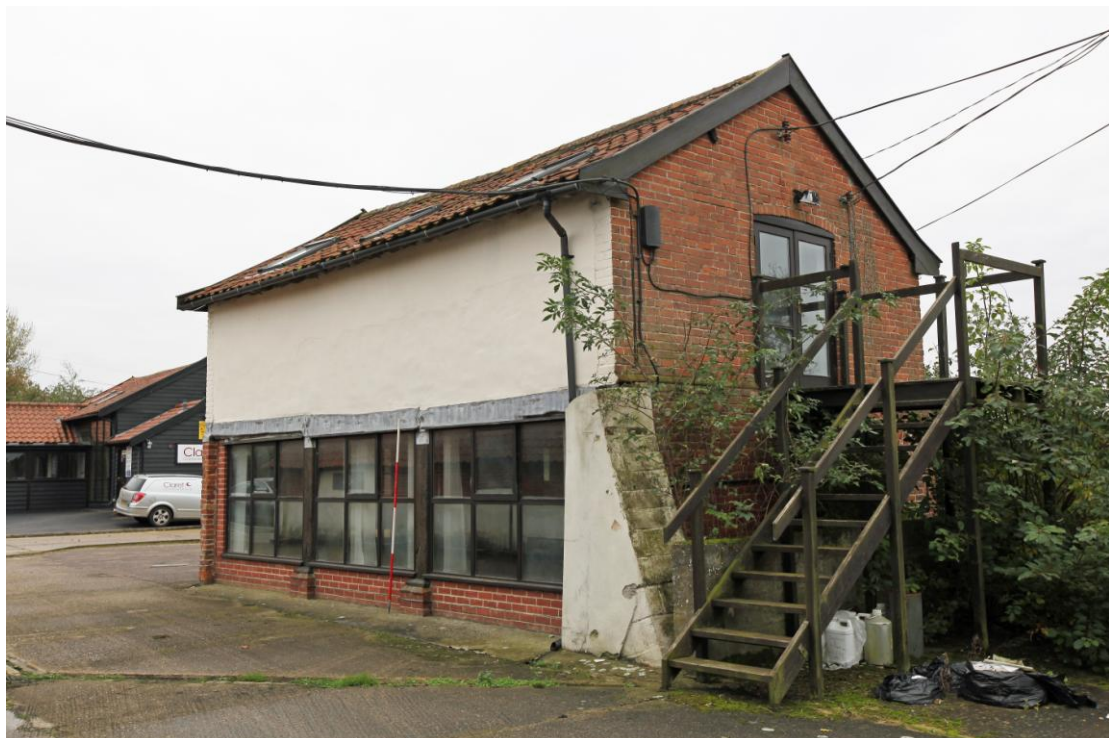
Illus. 6. Exterior of granary (C) from north-east showing renewed external stair to right and recently glazed open arcade of cart lodge to left. The previously converted timber-framed and weatherboarded building to the south of the site entrance is visible in the rear to left.

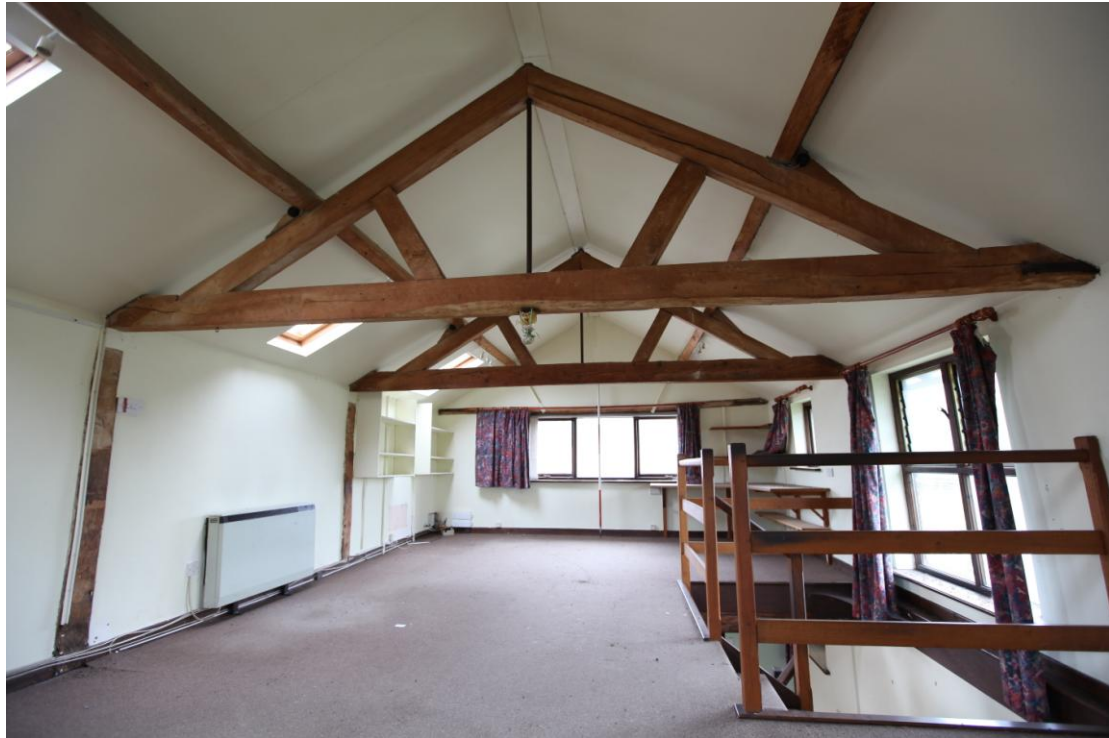
Illus. 7. Converted upper storey of granary (C) from north showing A-frame roof trusses with raking queen struts.

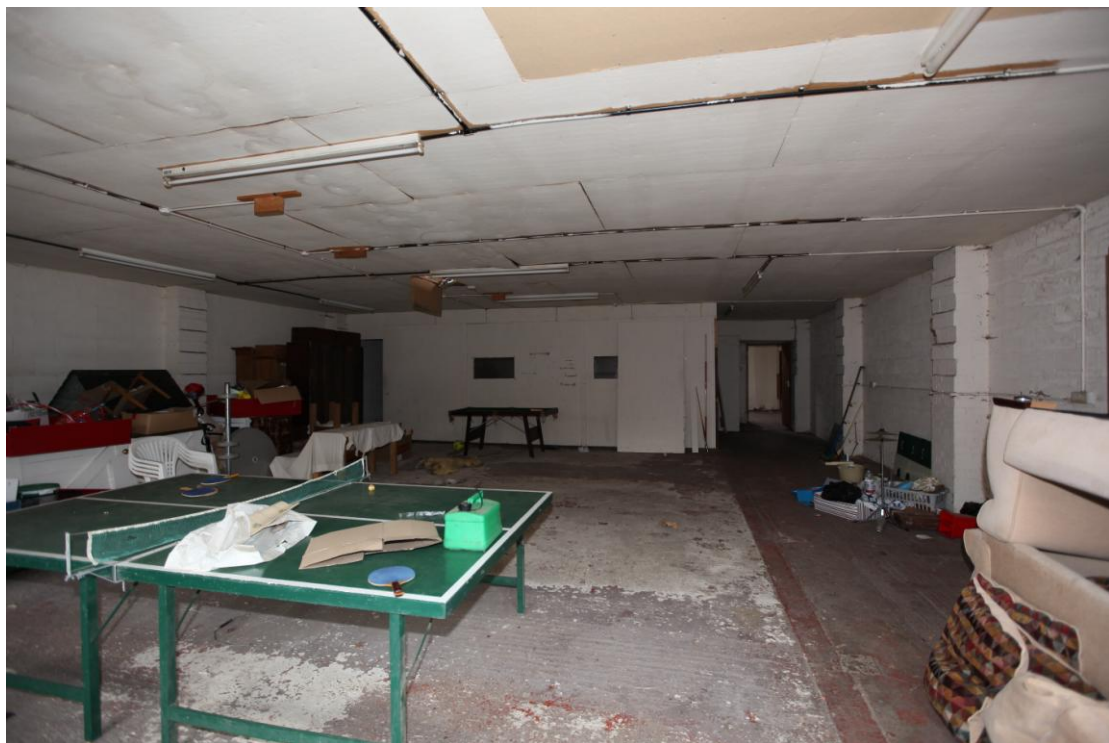
Illus. 8. Interior from south of partly converted covered yard (B) showing blocked but formerly open-sided shelter-sheds (D & F to left and right respectively).

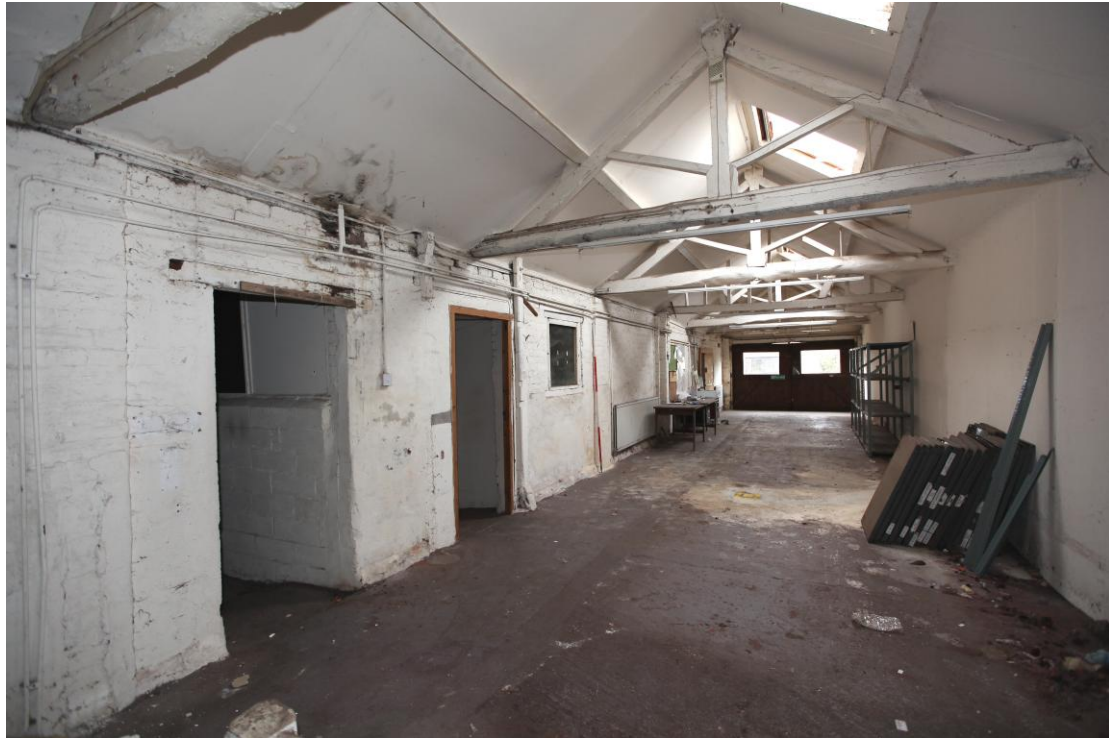
Illus. 9. Interior from east of rear range of yard (E) showing king-post roof trusses and doors to yard and sheds (F, B, D) to left. This area is understood to have operated as a milking parlour in the 20th century and latterly as a piggery.

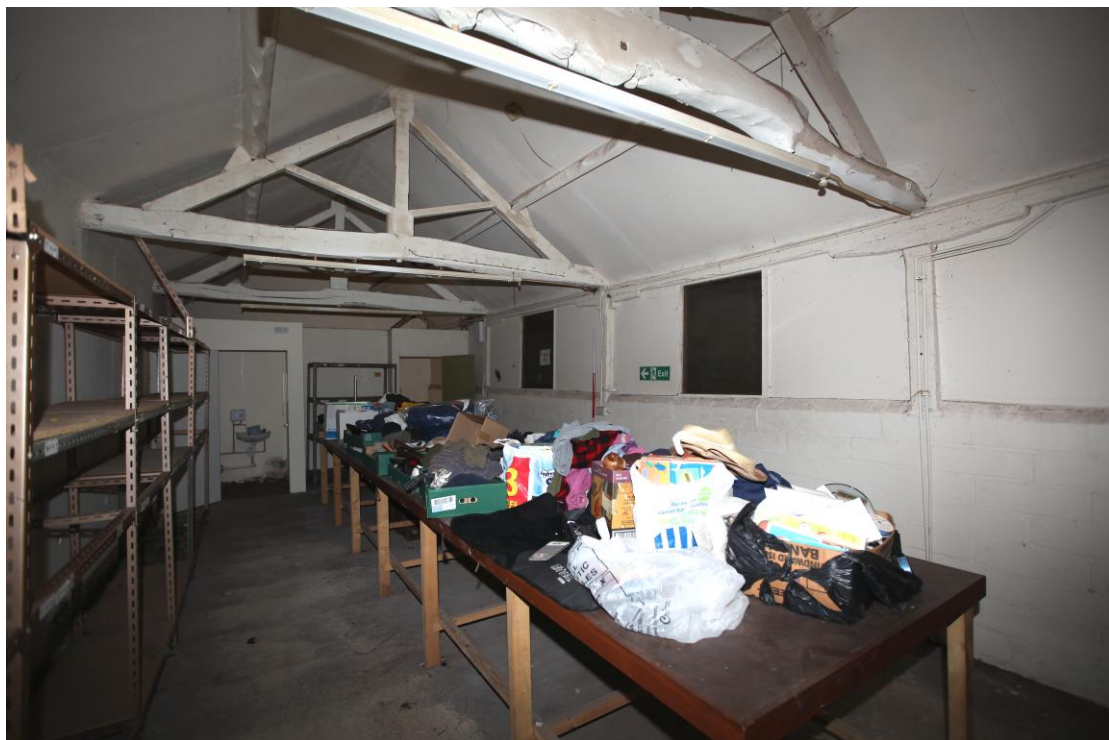
Illus. 10. Interior from north of eastern yard shed (F) showing arcade posts and shaped lintels of blocked open arcade to yard (B) to right.

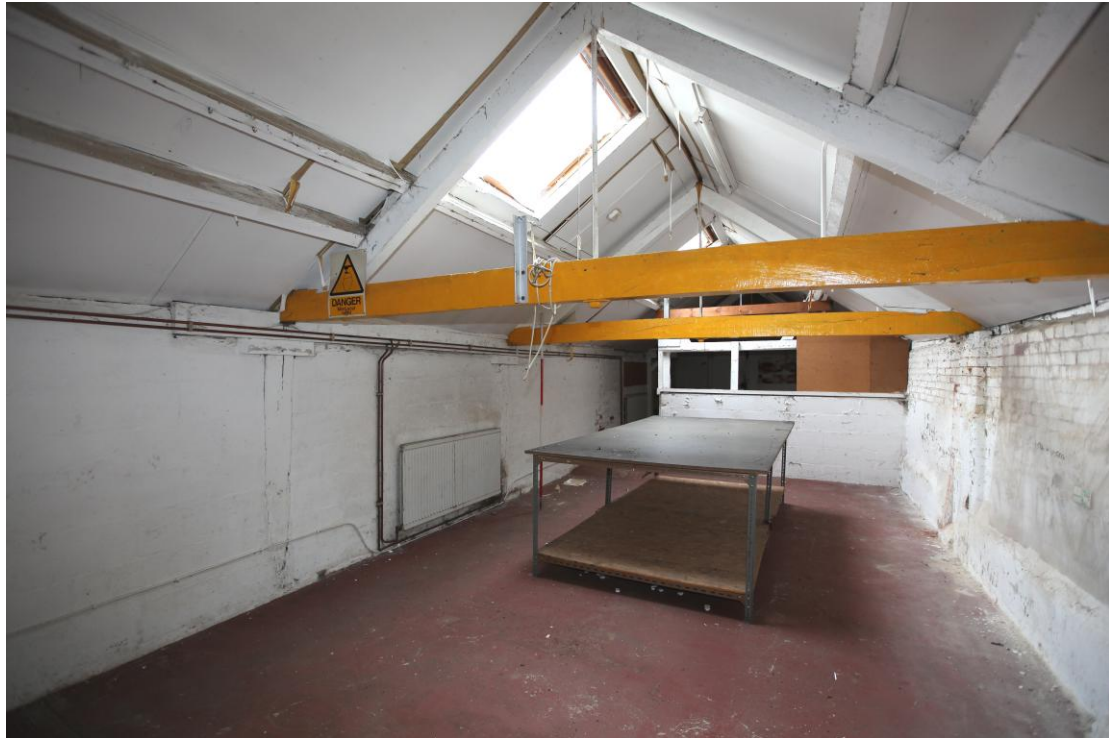
Illus. 11. Interior from north of western yard shed (D) showing arcade posts of blocked open arcade to yard (B) to left.

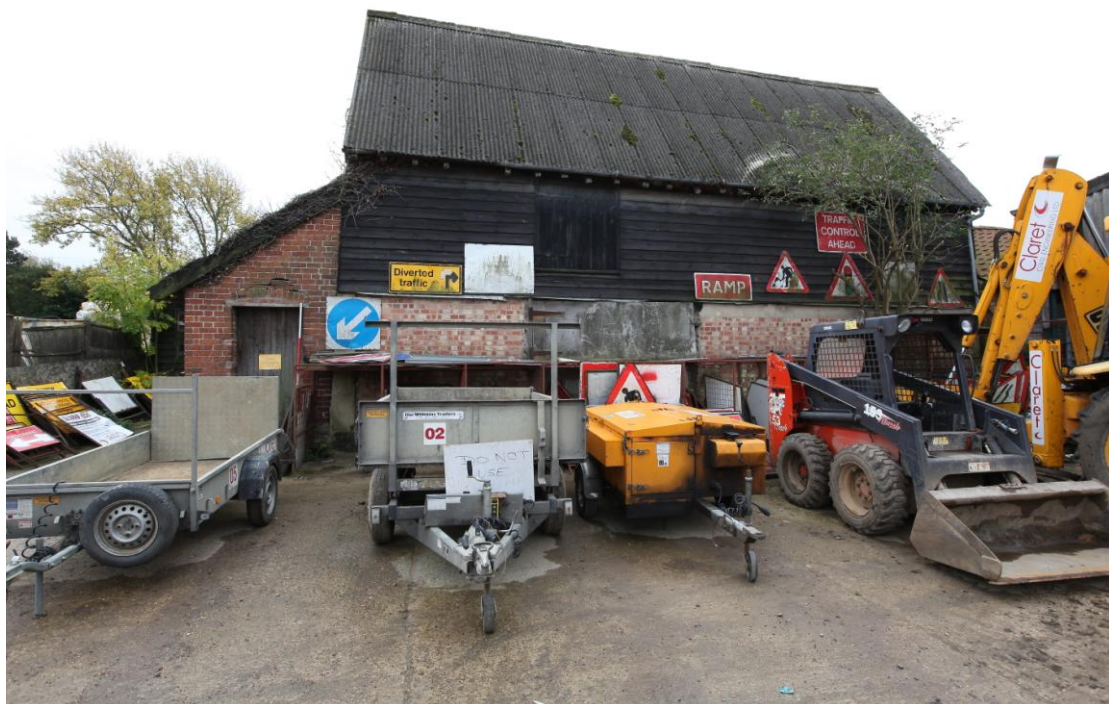
Illus. 12. Northern exterior of 'barn' (G) showing blocked first-floor loading door, corrugated asbestos roof covering and 20th century Fletton brickwork to lower storey. The loading door occupies the approximate position of an original 16th century loading door with a ground-floor entrance beneath, but is concealed internally. A second first-floor loading door lay to the right.

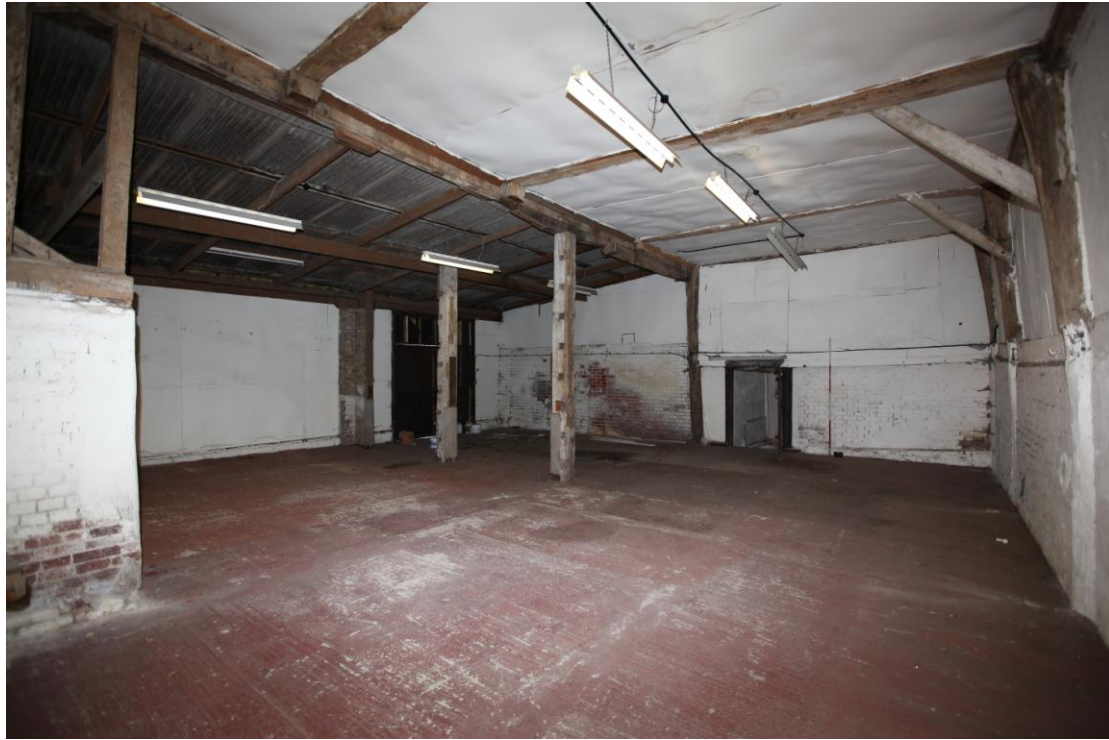
Illus. 13. Interior of 'barn' (G) from eastern gable showing original 16th century timber frame of four bays to right and 20th century lean-to extension to left. The southern elevation to the left has been largely removed along with the original ceiling but the vertical posts may be its recycled binding joists.

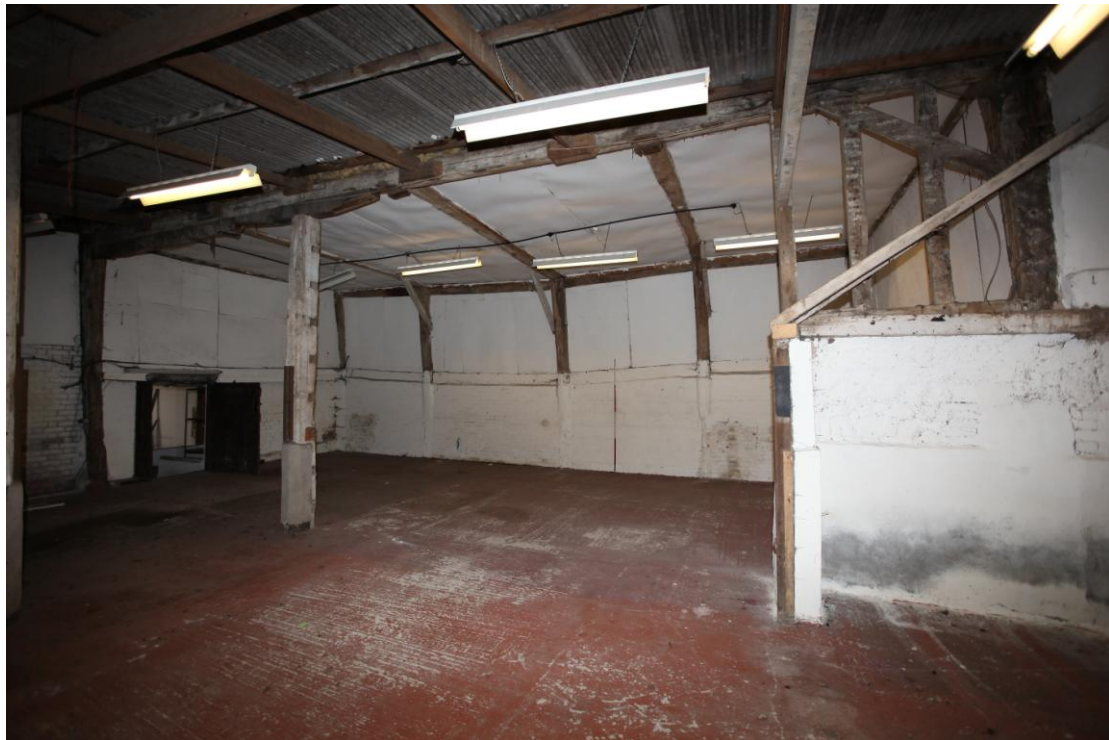
Illus. 14. Southern exterior of 'barn' (G) from 20th century lean-to showing original studwork with externally trussed brace to right and modern boarding concealing the roof structure and the studs of the northern internal elevation.
