BUILDING RECORDING REPORT

SCCAS REPORT No. 2011/040

Building 538, RAF Mildenhall MNL 641

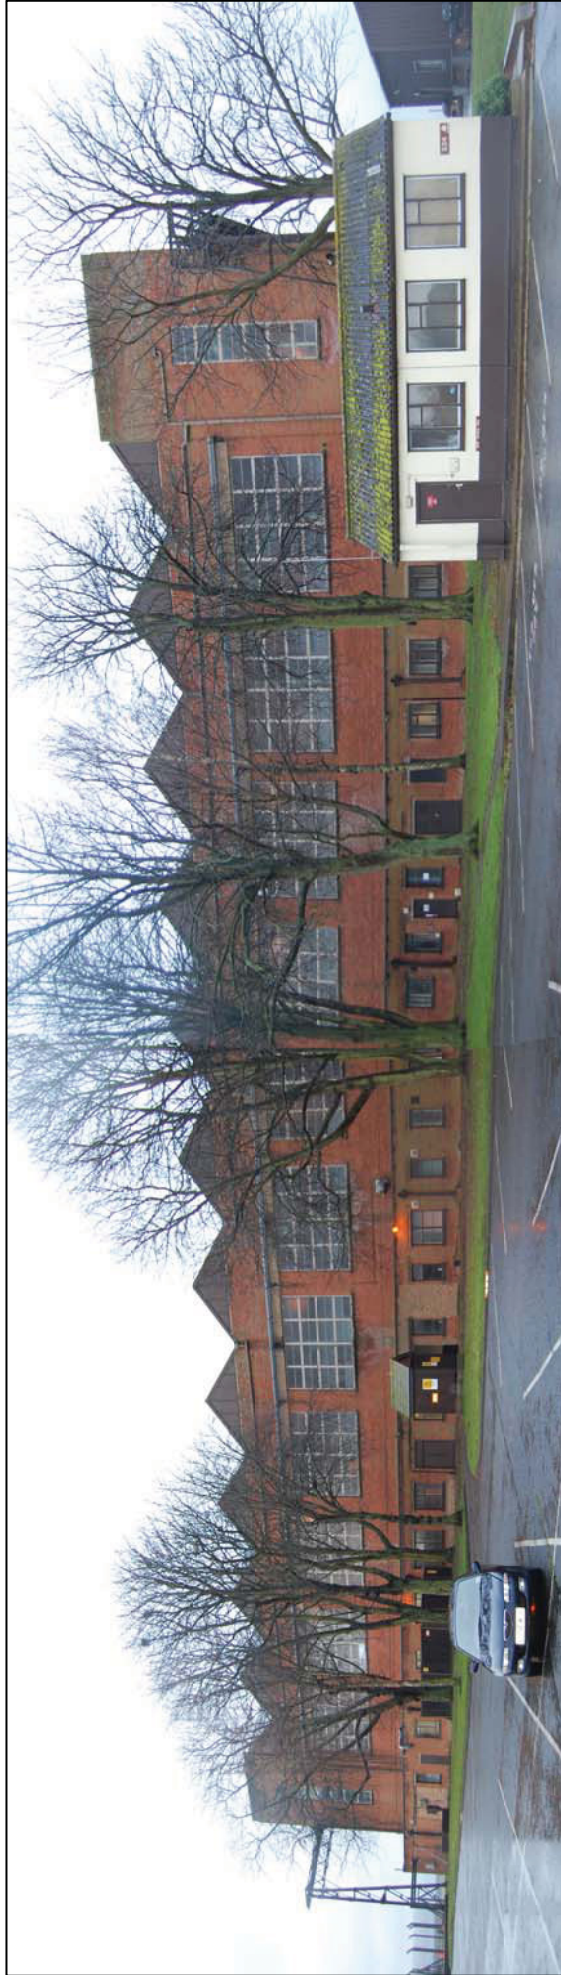
The main layout of the hangar was unaltered, being flanked by the single storey annexes, as was normal on most Type 'C' hangars (Plates 1 and 2). At the east and west end were the external sliding doors. Each set of sliding doors typically consisted of six doors, three on each side, which met in the middle and measured 10.75m high by 8m wide and weighed 12.5T (MoD, 2001). They were originally constructed from steel plate fixed to a steel frame and would open to the full width of the hangar. On Building 538 the surfaces of the doors had been replaced by newer metal sheeting externally, and by panelling internally. The overall structure of the hangar was made up of cavity brickwork with structural steel girders. The total length of the main building was 92m (WSW-ENE) or 93.4m including the thickness of the doors by 57.8m wide (NNW-SSE). The height of the building could not be ascertained as poor weather conditions hindered measurements being taken externally with the TST, however the internal height was measured at 10.7m to the base of the roof structure or 16.1m to the full height. The structure was set within a concrete slab, which was joined to the existing runway. It also had trench foundations.

Plate 1 . Building 538, north elevation (composite photograph)

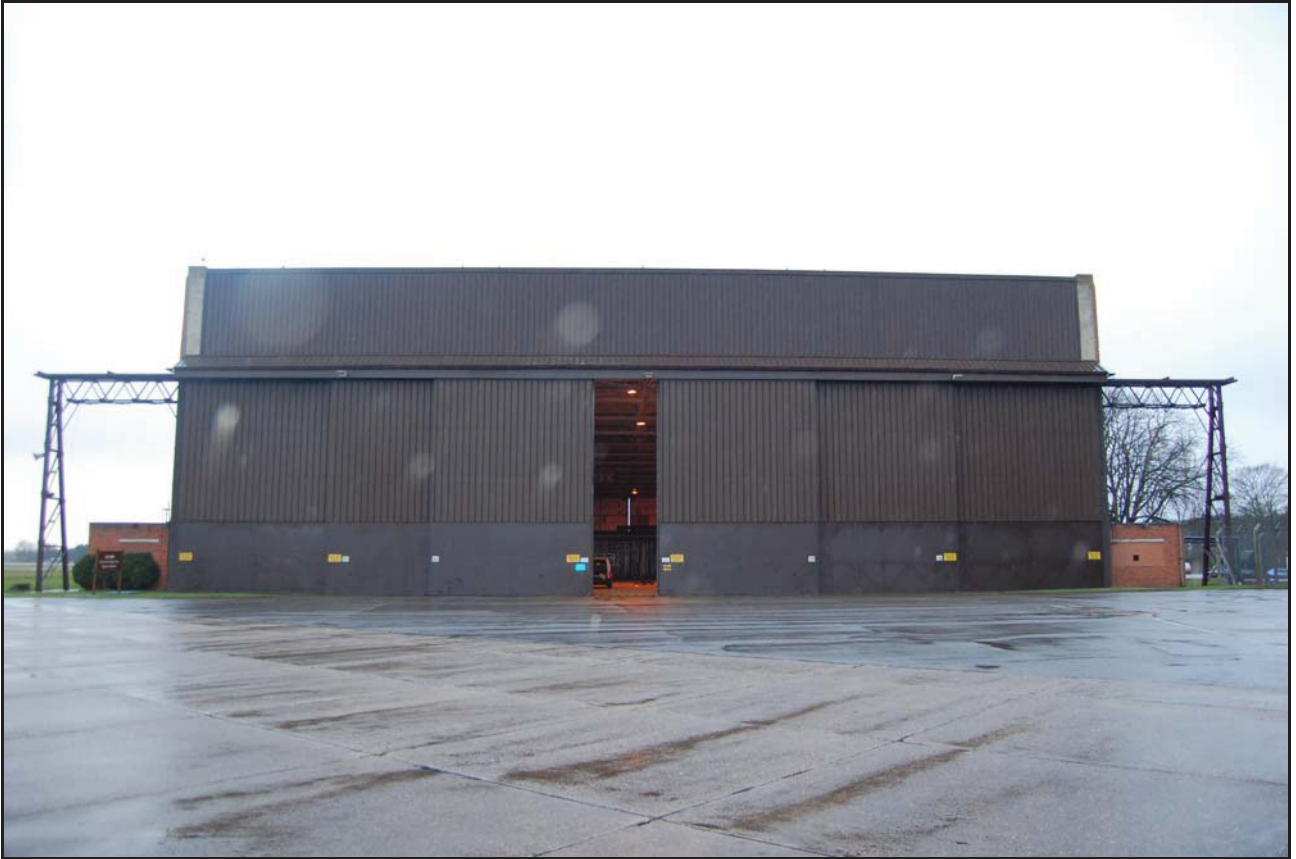
The main external features were the tracks and buffers for the sliding doors. There was a groove in the concrete for each pair of opposing doors, which were hung on a metal rail structure (Plate 2). A buffer was present at the end of each track, made of metal brackets attached to the ground, with thick timbers attached to these to absorb the impact from the doors.

Plate 2. Hangar doors, facing WSW

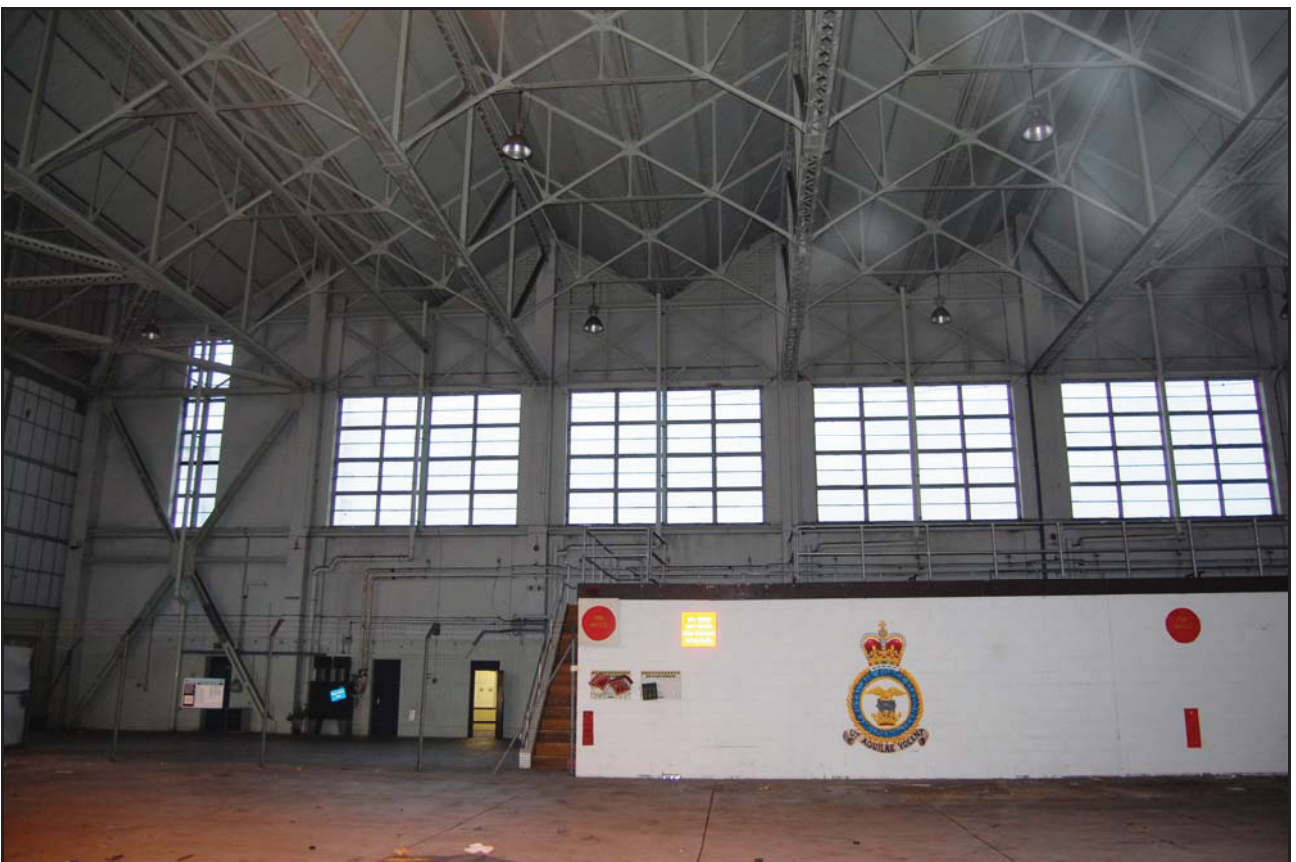
At six metres up the main walls the windows of the structure start. These obviously provided light inside the hangar but were also designed to 'disperse the blast if an incendiary should come through the roof and thus limit damage to the hangar and its contents' (Buchan-Innes, 2000). Those in the end bays measured 6.7m tall by 1.6m wide, whilst those in the other bays measured 4.5m tall by 6m wide (Plate 3).

Plate 3. Internal elevation showing window and roof detail, facing SSE

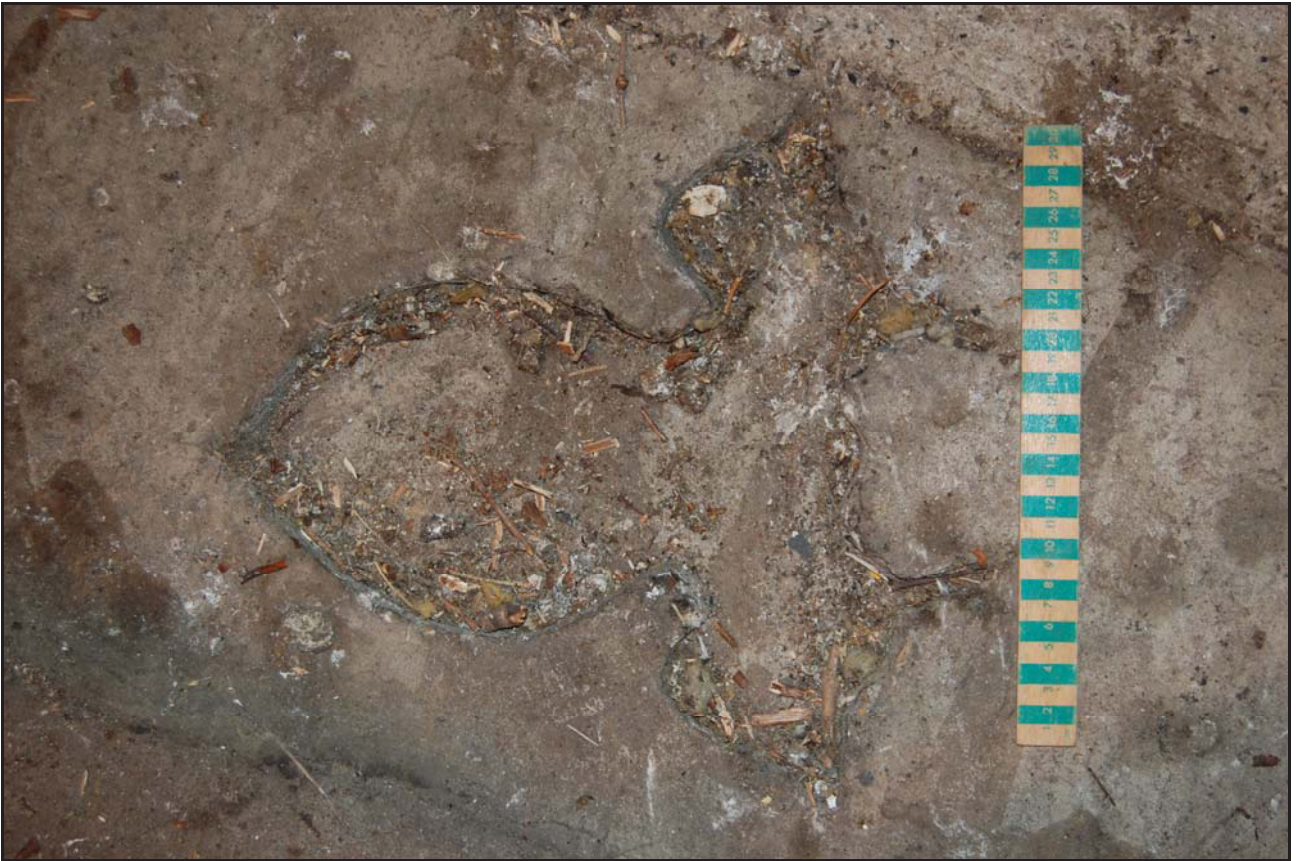
In the north-west corner of the main hangar was an impression of a Blackbird SR-71 reconnaissance aircraft (Plate 4 and Fig. 4). This had been made to mark the arrival of the Blackbird to RAF Mildenhall in the 1970s. Immediately west of this feature two areas of concrete had clearly been replaced. One of these ran into a recess into the northern

Plate 4. Impression of Blackbird SR 71 aircraft (0.3m scale)

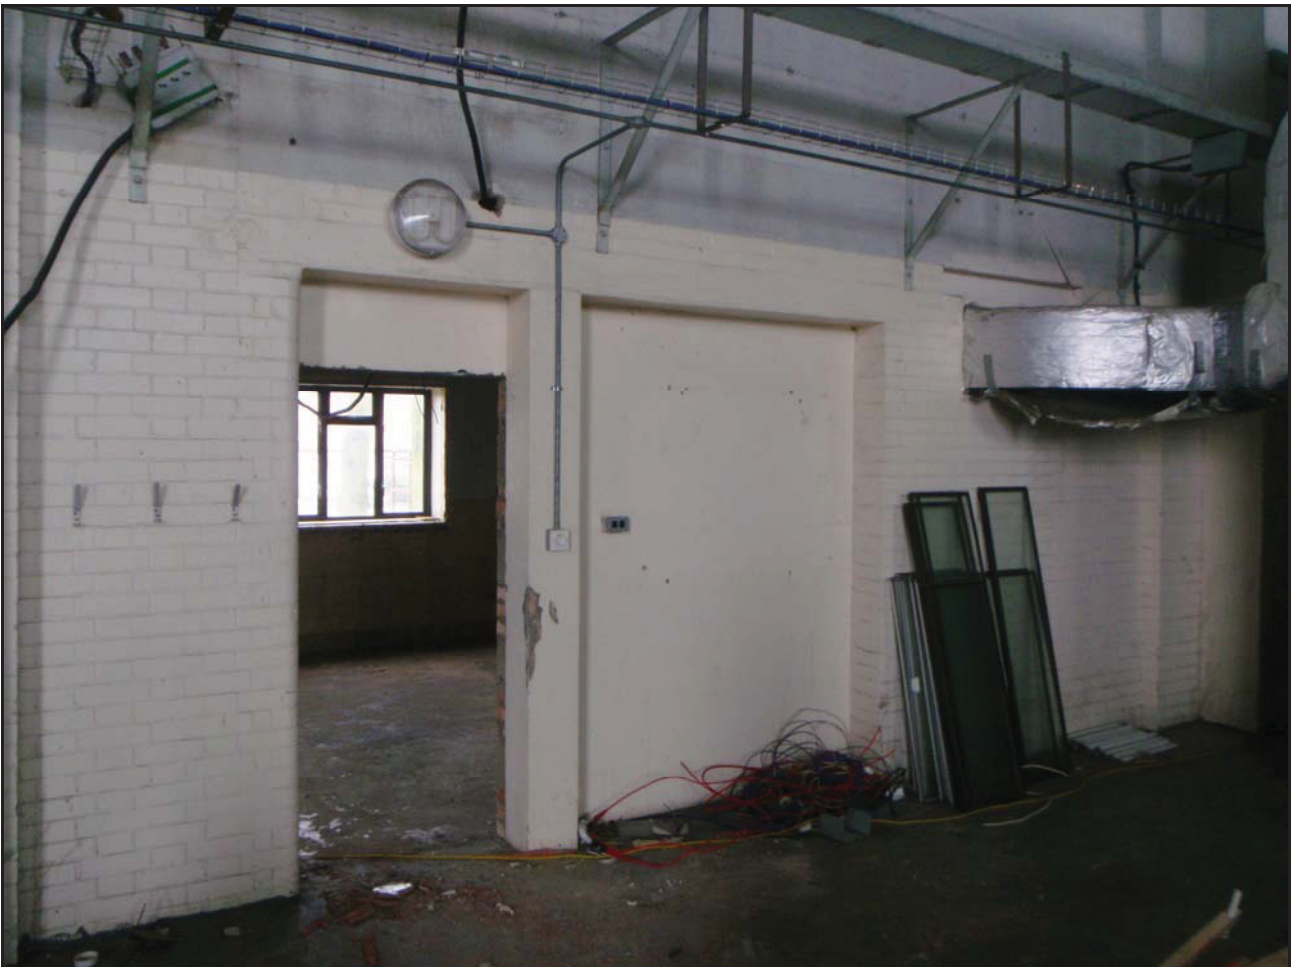
The layout of the annex rooms had been altered. It was clear that originally many of the northern rooms had been accessible by large doors suitable for bringing in machinery, etc. (Plate 5). Six of these doors were recorded in this annex. These varied between 2.8m and 5m wide by c.2.2m tall, although sometimes it was unclear if these were the original dimensions or whether they had been altered when the doors had been blocked up or altered. In particular the widest door (Room 1) was noticeably larger and different to the others, being marked by a pronounced recess into the wall. It was unclear, but this may have been two doors originally, particularly as it ran behind one of the structural columns (see 'Modified opening' on Figs. 2 and 3). From the layout of the surviving walls there had been at least five separate rooms which had made up the northern annex. However, in all likelihood several more rooms would have existed in the western half of the annex where very few original walls survived.

Plate 5. Blocked large door, converted into single door

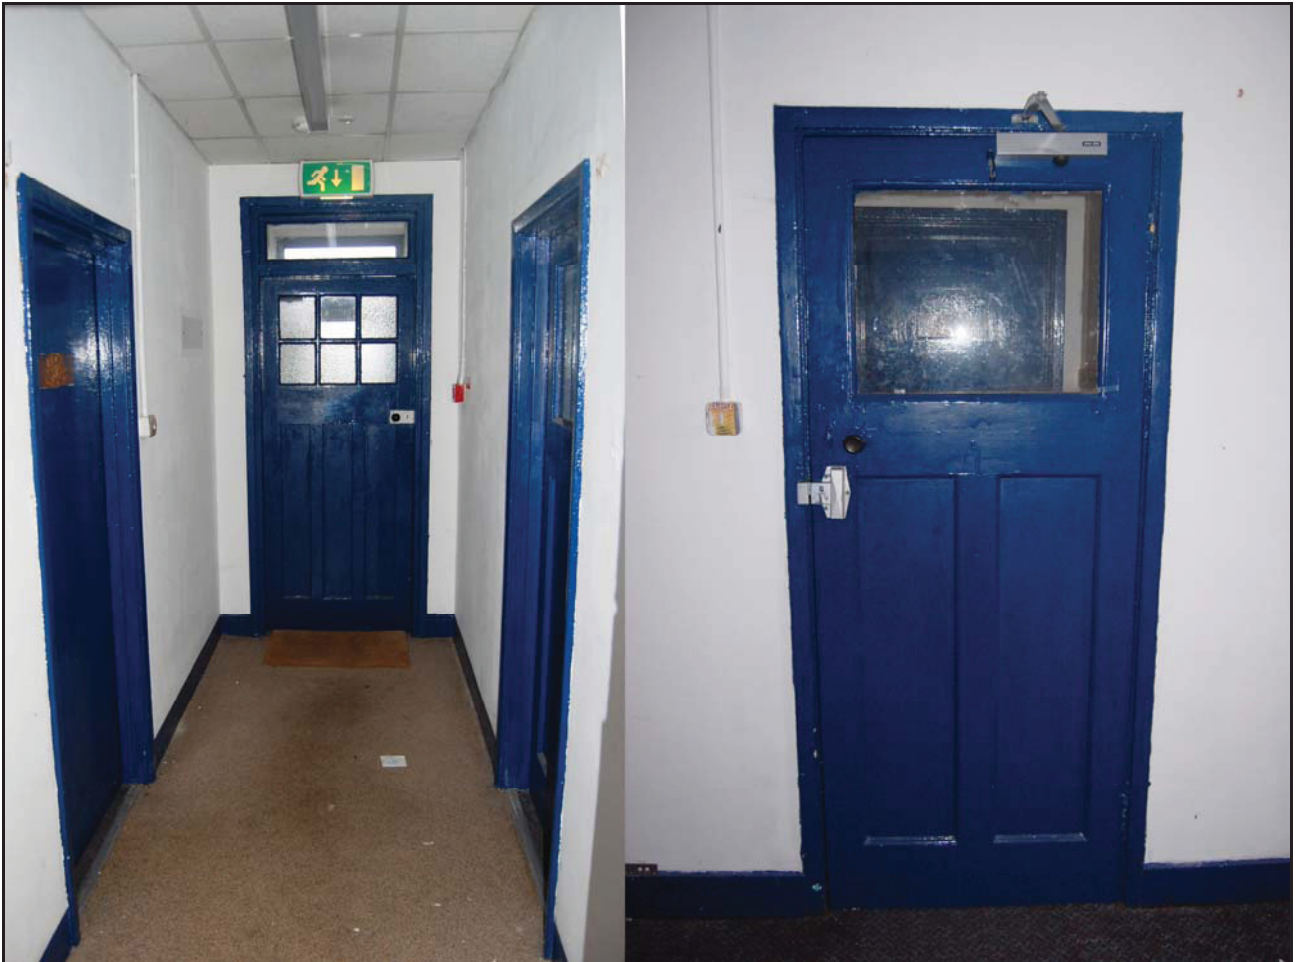
In this annex four original exits were still present. It is thought that this reflects the proximity of the runway to this side of the building and therefore the necessity to enter and exit this side more regularly. The two doorways at the east end of the annex still had their original doors intact (similar doors are shown on Plate 6). Midway along the annex a larger external corridor with a double door was present, mirroring that in the northern annex. It had two doors leading east and west to the adjoining rooms as well as one to the main hangar. Near the west end of the annex was the final exit.

Plate 6. Original doors

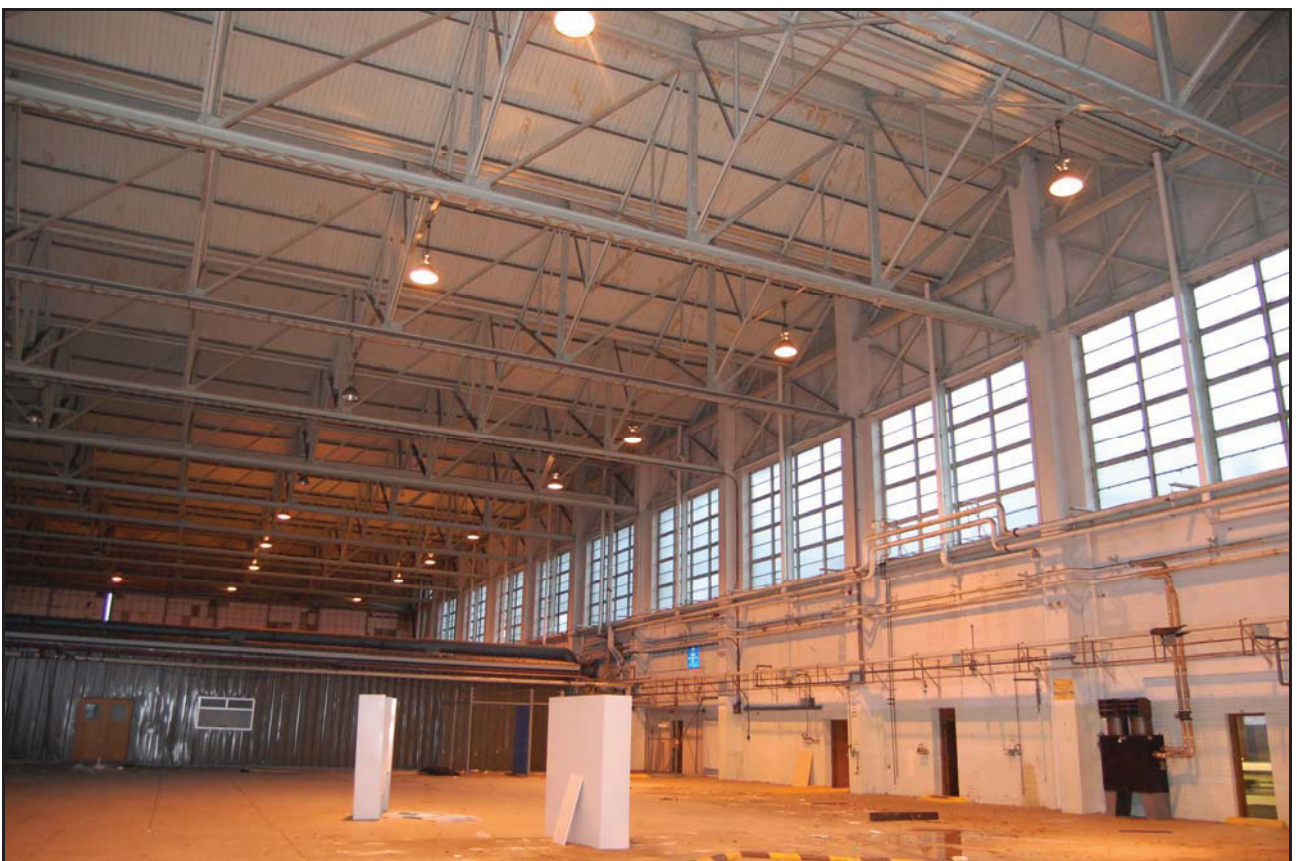
'The main girders span the full 45.72m span (150 feet) across the hangar between the columns at 7.62 m centres (25 feet) and support the secondary trusses. For both the Type C34 and Type C38 hangars there are typically three separate main girders ... The three girder types are similar in size and layout, but by utilising different member sizes have different capacities ... The secondary trusses span 7.62m (25 feet) between the supporting primary trusses. The truss depth varies along its span, having the depth of 4.9m at the supports and 1.23m at mid-span, thus forming valley gutters. The original roof was supported directly on the secondary trusses via timber sarking and purlins'

Plate 7. Internal, showing roof and structural detail

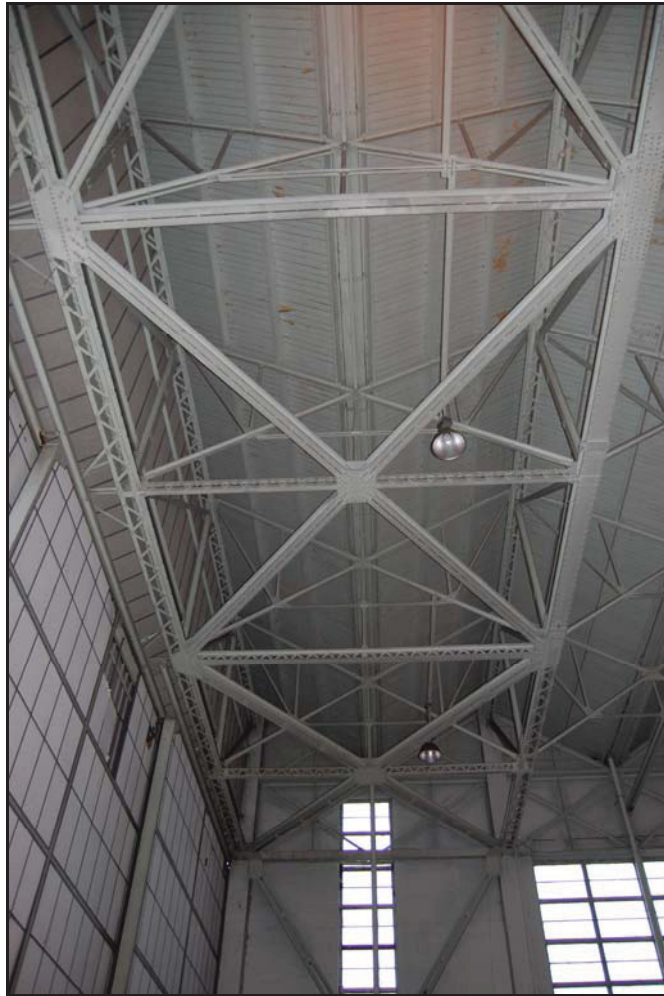
Plate 8. Roof structure of end bays

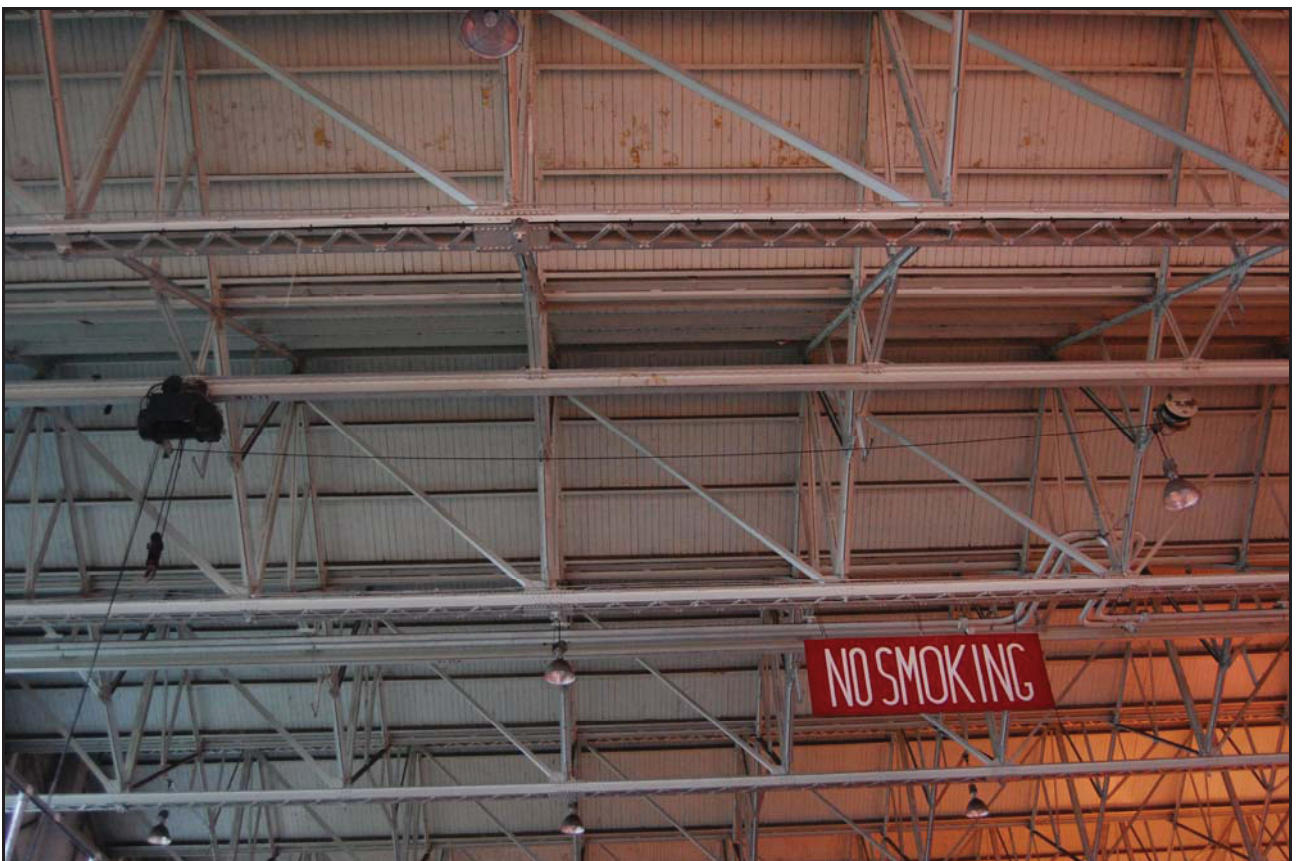
The roof appeared to be largely unaltered, except for the absence of the original timber elements. It would have been originally covered either with asbestos cement slates or sheeting. A motorised winch was present and it was not clear if this was a newer addition, although if it were new, no clear additions had been made to the roof's structure in order to fit or operate it (Plate 9).

Plate 9. Winch
