**Farm Buildings at
Retreat Farm,
Flixton, Suffolk
FLN 089**

Historic Building Record

December 2010

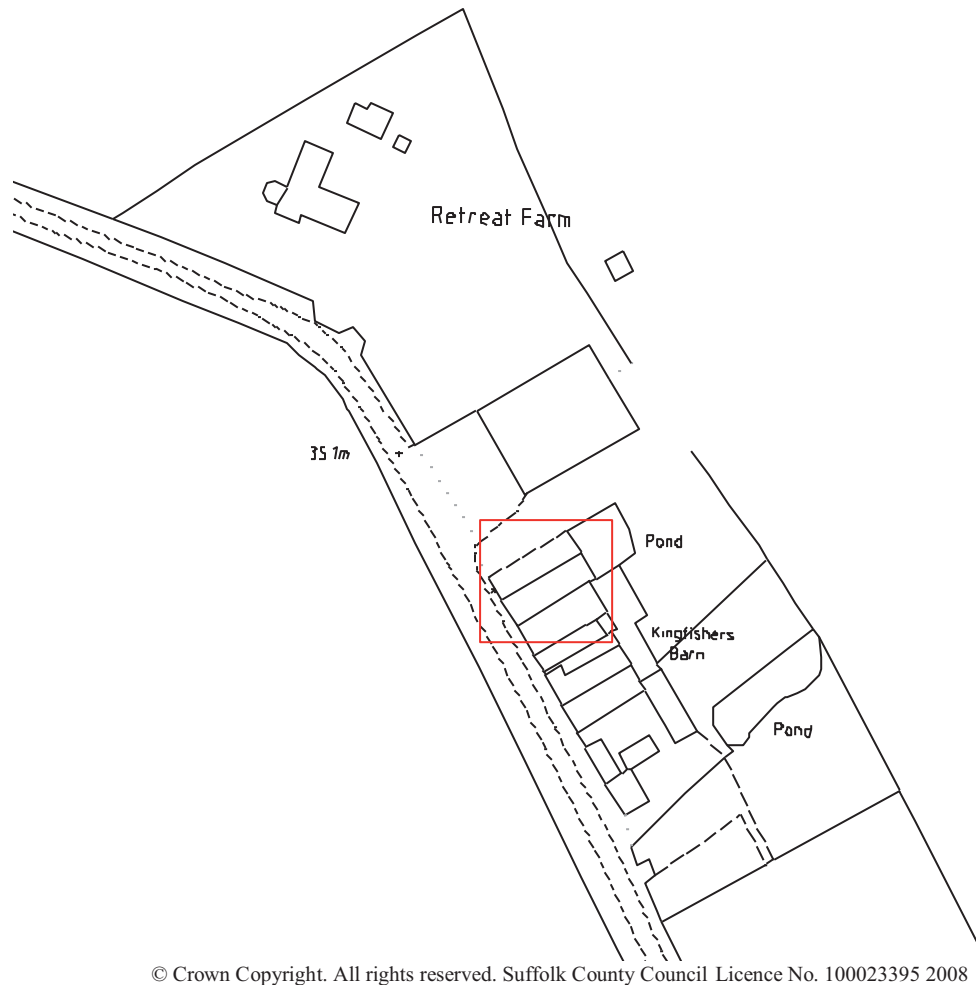
Figure 1 Current Ordnance Survey Site Plan.
Outlining the historic farm buildings to the east of Abbey Road in red and showing the unlisted farmhouse to the north. The southern half of the farm complex, including a thatched barn, has already been converted into a dwelling labelled Kingfishers Barn.

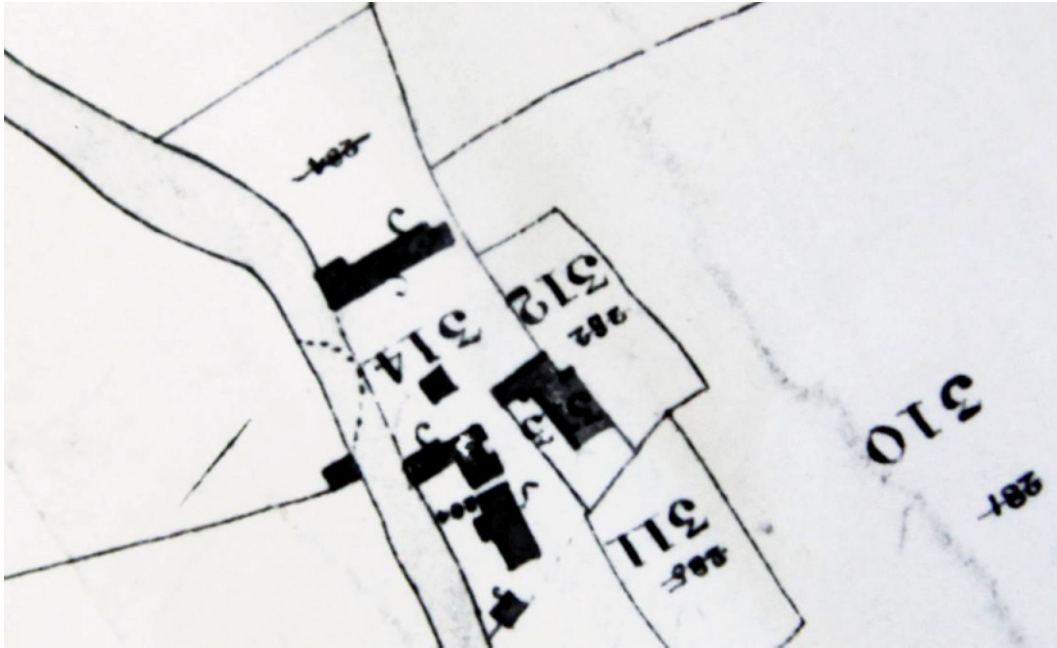
Figure 2. Retreat Farm on the Flixton title map of 1844 (Suffolk Record Office), which shows a dramatically different layout. The present thatched barn is shown to the south with a western porch and an earlier L-shaped range of buildings occupied the site of the stable and granary to the north (possibly including the granary), but the farmhouse lay immediately to the rear (no. 313) and has disappeared without trace. The site of the modern farmhouse on the bend in the road was empty.

The unusually large distance between the house and farm buildings is explained by the Flixton tithe map of 1844, on which the present house is conspicuous by its absence and an earlier farmhouse is shown immediately north-east of the barn (i.e. on an overgrown plot to the rear of the granary and eastern sheds – buildings 1-3 as numbered in figure 6 below). The map shows the thatched barn as a detached structure with a western projection that probably represents a porch (building 4) and an L-shaped range on the approximate site of the existing stable and granary (buildings 1 and 5). It is difficult to determine from the tithe map alone whether the latter were present in 1844, but the nature of their fabric and the absence of the adjoining sheds (of ostensibly identical date) suggest they were not.

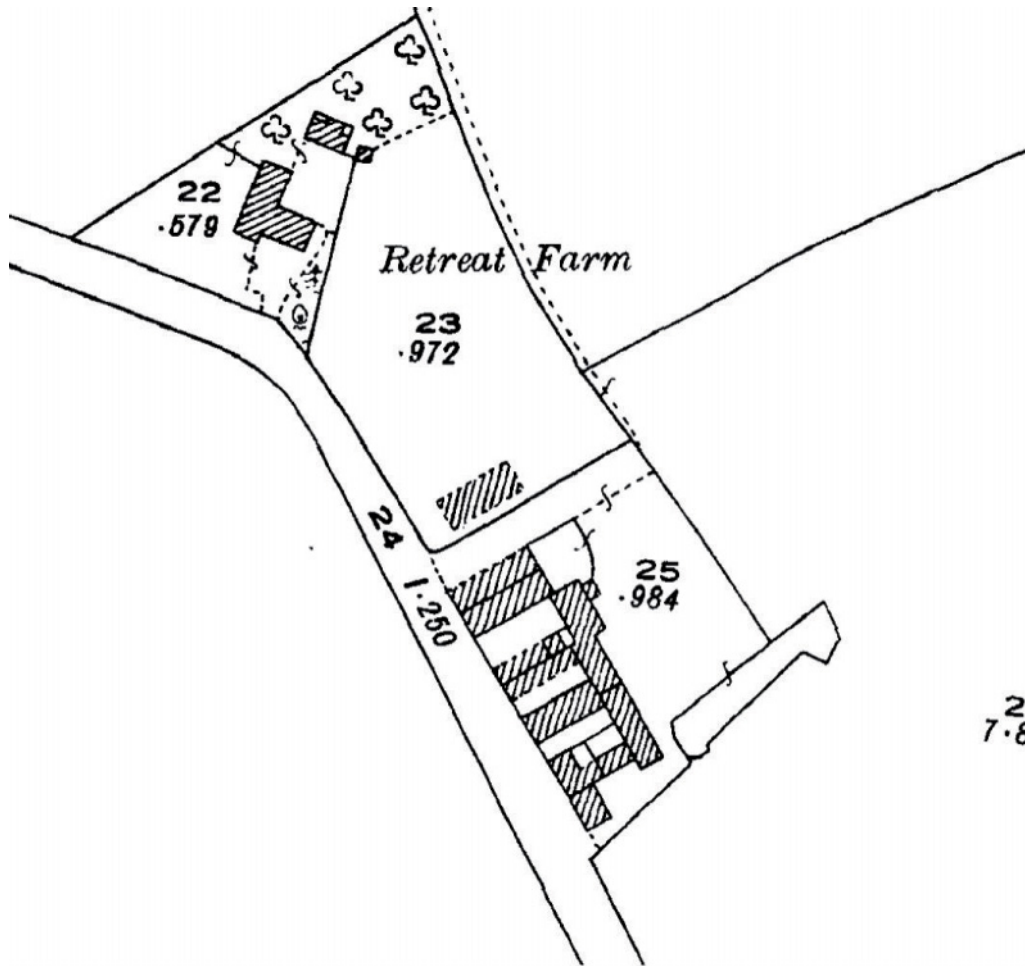
Figure 5
Third Edition Ordnance Survey of 1927. With the exception of a small projection from the eastern elevation of the granary adjoining the pond (of which no trace remains) the layout had not altered since 1904.

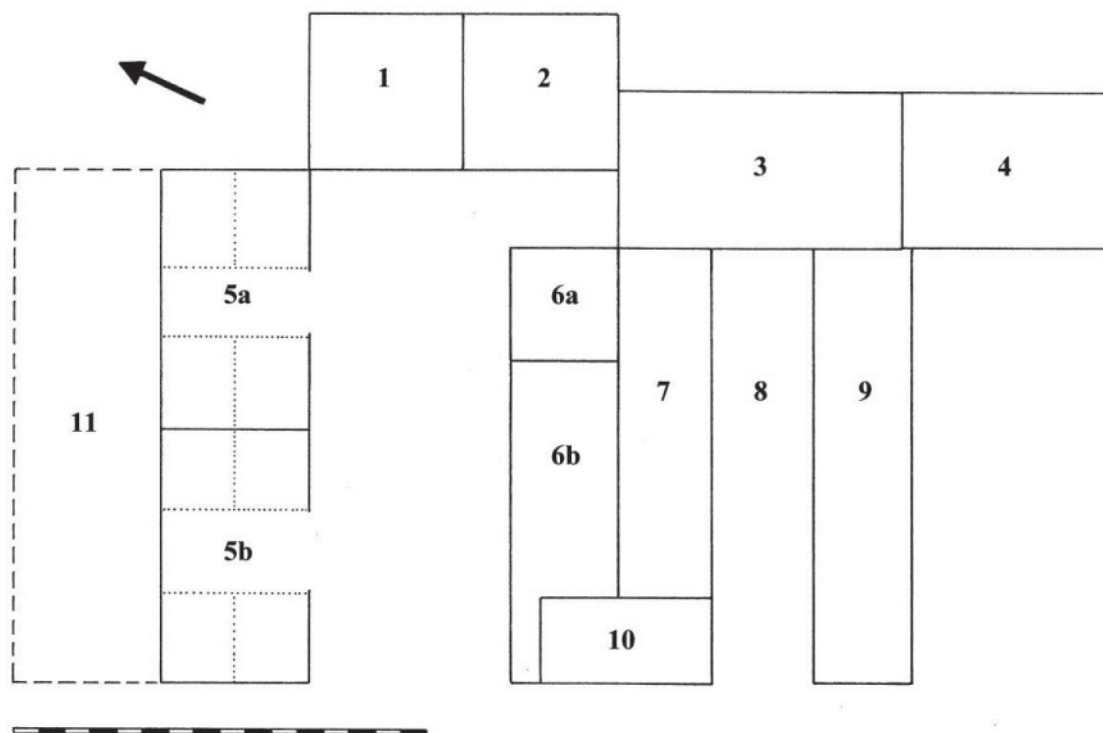
Figure 6
Block plan of the site identifying each historic building with a number for ease of reference in the text and photographic record.
Scale in metres.

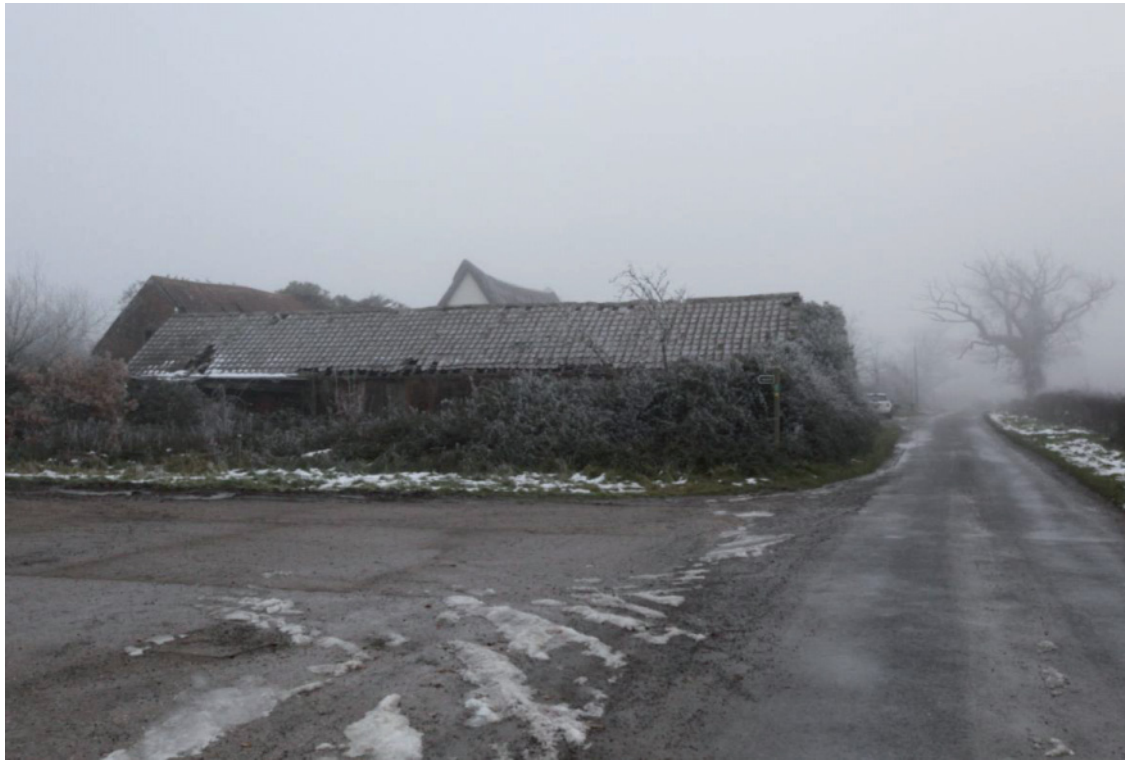
Illus. 1. Exterior of complex from north showing the site of the demolished cart lodge (11) with the pantiled roof of the stable (5) in the foreground and the steeply pitched thatched gable of the previously converted barn (4) in the rear.

An additional shed adjoined the northern elevation of the stable (5), as shown on the Ordnance Surveys. This was open-sided to the farm track on the north and presumably formed a cart and implement lodge, but had collapsed almost without trace by the time of inspection.

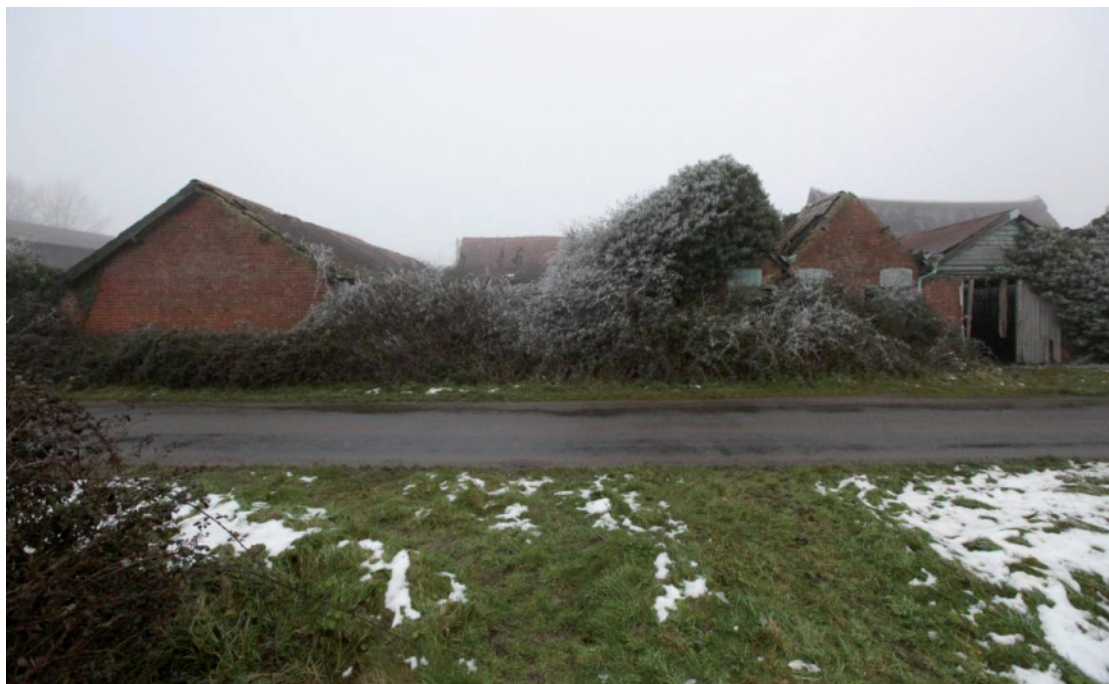
Illus. 2. Exterior of roadside western gables showing the stable (5b) to the left with the converted thatched barn (4) in the rear to right. The doors and windows of the enclosed feed sheds in the ends of the shelter-sheds (6 & 7) are visible behind brambles in the centre, with the shallow-pitched gable of the later covered yard (8) to the extreme right.

The western ends of the two central shelter-sheds (6 and 7) incorporate a series of small original sheds with doors and windows against the road. Their outline is indicated in figure 6 but not the internal partitions as access was prevented by impenetrable undergrowth. Sheds of this kind were normally used for storing animal feed but it is unusual for an example to extend only partly into the width of the adjoining shelter shed as occurs here to the north.

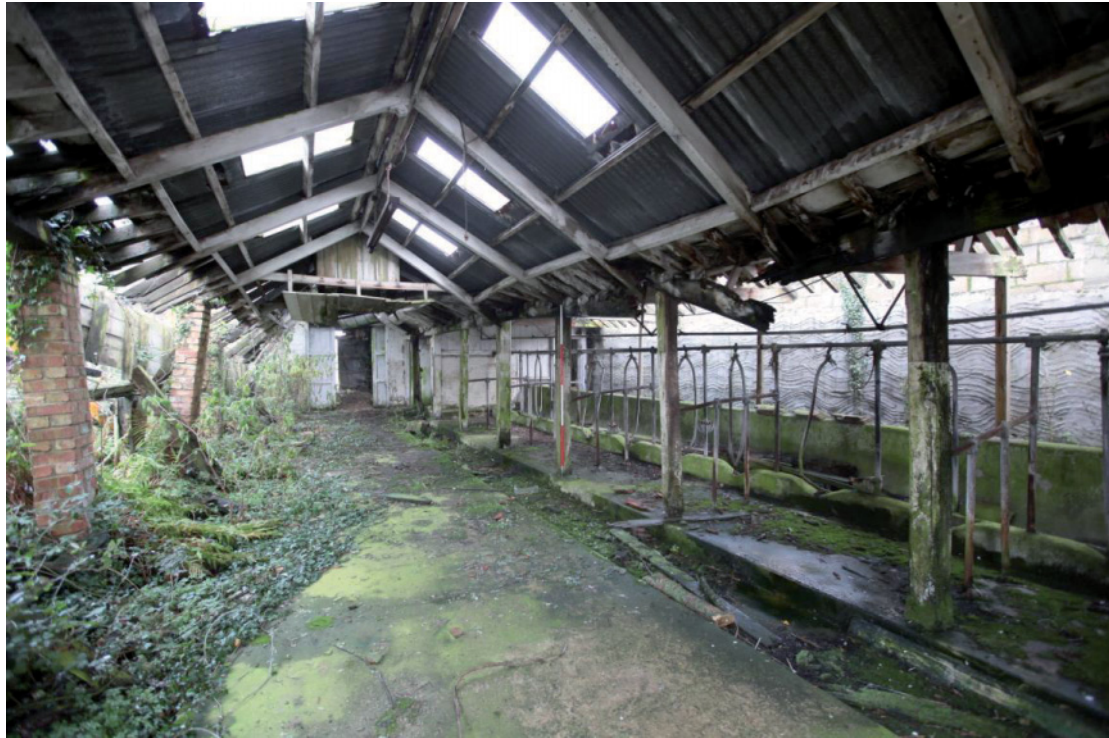
Illus. 3. Interior from west of the 20th century covered yard (8) showing the 20th century milking parlour stalls in the southern shed (9) to the right and the 20th century Fletton-brick piers of the largely collapsed shelter-shed (7) to the left.

Unlike the stable yard to the north, the sheds of the adjoining southern yard have been extensively altered – reflecting their continued use for cattle into the latter part of the 20th century. The northern shed (7) is shown as an open-sided shelter on the historic Ordnance Surveys above, but with the exception of its western gable has collapsed and largely disappeared. A series of secondary Fletton brick piers supports the northern plate of the 20th century corrugated iron roof which now covers the formerly open central yard (8), with a brick gable to the road, and a similar series of concrete piers has replaced the northern elevation of the southern shed (9). The latter is shown enclosed on the Ordnance Surveys and probably formed a cow-shed but was converted into a milking parlour and now contains a series of galvanised metal stalls. Its roof remains intact, however, and is of identical form to those of the stable yard.

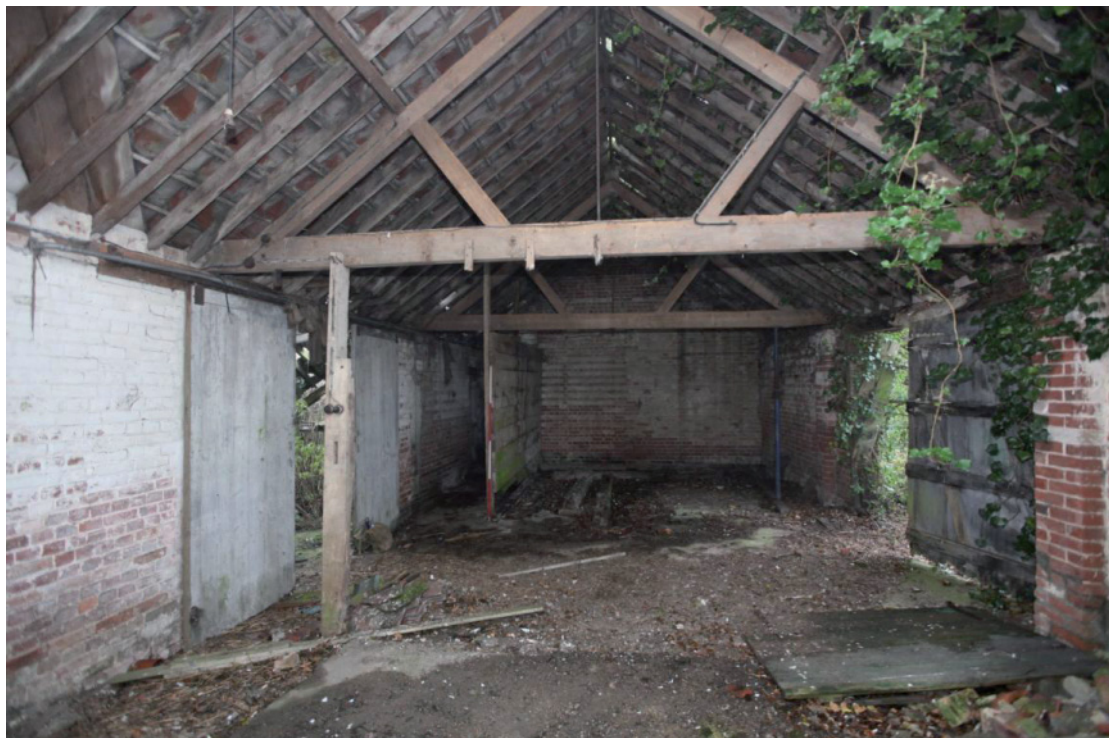
Illus. 4. Interior of the eastern shed (3) seen from the south, showing its softwood roof structure with original external double-doors to the right and inserted double doors to the southern yard (8) to the left. The narrow boarded passageway in the rear leads to a door which opens onto the horse yard.

The brick shed to the east of the southern yard (8) adjoins the northern gable of the earlier barn and is linked by an original doorway to the eastern gable of the southern yard shed (9). It is open to its roof of through-purlins supported on internal trusses with raking queen-struts and central iron bars (typical of the 1860s and 1870s). It now contains a central thoroughfare by which cattle would have entered the covered yard and milking parlour in the 20th century, but the yard door is a secondary insertion and the building was probably designed as a neat-house (bullock shed). A boarded partition forms a screened passage to a door in its northern gable which opens onto the horse yard.

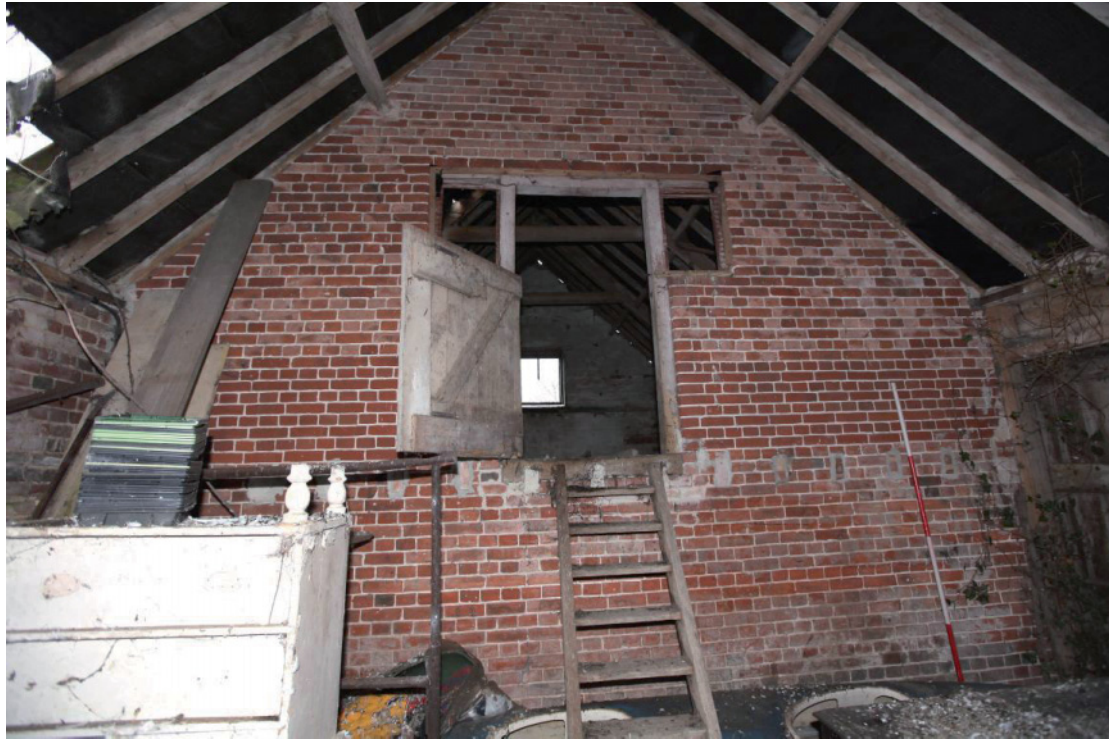
Illus. 5. Southern external gable of the granary (1) seen from the slightly later granary shed (2) and showing the ladder to the first-floor grain floor and the windows flanking the door. This gable was open to the elements before the granary shed was constructed.

The shed adjoining the southern gable of the granary is now open to its clasped-purlin roof structure but originally contained a grain floor supported on an internal shelf in its brick walls. The area beneath this floor, of which no trace survives (apart from the shelf and cement-filled joist apertures in the earlier granary, 1), appears to have been inaccessible and served only to raise the grain above the ground. The shed is entered by double doors from the east and was built as an early extension to the northern granary which is now accessible only from its interior. The present metal-framed window in the northern gable is secondary and probably replaced a wider external loading door.

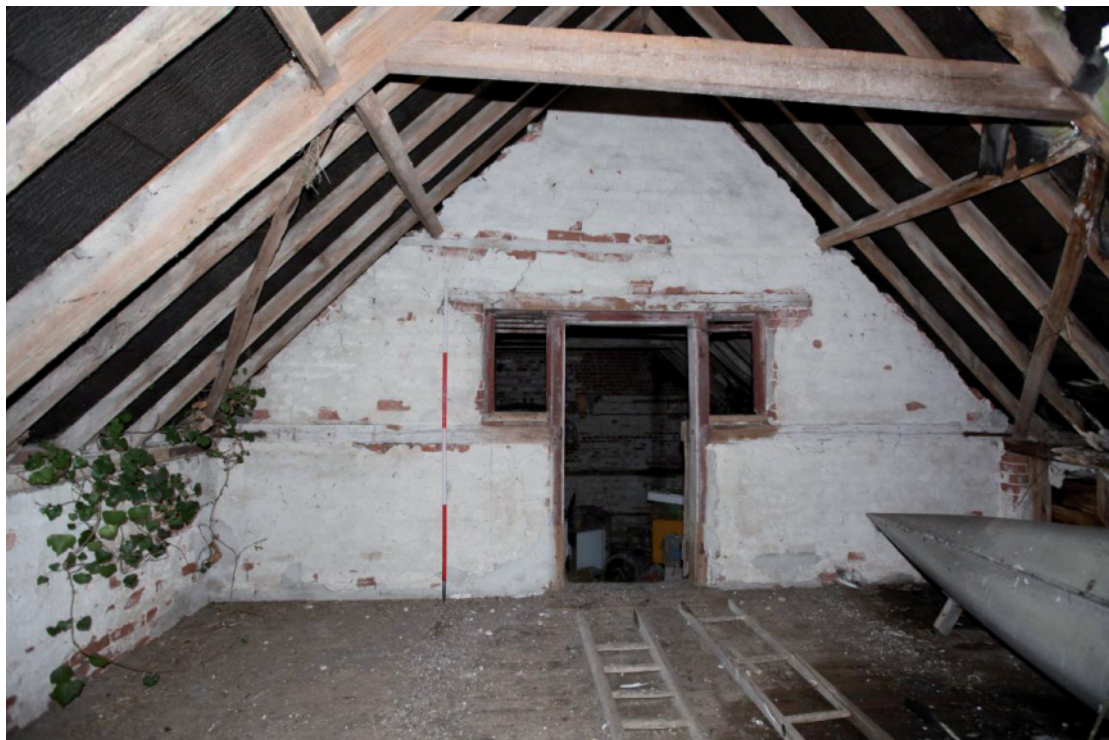
Illus. 6. Internal southern gable of the first-floor granary (1) showing the rendered brickwork with red pigment to the door and window frames (beneath later whitewash) and the roof structure of staggered butt-purlins.

The building in the north-eastern corner of the site adjoins a large pond to the north and extends to 5.8 m in length by 5.9 m in overall width (19 ft by 19.5 ft). It rises to 3 m in height at its eaves (10 ft) and contains a grain loft above a ceiling of tall-sectioned softwood joists. The lower storey of 2.1 m (7 ft) is entirely open to the west (facing the enclosed horse yard) where the upper wall consists of weatherboarded studwork but is otherwise featureless, while the grain loft is reached by a short ladder via a first-floor door flanked by two windows in the southern gable (originally external but now enclosed by the adjoining shed, 2). The northern gable also contains a window overlooking the pond. The pine roof structure of staggered butt-purlins contains pegged collars and a ridge board in a manner more often associated with the second quarter of the 19th century than the third, and it is possible this building pre-dates its neighbours by a decade or two. It appears to have been designed as a granary with a cart

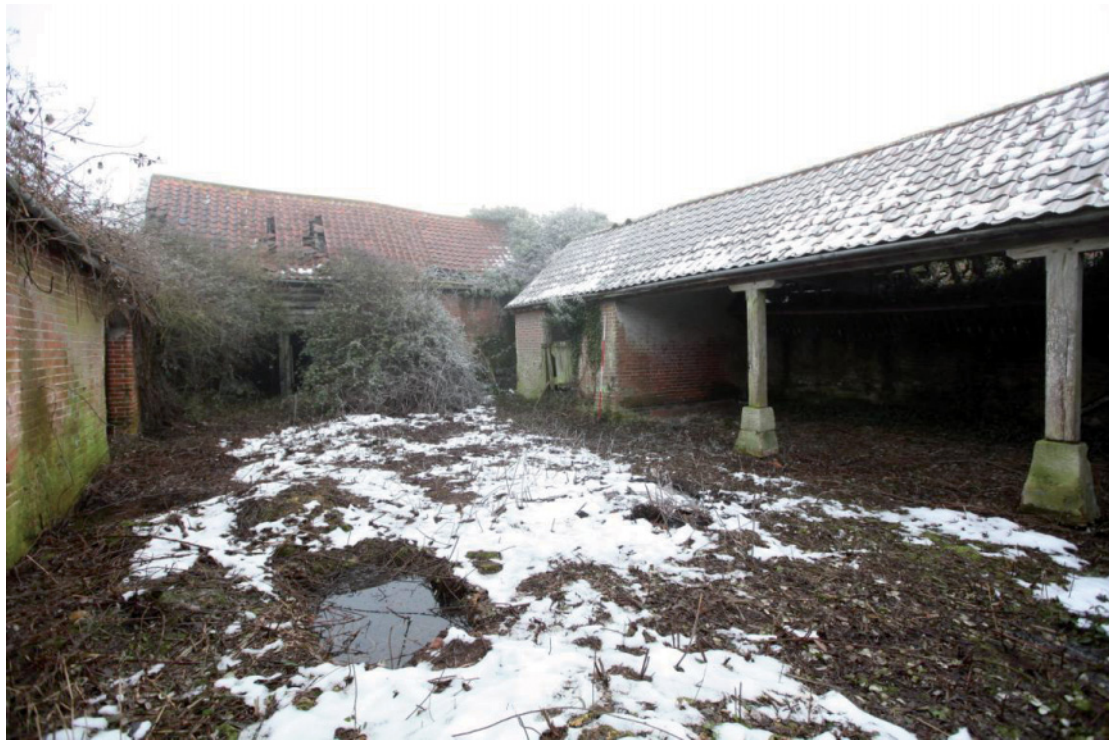
Illus. 7. Western end of the horse yard showing the open arcade (6b) and enclosed loose box (6a) to the right with the granary (1) in the rear and the stable (5) to the left. The boarded upper storey and open lower storey of the granary is visible between the brambles.

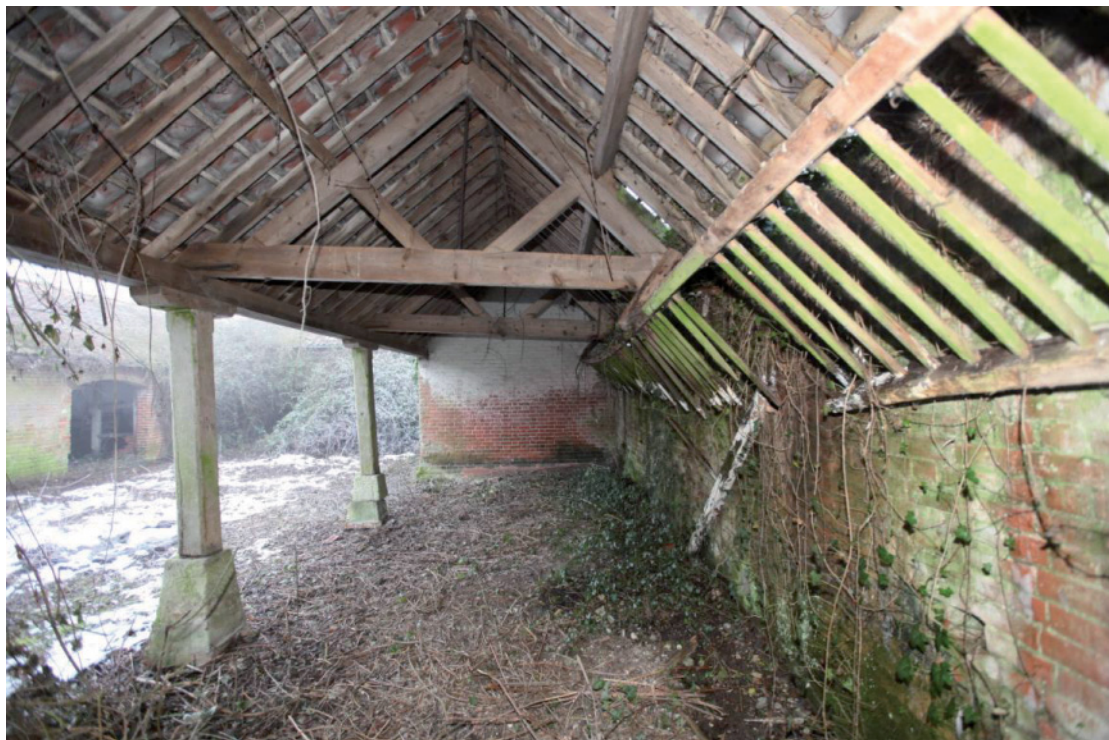
Illus. 8. Interior of the shelter-shed (6b) from the west showing the long hay rack to the right and timber posts on stone blocks adjoining the horse yard to the left.

The brick and pantiled shed to the south of the stable yard forms an open-sided shelter-shed which retains a 19th century wooden hay rack to the entire length of its southern interior and is of identical construction to the stable. Its arcade posts rest on stone piers and it contains a separate loose box of 4.25 m in length (14 ft) at its eastern end (entered by a central door from the yard and also retaining both a hay rack and boarded manger).

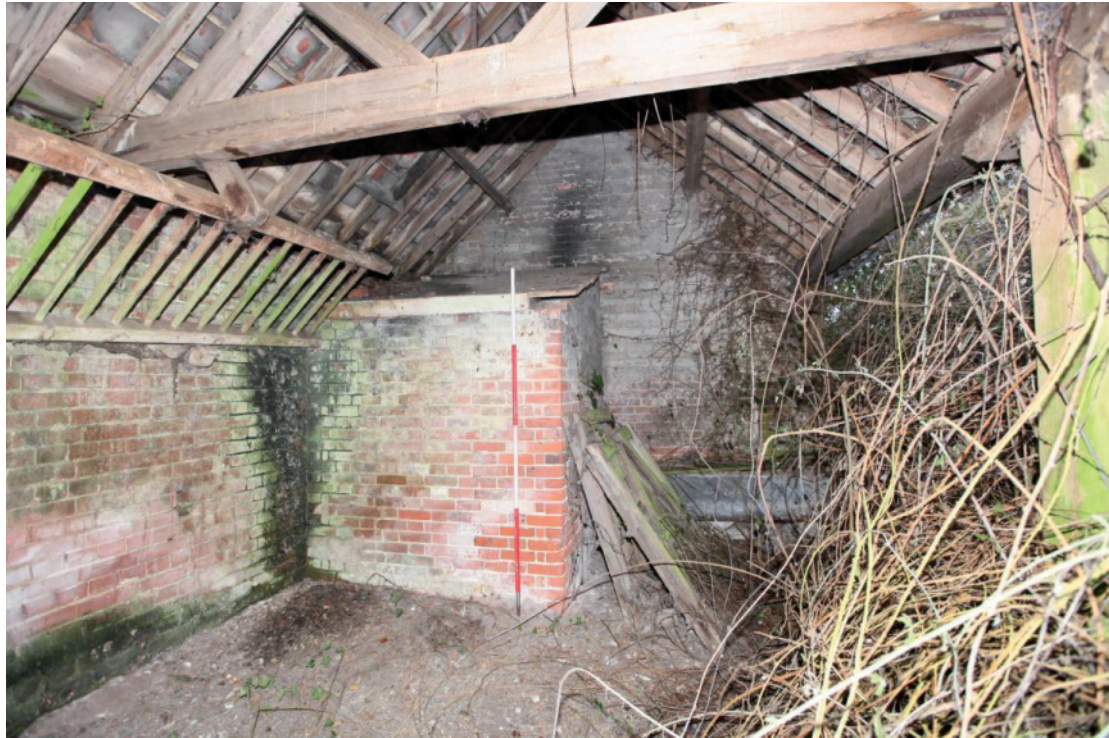
Illus. 9. Western interior of the shelter-shed (6b) showing the hay rack to the left and the enclosed brick shed (10) in its south-west corner which unusually extends across only half the shelter-shed's width. This is an entirely original arrangement.

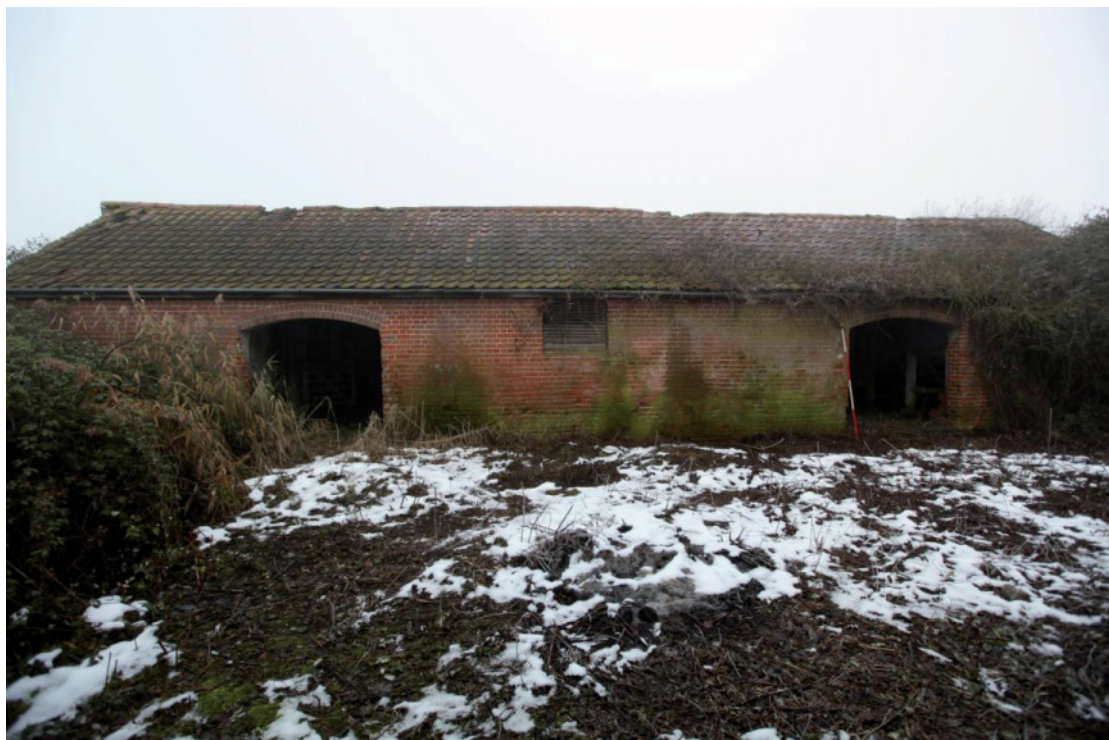
Illus. 10. Southern exterior of the single-storied stable (5) showing the arched entrance of the eastern stable (5a) to the right and the western stable (5b) to the left. The louvered window in the centre lights the south-eastern stall of the western stable (Duke).

The northernmost brick shed (excepting only the demolished cart lodge (11) described below) is a single-storied stable of unusual form. It extends to 20.5 m in length by 6.1 m in overall width and rises to 2.3 m at its roof-plates (68 ft by 20 ft by 7.5 ft) and is divided into two equal sections by a lateral brick partition. The softwood roof structure is identical to that of the eastern shed (3) with through-purlins supported on internal trusses with raking queen-struts and central iron bars. Each section is entered from the southern yard by a wide arched opening onto a boarded passage flanked by pairs of stalls on both sides. The boarded partitions of these stalls remain unusually intact, particularly to the west (5b), and still bear what appear to be the names of their original occupants on their door lintels. Each name is professionally painted in red on a white background with curved ends (imitating a metal name-plate) and was later over-painted in white but is now clearly visible where the over-painting has decayed. The eight horses were named (clockwise from each entrance): Ramper, Scott, Proctor, Duke (5b to the west) and Bonny, Diamond, Darling & Brag (5a to the east). A naive image of a horse has been incised into the boarded partition to the left of Ramper's stall, and a series of tally marks appear alongside the initials 'CB' to the west of the arched eastern entrance. The names presumably belonged to large Suffolk Punch or Shire horses that were difficult to accommodate beneath a hay loft in the traditional manner, and it is rare to find a

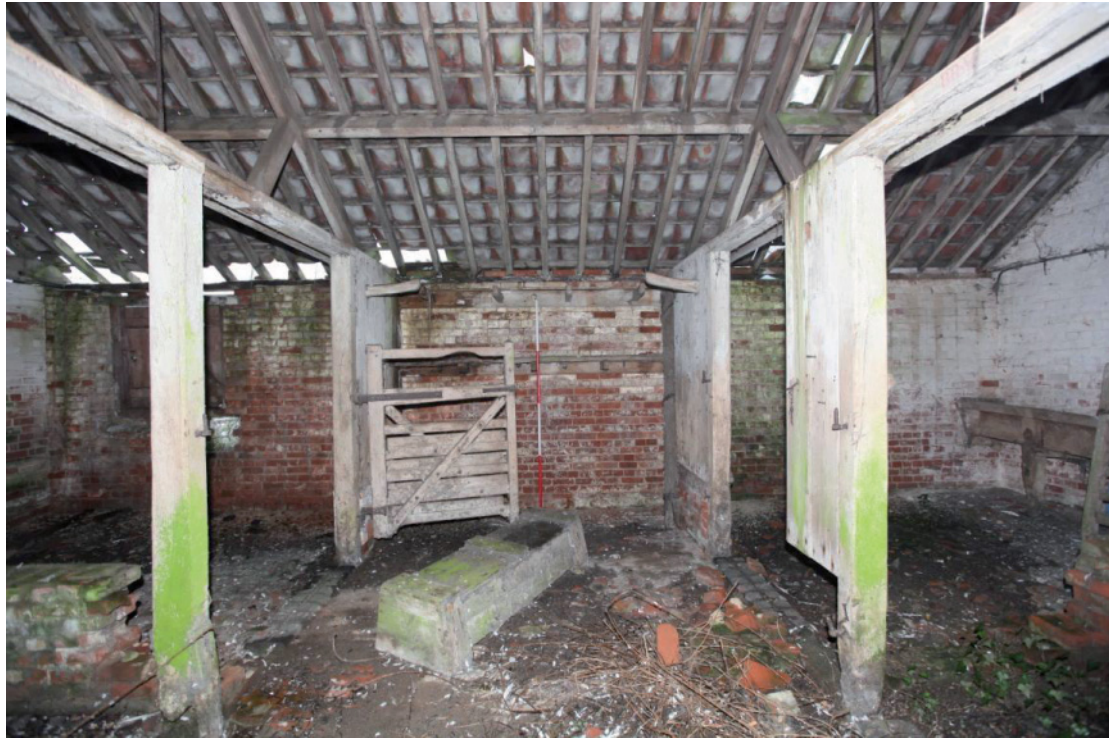
Illus. 11. Interior of the eastern stable (5a) showing its central passage with mutilated stall divisions to left and right. The remains of a boarded manger are visible to the right (in the stall marked Darling) and a window hatch to the left (Diamond), with two tiers of wooden harness hooks in the centre. The stalls in the foreground are named Bonny (left and Brag.

Each stable now contains a floor of 20th century cement tiles, but original brick floors survive in the central passages together with a series of wooden harness hooks to the rear (north). Several stalls contain the remains of boarded mangers but there is no evidence of hay racks as might be expected. Two stalls contain original windows that would have been obstructed by any such racks (a louvered window with chamfered mullions and red paintwork to the south-east of the western stable (Duke) and a hinged hatch opening onto the demolished cart lodge to the north-west of the eastern stable (Diamond)). Instead, each stall was provided with hanging hay baskets, as indicated by distinctively curved abrasion marks on the brickwork of Duke's stall.

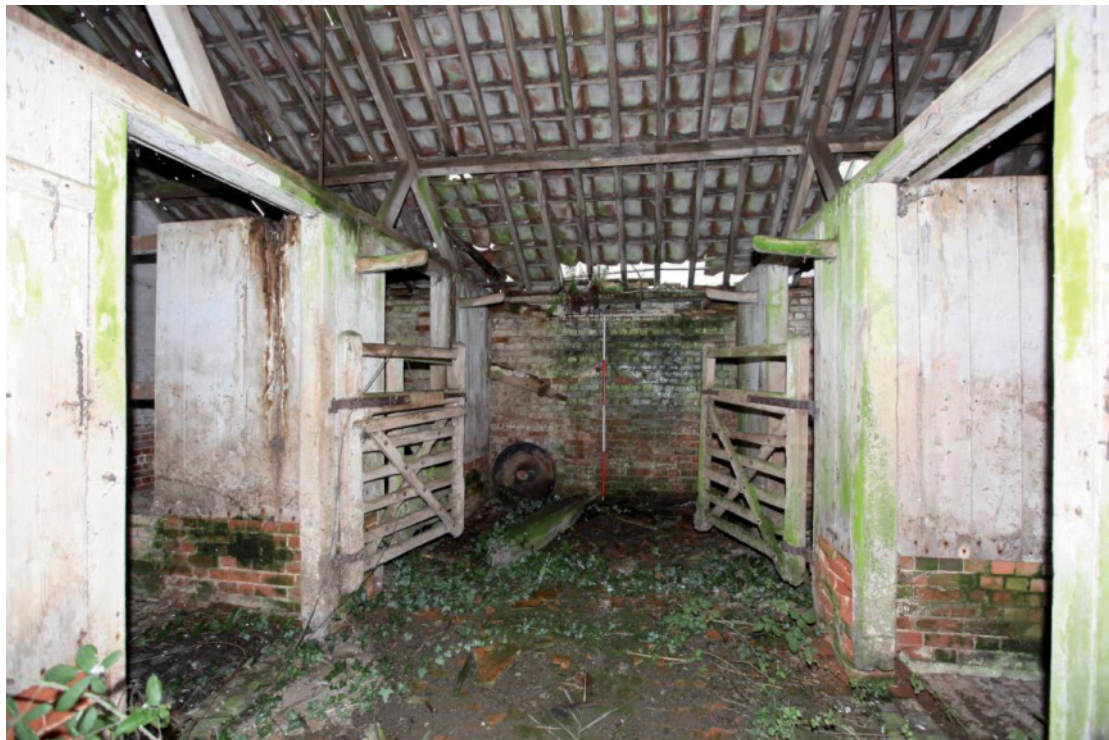
Illus. 12. Interior of the well-preserved western stable (5b) from its southern entrance showing the central passage with original harness hooks flanked by the doors to the four stalls named from left to right Ramper, Scott, Proctor and Duke. The boarding to the extreme left is incised with an image of a horse (illus. 16).

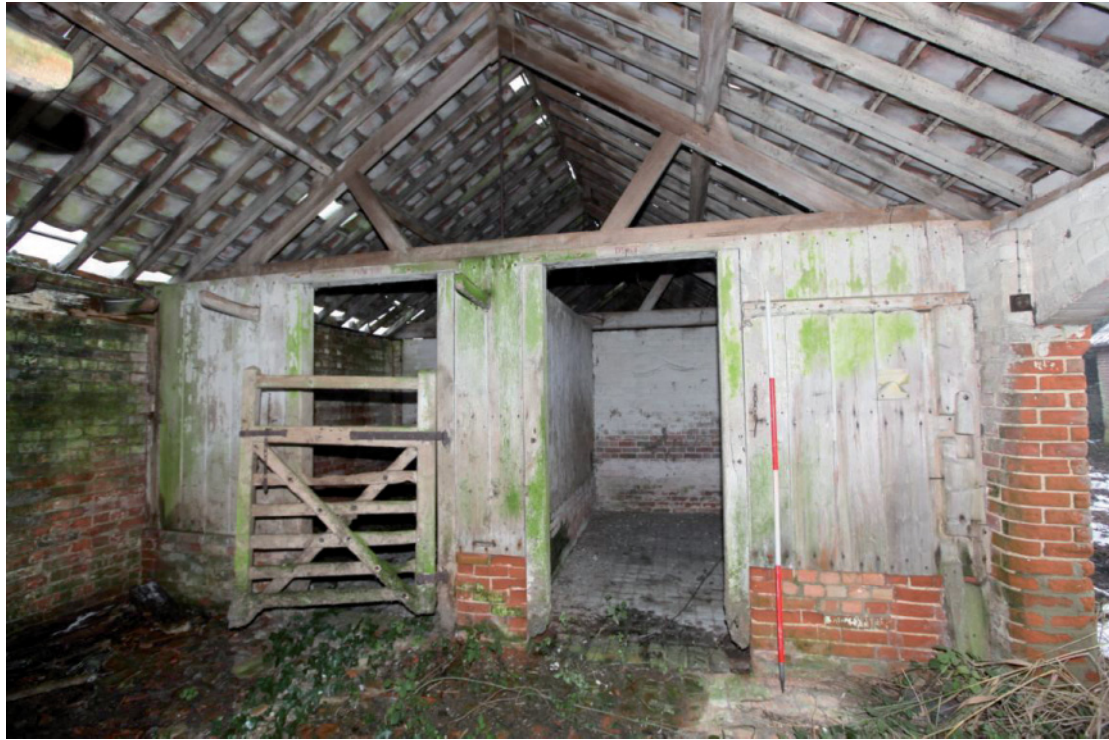
Illus. 13. The doors of the named eastern stalls of the western stable (5b) showing Proctor to left and Duke to right, with the arched entrance from the horse yard to the right.

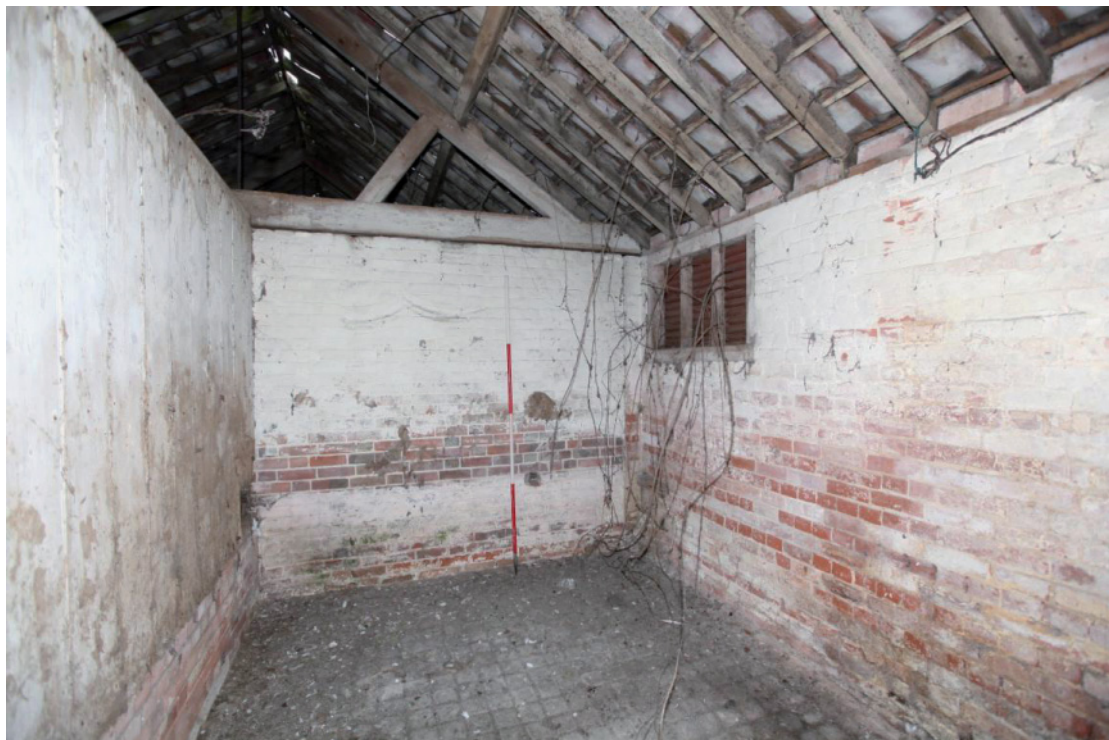
Illus. 14. Interior from the west of the south-eastern stall (Duke) of the western stable (5b) showing the original window to the southern yard to the right. The horizontal band of unpainted brick indicates the position of a missing manger but there is no evidence of a hay rack, which would have obstructed the window. Instead, a pair of curved abrasion marks to the left of the scale rod indicates the position of a hanging hay basket.

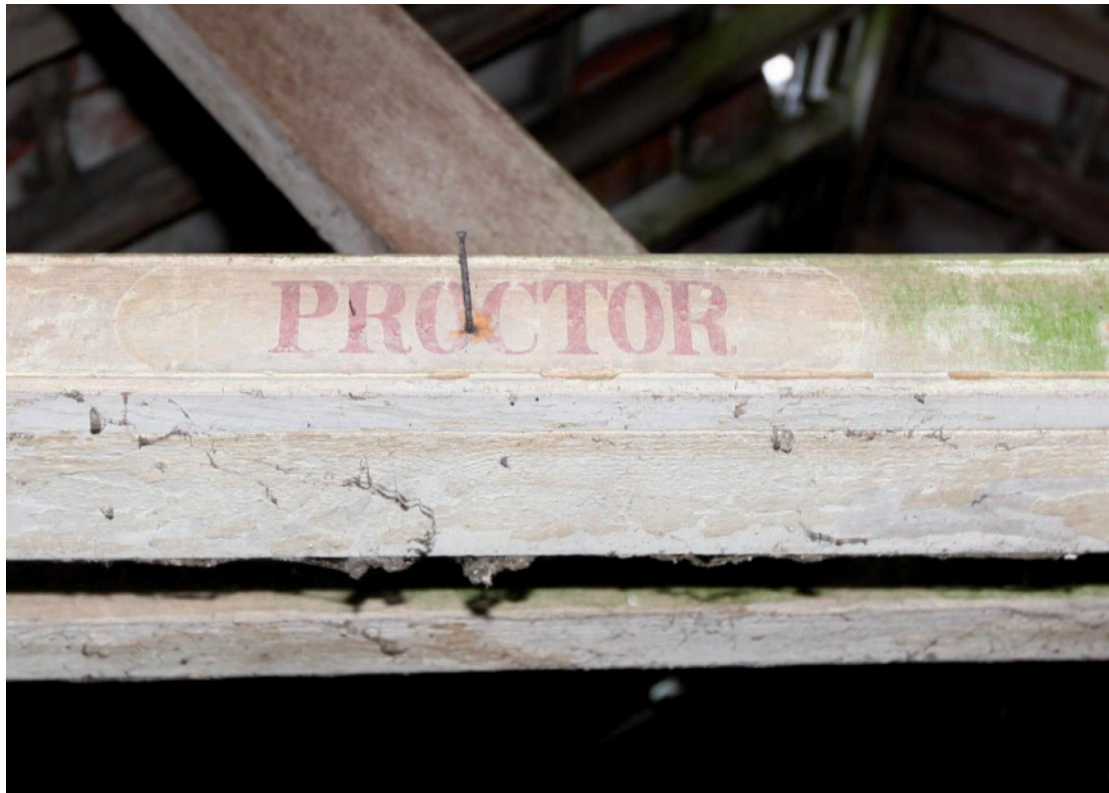
Illus. 15. Detail of the original painted name 'Proctor' on the door lintel of the north-eastern stall of the western stable (5b). The name is picked out in red on a white cartouche with curved ends, but was subsequently covered with whitewash.

complete set of eight names. These features could be incorporated into the converted dwelling, to which they would add considerable character.

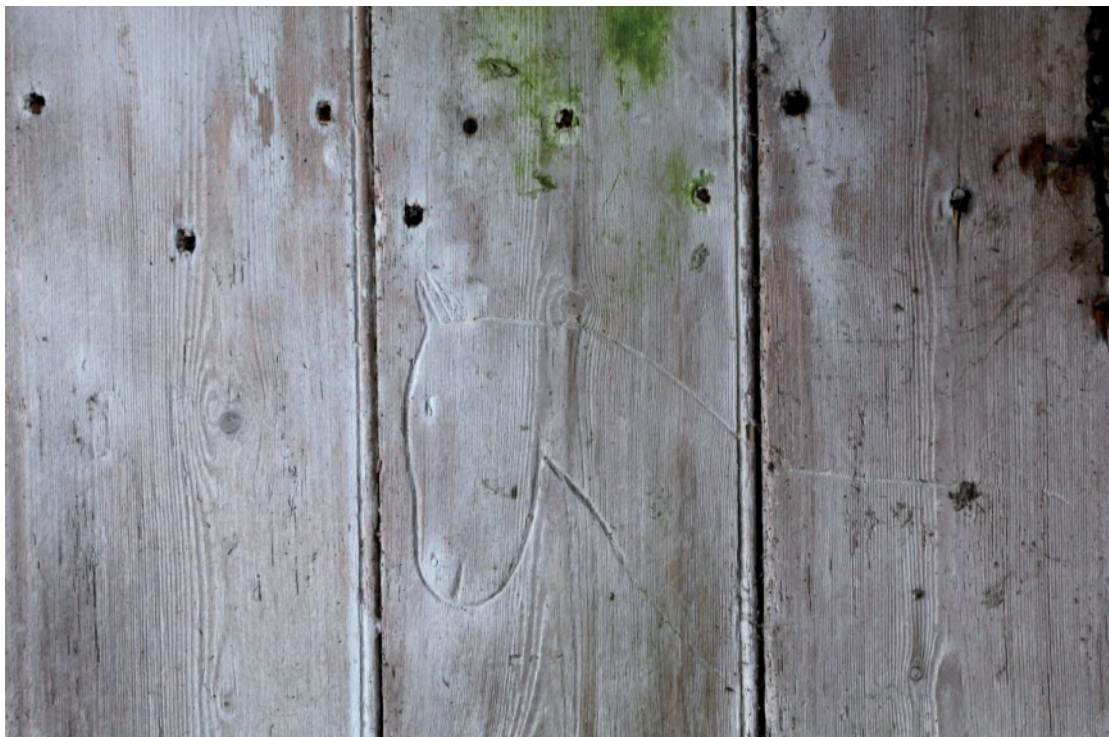
Illus. 16. Detail of the head and neck of a horse incised to the boarding to the left of the door to the south-western stall of the western stable (5b) bearing the name 'Ramper'. This image has been cropped but is shown with a scale in Appendix 1: it is approximately 20 cm in height.
