**The Old Maltings
Barton Mills,
Suffolk
BTM 049**

Heritage Asset Assessment

The Old Maltings, The Street, Barton Mills, Suffolk

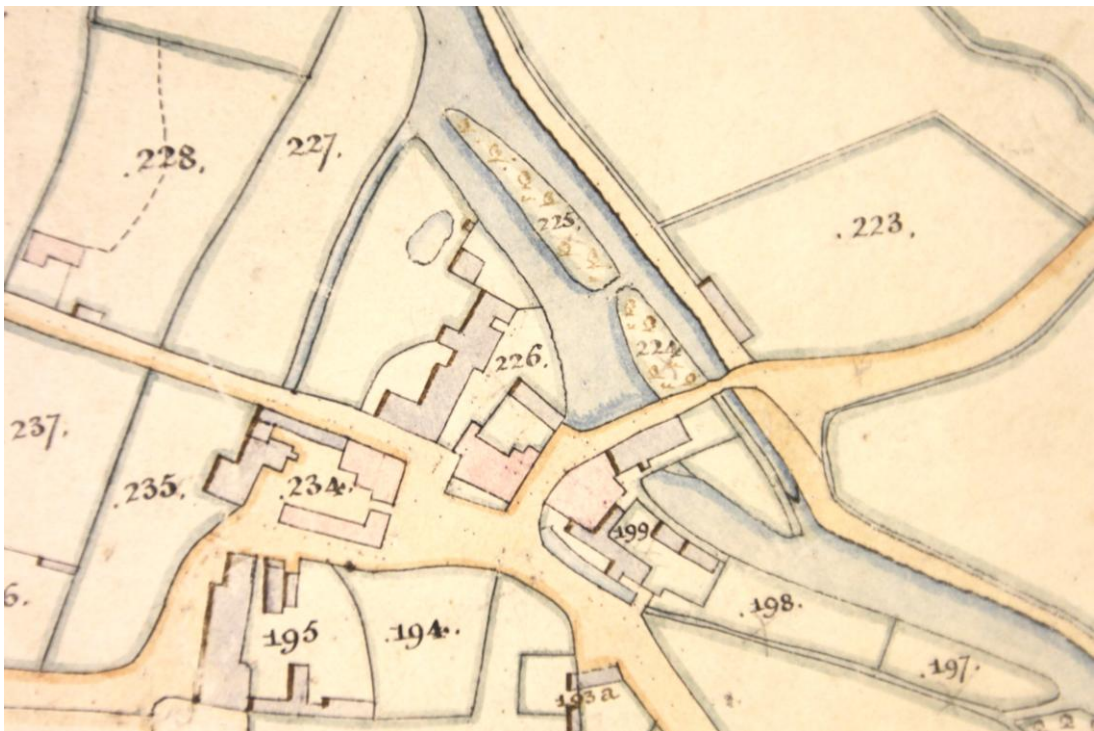
Figure 4. The Barton Mills title Map of 1838, which shows the outline of the buildings in more detail and defines the road more clearly to the south. No apportionment survives to identify the numbered plots.

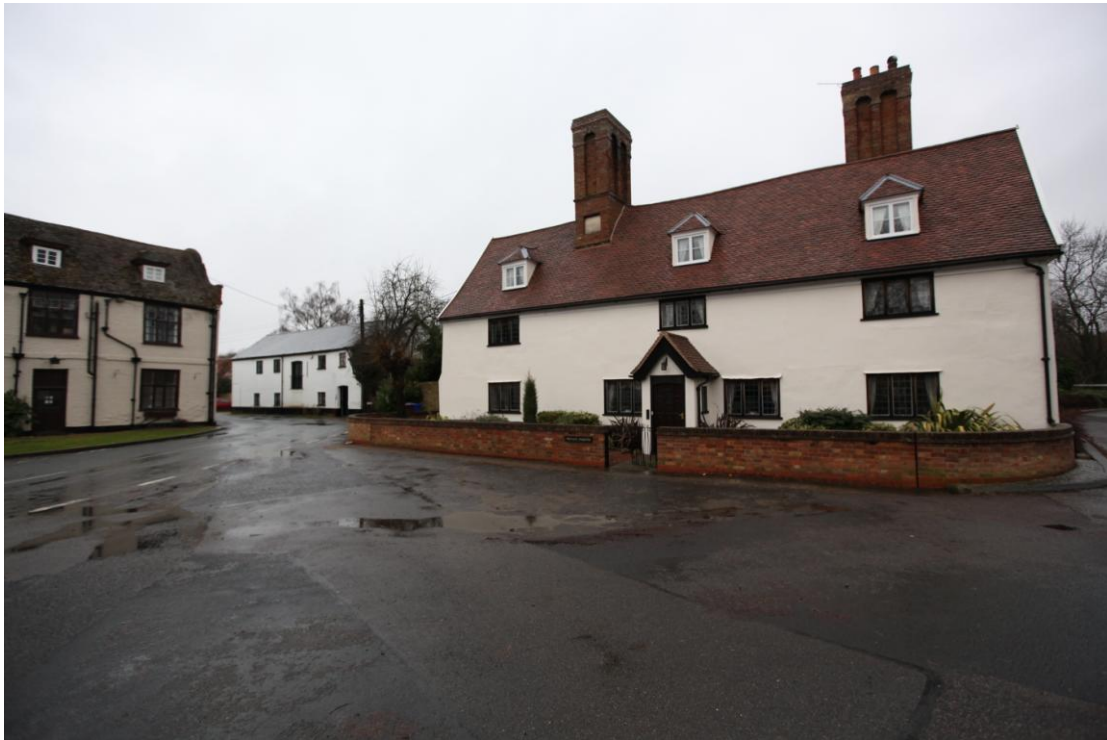
Illus. 1. General view of the site from the 18th century turnpike road to the south-east showing the conspicuous relationship of the maltings (centre rear) to two major grade II-listed buildings: The Mill House to the right (with imposing brick chimneys bearing the date 1668) and the old Bull Inn with 17th century Dutch gables to the left.

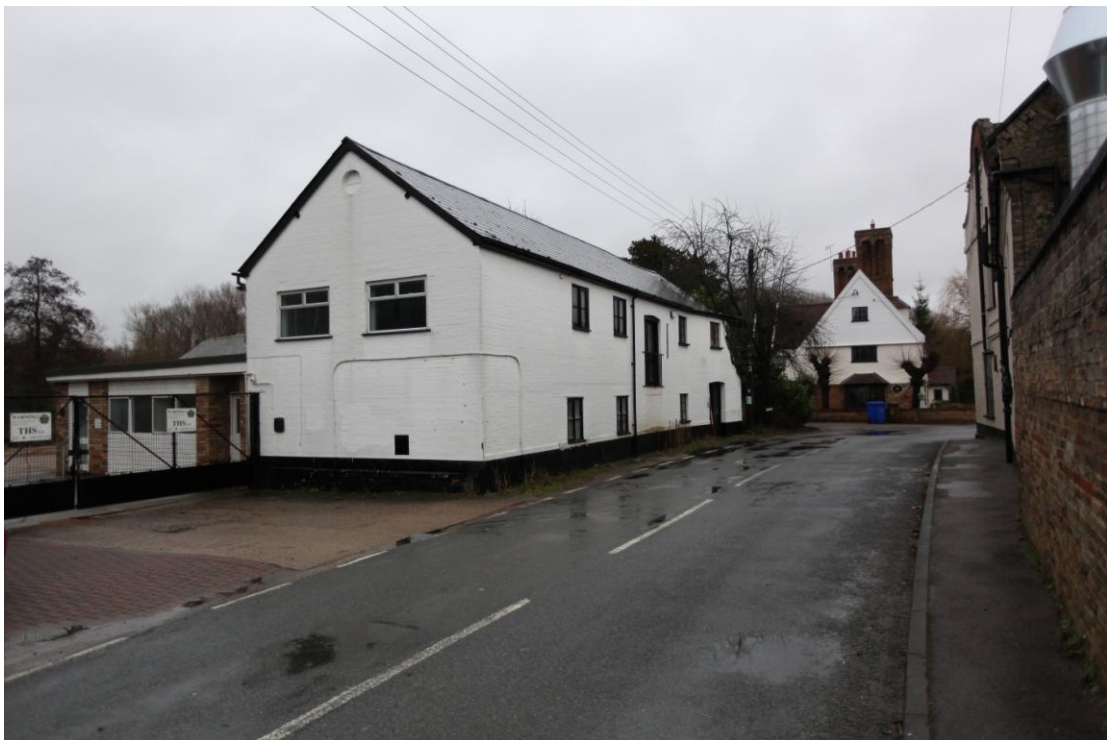
Illus. 2. The maltings from The Street to the west showing the late-19th century roadside range of painted brick (2 & 3) with the 20th century offices (4) to the rear (left).

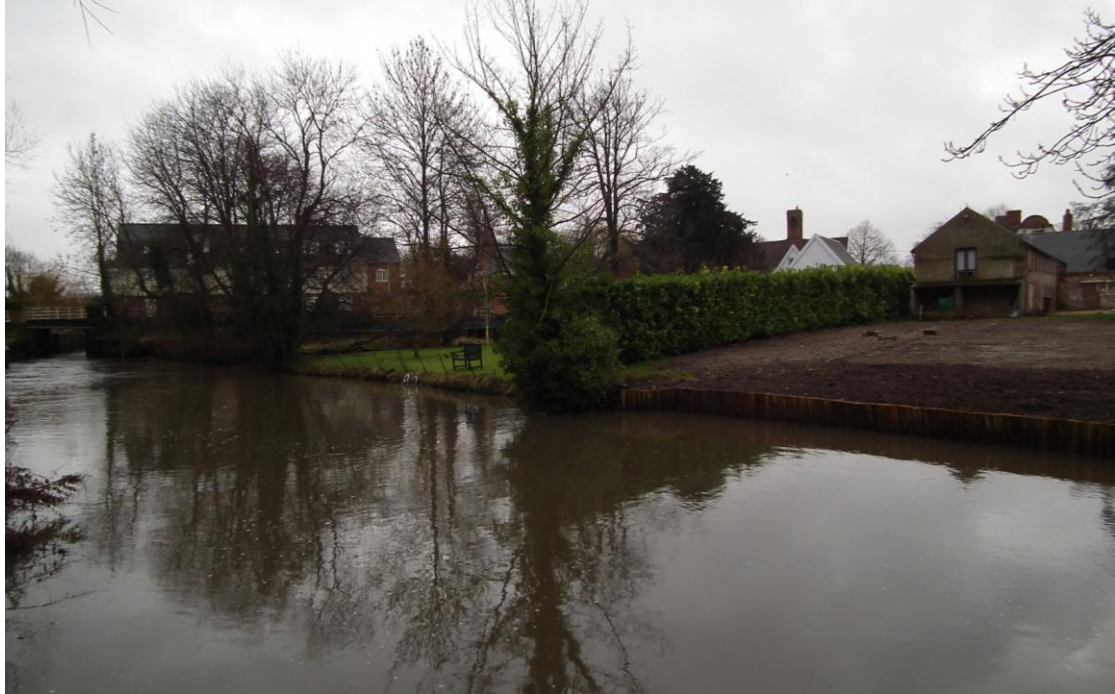
Illus. 3. General view of the 18th century ‘industrial site’ from the Millennium heritage walk on the opposite bank of the River Lark to the north, showing the maltings to the right and the bridge and converted corn mill to the left. The chimney of the Mill House is visible to the left of the maltings. The southern branch of the river formerly passed through the hedge to the right but has been filled.

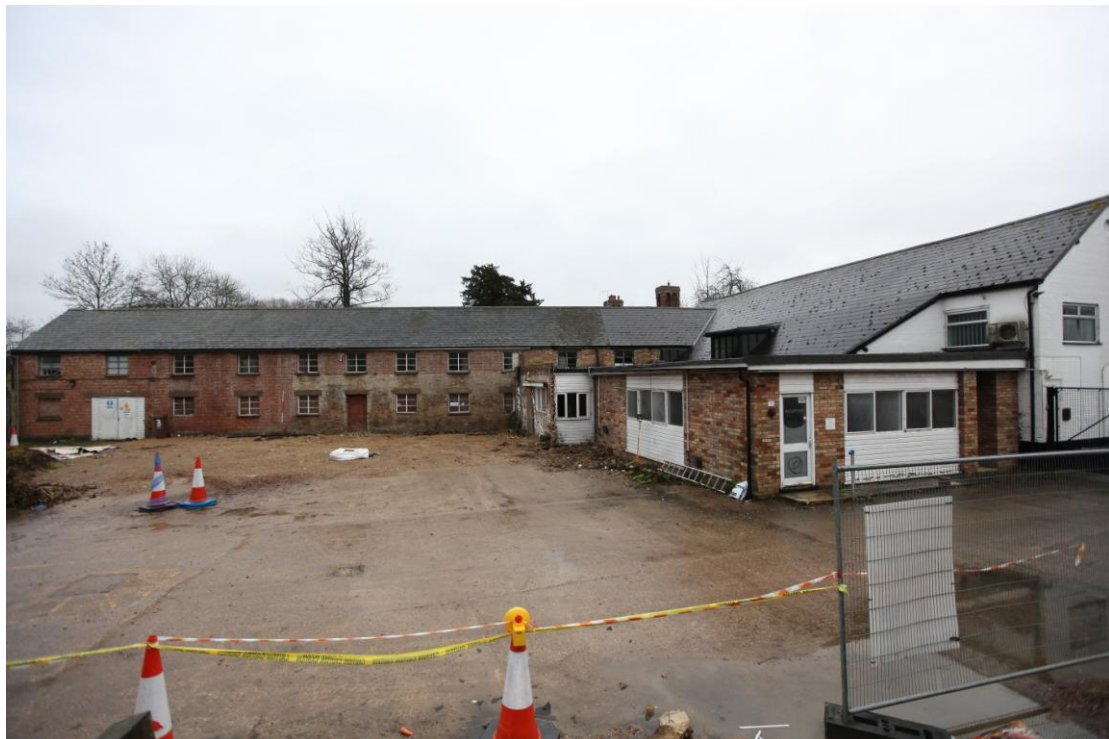
Illus. 4. The maltings from the west showing the 19th century street range (2 & 3) with the 20th century flat-roofed offices (4) to the right, and the much altered 18th century brick malting range (1) to the left.

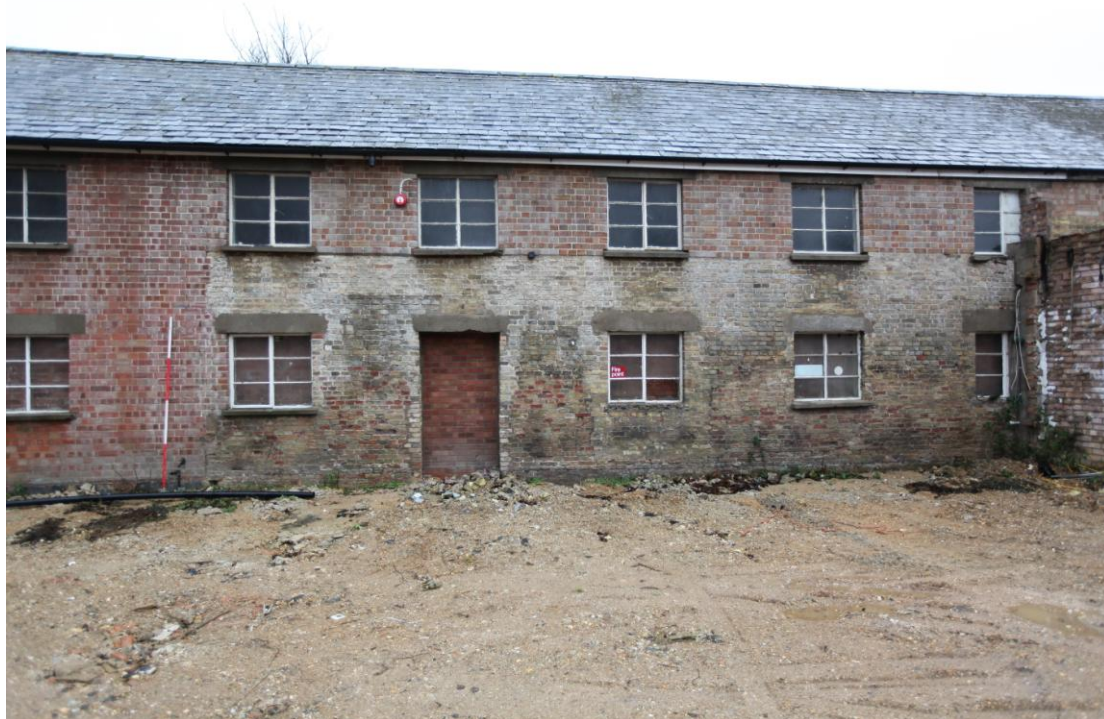
Illus. 5. The western exterior of the malting range (1) showing the remaining original brickwork to the right with 20th century Fletton brickwork above & left. The metal-framed Crittall windows date only from the building's extensive mid-20th century refurbishment which appears to have included the raising of its walls.

The original brickwork is exposed externally along the entire length of the eastern elevation and northern gable but rises to only 3.5 m at its maximum height and the upper courses consist of mid-20th century Flettons. The same early brickwork survives to a height of only 3 m in the western elevation (i.e. slightly lower) and the northernmost 14 m has been entirely rebuilt. The present metal-framed Crittall windows and external doors date only from this refurbishment, which included a new softwood roof structure. Early malting floors were often provided with relatively little headroom and it seems likely that the entire building was raised in height when it was converted into a warehouse for the adjacent mill. There is evidence of two original but blocked doors and/or windows at the northern end of the eastern elevation, where lintels of bricks set on edge can be discerned in conjunction with straight joints respected by closers (quarter-bricks) at a height of just 1.5 m (5 ft) – 0.5 m below the present window lintels. It is also clear that the building continued further to the north and has been truncated, since broken brickwork projects from both corners of the present gable. The missing structure also projected to the east and can be equated with a similar projection shown on the tithe map of 1838 and subsequent Ordnance Surveys: it may have formed the malting kiln which the structure must have possessed (and which is otherwise conspicuous by its absence) and was lost only after 1979 as it appears in figure 7.

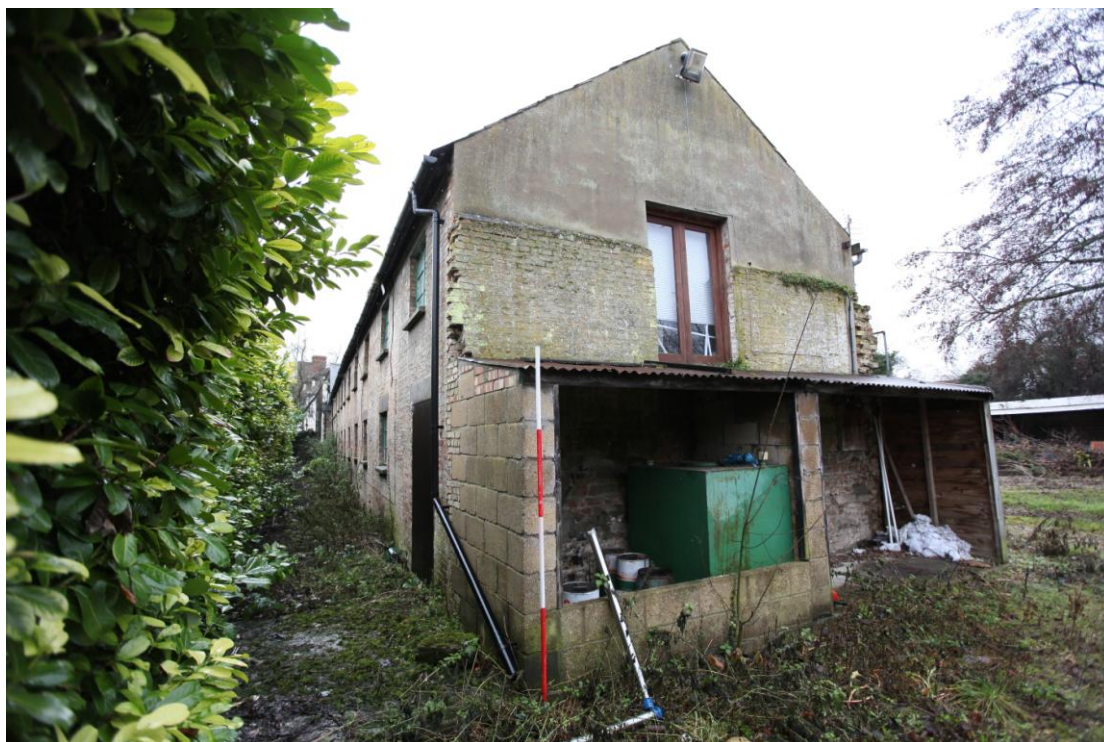
Illus. 6. The truncated northern external gable of the malting range (1) showing the remains of an outward step in the eastern elevation to the left-hand corner. The earlier brick fabric in the gable (beneath the modern cement render) probably illustrates the original height of the eaves. The laurel hedge marks the boundary with The Mill House.

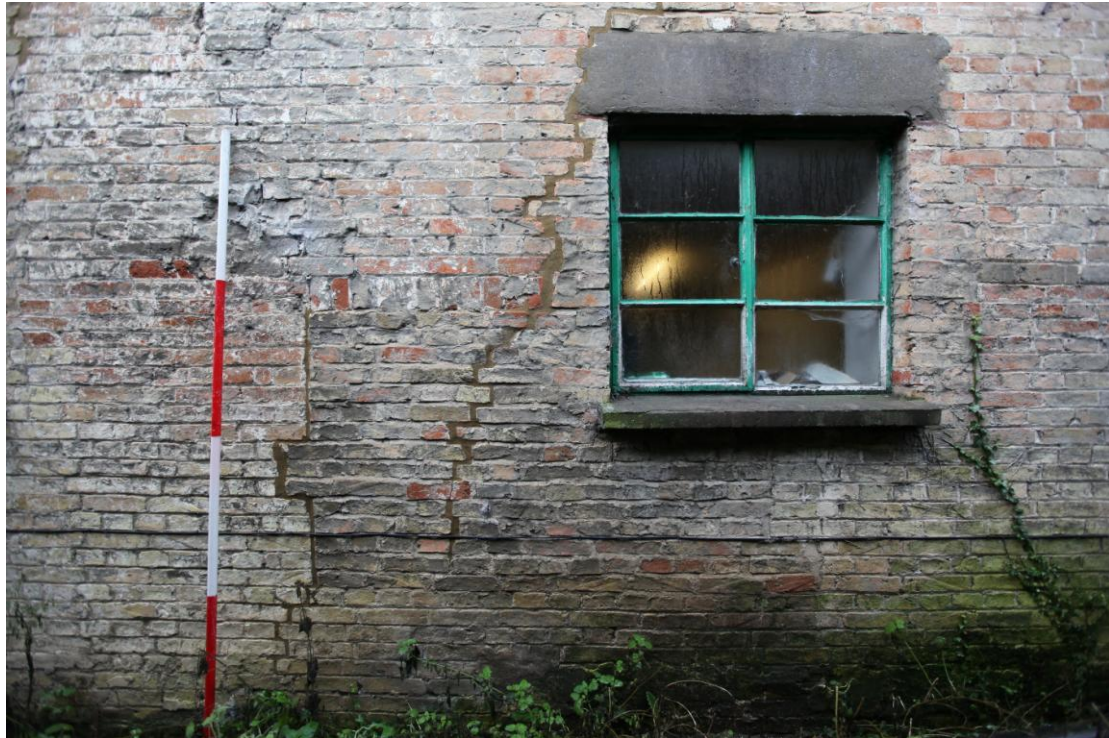
Illus. 7. Detail of the eastern external elevation of the malting range (1) showing its northernmost window (lighting the modern stair lobby, 1e) with evidence of a blocked original low door or window between it and the scale bar to the left. Note the straight joint respected by closers (quarter bricks) and the horizontal lintel of bricks set on edge (at the same height as the lower glazing bars).

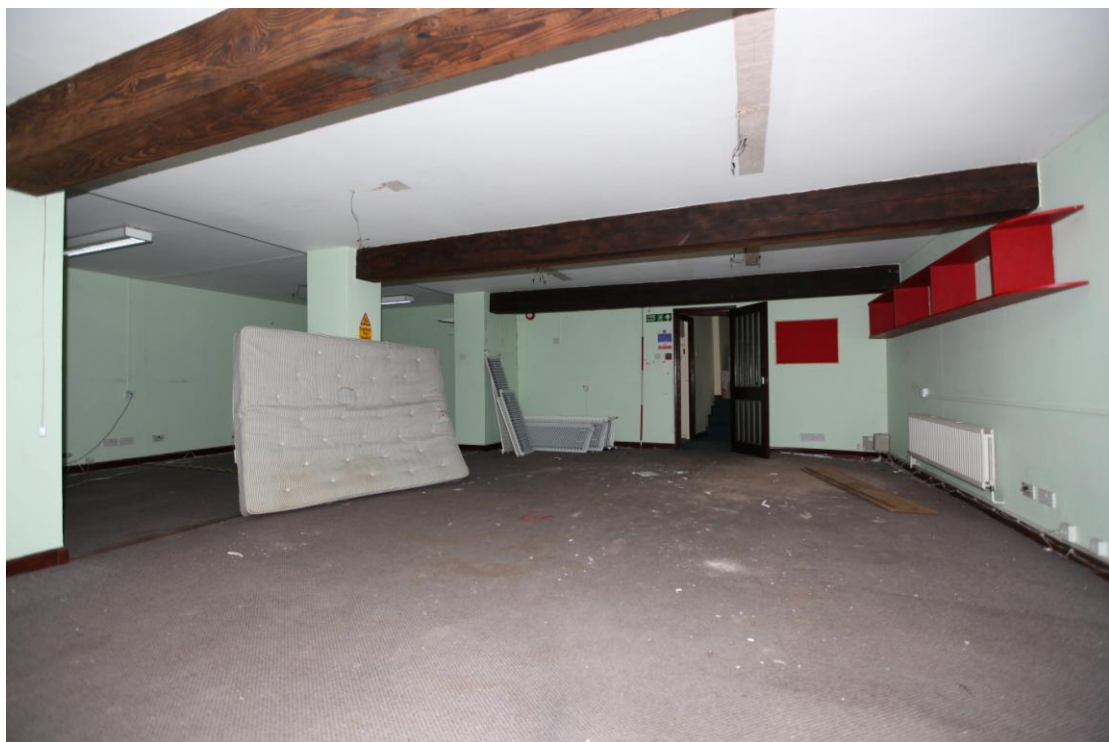
Illus. 8. The interior of the 19th century street range (3) from the west, showing the original pine binding joists. The historic fabric is otherwise entirely concealed by the dry-lining of a modern office (including the flint-rubble northern wall to the extreme left).

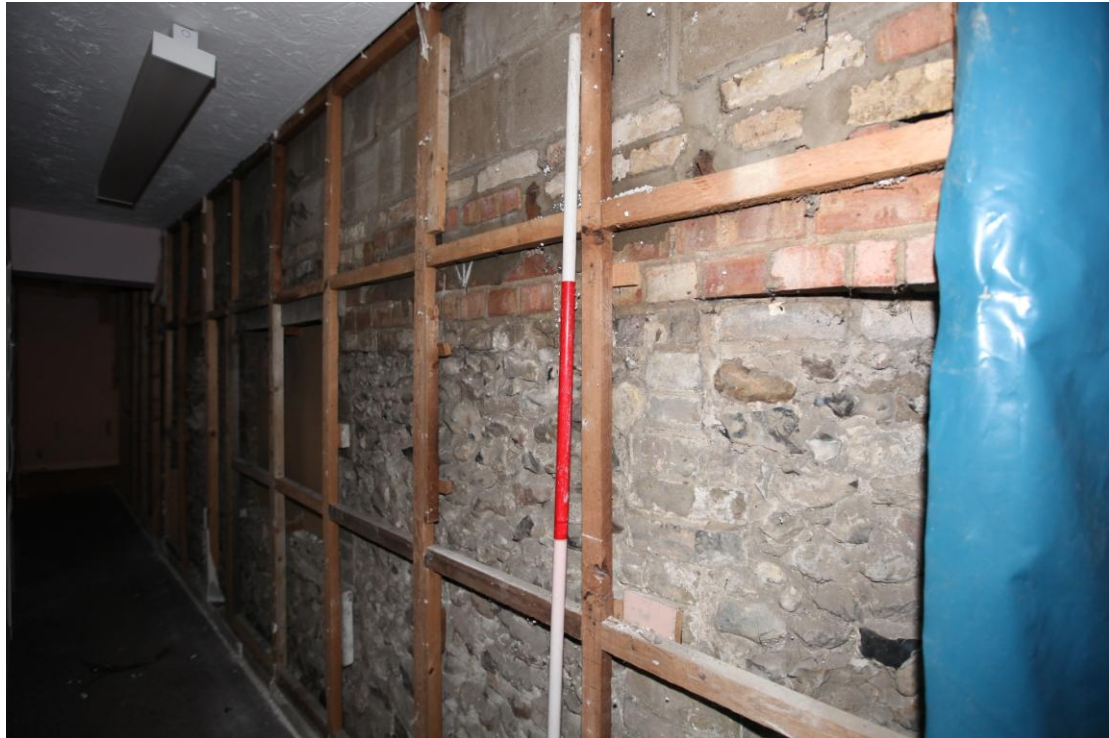
Illus. 9. The corridor of the 20th century rear office (4a) from the west showing the recently exposed flint fabric of the northern external wall of the street range (3) to the right. This wall contains evidence of two blocked windows (each with brick dressings) but has been rebuilt above in 20th century cement block-work and Fletton brick.

windows also appear to be insertions of the mid-20th century which interrupt the brickwork. The flint-rubble northern elevation probably belonged to a rear lean-to rather than the main structure, but may have been retained from the earlier structure on the site. Large vehicle doors to the east were approached from the adjacent Mill House but are now blocked by the aforementioned internal partitions. As in the eastern wing, more evidence of the historic fabric may well be revealed when the present dry-lining is removed during any future conversion work.

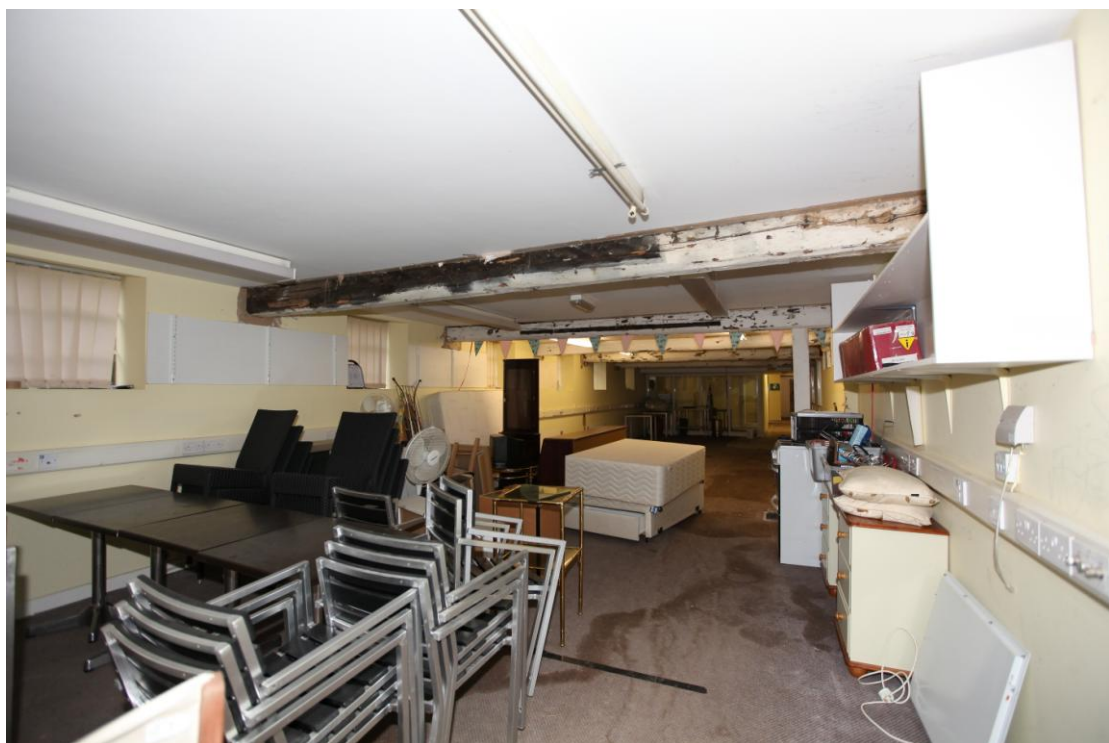
Illus. 10. The interior of the malting range (1) from the north showing the recently exposed and ostensibly original chamfered binding joists (with early grey pigment beneath later whitewash). The internal walls and common joists are concealed by late-20th century dry-lining.

The distinctive L-shaped outline is shown on the Barton Mills enclosure map of 1796 (figure 3) and the irregular colour (mixing red and white) and texture of the English-bond brickwork is consistent with a date in the latter part of the 18th century. The same date is also suggested by the impressive chamfered binding joists of the ceiling which represent the only early fabric exposed inside the building and preserve what may be original grey pigment beneath later whitewash. At least one joist bears an unusually large incised carpenter's Roman numeral (XXII) but these impressive timbers may have been re-used and may have been raised in height during the 20th century alterations (given the relatively low height of the original door and window lintels described below). The internal walls and common ceiling joists of the lower storey were entirely hidden by the dry-lining of late-20th century office fittings at the time of inspection, but more evidence of their origin and development may be revealed during any future conversion work. The present internal walls on both storeys (as indicated in figure 8) appear to consist only of 20th century brickwork, block-work or boarding, and there is no evidence of original partitions. This lack of internal subdivision is consistent with the layout of 18th and 19th century maltings elsewhere, in which the upper storey typically served as a malting floor and the lower storey as a general storage area. The various stairs are also modern.

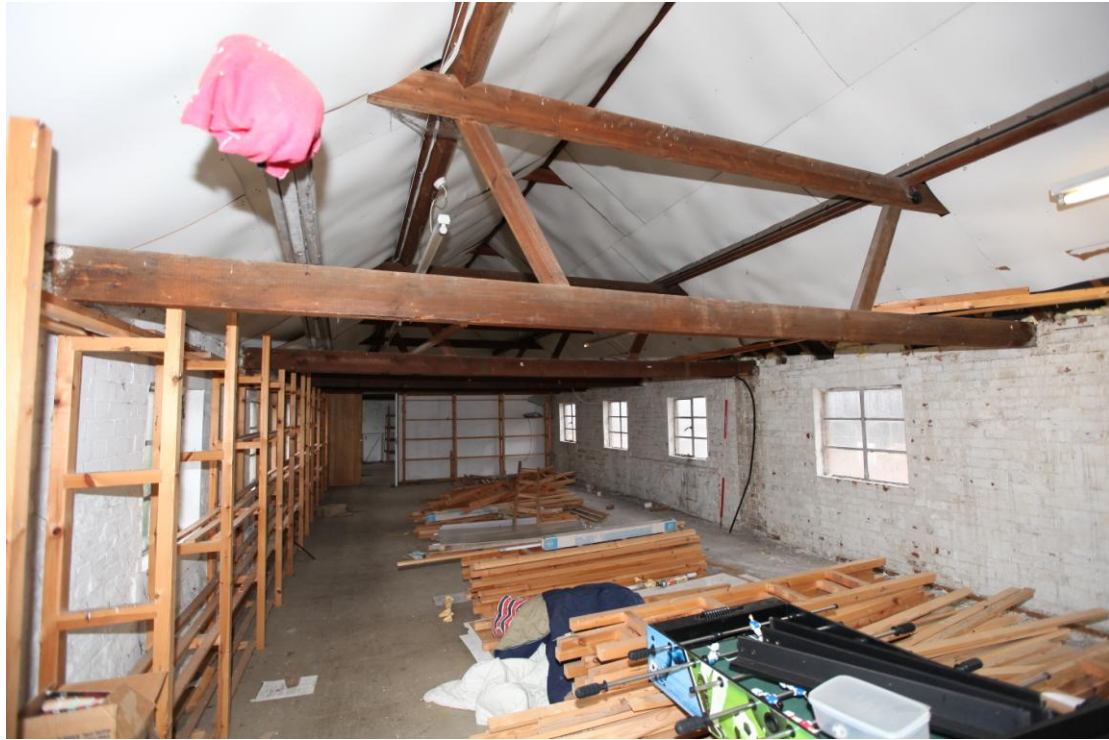
Illus. 11. The upper storey of the malting range (5b) from the north showing the 20th century softwood roof trusses and exposed brickwork of the external walls. Both the front and rear elevations have been raised by varying degrees, and the western elevation to the right largely rebuilt.

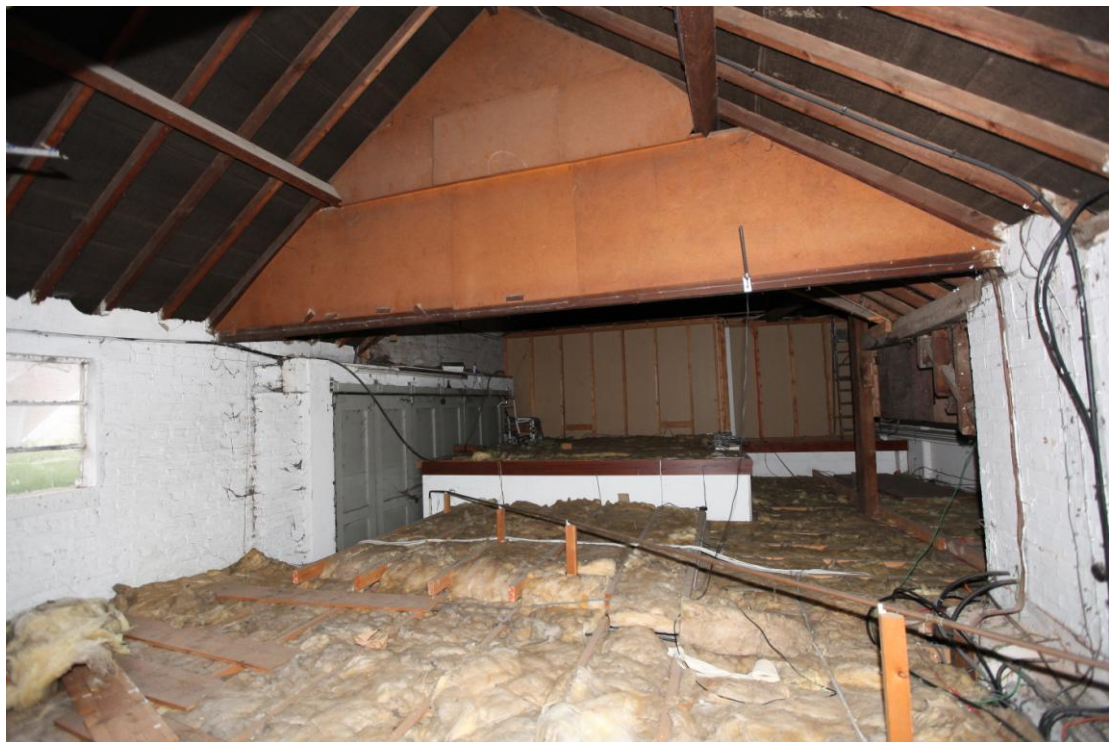
Illus. 12. The southern end of the first-floor malting range (5) showing its junction with the street range with the large 20th century vehicle doors to left blocked by late-20th century internal partitions.
