ARCHAEOLOGICAL MONITORING REPORT

SCCAS REPORT No. 2011/022

St Mary's Church, Cratfield 'Tea-point' in the tower

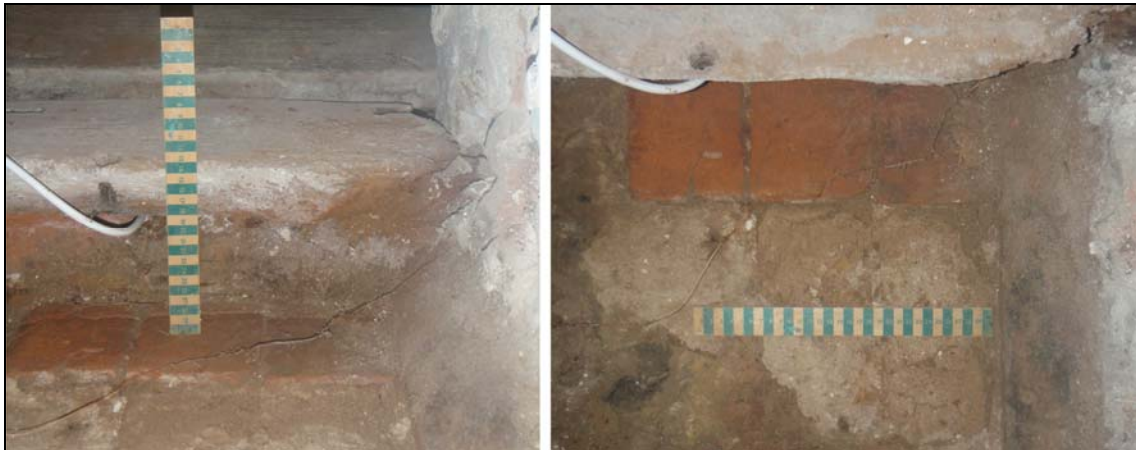
Figure 4. Tiled floor against dressed stone foot of the tower arch

Remaining *in situ* tiles of an earlier floor were recorded when the entire planked floor was lifted and the silt removed. An area of six tiles was found adjacent to the base of the tower arch on the south side and a layer of tile-impressed bedding mortar was recorded alongside the north wall between the tower arch and the clock case (Fig. 3). The tiles were plain, unglazed and measured 115mm². The tile floor level respected dressed limestone facing at the base of the tower which flared out in a chamfered foot (Fig. 4). The tiles were at the same level as those within the nave suggesting that the floor was once at a single level between the two. The west wall of the tower is built off a stepped footing of bonded flint, which

projects forward of the general wall face and is continuous below the west door. The height of the footing was just below the level of the tiles demonstrating that the tile floor reflects the original medieval floor level within tower even though the tiles themselves are undated. The threshold to the west door is however 310mm higher and shows that there was a step down into the church; examination of the moulding around the west door suggested that although the threshold had been re-set in the recent past, the level had not been altered significantly.

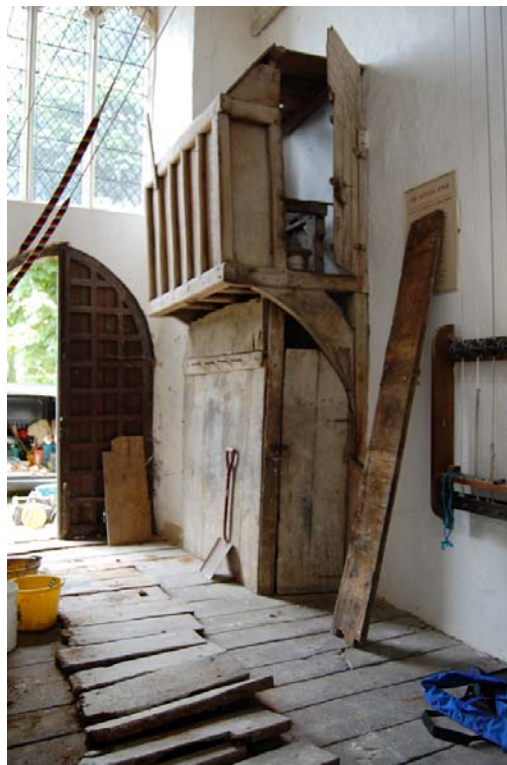
Figure 5. Clock-case against the north wall of the tower

braces which has been interpreted as a clock case (Fig. 5). The carpentry is consistent with medieval techniques and it is built into the fabric of the wall. Church accounts show that it was repaired as early as the 1530's, suggesting that it may be original to the tower (Mortlock 2009). The space beneath the overhang of the case has been enclosed with wide, pine boards to create a cupboard and an access door has been cut into the side of the case; the door hinges to the cupboard and access hatch suggest that these alterations and additions were made during the 18th century or later.

The sill-beam of the improvised broom cupboard below the overhang of the clock case lies directly onto the bedding layer of the tiles (layer 0003) and was constructed after the tiles were lifted which suggests that the cupboard element was added when the first suspended floor was installed; the sill is at the same level as the original joists and the boards would have been cut around the cupboard rather than it sitting on the floor. The subsequent raising of the floor buried the base of the cupboard which was infilled with rubble to bring its internal floor level up to that of the raised floor outside the cupboard. The cupboard is difficult to date, the door furniture dates to 17th-18th century and the coat pegs to 19th century, but these all appear to second-hand materials. A fragment of a gravestone, dated by the style of the script to the 17th-18th century had been used underpin the cupboard frame and the graffiti on the cupboard walls date to the turn of the 20th century.

The putative clock-case has been identified as medieval and is believed to be an original feature of the tower, however the position of the clock case prevents the west door from opening fully, suggesting that it may not have been originally intended for this location. Processions through the church were part of the normal observance of the liturgical calendar throughout the medieval period. However after the reformation such practices are likely to have ceased, and the passage through the west door may have become less important, and it is perhaps after this date that the clock was installed in its current location

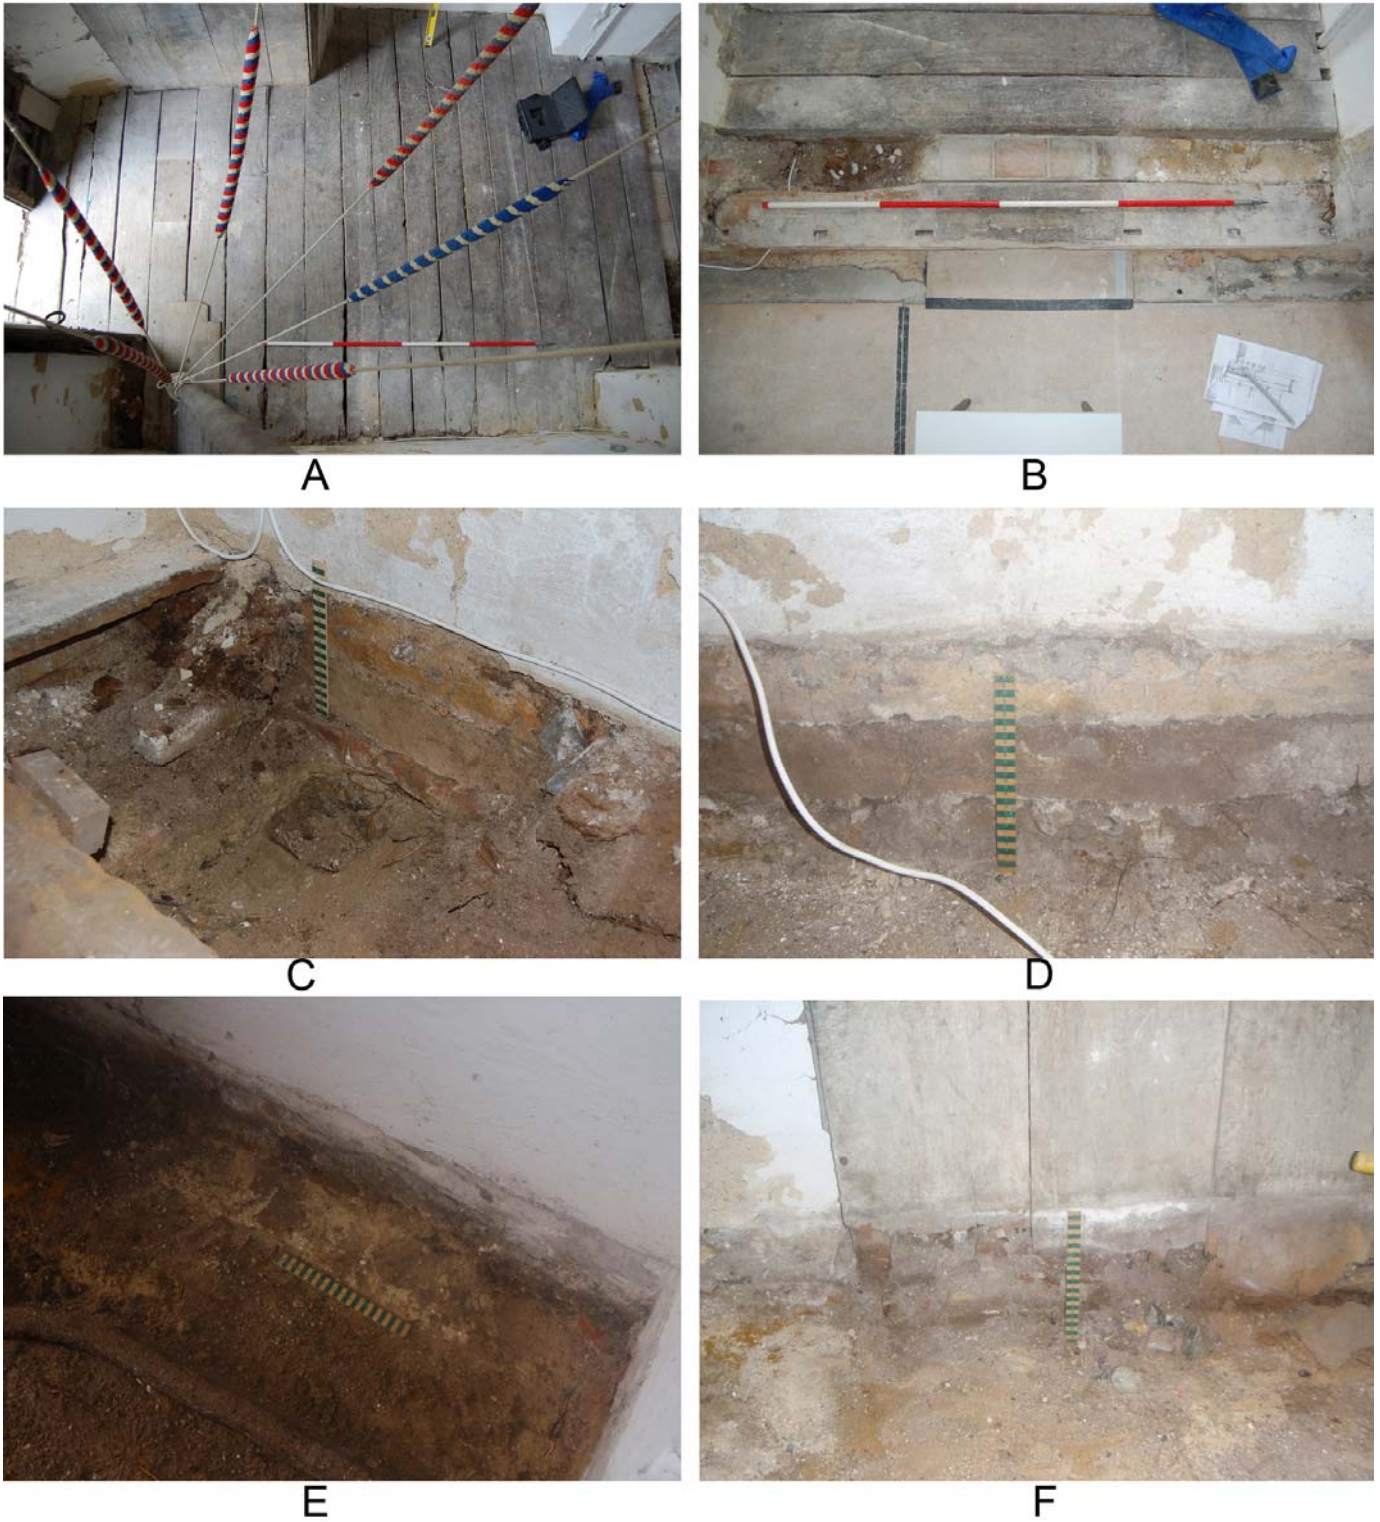
Figure 6. Selected photographs

- A) Tower floor prior to lifting of the floor boards**
- B) Sill beam for the stud wall that infilled the tower arch**
- C) C18th brick at the base of the plasterwork and a layer of green clay laid as a sub-floor below the level of the floor tiles**
- D) Phases of decorative schemes showing changing floor levels**
- E) Bedding mortar for floor tiles against the north wall of the tower showing impressions of tiles**
- F) Bottom rail and planking of cupboard beneath the clock case extending beneath the timber floor**
