**Outbuilding at Kent House,
Redgrave,
Suffolk
RGV 047**

Heritage Asset Assessment

Outbuilding at Kent House (Formerly the Bunch of Grapes Inn), The Street, Redgrave, Suffolk

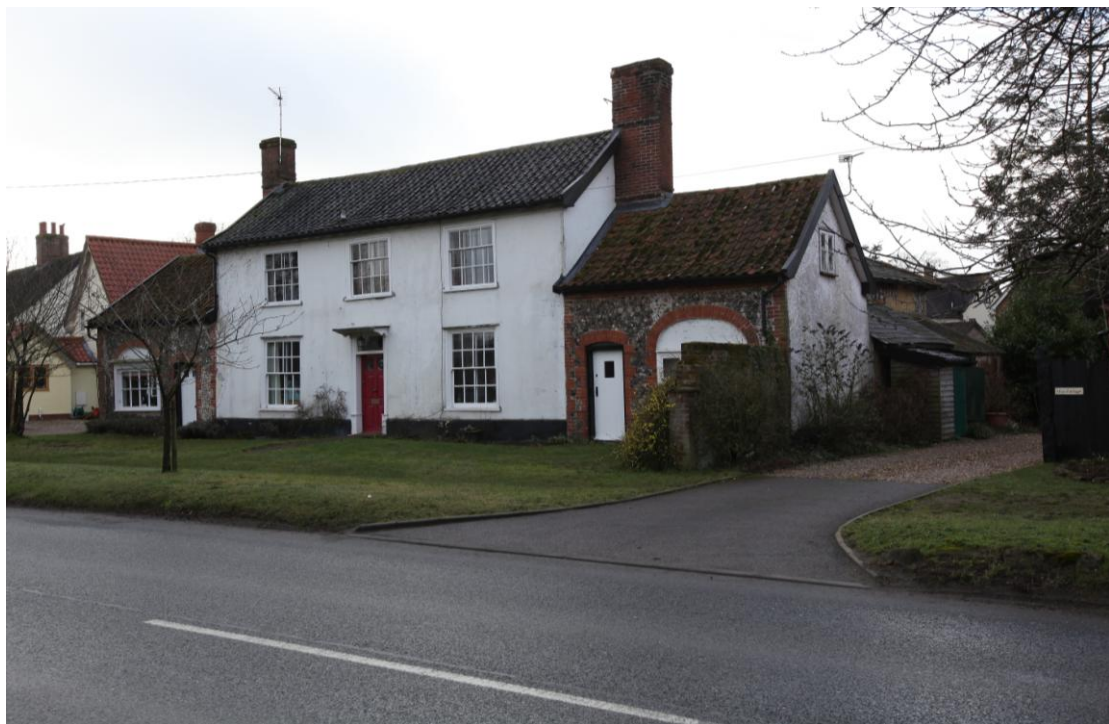
Illus. 2. Exterior of Kent House from the north-east showing the flint-rubble sometime Baker's shop to the right and the identical sometime butcher's shop to the left. The northern gable of the clay-lump outbuilding with its lean-to shed (4) is visible to the extreme right where it adjoins the drive of the neighbouring property (Fox Cottage).

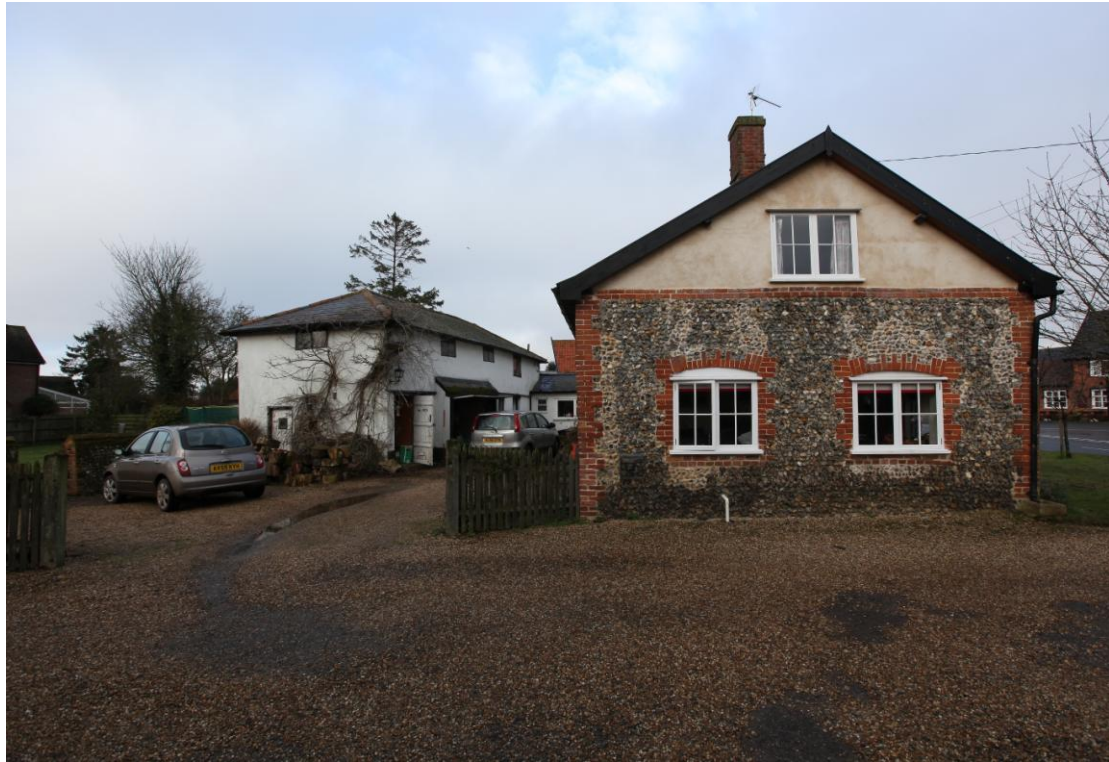
Illus. 3. General view of the site from the south-east showing the clay-lump outbuilding in the rear to the left and the gable of the flint-rubble sometime butcher's shop (now the kitchen of Kent House) to the right.

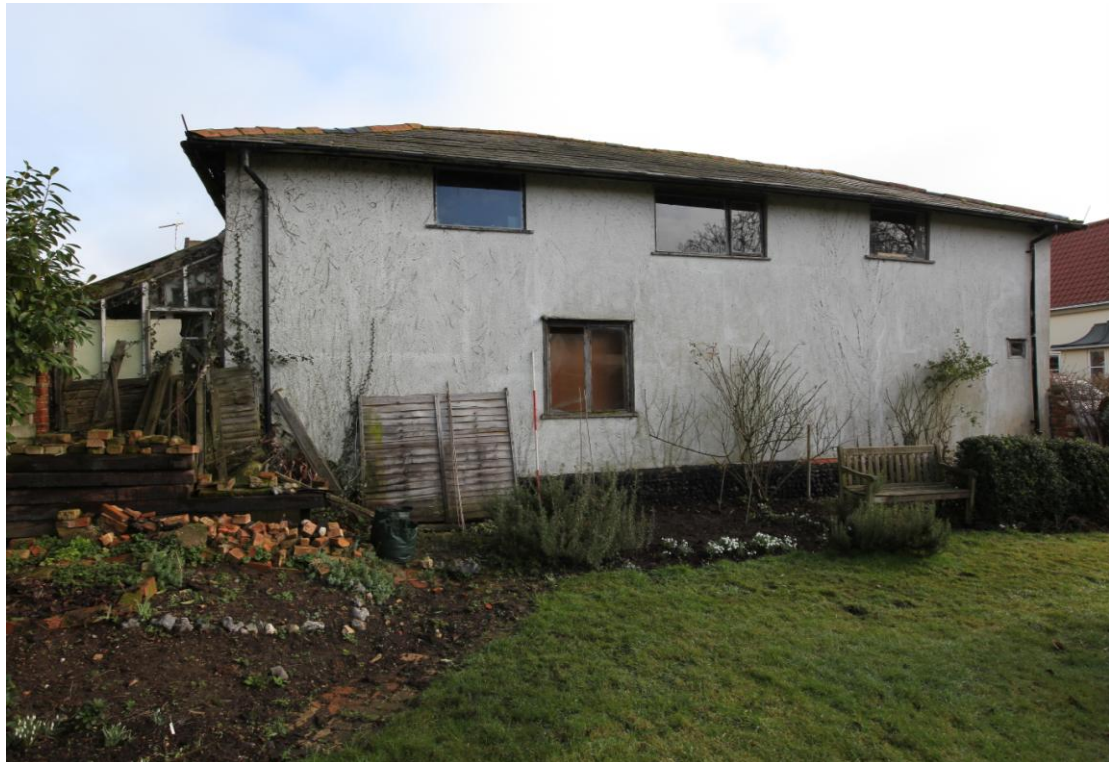
Illus. 4. The western exterior of the clay-lump outbuilding showing its shallow-pitched slate roof with late-20th century cement render and windows. The glazed lean-to shed adjoining the northern gable is visible to the left.

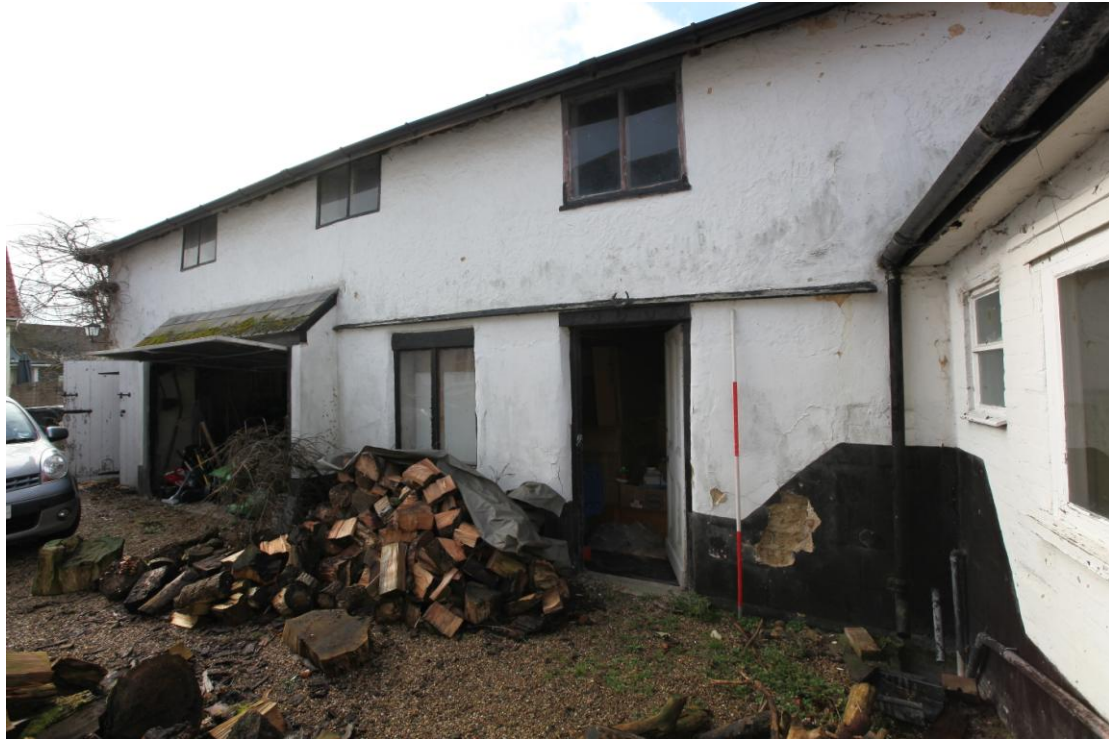
Illus. 5. The cement-rendered eastern exterior seen from the house to the north-east showing the late-20th century garage door (2) to the left and the door to the bakery (3) to the right with an adjacent fragment of exposed clay lump.

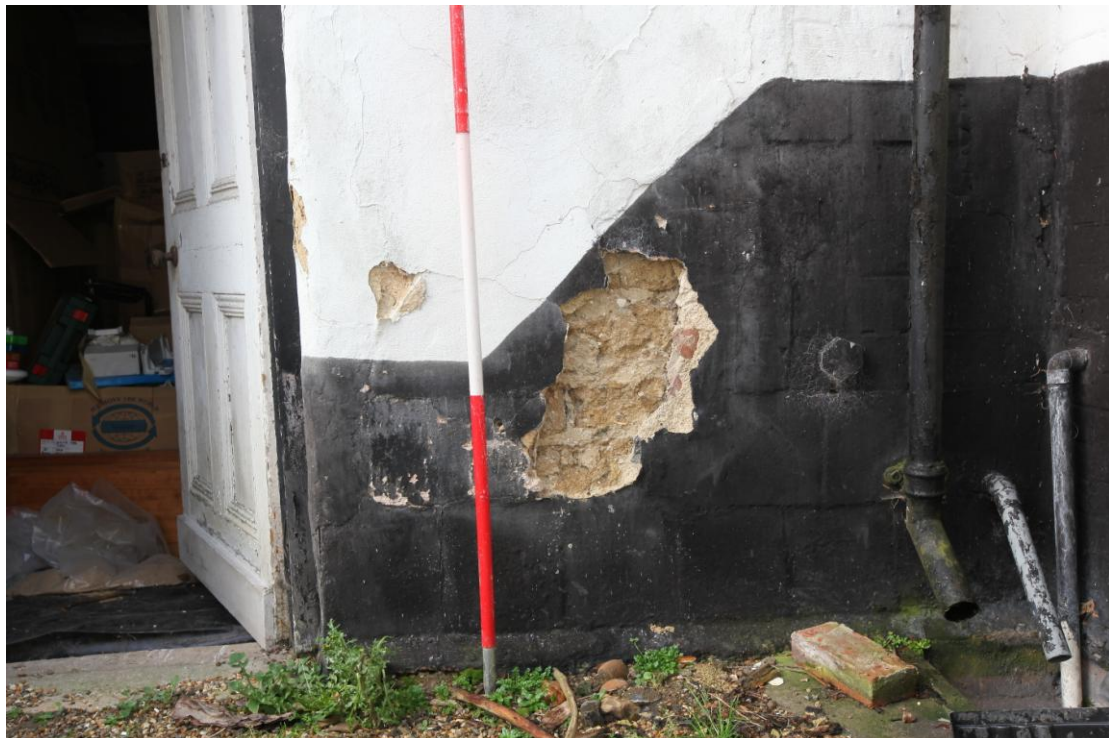
Illus. 6. Detail of the exposed clay-lump fabric in the eastern exterior to the north of the bakery door (3). This is the only exposed section of clay-lump in the building.

The walls appear to consist largely of clay-lump but with the exception of a small area of the eastern exterior (to the right of the bakery door) they are rendered in modern cement or otherwise concealed and may have been substantially rebuilt in brick and block-work at lower levels. The internal walls of the undivided upper storey (reached by a 20th century boarded stair at the southern end of the eastern elevation) taper inwards towards the roof-plates in an unusual manner which suggests they still consist of clay-lump. The slate-covered, shallow-pitched roof structure consists of uniform tall-sectioned softwood with a ridge-board and appears to have been rebuilt in the mid-20th century but includes a number of re-used collars that may derive from the original. The plate-glass windows of the upper storey are modern, and probably relate to an extensive restoration of the late-20th century when the building was converted into an antiques showroom, but some rectangular mullions and frames may be original.

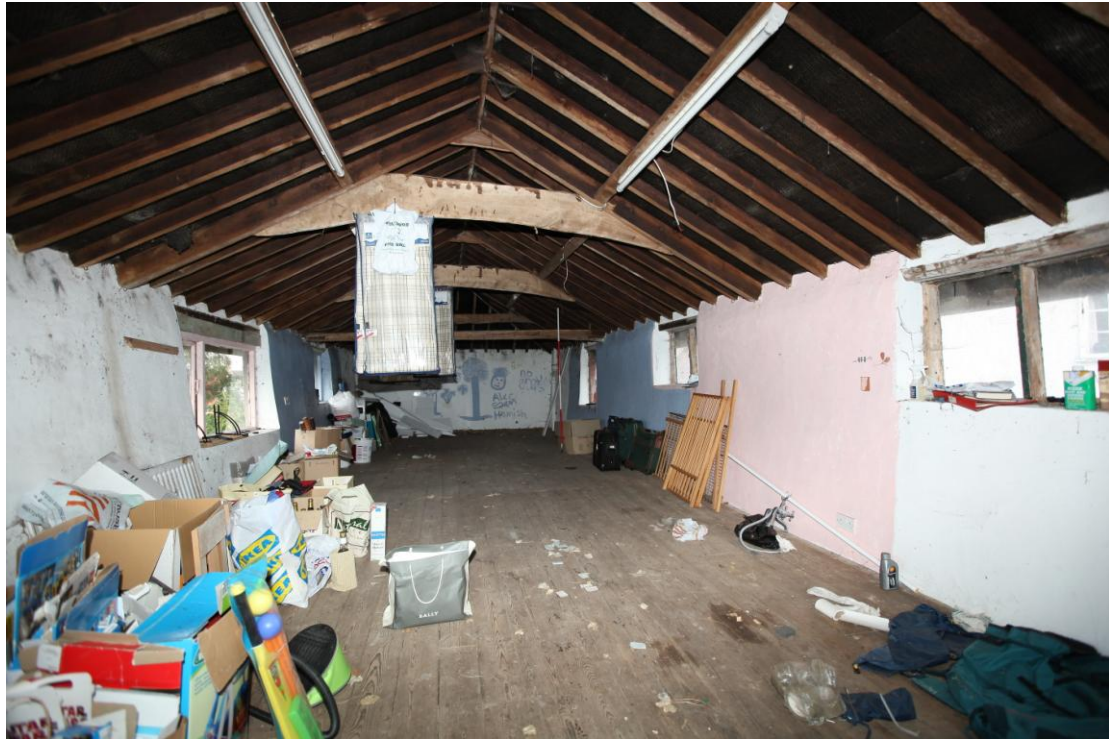
Illus. 7. The interior of the undivided upper storey seen from the south, showing its sloping clay-lump walls and the 20th century clasped-purlin roof structure of softwood joists and re-used collars.

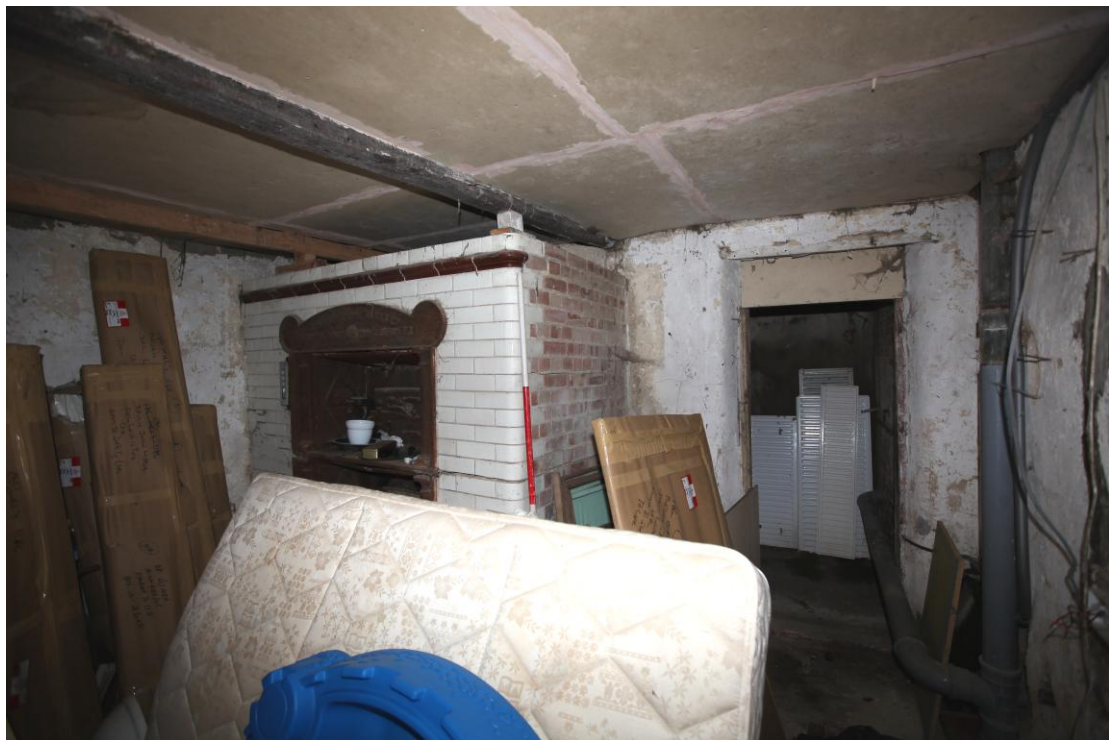
Illus. 8. The interior of the bakery (3) from the south showing the door to the gable lean-to (4) to the right and the bread oven of Fletton brick with white-glazed tiled facade to the left.

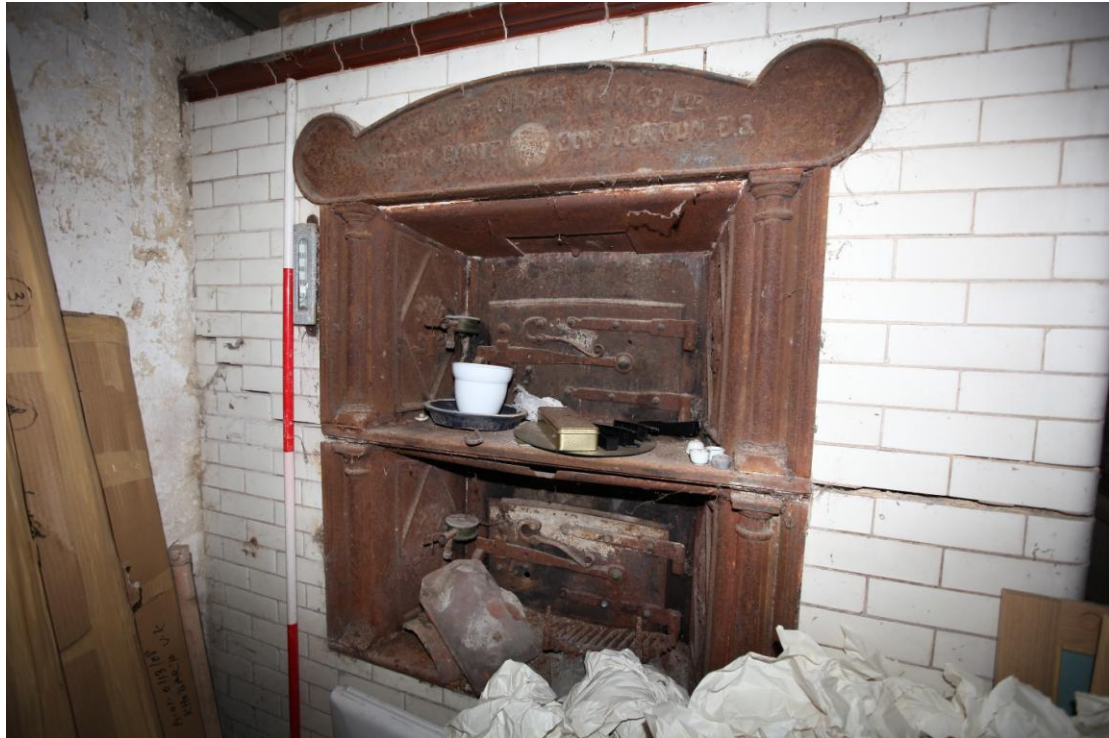
Illus. 9. The iron doors and decorative surround of the bread oven in the bakery (3) showing its cast wheatsheaf ornaments and the superscript 'Kent & Co. Globe Works Ltd. South Grove Bow London E3'.

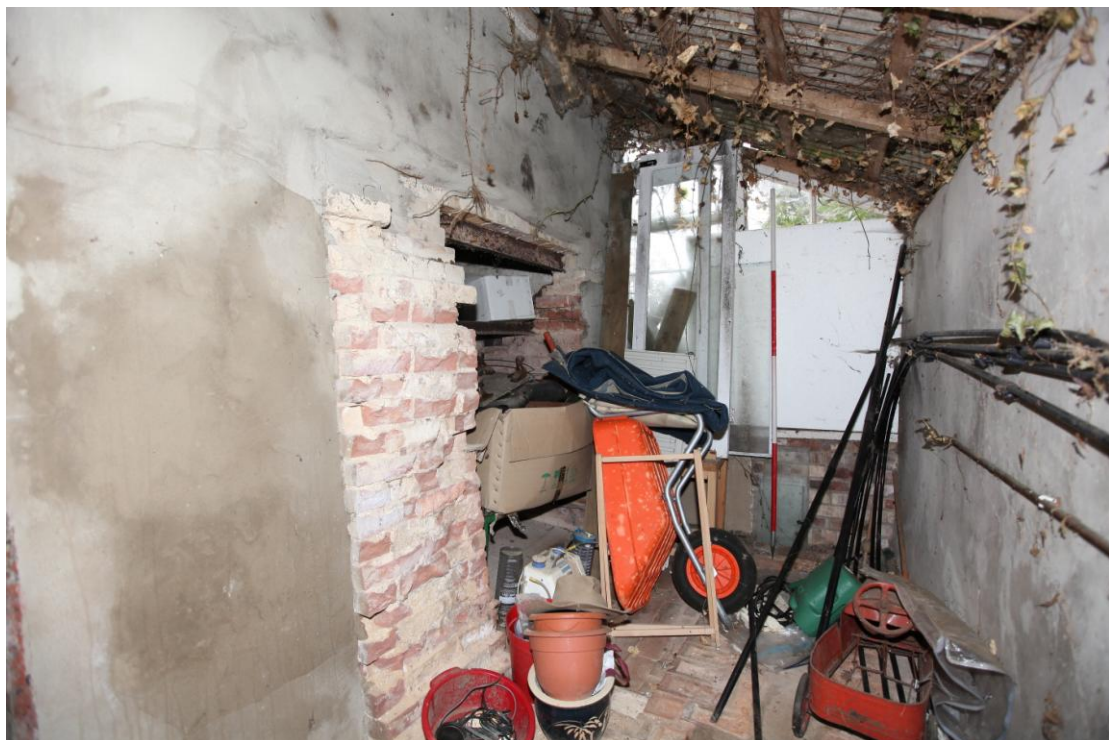
Illus. 10. The interior of the lean-to shed (4) from the east showing the truncated bread oven of Fletton brickwork to the left with cement-rendered walls and corrugated asbestos roof.
