An Archaeological Watching Brief at Knighton Hall, Knighton Road, Leicester

NGR: SK 599 015

ULAS Report Number 2011-079 ©2011 A13.2010

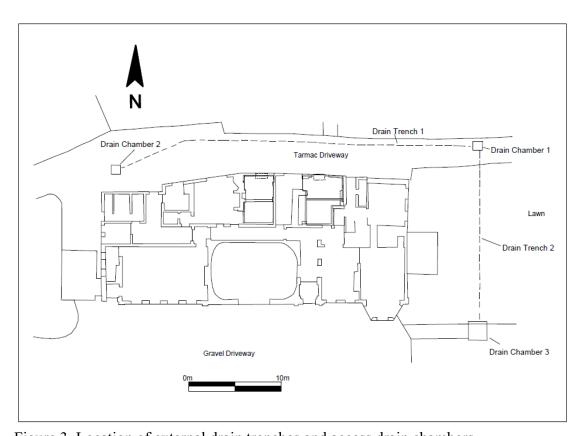
Figure 3. Location of external drain trenches and access drain chambers

Drain Chamber 1 (Figure 3)

Access drain chamber 1 was located at the rear of Knighton Hall on the east side of the tarmac drive. The natural clay was reached at a depth of 0.80m below the surface and comprised dark greyish-pinkish-brown silty clay with mottled bands of pale bluish-grey clay. On the south side of the chamber was a wall foundation, two courses high and a single brick wide, resting on the natural clay. The wall foundation was orientated north-east to south-west and probably supported a garden wall. A cobbled surface was also seen resting on the natural and comprised frequent small well-rounded pebbles concreted within a dark greyish-brown clayey-silt matrix for 0.10m deep. The cobbles were sealed by a layer of greyish-brown clay silt 0.22m thick. Overlying was another layer 0.20m deep consisting of coarse greyish-orange sand, which was sealed by very dark clay silt 0.18m thick containing an abundant quantity of charcoal, crushed brick and mortar. Above was a layer of gravel hardcore supporting a tarmac surface with a combined depth of 0.10m.

Drain Trench 1 (Figure 3)

Drain Trench 1 was excavated along the tarmac pavement at the rear of the property and connected Chambers 1 and 2. The stratigraphic sequence was broadly similar to that first observed in Drain Chamber 1 and the early cobble surface found overlying the natural was observed running the full length of the trench. A change in the sequence was a second more recent cobble surface found directly below the tarmac pavement. This had been laid on a 0.34m deep layer of fine pale pinkish-orange coarse sand. Towards the west end of the trench, the second cobble surface and coarse sand disappeared and was replaced with a loose grey-brown clay silt gravel layer mixed with building rubble and cobbles. This layer was thought to have been perhaps disturbance associated with the landscaping of the gardens at the rear of the building.

Drain Chamber 2 (Figure 3)

Access Drain Chamber 2 was excavated towards the west end of the tarmac path at the rear of the building. There was no change to the stratigraphic sequence that had been observed at the west end of Drain Trench 1. The lower early cobble surface overlying the natural was still present at 0.86m below the surface.

Drain Chamber 3 (Figure 3)

Access Drain Chamber 3 was located on the east side of the building towards the southern end of a garden lawn. The natural clay was reached at depth of 0.70m below the surface and was sealed by a 0.40m thick layer of subsoil which comprised brown clay silt mixed with occasional pebble and was heavily disturbed by root action. Overlying was a layer of garden soil 0.30m deep consisting of dark grey clay silt, which had been cut by a modern land drain. Finds found within the topsoil comprised a modern pottery sherd, glass bottle end and what appeared to off cuts from bone button manufacture (see Appendix 2 and 3 below).

Drain Trench 2 (Figure 3)

This trench was located on the east side of the property running north to south through a lawn and connecting Chambers 1 and 3. Towards the northern end of the trench the natural clay was reached at depth of 0.50m below the surface. Overlying natural was a 0.30m thick layer of subsoil which comprised brown clay silt mixed with occasional pebble and natural clay inclusions. The subsoil was sealed by a layer of garden soil 0.20m deep that consisted of dark greyish clay silt. Towards the middle of the trench a possible garden terrace cut was visible running west to east and changed the stratigraphic sequence. The feature comprised a near-vertical south-facing slope cut through the natural to a depth 0.50m. The terrace cut had a large flat piece of Swithland slate inserted as edging against the vertical terrace cut. The terrace cut contained an infill consisting of soft grey-brown silty clay mixed with natural red clay, cobbles and modern brick rubble 0.30m deep. Overlying was the same subsoil layer first observed in the northern half of the trench which now had a depth of 0.50m, but the topsoil above had the same depth of 0.20m.

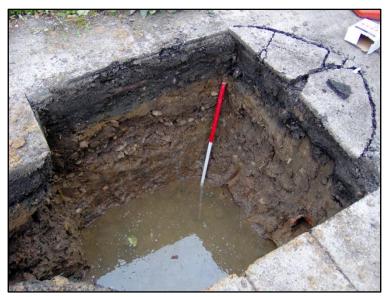
Plate 1. Drain Chamber 1 looking north east

Dimensions
1.20m square and 1.30m deep

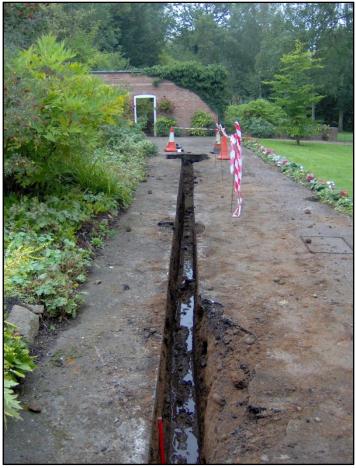
Plate 2. Drain Trench 1 looking east

Dimensions 0.30m wide and 1.30m deep

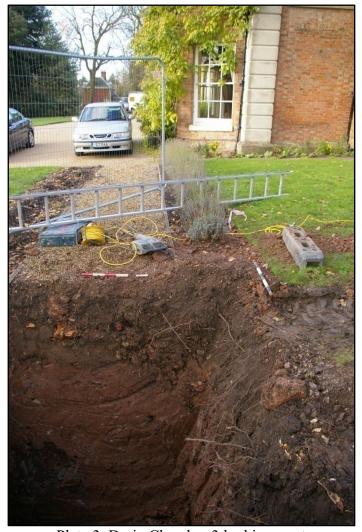
Plate 3. Drain Chamber 3 looking west

2.10m square and 2.70m deep

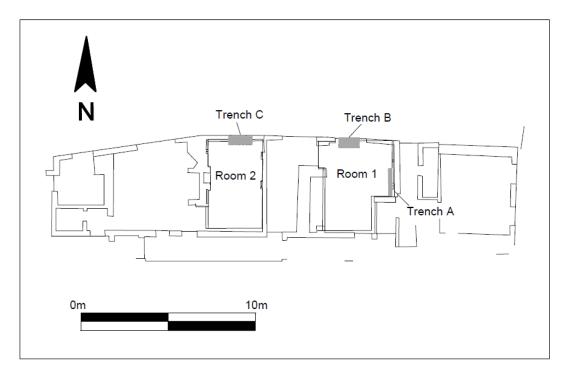
Figure 4. Location plan of Internal Remedial Foundation trenches

Internal remedial works were carried out which involved installation of new foundations to underpin walls within two of the ground-floor rooms located at the rear of the Hall and stripping of defective plaster from walls. The archaeological work involved inspection of three small hand excavated trenches and examination and recording of interior wall surfaces stripped of plaster.

Trench A was located within Room 1 towards the centre of the east internal wall. A small rectangular trench was excavated under the wall and the natural clay was reached at a depth of 0.20m. Sealing the natural was a layer of crushed stone gravel 0.10m deep which supported a modern concrete floor 0.10m thick. Early brickwork and timber elements were exposed when plaster was removed from the wall. The early brick wall was supported by a brick foundation 0.20m deep.

Trench B was also located within Room 1 towards the centre of the southern external wall. A small rectangular trench was excavated under the wall and natural clay was reached at a depth of 0.20m. Overlying the natural was crushed stone gravel 0.10m deep which supported a 0.10m thick modern concrete floor. Modern brickwork was exposed in the wall which had a foundation blue bricks 0.20m deep.

Trench C was located within Room 2 towards the centre of the south external wall. A small rectangular trench was excavated under the wall and natural clay was reached at a depth of 0.30m below the floor surface. Overlying the natural clay was crushed brick stone gravel 0.22m deep and sealed by a modern concrete floor 0.08m thick. Early brickwork was exposed in the wall and had a foundation which comprised stone rubble 0.30m wide and 0.20m deep.

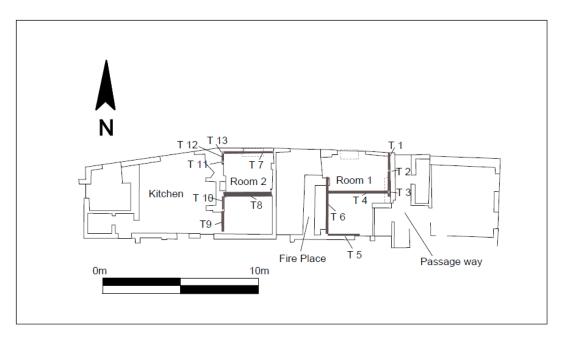
Figure 5. Location plan of timber elements found within Rooms 1 and 2 located at the rear of Knighton Hall.

The removal of plaster from internal wall faces exposed fragments of timber framing in Rooms 1 and 2. Other exposed timbers included ceiling beams in both rooms and a fireplace bressumer in Room 1. The location of all of these timbers was recorded (Figure 5) and each timber was allocated a number (T1 - T13).

Elements of an early timber-framed wall were exposed beneath later lath and plaster in the east wall of Room 1. Framed into a sill beam (T1) are two studs (T2 and T3). The studs are tenoned into the sill and the joints pegged (Plate 4 and Figure 5).

Timber T4 is a chamfered spine beam supporting the first floor joists over Room 1. The west end of T4 is carried on the fireplace bressumer T6. The bressumer spans the opening of a substantial inglenook fireplace heating Room1, which has two recessed cupboards (without doors) and a later brick hearth. Timber T5 is a beam at ceiling level in the south wall of Room 1, presumably part of a timber-framed wall (Plate 5 and Figure 5).

Within Room 2, T7 is a beam at ceiling level that presumably represents a vestige of a timber-framed north wall. Timber T8 is a spine beam supporting the first floor joists over Room 2. Various elements of a timber wall frame were exposed in the west wall of Room 2. Timbers T10 and T12 are beam fragments exposed at ceiling level, whilst T11 is the remains of a stud. At the north-west corner of the room, T13 appears to mark the position of a removed wall posts (Plate 6 and Figure 5). T9 is possibly a reset fragment supporting the wall above the wide entrance from Room 2 into the kitchen to the west.

All of the timbers were oak and all, with the exception of T9, appear to be *in situ* elements of a timber-framed range of building. From the limited investigation afforded by the remedial works, it is not possible to interpret with confidence the form of the timber-framed structure represented by the exposed timbers. It is probable that further elements are concealed within the fabric of the building. More detailed investigation may serve to elucidate the form and date of the remaining early fabric.

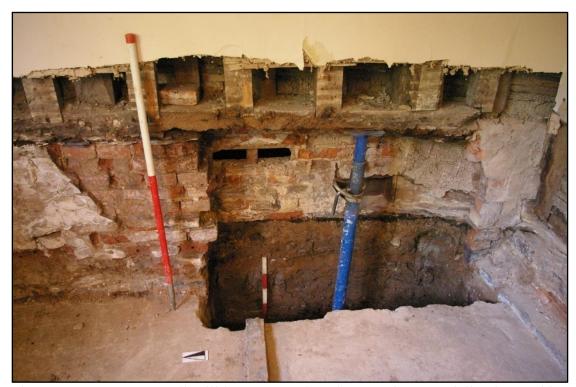
Plate 4. Room 1, west wall. Sill beam T1 and studs T2 and T3, partially obscured by later studwork to lath and plaster wall covering.

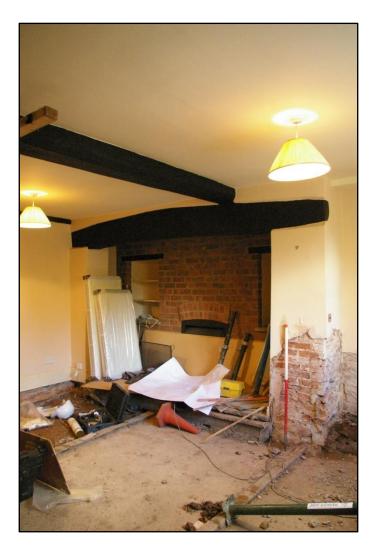
Plate 5. Room 1, looking south-east, showing the spine beam T4 supported on the fireplace bressumer T6.

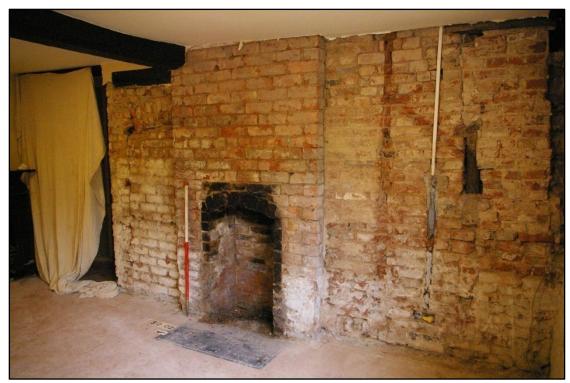
Plate 6. Room 2, looking south-west, showing the spine beam T8 at ceiling level and remnants of wall framing T10, T11 and T12 embedded in the brickwork of the west wall of Room 2.

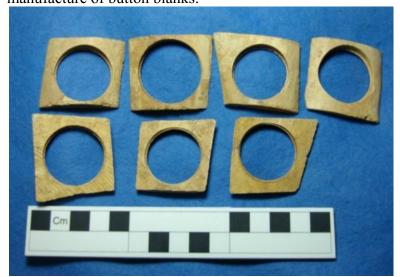
Nine fragments of animal bone were recovered from context 1 (topsoil) at Knighton Hall. A butchered large mammal (probably cattle) lumbar vertebra with un-fused epiphyses was recovered. However, the majority of recovered bones appear to indicate part of a manufacturing process. The fragments were regular in size and shape, consisting of rectangular and square sections, with length/width measurements of between 37mm and 43mm. They appear to have been produced from the thick cortical bone (up to 9mm thick) of the long-bone shafts of large mammals, such as horses or, most probably, cattle. Visible striations showed that each section was sawn and was flat on the inner side, while the un-sawn, convex outer face appears to reflect the natural curve of the bone surface. A circular hole in the centre of each fragment appears to have been punched or drilled out and a projecting ridge towards the inner surface possibly suggests that the bone was punched from both sides. The cut circles are very regular with diameters ranging from 29.5mm to 33.5mm, although most measure between 30mm and 31mm. The regularity of the cut-outs suggests that they may be machine-made and they are likely to represent waste off-cuts from the manufacture of button blanks.

Plate 7. (left): Bone off-cuts. Top row shows outer face and bottom row shows inner face

Plate 8. (right): Detail of cut-out.
