**An Archaeological Evaluation of
The Former Petrol Station, Main Street
Barton-under-Needwood, Staffordshire
(SK 18663 18707)**

ULAS Report No 2011-076
©2011

Planning Permission: PA/02379/019

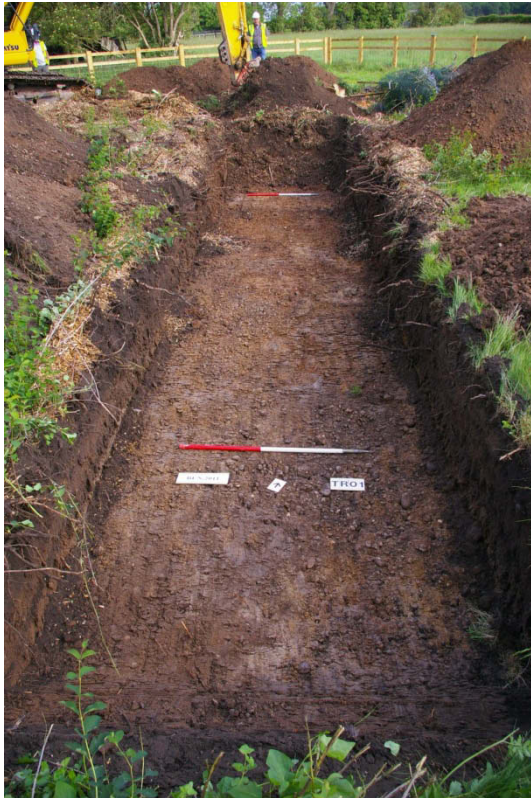
Figure 3: Trench 1 (looking north west).

Interval from NW End of Trench	0m	2m	4m	6m	8m	10m
Depth of Topsoil	0.2	0.2	0.2	0.25	0.25	0.3
Subsoil Depth	0.7	0.7	0.6	0.7	0.7	0.7
Top of Natural	0.7	0.7	0.6	0.7	0.7	0.7
Base of Trench	0.7	0.75	0.75	0.75	0.75	0.75

Trench 1 was aligned north west– south east, within the northern most part of the proposed development area (Fig. 3). The trench was 10m long.

Approximately 0.2m to 0.3m of garden soil was excavated, exposing a layer of silty clayey subsoil. Beneath the subsoil a horizon of light yellow brown mixed sands and gravels with frequent clay lenses was exposed. Excavation ceased at this level, approximately 0.7m to 0.75m below the existing ground level.

No remains of archaeological significance were found within the trench and it was recorded and released for backfilling.

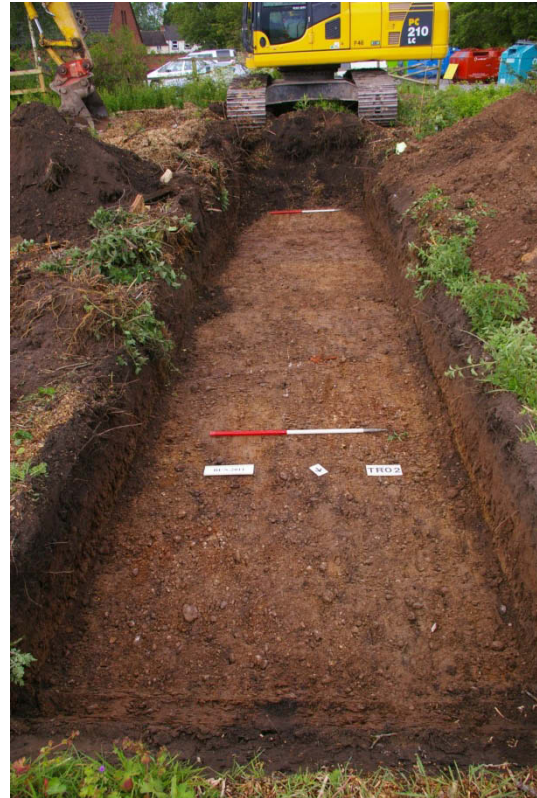
Figure 4: Trench 2 (looking south west)

Interval from NE End of Trench	0m	2m	4m	6m	8m	10m
Depth of Topsoil	0.2	0.25	0.25	0.3	0.3	0.3
Subsoil Depth	0.55	0.55	0.6	0.55	0.7	0.7
Top of Natural	0.55	0.55	0.6	0.55	0.7	0.7
Base of Trench	0.55	0.55	0.6	0.7	0.8	0.8

Trench 2 was 10m long and aligned north-east to south-west, approximately 7m north-west of trench 1 (Fig. 4).

A similar depth of garden soil and subsoil as trench 1 was excavated and the underlying substratum appeared very similar. Excavation ceased approximately 0.55m to 0.8m below the existing ground level. A single furrow, aligned west north-west-east south east was observed towards the southern end of the trench as well a ceramic field drain on the same alignment.

No remains of archaeological significance were found within the trench and it was recorded and released for backfilling.

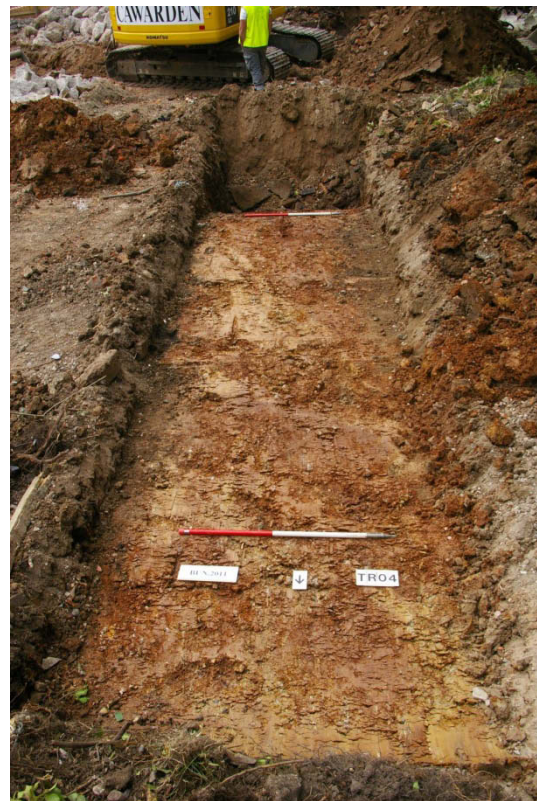
Figure 6: Trench 4 (looking south).

Interval from NNE End of Trench	0m	2m	4m	6m	8m	10m
Depth of Overburden	0.2	0.2	0.2	0.25	0.8	1.2
Top of Natural	0.2	0.2	0.2	0.25	0.8	1.2
Base of Trench	0.2	0.2	0.2	0.28	0.8	1.2

Trench 4 was 10m long and aligned north to south, approximately 10m north of trench 3 (Fig. 6).

As with trench 3, the demolition build-up lay directly onto weathered mudstone substrata. Approximately 0.2m of this stratum was excavated to confirm its extent and excavation ceased at approximately 0.2m below the existing ground level. This depth was increased at the southern end of the trench to approximately 0.8m to remove a deeper deposit of 20th century rubble.

No remains of archaeological significance were found within the trench and it was recorded and released for backfilling.

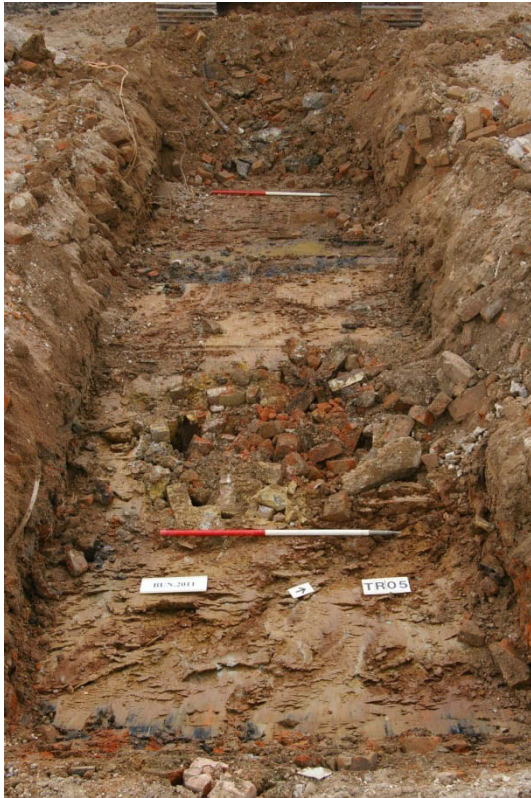
Figure 7: Trench 5 (looking west north west).

Interval from W End of Trench	0m	2m	4m	6m	8m	10m
Depth of Overburden	0.7	0.55	0.5	0.35	0.5	Service Trench
Top of Natural	0.7	0.55	0.5	0.35	0.5	Service Trench
Base of Trench	0.7	0.55	0.5	0.5	0.6	Service Trench

Trench 5 was aligned east to west approximately 6m north-east of trench 3 (Fig. 7) The trench was 10m long and 1.6m wide.

The stratigraphy was the same as that recorded within trenches 3 and 4. Excavation continued to approximately 0.55m to 0.7m below the existing ground level. A brick line structure, probably a vehicle inspection pit was observed at the eastern end of the trench.

No remains of archaeological significance were found within the trench and it was recorded and released for backfilling.
