**An Archaeological Watching Brief at
Holy Trinity Church, Church Street,
Barrow Upon Soar, Leicestershire**

NGR: SK 5764 1757

ULAS Report No. 2011-102
©2011

For: Barrow on Soar PCC

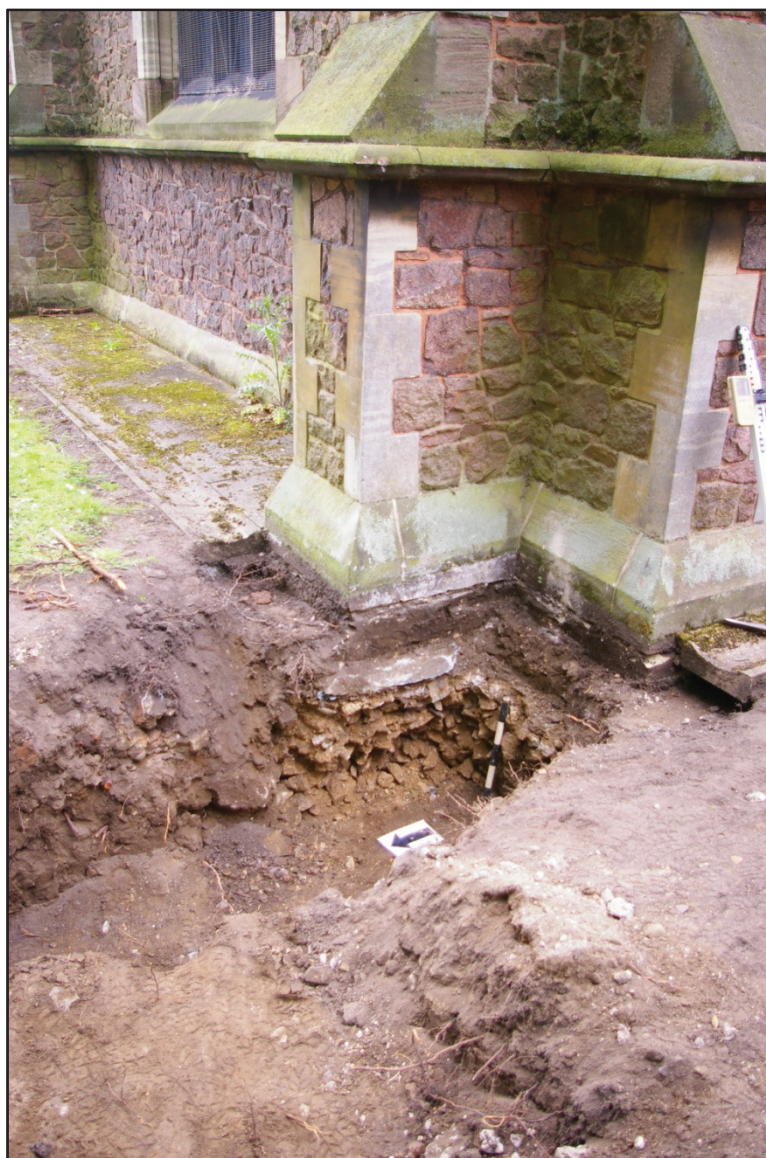
Plate 1. North Transept Foundations

During these initial excavations part of the north transept wall was exposed (Plate 1). The wall footings consisted of a modern concrete which comprised abundant stone gravel bonded with pale yellowish brown mortar matrix 0.55m deep. Overlying was course of slate 0.10m thick followed by a course of roughly hewn granite blocks 0.23m thick. The wall courses comprised ashlar limestone blocks and roughly hewn granite blocks.

The external wall face and foundations of both the North Transept and North Aisle appear to have been extensively refurbished. The foundations have had their stone removed and walls are underpinned with concrete. The walls external face comprised a mixture of ashlar blocks and granite and are again thought to be modern. The modern foundations and outer wall face are all probably associated with the 19th century refurbishment of the church.

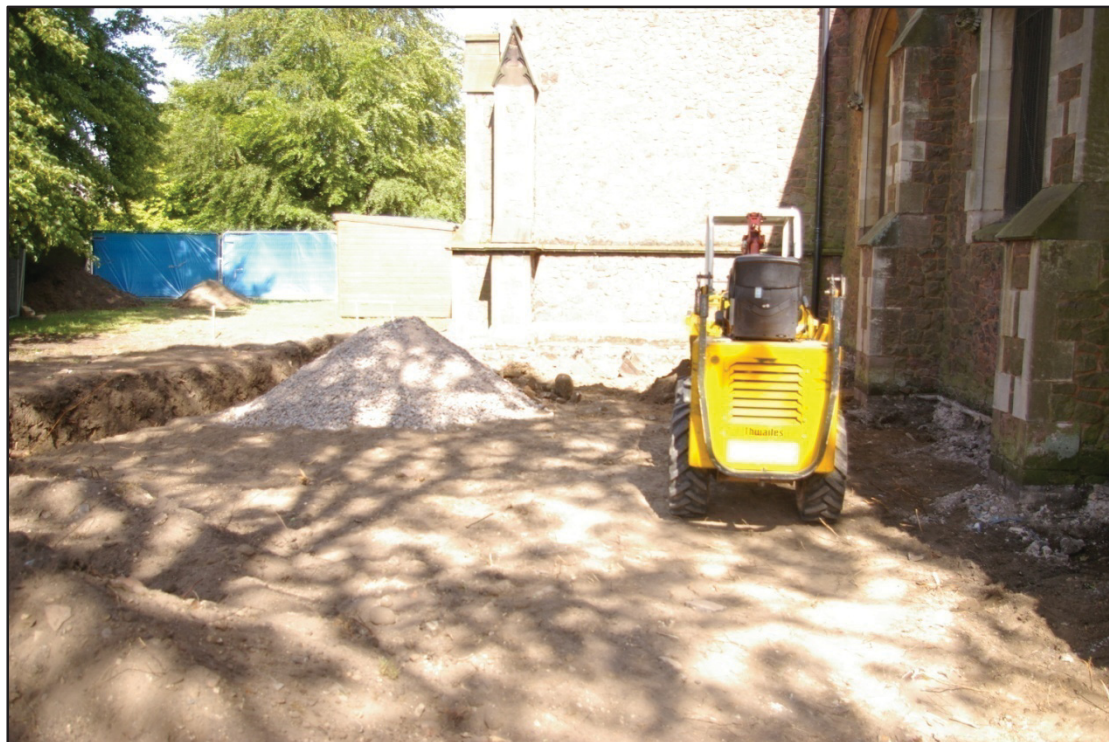
Plate 2. Area Strip and North Aisle foundations exposed

A third visit was undertaken on the 24th May 2011 and area strip had taken place for the internal floors of the new extension (Plate 2). The ground level was reduced by 0.45m and comprised of top soil and subsoil/graveyard (Figure 2). No graves were exposed at this depth with only a scatter disarticulated human bone found. In addition to area strip the other foundations trenches were excavated and measured 0.70m wide and 1.00m deep. No natural soil or features were observed at the base of these trenches. The north aisle wall foundation was exposed and consisted of the same modern concrete foundations and granite blocks that were observed supporting the North Transept. A scatter of loose stone rubble was observed within the trenches that abutted the North Aisle. These stones were thought to be the remnants of the former stone foundations that were perhaps removed from under the walls and replaced with concrete.

No grave cuts were observed within the stripped area and foundations of the new extension with only disarticulated human bone observed and graveyard in this area may have been extensively disturbed during the 19th century refurbishment of the church. No graves were reached directly under tomb stones that were removed during the topsoil strip and were presumed to be much deeper.
