An Archaeological Watching Brief
at Old Hall Farm,
Markfield Road,
Groby, Leicestershire
(SK 5241 0757)

ULAS Report No 2011-104
©2011

Planning Application: 10/00267/LBC

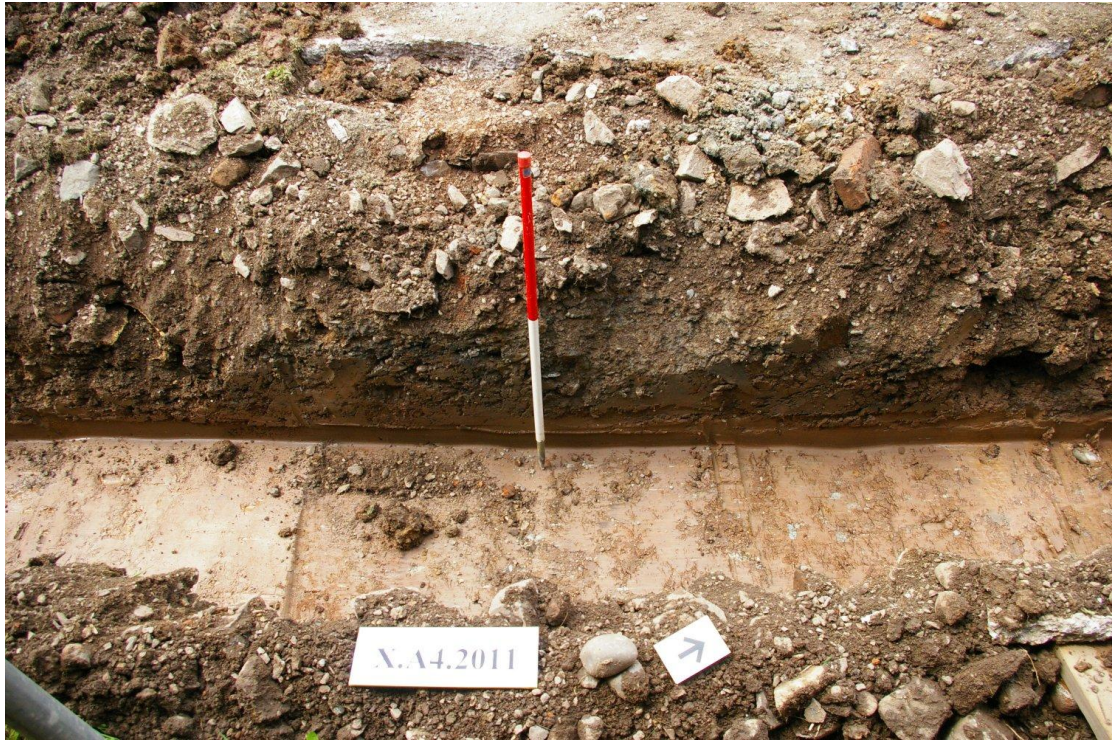
The service trench was approximately 1.1m wide and 1m deep; the exposed stratigraphy consisted of approximately 0.5m of modern overburden overlying weathered mudstone substrata. Towards the northern end of the service trench, adjacent to the westernmost gable of building A (Figure 4) an earlier surface of granite setts was exposed immediately below the concrete slab, probably indicating the original 19th-century track through the farmyard.

Figure 5 Representative section of service trench.

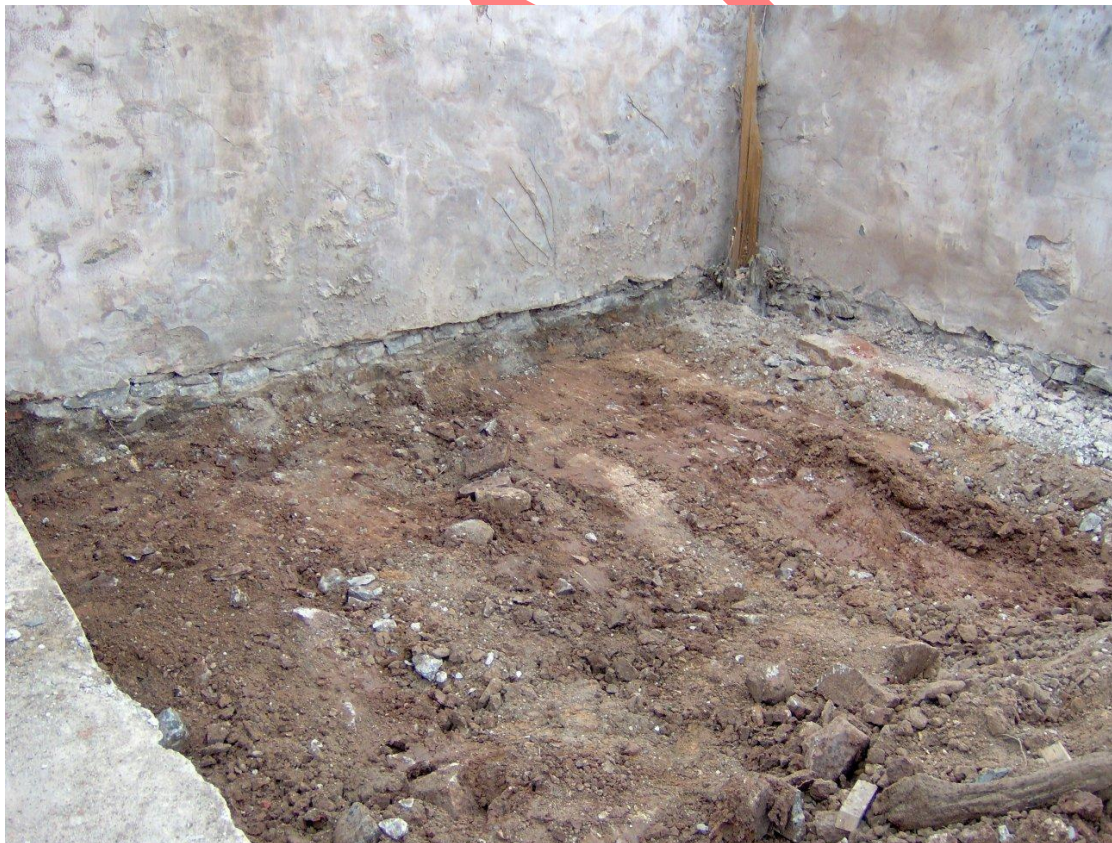
archaeological supervision ensure no unnecessary disturbance occurred. Below approximately 0.3m of concrete a surface of granite setts was exposed, below which was a 19th or early 20th-century demolition layer, which was not excavated. A short length of brick-built wall was uncovered. Most likely this wall and the demolition layer relate to one of the 19th-century buildings which are recorded within the proposed development area on early maps (*Figure 8*).

It was noted that the demolition layer became softer and noticeably sank towards the eastern part of the stripped area; this coincides with the alignment of the castle ditch, confirming that the ditch does continue within the proposed development area.

Figure 6 Area of lifted slab.

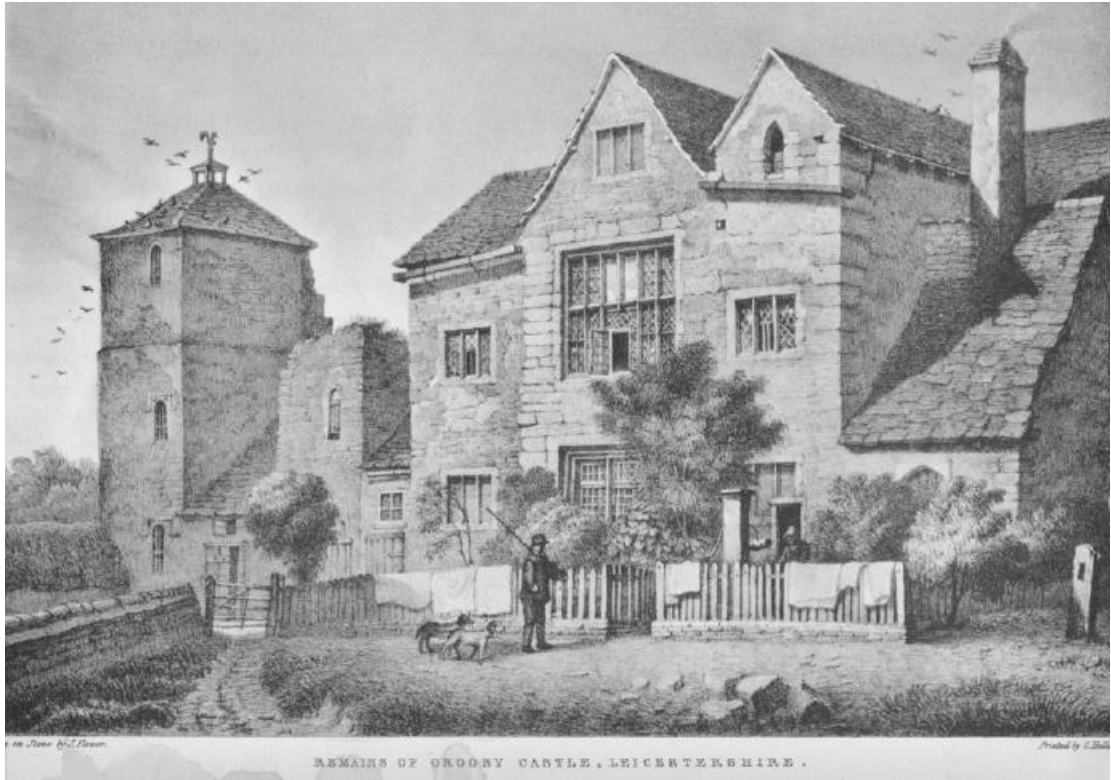
Figure 7a

Groby Old Hall from the east. (John Flower 1826). Comparison with Fig. 7b below suggests significant ground reduction may have taken place within the proposed development area.

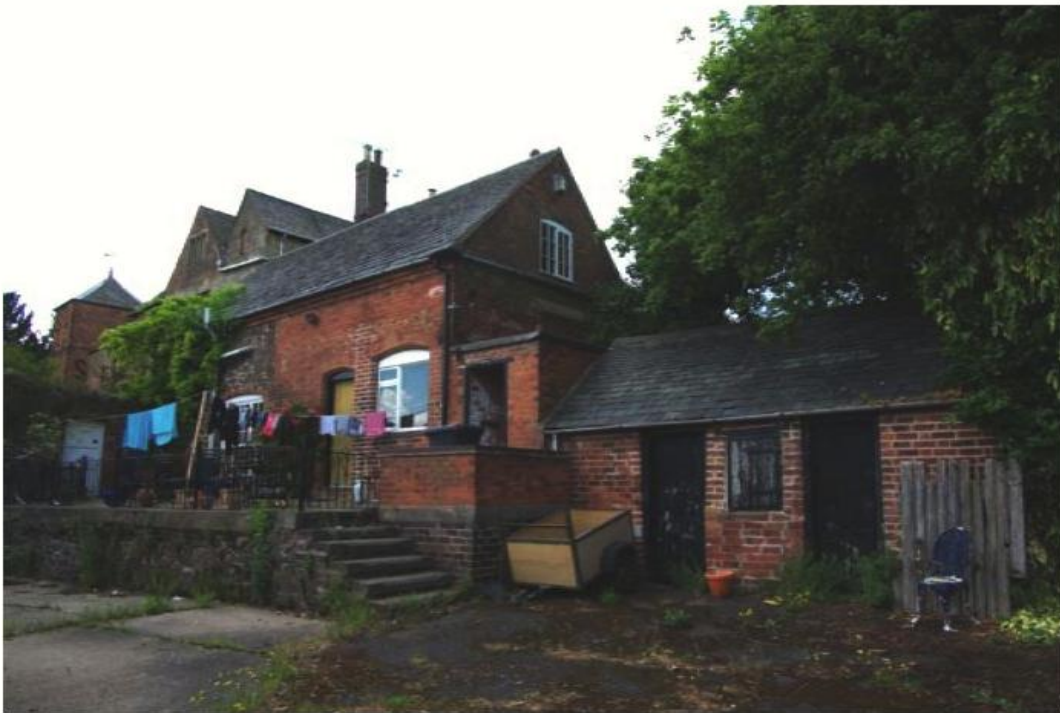
Figure 7b

Groby Old Hall from the north-east, showing evidence of ground reduction in the foreground, with retaining wall and steps.

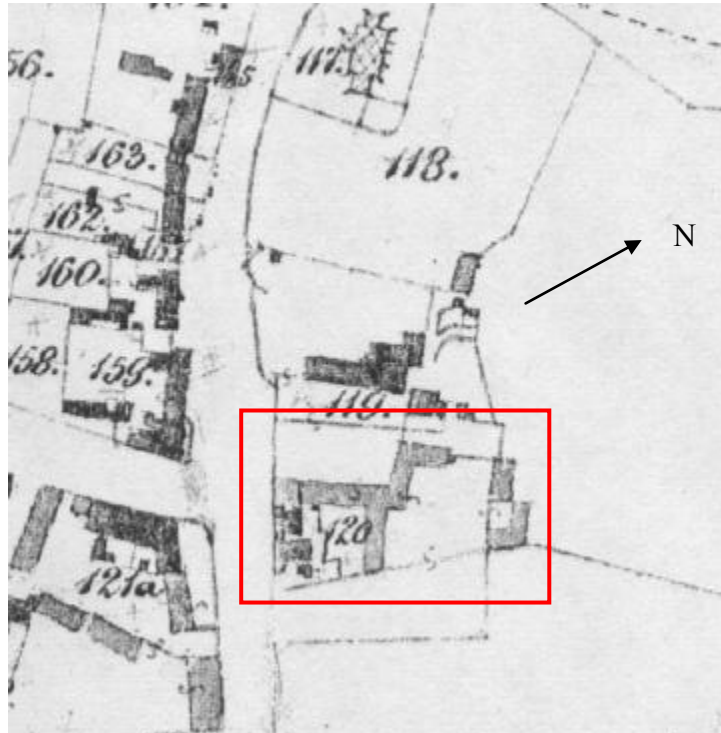
Figure 8

Extract from mid 19th century map (post-1840), showing buildings no longer standing within proposed development area.

The limited remains of an earlier brick-built structure were exposed within the southernmost section of the service trench at its northern end. This is likely to be an early 19th century building recorded on early maps of the site (Figure 8). The service trench followed the external face of the wall without disturbing it and it remained *in-situ*.
