An Archaeological Watching Brief at Groby Old Hall, Markfield Road, Groby, Leicester

NGR: SK 5239 0759

Neil Finn

**ULAS Report Number 2011-144**

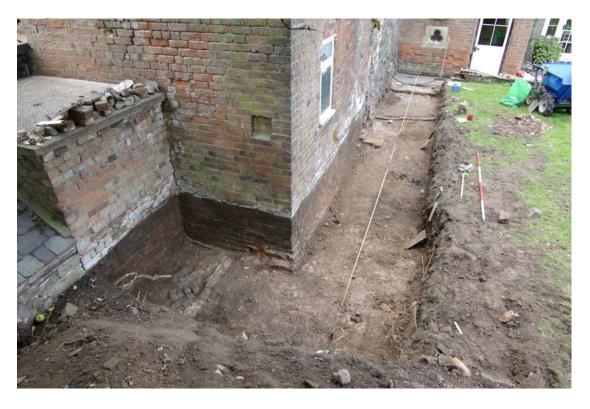
Photo 1. The excavated trench, looking south.

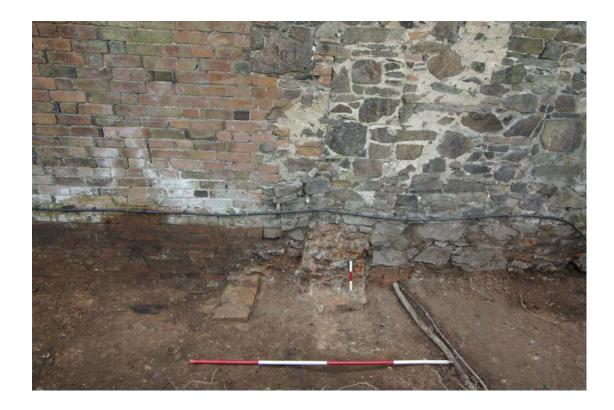
Aligned across the width of the longer leg of the trench was a brick-built wall foundation (01) (Figure 3; Photo 2). This was 0.5m wide and composed of bricks measuring 4½ inches (114mm) wide and 2 inches (50mm) thick. No complete bricks were exposed and no overall lengths were recorded for any bricks. The foundation was at least 8 courses high. The build was quite irregular with the incomplete brick

fragments set in a hard pale coloured mortar. The wall was within a wider foundation cut, exposed in plan in the base of the trench, which measured 0.65m wide.

The position of the wall footing (01) corresponded with the north-east end wall of the stone-built Range N, which was certainly extant by 1790 and was subsequently altered and incorporated into the cottage built in 1858.

That the wall foundation is constructed from early brick, but the structure above is stone-built, coupled with the fact that the wall foundation extends further to the north-west than Range N, suggests that this foundation is the vestige of an earlier structure that was re-used when the Range N building was constructed. The bricks are likely to be late 15<sup>th</sup> century in date, deriving from the gatehouse begun in the 1480s/90s but never completed, however these may be reused in their present context given the number of incomplete bricks that are evident within the foundation.

Exposed at the base of the longer leg of the trench was a truncated brick-built foundation (02) (Figure 3; Photo 2). This survived to a maximum of two courses high. The bricks measured  $11 \times 5\frac{1}{2} \times 2$  inches (279 x 140 x 50mm) and were set in mortar.

This foundation was overlain by the brickwork of the 1858 cottage. The brickwork of the cottage is quite different in character, the bricks measuring  $9\frac{1}{2} \times 4\frac{1}{2} \times 3$  inches (241 x 114 x 76mm), laid in irregular Flemish garden wall bond. The foundation (02) apparently predates the cottage, though the precise date and function are unknown; the bricks may be reused late 15<sup>th</sup> century bricks.

Cut into the natural clay of the longer leg of the trench was a cut feature (03) (Figure 3; Photo 2). This was exposed in plan at the base of the trench, but not excavated as it was not affected by the ground reduction work. The cut was not clearly defined but appeared to be sub-rectangular of sub-square in plan, extending beyond the limit of excavation to the north-west. The fill consisted of a mixed rubble deposit containing brick, mortar and charcoal fragments. Numerous pieces of 19<sup>th</sup> century pottery were visible within the fill, in addition to oyster shells, fragments of animal bone, clay pipe, and corroded iron objects/fragments. A rapid scan of a sample of the finds suggests an early 19<sup>th</sup> century date for the deposit. This appeared to be a dump of domestic debris. The nature of the cut feature into which it had been deposited was unclear.

Photo 2. The vertical 30cm photo scale is resting on wall foundation (01), with foundation (02) to the left of this and lead water pipes to the right. The 2m photo scale is lying on cut feature (03).

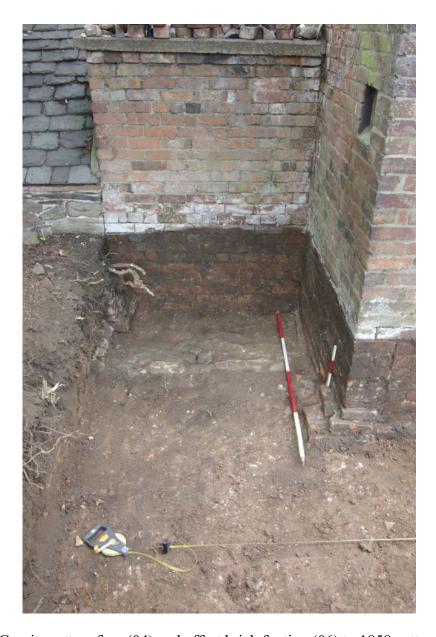
At the south-east end of the shorter leg of the trench was a surface composed of small granite setts (04) (Figure 3; Photo 3). The setts were well finished and measured 4 x 3 inches (101 x 76mm). A cement footing (05) for a brick kerb or wall formed an edging to surface (04). The surface was 0.8m wide and may have formed a path along the back of Range Q. The surface is likely to date to the 19<sup>th</sup> or early 20<sup>th</sup> century.

An offset brick footing was exposed on the north-east and north-west sides of Range P (Figure 3; Photo 3). The bricks were identical to those of the superstructure and are attributable to the 1858 build.

Photo 3. Granite sett surface (04) and offset brick footing (06) to 1858 cottage range.

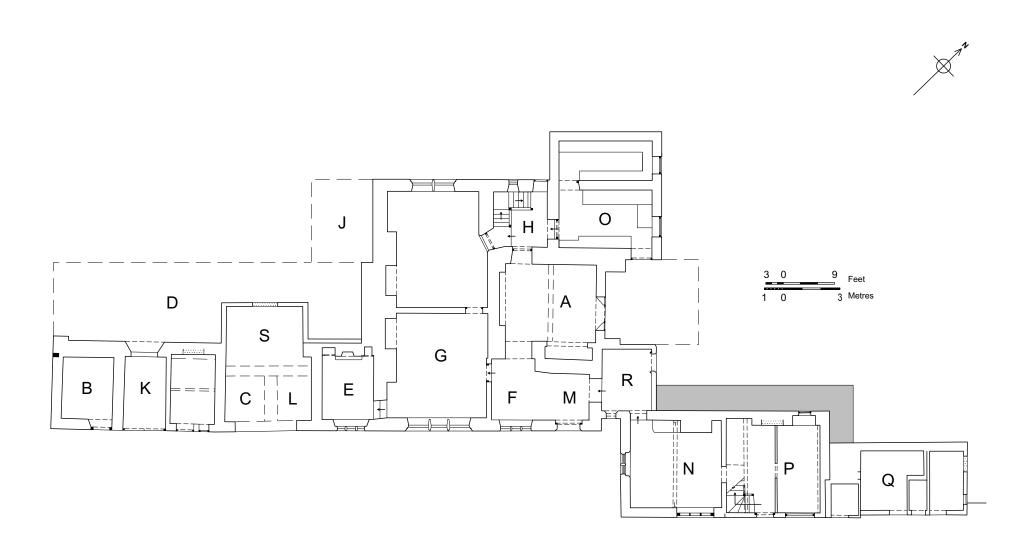
The excavated material consisted principally of topsoil. Towards the base of the trench the natural ground was reached, this consisting of a pinkish coloured marl of the Mercian Mudstone group. Various archaeological remains were exposed (Figure 3), these are described below. Letter codes used to identify different elements of the standing building relate to the earlier Historic Building Assessment (ULAS report 2009-126); these are identified on Figure 2.

Figure 2. Groby Old Hall: Ground floor plan locating the various built elements. Watching brief area shaded. Scale 1:200

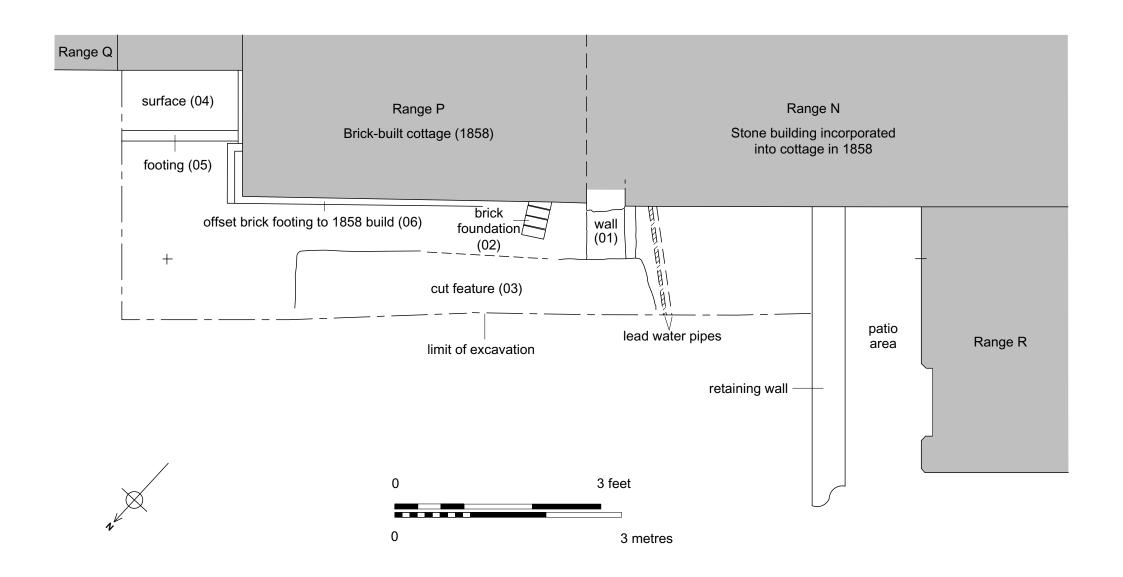
Figure 3. Plan of the excavated trench. Scale 1:50
