**Groby Old Hall, Markfield Road,  
Groby, Leicestershire:  
Historic Building Assessment  
NGR: SK 5239 0759**

**For: Mr and Mrs Dickens**

**ULAS Report Number 2009-126**

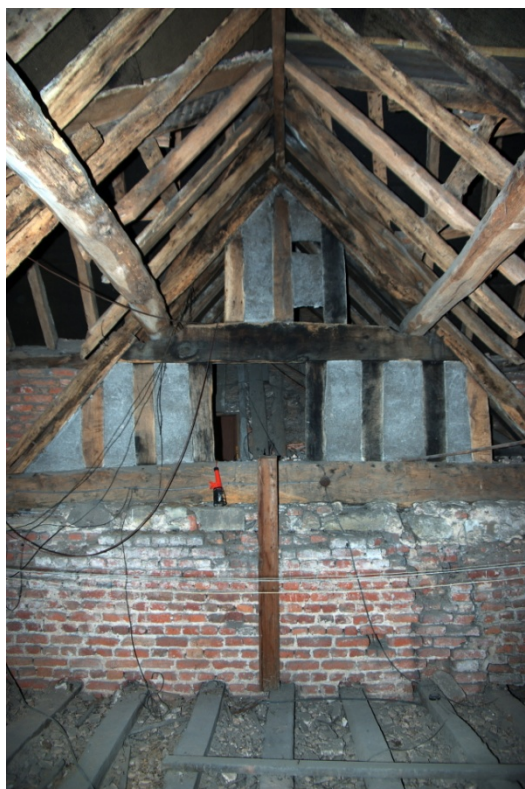
Photo. 1. Smoke-blackened 15<sup>th</sup> century roof truss over former open hall (Range A)

Smoke blackening of the roof truss and the few remaining original common rafters (Photo. 1) indicates that the hall was originally open from the ground floor to the roof and heated by an open hearth. Subsequently the hall was floored over and a lateral chimneystack added on its south-west side. The chimneystack is brick-built and the first and attic floor structures appear to have been inserted around 1600, to judge from the moulded brackets which support the transverse beams at ceiling level (Photo. 2). The original ground floor level of the hall appears to have been reduced significantly to provide the necessary head height for two full storeys plus an attic. Two stone buttresses against the north-east gable wall of the hall have *c.*1m of their foundations exposed, suggesting the extent of the ground reduction.

At the core of the building is the remnant of a former open hall, attributable to the 15<sup>th</sup> century based on the form of its roof structure. Only a single bay remains and it is likely that the hall originally extended to the north-west by at least another bay. One roof truss survives, at the junction between this range and the adjacent cross-wing to the south-west (Figure 5, Photo. 1). A roof truss on the line of the north-east gable wall has been replaced in brick, apparently as recently as the 19<sup>th</sup> century to judge from a sketch made by the Leicester artist John Flower around the 1820s, which seems to show a timber-framed gable (Figure 12). The surviving roof truss, illustrated in Figure 5, is a principal rafter truss with tiebeam and collar. The purlins are clasped between collar and principal rafters (note: the purlins have been replaced at some stage however the original housings are clearly discernible). In Leicestershire clasped purlin roofs of this type typically occur in higher status buildings of the 15<sup>th</sup> century. Dated examples include 7 Main Street, Frisby-on-the-Wreake, tree-ring dated to 1417, the gatehouse of Leicester Castle rebuilt after a fire in 1446-7, the former manor house at Sparrow Hill, Loughborough of 1475 and 10-14 Churchgate, Hallaton with a tree-ring felling date range of c.1484-1509 (Arnold and Howard n.d.; Finn 2007; Hill 2003). These examples illustrate that this roof form spans the entire 15<sup>th</sup> century, making it difficult to narrow down the date of the Hall range at Groby without tree-ring dating. This is a closed truss with close-studding. The interstices between the

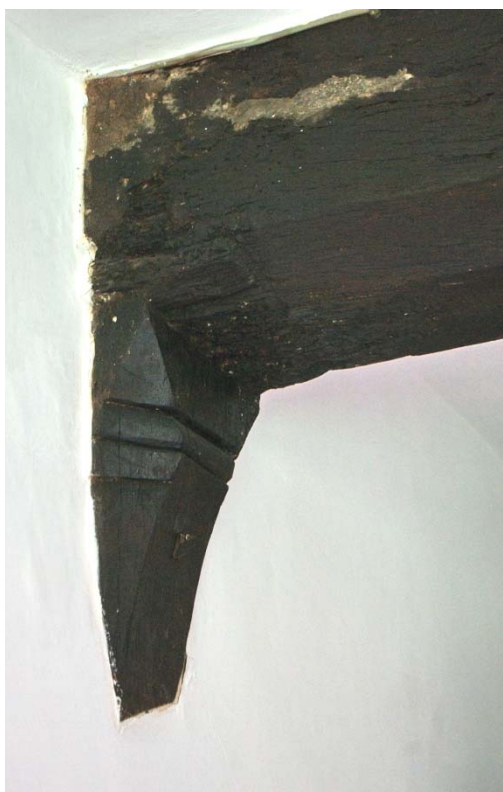
Photo. 2. Moulded bracket supporting inserted floor in former open hall

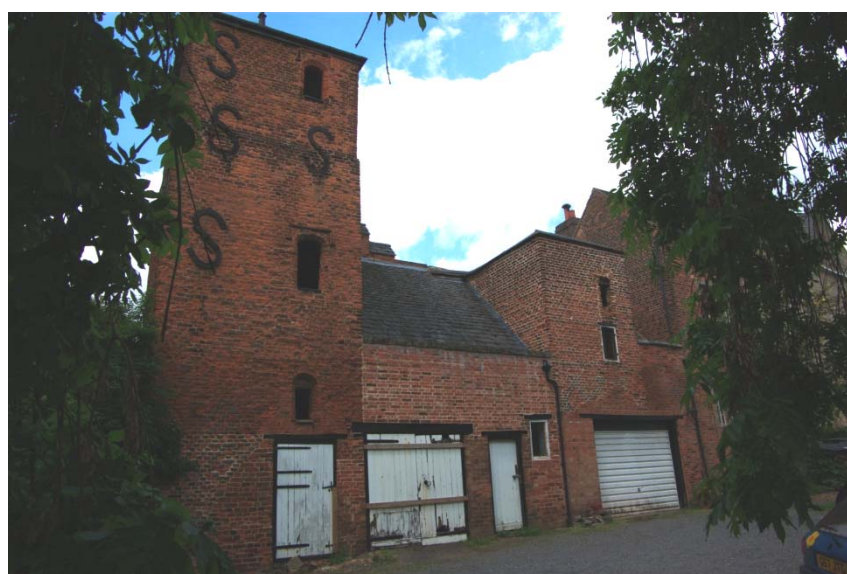
Photo. 3. Late 15<sup>th</sup> century brick towers (Range B to left & C to right) from the SW

There can be little doubt that the two towers towards the south end of the Old Hall (B & C on Figure 1; Photo. 3) are the work of Thomas Grey, first marquis of Dorset. These towers are linked by a wall that is the remnant of a now lost (or never completed) range of building (D on Figure 1). Surviving doorways in the north-west elevation of tower B demonstrate that range D was (or was intended to be) a three-storey structure (Photo. 4). Similarly, there are truncated first and second floor window openings with brick hoodmoulds at the west corner of the same tower. The splayed opening at first floor level in the wall between the two towers is also a window, with intact brick hoodmould to its external (south-east) face, now obscured by the roof of a later lean-to range (Photo. 6). A third 'tower' (E on Figure 1) is constructed in a slightly different brick and was initially thought to be a later addition, post-dating the construction of the 16<sup>th</sup> century cross-wing (Range G). However a blocked first floor doorway in its north-west elevation is similar to the doorways in tower B and evidently also communicated with the missing range D. It is possible therefore that this is also part of the late 15<sup>th</sup> century build, the differing colour and texture of the brickwork reflecting the fact that bricks were fired in clamp kilns at this period and no two firings produced identical results. Variations in the size, colour and texture of the bricks, even within a single structural element, coupled with the fact that extensive re-pointing and localised rebuilding has occurred over subsequent centuries, make it difficult to distinguish coherent phases within the brickwork at

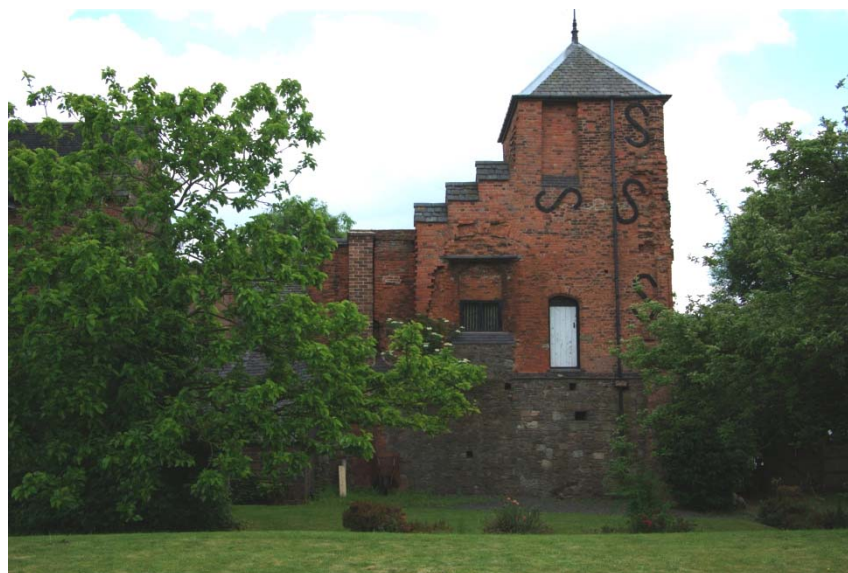
Photo. 4. Tower B from the NW showing 1<sup>st</sup> & 2<sup>nd</sup> floor doors and splayed window opening to 'lost' Range D

In the north-west elevation there are first and second floor doorways, the latter blocked, that would have given access to the 'lost' range D (Photo. 4). The treatment of the first floor doorway is a little more elaborate than that above, with chamfered brick detailing. At the south corner there are the vestiges of first and second floor windows with shaped brick hoodmoulds and reveals. At ground floor level on the south-west elevation are a series of sandstone quoins, possibly one side of an opening, or more likely perhaps marking the corner of an earlier boundary wall (see Range D, below).

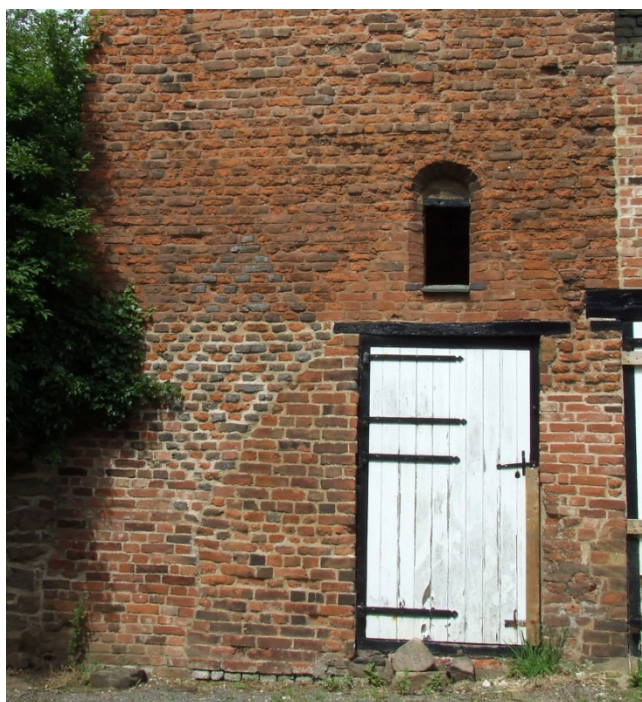
The tower closest to the road (Range B on Figure 1, Photos. 3 & 4) stands three storeys high above a brick-vaulted undercroft, the only access to which is through a small hole in the top of the vault in the centre of the ground floor area. The upper stage of the tower steps in slightly and could be later in date. There are other unresolved constructional breaks that may or may not indicate distinct building phases. There are three small arch-headed window openings in the south-east elevation, the upper two with brick hoodmoulds. There is an inserted doorway below the lower window, adjacent to which is a diaper-work pattern of diamonds within diamonds picked out in vitrified headers. The pattern is somewhat irregular and a portion of it has been destroyed in making good the brickwork around the inserted door (Photo. 5).

Photo. 5. Truncated diaper work and inserted door in south-east elevation of tower B

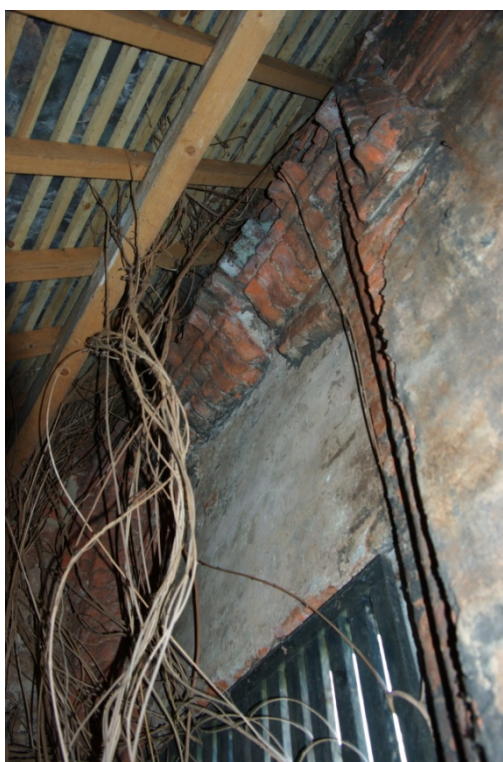
Photo. 6. Brick hoodmould to window in south-west wall of former Range D

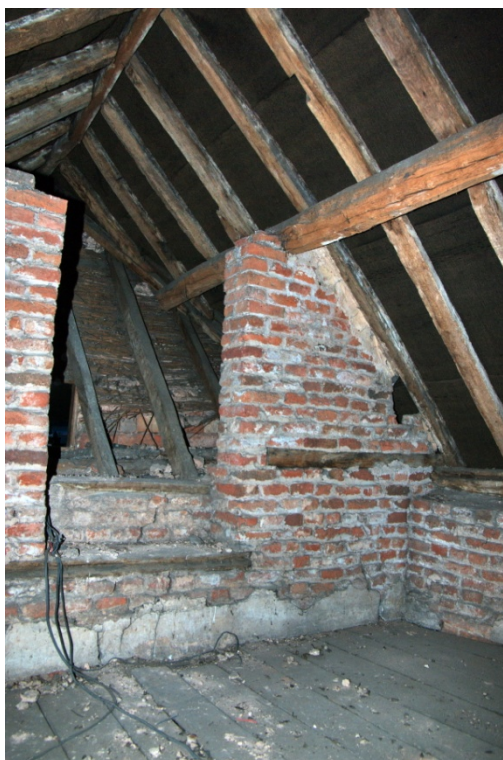
Photo. 7. Attic room Range E with steps down from blocked entrance in Range G

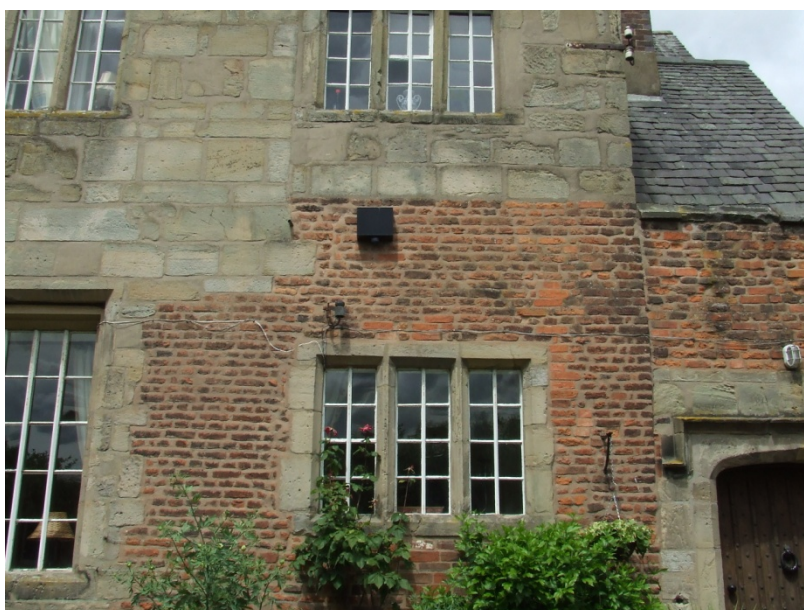
The lower section of the south-east wall of this block is brick-built, the brickwork also extending into the lower part of the cross-wing range G (Photo. 8). The brickwork might be interpreted as the remains of a fourth tower, into which the 3-light stone mullioned window is clearly a later insertion. Little more of this block remains however, hampering interpretation: the ground-floor section of the north-west wall of this range was removed probably in the mid 19<sup>th</sup> century to enlarge the hallway (see

Photo. 8. Early brickwork in the lower section of Range F

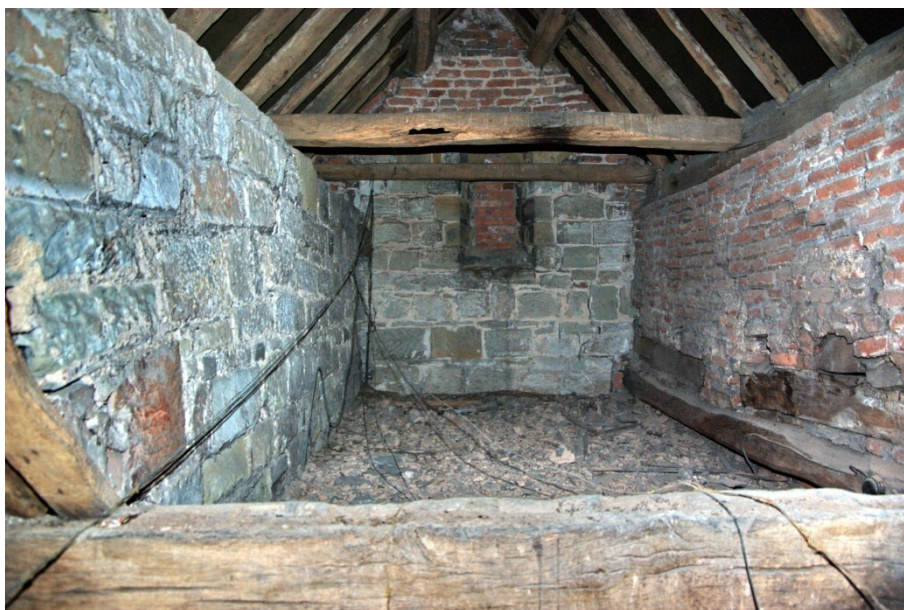
The upper portion of Range F is stone-built (above the brickwork noted in the previous section) though the south-east gable reverts to brick. The stone is similar to that of the cross-wing and stair tower ranges (G & H respectively). This range and the stair tower have the appearance of being a single range, parallel with the cross-wing on its north-east side, and are often described as such (e.g. Pevsner and Williamson 1992, 170). Although the ridge line is continuous, ranges F and H are separate structures located one either side of the 15<sup>th</sup> century hall (see Figure 5). There is a more or less vertical constructional break in the stonework of the south-east (front) elevation, between this range and the cross-wing (Range G), suggesting that these two elements are not precisely contemporary. There are 3-light stone mullioned windows at ground and first floor level and a small arch-headed window in the gable, now blocked. In the attic space, formerly accessed from the attic of the cross-wing, it is apparent that at least some of the masonry used to construct this range (and by extension the cross-wing and stair tower ranges) is reused. Moulded blocks of stone have been laid with their carved faces towards the core of the walls (Photo. 9). Presumably this stonework was salvaged from an earlier structure on the site, either one of the medieval manorial buildings or possibly the chapel, which Burton notes as being ‘ruinated and gone’ by the early 17<sup>th</sup> century. The roof of this range is supported by a principal truss, the curved principals tenoned into a tiebeam and halved at the apex to carry a ridge beam. The purlins run over the backs of the principals and are supported by the projecting ends of raking struts that are nailed into position. The form of the truss is not closely dateable and could be either 16<sup>th</sup> or 17<sup>th</sup> century. The stair tower range H has an identical roof structure (see Photo. 13).

Photo. 9. Former attic room Range F, reused stonework and blocked window

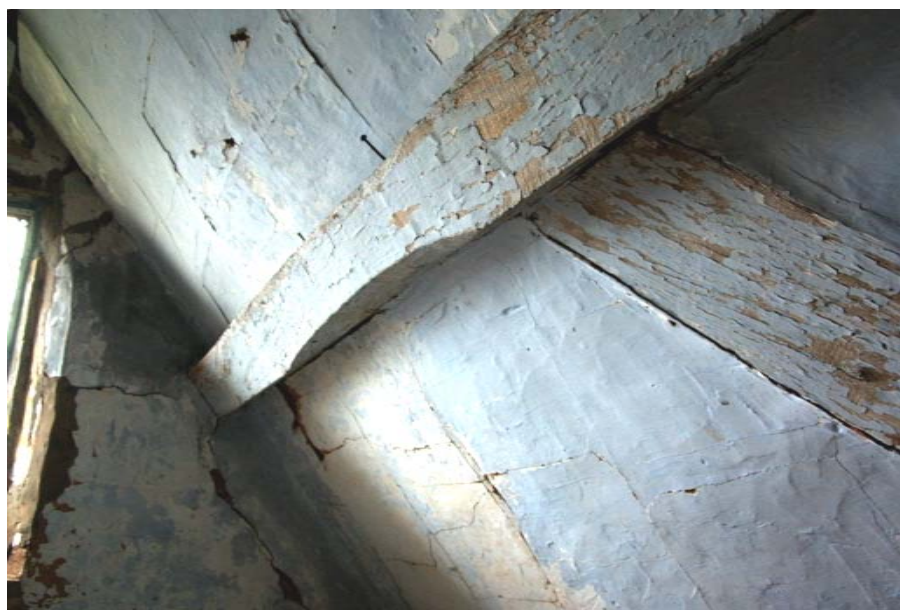
Photo. 10. Trimmed purlin in Range G indicating former door into adjacent attic room

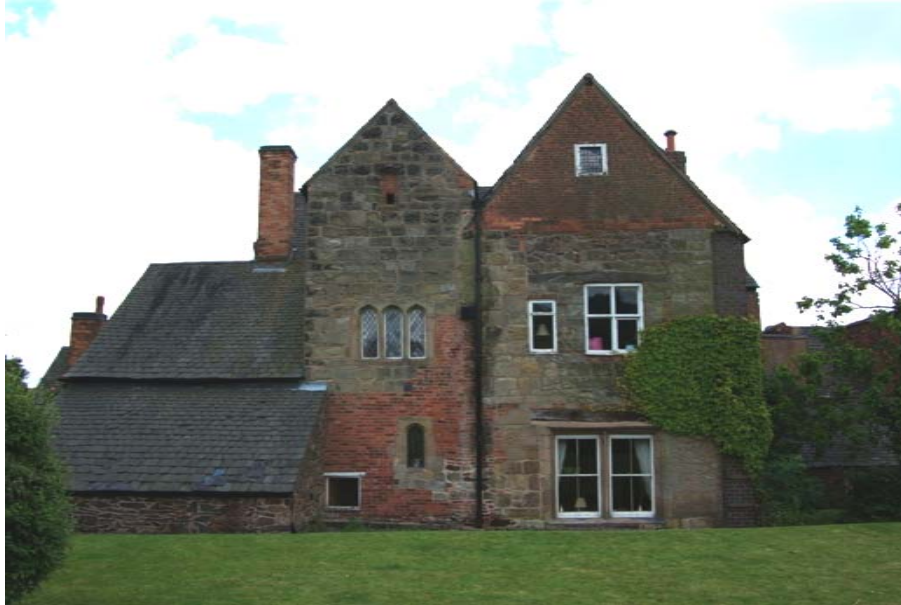
Photo. 11. North-west (rear) elevation with Range H gable (left) & cross-wing (right)

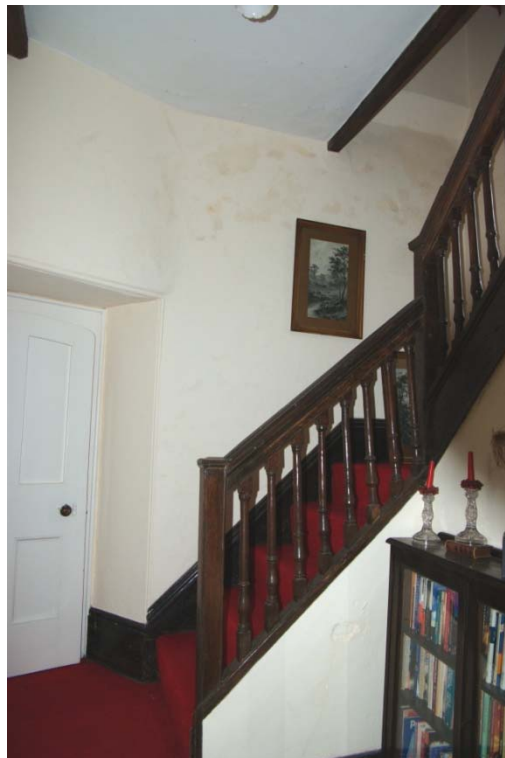
The closed string oak staircase is attributable to the early-mid 18<sup>th</sup> century, based on the form of the handrail and turned balusters (c.f. Hall 2005, 112; 127). However this

has subsequently been altered and the first floor balustrade is later, copying the earlier baluster form. The staircase rises only to the first floor and the attic room above was formerly accessed from the cross-wing attic, but is no longer in use.

Photo 12. 18<sup>th</sup> century staircase within Range H

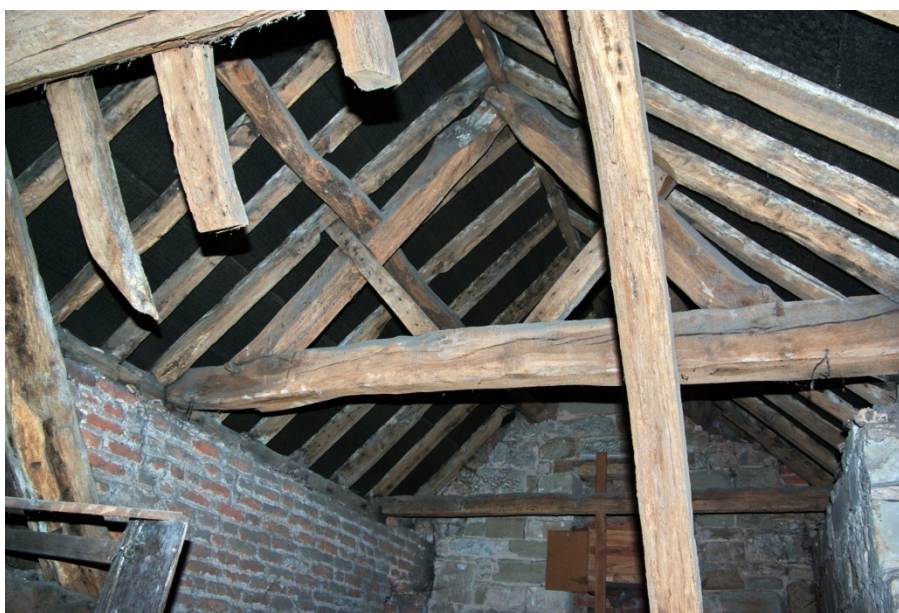
Photo. 13. Attic room Range H, showing roof truss (identical to that in Range F)

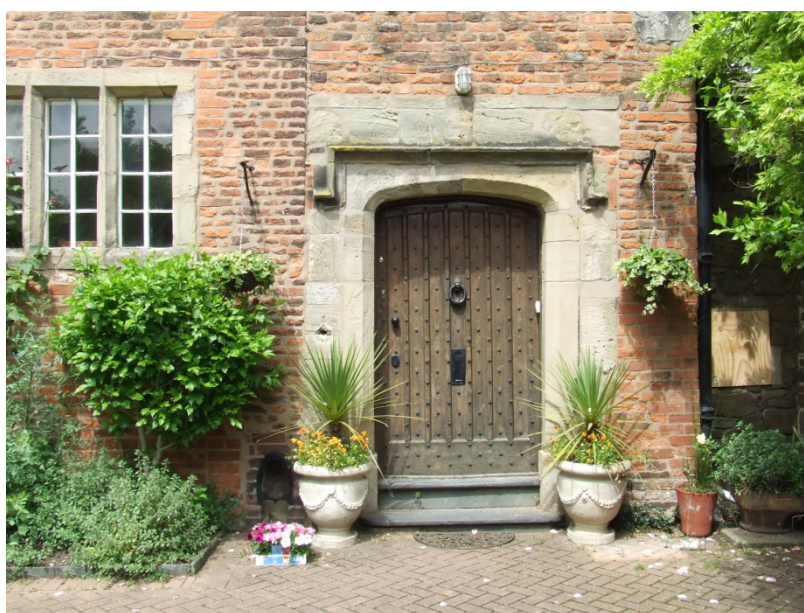
The principal entrance to the Old Hall today is in a small block that backs on to the stack of the hall fireplace, its tall, slated roof now partly masked by a parapet wall (range M); the present doorway is attributable to the mid 19<sup>th</sup> century (Photo. 14).

Photo. 14. Entrance Range M, with mid 19<sup>th</sup> century door surround

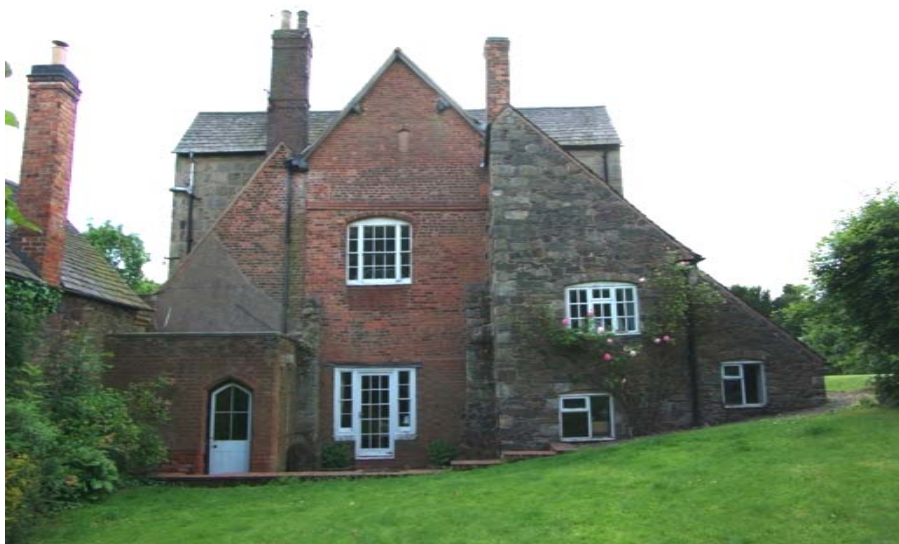
Photo. 15. Service Range O (right), former open hall Range A (centre), Range R (left)

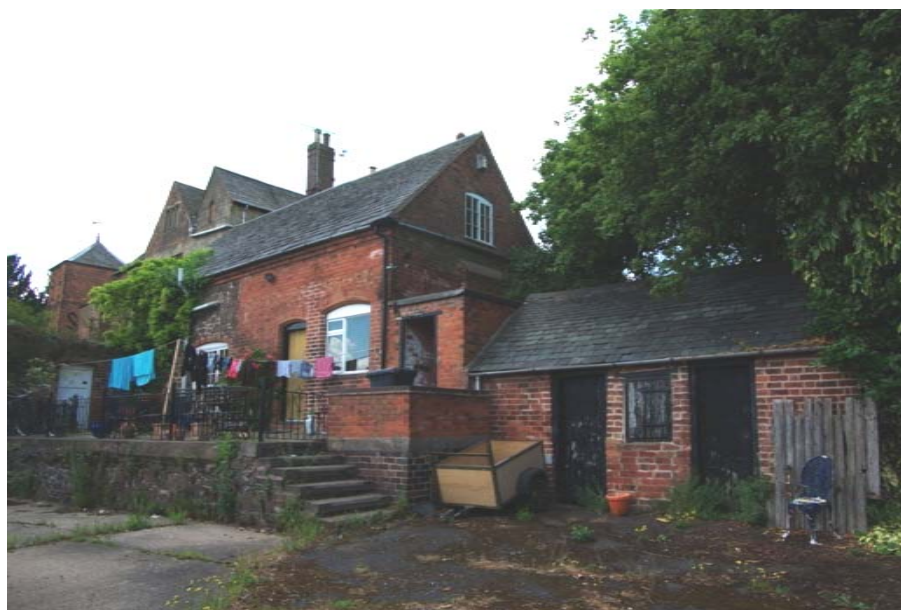
Photo 16. Cottage Range P, incorporating earlier stone-built Range N to left

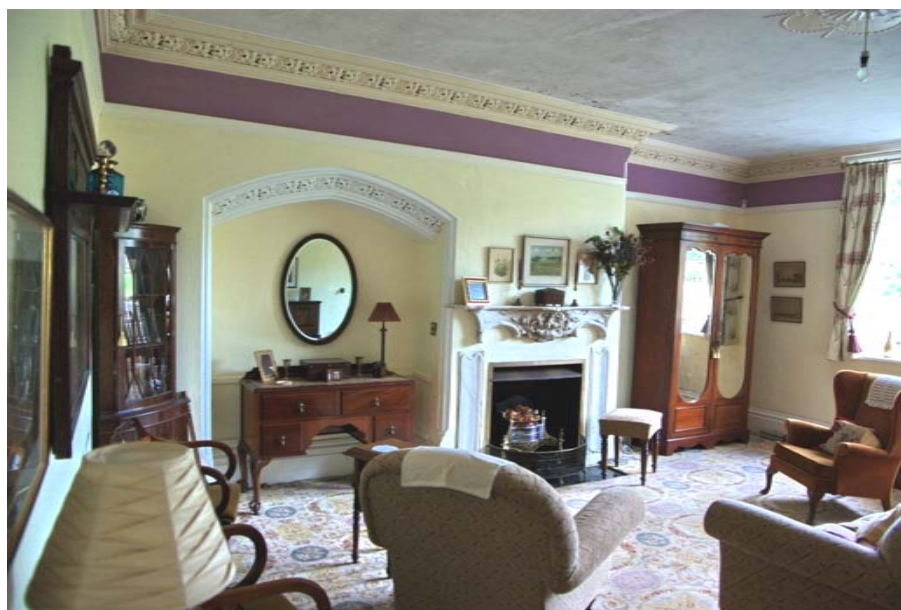
Photo. 17. Decorative scheme of 1858, cross-wing Range G (fireplace altered later)

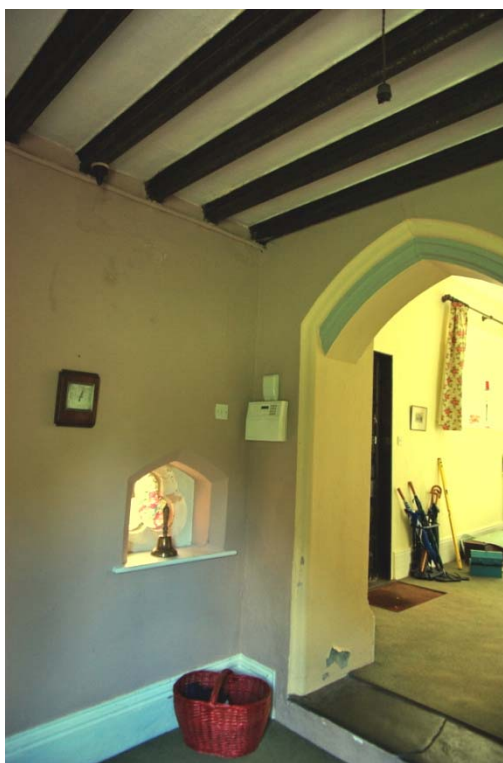
Photo. 18 Interior view looking from Range R into entrance hallway Range M

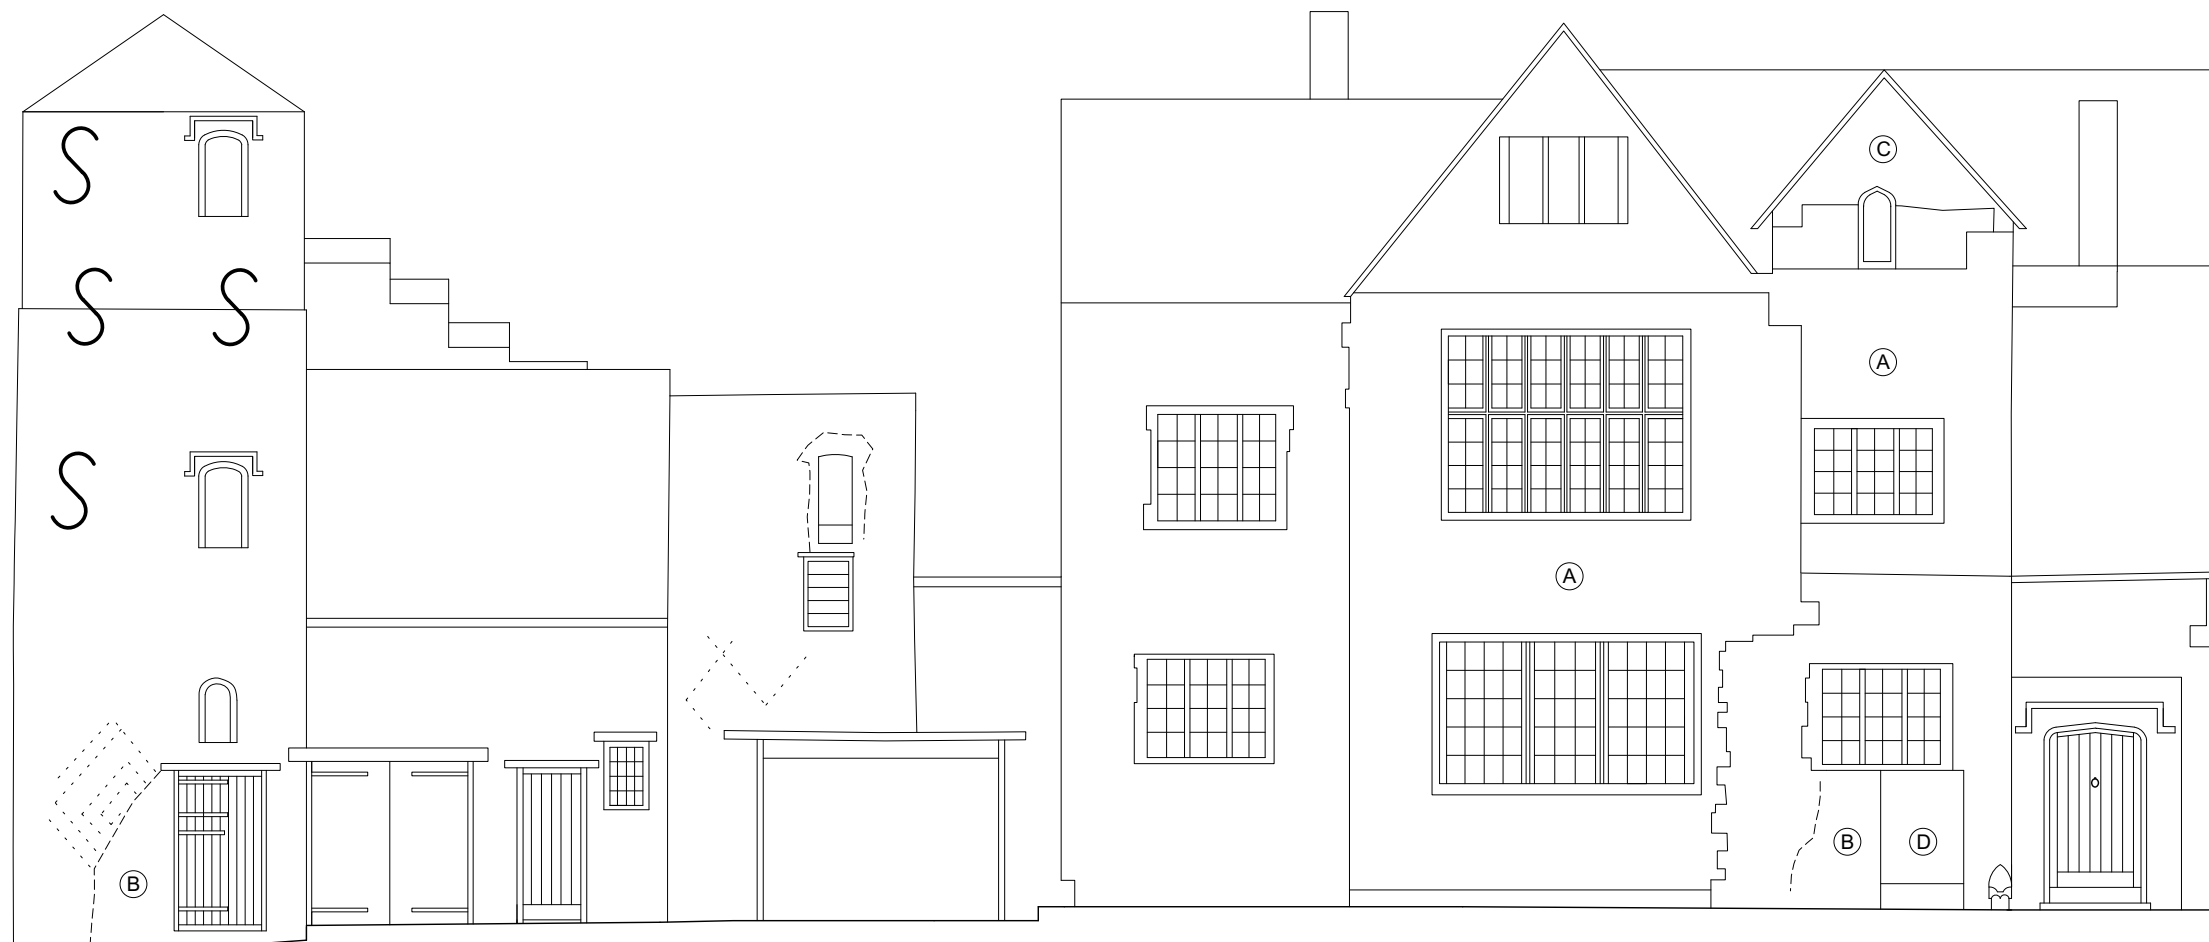
Walls are brick except for (A) sandstone  
 (B) rebuilt brickwork  
 (C) rendered  
 (D) blocked doorway  
 diaper work

Figure 1a. Groby Old Hall : frontage elevation (south-east facing). 1:100

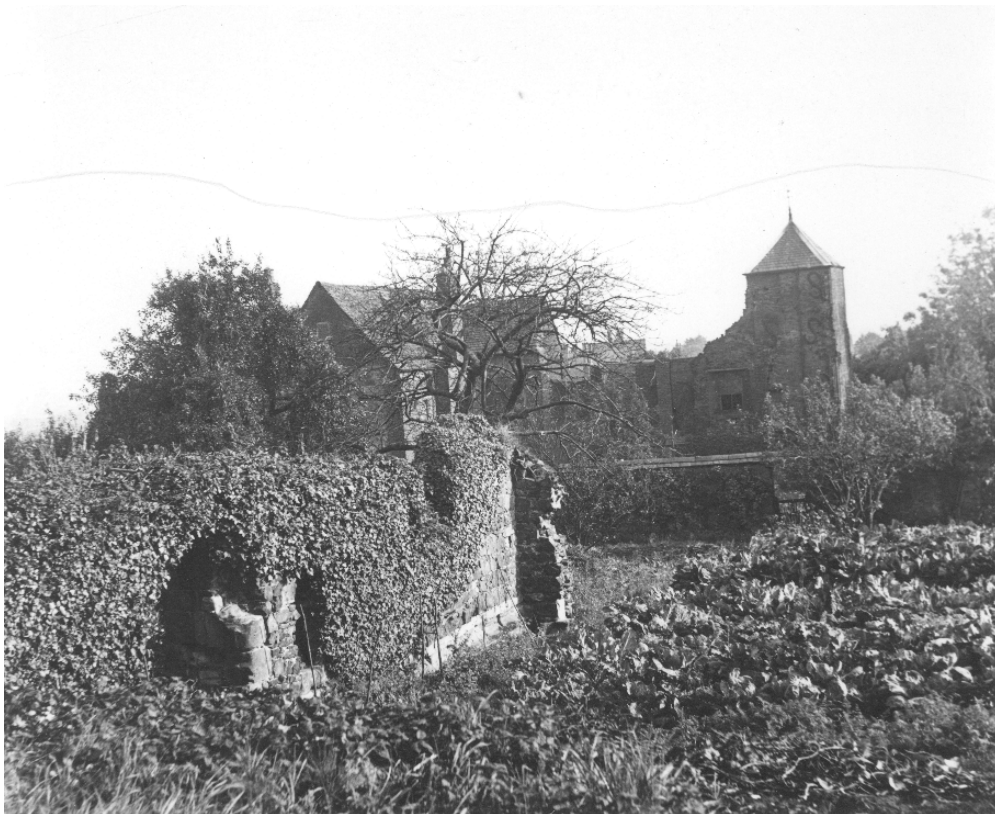
Figure 28. Groby Old Hall from the NW showing ruined wall with arched doorway October 1951.

In the south-west wall of the cross-wing, at first floor level, is an arch-headed stone door surround, visible from the rear garden (see Figure 28). There is evidence for a
