**Archaeological Walkover Survey and
LiDAR study, Hillsborough Promontory
Fort, Ilfracombe, Devon
NGR: SS 5323 4776**

ULAS Report No 2011-121.
©2011

For: North Devon AONB

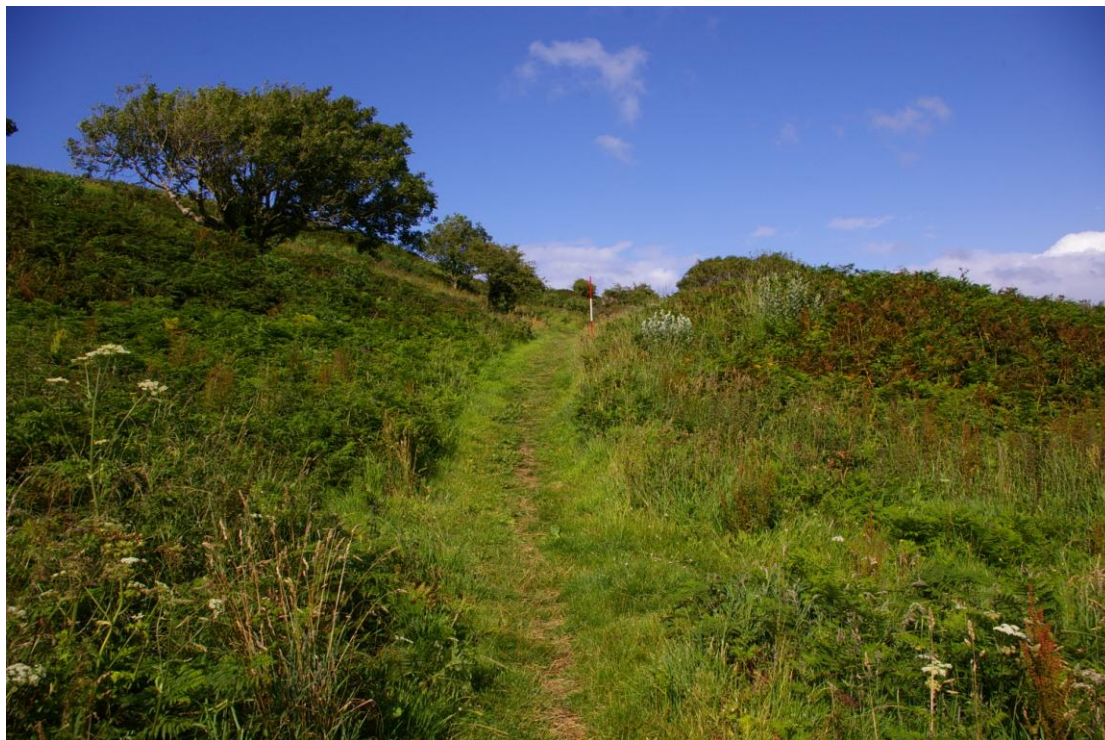
Figure 2: 2210, Path through lower ramparts, from south west.

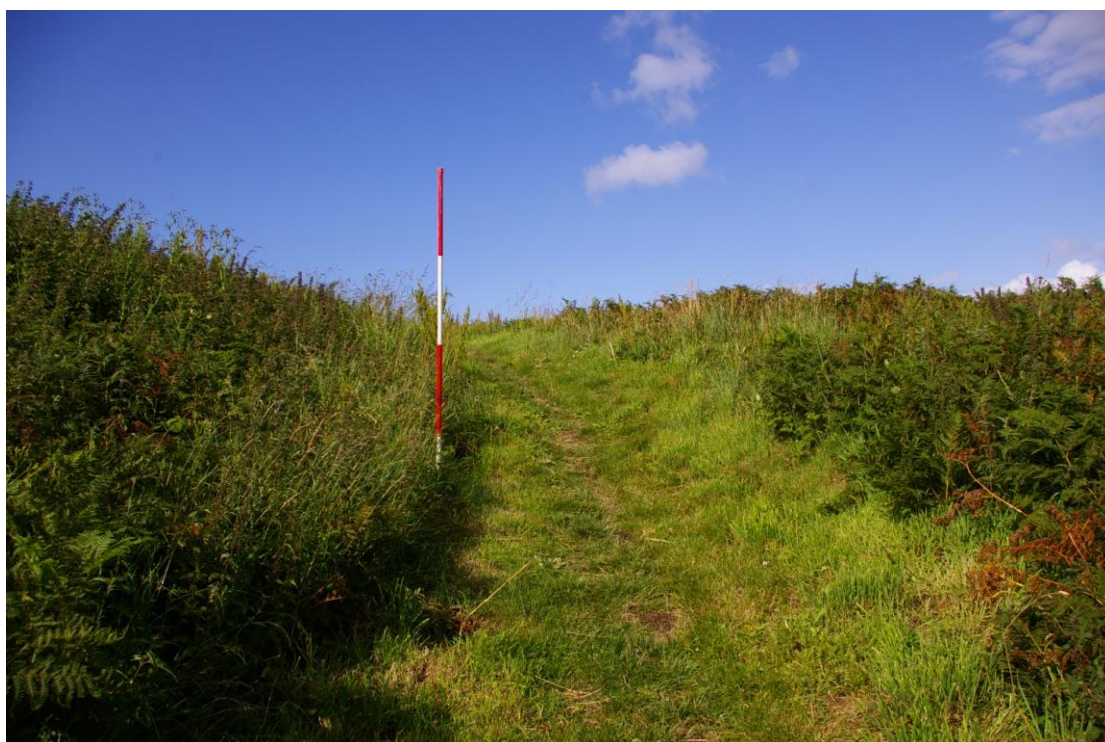
Figure 3: 2210: Path between upper ramparts from south west.

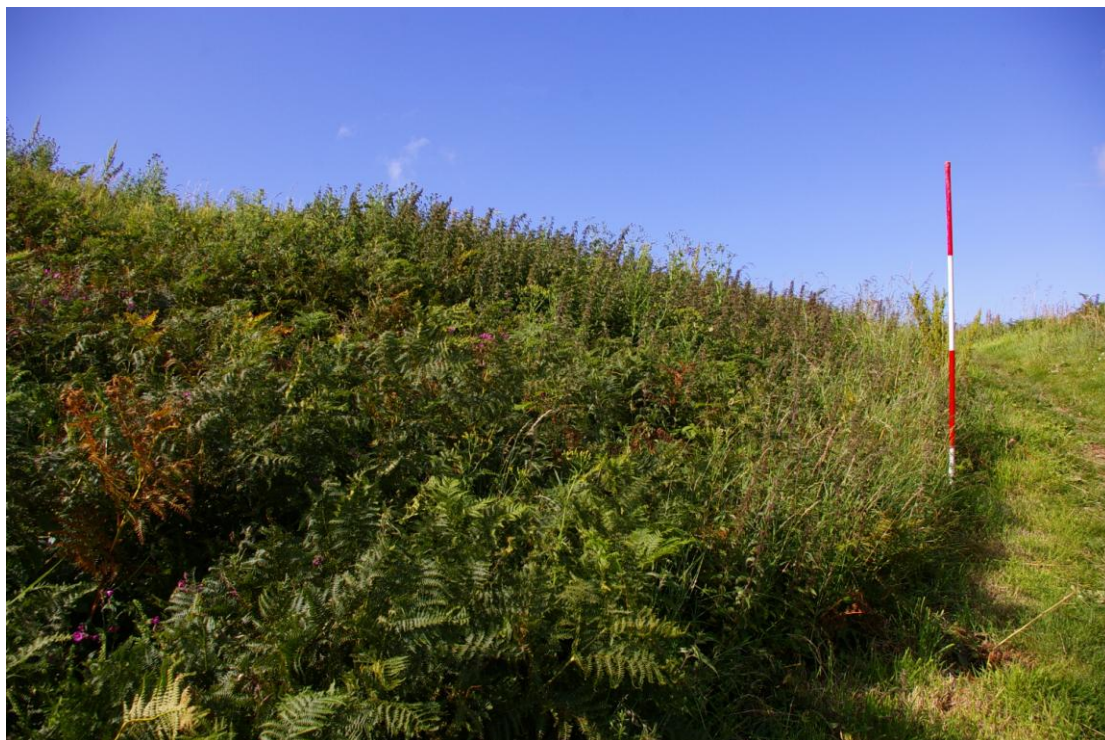
Figure 4: 2210. Eastern tail of upper western rampart

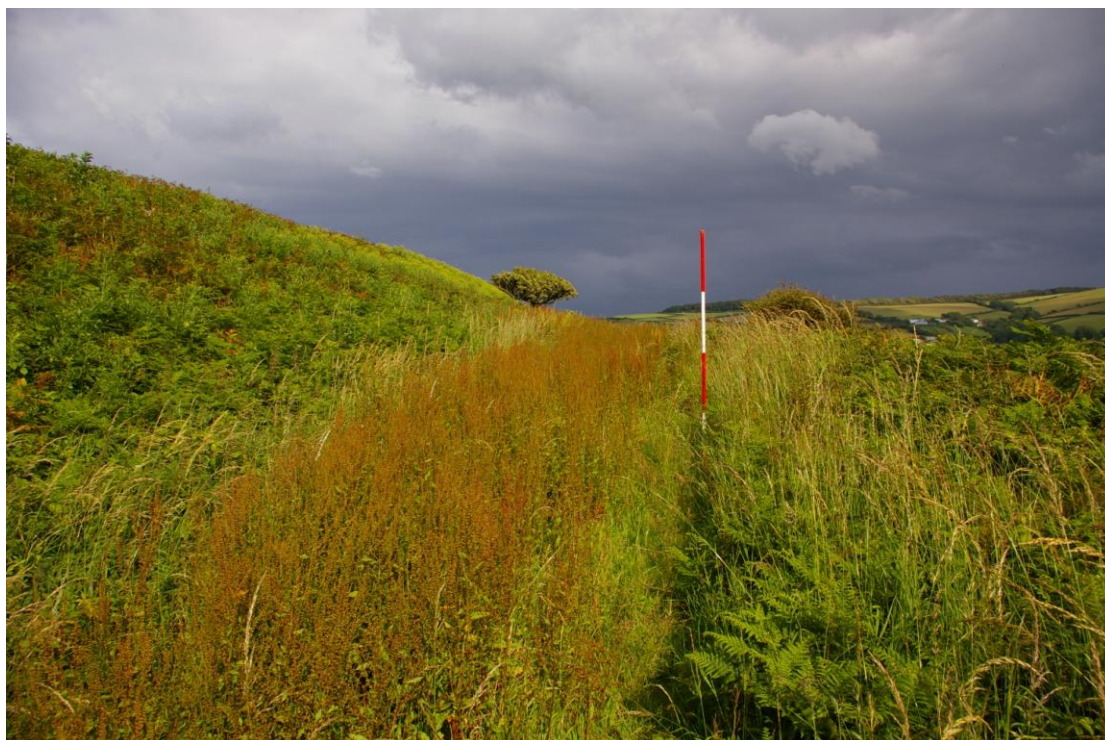
Figure 7: Berm between ramparts, facing east, from 253140/147670 (approx)

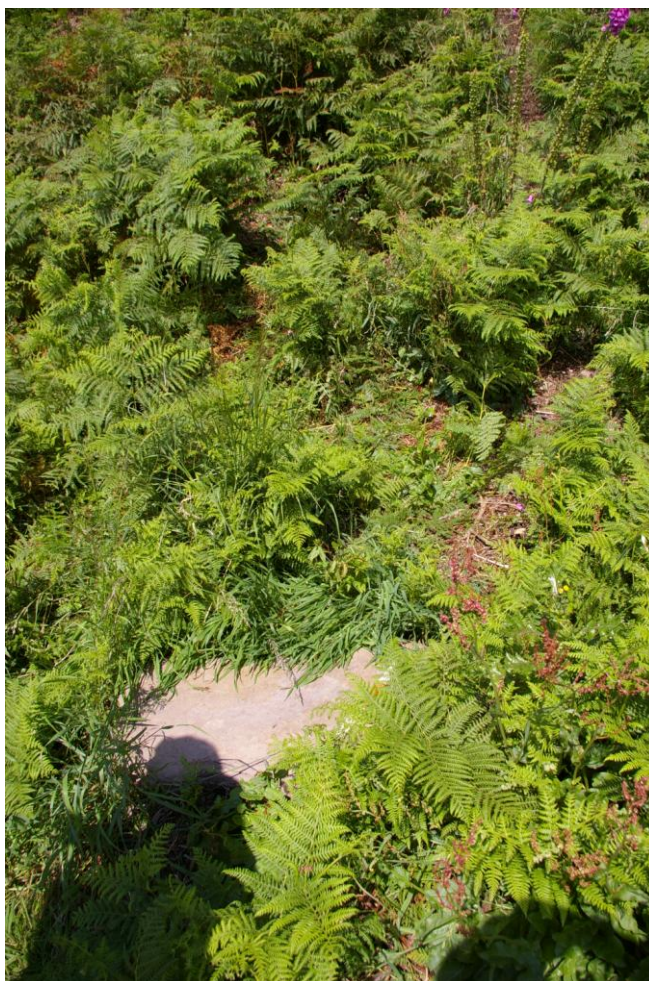
12535: Possible Cist at Hillsborough Promontory Fort

Figure 8: 12535. Between the ramparts and facing north broadly in the same location as the previously identified cist, a stone slab on the ground surface, and possible evidence of slumping in the upper rampart (obscured by bracken background central).

Surface remains of a stone slab and possible evidence of slumping in the southern edge of the upper rampart may indicate the presence of a construction within the upper rampart – feasibly the disturbed and infilled cist. Further more detailed survey within this location would be needed to permit the drawing of any firmer conclusions. These features were not located with any precision.

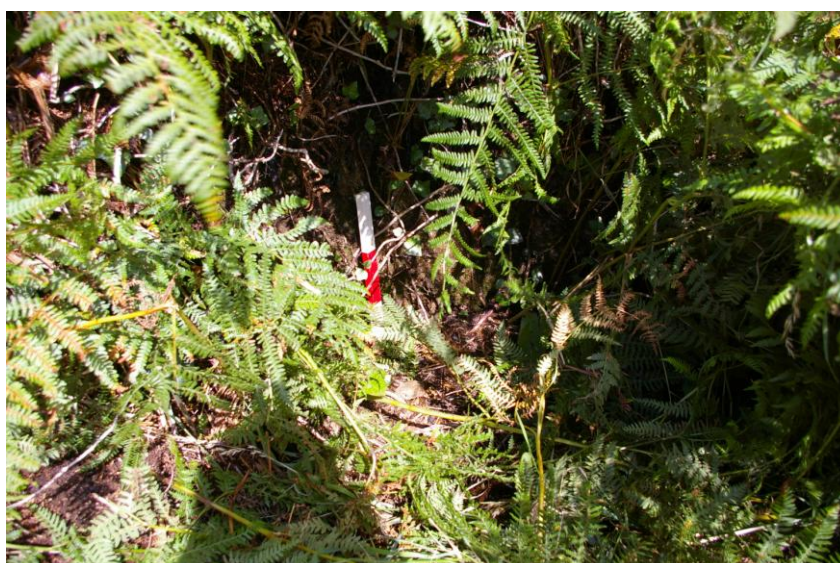
Figure 9: Disturbance, possibly evidence of slumping in the upper rampart

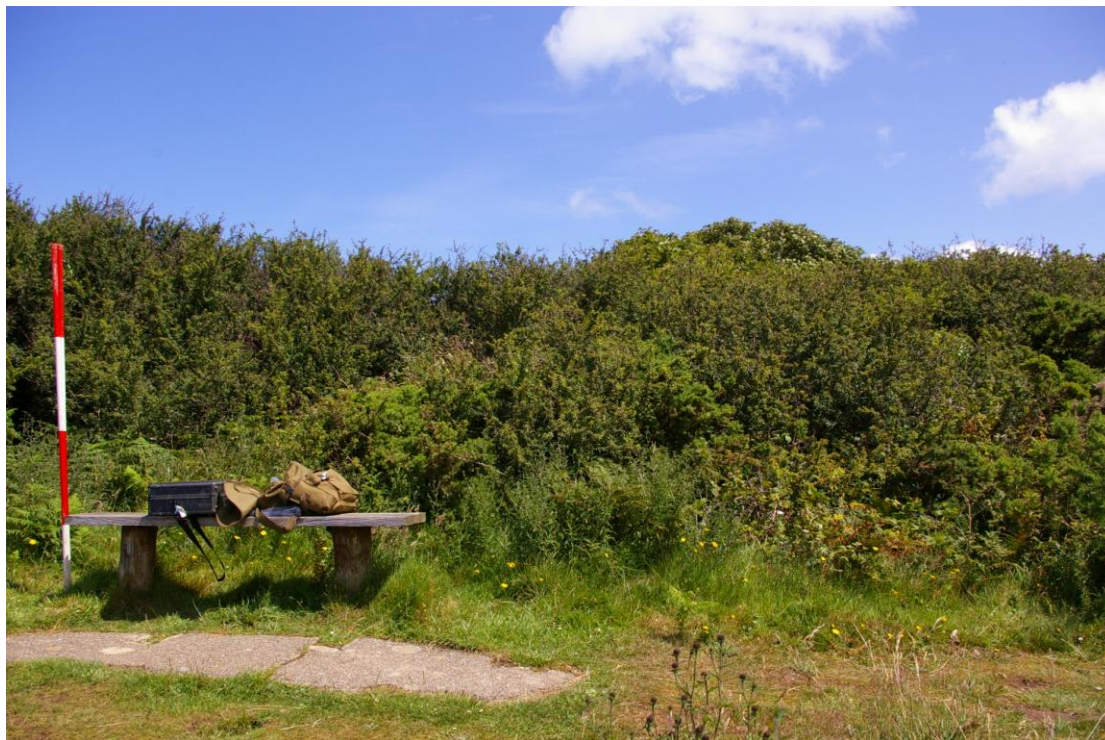
12538 *Possible Mound in Hillsborough Promontory Fort.*

Figure 10: 12538, Natural mound from south. *This is now discounted and attributed as a natural feature.*

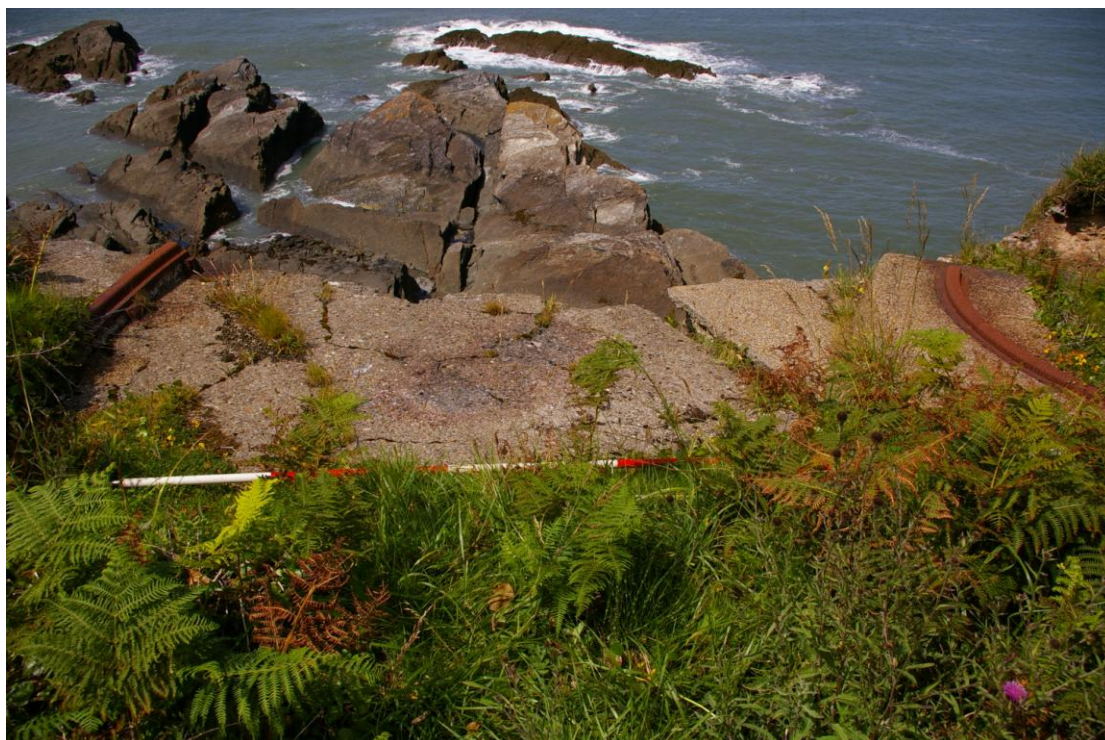
56279 *Gun Battery at Beacon Point, Hillsborough*

Figure 11: 56279; Gun Battery from south. The cast iron tracks are at 3.90m centres, although this has been widened by cracking in the concrete on which they are set. A low retaining wall lies on the right hand side. The structure is eroding over the cliff edge.

UID	Monument Name	Type	Significance	Form	Recommendations
63451	Linear Earthwork at Hillsborough Promontory Fort	LINEAR FEATURE		Earthwork	
56279	Gun Battery at Beacon Point, Hillsborough	BATTERY	Medium?	Documentary Evidence (Photographic)	This structure is at risk of being lost to erosion in its entirety. A recording programme should be established to record the remaining form in sufficient detail. Such a programme would require detailed Risk Assessment at an early stage.
12538	Possible Mound in Hillsborough Promontory Fort	MOUND		Documentary Evidence (Cartographic)	
Observation 1	Remains of Tea shop, with wooden benches		Low		The remains of this structure are being lost in scrub. If area of structure can be cleared and the view to Ilfracombe harbour re-established, the benches that have been installed might be used by visitors.
Observation 2			Low		The presence of the stone work needs to be noted so that it is respected when the recutting of paths occurs.

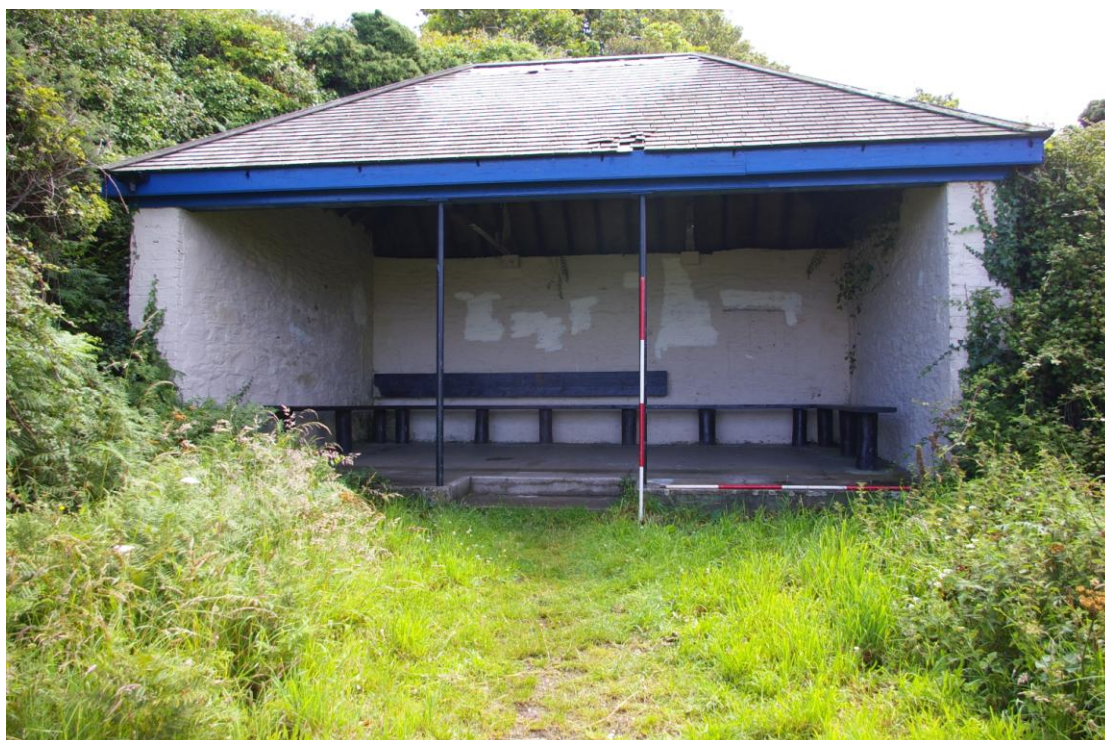
54970 *Shelter in Hillsborough Promontory Fort*

Figure 12 HER 54970: Shelter from west

UID	Monument Name	Type	Significance	Form	Recommendations
	Promontory Fort				
54970	Shelter in Hillsborough Promontory Fort	BUILDING	Low	Extant Building	This structure is of local interest and continuing use on the site. Clear vegetation to maintain view to Ilfracombe. Possibly include interpretation board (perhaps within shelter?) illustrating historic context of shelter and other shelters on the site, and explaining how Hillsborough became part of Ilfracombe's tourist itinerary in the Victorian/Edwardian periods. See 1 st edition Ordnance Survey of shelter.
75628	Shelter in Hillsborough Promontory Fort	BUILDING	Low	Extant Building	This rock cut structure is local interest and continuing use on the site. Research date of construction and identify any historic photographs showing the structure for possible inclusion on interpretation boards.
75630	Shelter in Hillsborough Promontory Fort	BUILDING	Low	Ruined Building	This ruined structure cut into the northern side of the hill is lost in overgrowth. If this structure remains unroofed, there will be inevitable long term damage to the remaining fabric, and ultimately collapse and loss. If the structure is allowed to collapse, any potential impact on the path which passes 2m to the south needs to be assessed as this may present a hazard.

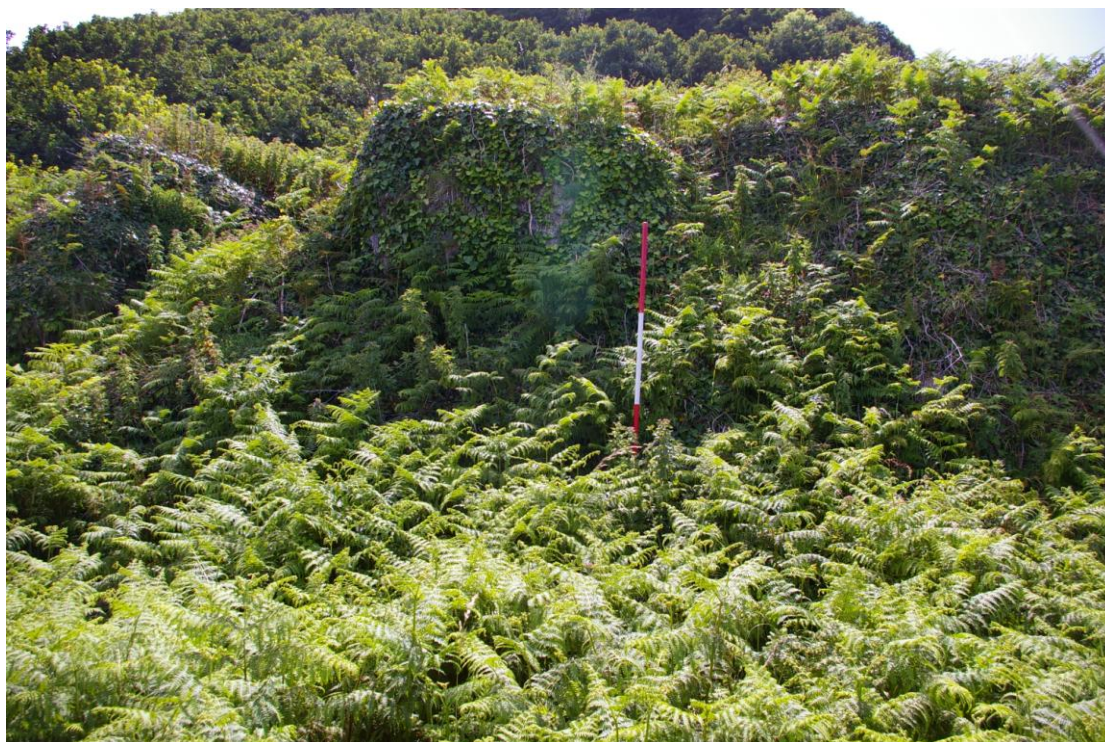
62893 *Limekiln at Hillsborough*

Figure 13: 62893; Limekiln from north.

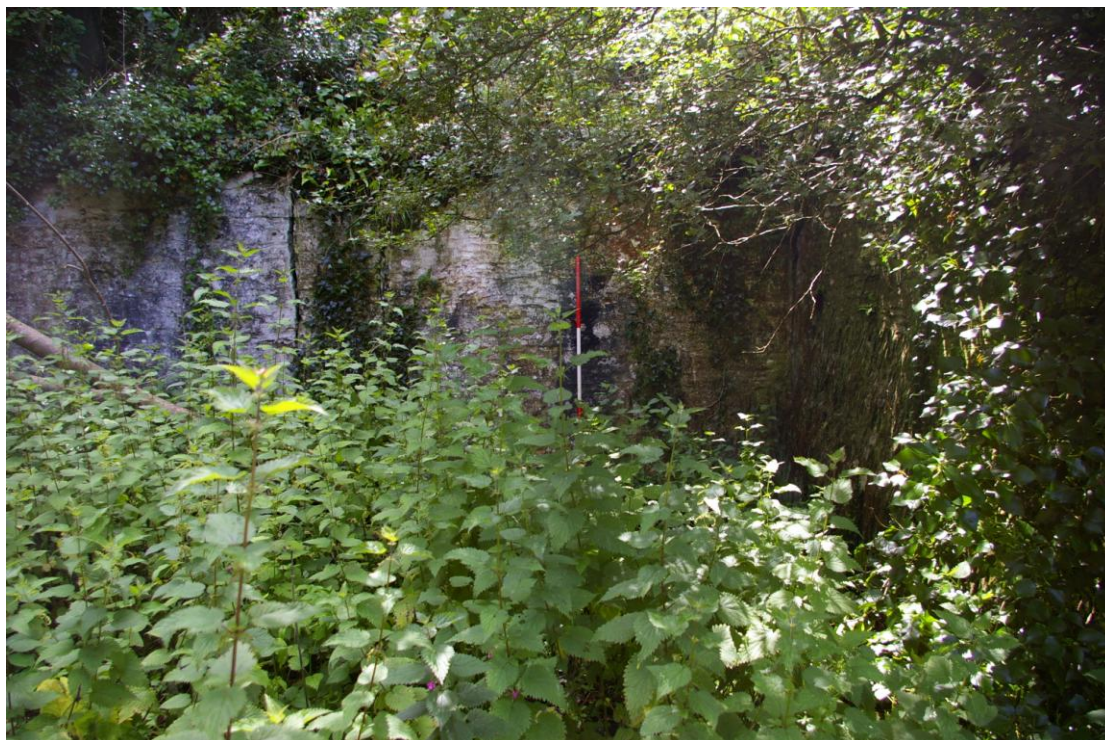
75630 *Shelter in Hillsborough Promontory Fort*

Figure 17: 75630: Interior of roofless shelter from north

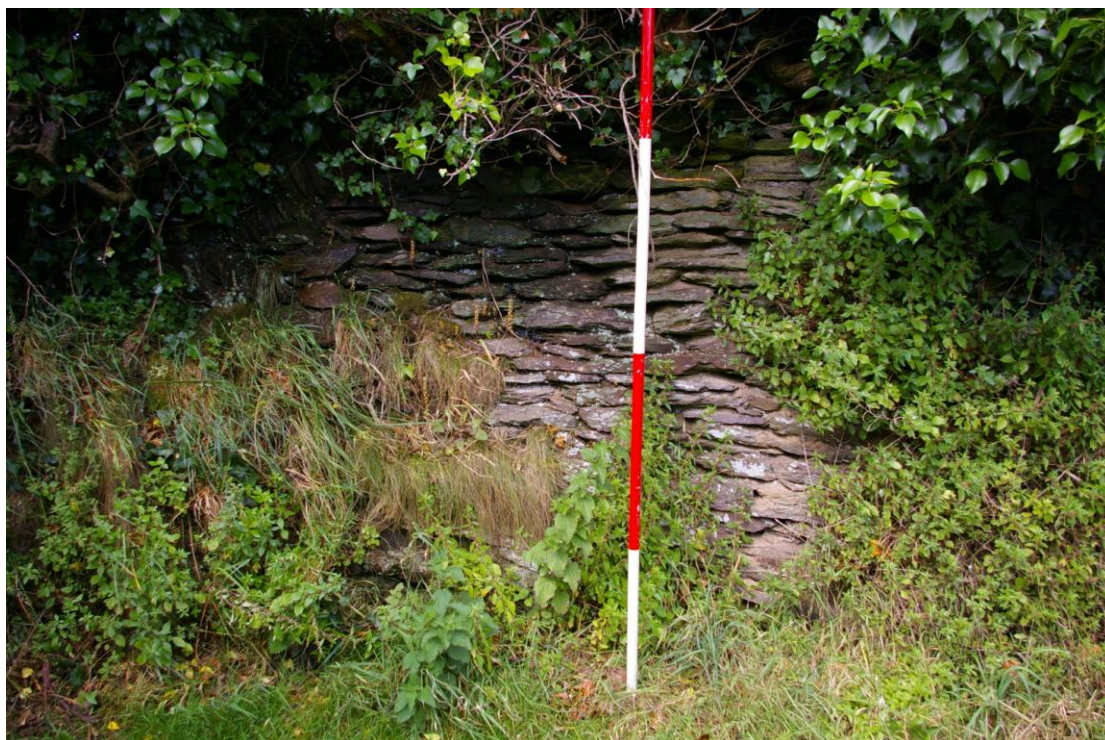
75634 *Small Building in Hillsborough Promontory Fort*

75634	Small Building in Hillsborough Promontory Fort	BUILDING	Modern	SS5303447738	Extant Building		Only rear of structure viewed, as too overgrown to enter
75637	Tree Clump near Hillsborough Promontory Fort	TREE CLUMP	Modern	SS5310947632	Documentary Evidence (Cartographic)		Not visited
75638	Guide Post in Hillsborough Promontory Fort	SIGNPOST	Modern	SS5337348038	Documentary Evidence (Cartographic)		Not visited
75639	Guide Post in Hillsborough Promontory Fort	SIGNPOST	Modern	SS5334248005	Documentary Evidence (Cartographic)		Not visited
75640	Guide Post in Hillsborough Promontory Fort	SIGNPOST	Modern	SS5338347971	Documentary Evidence (Cartographic)		Not visited
75641	Guide Post at Hillsborough Promontory Fort	SIGNPOST	Modern	SS5323247506	Documentary Evidence (Cartographic)		Not visited
75642	Guide Post at Hillsborough Promontory Fort	SIGNPOST	Modern	SS5299847636	Documentary Evidence (Cartographic)		Not visited

Figure 19: 75634, External wall of small building from east.

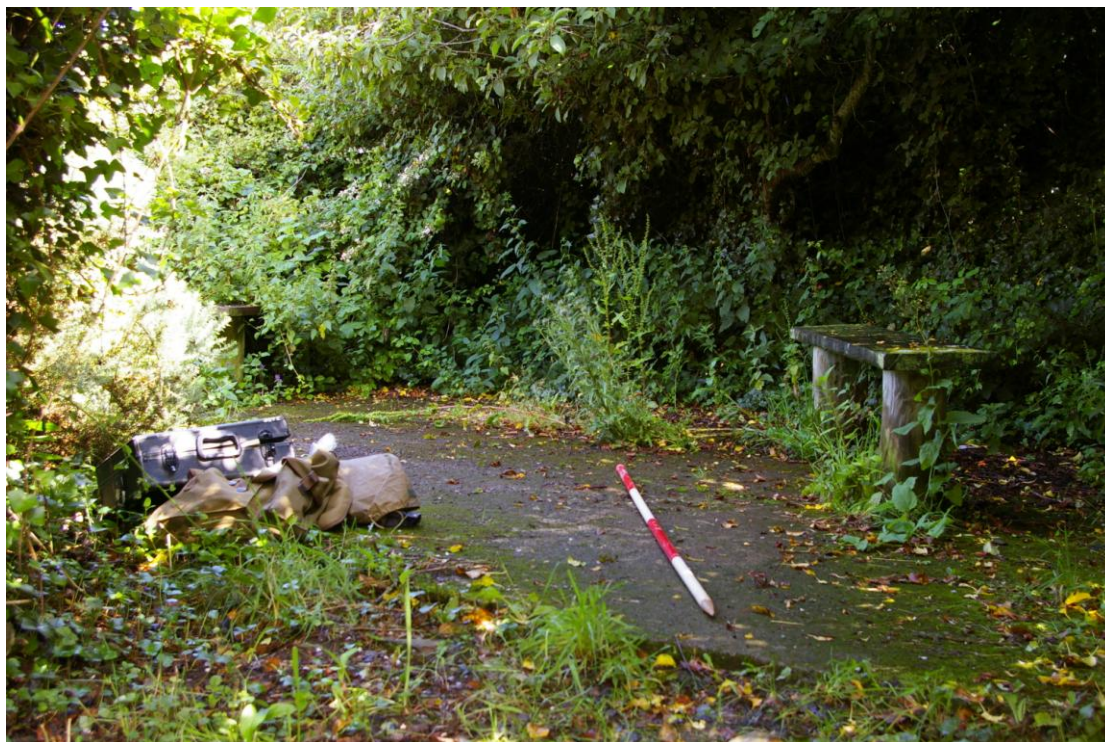
Observation 1: 252969/147654: Structure

Observation 1. 252969/147654: Immediately adjacent to the path descending toward Raparee Cove, some 37m west of the intersection of this path with the coastal path, the floor of a rectangular building survives. A structure is represented here on the 1932 1:2500 3rd Revision but is not present on the 1:2500 1st edition of 1904. This is interpreted as the remains of a tea shop which features in some of the historic photographs from the site. Wooden benches facing the view toward Ilfracombe harbour have been added. The area is now much overgrown.

Figure 23: Observation 1: Base of structure from south. Probable site of tea shop.

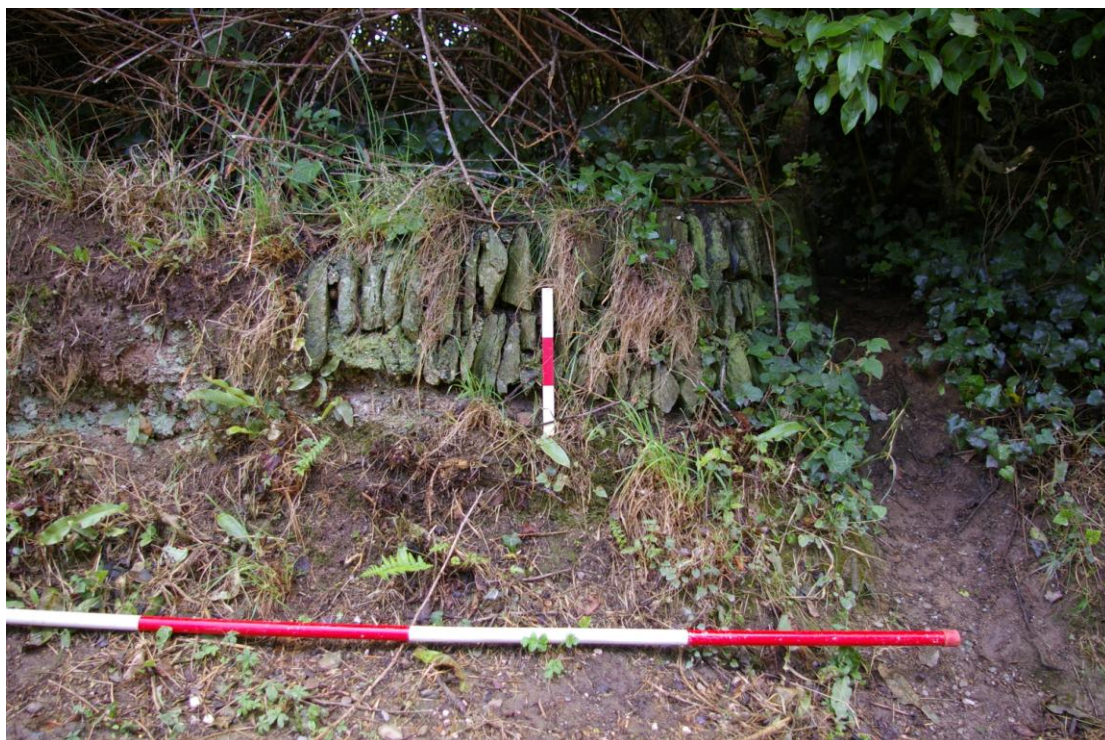
Observation 2: 53006/147640: low stone wall

Observation 2. 253006/147640: A low stone wall consisting of two courses of vertically pitched stones capped with a thin layer of concrete was exposed on the eastern side of the coastal path 11m north of its intersection with the path to Rapparee Cove. The wall was 'L' shaped, 1.2m long, 1.2m deep and 0.30m high. The face of the wall was curved as if on the northern side of an entrance to a building or an enclosed area.

Figure 24: Observation 2, retaining wall from west on eastern edge of coastal path. The wall is L shaped in plan with a return on the southern side.

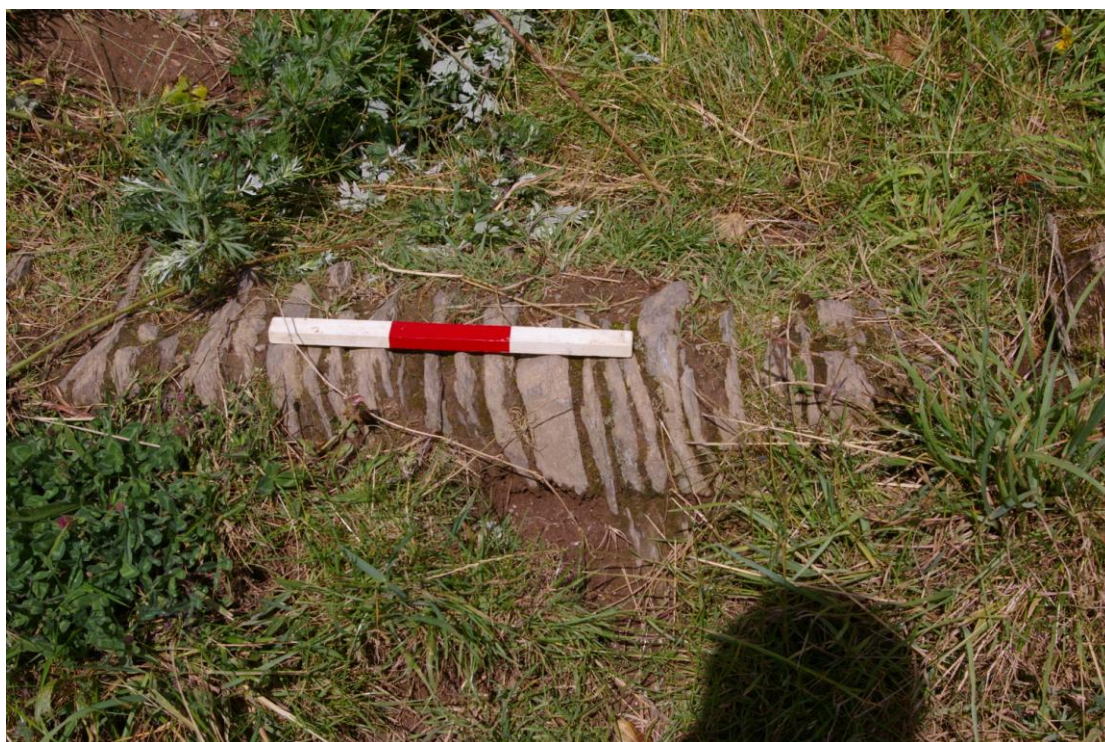
Observation 3: 253038/147741: Path edging

Observation 3. 253038/147741: Path edging to 4m north of 75634. Vertically pitched stones similar in style to those noted at 1 (above). The 3rd revision 1932 map shows a small rectangular building (?) on the western edge of the coast path in this area.

Figure 25: Observation 3, path edging from east, to north of structure built at western end of upper rampart.

Observation 3			Low		The presence of the stone work needs to be noted so that it is respected when the recutting of paths occurs.
Observation 4					
Observation 5			Low		The railings are aesthetically finer than the concrete posts and tubular rail that succeeded them but of low value.
LiDAR interpretation A	possible bank slippage is visible on both ramparts broadly centrally		Unknown		Confirm through ground survey
LiDAR interpretation B	The entrance through the upper rampart is not consistent with the Ordnance Survey plan as recorded. The in-		High		Confirm through ground survey

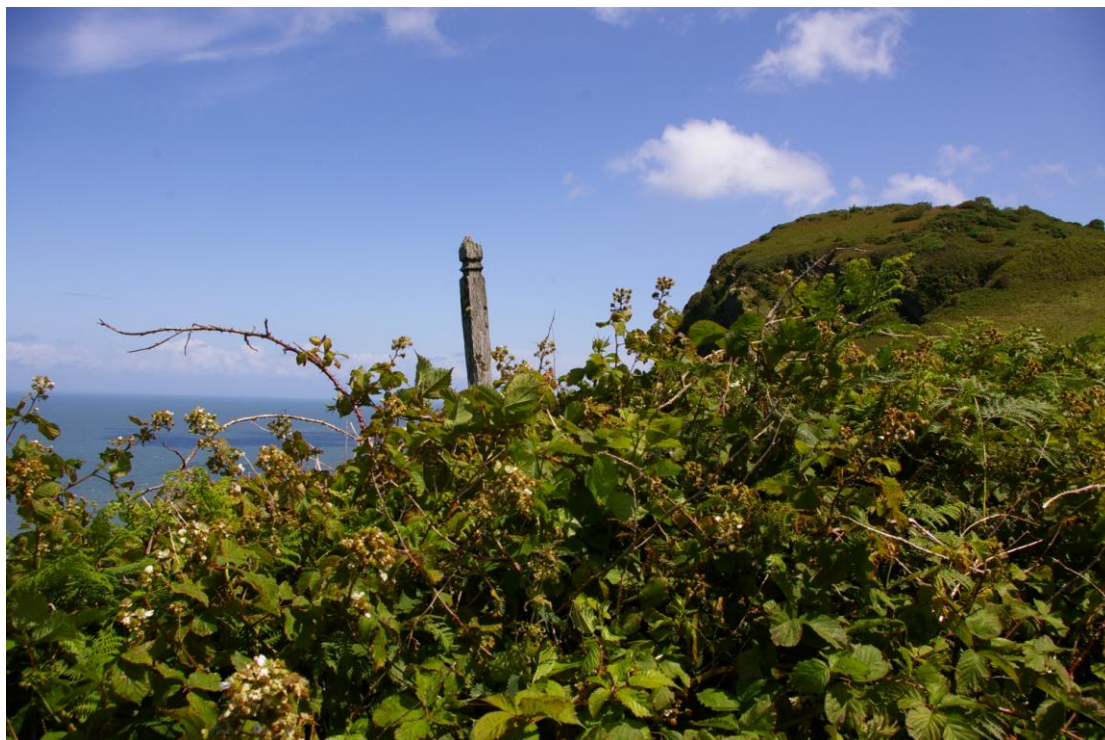
Observation 4: 253100/147775 Wooden sign post

Observation 4. 253100/147775 Wooden sign post 3.5m west of coastal path. Remains of sign indicator visible on northeast face only. "To the top"?? Moulding visible around post near top.

Figure 26: Observation 4: Sign Post from south. Peak of Hillsborough in background.

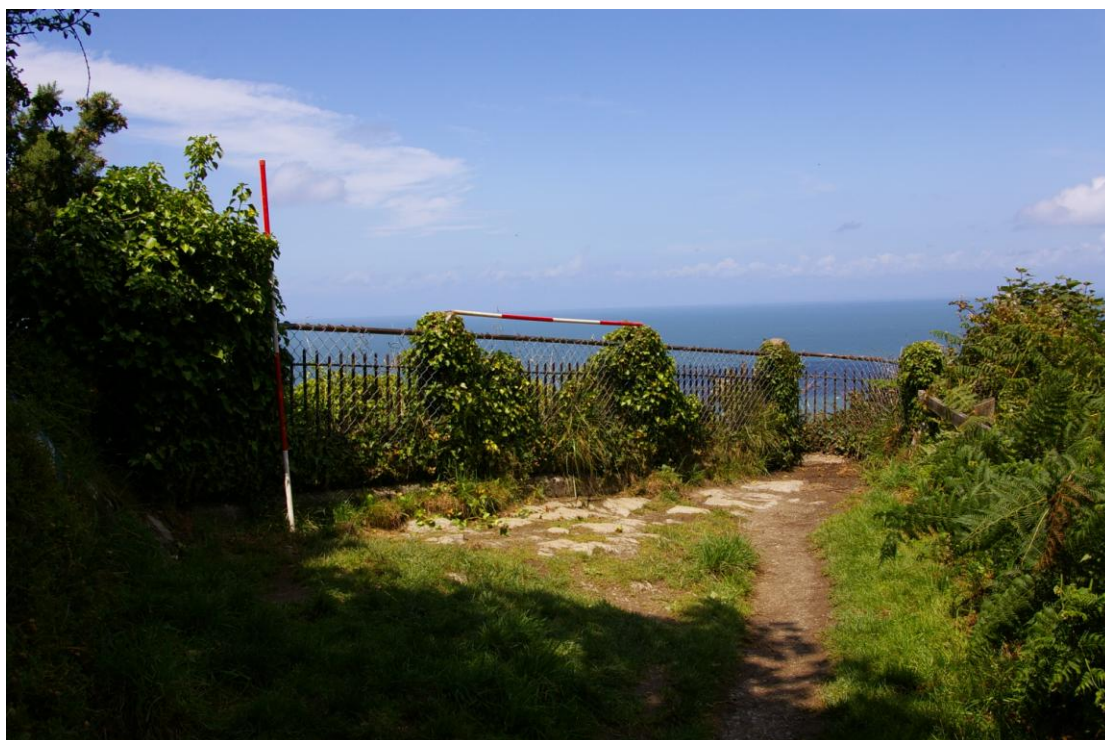
Observation 5: 253274/147974 wrought iron railings

Observation 5. 253274/147974 A 6m length of wrought iron railings at 82mm centres skirts around a viewing point area on the north-west side of the promontory. Concrete posts at 1.9m centres, a safety rail of steel tubing and chicken wire infill have been later added.

Figure 27: Observation 5; wrought iron railings guarding vantage point from south
