**An Archaeological Evaluation at  
White Barn, 45 Cressingham Road,  
Reading, Berkshire.  
NGR: SU 7275 7089 centre**

ULAS Report No. 2011-129  
©2011

**An Archaeological Evaluation at  
White Barn, 45 Cressingham Road,  
Reading, Berkshire.**

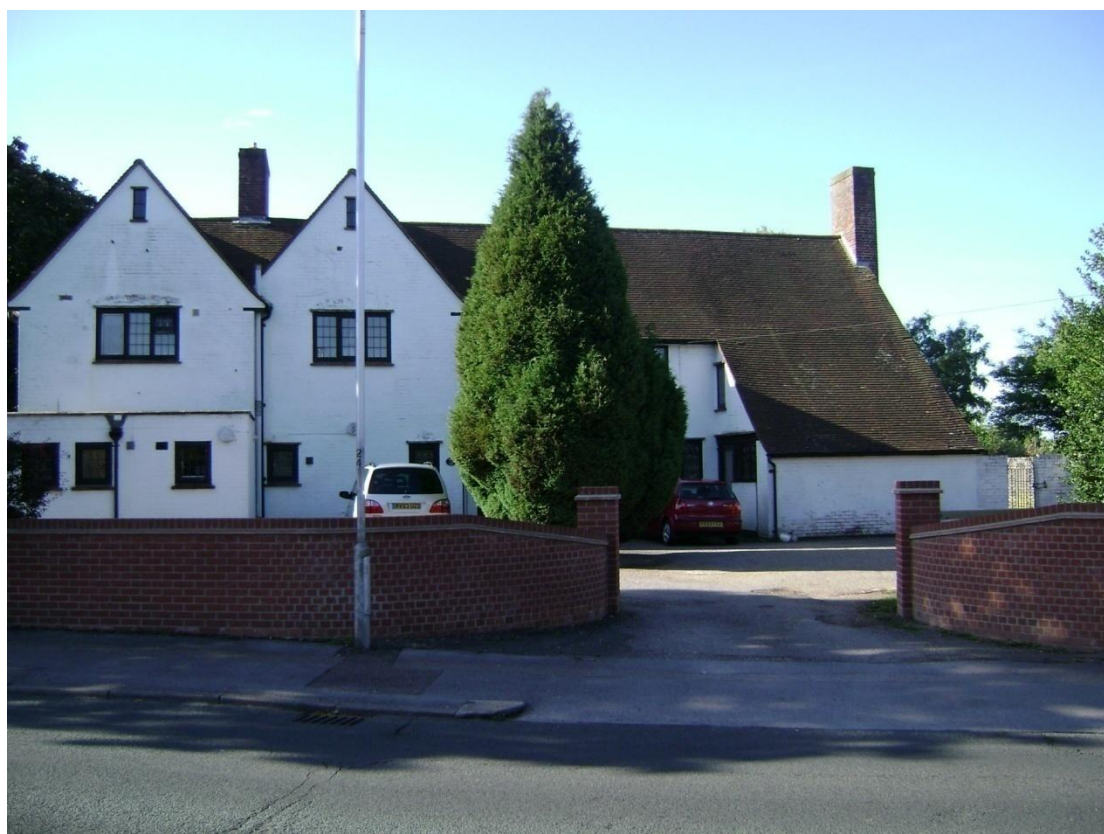
Figure 3. White Barn, 45 Cressingham Road

Looking south. Trench location is to the right of the picture behind the iron gate

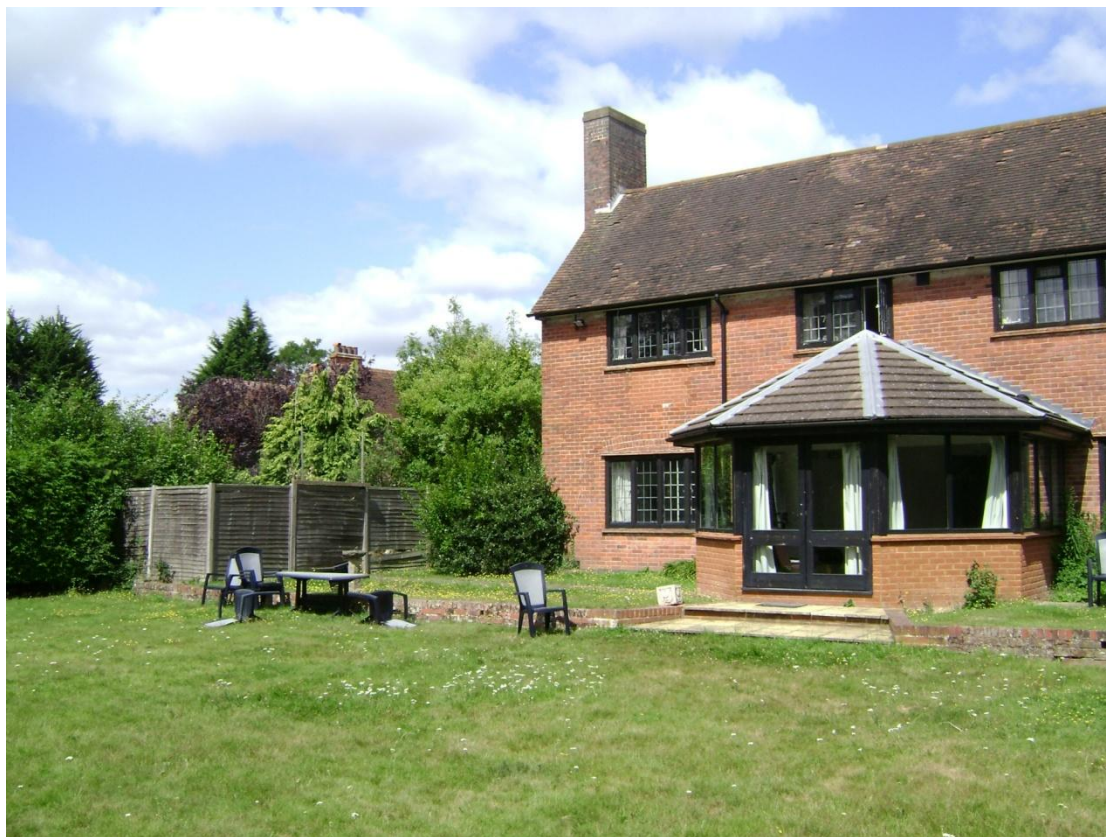
Figure 4. Rear garden of White Barn

Looking north-west. Trench is behind the wooden fence on the left. Note the small terraces in the lawn

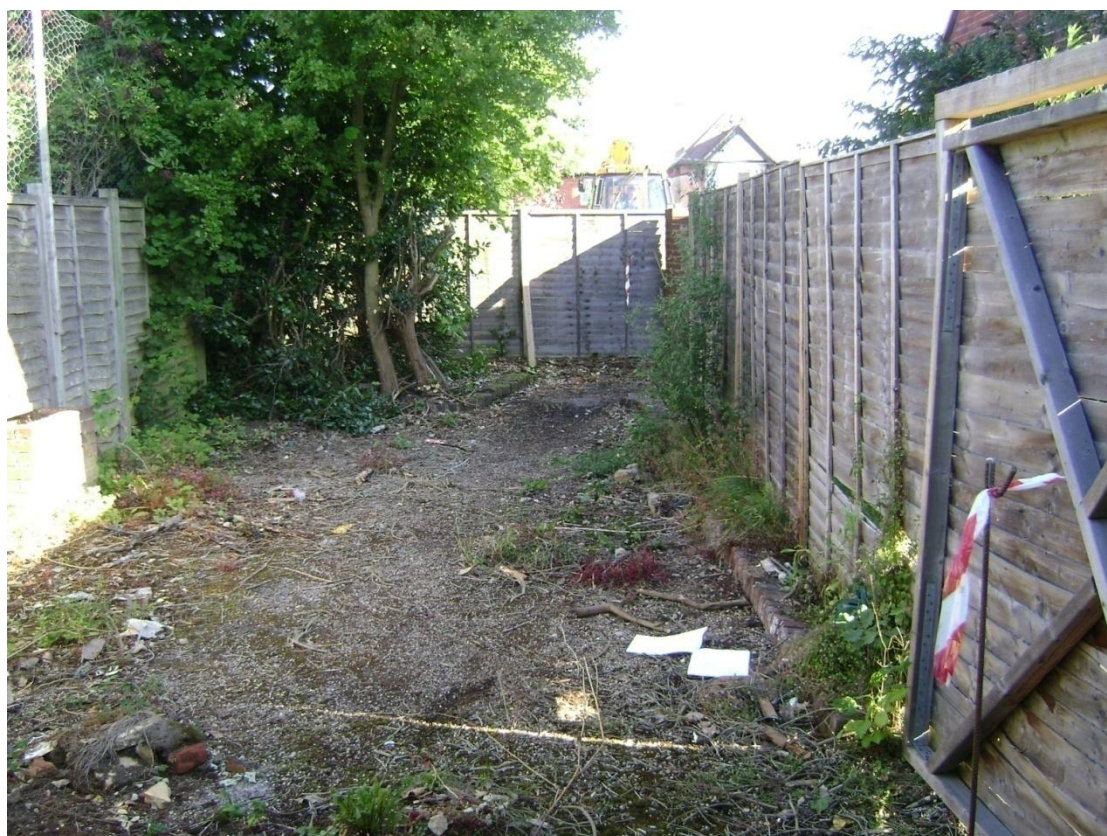
Figure 6. Trench prior to excavation  
Looking north.

The area enclosed by the fencing was covered by a thin layer of tarmac with a raised line of bricks along the eastern side. Another wooden fence ran along the western side of the area (Fig. 6). Removal of the tarmac at the south end of the trench revealed a thick layer of concrete laid on a course of unbonded bricks. The concrete surrounded a large rectangular concrete pond full of rubble backfill and appeared to be acting as a large patio around the pond. The bricks beneath the concrete patio were sat on a thin layer of mixed bedding material on top of a mid orange brown clay natural with occasional sandy patches and some small sub-rounded pebbles. The pond still had a large quantity of stagnant water along with the rubble and it was decided to leave this in-situ (Fig. 7). The location of the pond indicates that it runs beyond the eastern edge of the trench towards the house as indicated by the staff member.

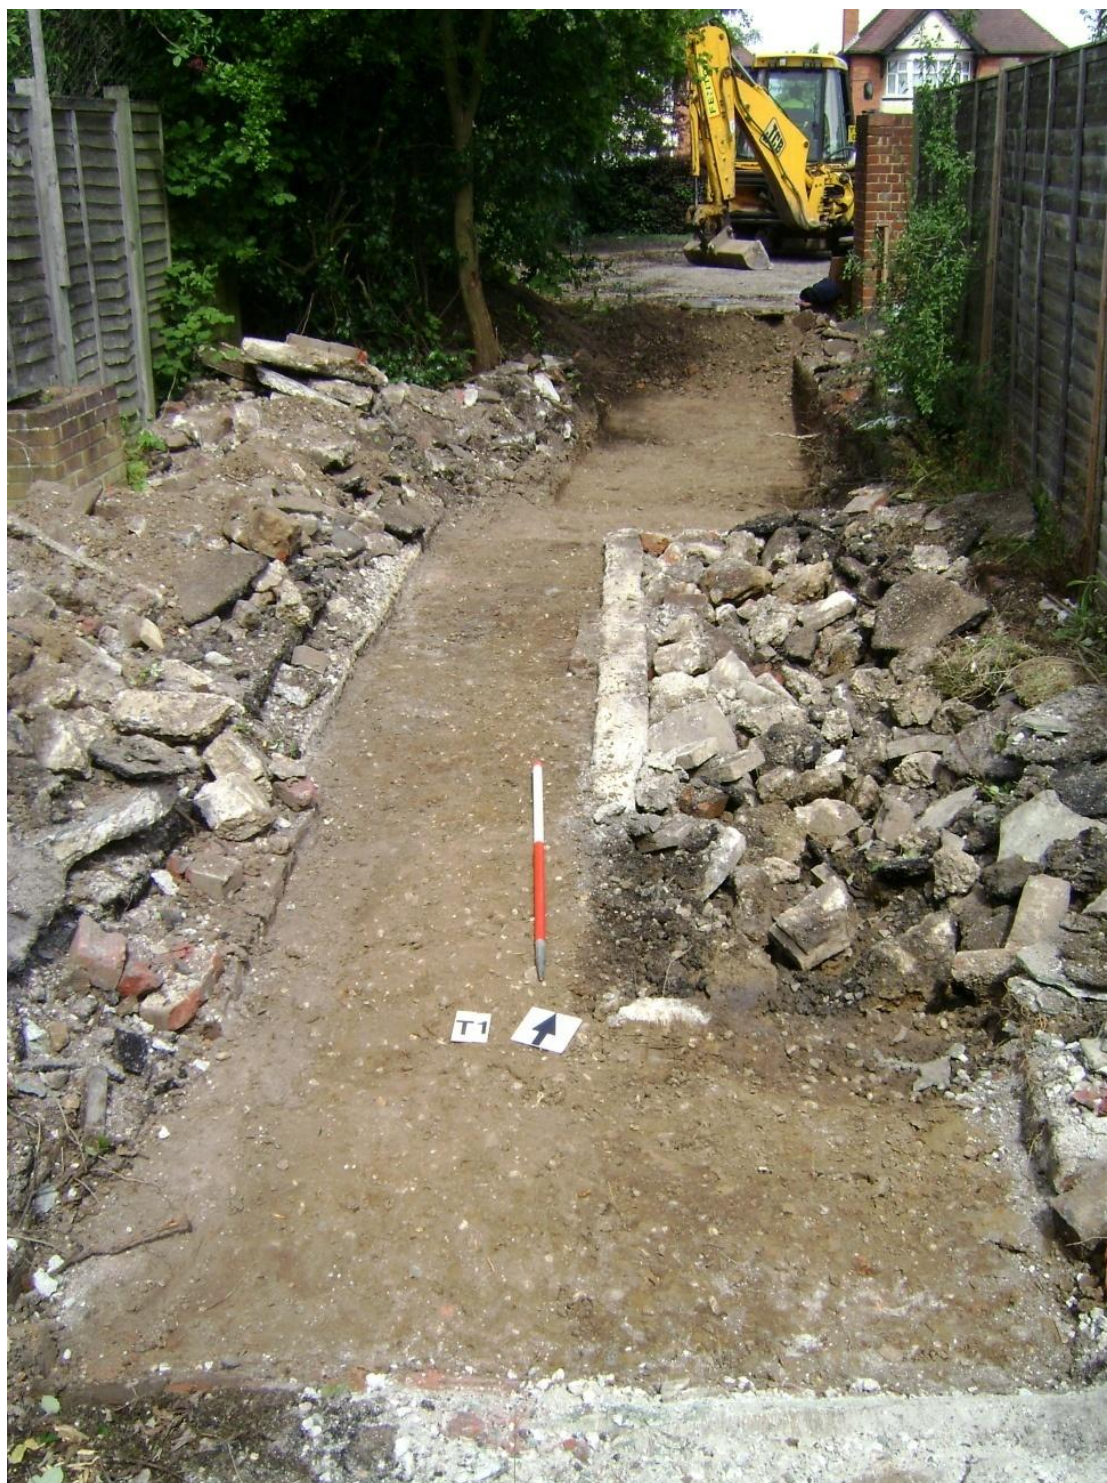
To the east of the pond was large semi-circular area of disturbance which contained modern brick fragments, slate and coal in a mid brown clay matrix. Beyond the pond, to the north, the concrete patio extended towards the fence and wall line level with the front of the house. There was some dark grey-brown sandy-silt subsoil here but it was quite disturbed by root action (as was the underlying natural clay). The subsoil also appeared to be quite badly mixed due to the laying of the concrete (Fig. 8). No archaeological features were seen in the natural.

Figure 7. Trench after initial 10 metre excavation  
Looking north-west, 1m scale. Backfilled pond on right of picture

Much of the area around the trench had been disturbed and most, if not all, of the subsoil had been removed probably when installing the pond and the patio. The rectangular design of the concrete pond was reminiscent of the 1930s and was probably built at the same time as the house. The thick concrete patio may be contemporary with the pond or could be a later addition. Either way the thickness of the concrete and bedding layer of bricks appears to have removed any chance of survival for any archaeological deposits.

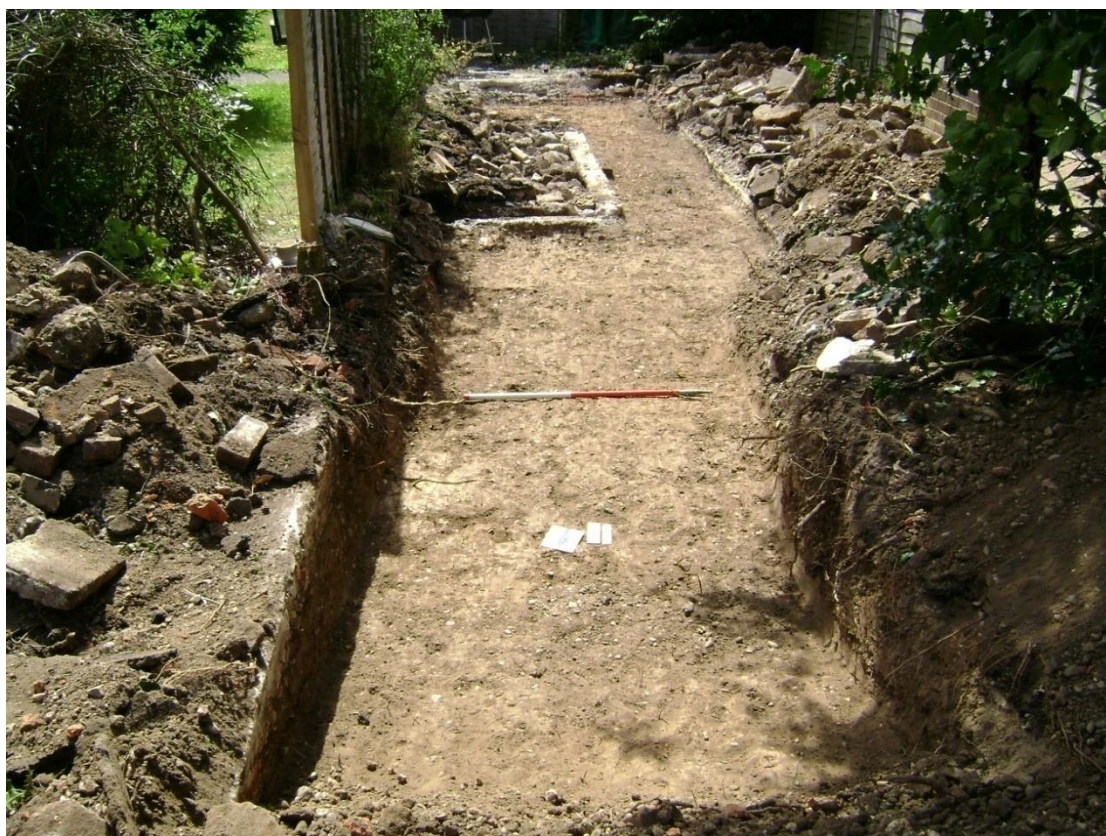
Figure 8. Trench after initial 10 metre excavation  
Looking south-east, 1m scale.

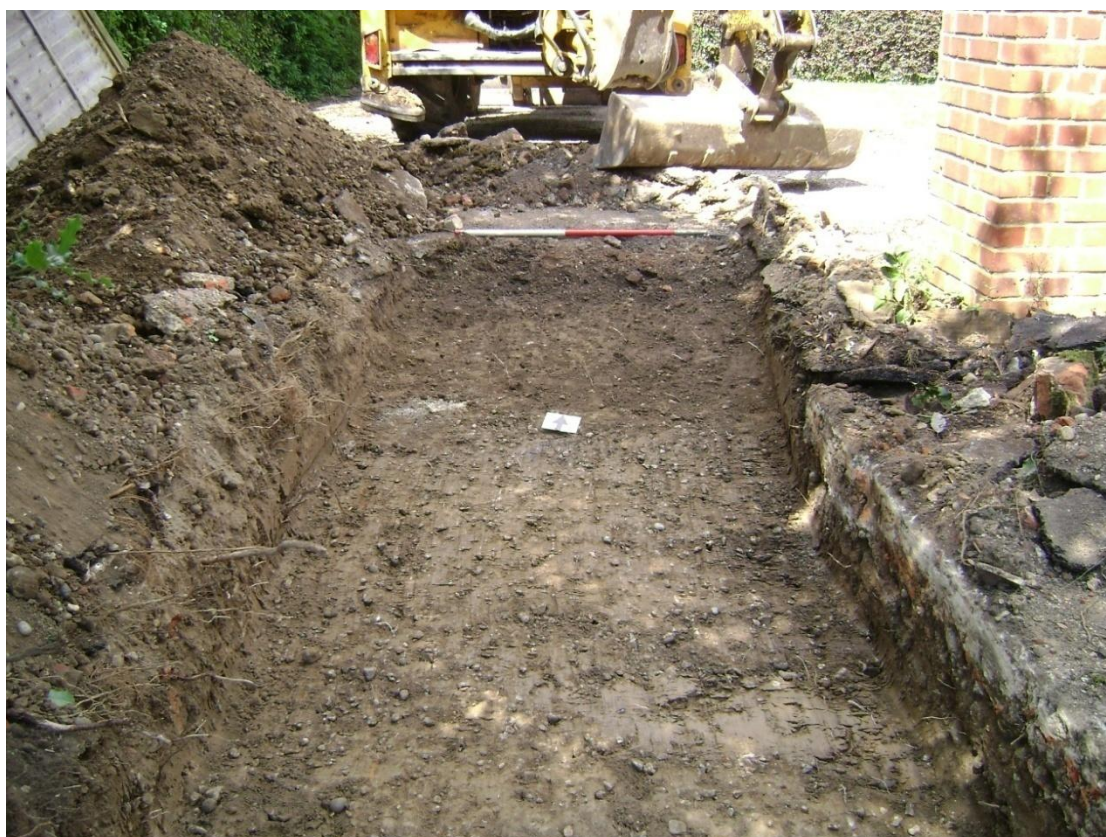
After discussions with the Planning Archaeologist it was decided to extend the trench northwards by 4 metres in order to assess the potential for archaeological survival beneath the tarmac driveway to the front of the house (Fig. 9).

The concrete patio, as noted in the original 10m trench, was seen extending up to the fence dividing the front garden from the side of the house. Beyond the fenceline, to the north, the tarmac drive was seen to be laid on a bedding layer of sand and ash with an average depth of around 0.18m. A thin layer of mixed subsoil and building debris was below this leaving a thin layer of sandy silt subsoil approximately 0.1m in depth. The same mid orange brown clay natural as noted elsewhere was observed beneath the subsoil. No archaeological features were noted in the natural (Figs. 10 and 11).

Figure 9. Additional 4 metre extension to north end of trench  
Looking north-west, 1m scale

In the extended portion of the trench there seems a little less disturbance with the tarmac surface being relatively thin. Beneath this the sand and ash bedding layer has only partially disturbed the subsoil leaving a thin 0.1m layer of potentially undisturbed subsoil. The extent of the proposed landscaping in this area is not clear but it would appear that unless it extends approximately 0.3m below current ground level it would not impinge on any archaeological deposits that may or may not be present. Overall, no archaeological features or deposits were observed during the evaluation. It seems likely that much of the area around the trench will have been similarly disturbed.
