**An Archaeological Watching Brief at  
Willow Barn, Hillcrest Lane,  
Husbands Bosworth,  
Leicestershire.  
NGR: SP 641 844**

ULAS Report No. 2011-090  
©2011

**For: Axon Beckett**

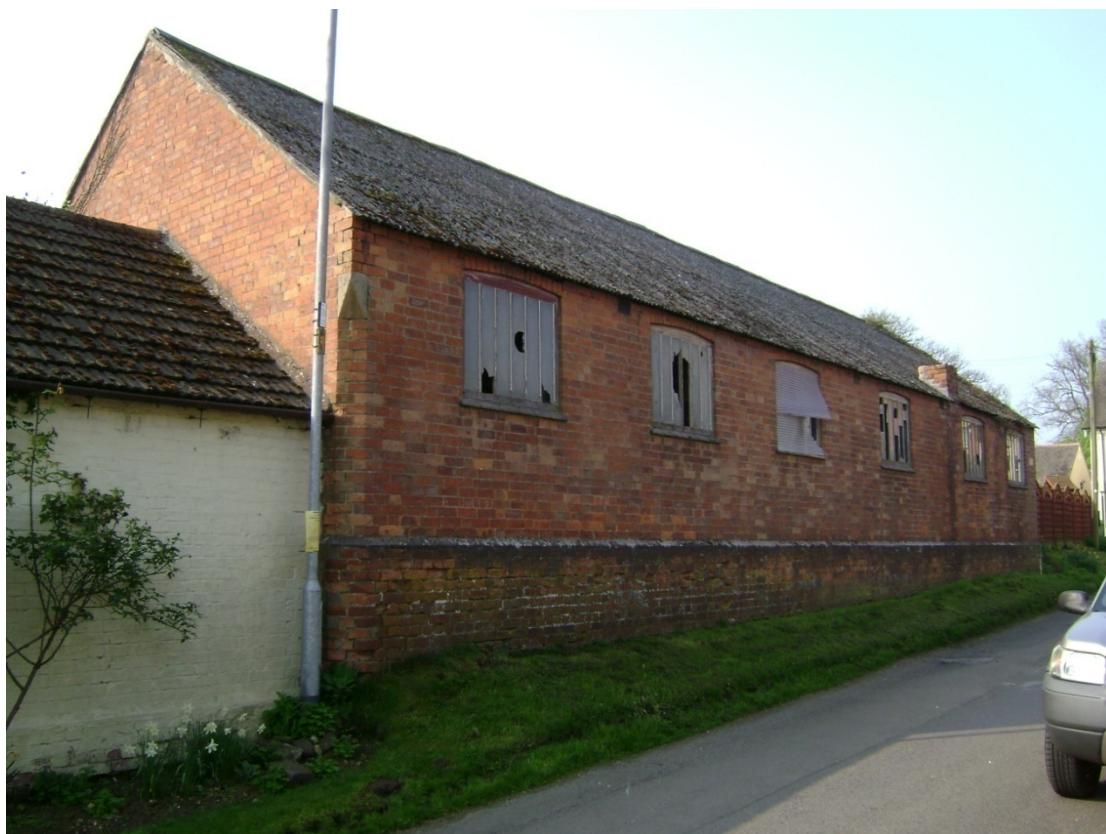
Figure 3 Willow Barn seen from Hillcrest Lane.  
Looking south-west

The site is located on the southern side of Hillcrest Lane and to the east of 42 Bell Lane, Husbands Bosworth (Fig. 2). It consists of a long single storey brick-built barn which has its longest elevation running parallel to Hillcrest Lane which forms a very shallow hollow way running east to west (Fig. 3). The roof is currently made from corrugated sheeting but was presumably slate when originally built at some point in the mid to late 19th century. The rear of the property slopes down from south to north by approximately 0.5m and was a covered in a mix of grass and unpaved yard prior to the start of development work (Fig. 4). Vehicular entry to the site is from Bell Lane which runs to the west of the property. A small pedestrian alleyway runs along the western side of the barn from Hillcrest Lane to the rear of the property.

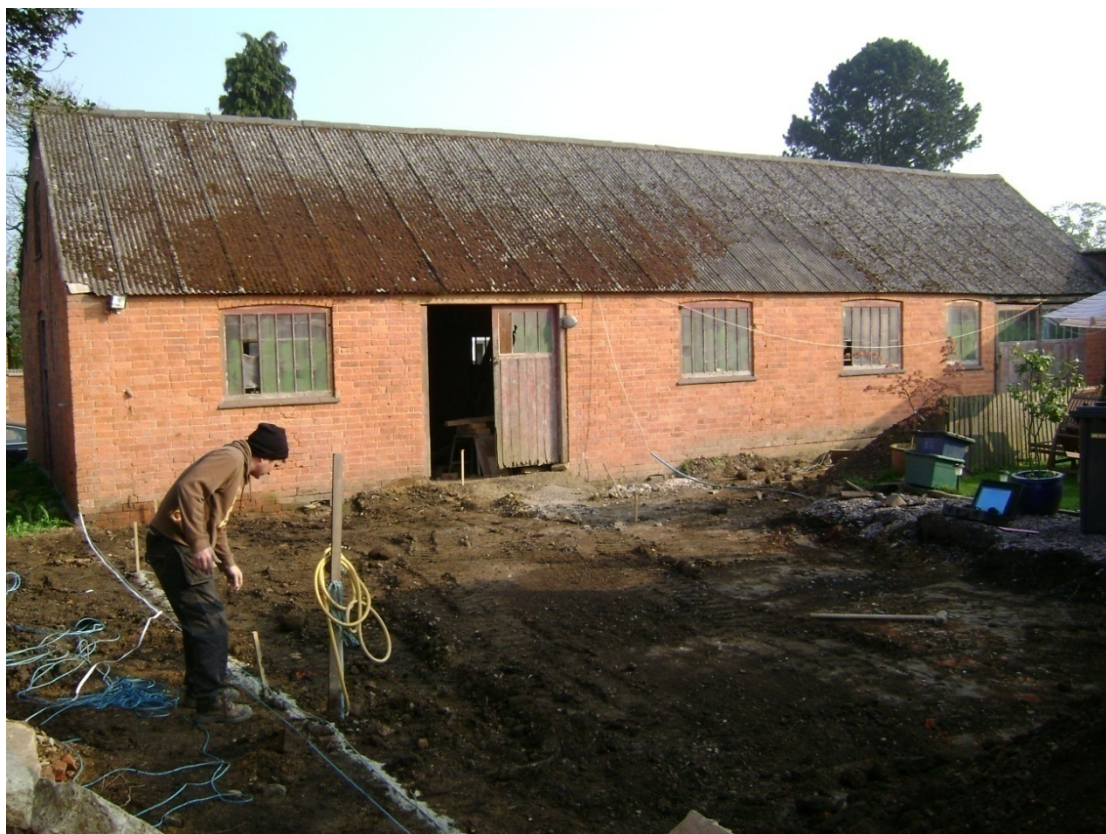
Figure 4 Location of extension prior to excavation of foundations  
Looking north-east

Prior to the watching brief the area of the proposed extension had been levelled by removing a small area of turf, on the eastern side, and approximately 0.3m of disturbed building rubble and silty clay which formed a crude yard surface behind the barn. Despite this initial ground reduction the area was still covered in a layer of dark brown clay silt filled with brick rubble and other debris (Fig. 4).

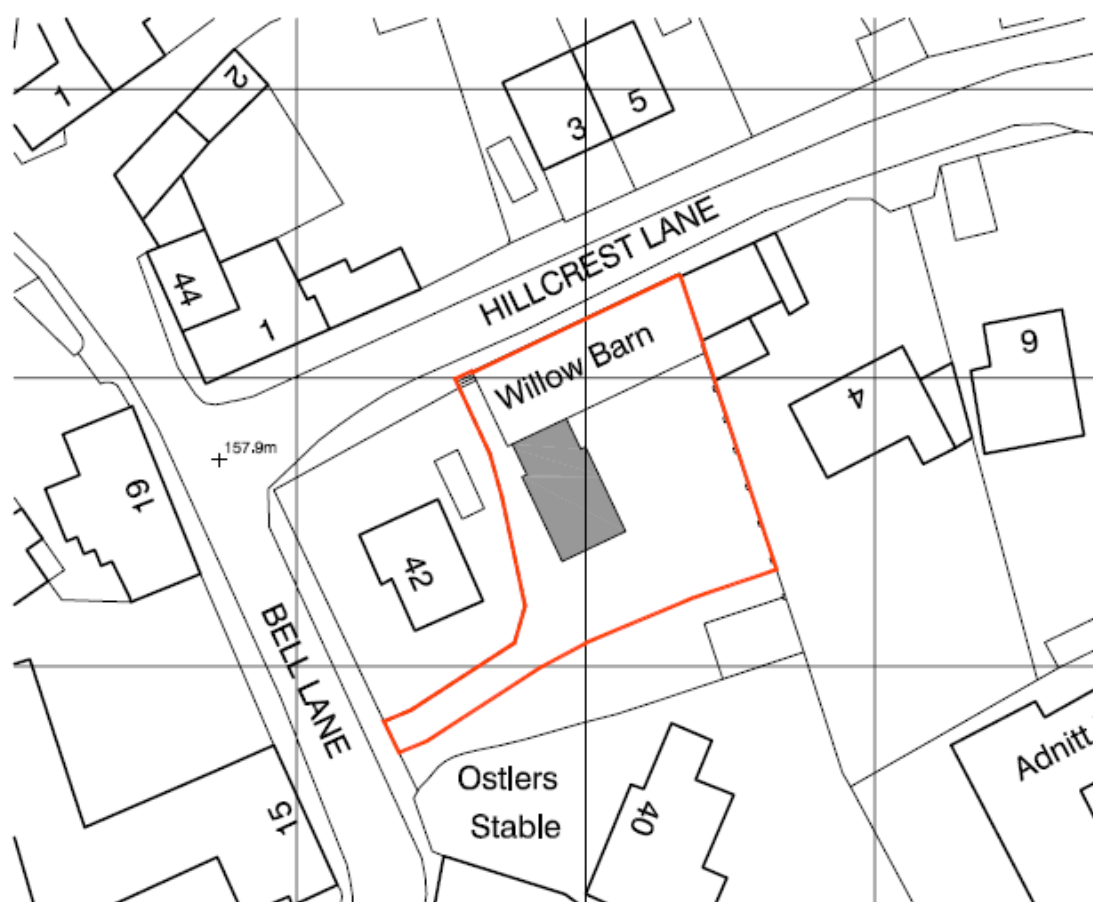
Figure 5 Proposed location of extension  
Extension shown in grey, property boundary shown in red  
Plan provided by developer. North to top of page. 25m grid squares

From discussions with the owner, the barn was used as a wheel wrights and coffin makers before being used as a light engineering workshop. It was in use as a workshop until recently before closing down and being purchased for redevelopment by the present owner. It is proposed that a single storey extension will be attached to the south-western corner of the barn to create a large L-shaped dwelling with a large courtyard style garden to the east (Fig. 5). The garden will remain virtually unchanged and will cover any surviving chapel remains that may still exist.

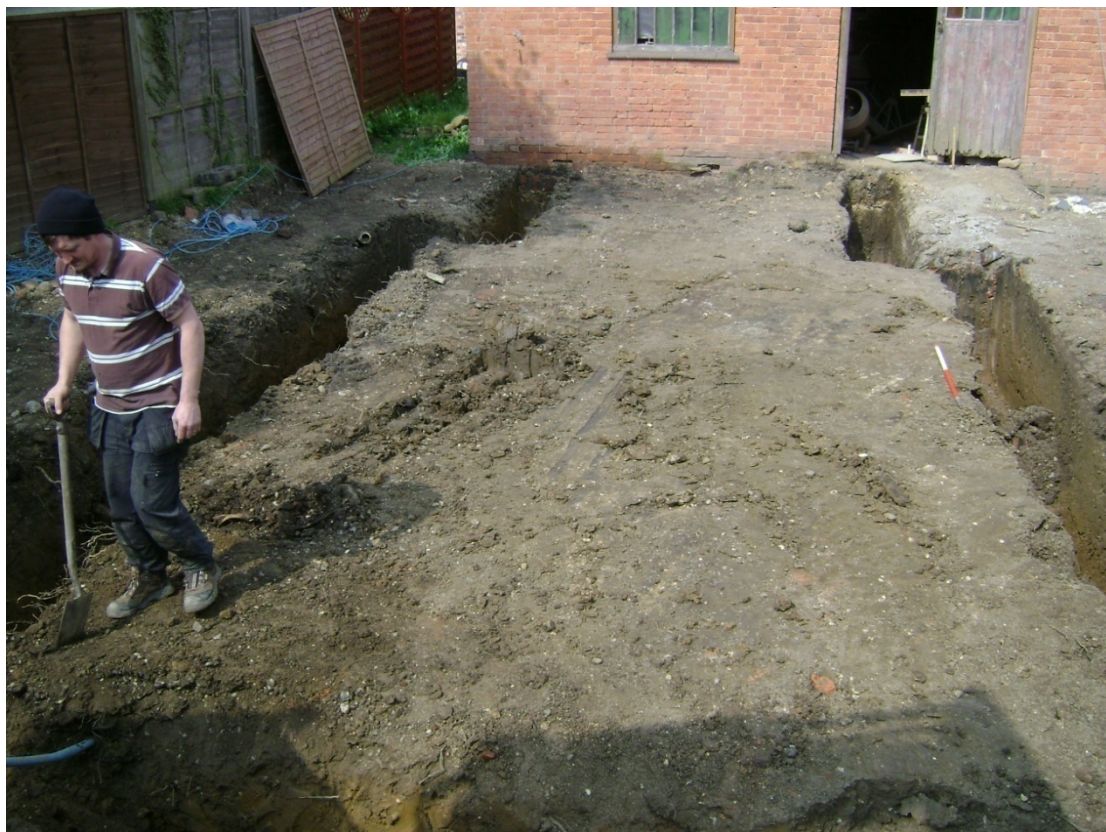
Figure 6 Excavated foundation trenches  
Looking north. 1m scale

Excavation of the foundation trenches showed that this layer of disturbance varied in depth from 0.1m to 0.45m down onto the top of the mid yellow brown silty sandy clay natural substrate. The base of the disturbed layer was relatively flat across the area of the foundations despite the general slope of the site from north to south. The foundation trenches measured 0.6m in width and were 1m in depth cutting through the disturbed layer and into the natural (Figs. 6 and 7). At the joint of the foundation trench with the barn wall it could be seen that the barn had quite shallow foundations approximately 0.4m below present ground level. No archaeological features or deposits were observed within the development area.
