**Holy Trinity Church, Church Street,  
Barrow Upon Soar, Leicestershire:**

**Historic Building Inspection and  
Recording**

**ULAS Report Number 2011-174**

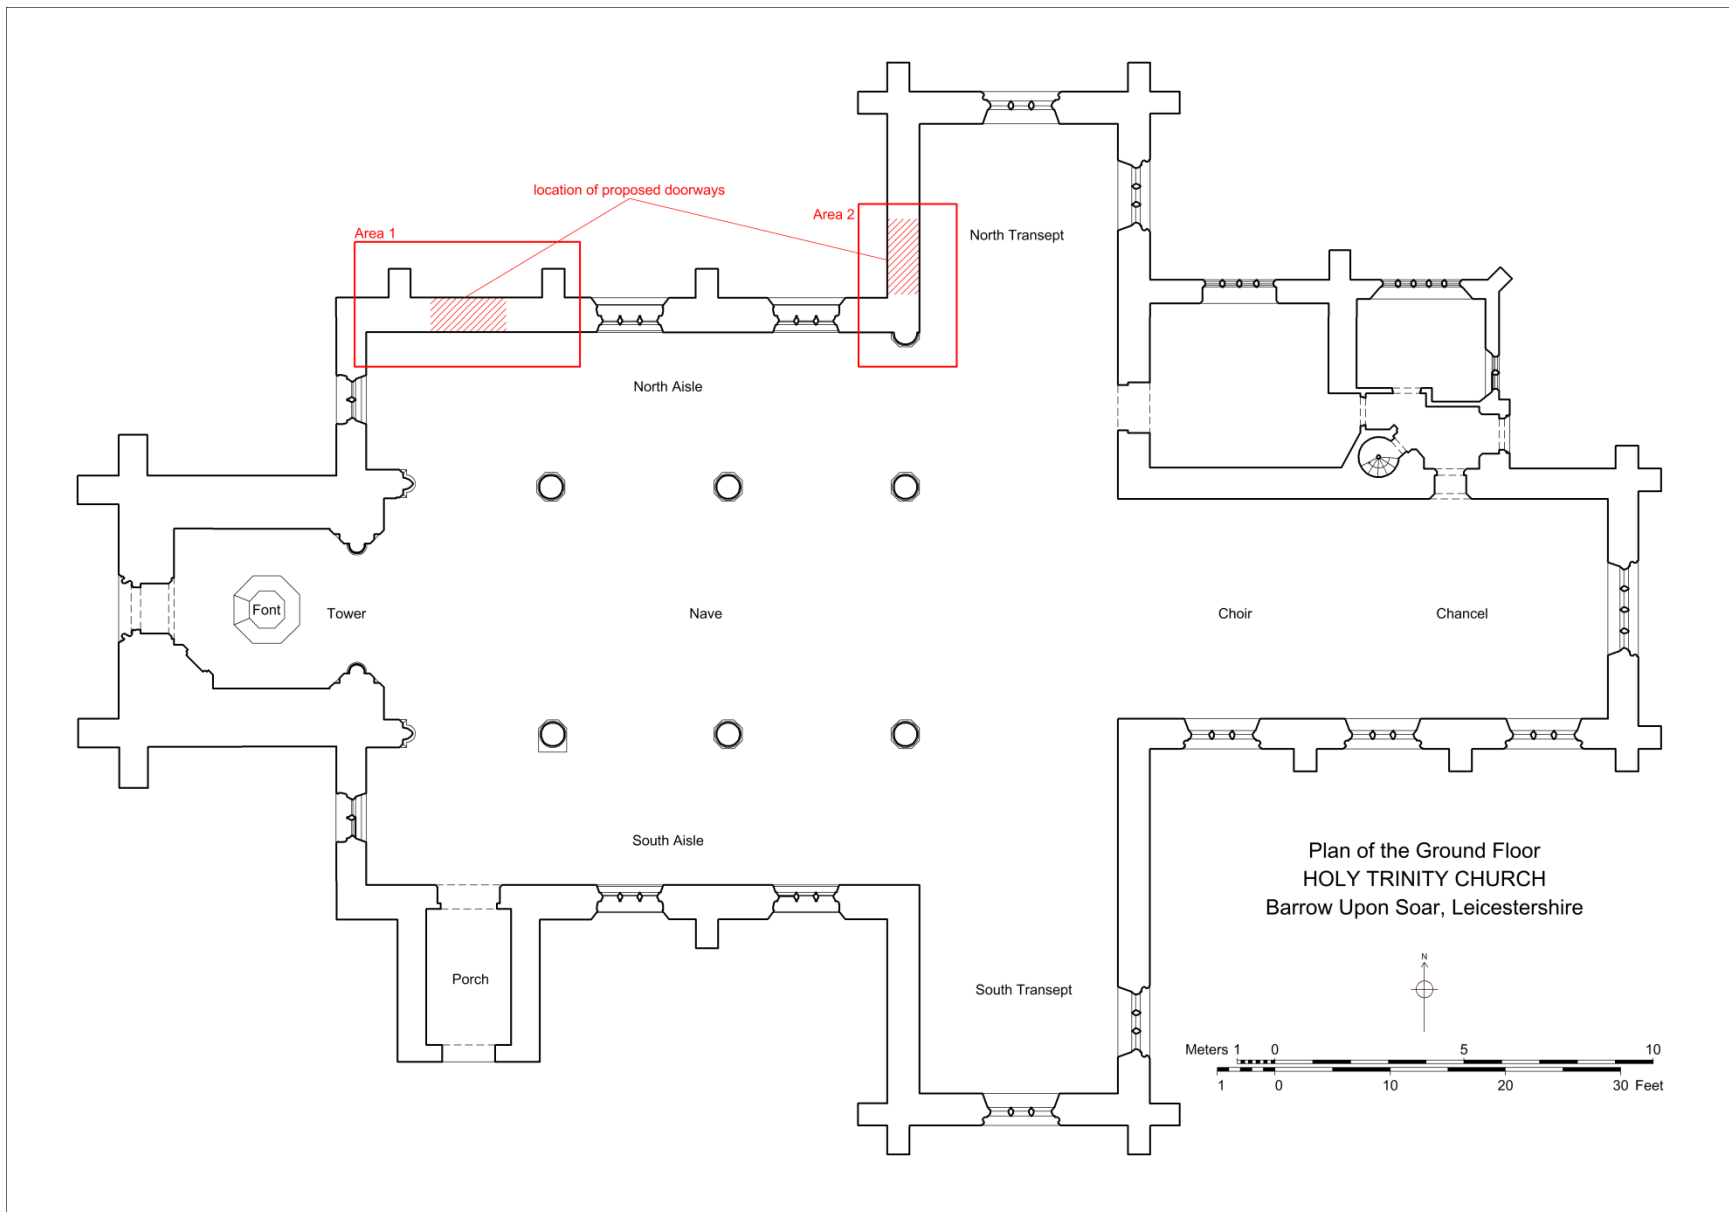
Figure 3: Holy Trinity Church, Ground Floor Plan, scale 1:200 (derived from survey drawings supplied by Caroe & Partners, Chartered Architects)

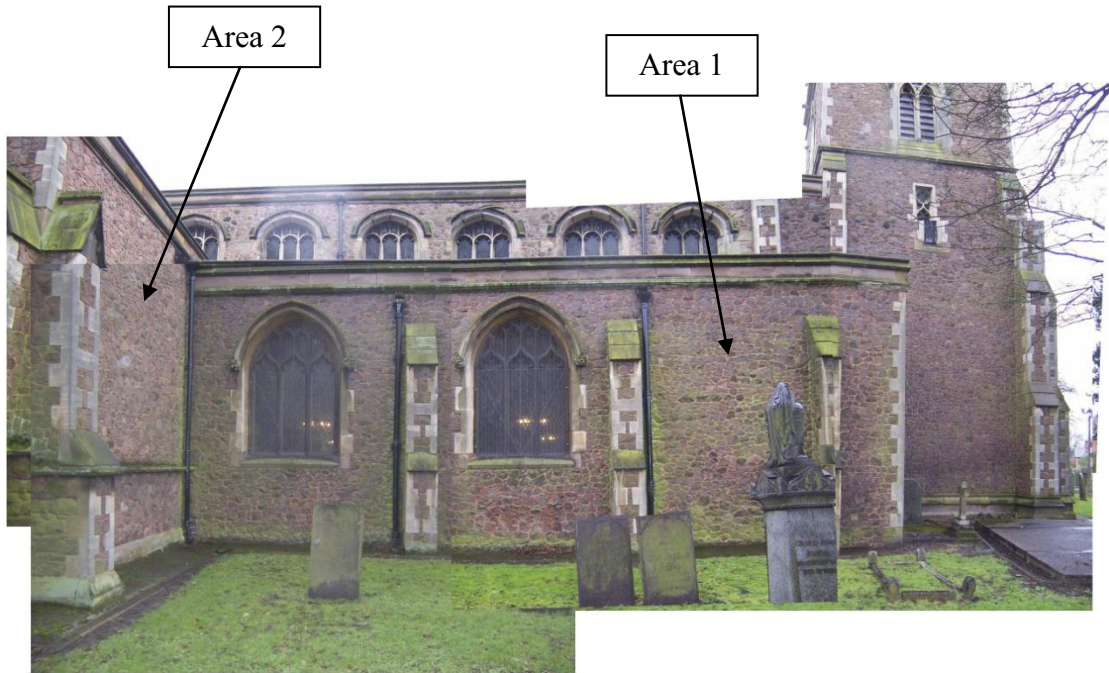
Plate 1: Composite photo showing the external area of work, looking south.

Area 1 was located behind the blank wall to the right of the aisle windows. Area 2 was located behind the blank transept wall to the left of the aisle windows.

The archaeological mitigation carried out in May 2011 (Higgins) against the external wall face of the north aisle (Area 1) and the north transept (Area 2) identified that the wall foundations in both areas had been stripped of their stonework and that the walls had been underpinned with modern concrete. This was thought to be evidence of the work carried out during the 1868-70 restoration. The external face of the walls themselves was built with a mixture of random granite rubble and ashlar masonry which was also thought to be of modern construction (Plate 1).
