**An Archaeological Strip, Plan  
and Sample Excavation at  
The Grange, Main Street,  
Slawston, Leicestershire.  
NGR: SP 7773 9452**

ULAS Report No. 2011-063  
©2011

**For: Mr A Smith**

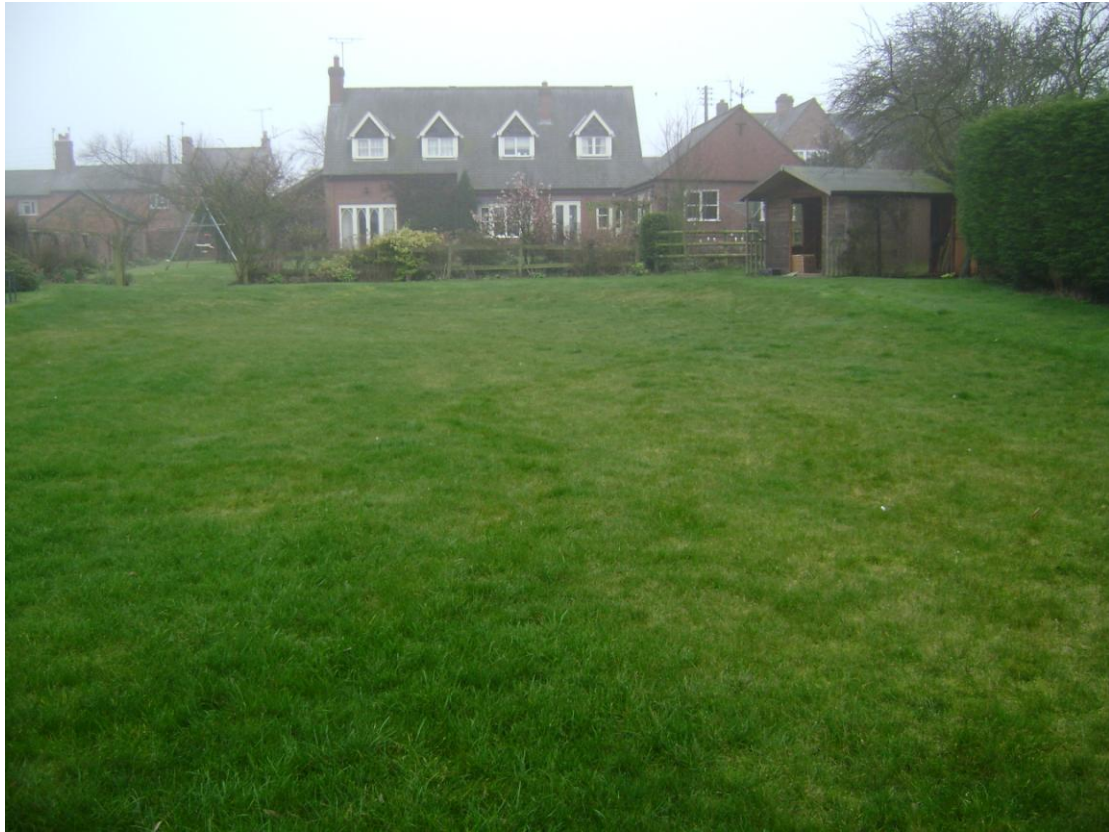
Figure 6 Development area  
Looking south. 1m scale

The development proposal is to build a new tennis court to the rear of Orchard House and its brick-built garage (Figs. 5 and 6). The site of the court is currently used as a paddock and landscaped garden. Prior to this work the western boundary of the site comprised a red brick wall and a row of mature *Leylandii* trees, while along the northern boundary was a hawthorn hedge, a beech hedge ran along the eastern boundary and a wooden post and rail was to the south. The brick boundary wall extended northwards beyond the rear of the modern garage by approximately 18m before giving way to the row of *Leylandii*. The whole of the proposed tennis court site was covered in turf but appeared to have been landscaped to create a large rectangular depression approximately 0.4m deep running along the length of the site from north to south. The landscaping has left a narrow bank, at original ground height, along the western side of the site. A small wooden summerhouse was also laid on slabs on top of the turf in the south-western corner. A number of modern land drains were known to have been laid across the site within the last 10 to 15 years.
