An Archaeological Watching Brief at
18 Chapel Lane,
Nether Broughton,
Leicestershire.
NGR: SK 6944 2576

ULAS Report No. 2011-066
©2011

For: Mr Ian Hardwick

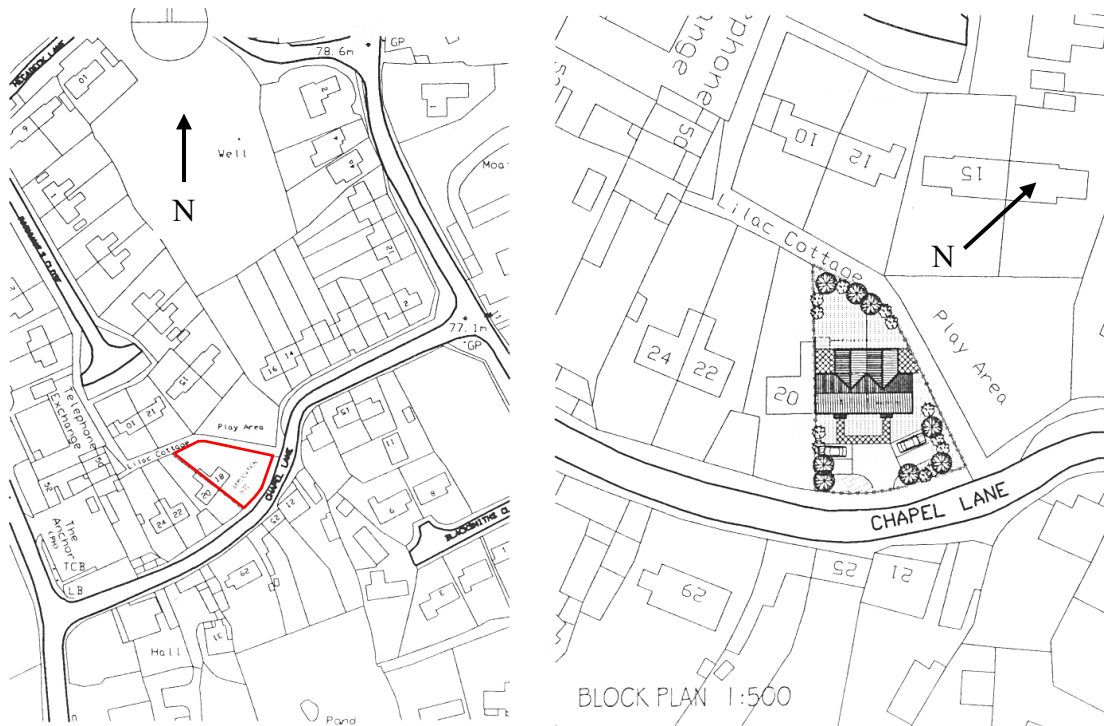
Figure 3 Development area prior to work
Plan (NTS) supplied by developer.

Number 18 Chapel Lane is one of a small development of council houses in the centre of the village (Figs 2 and 3). Prior to redevelopment the house was a typical semi-detached Airey House (Fig. 4). Airey Houses were built in large numbers across the country in response to the severe housing shortage in the immediate post-Second World War period. They were designed by Sir Edward Airey under the Ministry of Works Emergency Factory Made Housing Programme. Offsite house production employed modular construction line techniques to produce metal reinforced concrete frames with ship lap concrete panels forming the outer skin. Although fast and cheap to build the houses are now beginning to show their age and many are being demolished or refurbished. As part of the redevelopment the entire concrete ship lap skin is to be removed and replaced with modern materials. At the same time the building will be extended to the north and east to create two dwellings (Fig. 5).

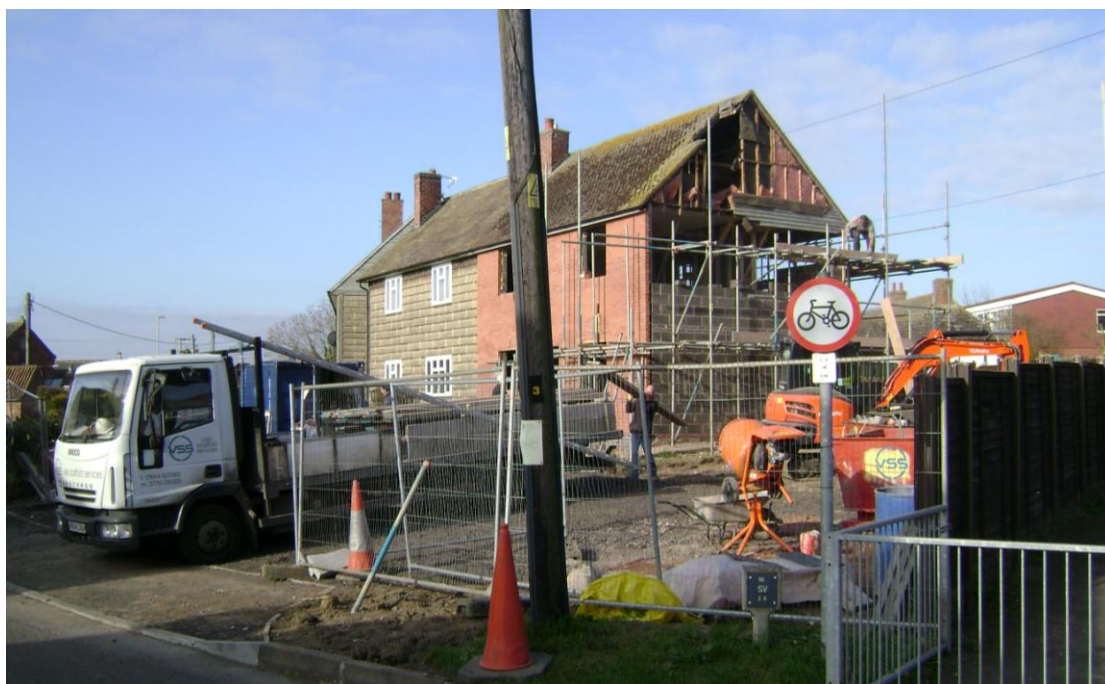
Figure 4 18 Chapel Lane showing that it has had its concrete ship lap skin removed. Looking north-west

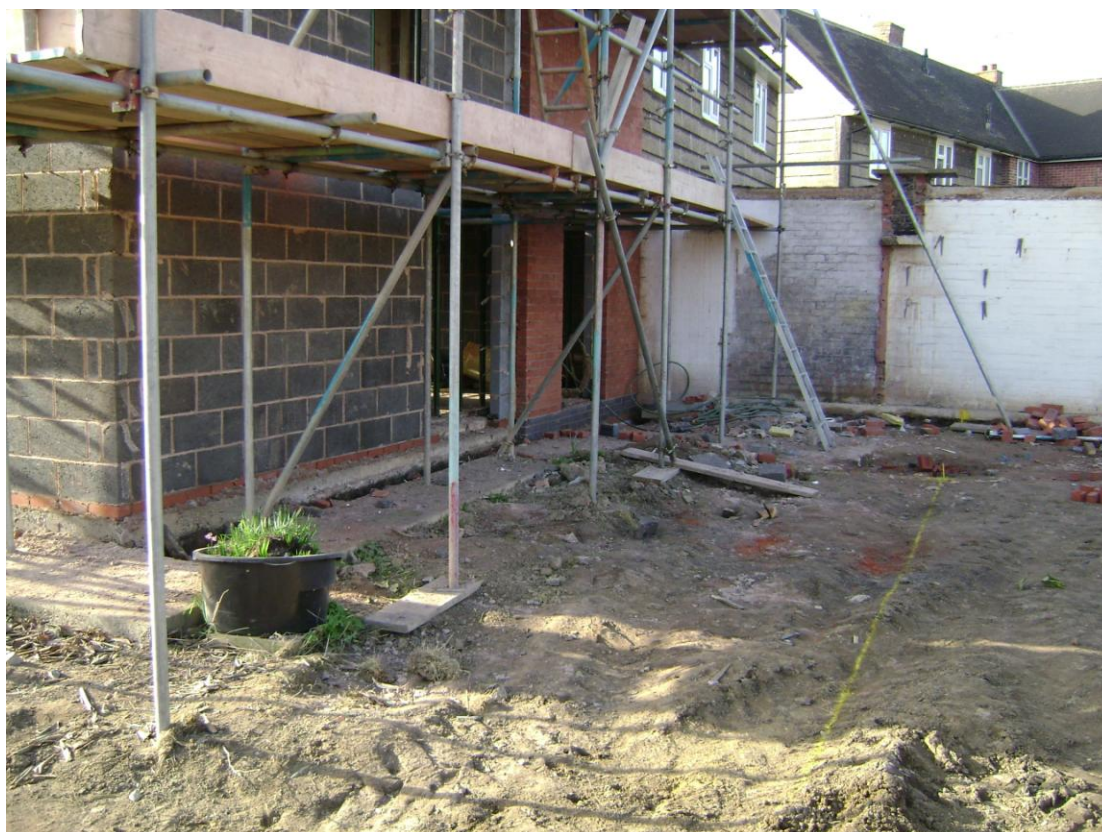
Figure 6 Site before foundation trench excavation looking south. The yellow paint line indicates trench location. The painted white wall is the rear of the adjacent property's toilet block.

Prior to the watching brief the entire concrete skin of the house had been removed in preparation for the refurbishment of this portion of the building. Most of the garden surrounding the house had already had its turf and some subsoil removed in order to create a flat working surface around the house. This had resulted in a somewhat disturbed ground level (Fig. 6). The former outside toilet, washhouse block and coal store which joins Number 16's block had already been demolished in preparation for the foundations of the new construction. A sewer or large drain pipe ran down the slope of the garden from the rear fence towards the location of the former toilet.

Up to 0.3m of mid-grey brown clay-silt topsoil survived towards the north-western corner of the site. Around the house and proposed trenches the disturbed subsoil was seen to consist of a mid-yellow brown silty-clay but with a range of modern building debris pressed into the surface. In places a pale yellow brown sandy-clay natural substratum could be seen showing through the subsoil.

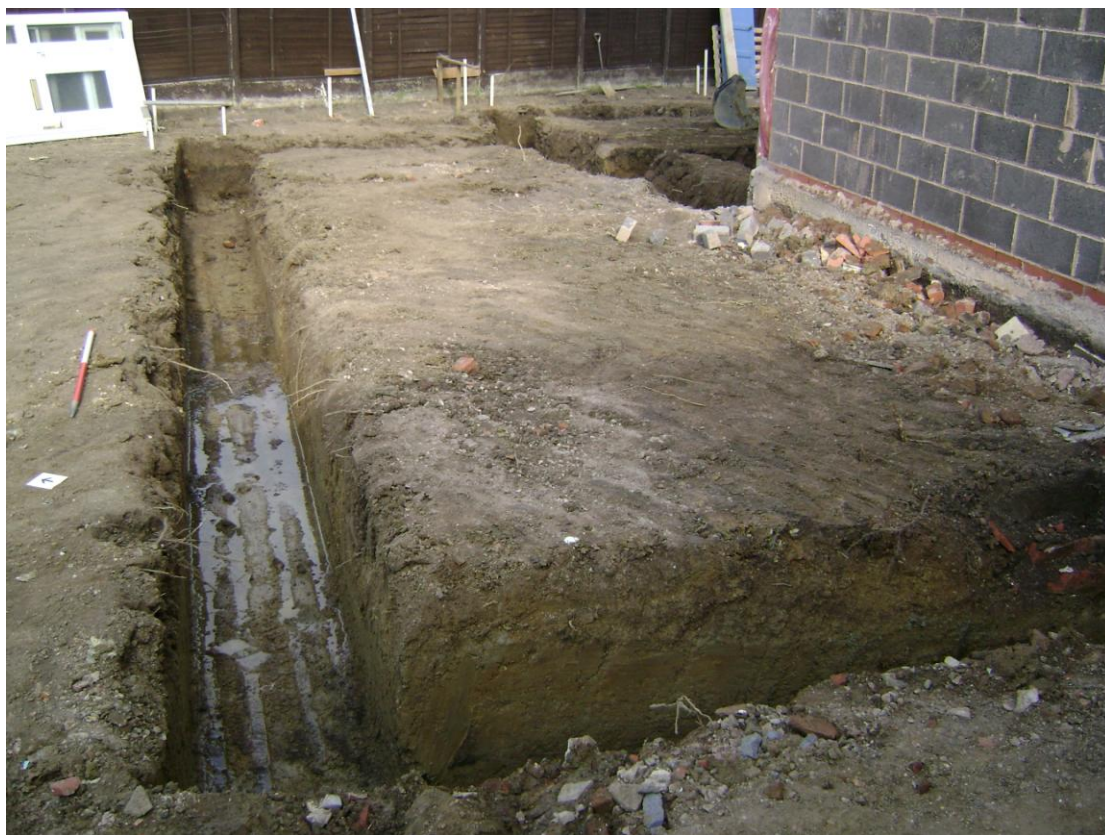
Figure 7 Foundation trenches on north-west side of house
Looking north-east. 1m scale

Foundation trenches measuring 0.6m in width and 0.9m in depth were excavated along the proposed internal and external wall lines (Figs. 7, 8 and 9). The trenches revealed the natural substratum to consist of pale yellow brown sandy-clay with patches of mid-brown sand. Towards the base of excavation the natural began to

change to a mottled bluish grey clay with yellow brown sandy-clay. No archaeological features or deposits were observed within the development area.

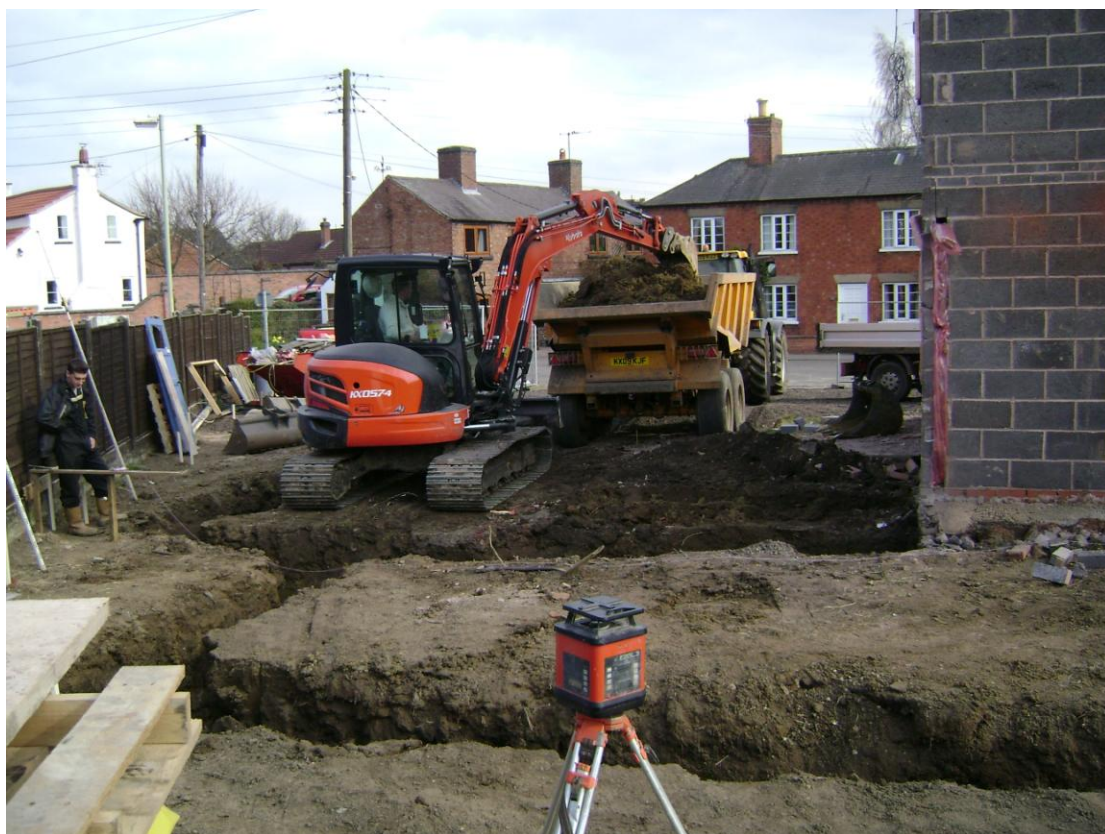
Figure 8 Foundation trenches on north-east side of house looking east

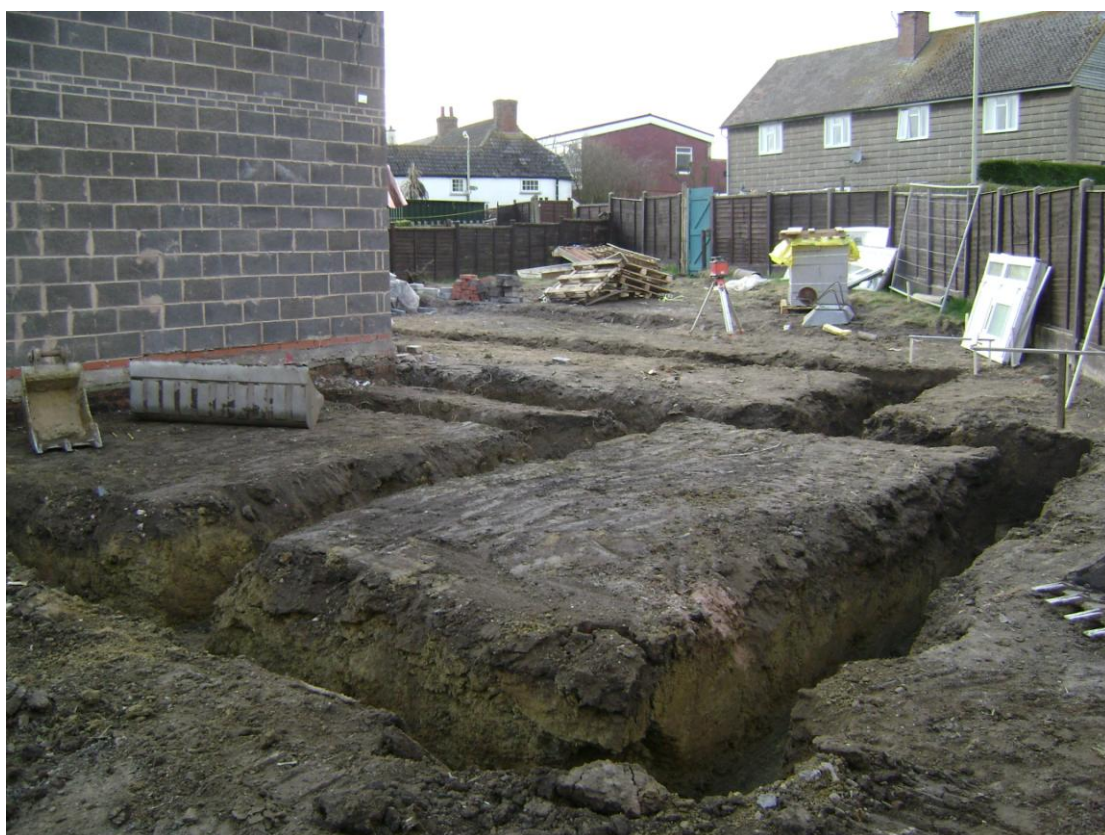
Figure 9 Final foundation trenches looking south-west
