**An Archaeological Watching
Brief on land at Church Farm,
10 Melton Road, Waltham on
the Wolds, Leicestershire,
SK 801 250**

ULAS Report No 2010-209.

**An Archaeological Watching Brief
on land at Church Farm,
10 Melton Road, Waltham on the Wolds,
Leicestershire**

NGR: SK 801 250

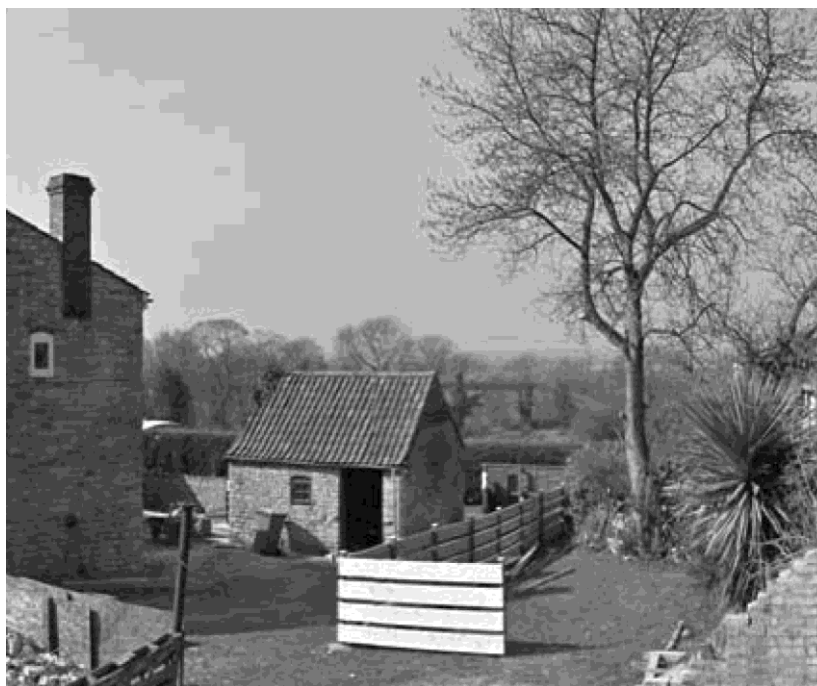
The demolition of a small, stone-built, single-storey stable building had been undertaken prior to the preliminary watching brief visit. The structure appears on the 19th century Ordnance Survey map of the area, but was not recorded as part of the photographic survey of the buildings associated with Church Farm, as it formerly served as an auxiliary structure to number 14 Melton Road on the adjacent plot and was not known to be included as part of the development plans. Plate 1 below, shows the building as it appeared prior to demolition and has been taken from the Google website:

Figure 4. Single storey structure demolished to make way for new garage. Looking south-west.

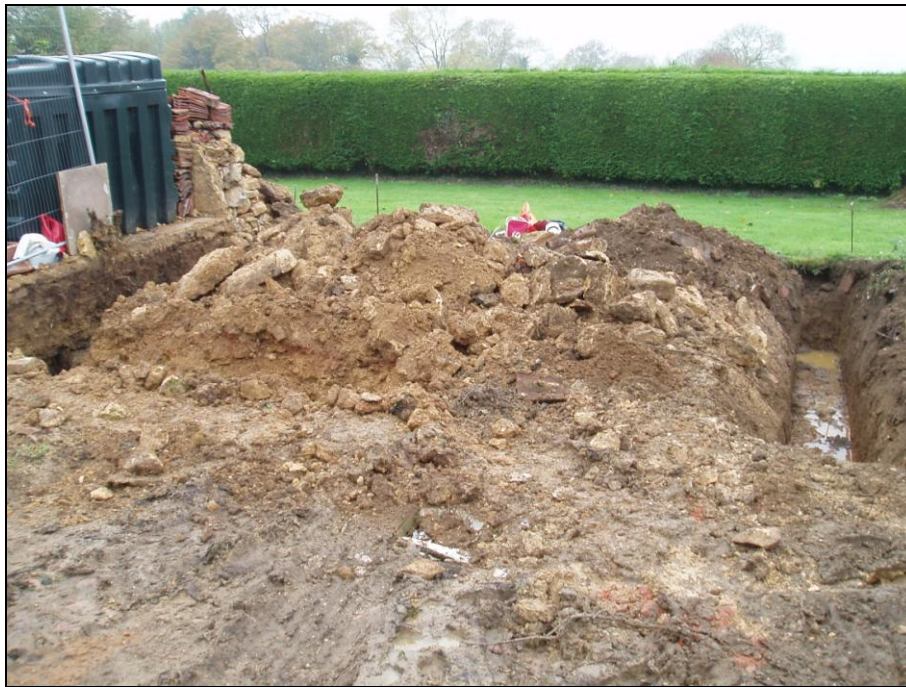
Inspection of the sections revealed the ground to have been heavily disturbed, during the construction and subsequent demolition of the outbuilding, with the overburden consisting of brick and stone rubble within a sandy silt matrix. The ground was less disturbed on the western side of the plot, where the line of the foundation trench was excavated through turf revealing a layer of topsoil measuring 0.3m deep, overlying a 0.6m depth of silty clay subsoil, containing fragments of brick and ironstone. The natural geological substratum consisted of clay and was reached at a depth of 0.8m-0.9m below the ground surface.

Figure 7. Footprint of new garage, looking west.

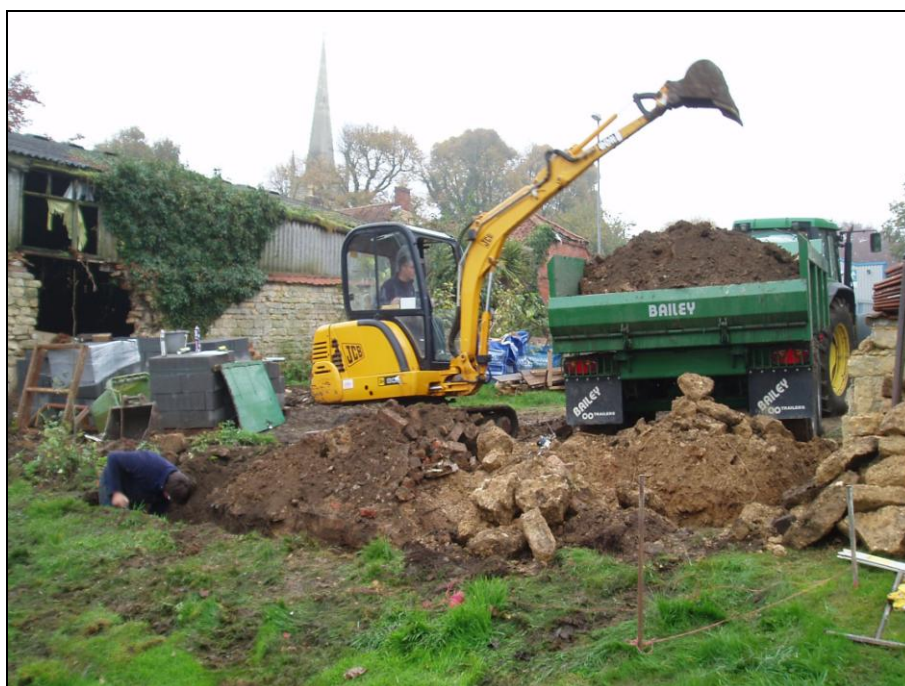
Figure 8. Footprint of new garage, looking east.

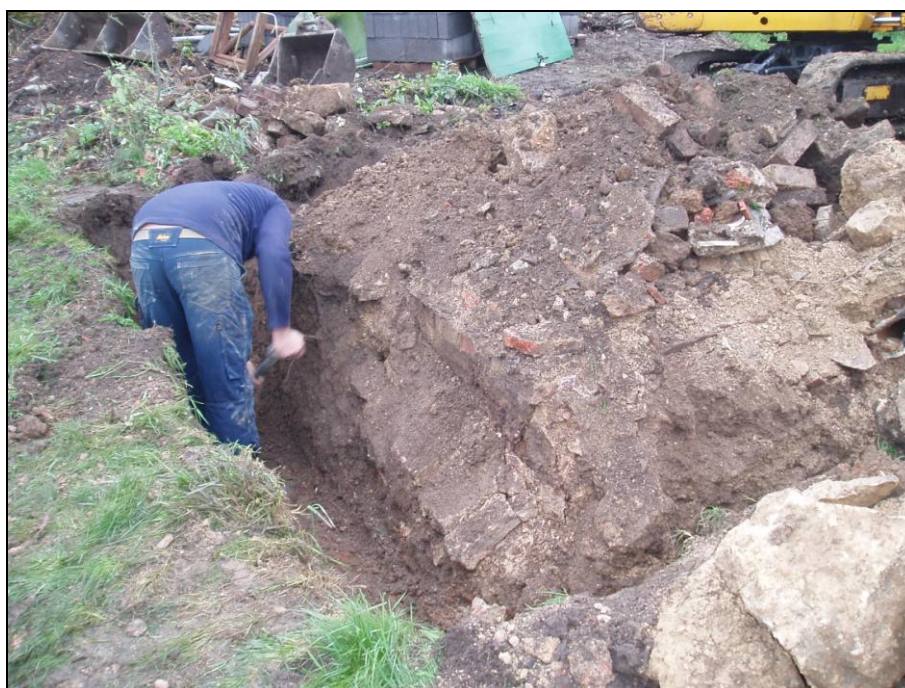
Figure 9. Western wall-line of garage. Looking north.

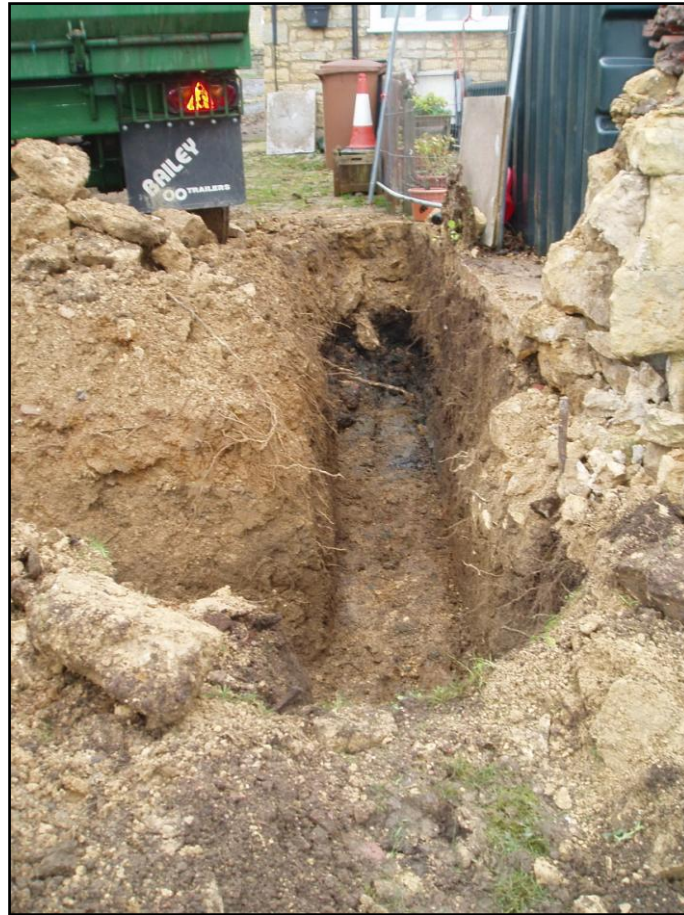
In the south-eastern corner of the plot, the base of the trench was excavated through an area of dark, greenish, grey/brown clay silt, which may represent the remains of farmyard waste or slurry. No clear edges were observed to indicate whether this had collected within a sump or through natural seepage, and no archaeological finds were observed within it.

Figure 10. South-eastern corner of building plot, looking east towards possible slurry pit.

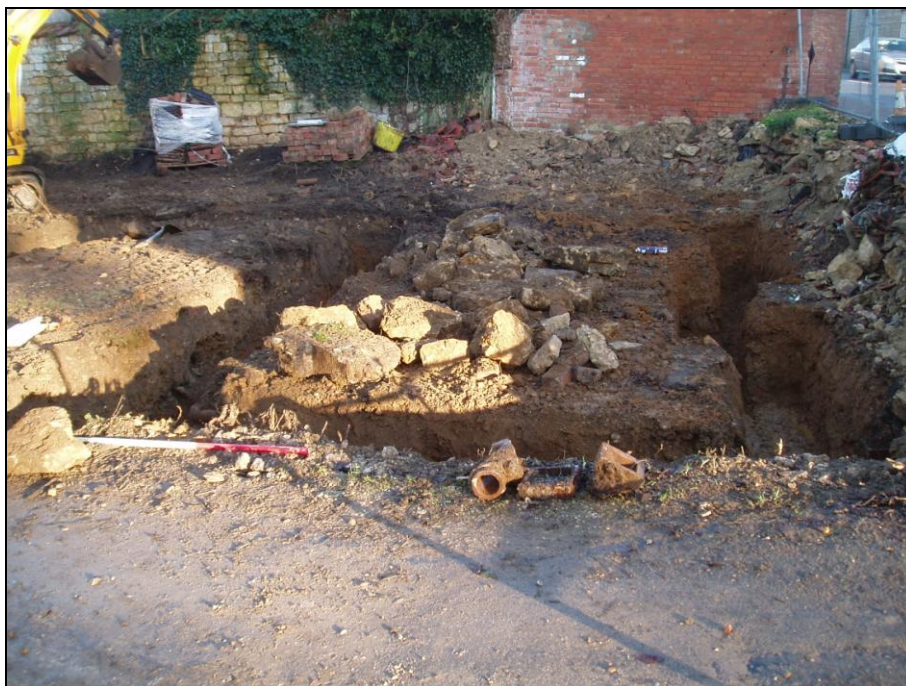
The second watching brief visit was carried out in order to monitor the excavations of footings for a double garage and retaining wall, located adjacent to the Melton Road frontage, on the site of an earlier farm building which had collapsed prior to the photographic survey. The footings were excavated to a depth of between 0.8m and 1m in depth, to reveal the natural sandy clay and ironstone geological substratum, which was overlain with a layer of brick and stone rubble, mixed with topsoil measuring up to 0.6m in depth. No archaeological deposits or features were visible in this area.

Figure 12. Footings for double garage, looking north.

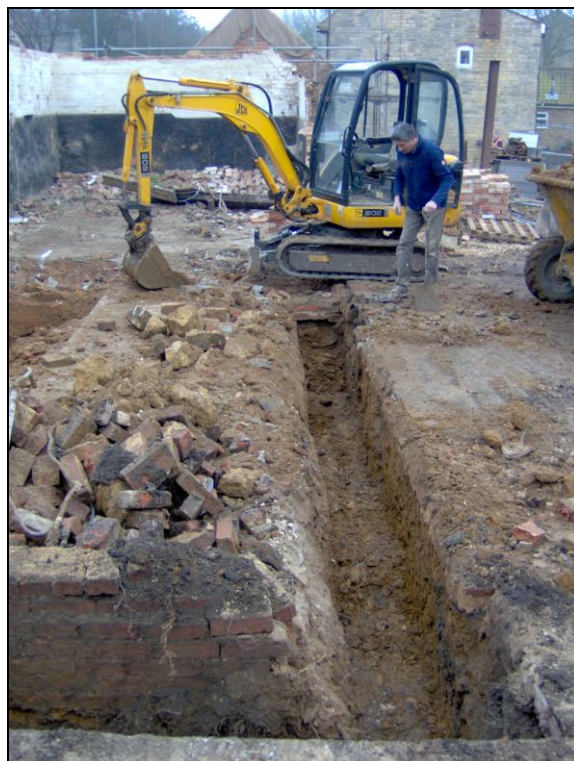
As a result of the earlier episode of levelling, the majority of the footprint was excavated directly into the natural geological substratum, to a depth of between 0.75 and 1m below the ground surface. At the northern end however, where the footprint extended beyond that of the earlier building, disturbed layers of topsoil and subsoil were revealed. Where recorded, topsoil consisted of gritty, dark greyish brown, silty clay, measuring up to 0.3m in depth, overlying a 0.6m deep layer of subsoil consisting of dark orangey brown, sandy clay. In the north-western corner of the plot, the remains of a deep, square-cut pit with vertical side was observed to cut through the subsoil, but was sealed by the topsoil. The element of this that was recorded, measured at least 0.5m long by 0.5m wide and 1m in depth. The pit was filled with very dark, blue-grey clay, containing fragments of modern brick and is likely to represent the remains of a sump or cess-pit, located against the outer wall of the cow-house, into which the internal drains would have lead. No deposits of archaeological significance were located in this area.

Figure 14. Footings for new single garage, looking south along western trench.

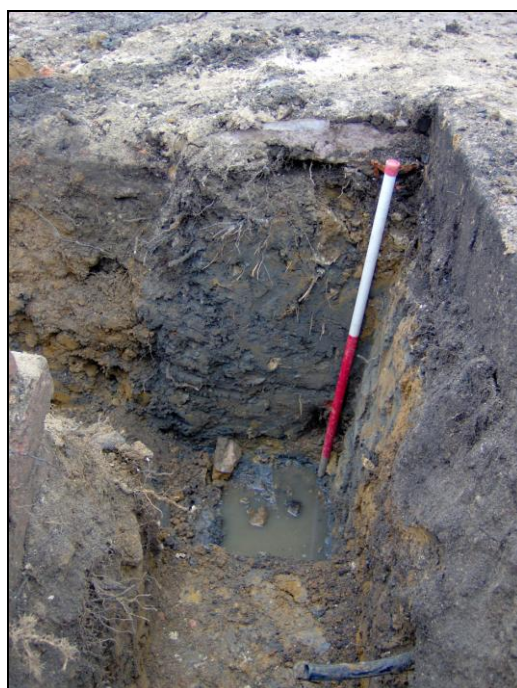
Figure 15. Square-cut cess pit in north-western corner of plot, looking west.

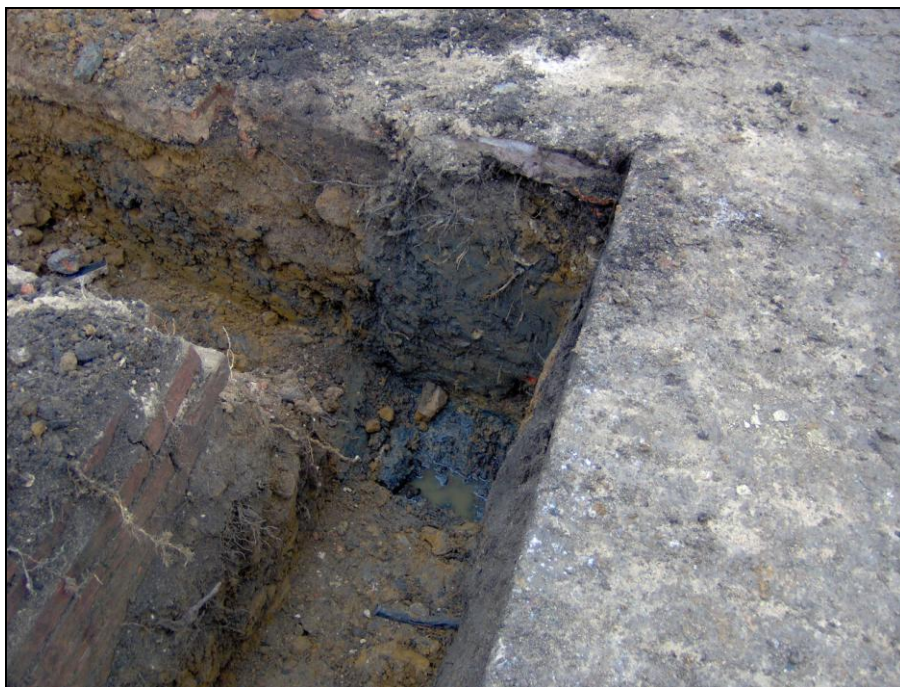
Figure 16. As above, with remains of northern external wall of former cow-house visible on left-hand side.

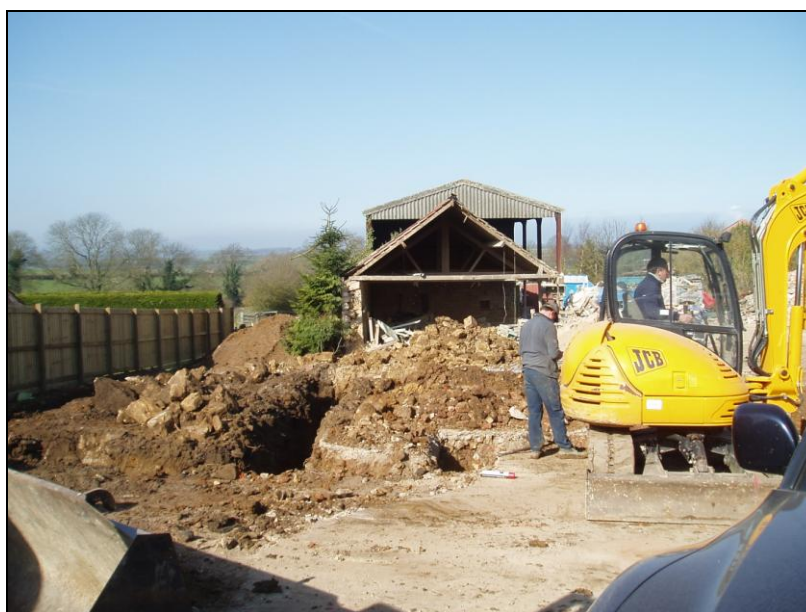
The footings for house plots 1a and 1b were excavated to a maximum depth of 1.2m, through a 0.5m deep layer of made-up ground, containing brick and stone rubble pieces, which overlaid the natural geological substratum. The made-up ground was sealed by a thick layer of concrete, presumably relating to the floor of the building which previously stood on the site. The southern-most trench of Plot 1a, revealed traces of earlier stratigraphy within the sections, in the form of a layer of buried topsoil, measuring approximately 0.4m deep, lying above the natural sandy clay, but sealed in this area by the layer of modern overburden.

Figure 18. Excavation of footings for house plots 1a and 1b. Looking west.

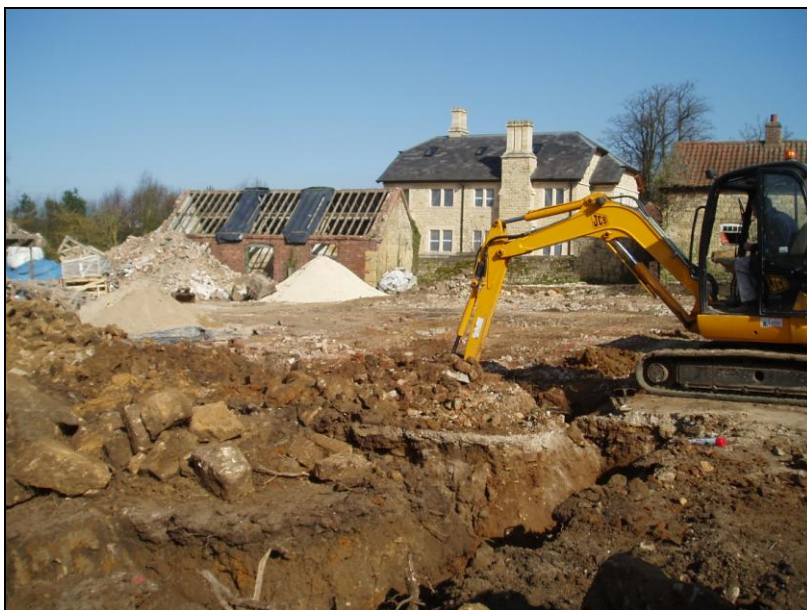
Figure 19. As above, looking north.

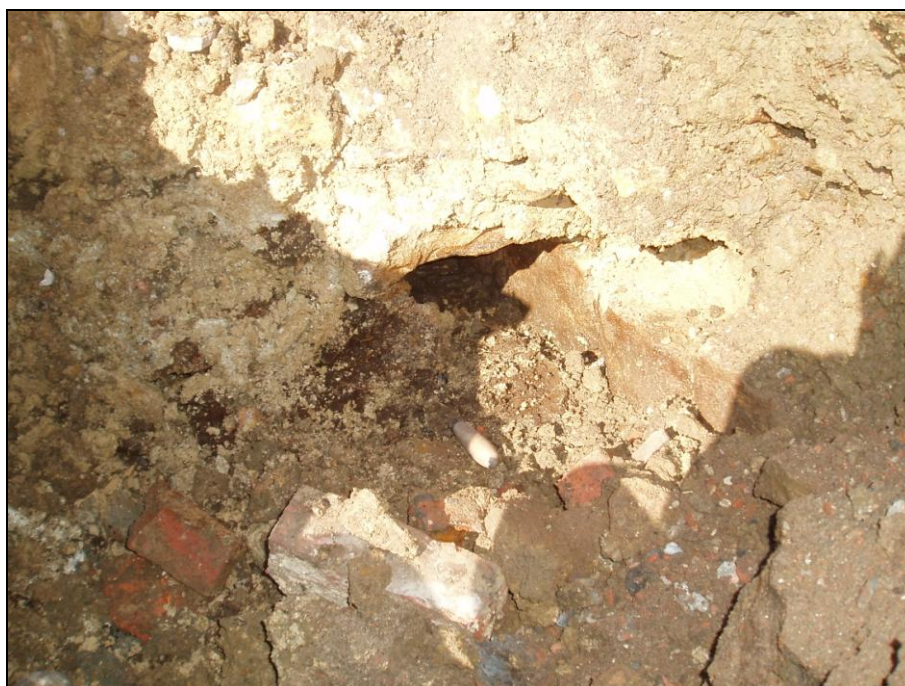
At the western end of the dividing wall trench between plots 1a and 1b, the machine was observed to truncate a stone-lined drain, likely to have been associated with the 18th century barn which previously stood on the site. The drain opening measured roughly 0.3m square and was located approximately 0.8m below the ground surface, and appeared to be aligned east/west although this could not be seen in plan. The visible remains consisted of roughly square-cut sandstone ‘slabs’ and the drain was still open, having clearly been active until the demolition of the structure above.

Figure 20. Remains of stone-lined drain seen in east facing section of plot 1a, with trowel shown for scale. Looking west.

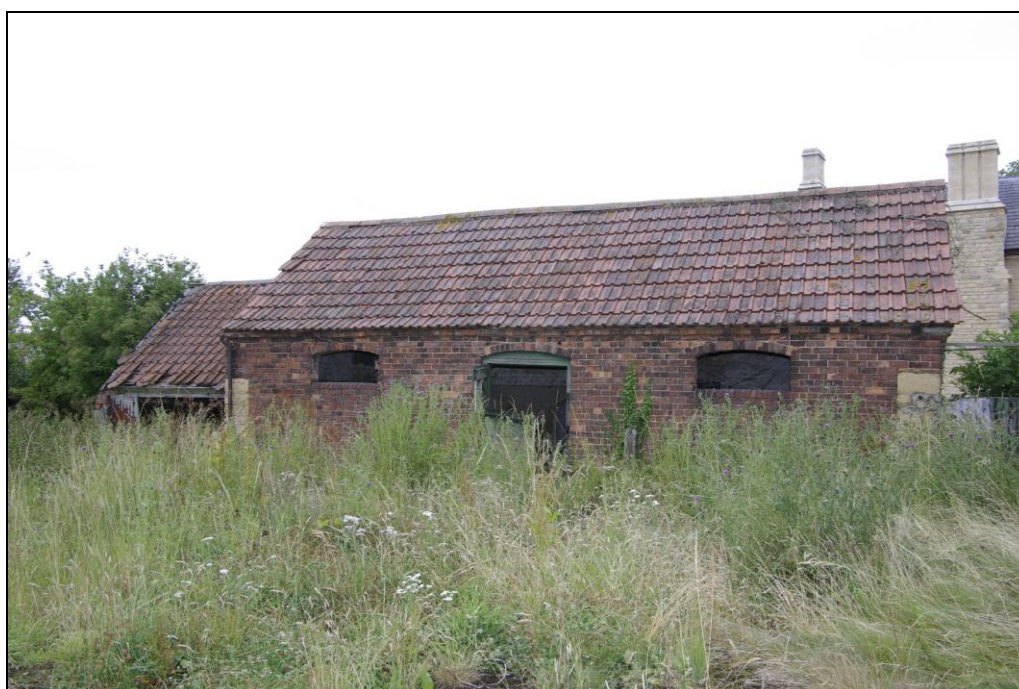
Figure 22. 19th century cowshed prior to development.

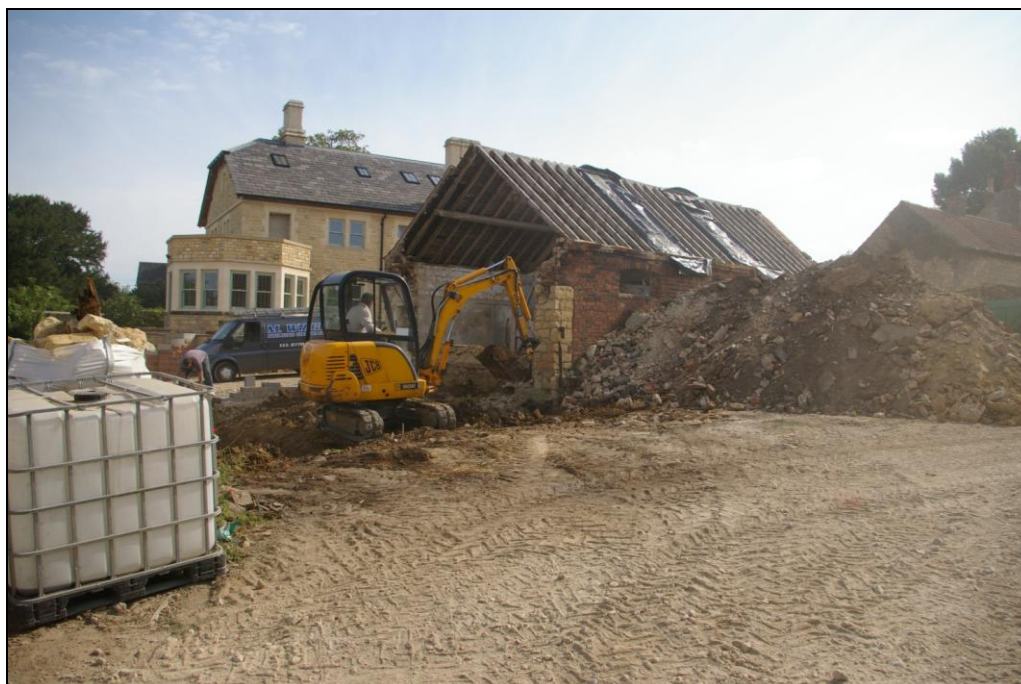
On the western side, foundation trenches measured 0.6m wide and were excavated to a depth of 1m, through ground which showed evidence of previous disturbance, probably during the construction and demolition of the lean-to structure. Revealed within the northern foundation trench and running beneath the northern wall of the 19th century structure was a stone-lined drain, with the opening measuring roughly 0.3m square.

Figure 24. Excavation of footings on the western side of the 19th-century cowshed. Looking north.

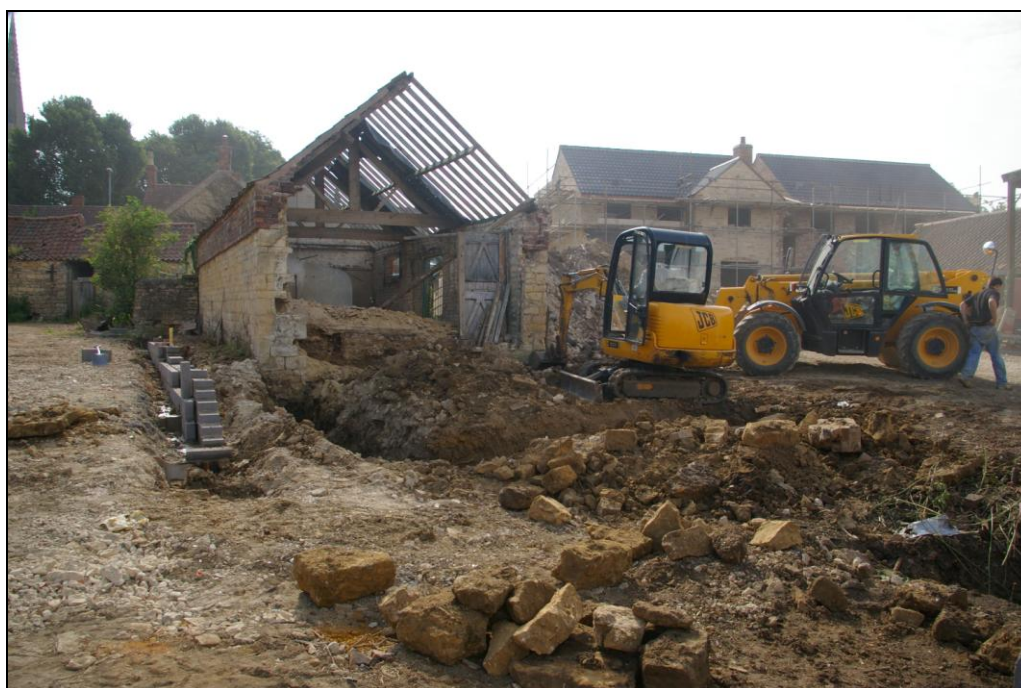
Figure 25. As above, looking east.

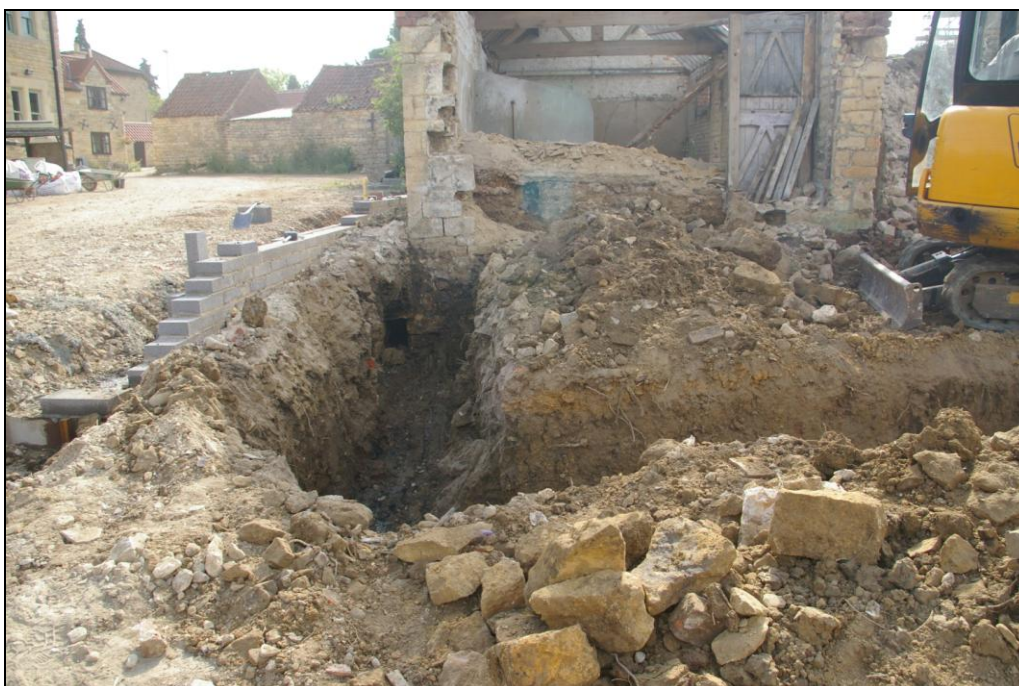
Figure 26. Detail of above, with opening for drain located beneath northern wall of existing building. Looking east.

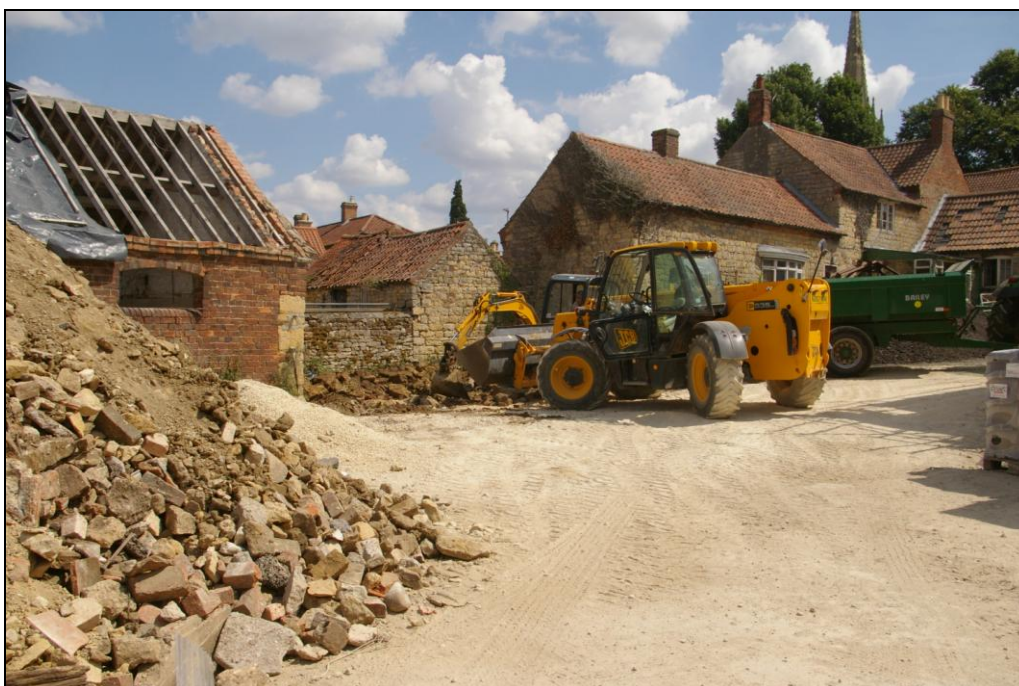
On the eastern side of the existing structure, foundation trenches measured 0.5m wide and up to 1.4m deep. The overburden on this side consisted of a layer of rich, loamy garden soil measuring 0.8m deep, overlying the natural sandy clay substratum, with evidence for previously disturbed ground on the southern side. A stone drain revealed in the northern foundation trench appeared to be a continuation of the same drainage feature seen on the eastern side of the existing structure; this appeared to curve towards the south-east and was still open and found to contain water.

Figure 27. Excavation of footings on eastern side of 19th century cowshed.

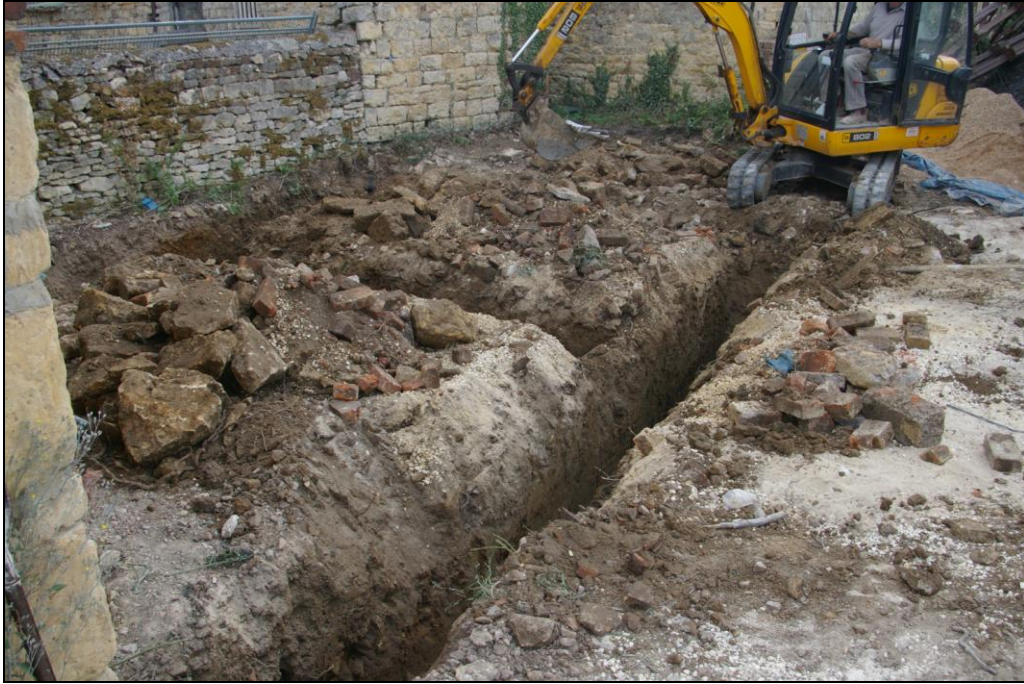
Figure 28. Detail of above, looking north-east.

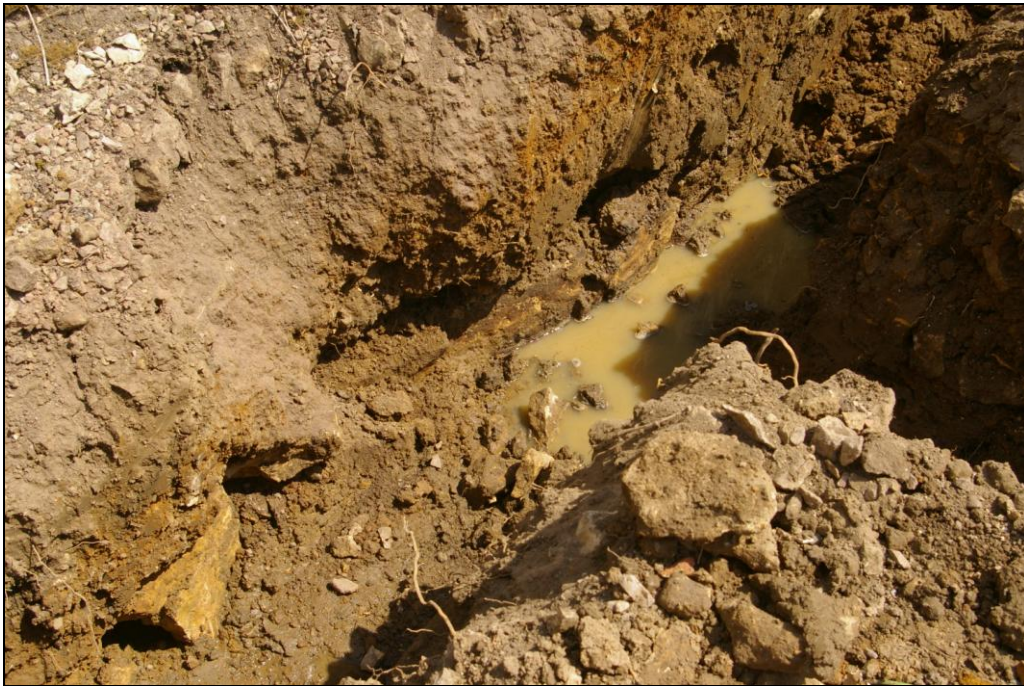
Figure 29. South-facing section of northern trench, showing northern 'wall' of stone drain.
Looking north-east.
