**Poplars Farm,  
Kirby Bellars, Leicestershire:  
Historic Building Study  
NGR: SK 730 159**

ULAS Report No 2010-096  
©2011

## Poplars Farm, Kirby Bellars, Leicestershire: Historic Building Study

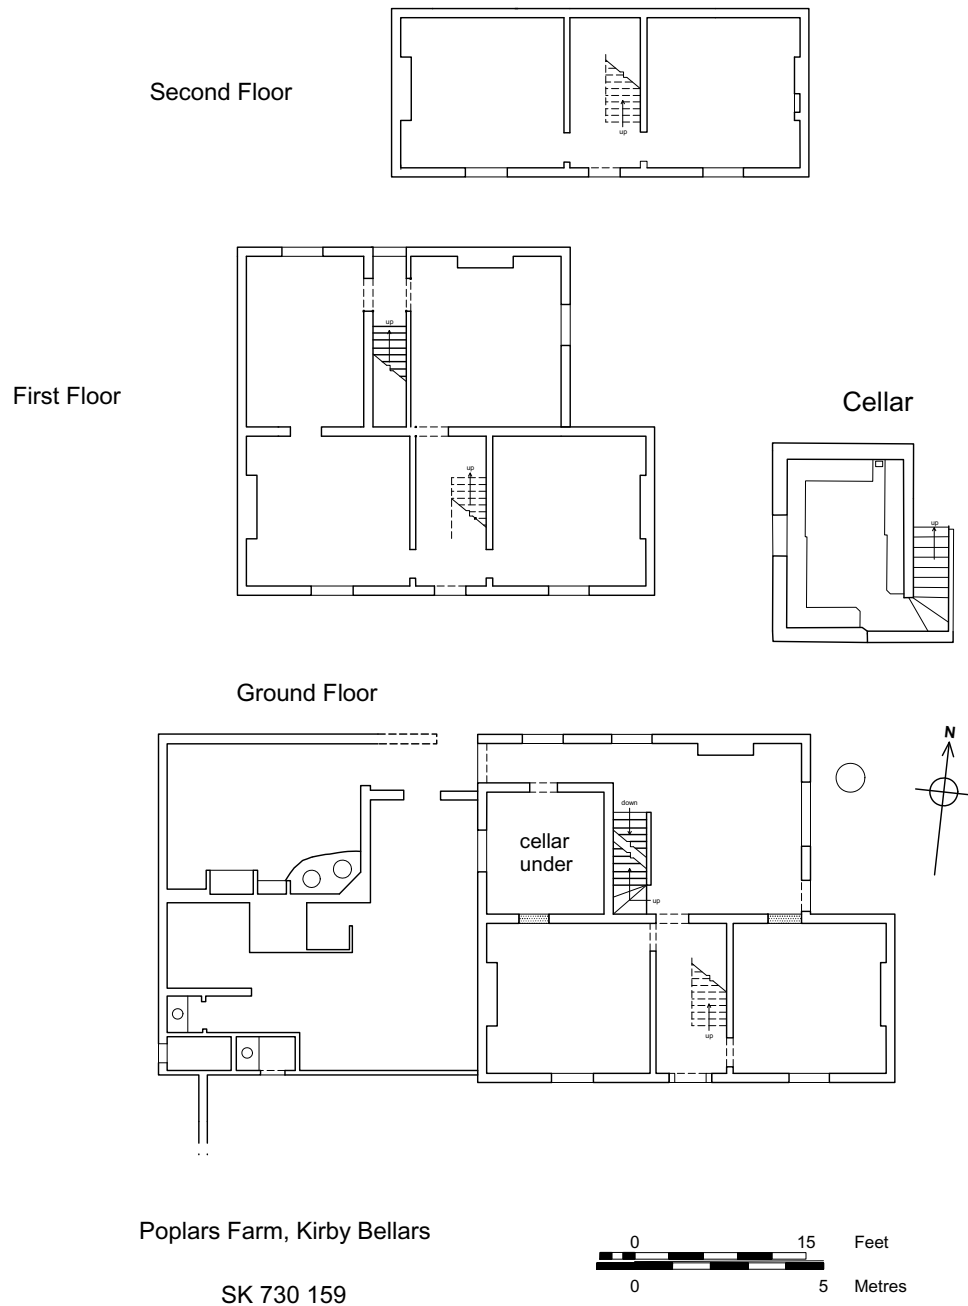
Figure 3. The farmhouse: floor plans (upper floors approx. only)

The principal, southern range of the farmhouse is a tall and narrow 3-storey Georgian structure, probably built towards the end of the 18th or early in the 19th century (see below). This is constructed in brick and was formerly rendered, with traces of render remaining in places. The roof was slated although little of the roof structure now remains. The south elevation has a regular pattern of fenestration arranged around a central doorway (Photo 1). Door and window openings have brick cambered arch heads and the windows have stone sills; there is a dentilated brick eaves course. Timber sash windows have exposed sash boxes. The timber door surround has a simple glazed over-door light of a type common from the late 18th century onwards, with an identical example being illustrated in the *Practical House Carpenter* of 1830 (Hall, 2005, 29). The doorway opens onto a central hall with the remains of the principal staircase on the east side. Rooms on either side of the entrance hall were described in sale particulars of 1959 as the ‘sitting room’ and the ‘front room’. Gable chimneystacks serve fireplaces in each of the ground and first floor rooms with built in cupboards and shelving in arch-headed alcoves on either side of the stack. The remains of a semi-circular cast iron fire grate were noted in one of the ground floor rooms (Photo 2). Access to the rear range is through a door at the back of the hall;

blocked door opening in both the 'sitting room' and 'front room' indicate different circulation routes in the past. On the upper floors there are two bedrooms per floor, one either side of the central staircase and landing area. Upper floors are of plaster on reed construction.

The rear (north) range of the farmhouse is lower (two storeys), wider and shorter than the frontage range, but is constructed in similar brickwork and appears to be contemporary with it (Photo 3). Although the brickwork of the west elevation of the house is very varied (Photo 4), the only suggestion of a structural break between the two ranges is in the uppermost section of the wall, seemingly reflecting an area of localised repair or rebuilding, rather than separate phases of construction. Similarly the brickwork of the east gable wall of the rear range appears to be tied in to the north wall of the frontage range. The roof is slated. The rear range is in a plainer style than the frontage range. Door and window openings have segmental arched heads and windows, where these survive, are horizontal (Yorkshire) sliding sashes. The larger of the two ground floor rooms is a kitchen, heated by a fireplace in the north wall. The second, unheated, room is a dairy, with large, shallow sinks ranged along the west wall and wooden shelving lining the other walls. Between the two rooms a dogleg staircase rises to a first floor landing and two bedrooms; the first floor structure is of plaster on reed. Below this a flight of stairs descends to a cellar beneath the dairy (Photo 5). The north, west and much of the south wall of the cellar are constructed in ironstone, as is part of the east wall. It has a brick vault and is lit by a window in the west wall; there is a brick thrall on all sides.

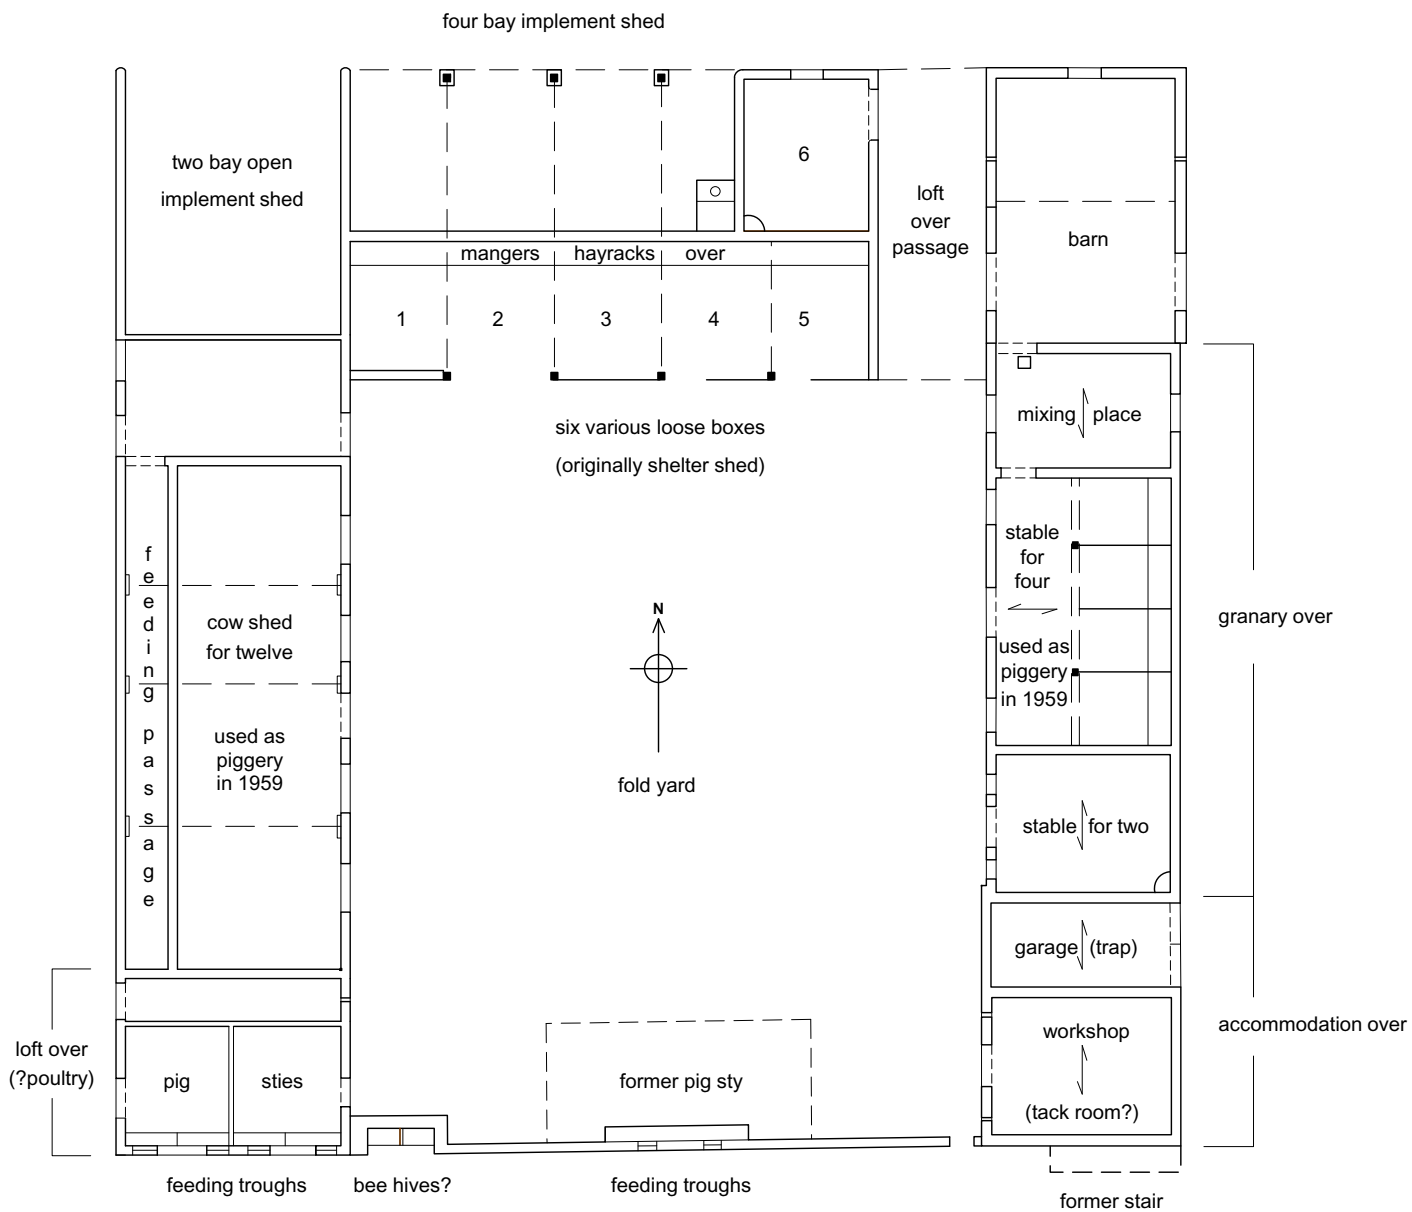
Figure 5. The farmyard buildings

The lower storey of the east range, excluding the barn at the north end, is constructed in similar brickwork to the house and is broadly contemporary with it, dating from the later 18th or early 19th century (Photo 7); the upper storey and the barn were added later, after the middle of the 19th century (see below). This range of building includes stabling for horses and a trap house as well as other accommodation.

The ranges on the north and west side of the courtyard appear to have been constructed as one build, using the same orange-red coloured brick and with identical detailing such as bull-nosed bricks to door reveals, piers and corners (Photos 10-13). Roof trusses are all of similar suspended king post type.

The layout is conventional, with the fold yard facing south to benefit from the sun (eg. Brunskill 1987, 70). The west range consists of a cow shed with integral feeding passage (Photo 10), with at one end a pair of pig sties (Photo 12) and at the other a two-bay implement shed (Photo 13). The north range has a 5-bay shelter shed (Photo 10) facing the fold yard (subsequently divided into separate loose boxes). Backing onto this is a 4-bay implement shed and a loose box opening off the entrance to the yard at the east end of this range (Photo 11). In one corner of the implement shed is an earth closet. The east range includes stabling, a trap house and probably a tack room at the south end; to the north is a barn and mixing place. On the upper floor, accessed via an external flight of stairs, there is heated groom's accommodation at the south end (Photo 9), with a granary over the stables beyond this.

Based on the available evidence, the development of Poplars Farm along ‘model farm’ lines seems to have occurred in the 1850s - 1860s, during the boom years of British agriculture. The relative size and configuration of buildings demonstrates an emphasis on the rearing or fattening of livestock, with only modest provision for the processing and storage of cereal crops (Figure 5; Photo 8).

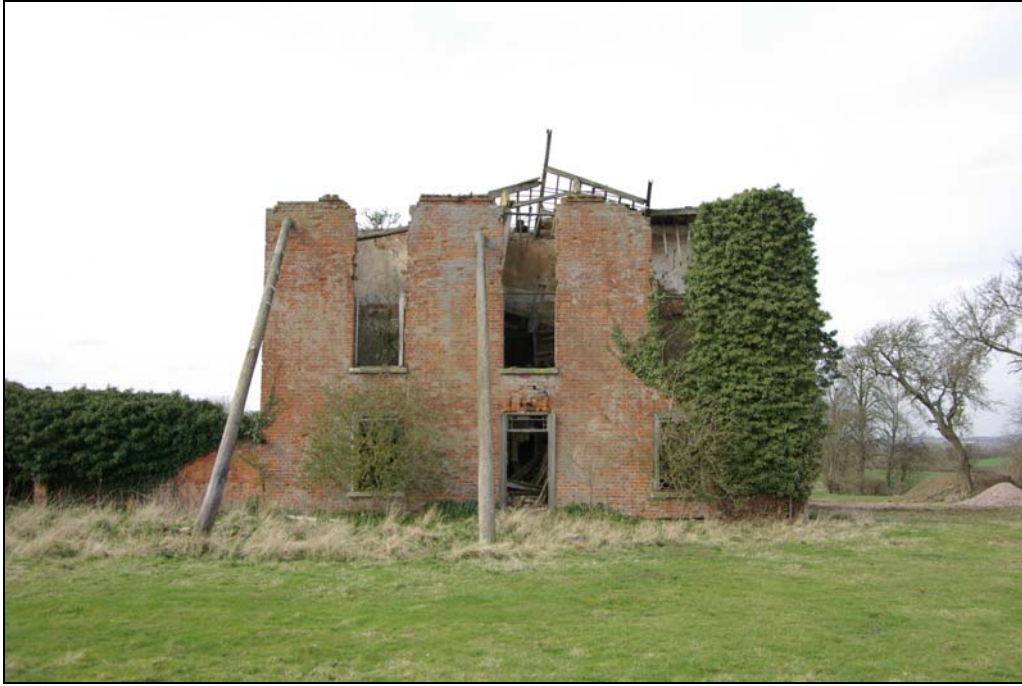
Photo 1. Poplars Farm, south (frontage) range, looking north

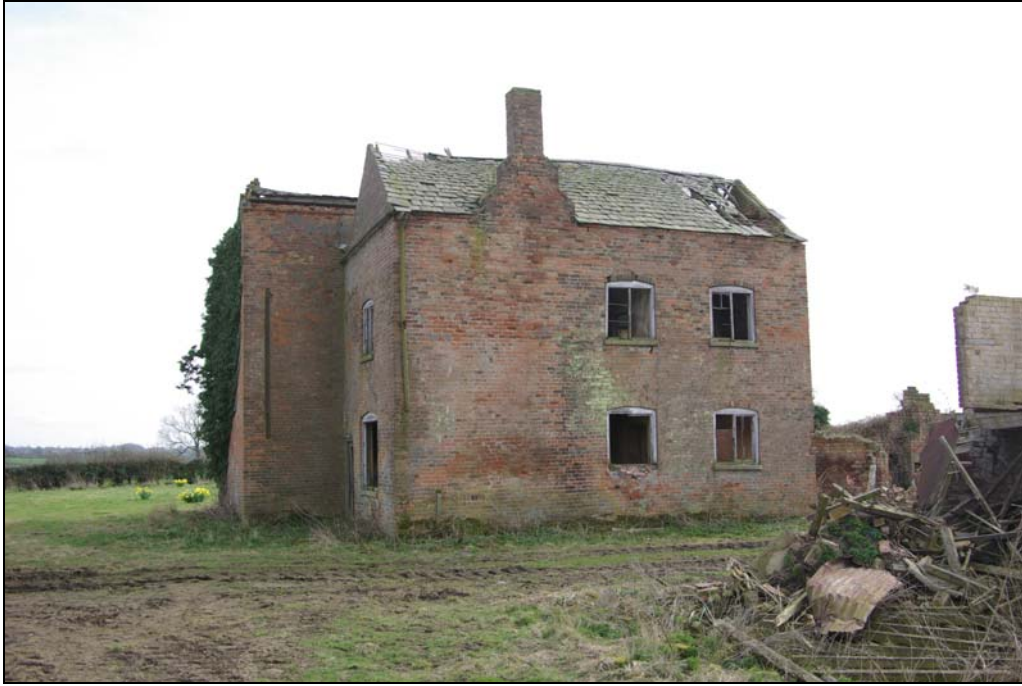
Photo 3. North (rear) range of farmhouse, looking south

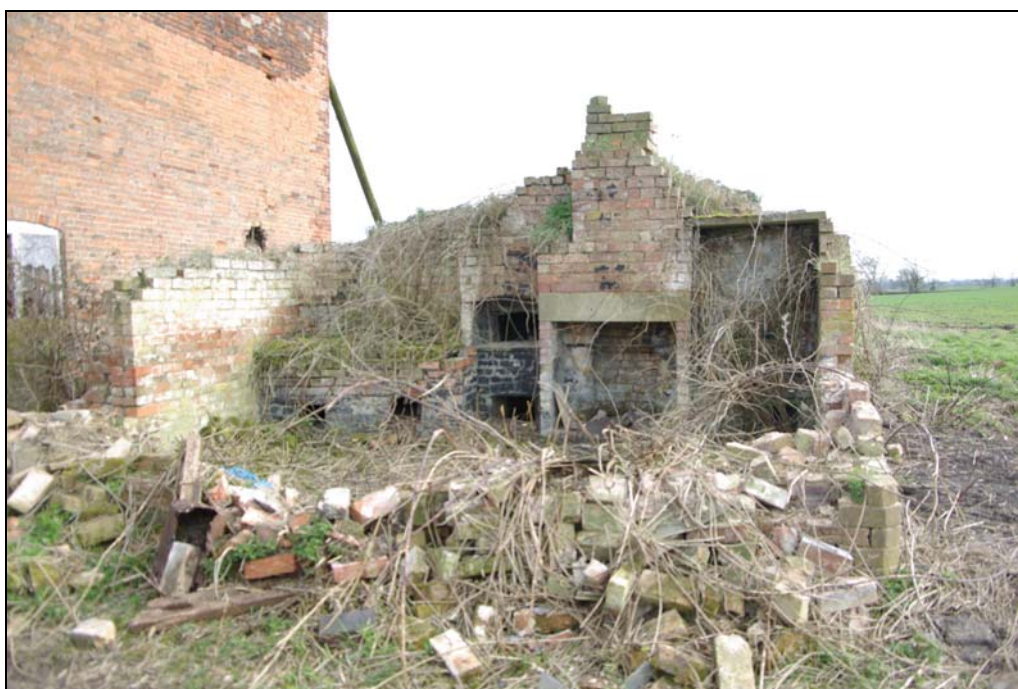
Outbuildings on the west side of the house, now largely ruinous, include a bakehouse with oven and fireplace (Photo 6). Two cast iron 'coppers' for heating water suggest that this doubled as a washhouse. There are two earth closets, one accessed from the yard and the other from the garden to the south. A well is located by the north-east corner of the house.

Photo 6. The Bakehouse, looking south

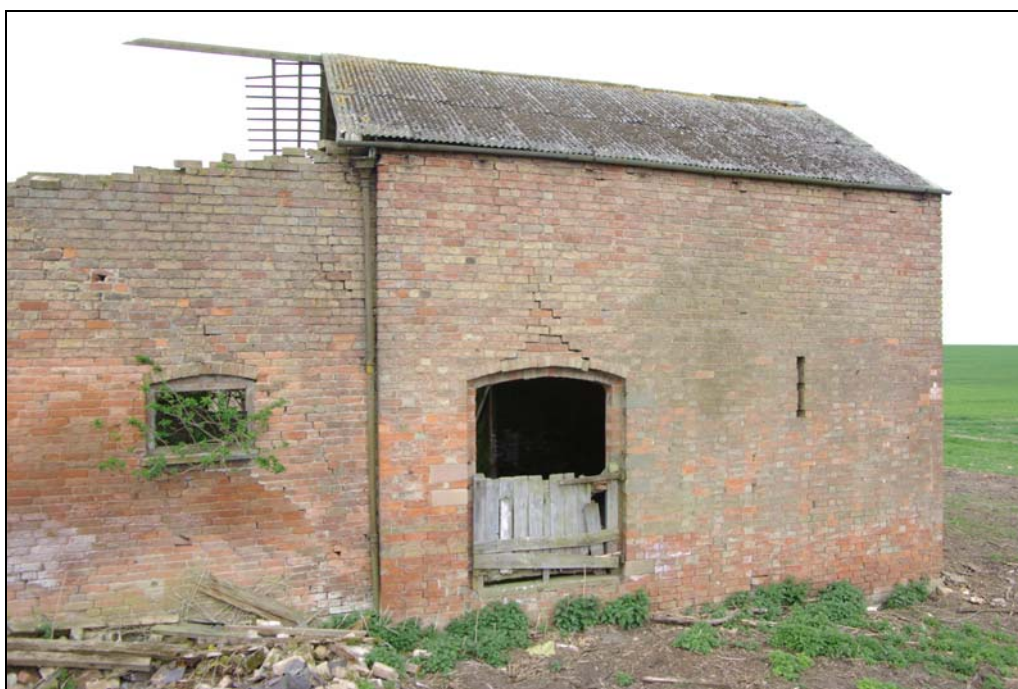
It seems unlikely that the barn referred to in this document is the present barn at the north-east corner of the farmyard (Photo 8), for the reasons set out below, which suggests there was an earlier barn that is no longer extant; presumably this was one of the buildings illustrated on the 1824 OS map, located to the north-west of the farmhouse.

The development appears to have occurred in stages, though whether this was over a period of months or years is not known. Construction of the barn and addition of the upper storey over the earlier stable range, forming the east side of the courtyard, seem to have occurred in a single event, judging by the brickwork of the eastern elevation (Photo 8).

Photo 8. The barn at the north end of the east range, looking west

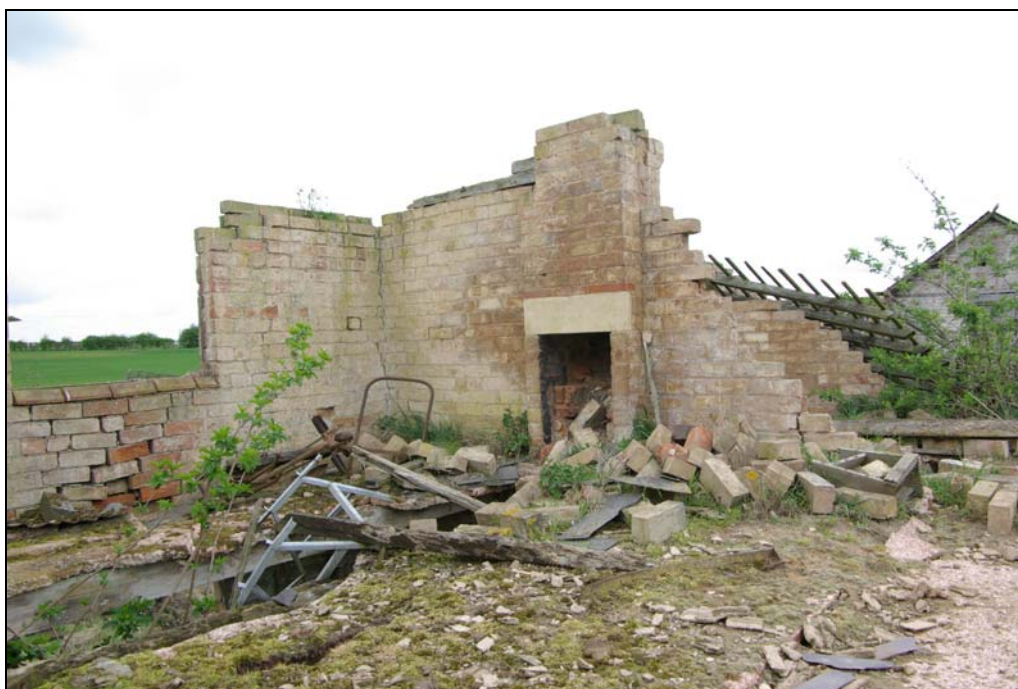
Photo 9. First floor groom's accommodation at south end of east range, looking north-west

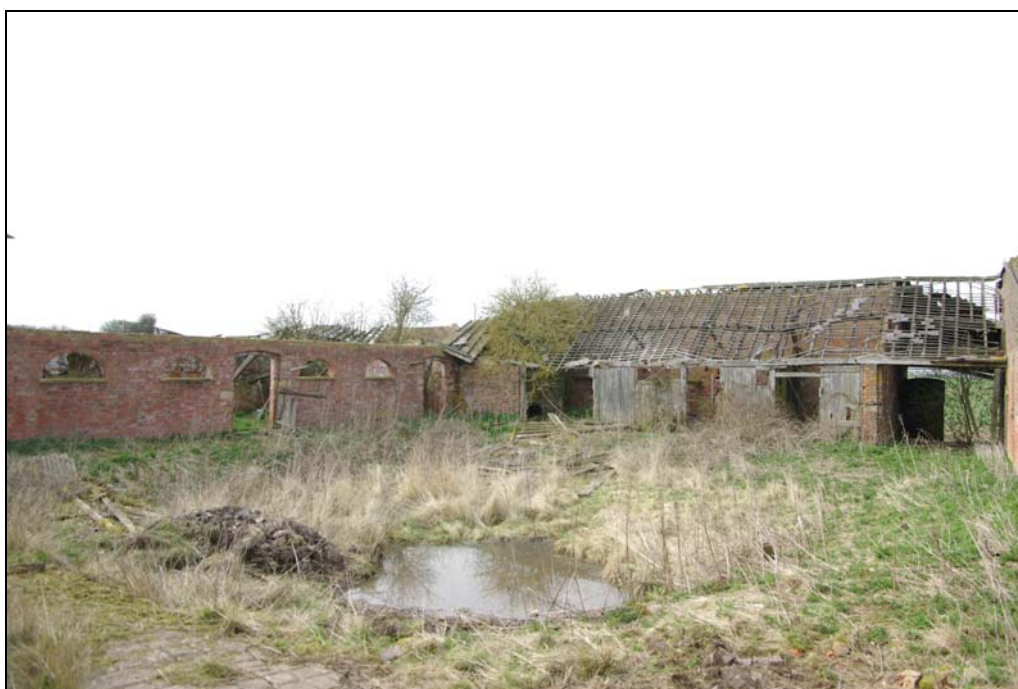
On the north side of the crew yard timber partitions have been installed into what appears originally to have been an open-fronted shelter shed (Photo 10). Other than this, none of the farmyard buildings appear to have been altered significantly since the mid 19th century making this a very complete example of its type, notwithstanding that some of the structures are in a poor state of repair.

Photo 10. North and west ranges of farmyard buildings, looking north-west

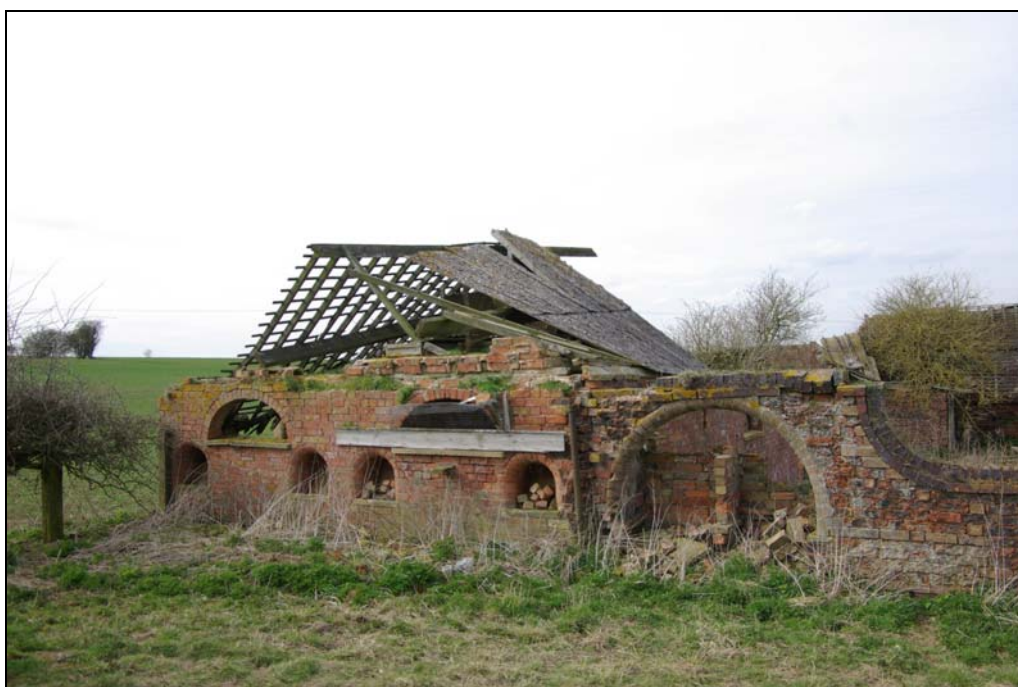
yard. An arch-headed recess in the south side of this wall, adjacent to the west range, may have accommodated beehives (Photo 12).

Photo 12. Pig sties at south end of west range and recess for ?beehives, looking north-west

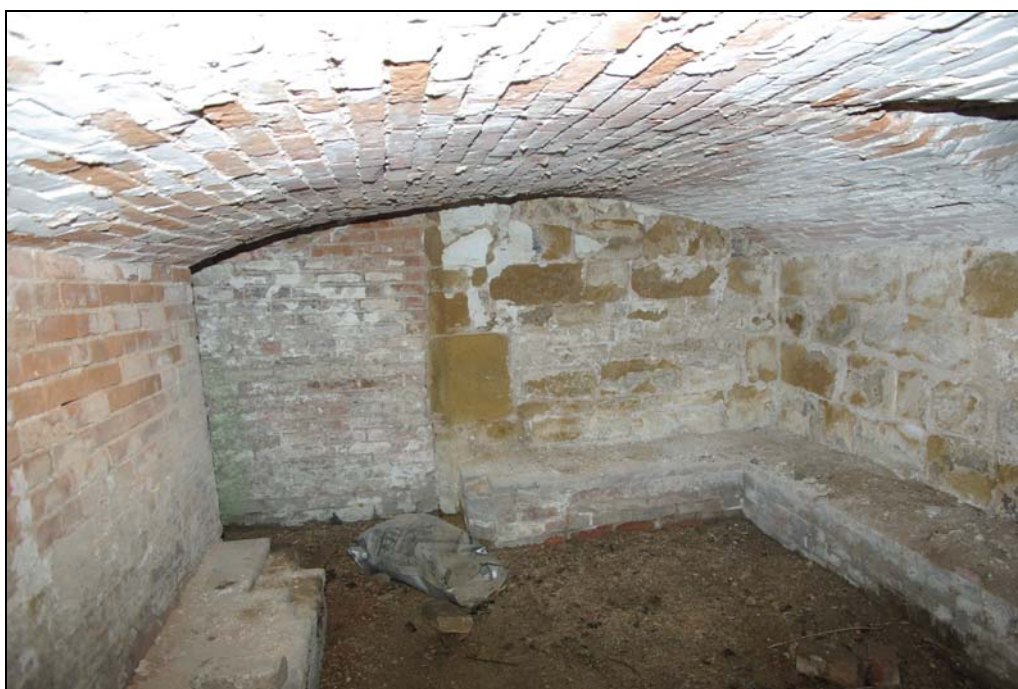
Photo 14. Brick and stonework in cellar beneath the dairy, looking north

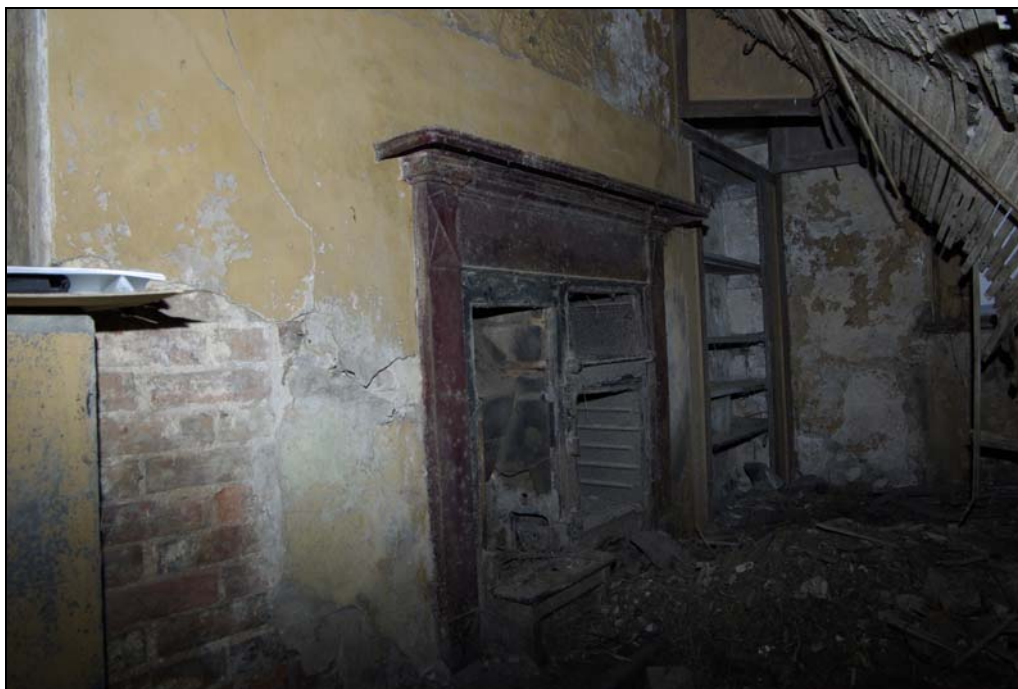
Photo 15. Cast Iron range in former kitchen, looking north-east

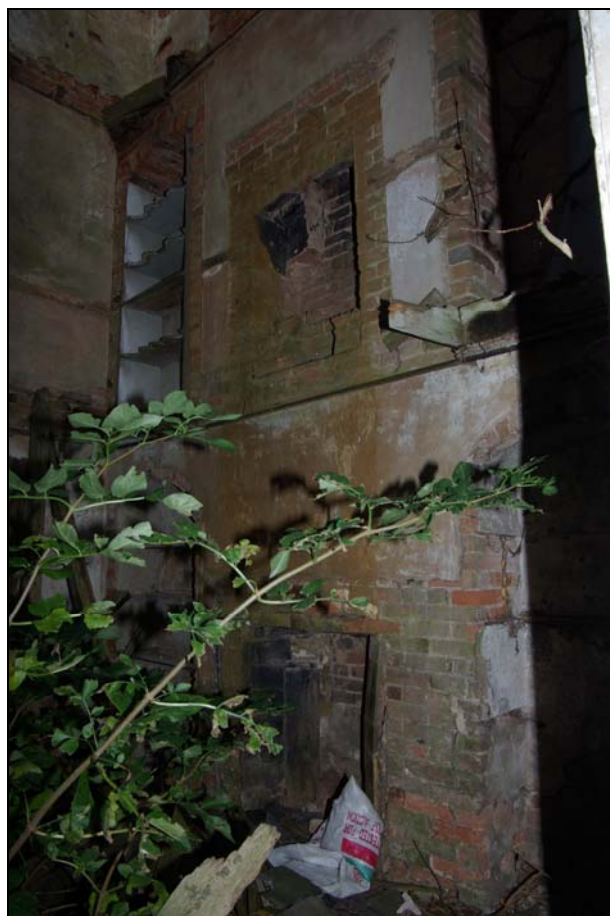
Photo 16. Decorative shelves in first floor room, looking north.
