**An Archaeological Watching Brief
On land at The Black Horse,
17, Market Place,
Market Bosworth,
Leicestershire, (SK 406 030)**

For: Market Bosworth Parish Council

ULAS Report No. 2005-171 ©2005

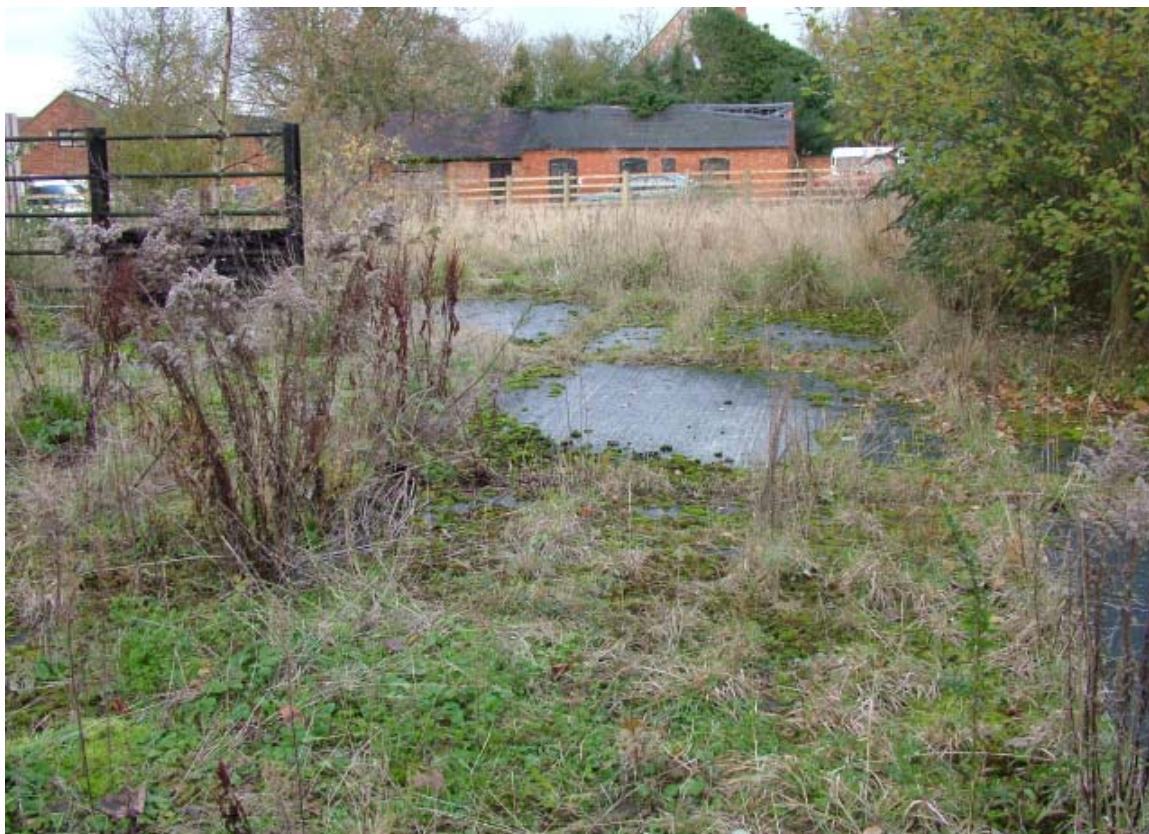
Plate 1: Site before commencement of work, looking north

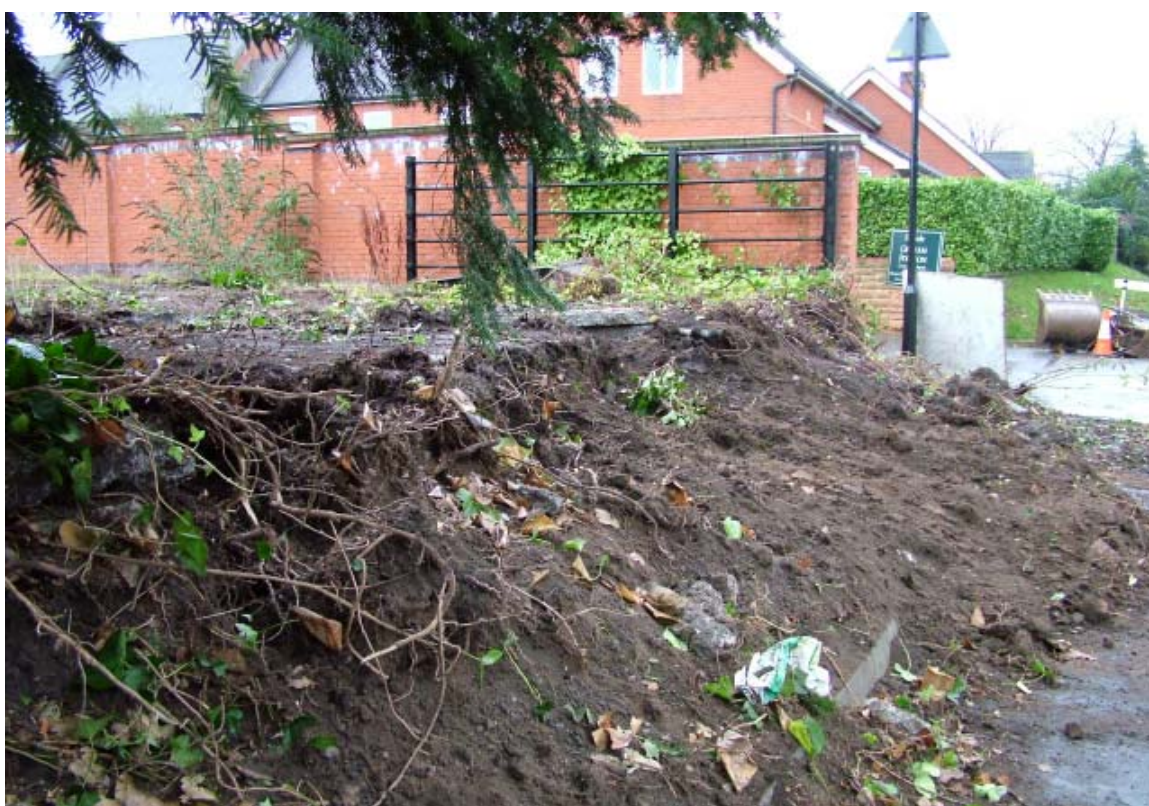
Plate 2: Proposed entranceway prior to excavation and after removal of railings and shrubs, looking east northeast

The development site is located in the village of Market Bosworth, adjacent, and to the south of the existing car park of The Black Horse Public House and on the northern side of Rectory Lane (Figure 2). It consists of an area of c.730 square metres. Prior to the development the land consisted of a concreted surface, partially enclosed by fencing and railings (Plate 2).

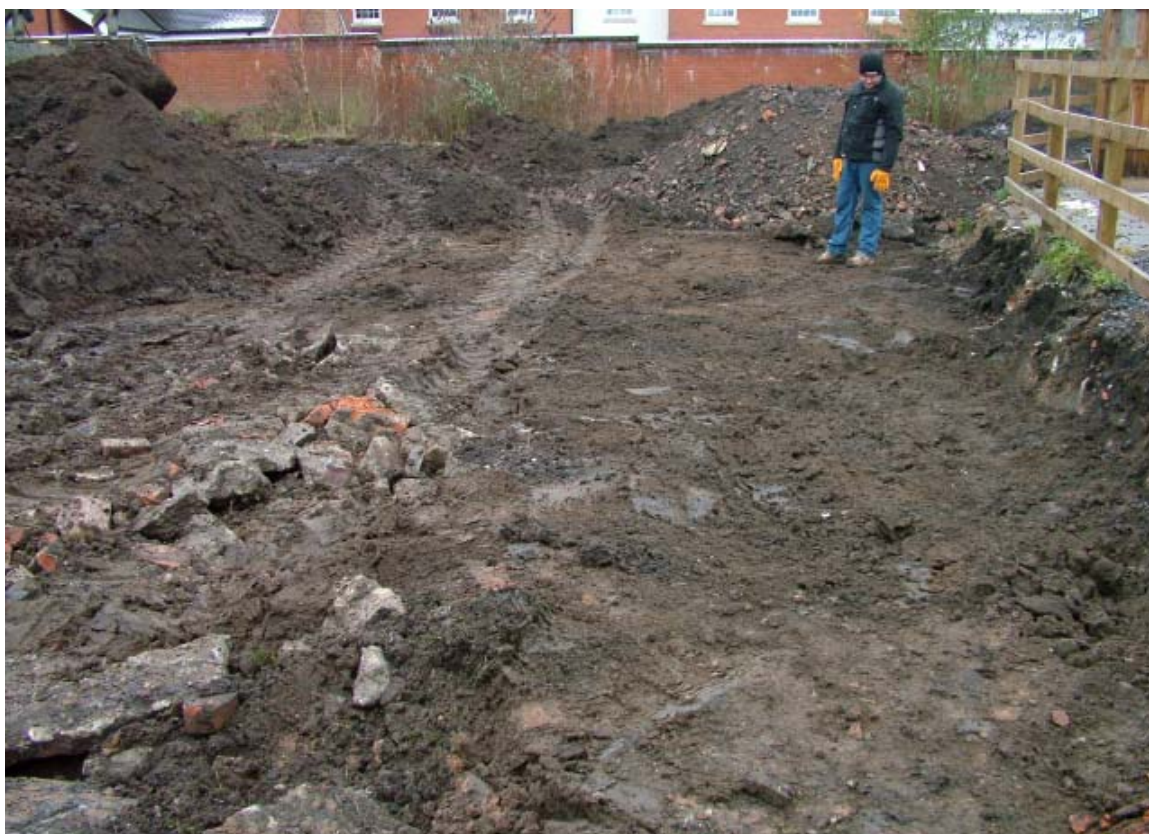
Plate 3: Area stripped of topsoil close to west corner of site, looking east

The concrete on the site had been broken on 24/11/05 and the clearing for the debris and the excavation of formation levels was begun on 28/11/05 and continued throughout the following week. The topsoil stripping was observed on 28/11/05 and 30/11/05. The topsoil was stripped to a depth of 0.2m-0.3m and this exposed the brown subsoil beneath (Plate 3). In places the stripping exposed areas that had been previously disturbed. These included a patch of building debris close to the western side of the site near the small brick sheds and also in under the concreted area in the northeast corner of the site (Figure 3).

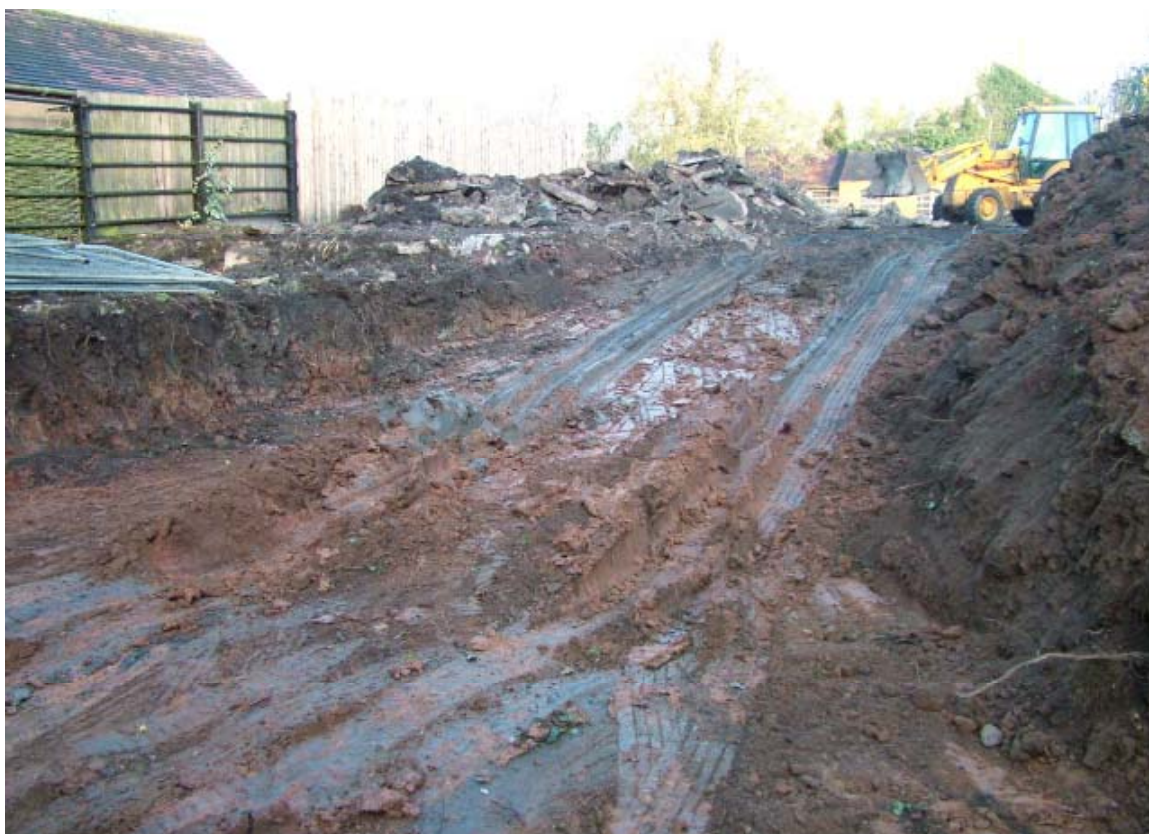
Plate 4: Entranceway after excavation but before laying hardcore

The site was initially visited on 23/11/05 and the excavation of the entranceway from Rectory Lane into the car park was observed. This required the removal of small shrubs and a large set of railings, with their footings, and the removal of a substantial amount of soil and natural clay. The depth of the excavation at the front of Rectory Lane was approximately 0.8m, which rose up in a 1:10 slope onto the main car park area for 10m (Plate 4).

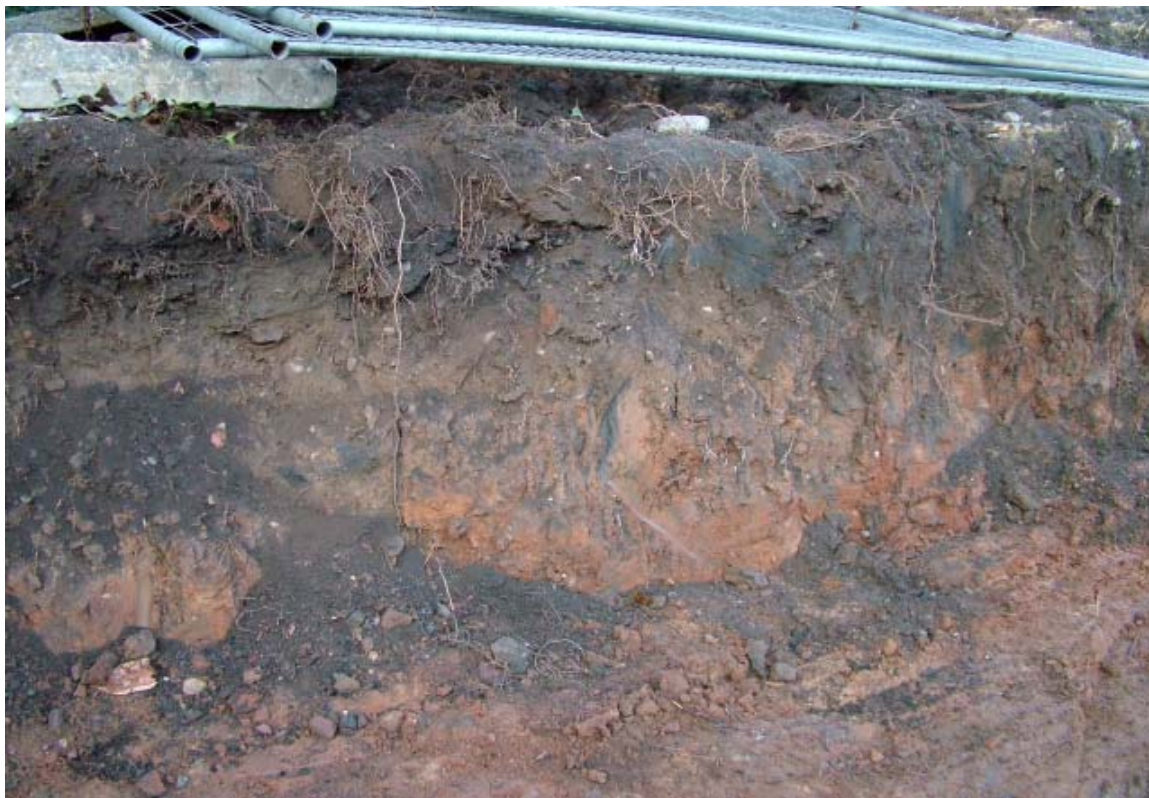
Plate 5: West facing section at entranceway, looking northwest

The entranceway was completed on 28/11/05. The sequence of deposits visible in the section at the entranceway of the car park was very clear and consisted of 0.2m of very dark brown loam topsoil, overlying 0.3m of brown subsoil (Plate 5). This overlay the natural substratum of brownish orange sandy clay. No archaeological features were observed during these visits. A clay pipe and a small stoneware bottle were recovered from the topsoil.

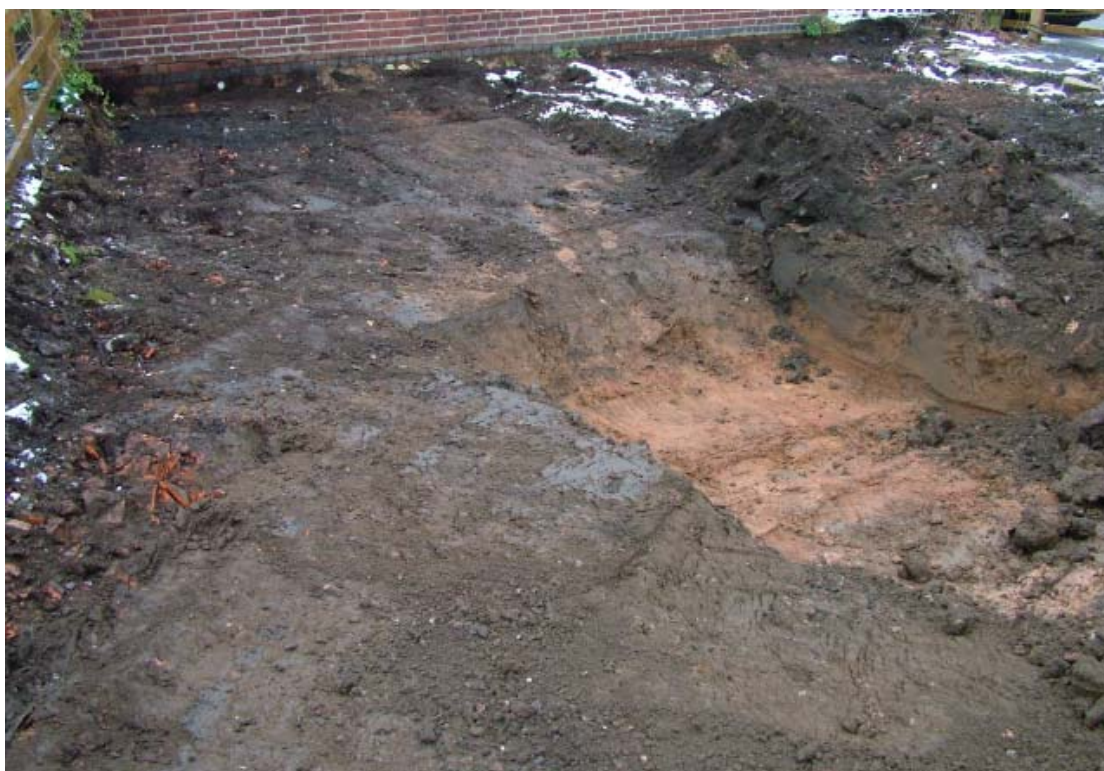
Plate 6: Excavation of waterlogged area to western side of site, showing natural substratum. Disturbed area to left and rear of picture

A slightly waterlogged area close to the western edge of the site was excavated to a depth of around 0.6m to a more substantial layer. This exposed the natural substratum below the subsoil (Plate 6). The natural substratum consisted of patches of soft clayey sand and clay and occasional patches of gravel. No archaeological features were observed during these visits, although a few sherds of pottery and two small coin-shaped objects were recovered from the topsoil.

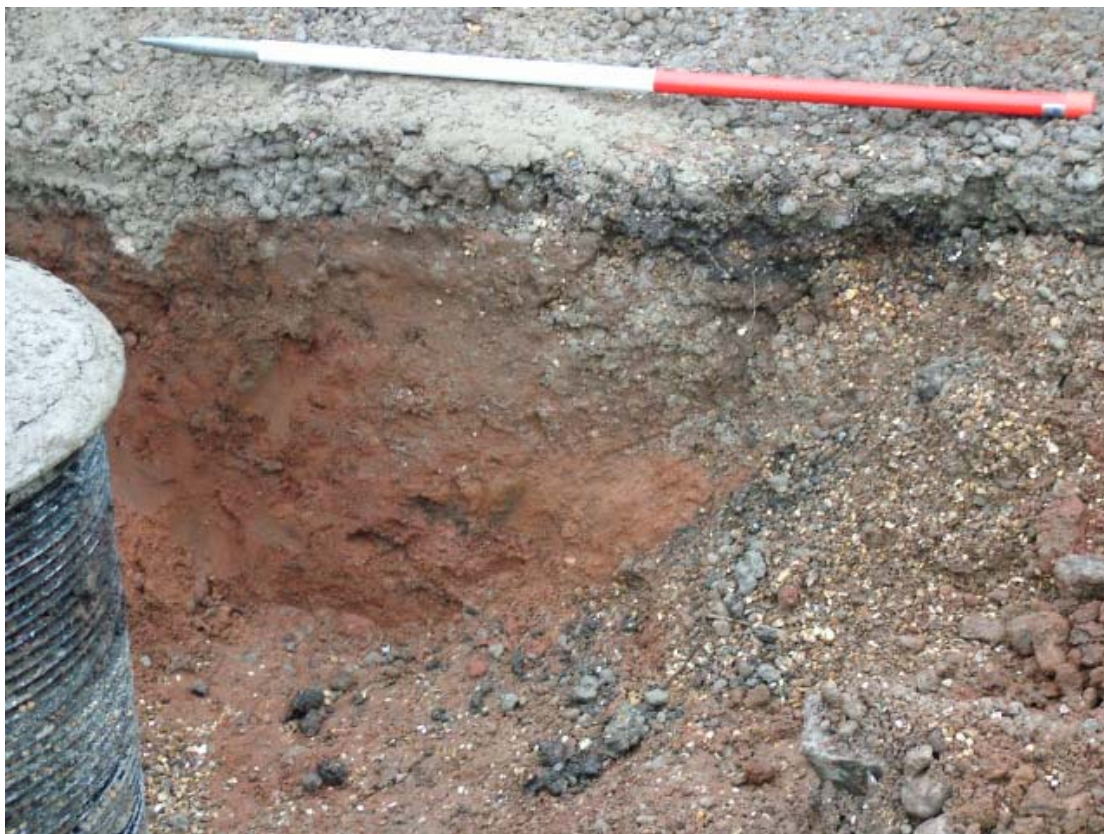
Plate 7: South facing section of service trench in northwest corner, looking north

During the visit of 06/12/05 the improvement of existing services was observed. (Figure 3). This consisted of a small amount of excavation around the existing drains. For the most part the areas were disturbed, although it was possible to observe the sequence of the area in the northwest corner (Figure 3 & Plate 7). This consisted of a 0.15m layer of subsoil overlying red sand. No archaeological finds or features were discovered during these excavations.
